**Re: Kiggavik – Follow-up Report to August 04, 2008 spill of drill cuttings**

**AREVA Resources Canada Inc.  
Kiggavik Project, Nunavut**

**Final Incident Report for August 4, 2008 Spill**

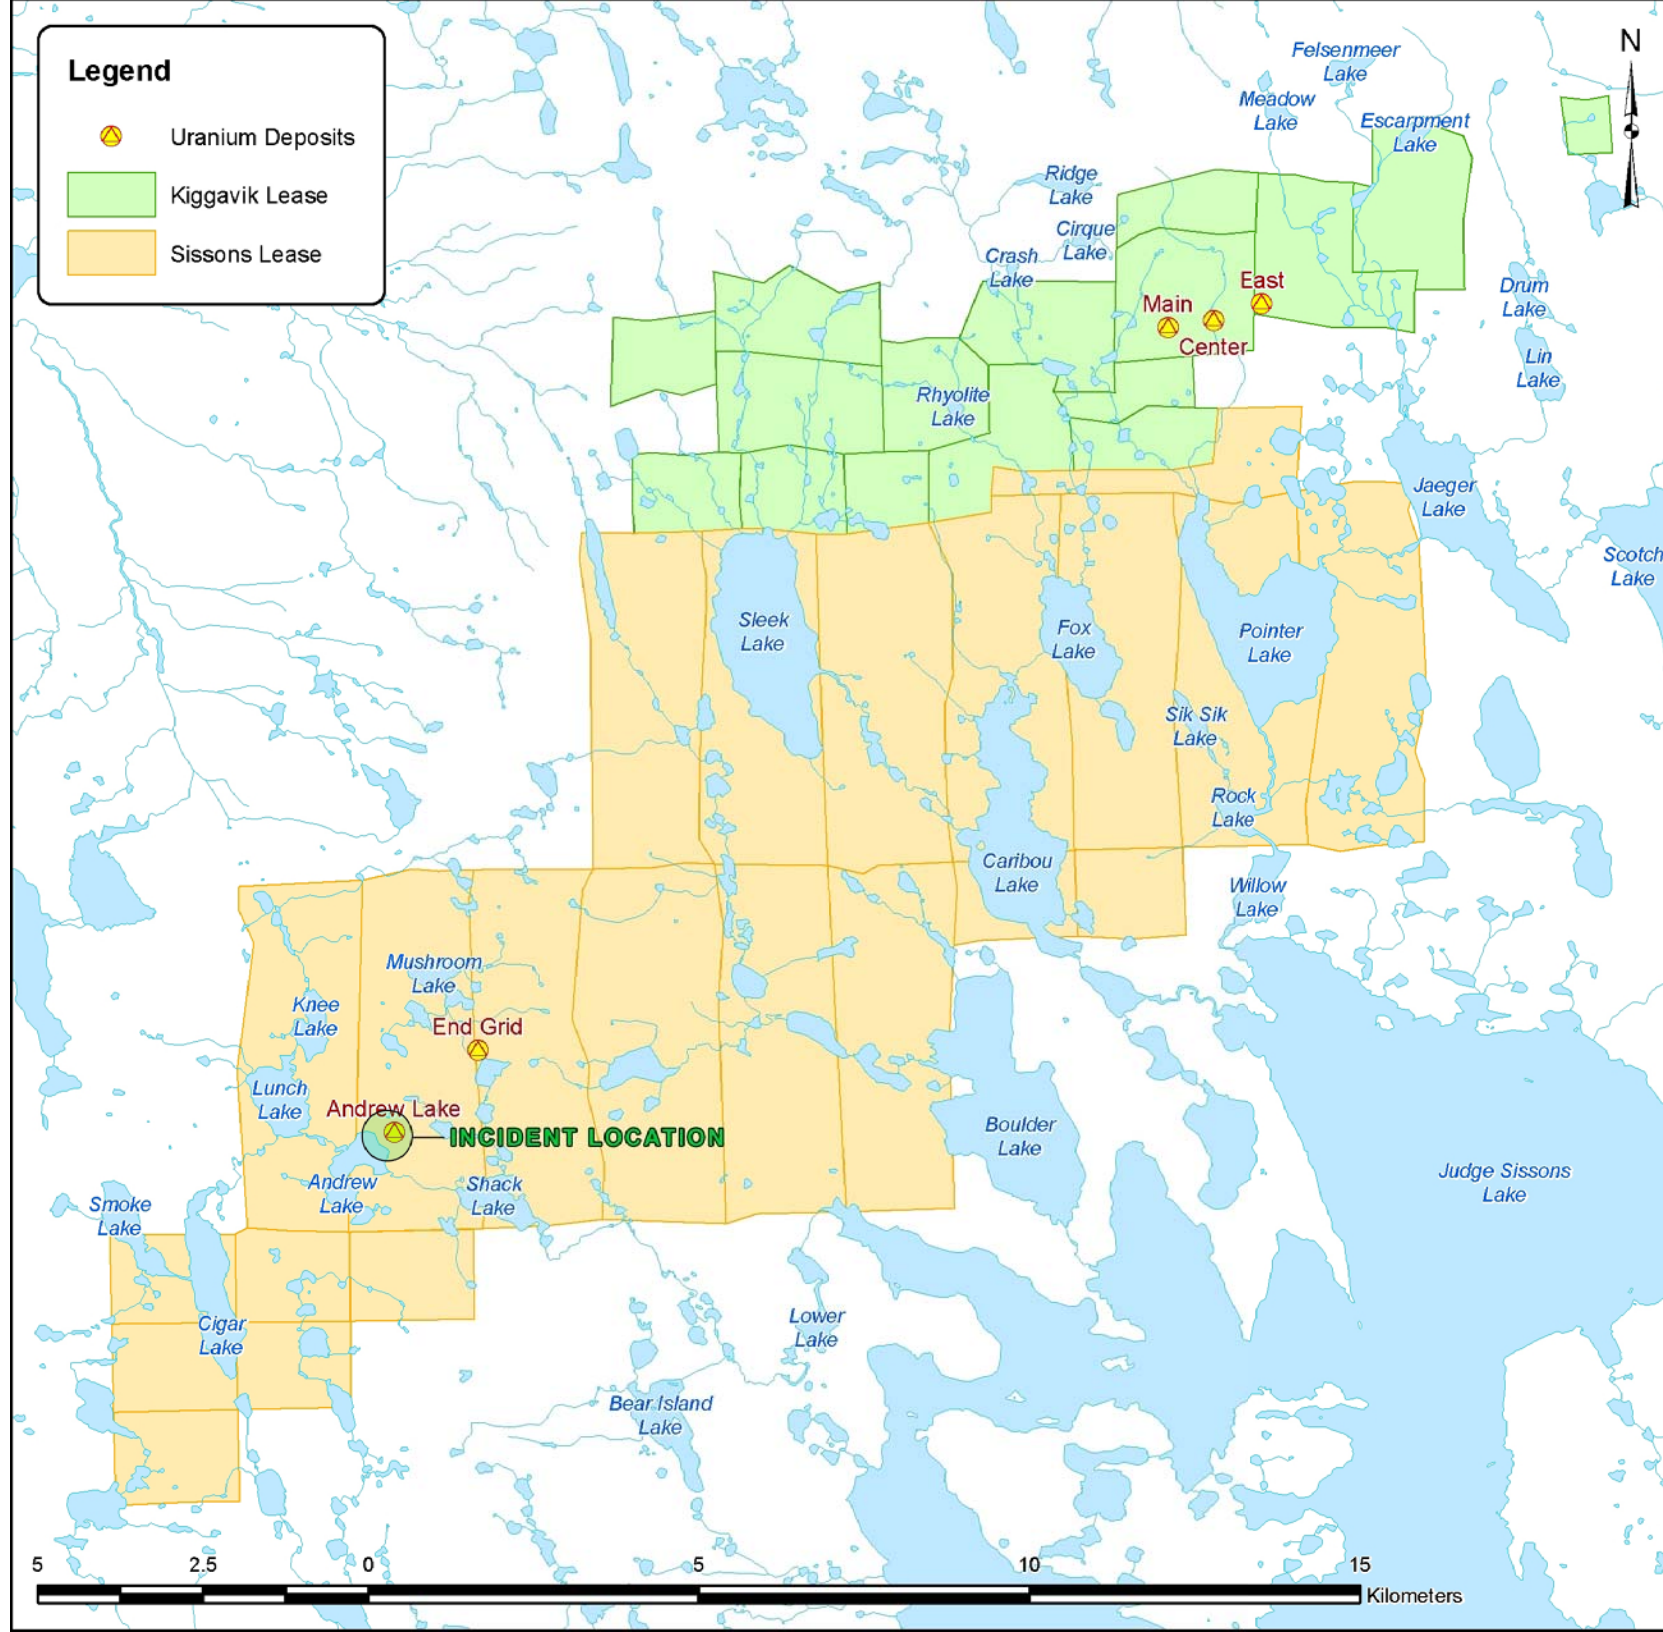
- The helicopter was lifting a bag of cuttings to transport it to the radioactive storage area.
- Upon lifting the cutting bag, the bag tore on the Cuttings separator harness.
- The side of the bag failed and approximately 0.25 m<sup>3</sup> of cuttings spilled onto the tundra, covering an approximately 2 m<sup>2</sup> area.
- The drillers immediately surrounded the spill with sand bags and started shoveling the mineralized cuttings into a cuttings tub (pictures 1 and 2).

**Photo #1: Spill of drill cuttings**

- The spill was caused by a combination of events
  - Failure to adequately follow procedures for the transport of cuttings properly
  - Secondary containment should be used under the bag and separator. Collecting tubs will be used under the bags to ensure any possible spill will be contained.
