# Follow Up Report: #2022136

## April 18<sup>th</sup>, 2022

### 0.5 L Engine Oil on Water Body A8 – Drill Rig#7

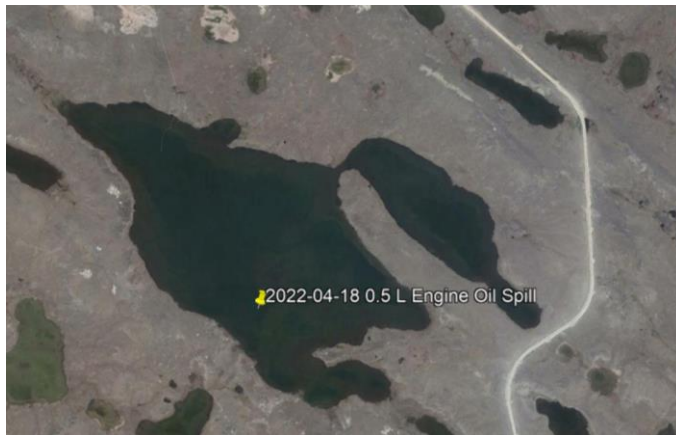
**Figure 1: Incident Location**

On April 18<sup>th</sup>, 2022 at approximately 11:30, Environment Technicians were conducting an inspection of surface Drill# 7 M22-3396, operated by Orbit Garant. During the inspection, areas with small amounts engine oil coming out of the drill shack and from underneath the drill onto the lake ice were observed. It is estimated approximately 0.5 L of engine oil was released onto the lake ice.

The coordinates of the spill are: 63° 0' 39.3" N, 92°12' 17.1"W, on the water body A8

During the inspection, Environment technicians notified the drillers of the issues and the Orbit Garant supervisor was also notified. Absorbent pads were placed to clean the engine oil and a shovel was used to clean up the remaining material. The contaminated snow and ice were disposed in a quatrex bag.
