**WATER LICENCE INSPECTION FORM**☒ Original
☐ Follow-Up Report

Licensee	Licensee Representative
Anconia Resources Corporation	Jason Brewster
Licence No. / Expiry	Purpose
2BE-MRC1217/ April 15 th , 2017	Exploration
Land Authorization No. / Expiry	Project Name
N2012C0006/ February 27 th , 2019	Marce Project
Date of Inspection	Inspector
September 16 th , 2021	RMO C. Wilson
Activities Inspected	
<input type="checkbox"/> Camp	<input checked="" type="checkbox"/> Drilling
<input type="checkbox"/> Roads/Hauling	<input type="checkbox"/> Other:
<input type="checkbox"/> Mining	<input type="checkbox"/> Construction
<input type="checkbox"/> Reclamation	<input type="checkbox"/> Fuel Storage

An inspection of Anconia Resources Corporation's ('Anconia'), Marce Project was completed by Crown-Indigenous Relations and Northern Affairs Canada's, Resource Management Officer, Christine Wilson ('Inspector'). The inspection was conducted to ensure compliance with applicable terms and conditions of water licence no. 2BE-MRC1217.

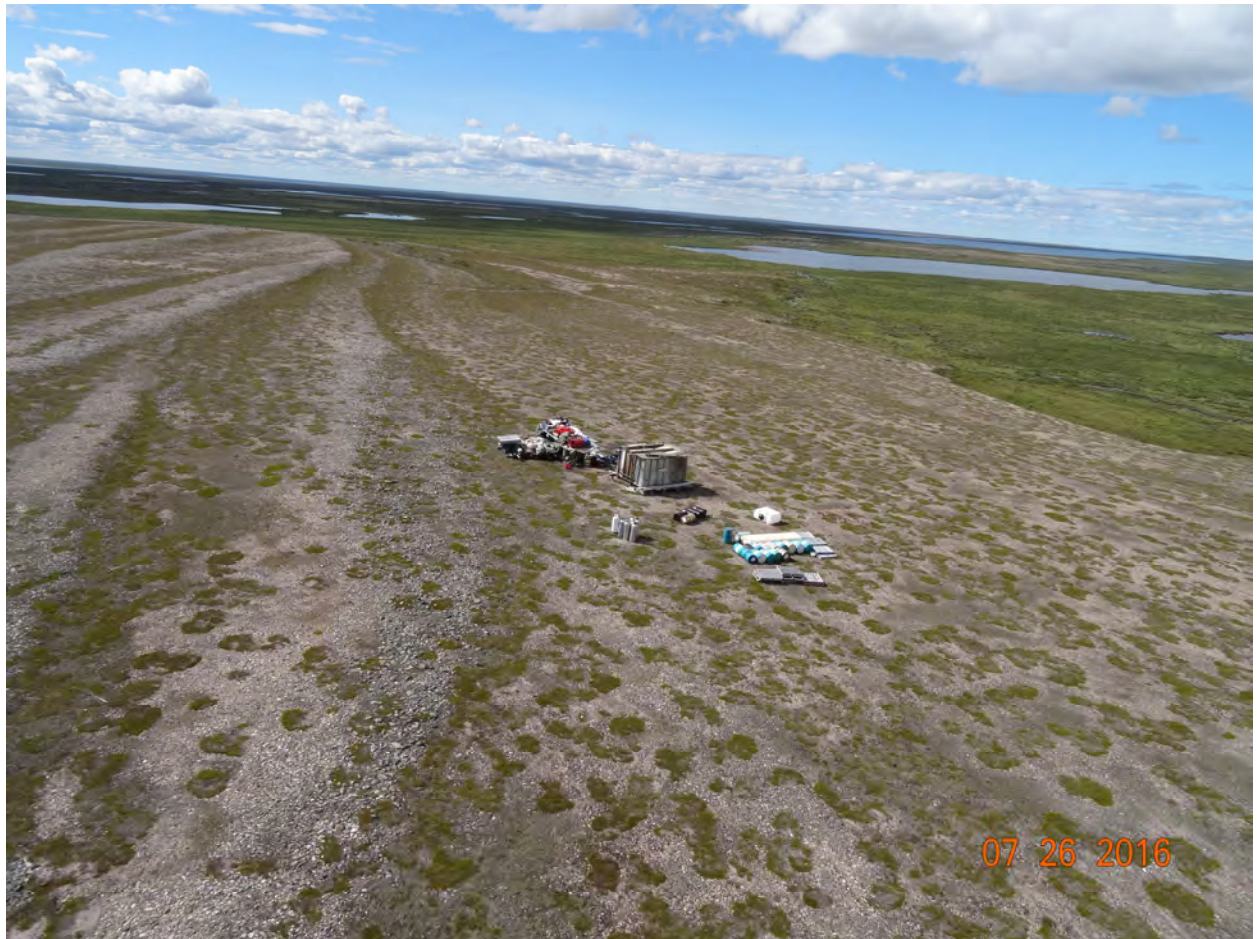
Drill Site 2

1. The materials located at the laydown have been removed; all the clean wood burned and ash backhauled (photo 1 and photo 2).
2. Numerous locations of windblown garbage is noted around the laydown (photo 3- photo 7). Materials as follows; three tarps, an oil jug, metal siding, a small secondary containment berm and insulation.
3. Three empty red and yellow drums (photo 8) are at the end of the airstrip at N62° 40' 9.5", W95° 29' 5.6".
4. Two drill holes at the West end of the air strip require removal or to be cut off at ground level. Locations are listed as follows:
 - drill site 1 approximately located at N62° 40' 6.04", W95° 29' 6.17" (photo 9); and
 - drill site 2 approximately located at N62° 40' 8.40", W95° 29' 7.01" (photo 10).
