October 16, 2013

**Commander Resources Ltd**  
11<sup>th</sup> Floor, 1111 Melville Street  
Vancouver, BC V6E 3V6

**Subject: Securing of Camp Site at FOX-3 Dewar Lakes, Nunavut – Final Report**  
**(O/Ref.: CO 3666)**

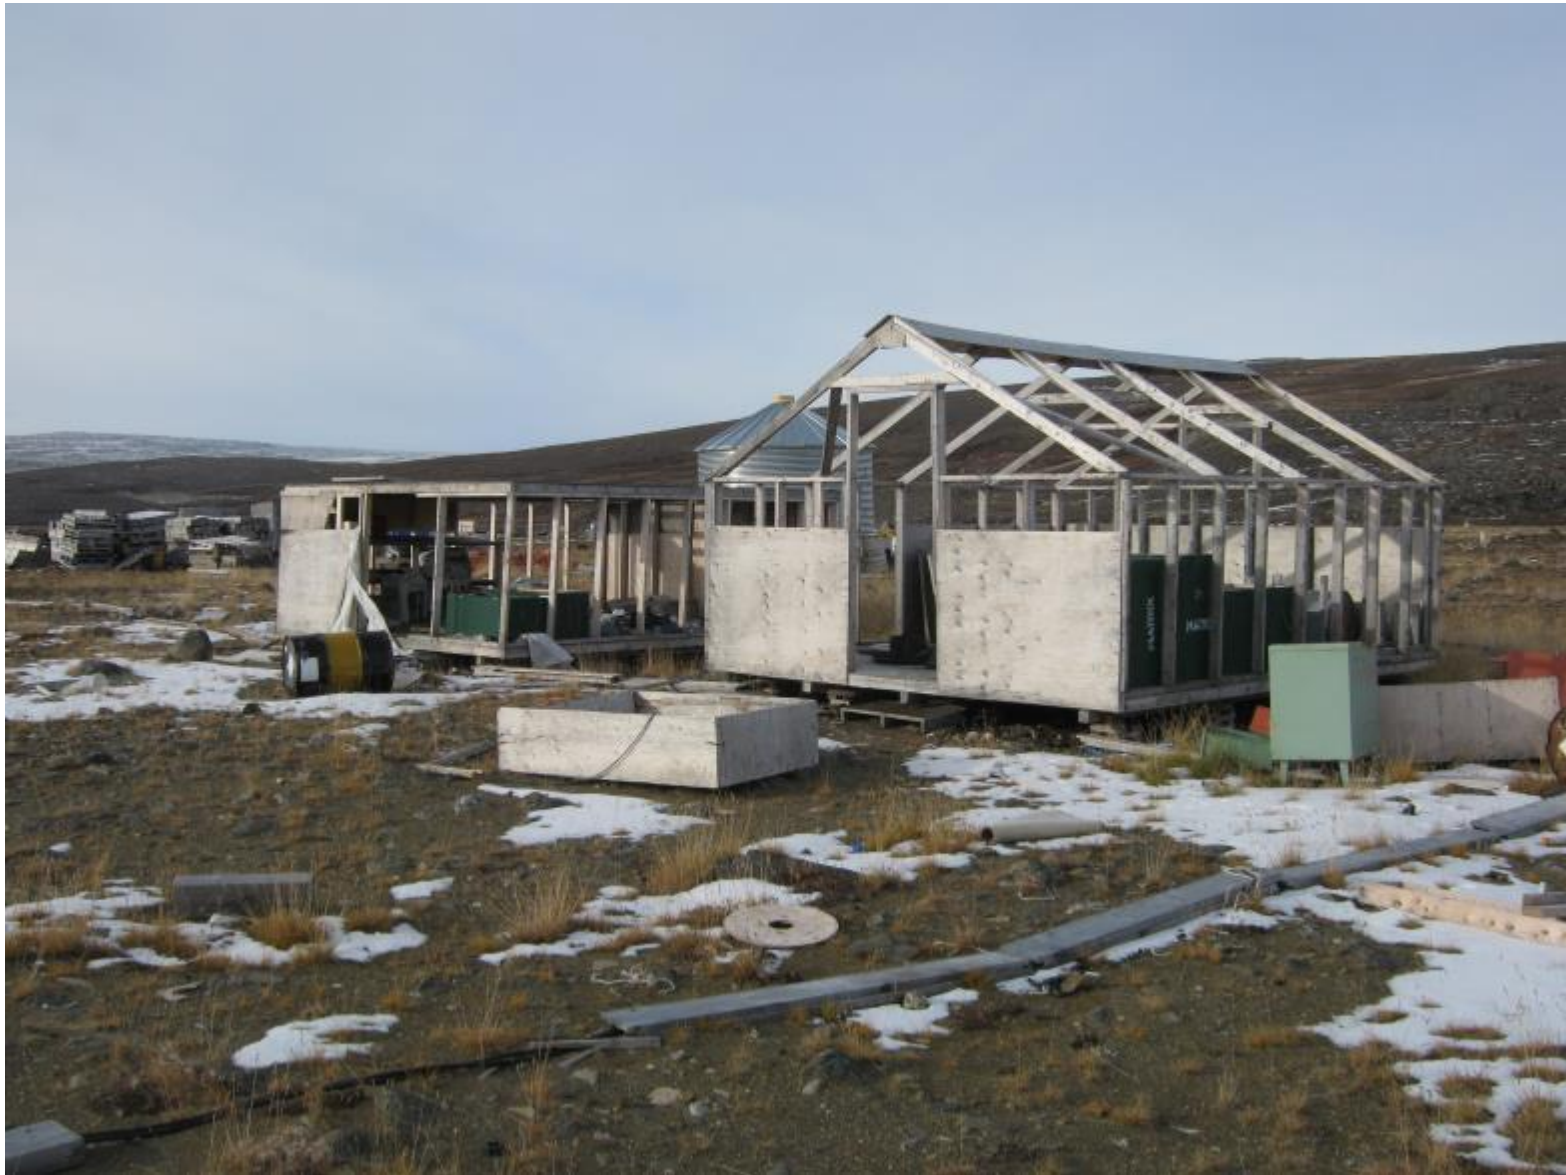
Figure 7 – Damaged hut and exposed interior

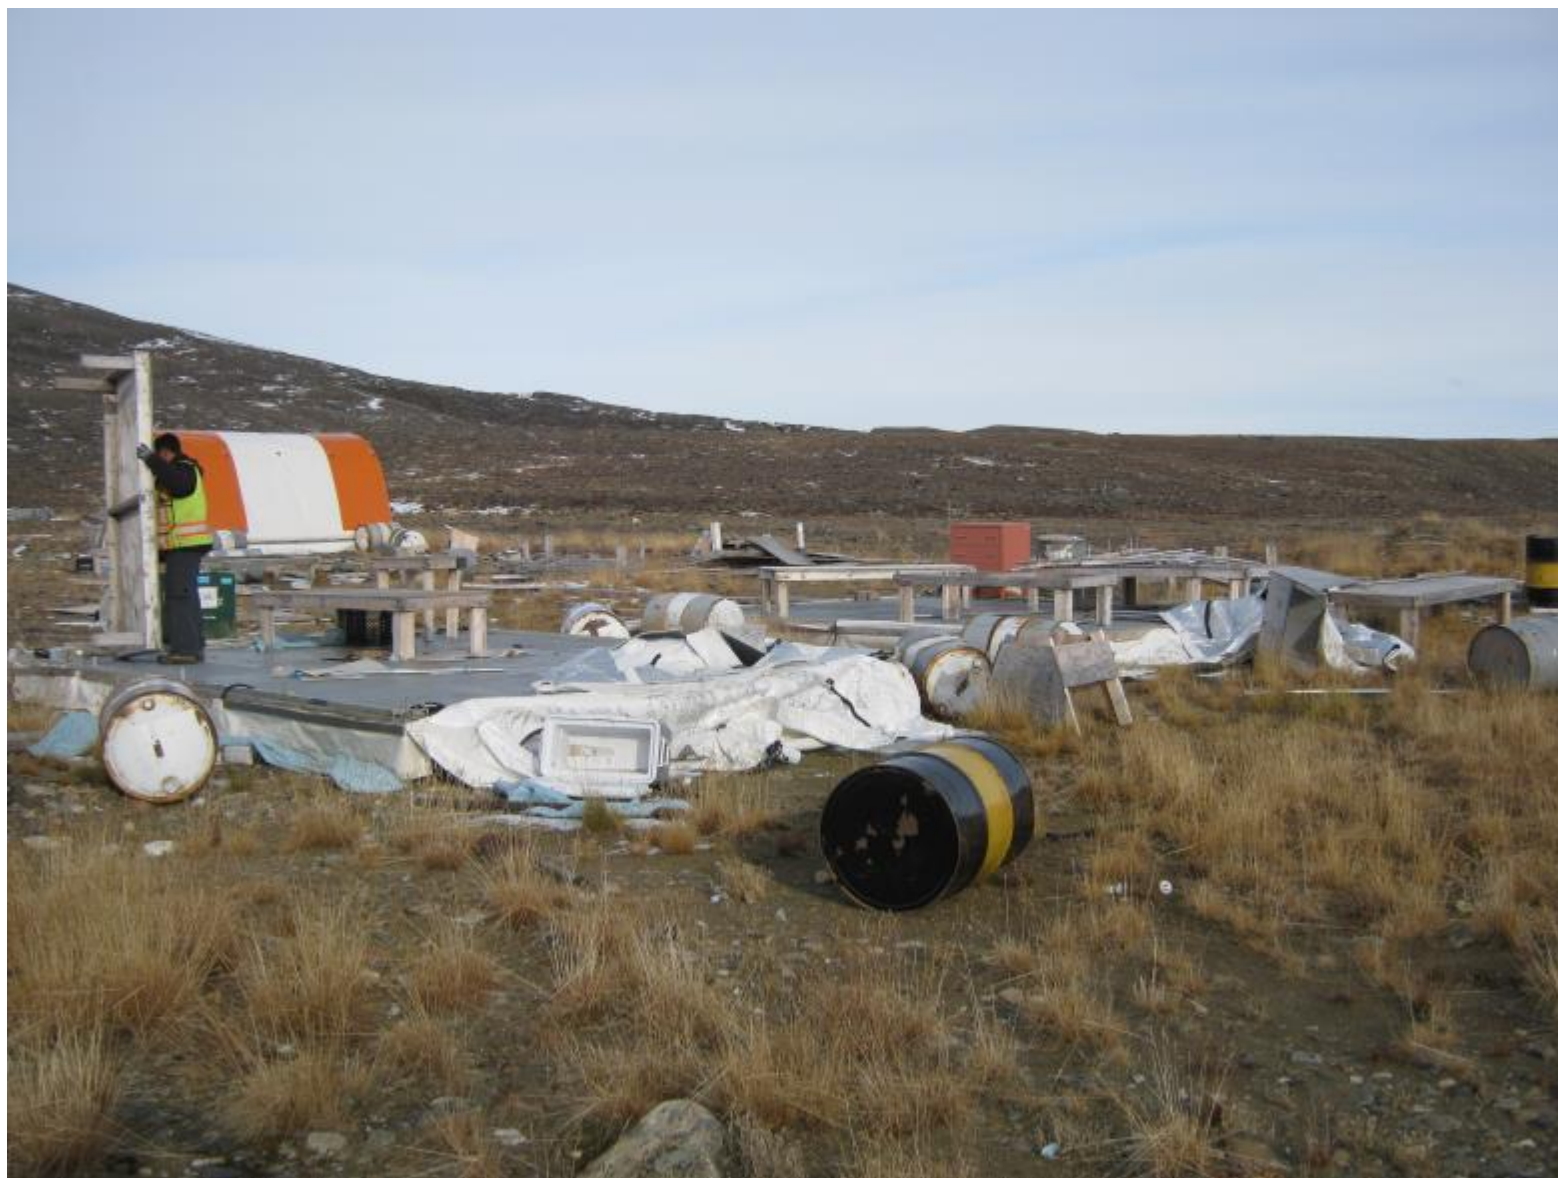
Figure 10 – Damaged hut and exposed items; general site view

Wood was generally salvaged for repairs on-site, while broken pieces were stacked together in piles and covered with a tarp.

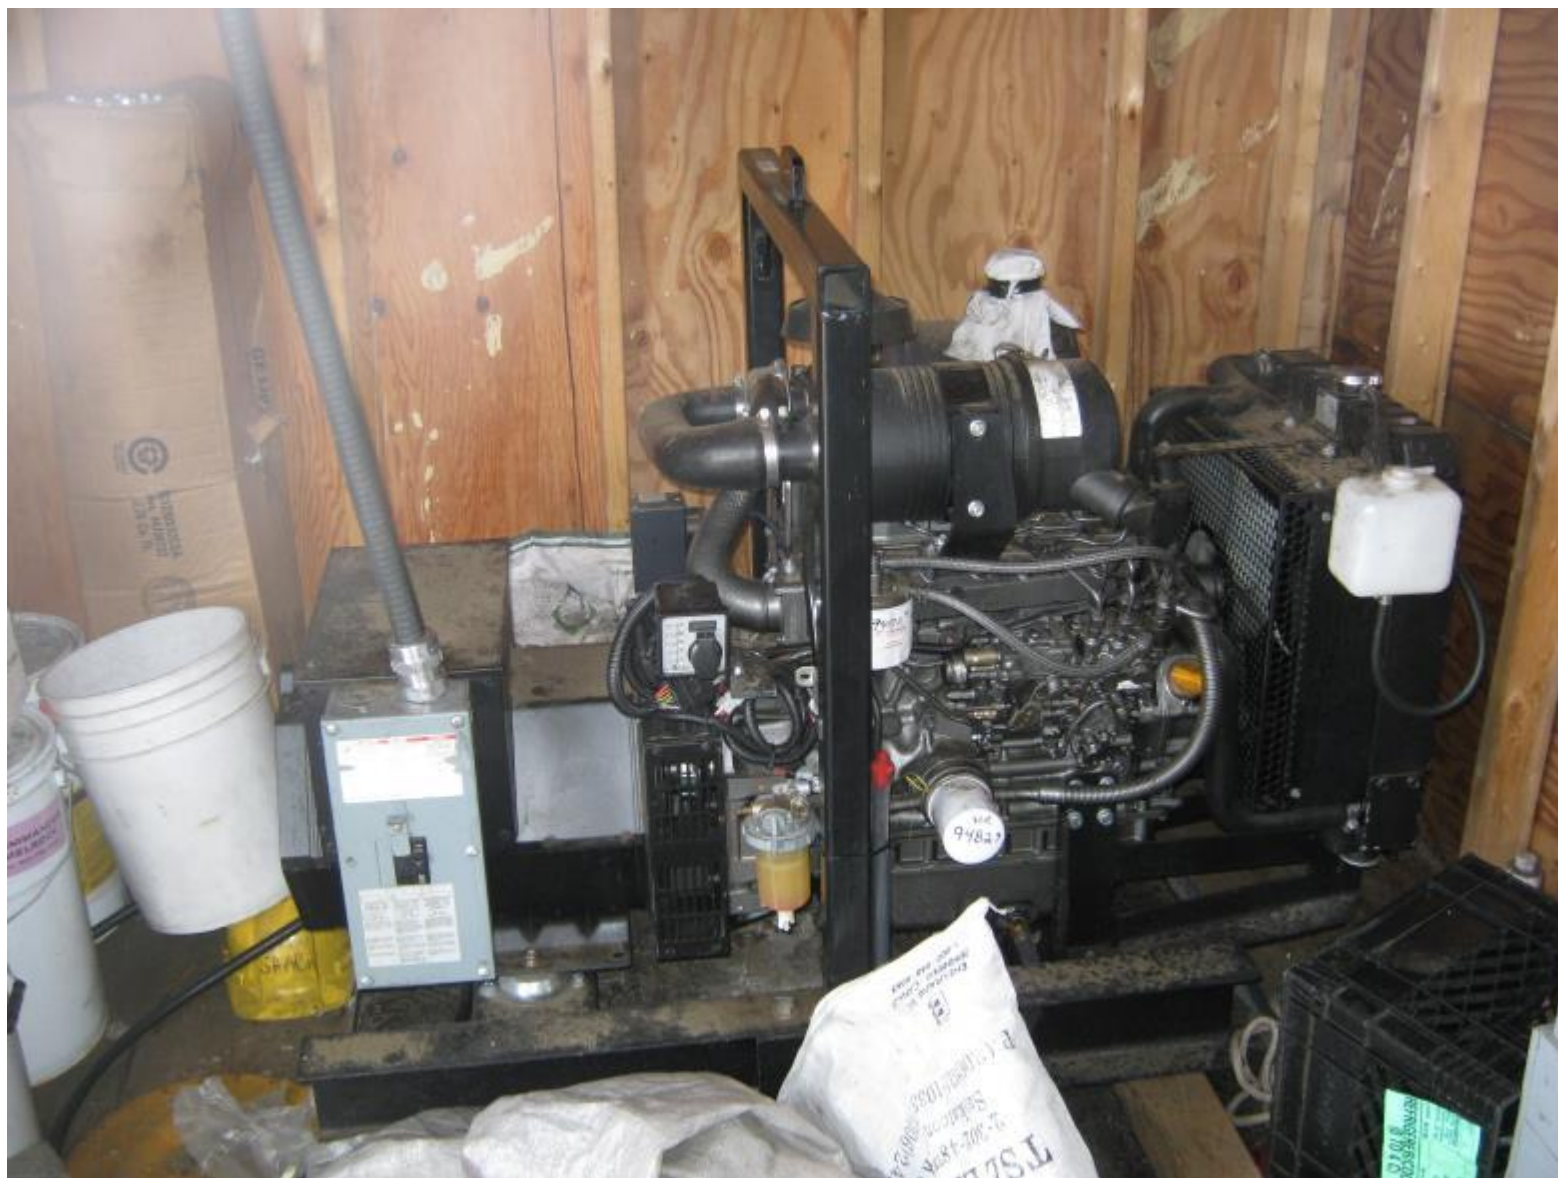
Figure 17 – Shed and attachment with open/ missing doors

The two generators found on-site were secured by fixing the shed that is used to house them. The doors to the shack and attachment were reinstalled and properly closed, while all structure holes were covered.

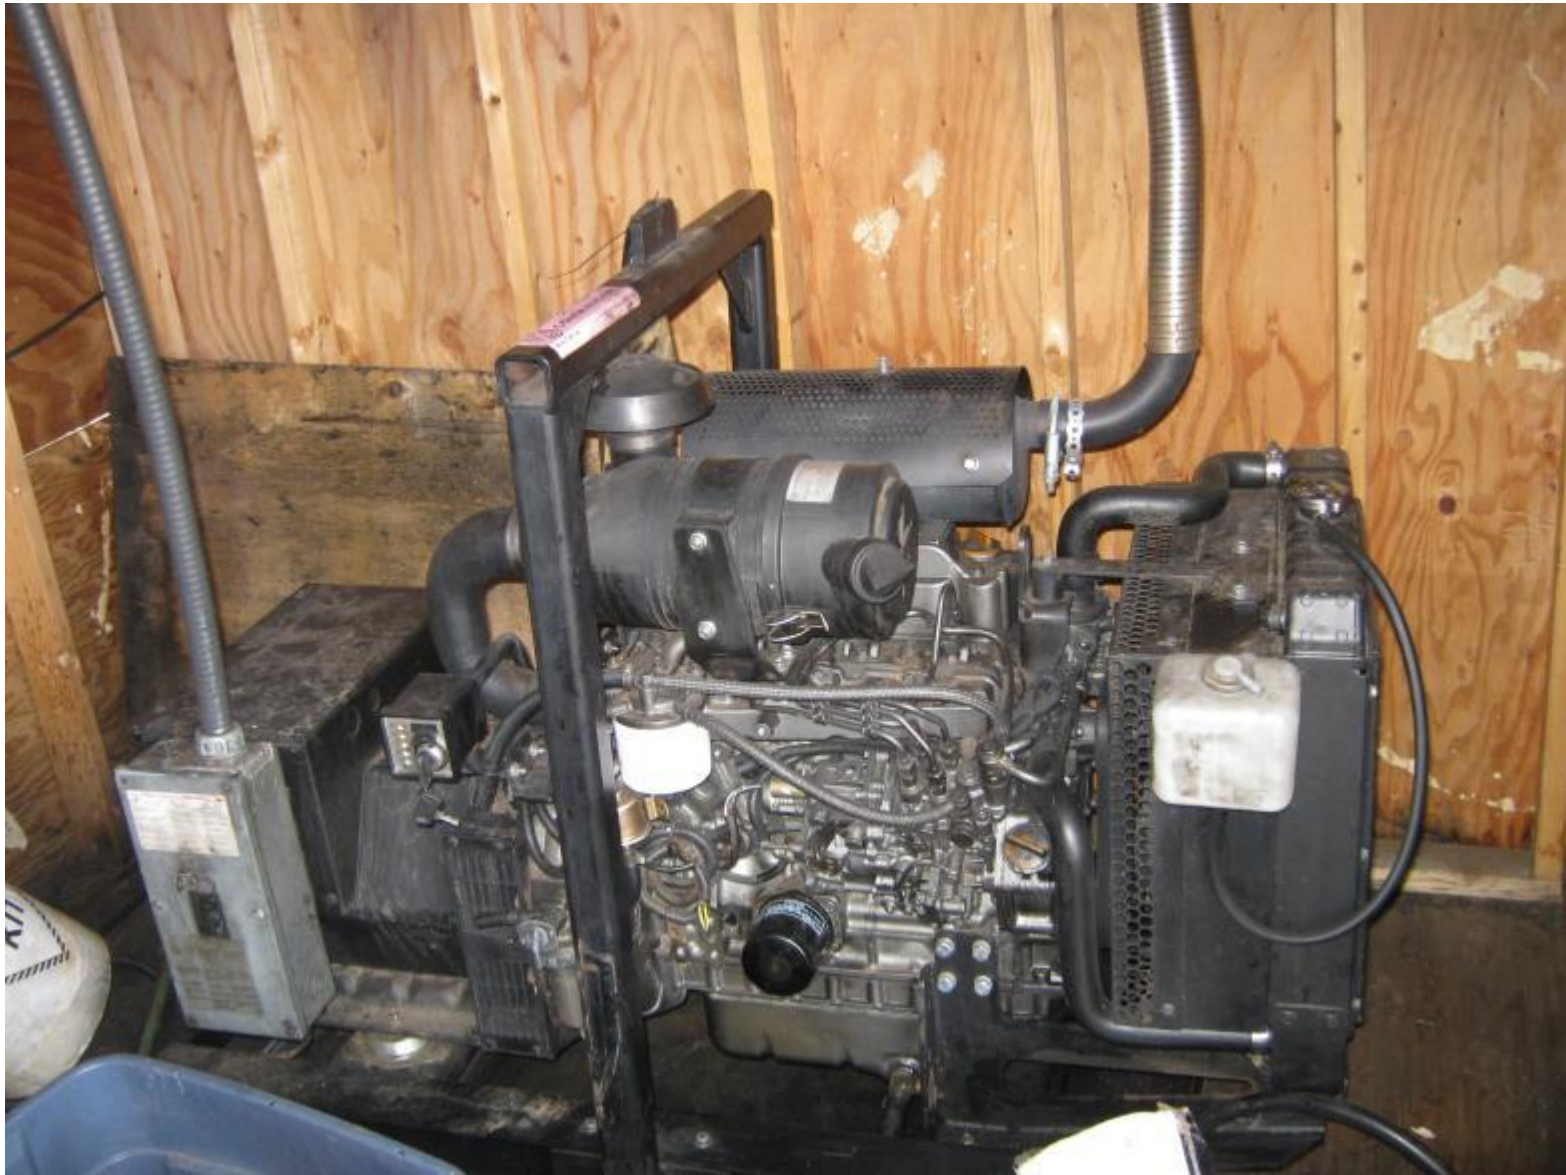
Figure 18 – Generator 1 in shed
