Memorandum

To	Karyn Lewis (LMI)	Project #	924-3
CC	Sara Wilkins (Norwest)	Date	November 30, 2017
From	Alvin Tong, P.Eng.		
Subject	Ulu Access Road Maintenance

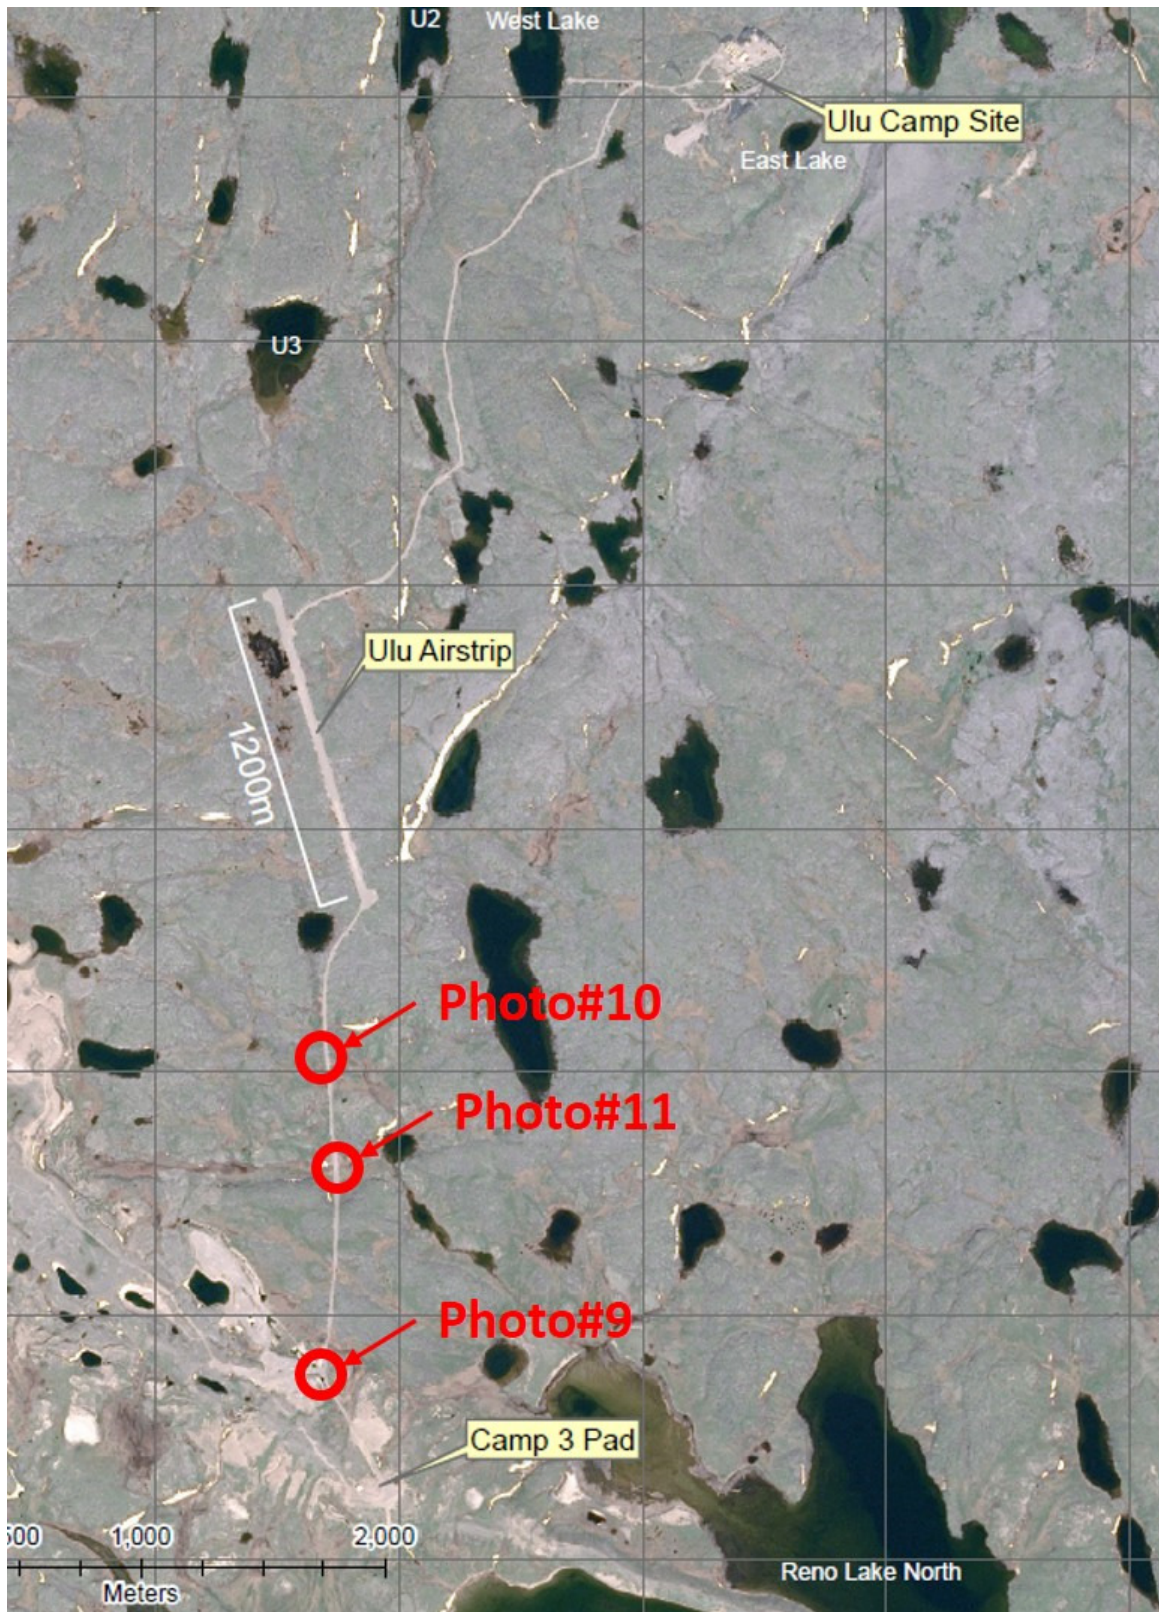
Figure 1: Inspection Photograph Locations

Three photographs provided in the INAC July 6, 2017 inspection form (INAC 2016) and shown below outline the inspector observed road issues. The approximate locations of the issues are shown in Figure 1, and the photograph numbers and coordinates are referenced from the inspection form. The coordinate provided for Photo 10 in the inspection form corresponds to non-disturbed area north of the site. The photo location shown in Figure 1 is adjusted based on Norwest field observation.

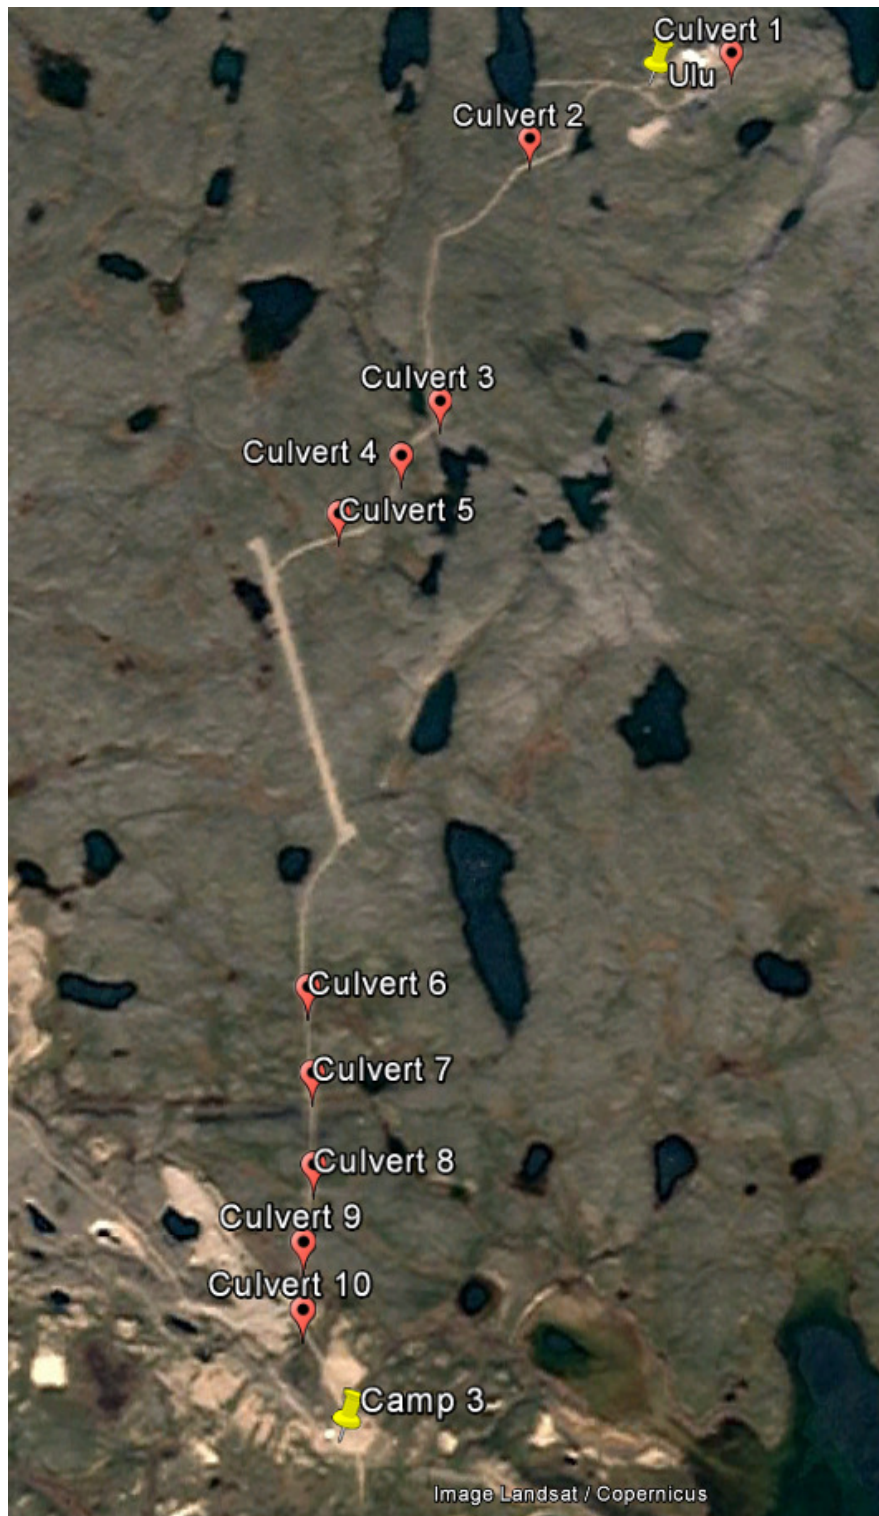
Figure 2: Culvert Locations (coordinates provided by Bonito, Photograph courtesy of Google Earth®)

All of the culverts along the road have been scouted by Bonito with a handheld GPS and inspected in July 2017 (INAC 2017a), with their locations are shown in Figure 2. Table 1 shows the coordinates and status of the culverts. The culverts were found to be intact and functional such that that water could flow through them. The road sections with erosion have been repaired in 2017 and the road was trafficable during the engineer's August 30th, 2017 site visit. New coarse road fill, with a more resistance to erosion than the in-place esker sand, was placed to stabilize the eroded areas and reduce the potential for further erosion. The road stabilization and repairs and silt fences installations are shown in the Photo 1 and 2 below, which taken by the INAC inspector in August 2017 (INAC 2017b). Bonito has additionally installed silt fences downstream of the erosion areas to further protect downstream waterbodies, and as requested by the INAC inspector following the August inspection (Photo 3).
