2013 Annual Geotechnical Inspection of Selected Structures – Ulu Gold Project, Nunavut

Bonito Capital Corporation

SRK Consulting (Canada) Inc.
1CB027.001
October 2013

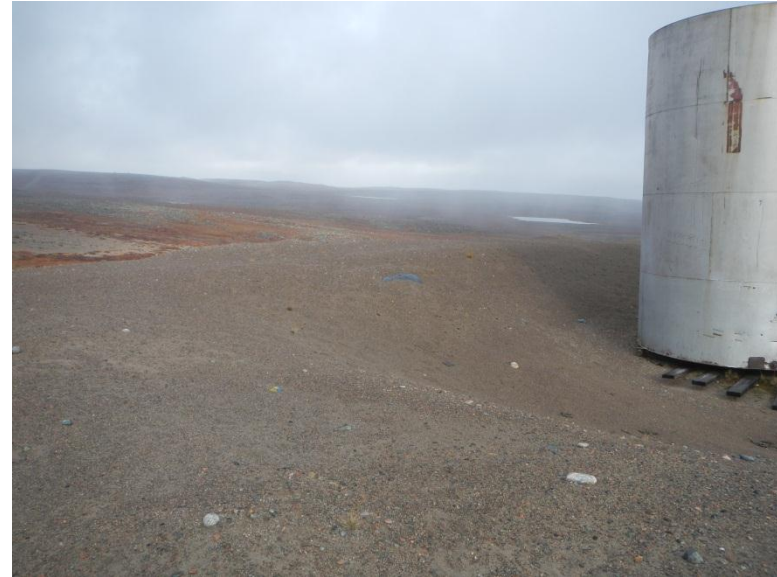
Ulu Camp 3 tank farm

The main concern observed during the Camp 3 inspection is that one fuel tank is leaning because of broken cribbing at its base. It is recommended that the cribbing be repaired. The tank should be set upright and level to prevent toppling and damage to the tanks and containment berm. Alternatively, the leaning tank should be decommissioned and removed from the containment berm. The fuel tank farm containment berm was in generally good condition. The parts of the liner that are exposed should be repaired.

- Cover all exposed liners and leading edges with granular fill for overliner protection;
- Repair all damaged liners;
- Replace the broken cribbing at Camp 3 and re-level the fuel tank or decommission the tank;
- Repairs and perform maintenance on the liner in the mine sump shall be completed prior to utilizing it.
- BCC may wish to submit a request to the Nunavut Water Board for an amendment to the inspection schedule as there is no mining or exploration activity. The proposed inspection schedule would consist of bi-weekly inspections during May and June freshet, monthly inspections from July to October of the fuel containments and mine sump, and an annual inspection of the storage pad when the site is in care and maintenance status. The inspection schedule stated in the Part D. Item 8.e of Water Licence is:

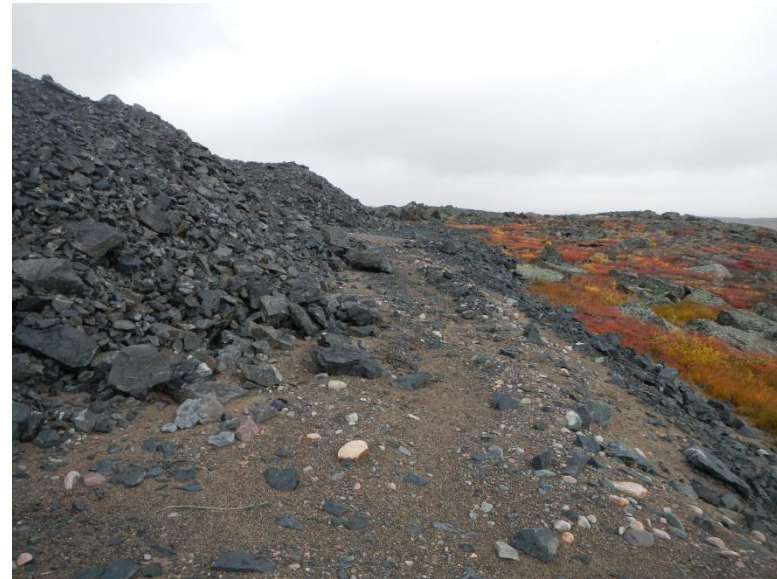
Ulu ore pad

There are minor erosion issues near each crest of the fuel containment berms where liners are exposed and damaged. The erosion should be repaired to prevent further damage to the liner, as well as to prevent leakage during periods of high water levels. Both the ore storage and portal laydown pads are in satisfactory geotechnical condition.
