# **Water Licence Inspection Report**

Orginization	Representative			
Hamlet of Chesterfield Inlet	Paul Bosetti			
Authorization No. / Expiry	Representative's Title			
3AM-CHE2333/ December 19 <sup>th</sup> 2033	Senior Administrative officer			
Inspection Date	Inspector			
July 17 <sup>th</sup> 2024	Atuat Shouldice			
Other Authorization/s				
Activities Inspected				
☐ Camp, Commercial ☐ Drilling ☐ Mining ☐ Construction ☐ Reclamation ☐ Fuel Storage ☐ Roads/Hauling ☐ Winter Hauling				
☐ Camp, Private ☑ Other Municipal

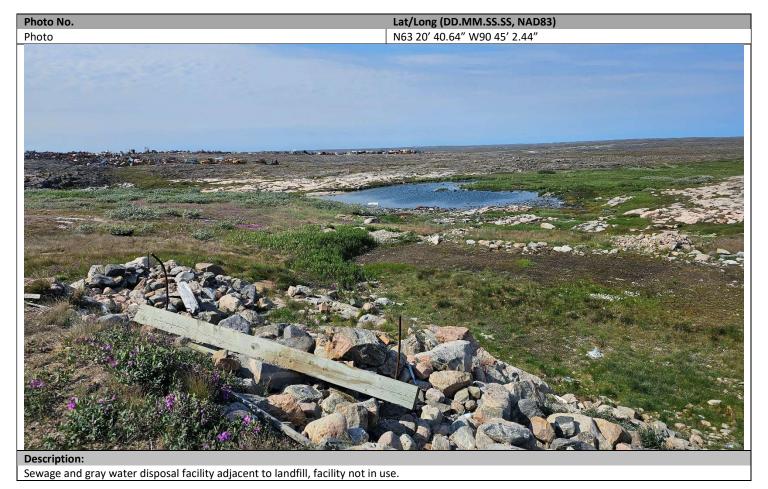
Open burning of municipal waste shall be conducted only in accordance with the Government of Nunavut's Environmental Guideline for the Burning and Incineration of Solid Waste (2012), at the designated location at the Solid Waste Disposal Facility, during inspection conditions were being followed under water licence conditions Part E item 8.

The Hamlet has been colleting discarded batteries, empty propane, waste oil and storing items in shipping containers. The hamlet is following Licence conditions item Part E item 7.

Landfill photo of segragated locations for opening burning, demestic waste, and hazardous waste storage.
