# IGLOOLIK WASTEWATER TREATMENT FACILITY

## SEWAGE LAGOON BERM 2022 DAM SAFETY INSPECTION, IGLOOLIK, NUNAVUT

PROJECT NO.: TE0223017  
DATE: OCTOBER 2022

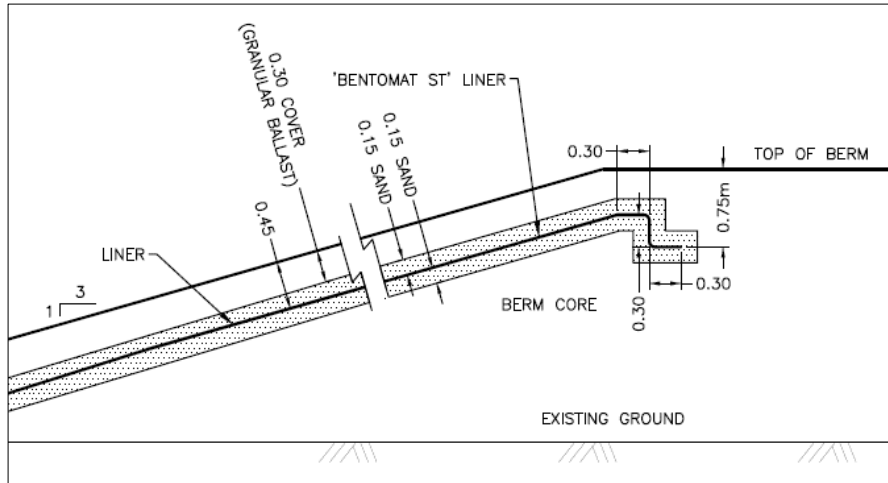
**Figure 3-3: Igloolik Sewage Lagoon Facility – Configuration of Lagoon Slope and Liner Detail**

The erosion of the upstream slope reduces the soil cover thickness over GCL liner. Figure 3-3 shows the soil cover and GCL liner details. The GCL liner requires a minimum soil cover thickness to provide sufficient confining pressure in its normal operation condition. The minimum soil cover is 300 mm as per the manufacturer' guideline applicable for Bentomat ST, i.e., the GCL product used in Igloolik lagoon project (Section 10.4 in Appendix C). Without sufficient soil cover, the permeability of the GCL liner is expected to be negatively impacted as the bentonite in the GCL may not function well with the confining pressure below the minimum requirement.

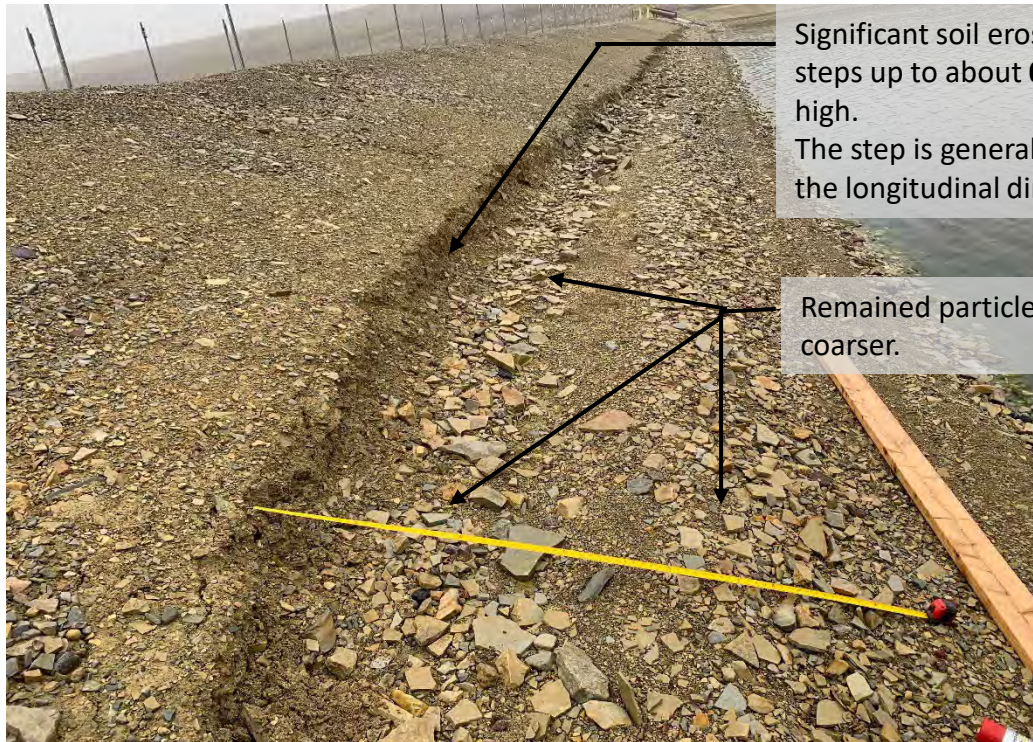
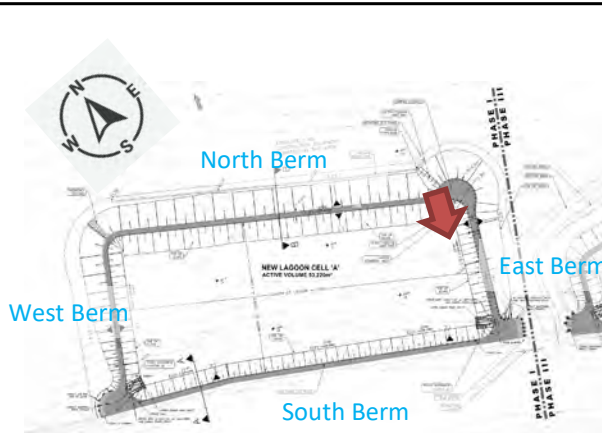
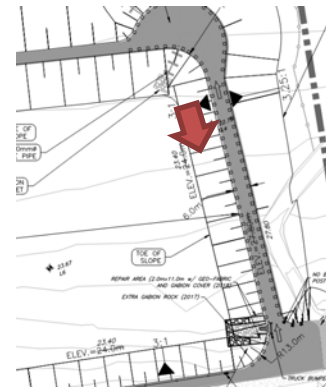
FIGURE  
A2

Significant soil erosion, with steps up to about 0.2 to 0.3 m high.  
The step is generally uniform in the longitudinal direction.

Remained particles at steps are coarser.

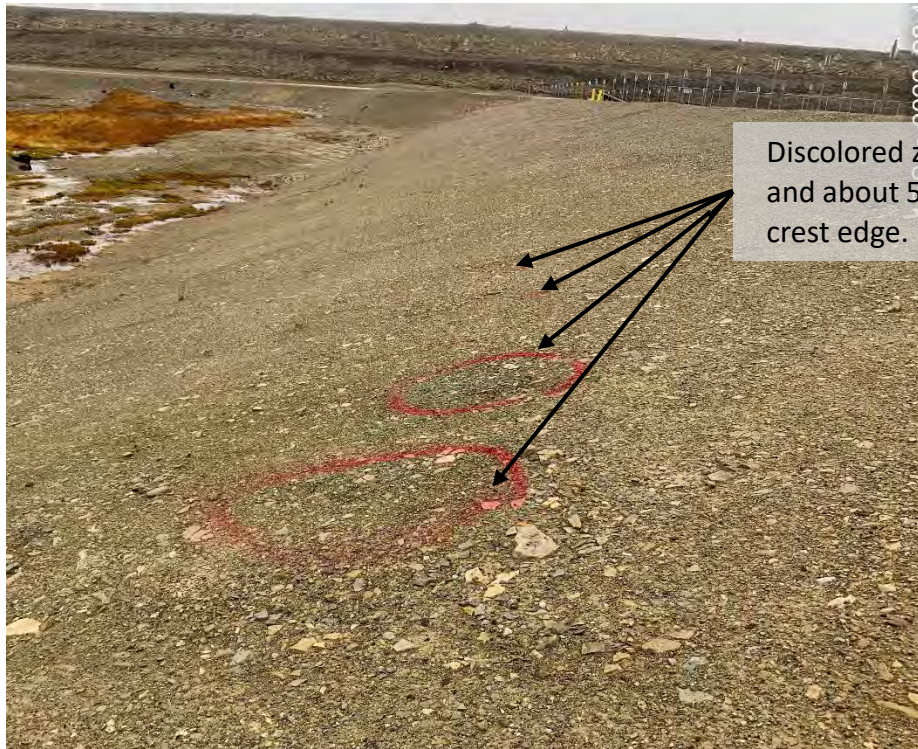
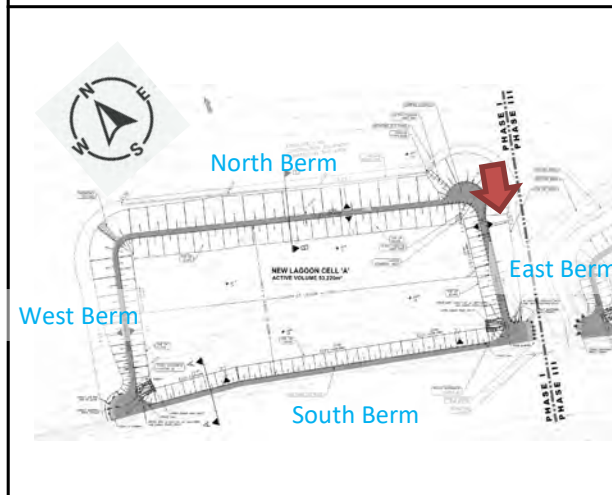
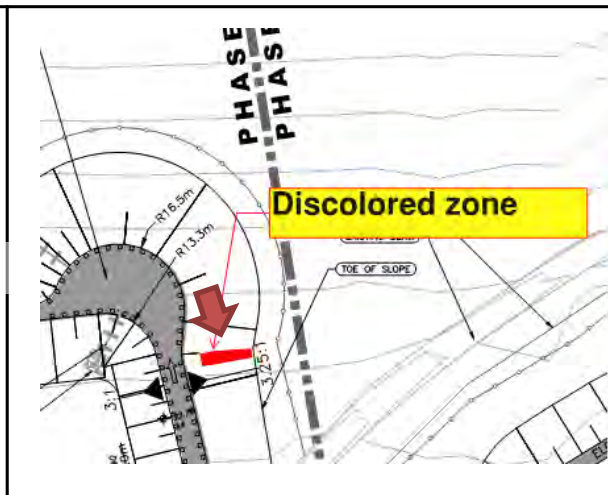
FIGURE  
A5

Discolored zone about 5 m wide, and about 5 m distance from the crest edge.

Active seepage zone observed when Cell A had high water level.

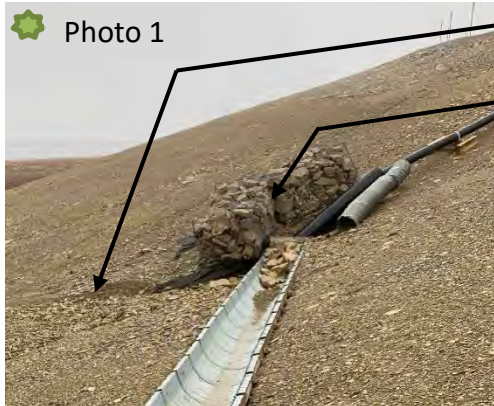
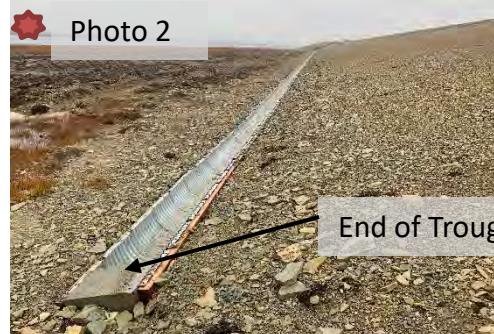
FIGURE  
A11

Sign of water flow to east

Connection between trough and outlet pile

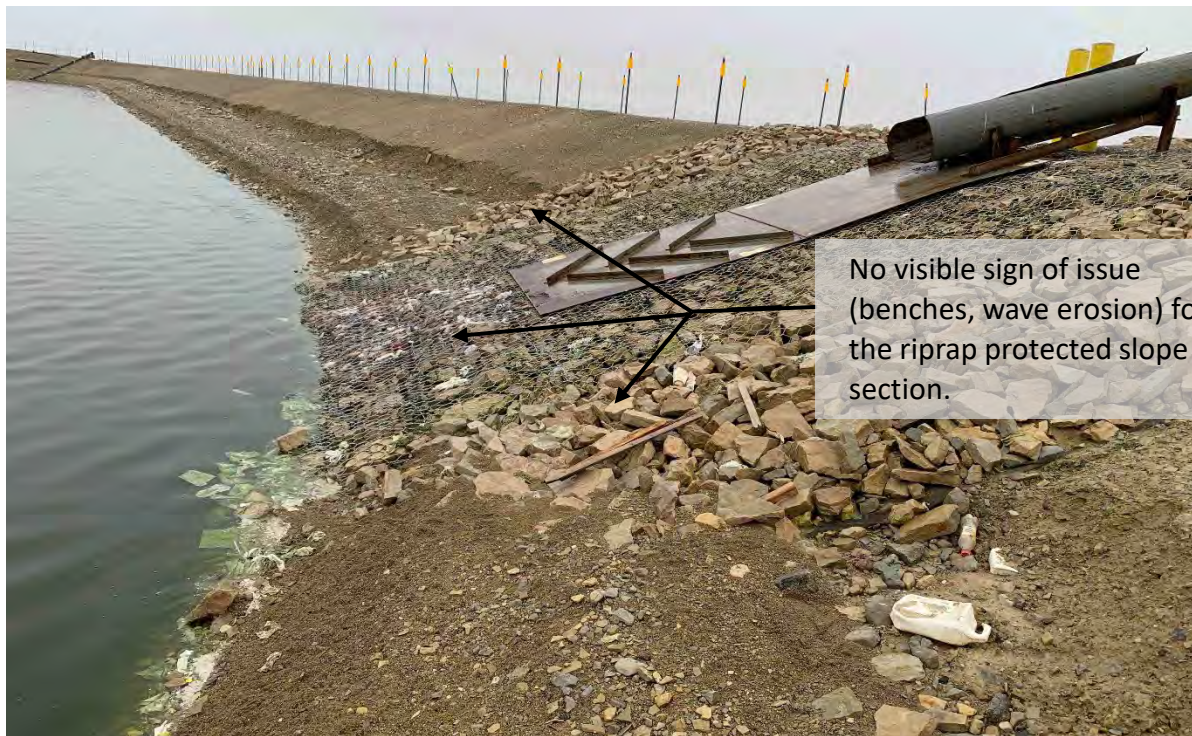
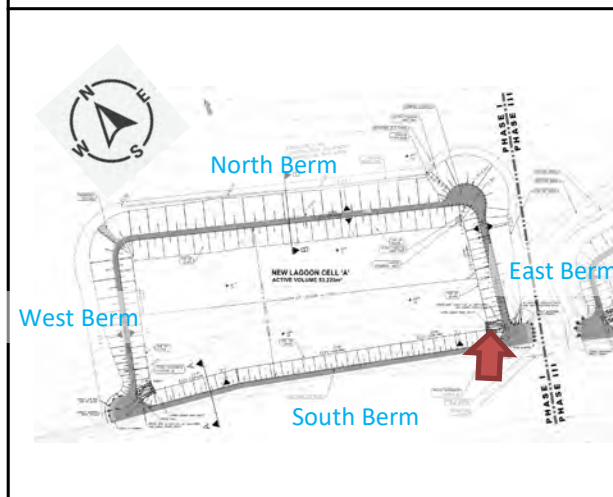
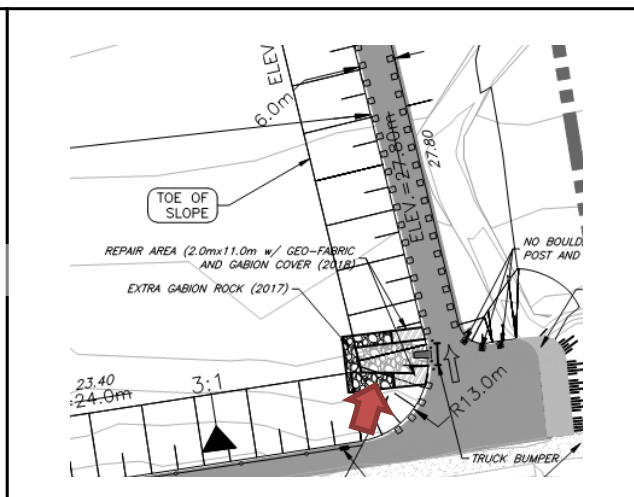
FIGURE  
A13

| Attributes | |
|---|---|
| Photograph | A – US – East Truck Discharge Facility (#2) |
| Observations | -No visible sign of issue (benches, wave erosion) for the riprap protected slope section, regardless the presence of gabion box.<br>-Truck Discharge Facility equipment in a good condition. |
| Remarks | East truck discharge area is in a good condition. |

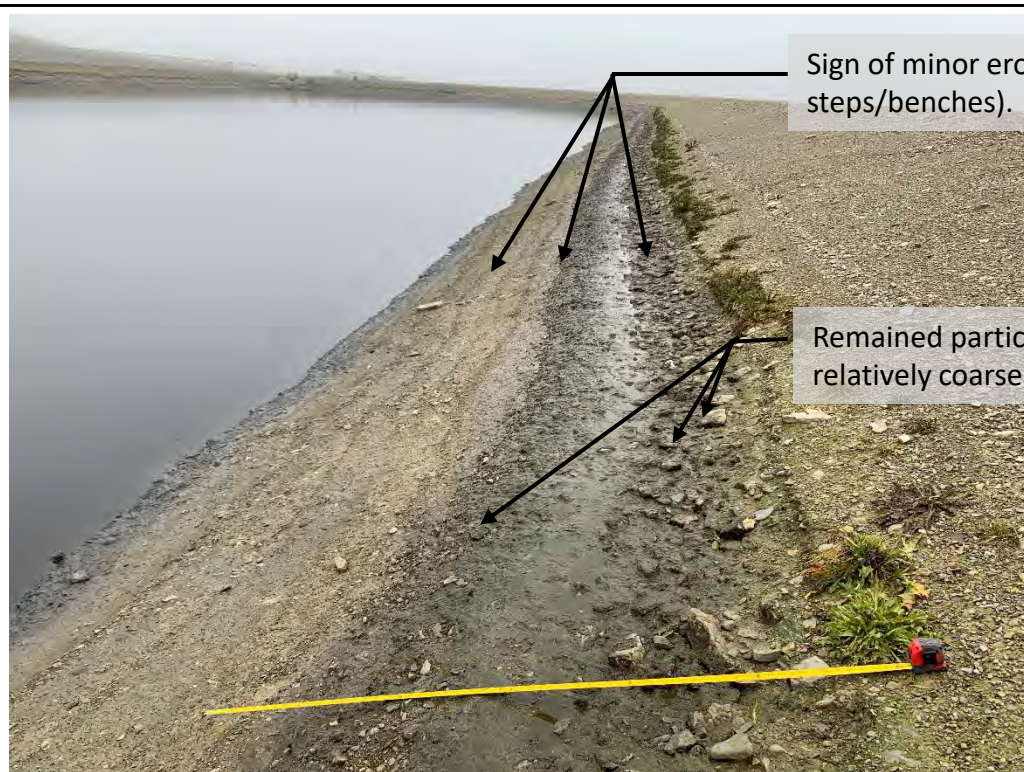
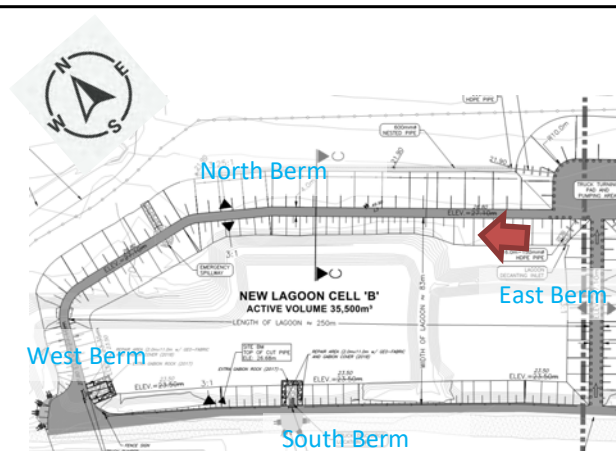
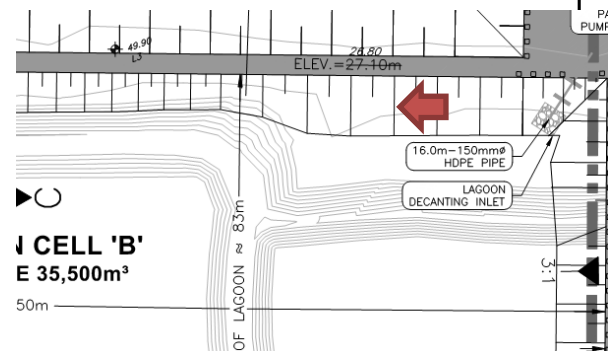
FIGURE  
A15

| Attributes | |
|---|---|
| Photograph | B – US –North Berm |

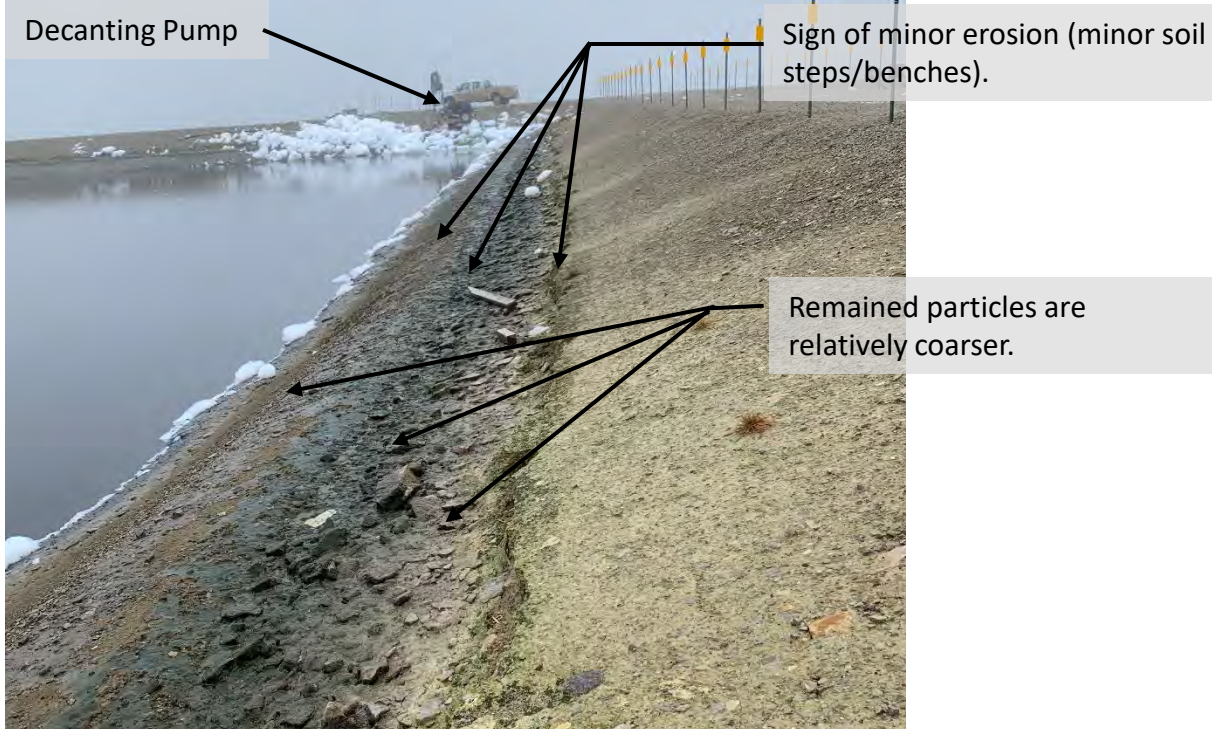
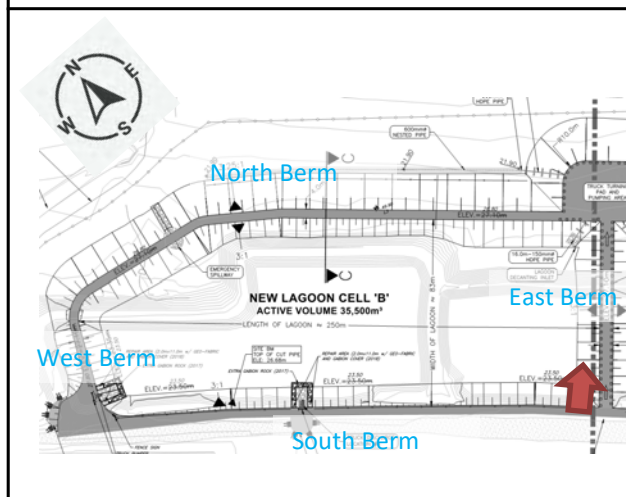
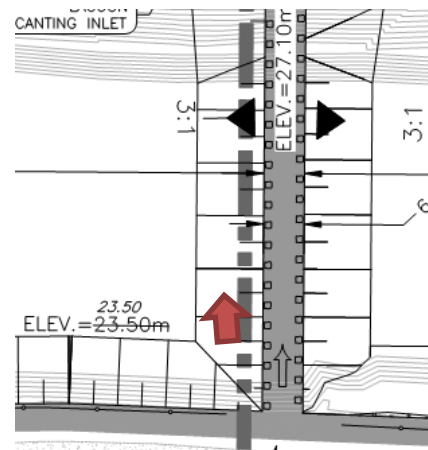
FIGURE  
A16

| Attributes | |
|---|---|
| Photograph | B – US –East Berm |

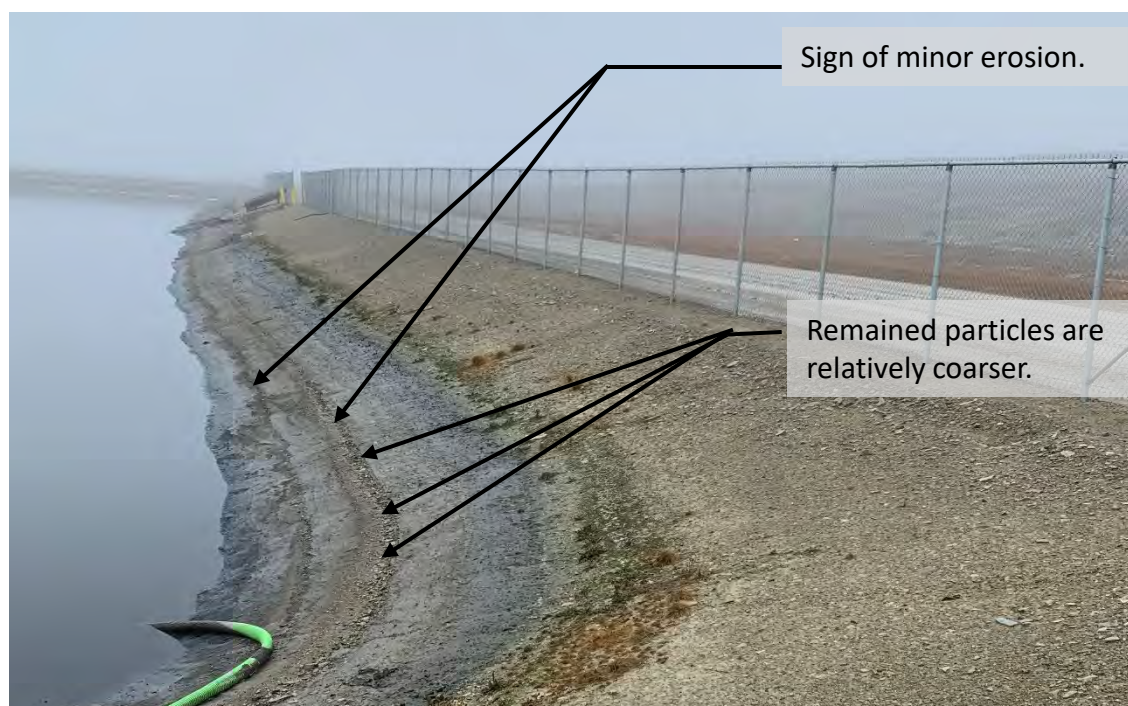
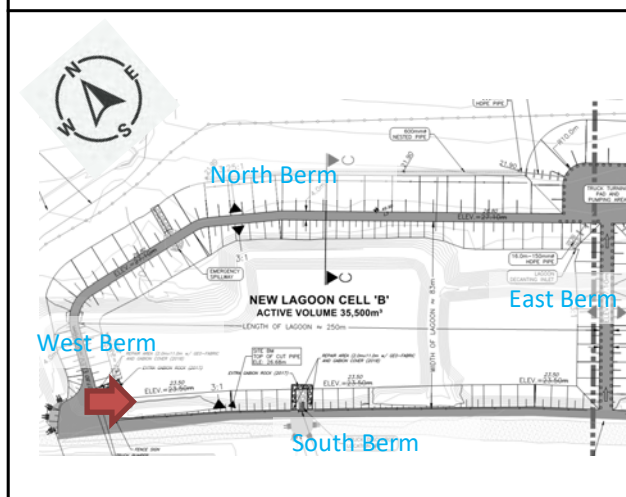
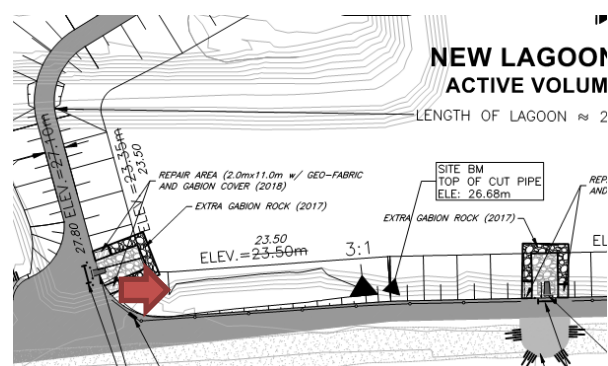
FIGURE  
A17

| Attributes | |
|---|---|
| Photograph | B – US –South Berm |

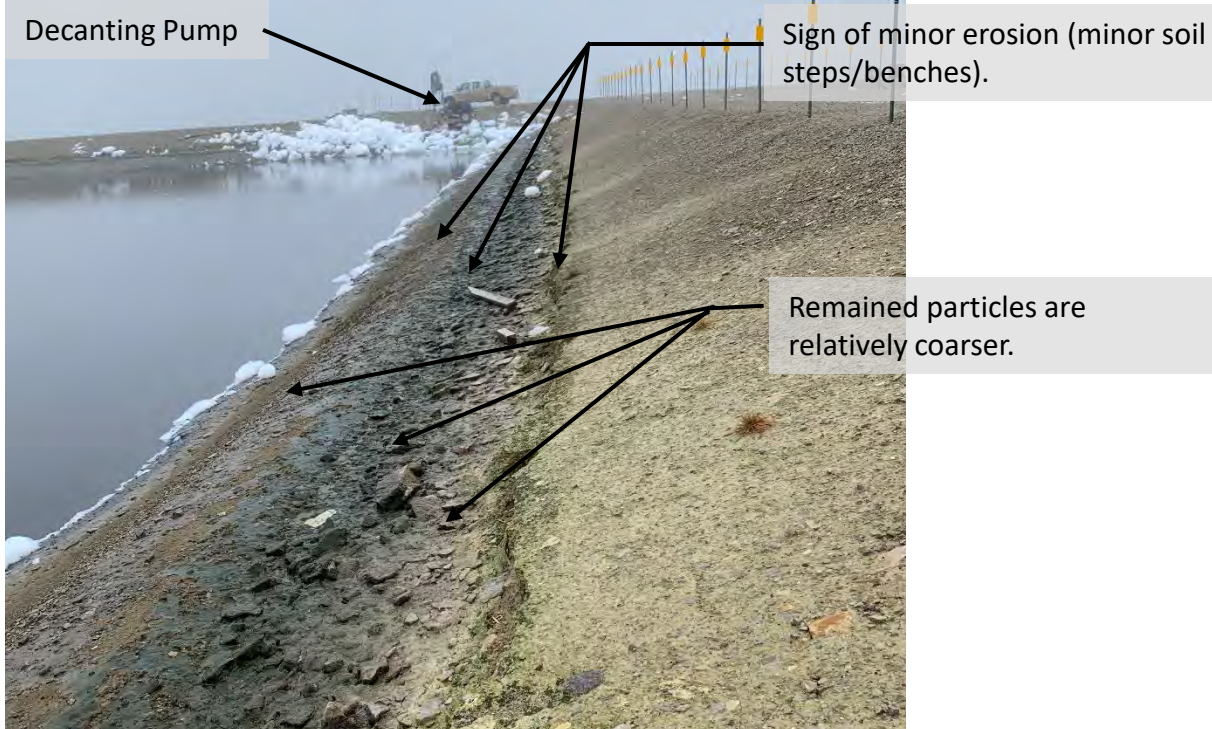
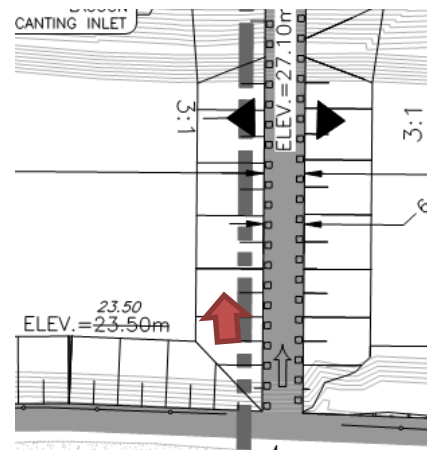
FIGURE  
A18

| Attributes | |
|---|---|
| Photograph | B – US –East Berm |

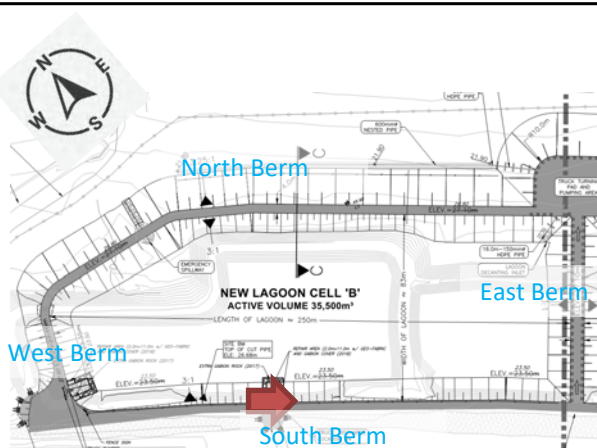
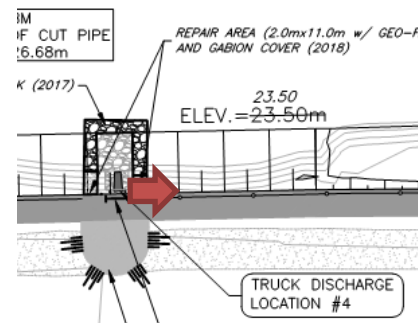
Minor cracks

| Photograph | B – Upstream Slope – South Berm |
| Observations | Minor cracks were observed near crest, parallel with the longitudinal direction. |

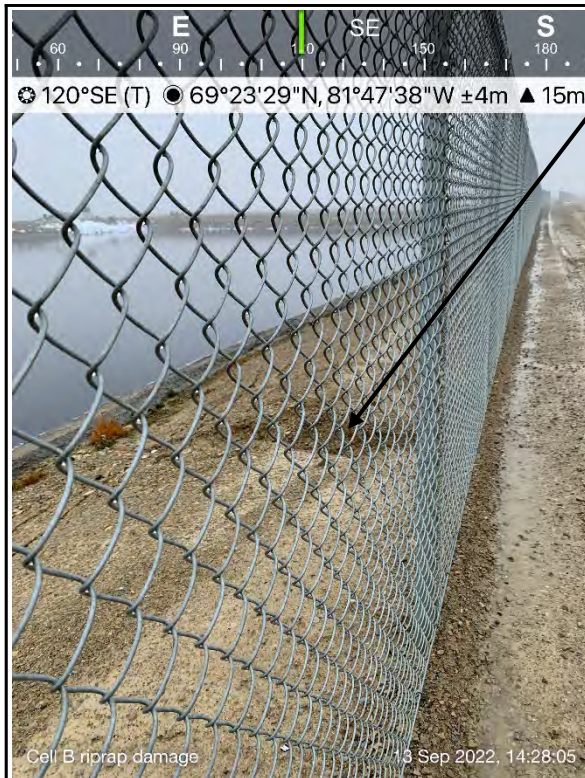
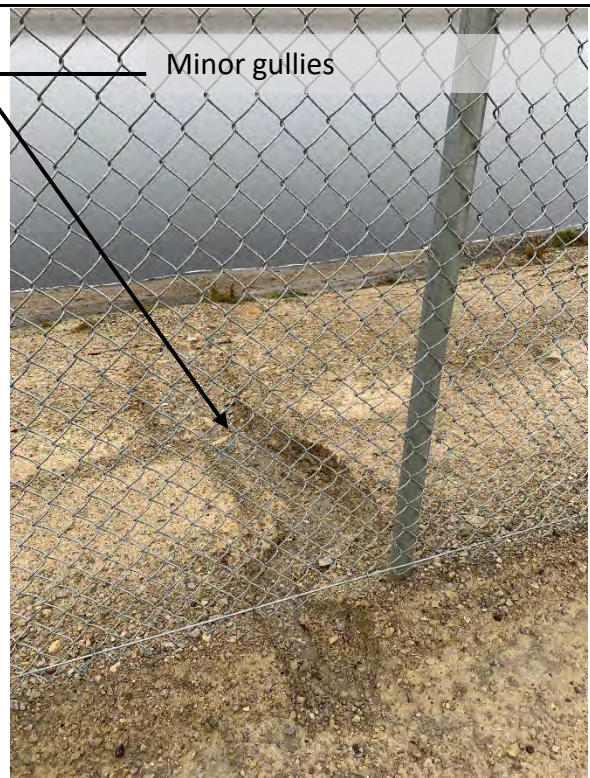
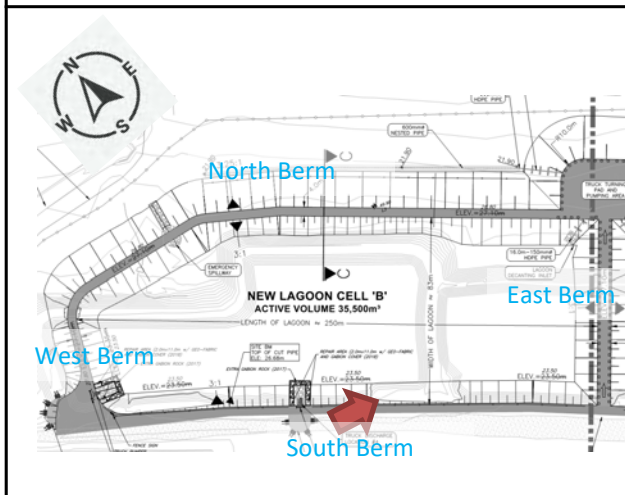
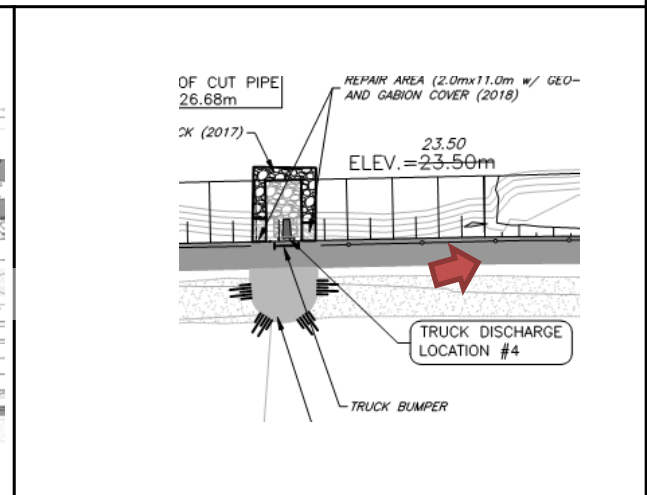
FIGURE  
A20

| Attributes | |
|---|---|
| Photograph | B – Upstream Slope – South Berm - Minor Gully |

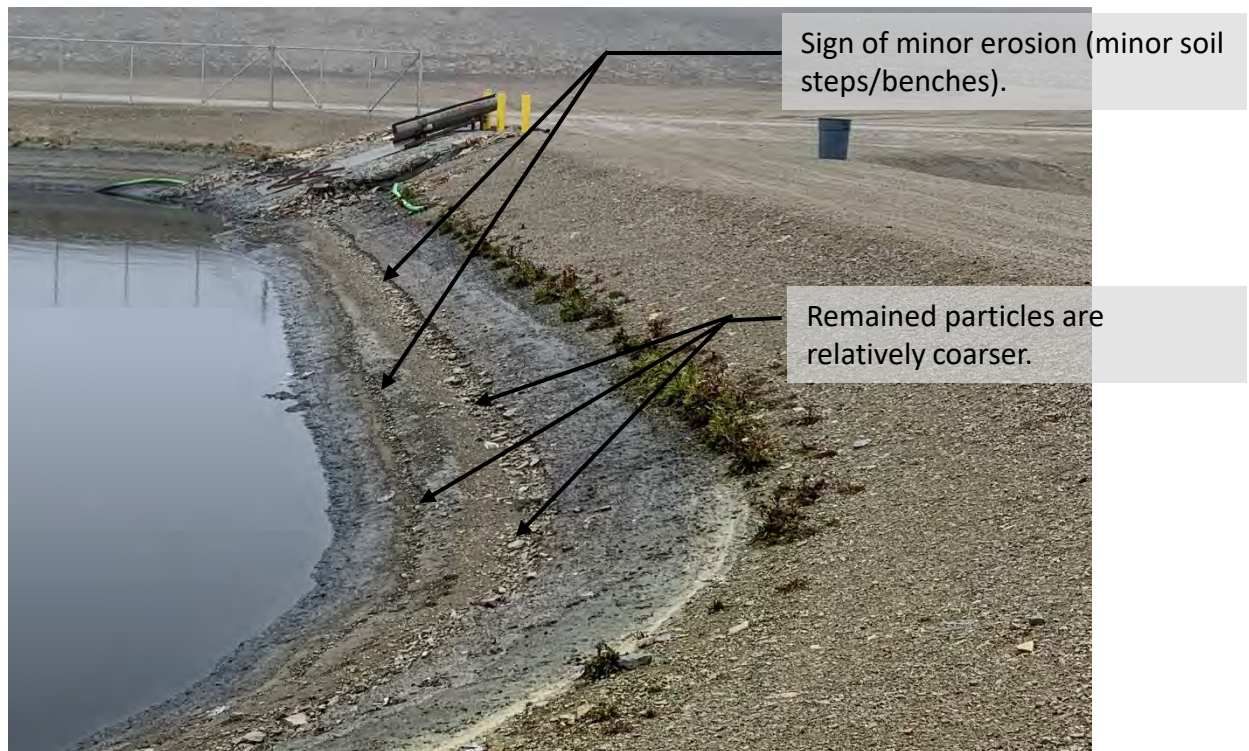
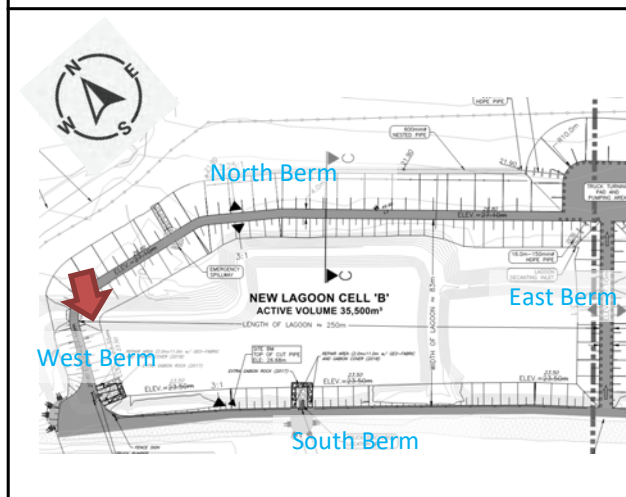
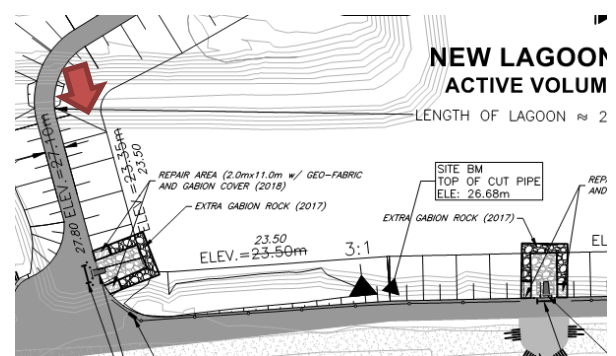
FIGURE  
A21

| Attributes | |
|---|---|
| Photograph | B – US – West Berm |

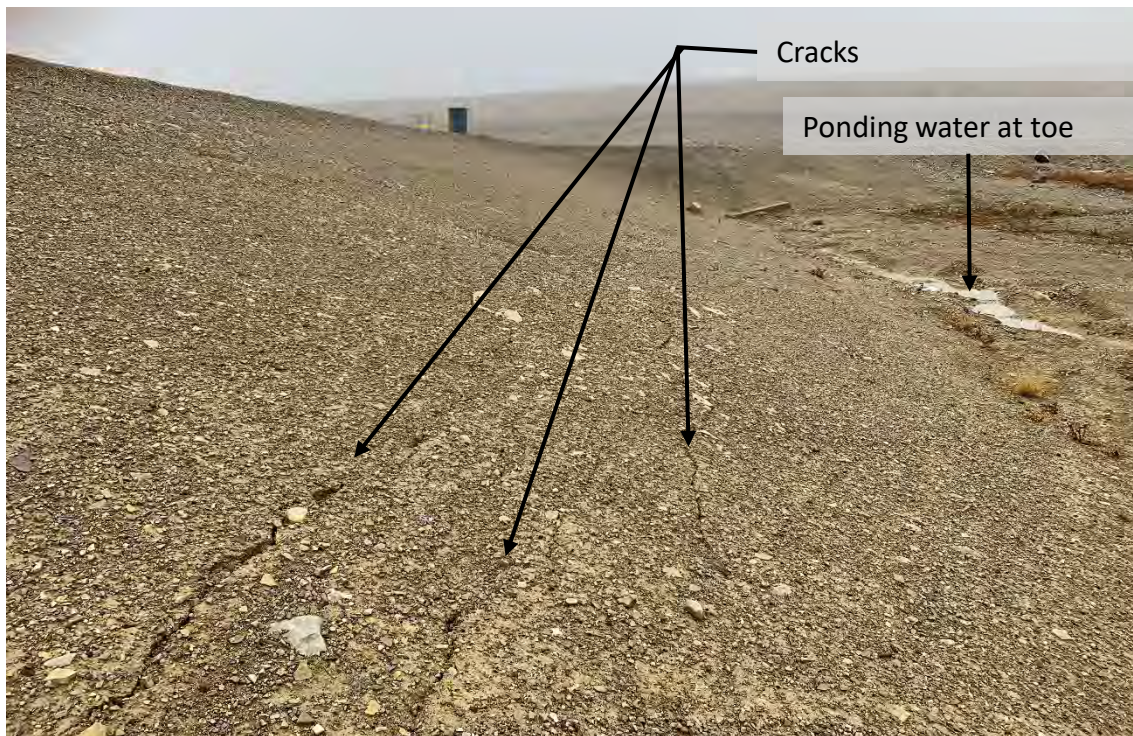
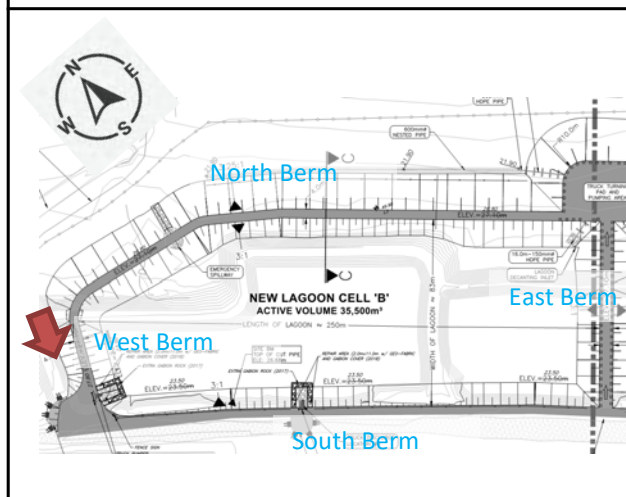
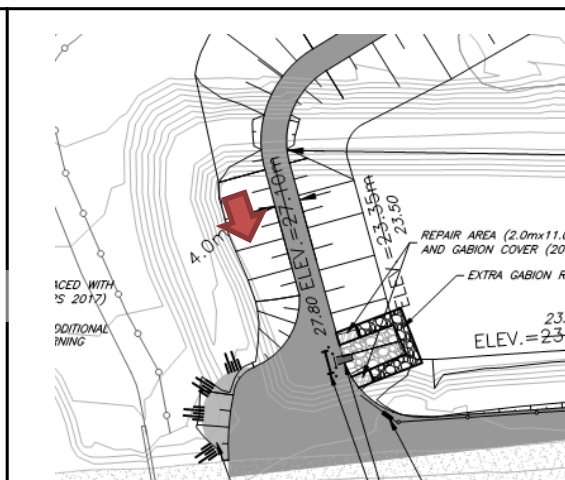
FIGURE  
A23

| Attributes | |
|---|---|
| Photograph | B – DS Slope – West Berm |
| Observations | Minor cracks at downstream slope. The cracks are generally parallel with the longitudinal direction. |
| Remarks | Ponding water at toe. The water is clear and there was no sign of active seepage. The downstream slope is in a generally good condition. Some cracks were encountered and are likely due to frost action and/or thermal stabilization after construction. |

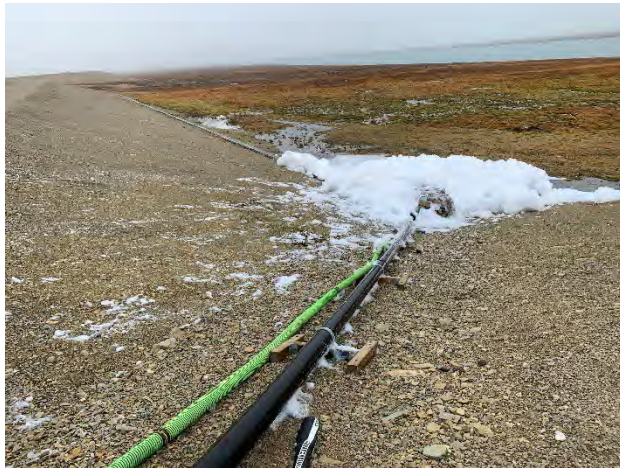
Decanting pump in operation  
Downstream - Outlet

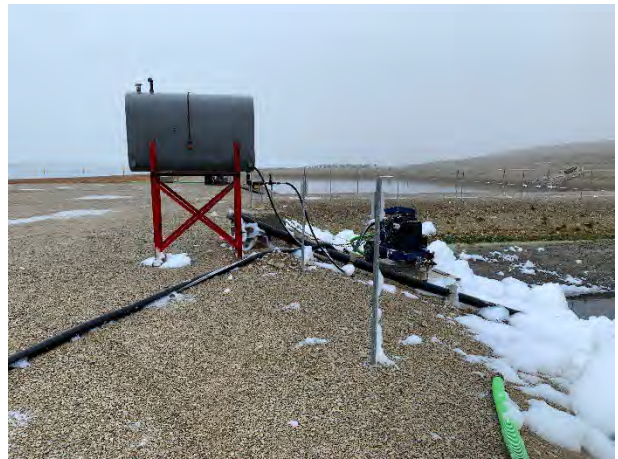
Decanting pump in operation  
Upstream - Inlet

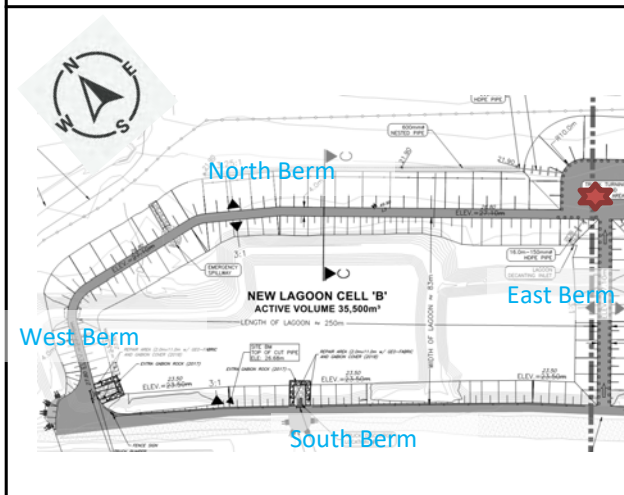
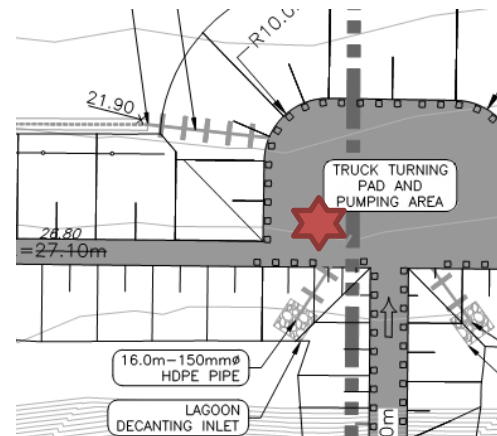
FIGURE  
A24

| Photograph | B – Decanting Pump |

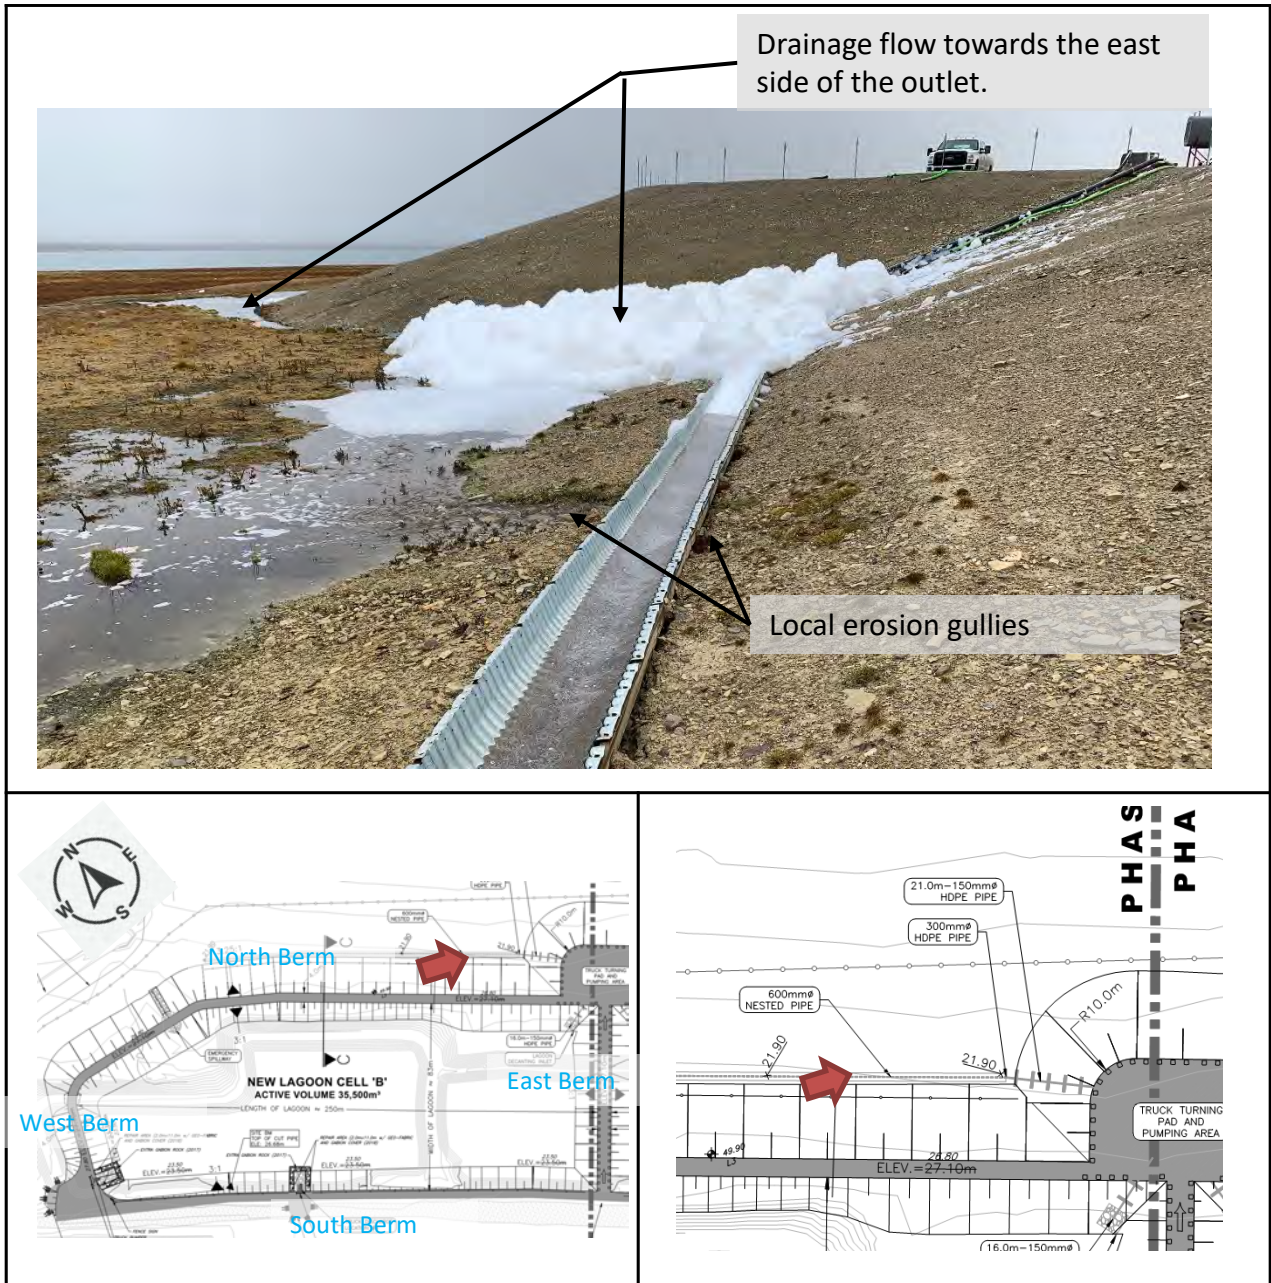
FIGURE  
A25

| Attributes | |
|---|---|
| Photograph | B – Trough |

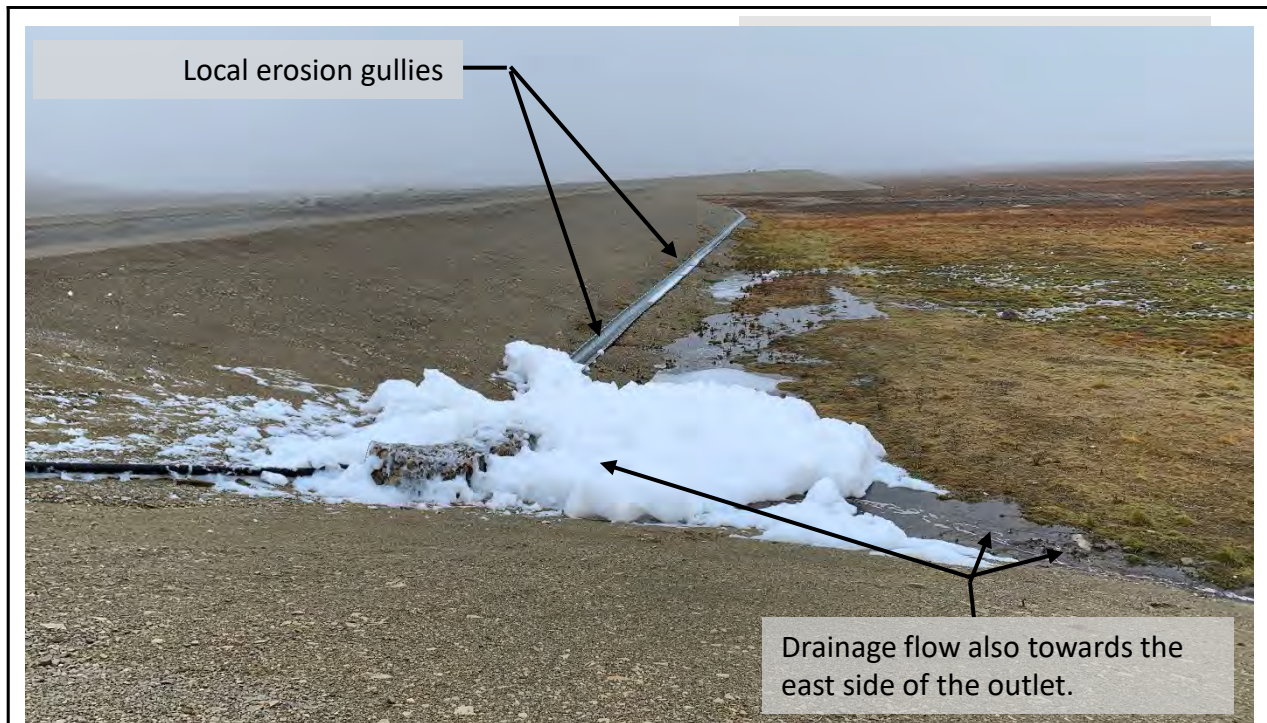
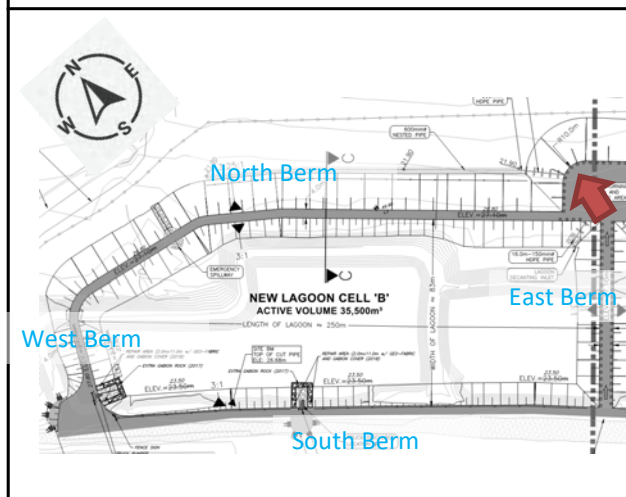
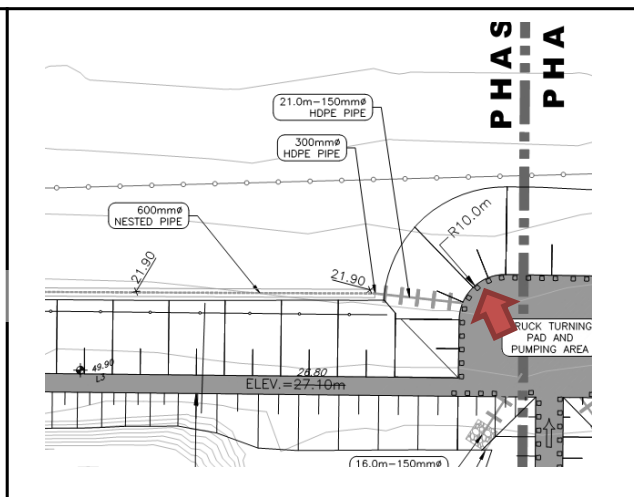
FIGURE  
A26

| Attributes | |
|---|---|
| Photograph | B – Trough |

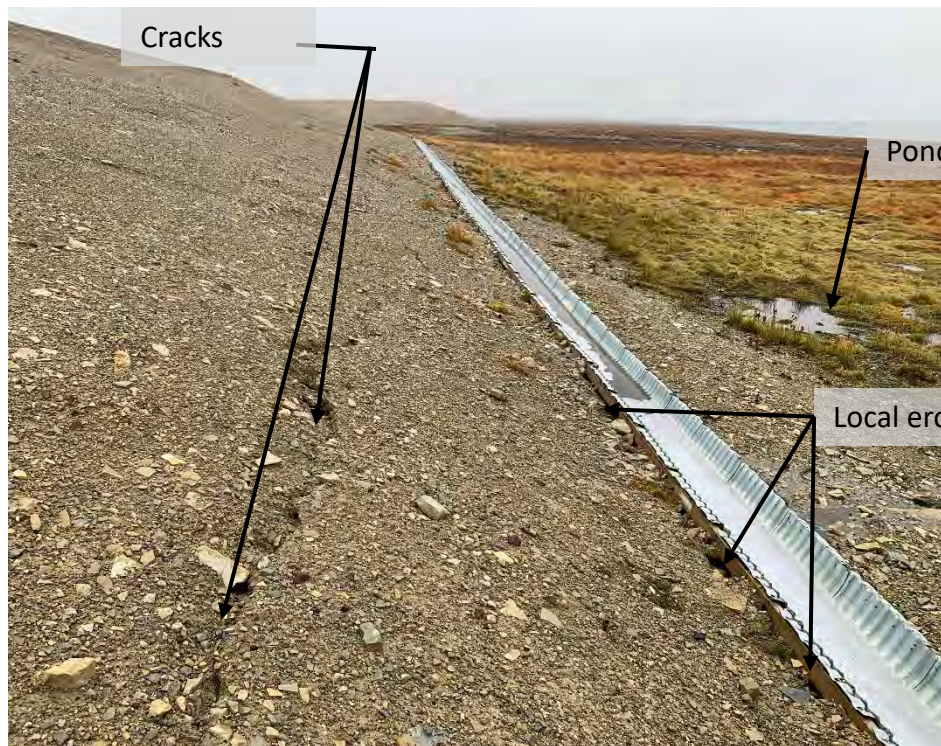
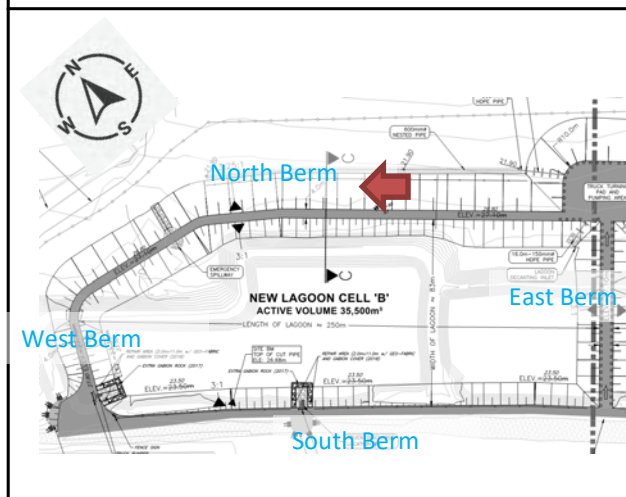
FIGURE  
A27

| Attributes | |
|---|---|
| Photograph | B –Trough - North Berm |
| Description | View of cracks and erosion at downstream slope and trough |
| Observations | Cracks at d/s slope near the tow trough. Some erosions near the trough. Ponding water near the toe, water is clear and there is no sign of active seepage. |
| Remarks | Water level in trough is well below the side wall. Signs of erosion near the trough. Cracks observed at d/s slope near the trough. |

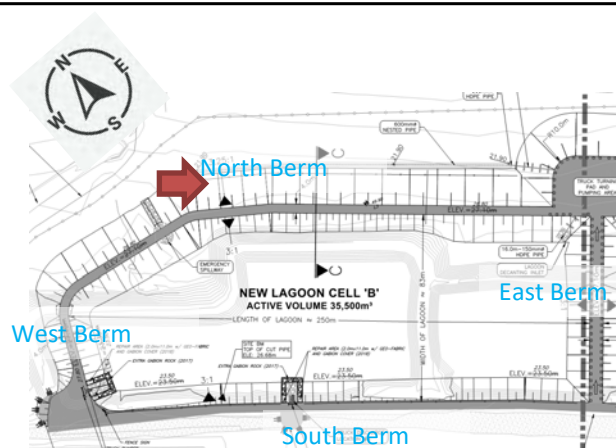
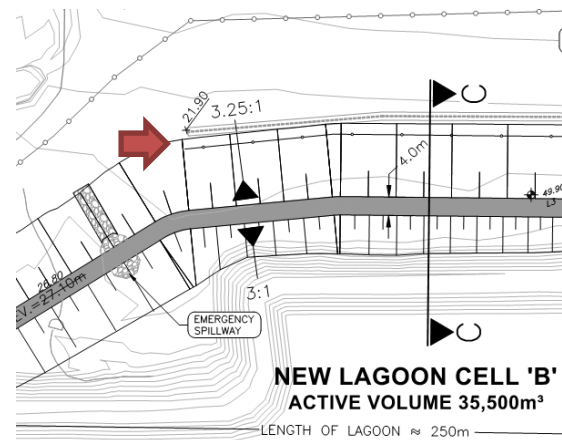
Dry condition at the end of the drainage trough.

| Attributes | |
|---|---|
| Photograph | B –Trough - North Berm |
| Observations | Dry condition was encountered along the westerly one third of the trough. |
| Remarks | The site grading may cause the dry condition of the trough during decanting. |

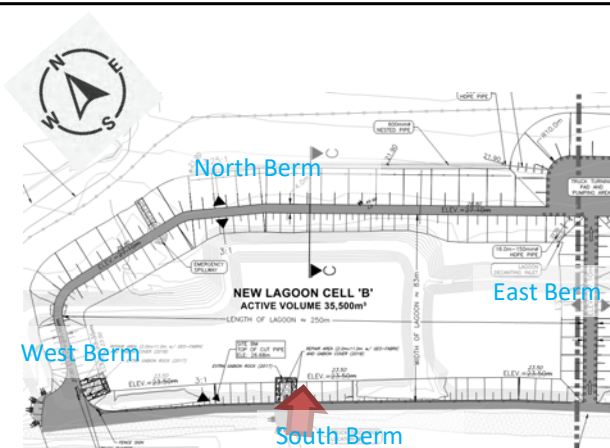
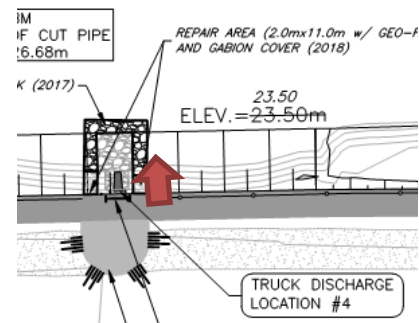
| Attributes | |
|---|---|
| Photograph | B – US –East Truck Discharge Facility (#4) - Local Riprap Damage |

Local riprap damage

| Attributes | |
|---|---|
| Description | View of local riprap damage at upstream slope |
| Observations | Sign of riprap damage from waste-water dumping. The operation staff indicated that the riprap damage was due to the truck dumping away from the designed location. |
| Remarks | There are signs of local riprap damage from truck dumping slightly off the designed discharge location. |

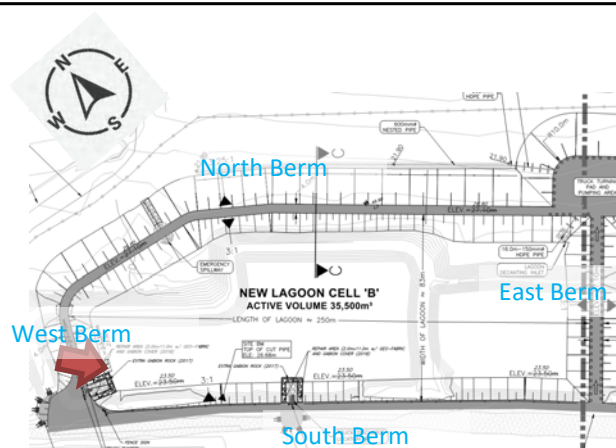
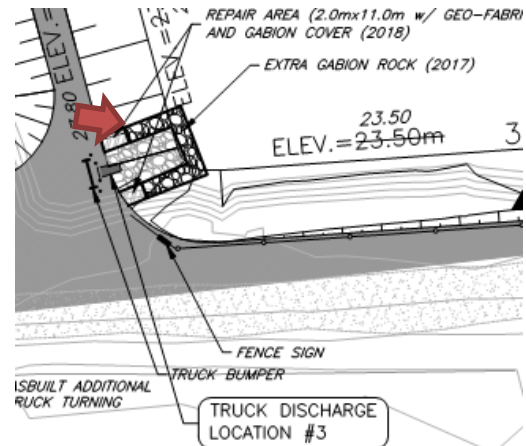
| Attributes | |
|---|---|
| Photograph | B – US –West Truck Discharge Facility (#3) -Local Riprap Damage |

Local riprap damage

| Attributes | |
|---|---|
| Description | View of local riprap damage at upstream slope |
| Observations | Sign of riprap damage from waste-water dumping. The operation staff indicated that the riprap damage was due to the truck dumping away from the designed location. |
| Remarks | There are signs of local riprap damage from truck dumping slightly off the designed discharge location. |
