# IGLOOLIK WASTEWATER TREATMENT FACILITY

## SEWAGE LAGOON BERM 2022 DAM SAFETY INSPECTION, IGLOOLIK, NUNAVUT

PROJECT NO.: TE0223017  
DATE: OCTOBER 2022

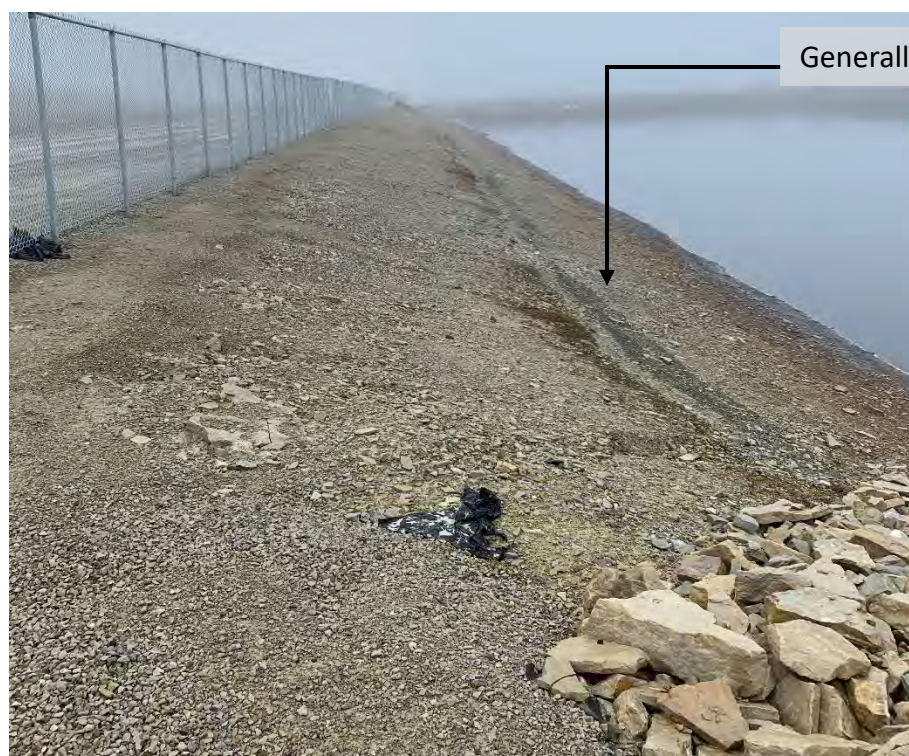
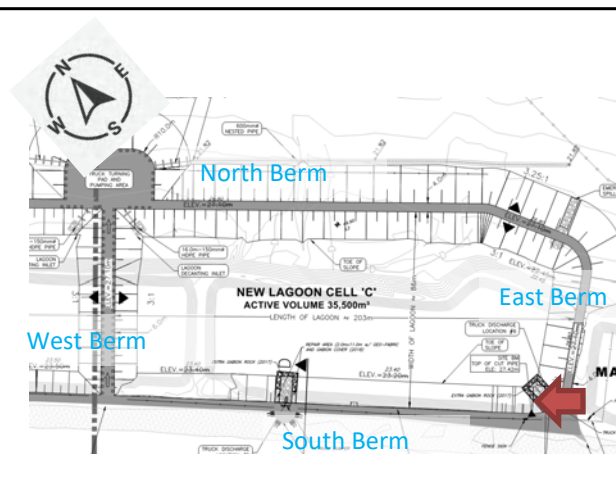
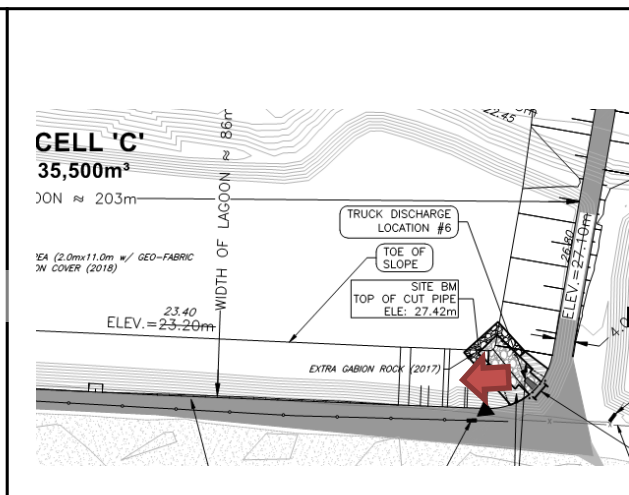
FIGURE  
**A32**

| Attributes | |
|---|---|
| Remarks | The slope is in a good condition |

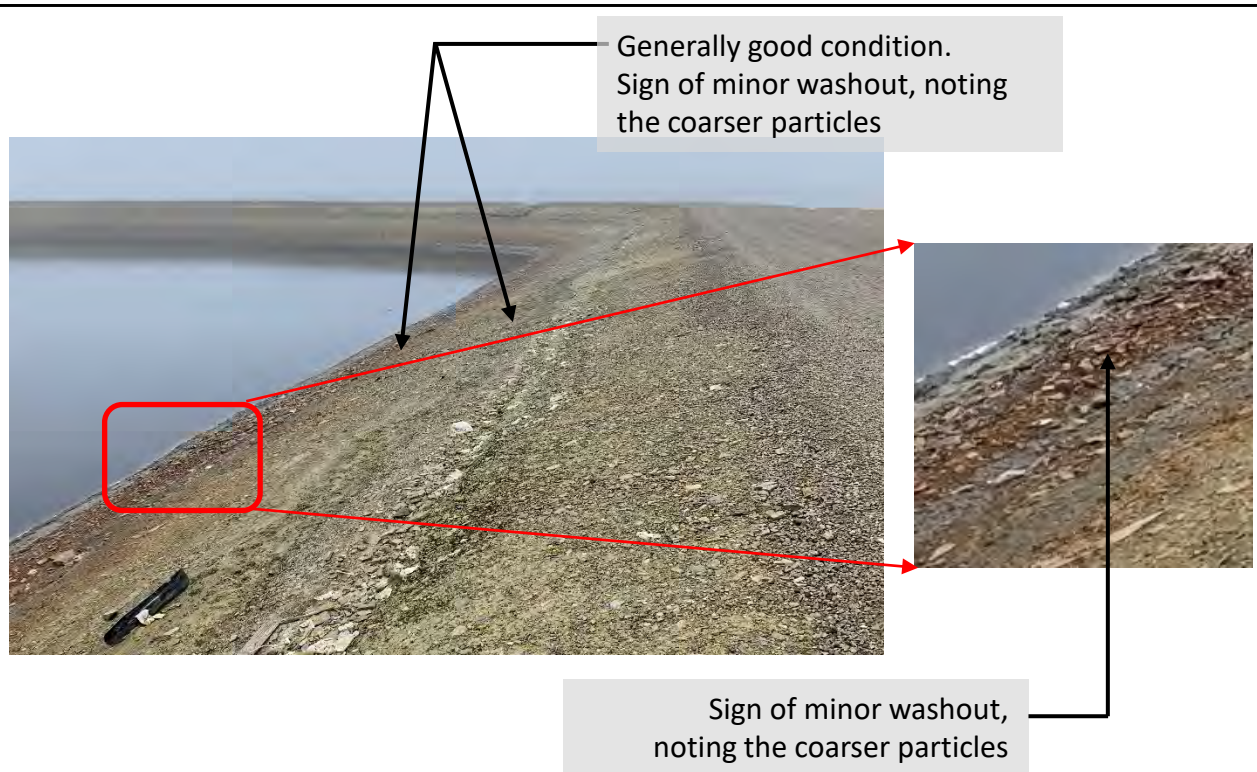
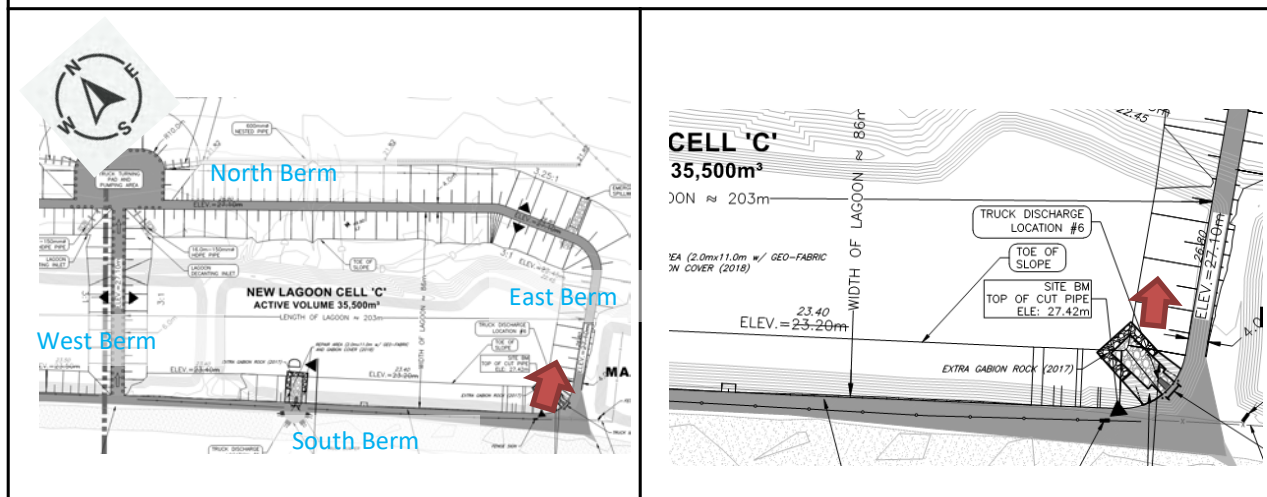
FIGURE  
A33

| Attributes | |
|---|---|
| Remarks | The slope is in a good condition |

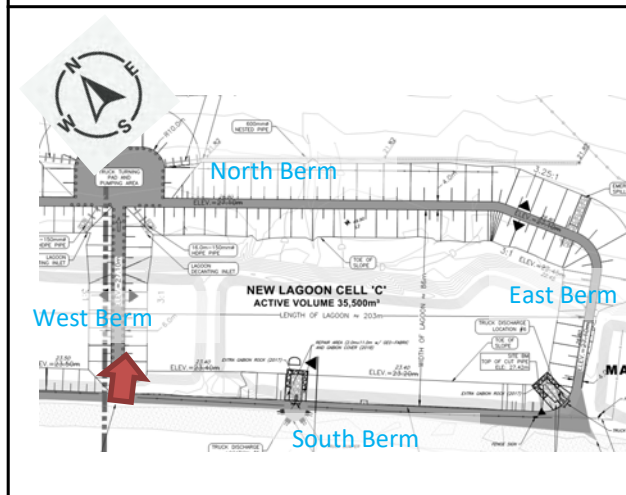
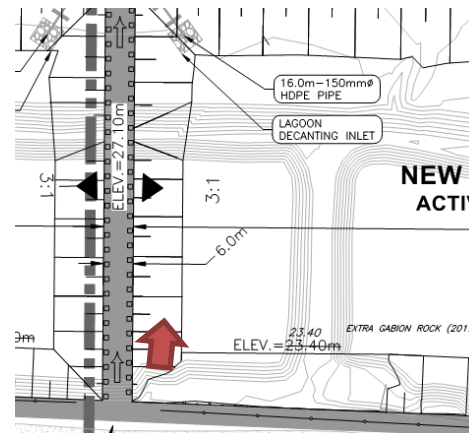
| Photograph | C – US – West Berm |

Generally good condition.

Sign of minor washout, noting the coarser particles

| Remarks | The slope is in a good condition |

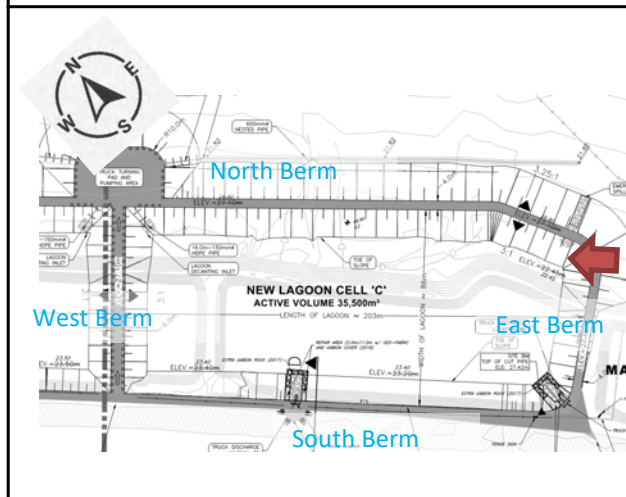
| Photograph | C – US – North Berm |

Generally good condition.

| Remarks | The slope is in a good condition |

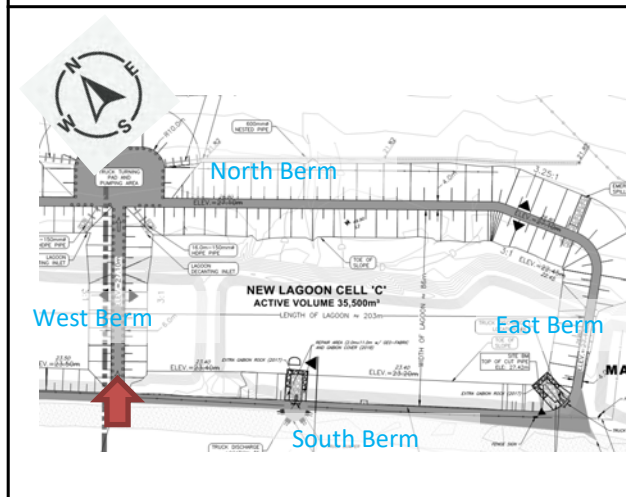
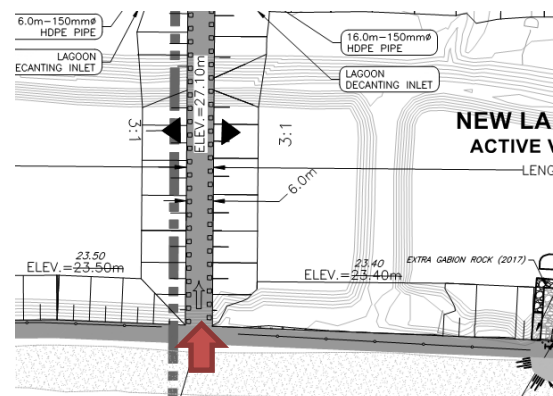
| Photograph | C – Crest – West Berm |

Crest generally in a good condition.

| Observations | No signs of settlement, erosion, cracks. |
| Remarks | The crest is in a good condition. |

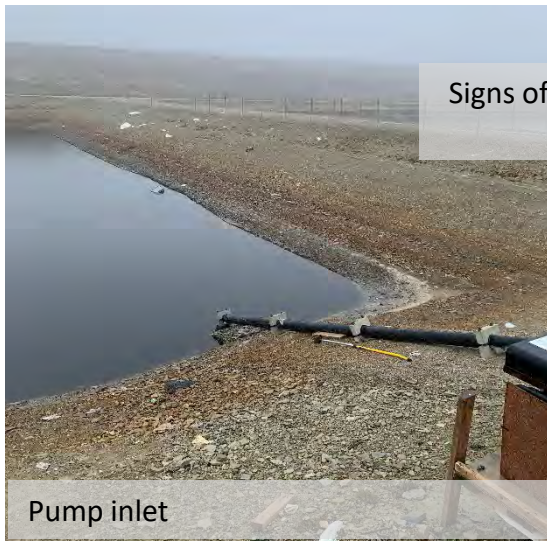
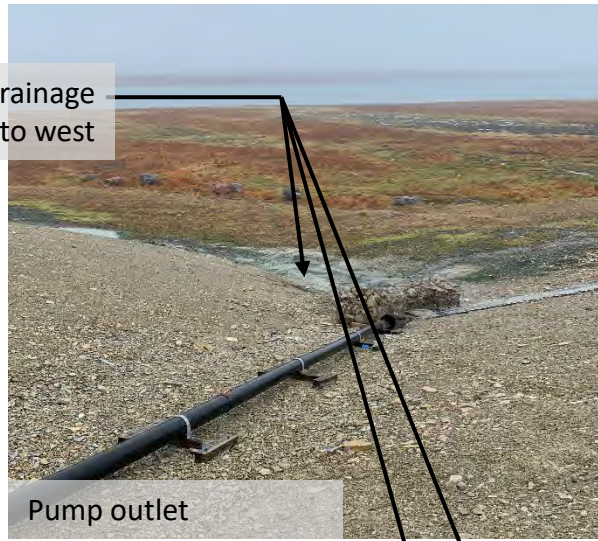
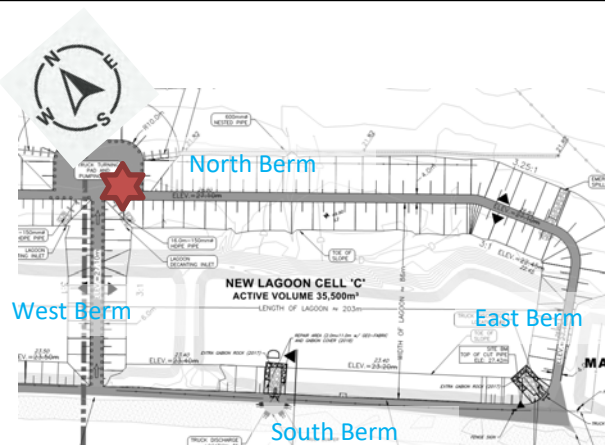
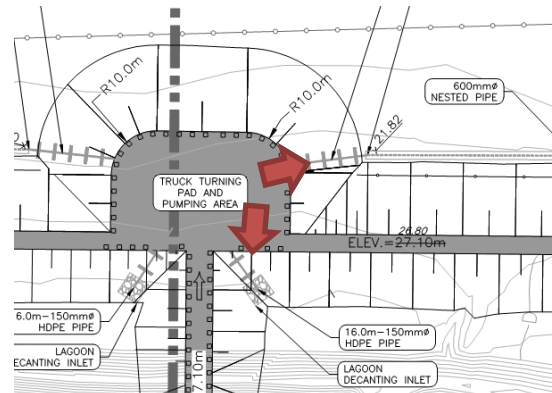
FIGURE  
A37

| Remarks | The pump equipment appears in a good condition. It indicates that some drainage may flow to west instead following the trough as designed. |

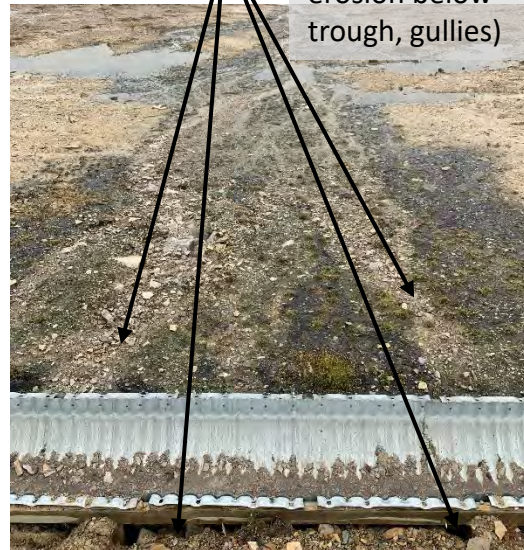
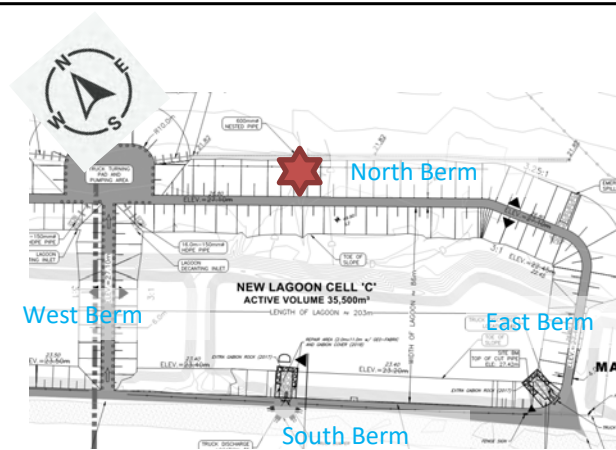
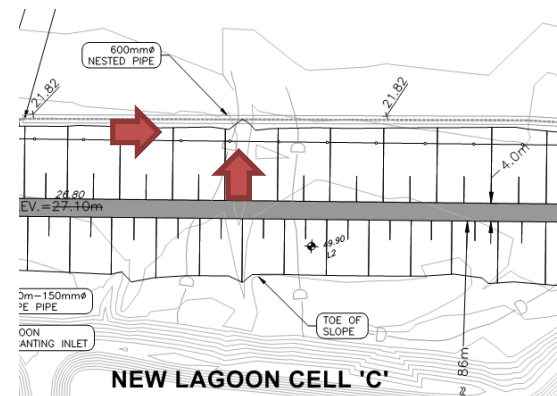
| Photograph | C – DS – North Berm |

Minor cracks near the toe line

Signs of erosions (e.g. erosion below trough, gullies)

| Observations | Downstream slope generally in a fair condition.<br>Minor cracks at downstream slope near the toe line.<br>Signs of erosion near the trough. |
| Remarks | Downstream slope generally in a fair condition.<br>Signs of erosion and soil cracks near the trough. |

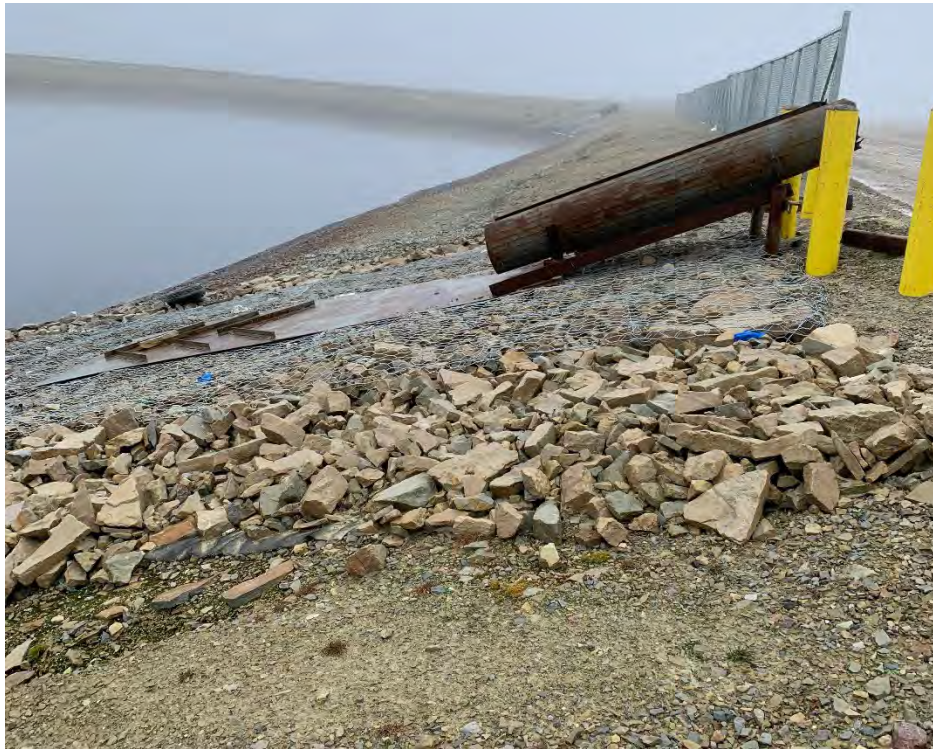
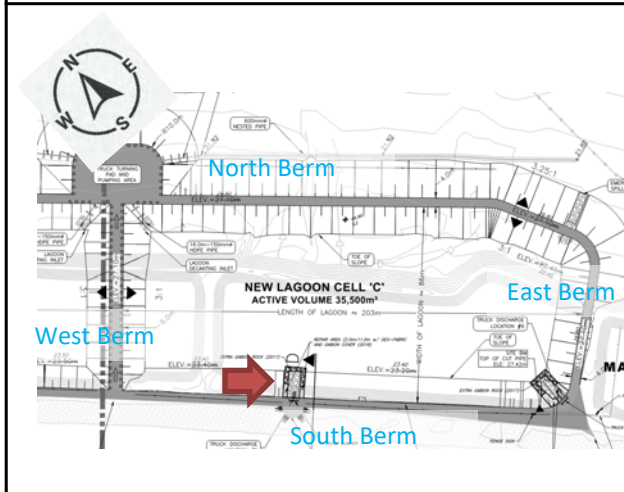
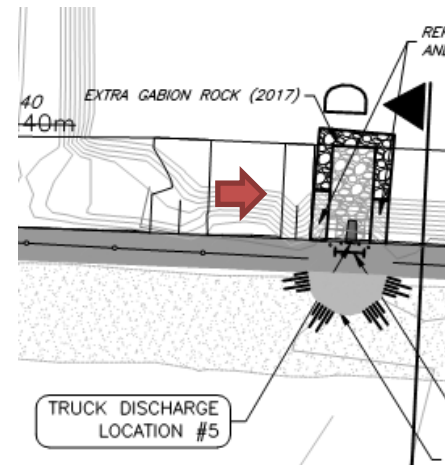
FIGURE  
A40

| Attributes | |
|---|---|
| Observations | Riprap in a good condition.<br>Discharge equipment in a good condition. |
| Remarks | The area is in a good condition |

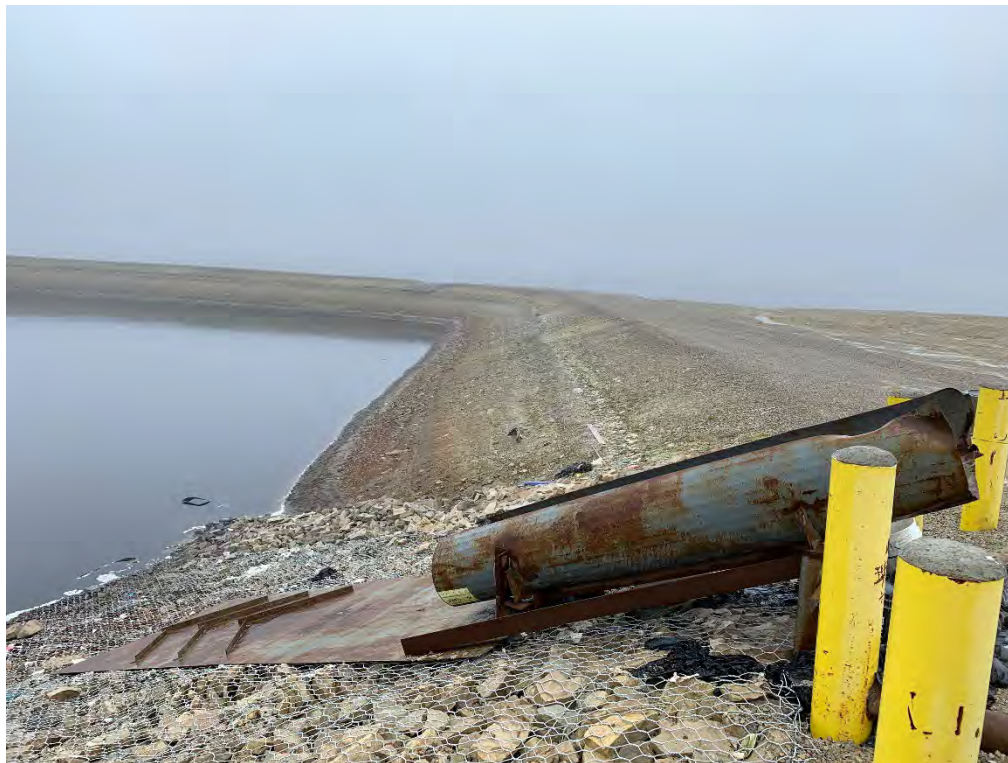
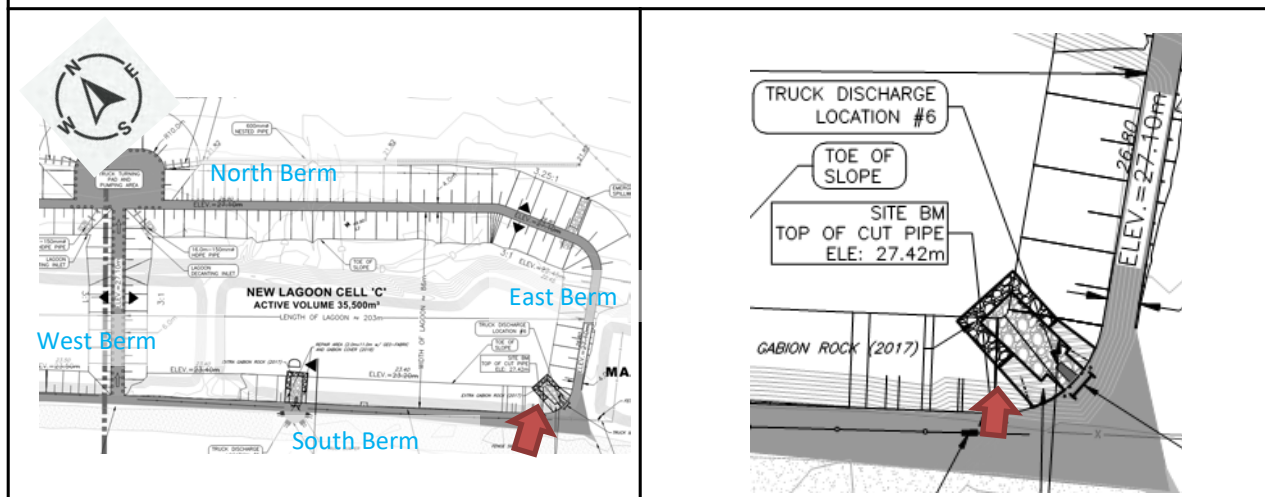
FIGURE  
A41

| Attributes | |
|---|---|
| Observations | Riprap in a good condition.<br>Discharge equipment in a good condition. |
| Remarks | The area is in a good condition |

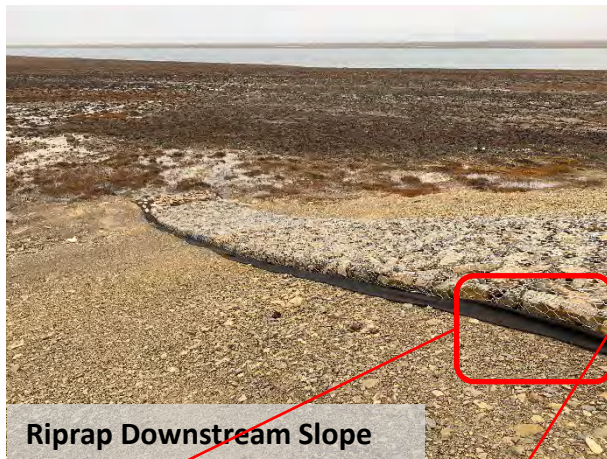
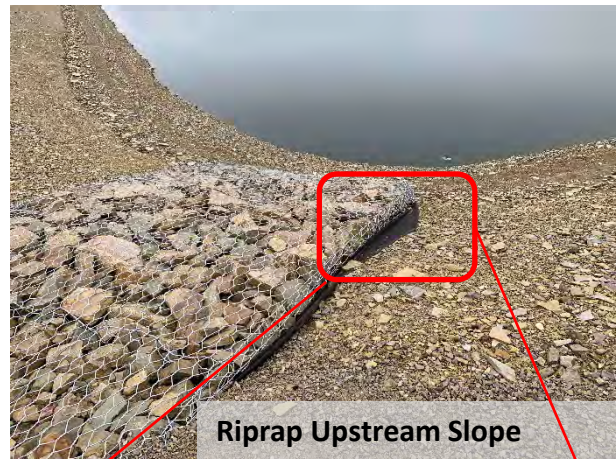
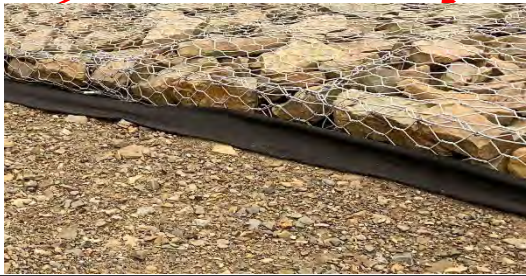
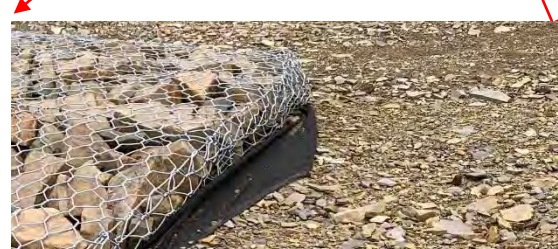
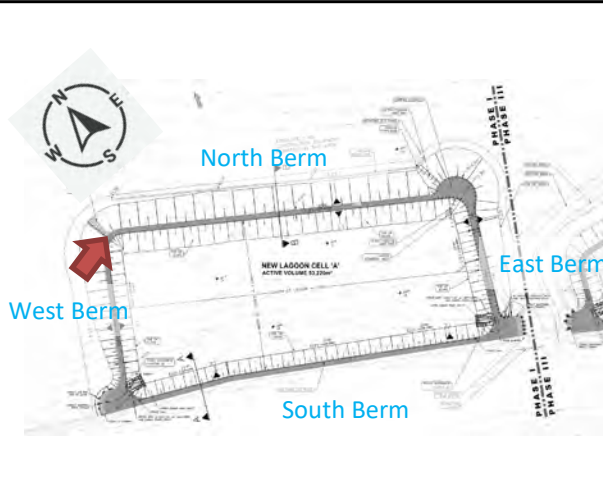
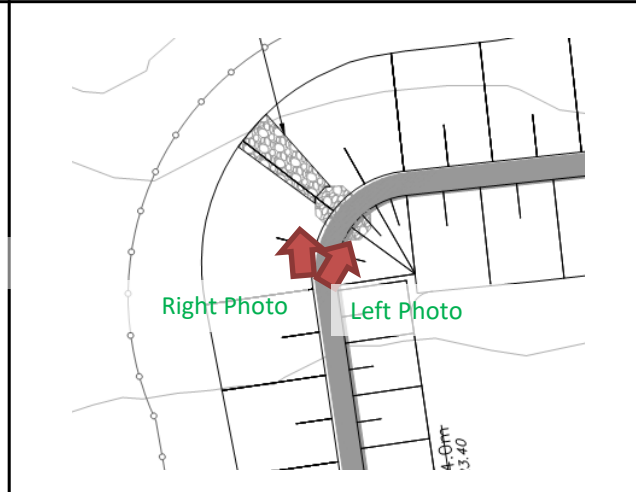
| <b>Photograph</b> | A – Spillway |

| <b>Observations</b> | Riprap at spillway is in good condition. No sign of riprap damage.<br>Riprap baskets are likely placed <b>above</b> the slope.<br>The thickness of riprap is about 200 to 250 mm. |

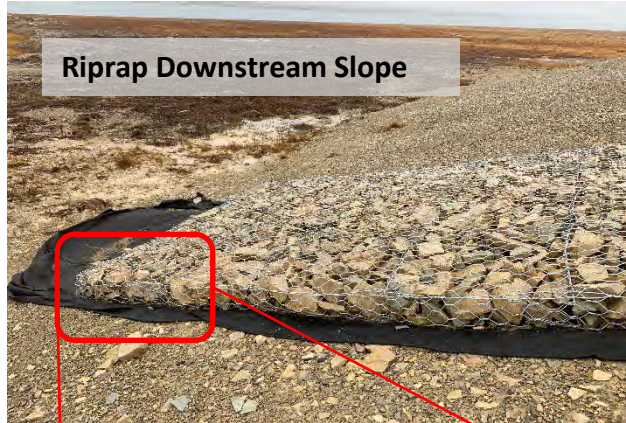
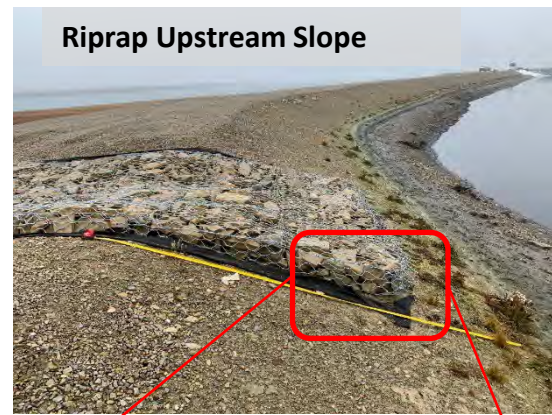
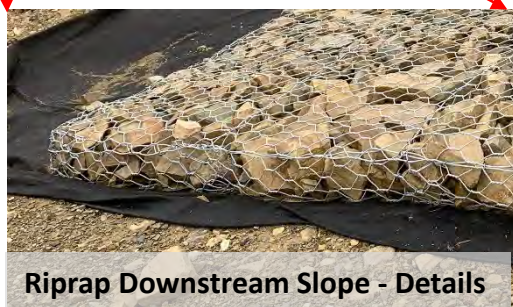
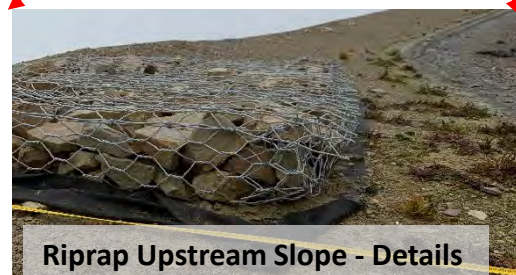
FIGURE  
**A44**

| Attributes | |
|---|---|
| Observations | Riprap at spillway is in good condition. No sign of riprap damage.<br>Riprap baskets were placed <u>above</u> the slope.<br>Riprap at downstream slope does not extend to the toe. |

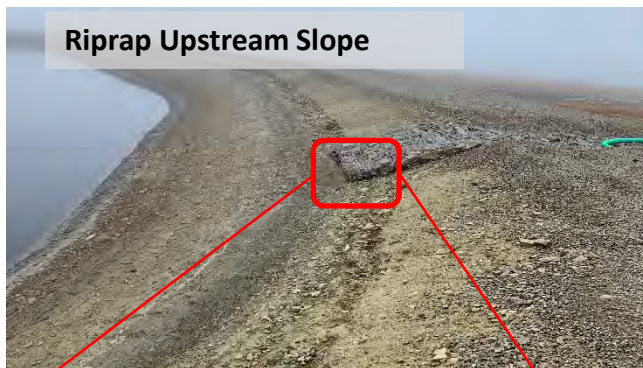
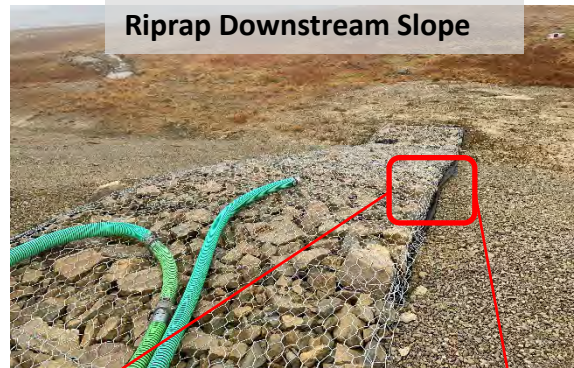
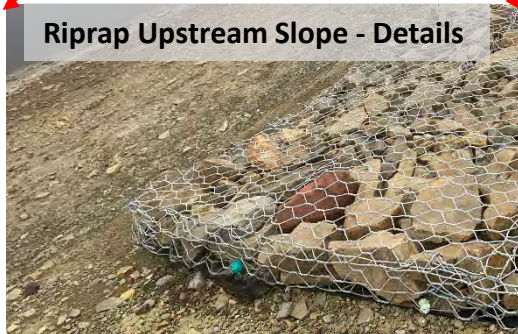
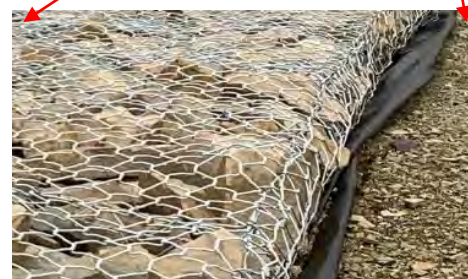
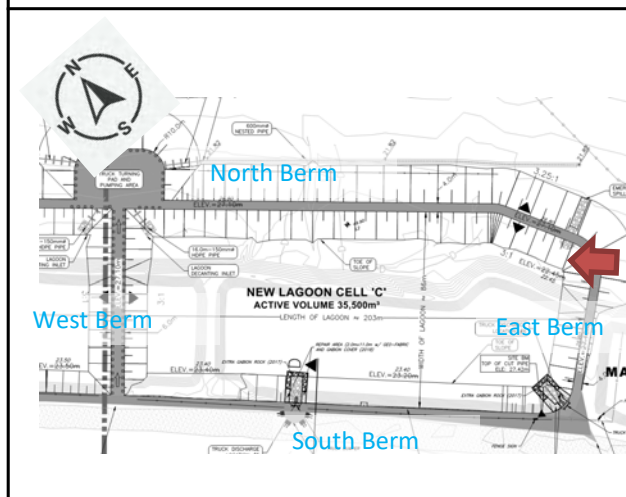
| Photograph | C – Spillway |

| Observations | Riprap at spillway is in good condition. No sign of riprap damage.<br>Riprap baskets are likely placed <u>above</u> the slope. |

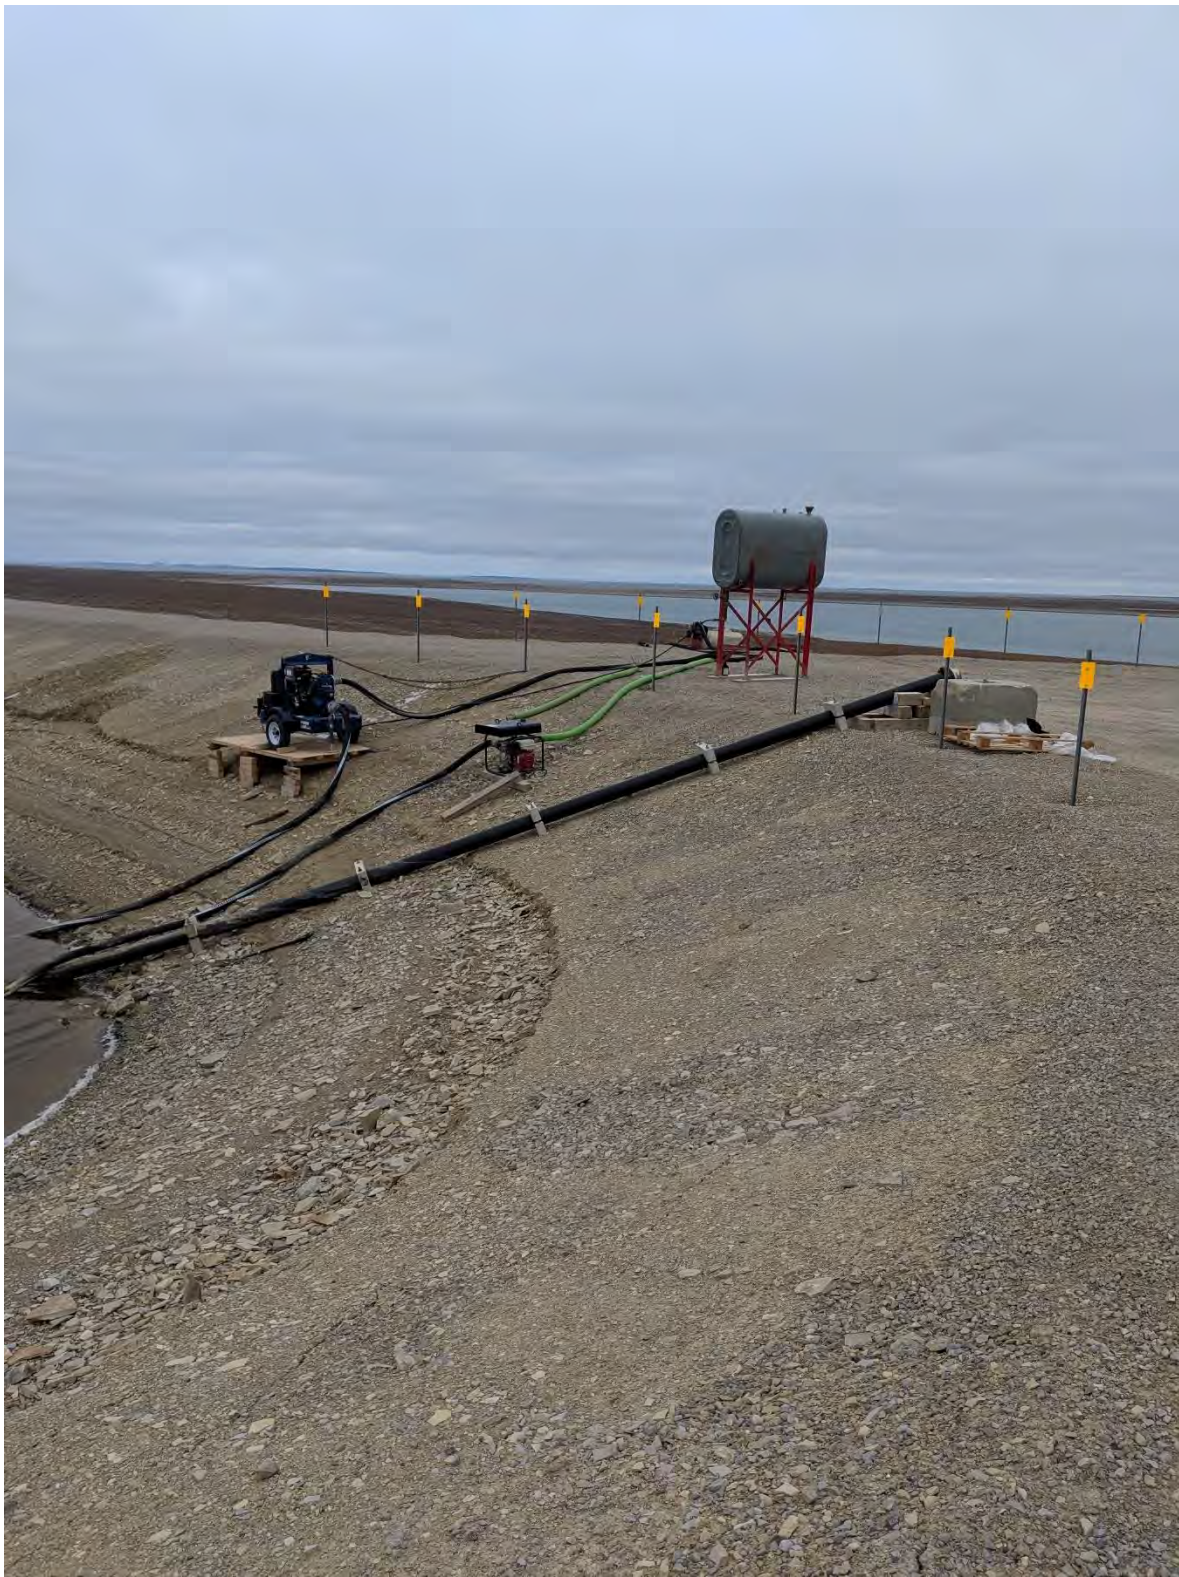
2. The soil around the lagoon cells presents some cracking suggesting settlement during freeze-thaw cycles. This is not expected to impact the lagoon's function. See picture 1

**Photograph #1: Settlement Cracking of the soil around the lagoon.**

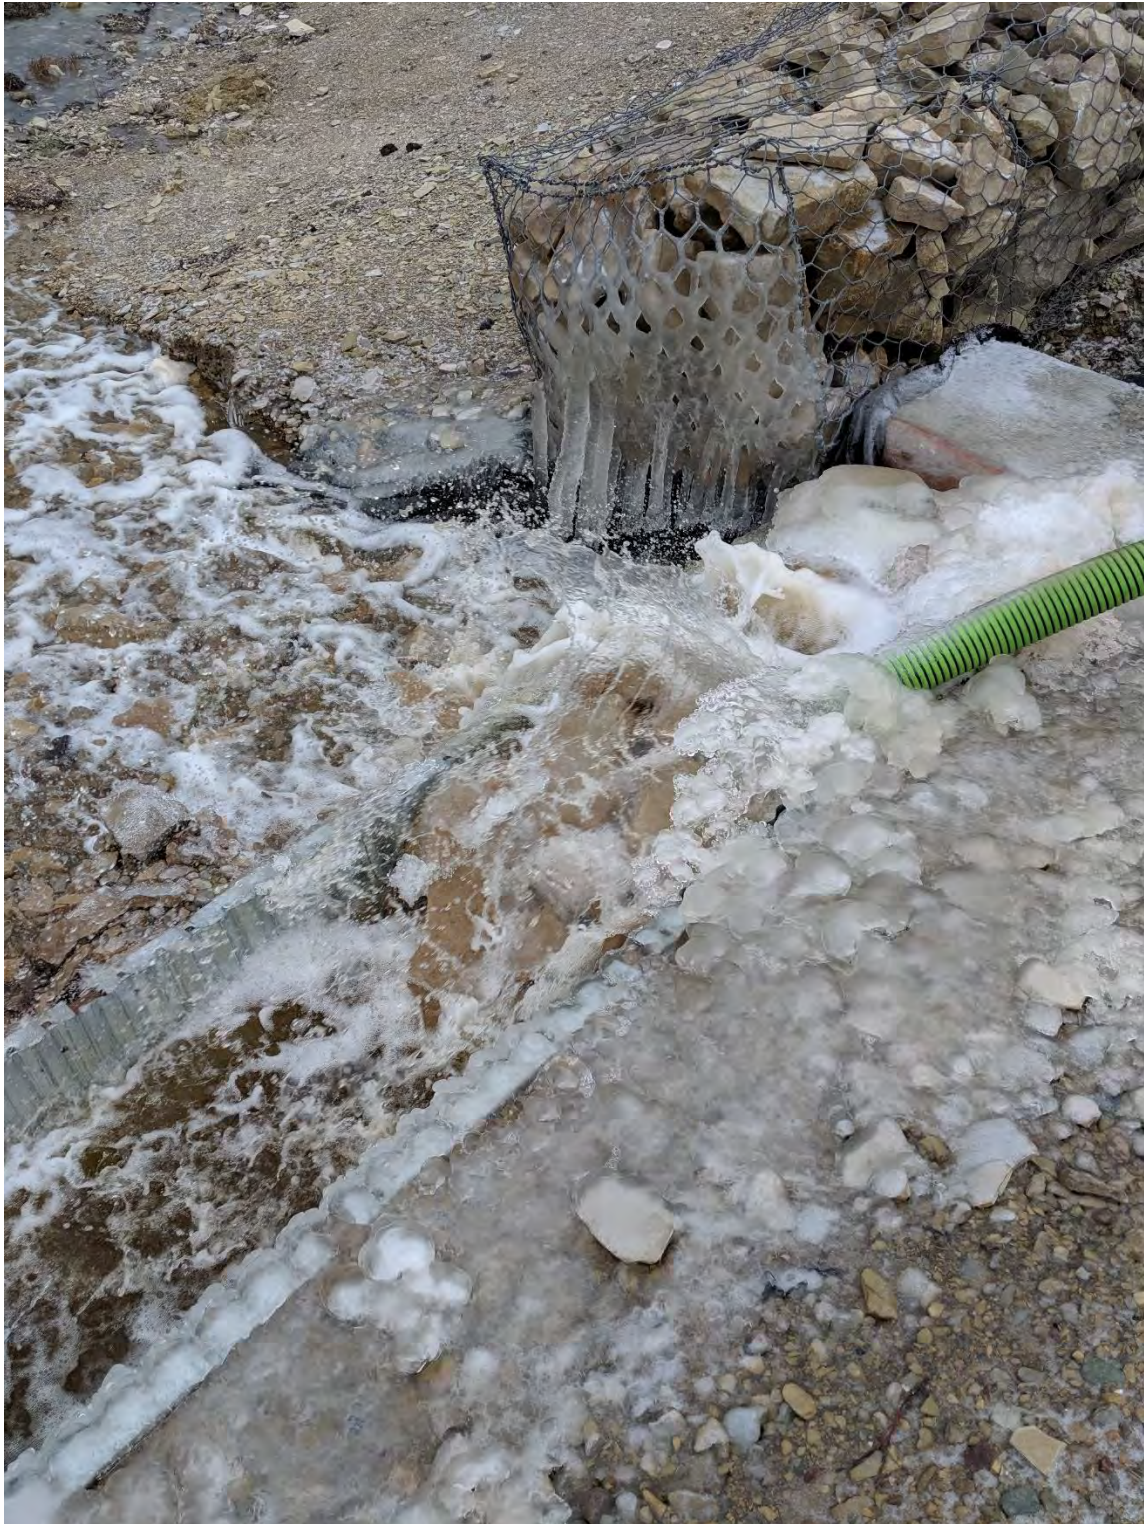
3. The wastewater within one cell of the lagoon was being pumped into the troughs located on the north side of the cell. From there, the water was decanting into the natural wetland and flowing across the wetland before making its way to the ocean. See picture 2 for pumping setup.

Photograph #2: Pumping operations.

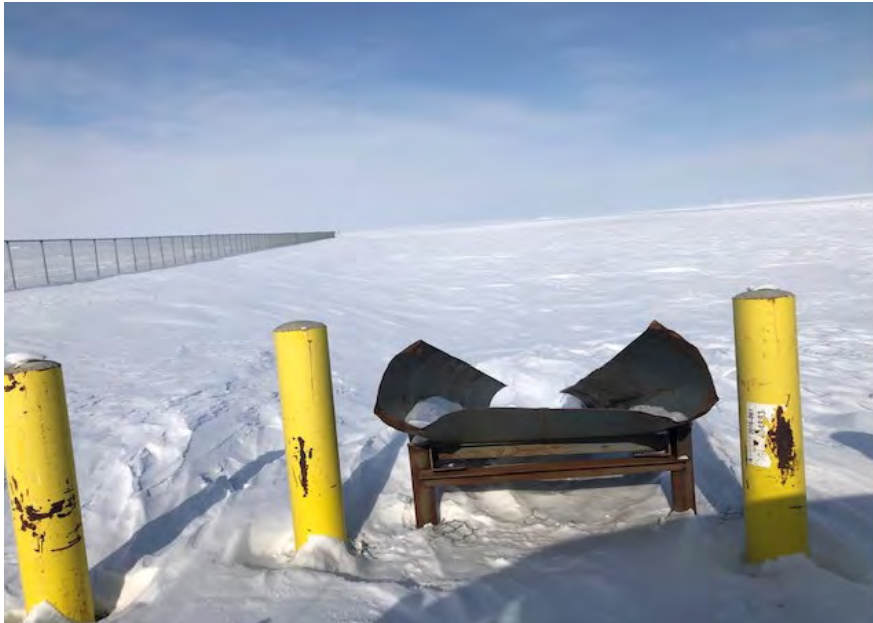
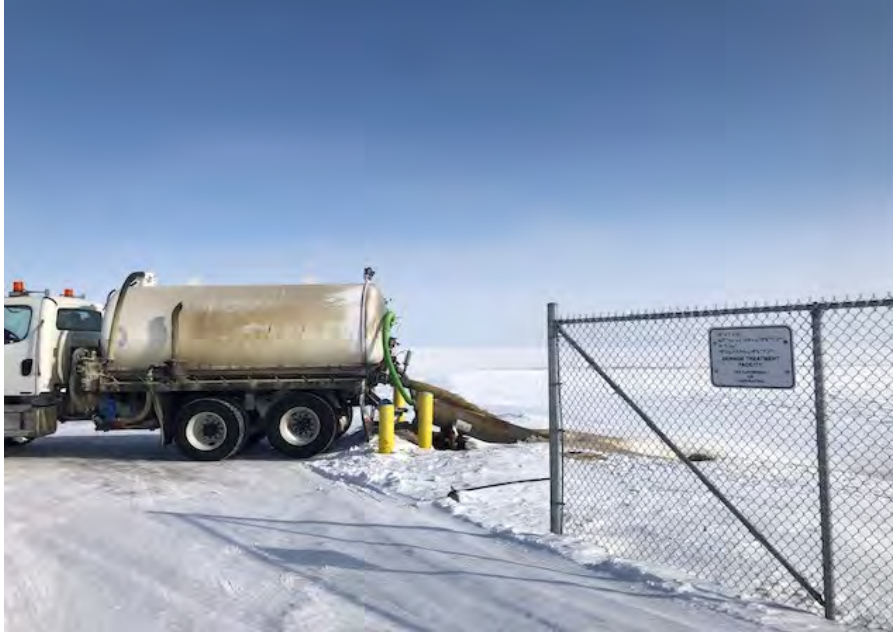
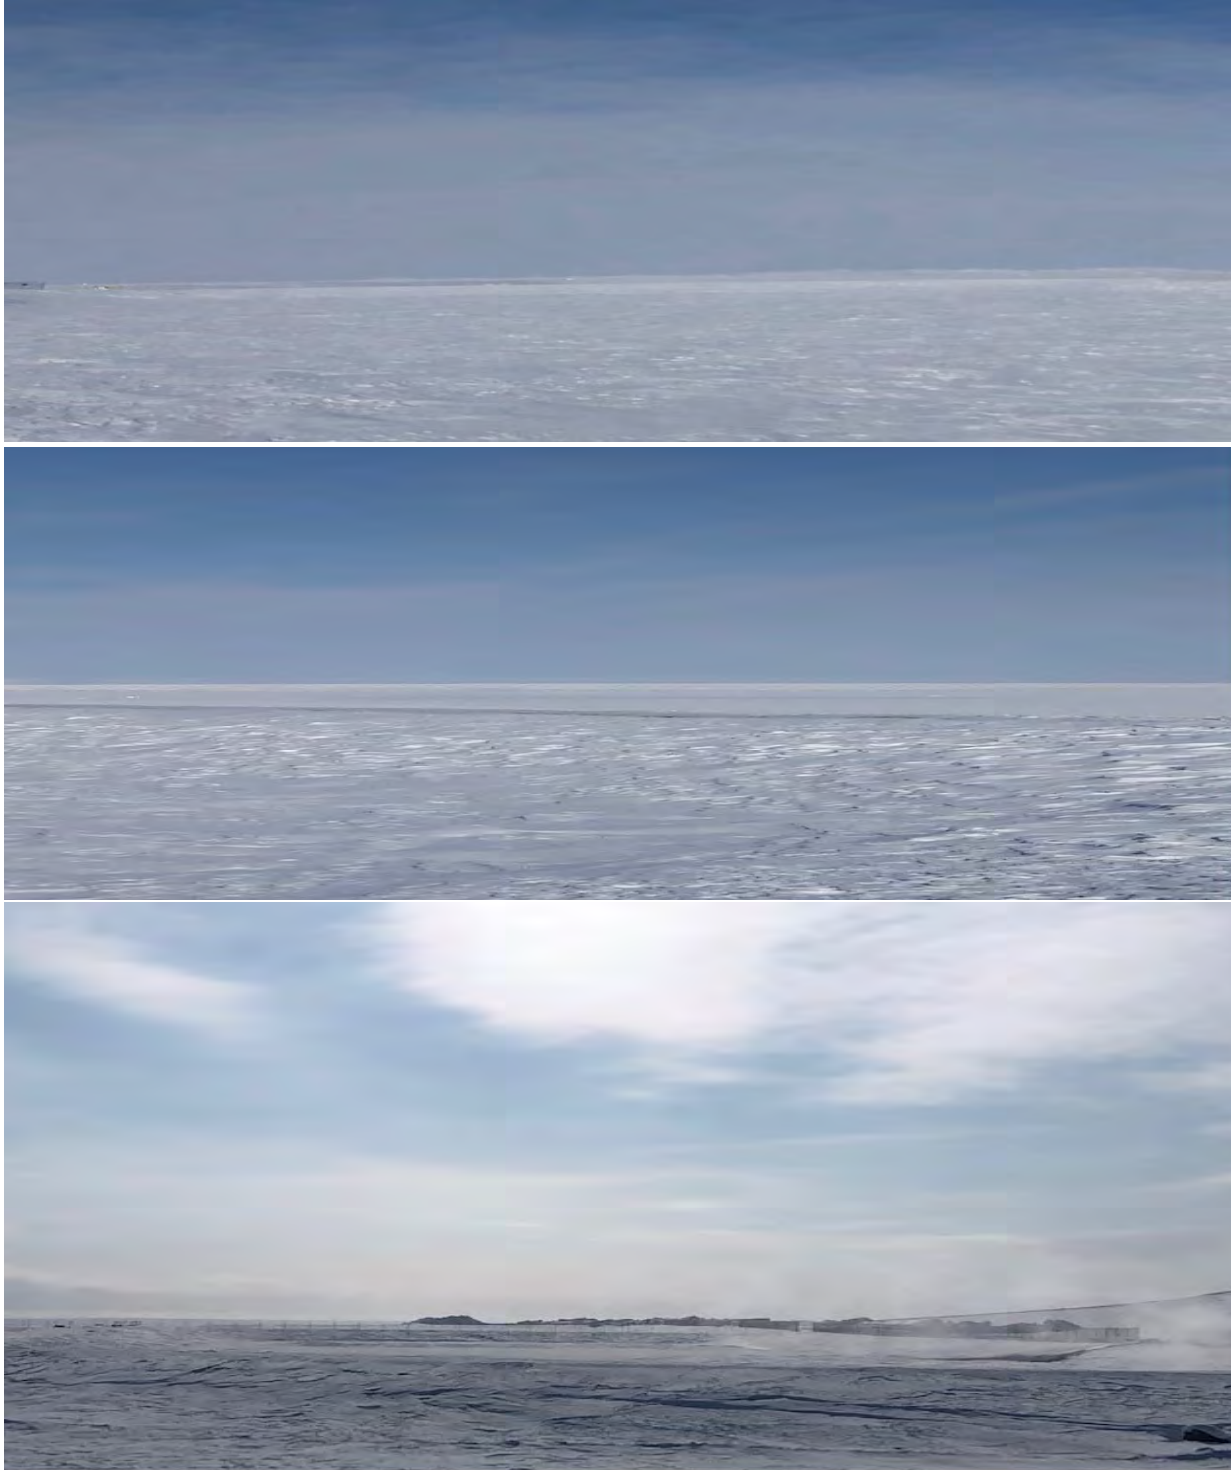
April 20<sup>th</sup> 2022.

**Upon visiting the sewage lagoon location, and visually inspecting cells A,B and C, attached photos are witnessing there was no visible sewage exfiltrating/seeping/or overflowing the lagoon cells.**

As per pictures taken, and visual inspection completed, CGS staff could not identify or confirm any faulty or concerning issues on either of 3 sewage lagoon cells. CGS rep and Municipality Director of Public Works agreed that summer inspection would be a must to:
