IGLOOLIK WASTEWATER TREATMENT FACILITY

SEWAGE LAGOON BERM 2022 DAM SAFETY INSPECTION, IGLOOLIK, NUNAVUT

PROJECT NO.: TE0223017
DATE: OCTOBER 2022

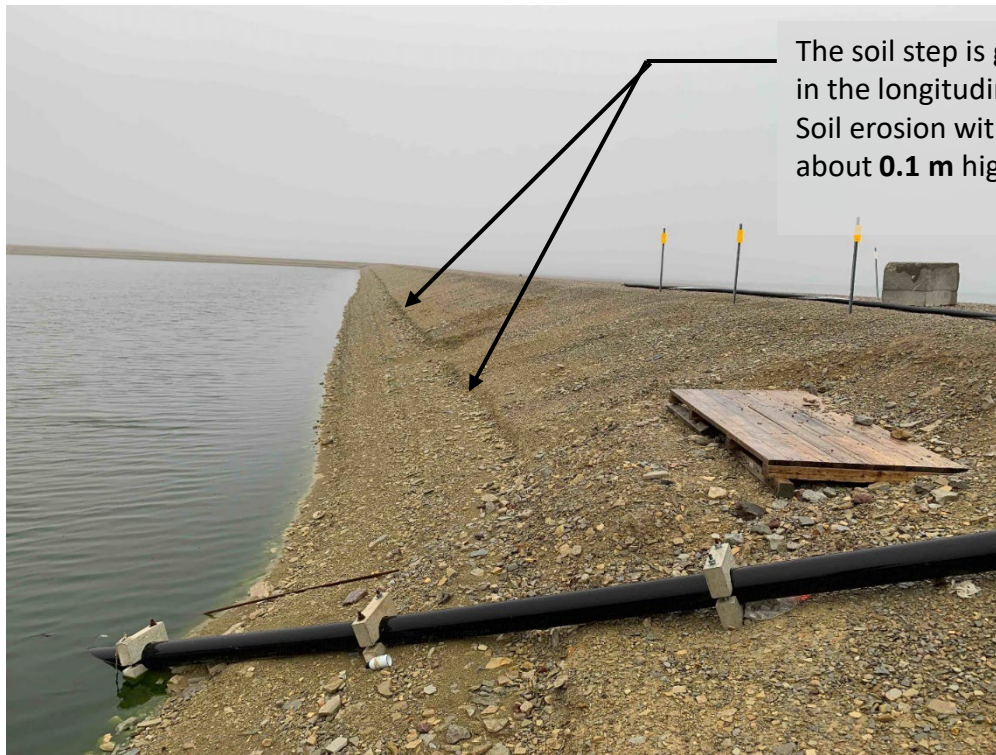
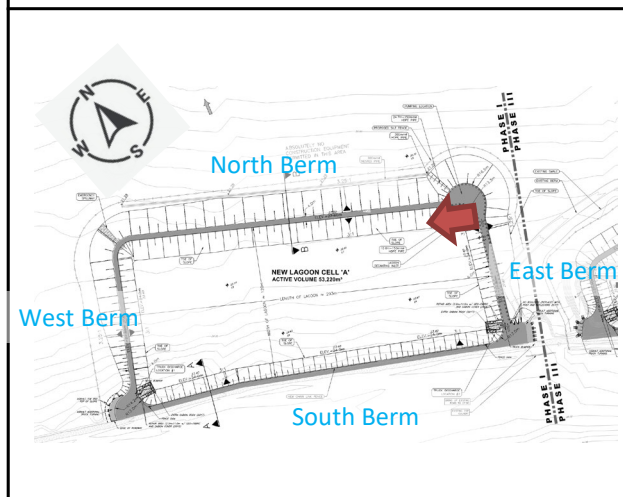
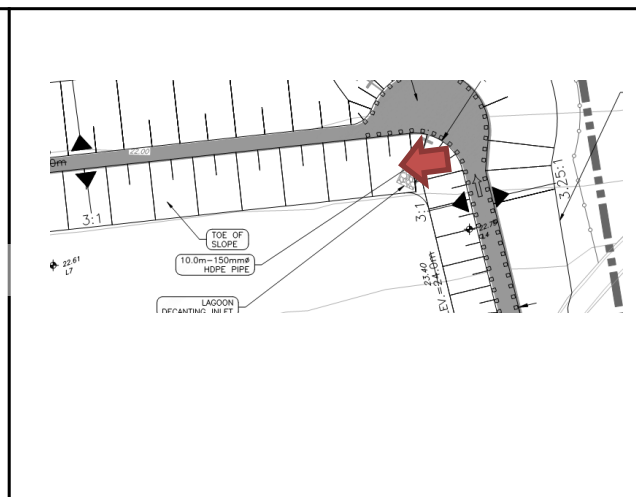
FIGURE
A1

Attributes	
Photograph	A – US –North Berm
Description	View of upstream slope
Observations	The soil step is generally uniform in the longitudinal direction. Soil erosion with steps up to about 0.1 m high. No sign of GCL exposure.
Remarks	There are signs of significant erosions.

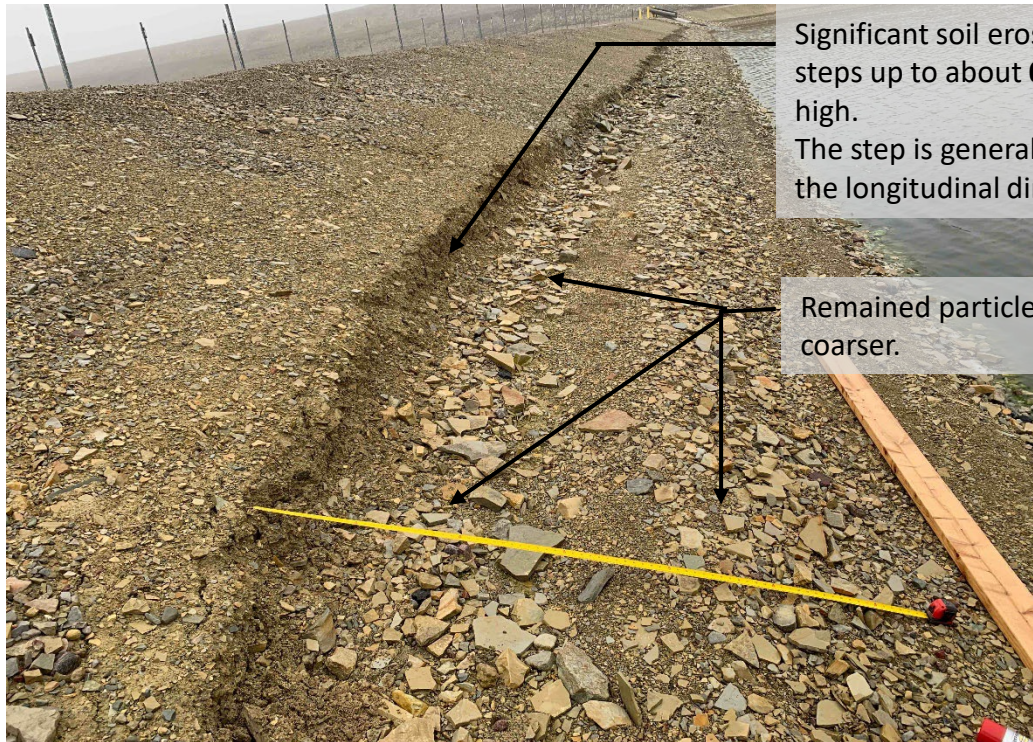
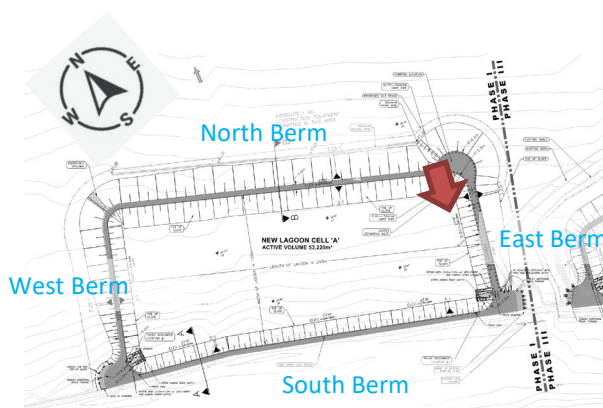
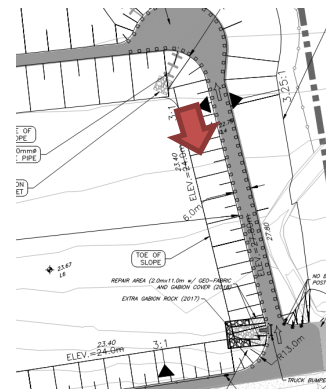
FIGURE
A2

Attributes	
Photograph	A – US –East Berm
Description	View of upstream slope
Observations	Significant soil erosion, with steps up to about 0.2 to 0.3 m high. Steps are generally uniform in the longitudinal direction. Remained particles at steps are coarser in general, indicating finer particles have likely been washed out. No sign of GCL exposure.
Remarks	There are signs of significant erosions.

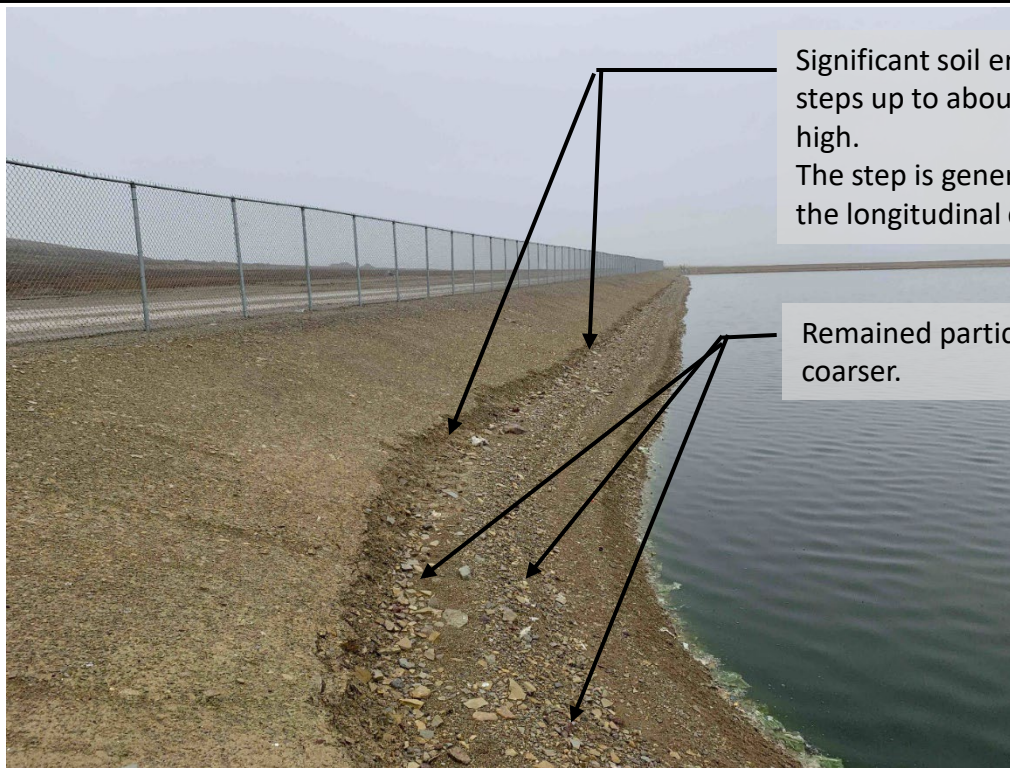
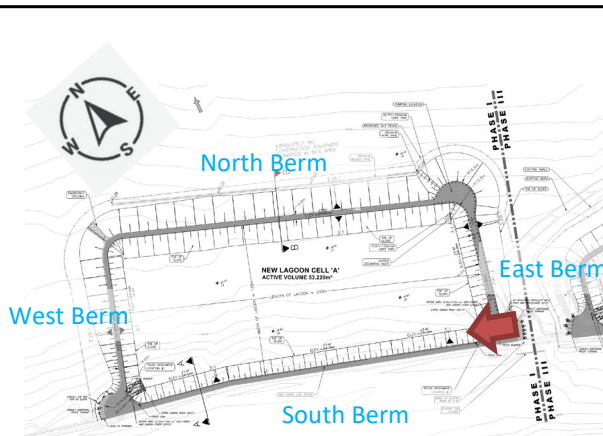
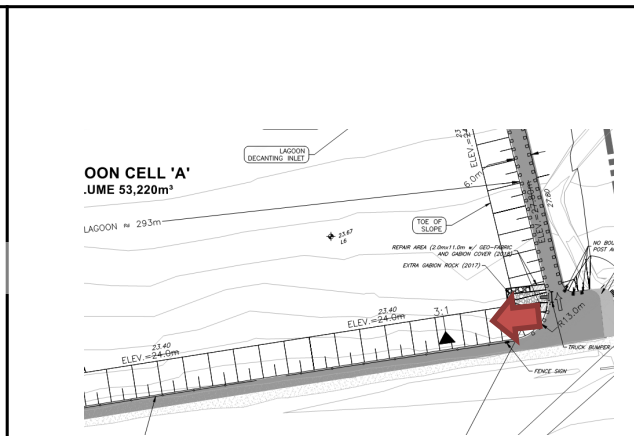
FIGURE
A3

Attributes	
Photograph	A – US –South Berm
Description	View of upstream slope
Observations	<p>Soil erosion, with steps up to about 0.1 to 0.15 m high.</p> <p>Steps are generally uniform in the longitudinal direction.</p> <p>Remained particles at steps are coarser in general, indicating finer particles have likely been washed out.</p> <p>No sign of GCL exposure.</p>
Remarks	There are signs of significant erosions.

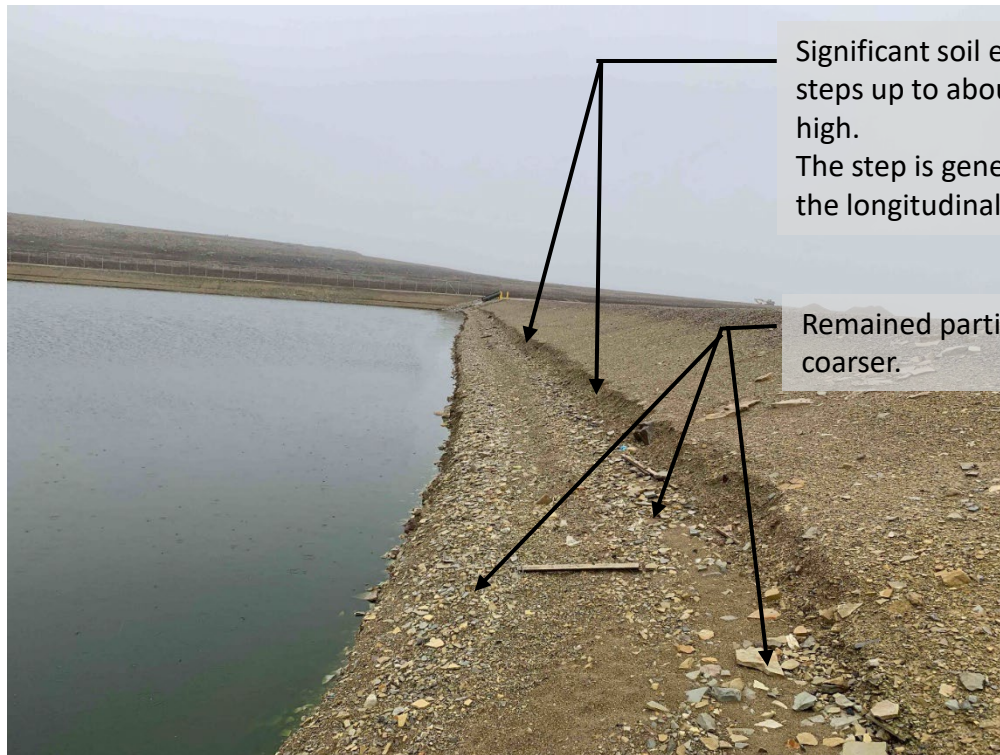
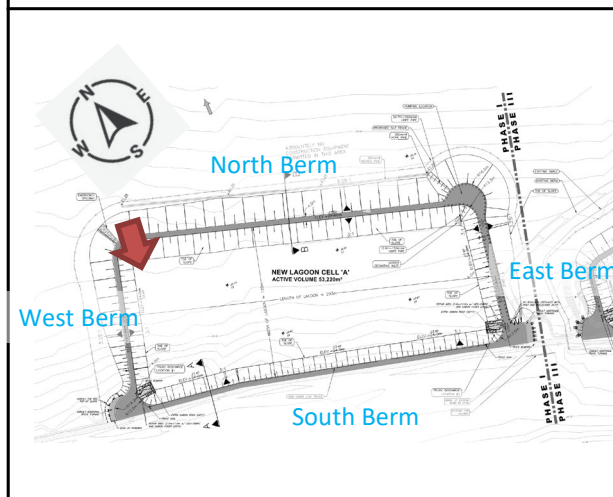
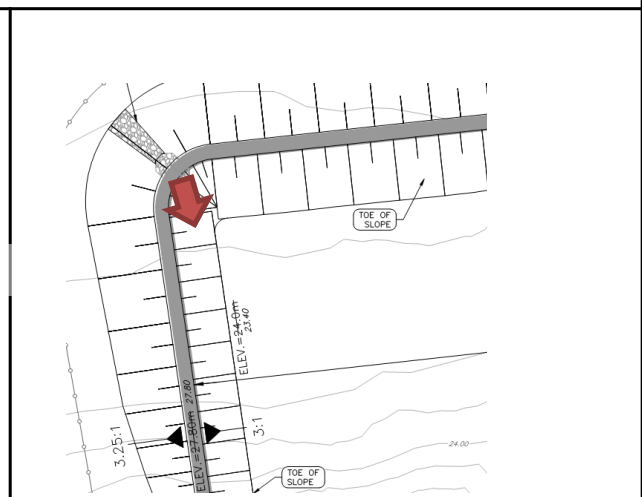
FIGURE
A4

Significant soil erosion, with steps up to about 0.2 m to 0.3 m high.
The step is generally uniform in the longitudinal direction.

Remained particles at steps are coarser.

Attributes	
Photograph	A – US – West Berm
Description	View of upstream slope
Observations	Soil erosion, with steps up to about 0.2 to 0.3 m high. Steps are generally uniform in the longitudinal direction. Remained particles at steps are coarser in general, indicating finer particles have likely been washed out. No sign of GCL exposure.
Remarks	There are signs of significant erosions.

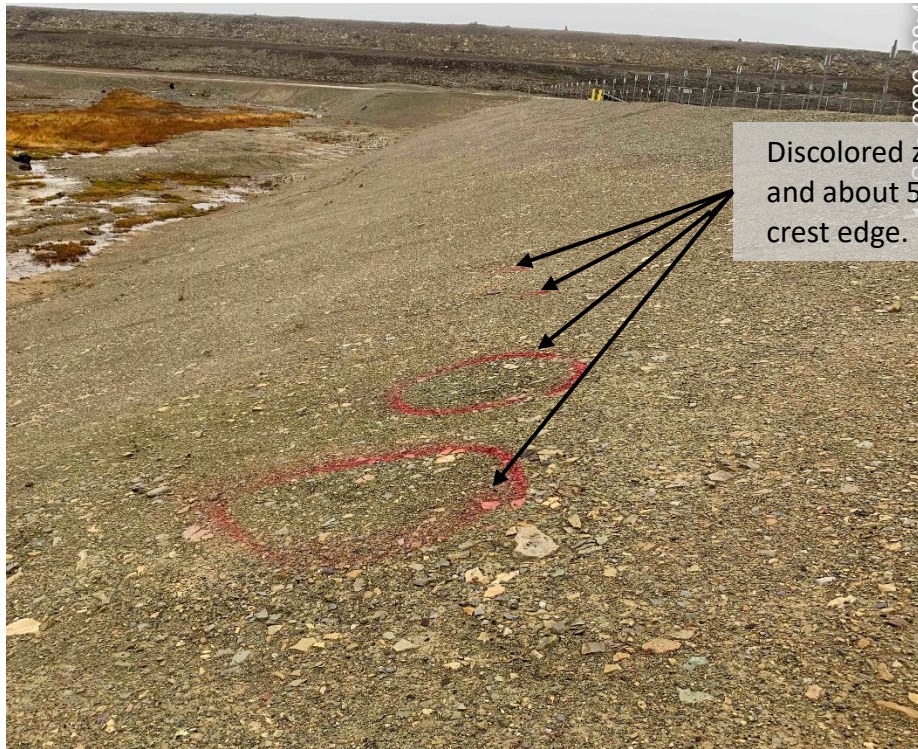
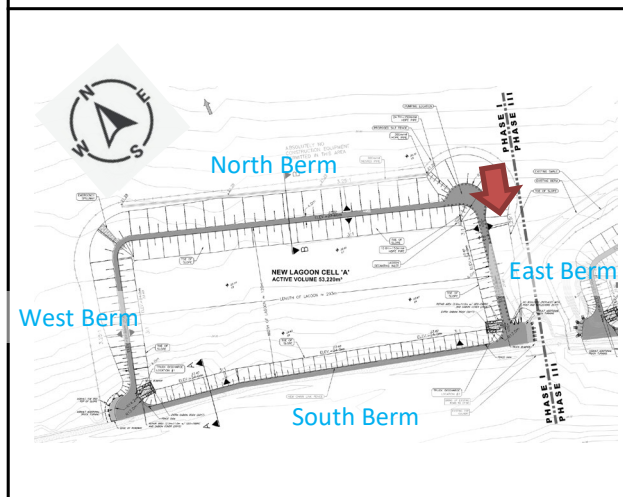
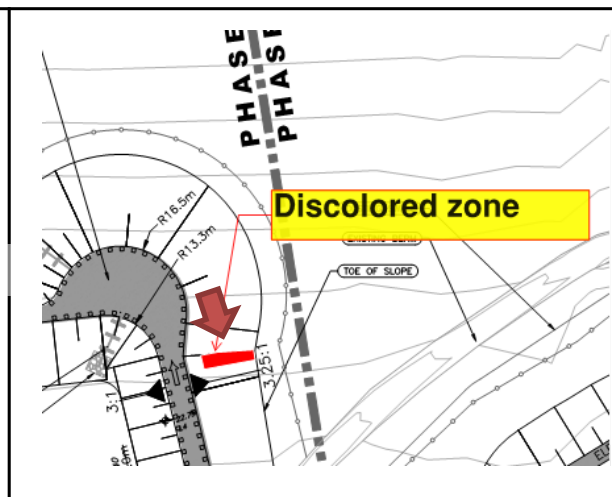
FIGURE
A5

Attributes	
Photograph	A – DS – Seepage at East Berm
Description	View of sign of seepage at downstream slope
Observations	<ul style="list-style-type: none"> - A discolored zone encountered at downstream slope at east berm. - The discolored zone about 5 m wide and about 5 m distance from the crest edge. The elevation of this zone is about 1.5 m below the crest. - No sign of active seepage / sink holes during inspection.
Remarks	The discolored zone indicates a previous seepage at the downstream slope of East Berm.

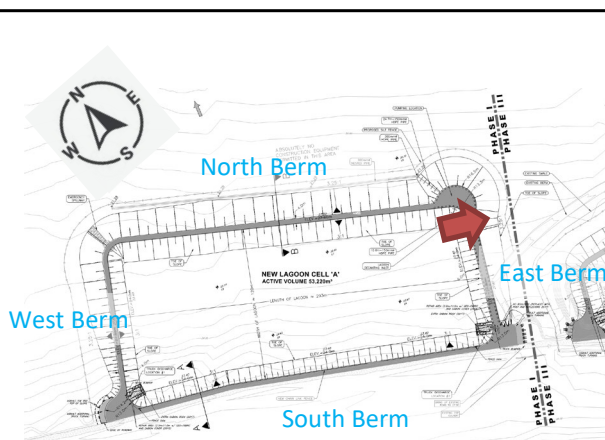
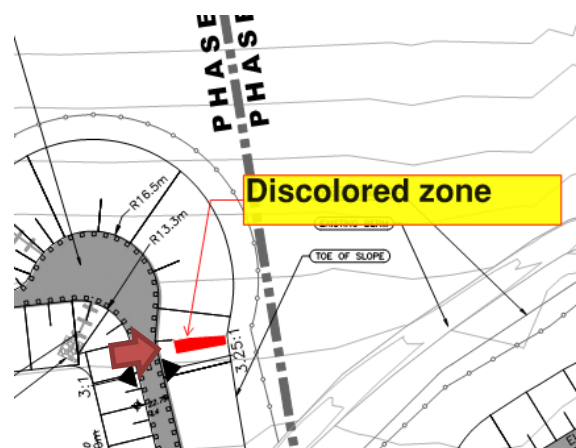
Active seepage zone observed when Cell A had high water level.

Note: Photo was taken by Mr. Steve Weedmark on August 29 2021.

Attributes	
Photograph	A – DS – Seepage at East Berm
Description	View of seepage from downstream slope
Observations	- Active seepage was observed during high water level in Cell A.
Remarks	The photo confirmed the presence of seepage from downstream slope of East Berm.

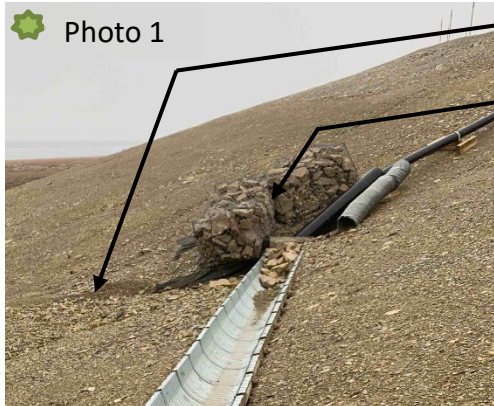
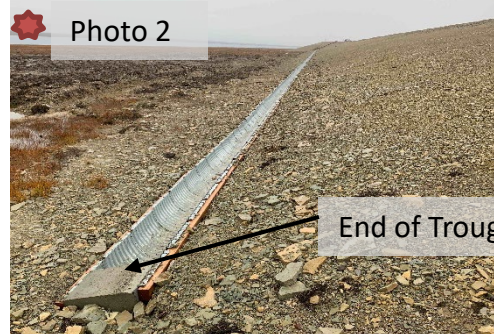
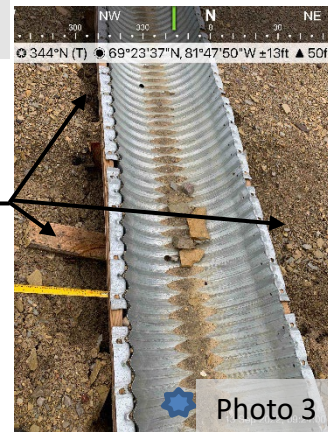
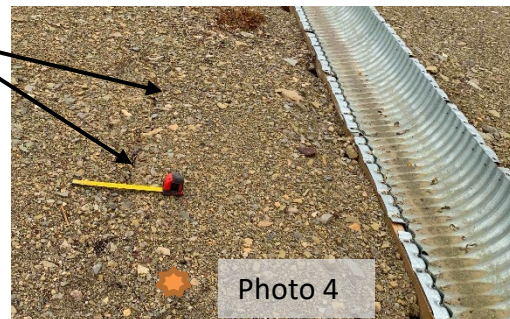
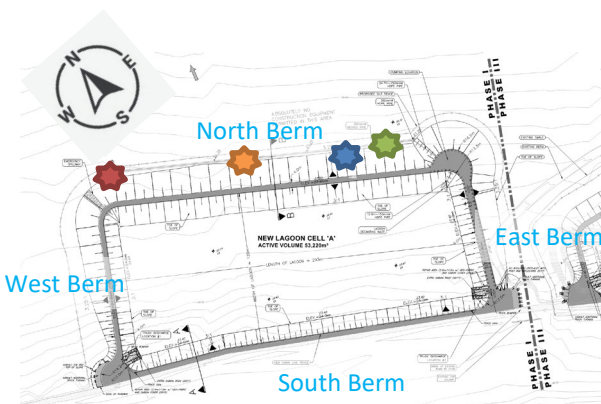
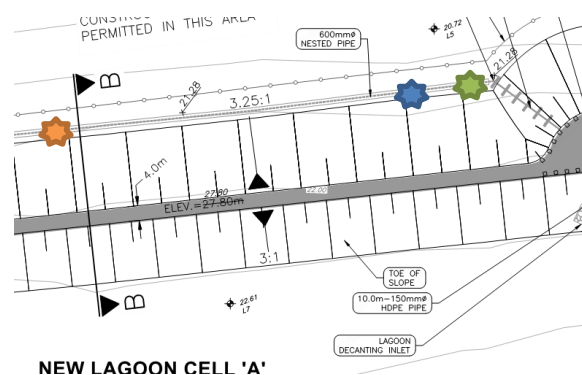
FIGURE
A11

- The inlet and outlet pipes were generally in good condition.
- The trough was dry and was not in operation during the inspection.
- There were signs of water flow (evident by discolored zones) towards the east, the opposite direction of the trough, see Photo 1 in Figure A12.

- There was no obvious sign of water near the west end (outlet) of the trough (see Photo 2 in Figure A12), indicating that the decant flow may not always reach the west end to fully utilize the trough.

- Significant erosion (wash-out) was observed below and near the trough (see Photo 3 in Figure A12). The erosion scars below the trough were up to 400 mm deep and 200 mm to 400 mm wide at both upstream and downstream sides. This is possibly due to the localized water flow through the perforations during decanting. Runoff from the downstream slope may also contribute to the erosion at a certain level.

Sign of water flow to east

Connection between trough and outlet pile

Erosion below trough

Cracks at downstream slope near the trough

Photograph	A – Trough
Description	View of trough
Observations	<p>Trough is currently not in operation. Dry condition for the trough. (See Photo 1, 2)</p> <p>Erosions below trough up to 0.4 m deep and 0.2 m to 0.4 m wide for both sides. (See Photo 3)</p> <p>Cracks at downstream slope near trough are about 10 to 25 mm (See Photo 4)</p>
Remarks	<p>Significant erosions near the trough.</p> <p>Cracks at downstream slope near trough are local and isolated with a width from 10 mm to 25 mm.</p>

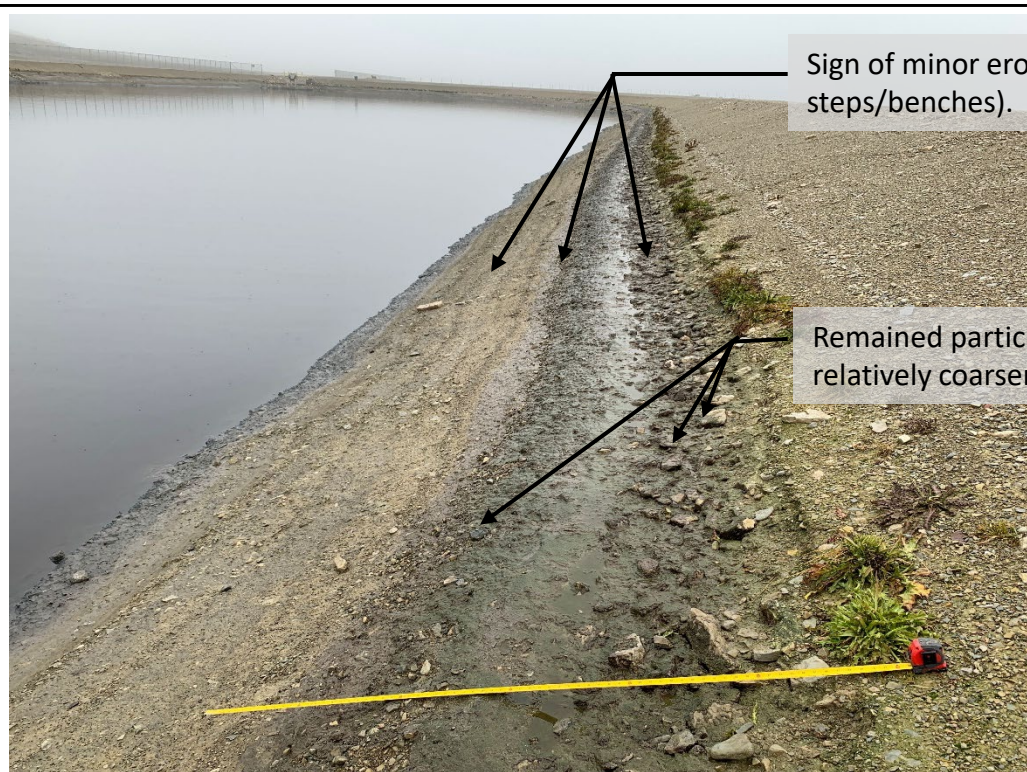
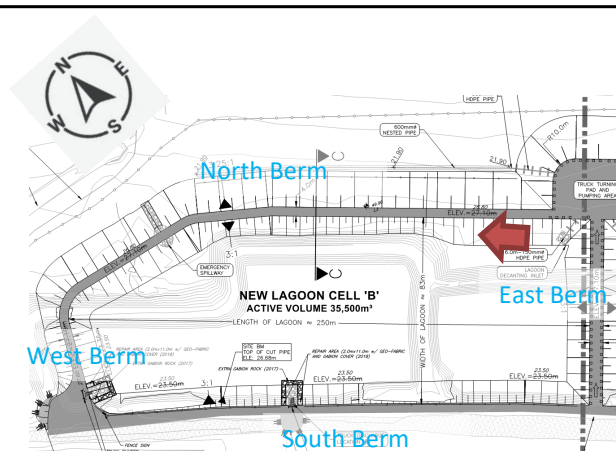
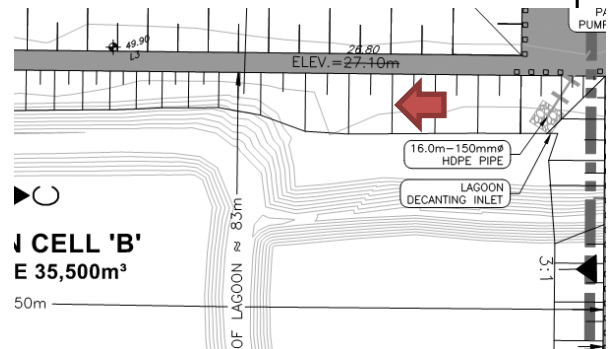
Sign of minor erosion (minor soil steps/benches).

Remained particles are relatively coarser.

Attributes	
Photograph	B – US –North Berm
Description	View of upstream slope
Observations	Sign of minor erosion, noting coarser particles at upstream slope. No visible soil steps or benches. No sign of GCL exposure.
Remarks	There is signs of minor erosion.

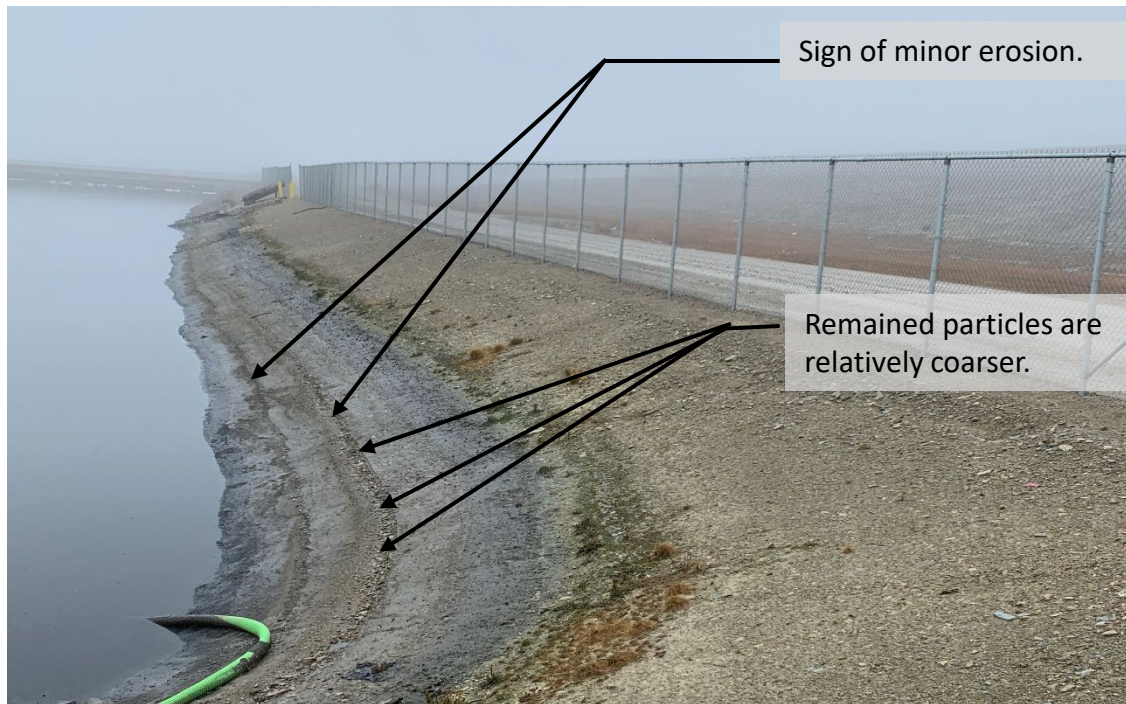
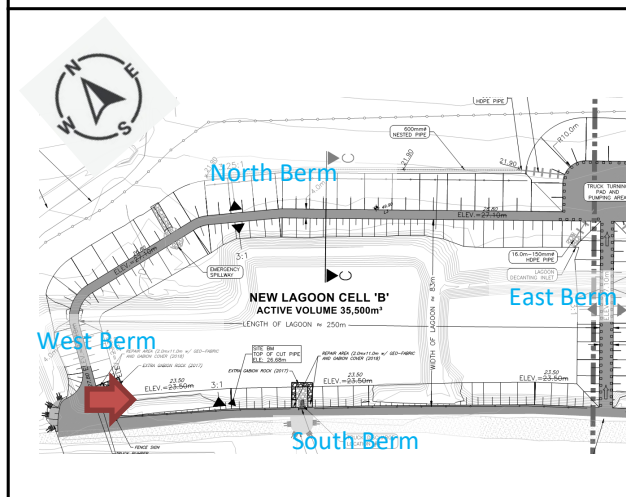
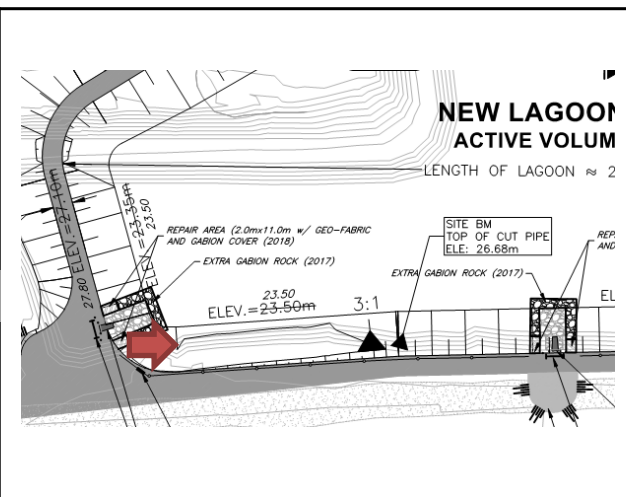
FIGURE
A17

Attributes	
Photograph	B – US –South Berm
Description	View of upstream slope
Observations	Sign of minor erosion, noting coarser particles at upstream slope. No visible soil steps or benches. No sign of GCL exposure.
Remarks	There are signs of minor erosion.

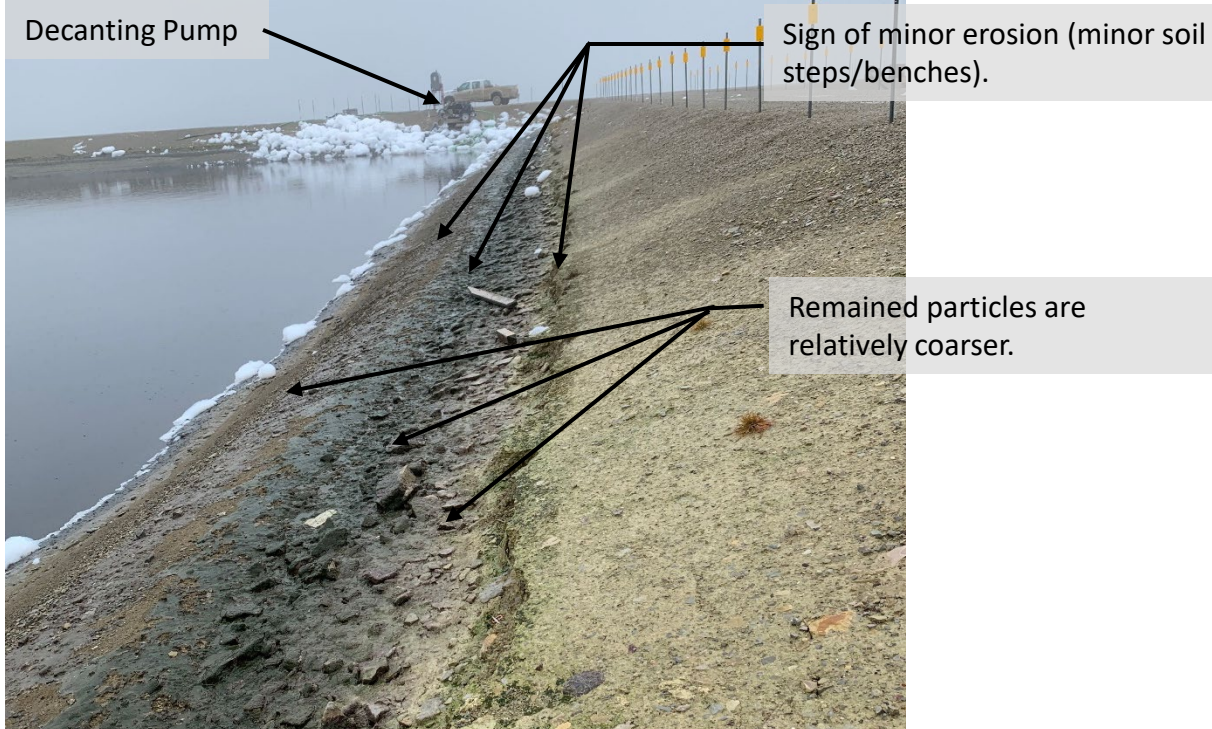
FIGURE
A18

Attributes	
Photograph	B – US –East Berm
Description	View of upstream slope
Observations	Sign of minor erosion, noting coarser particles at upstream slope. No visible soil steps or benches. No sign of GCL exposure.
Remarks	There are signs of minor erosion.

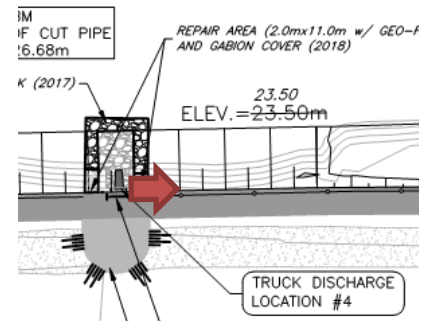
Minor cracks

Attributes	
Photograph	B – Upstream Slope – South Berm
Description	View of upstream slope
Observations	Minor cracks were observed near crest, parallel with the longitudinal direction.
Remarks

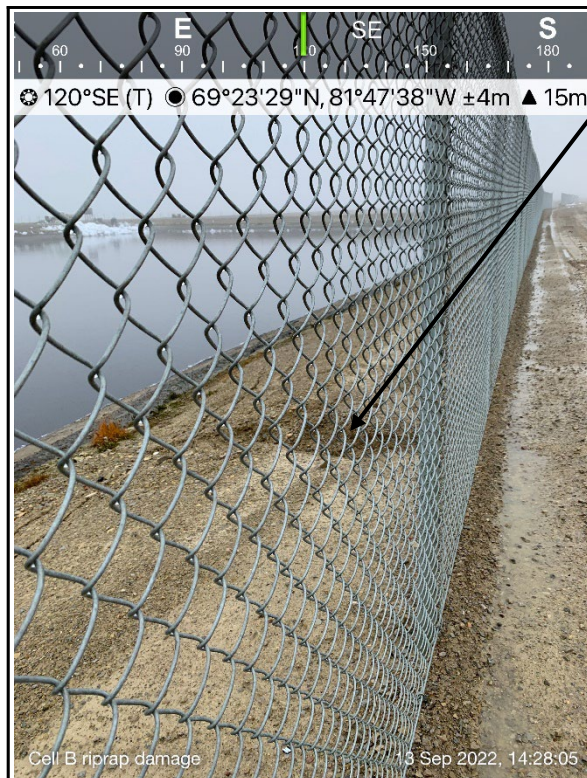
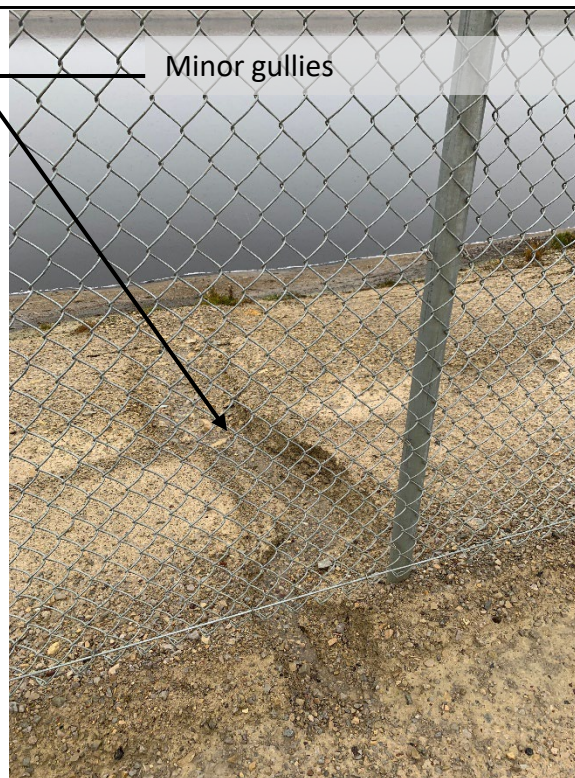
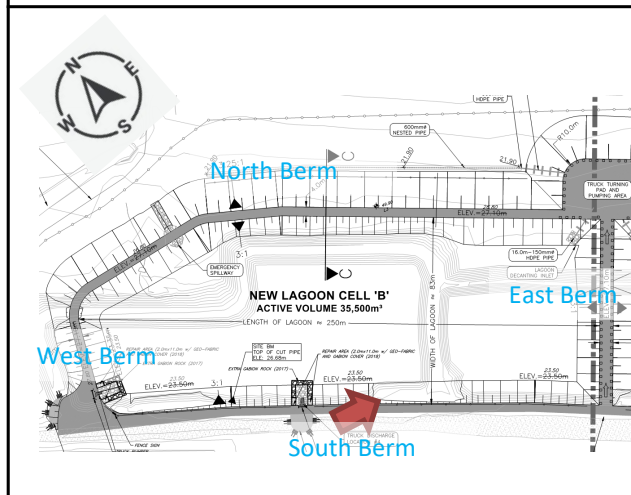
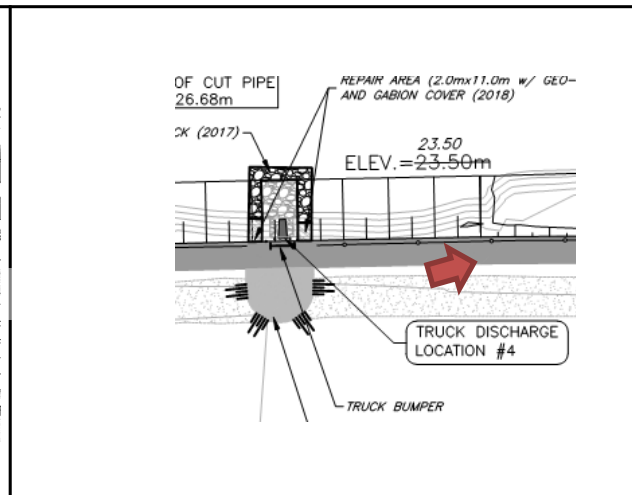
FIGURE
A20

Attributes	
Photograph	B – Upstream Slope – South Berm - Minor Gully
Description	View of minor gullies near crest
Observations	Local and isolated gullies.
Remarks	Routine maintenance to address this issue.

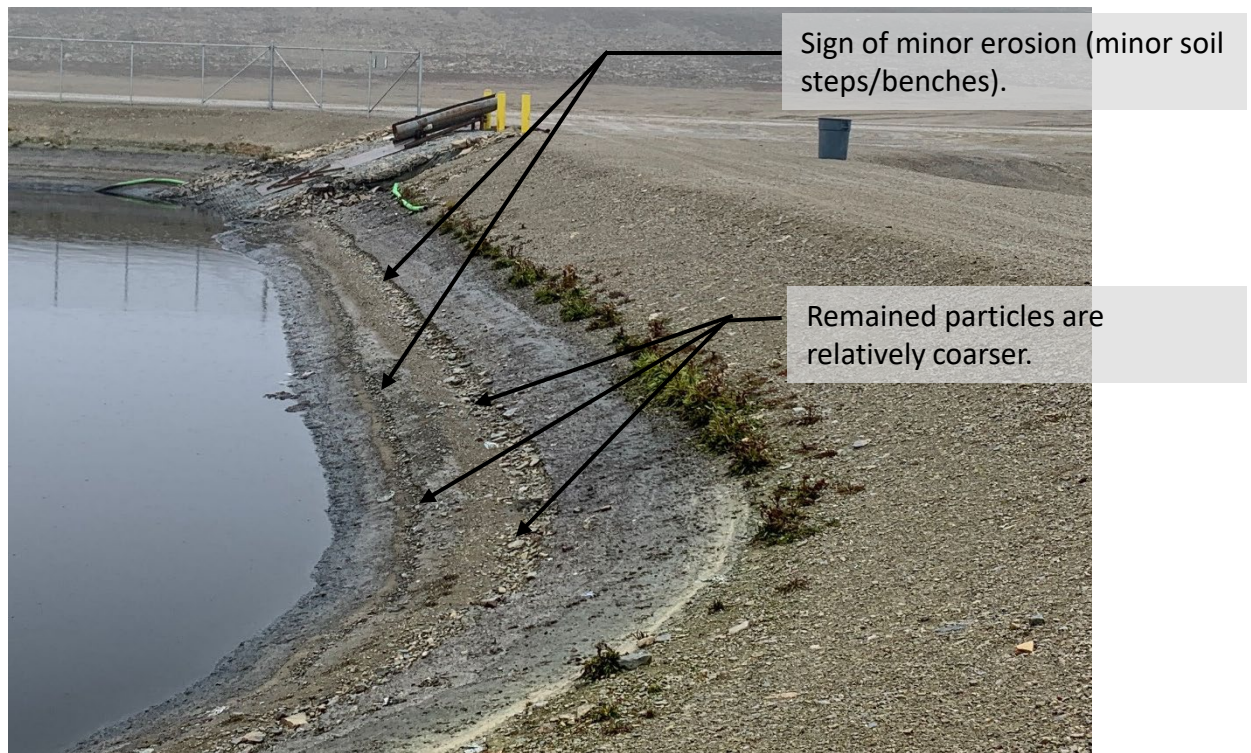
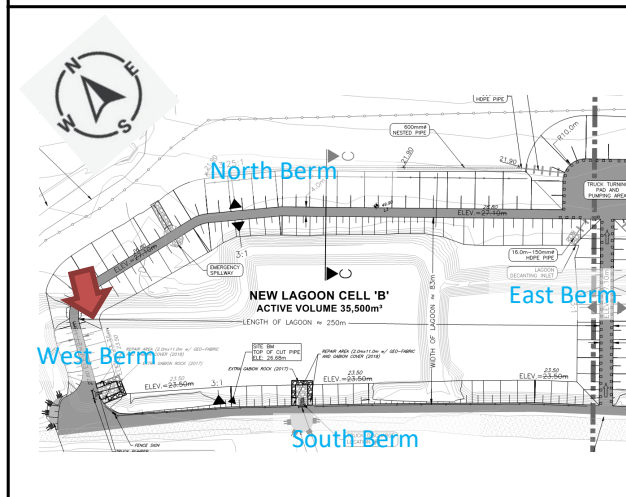
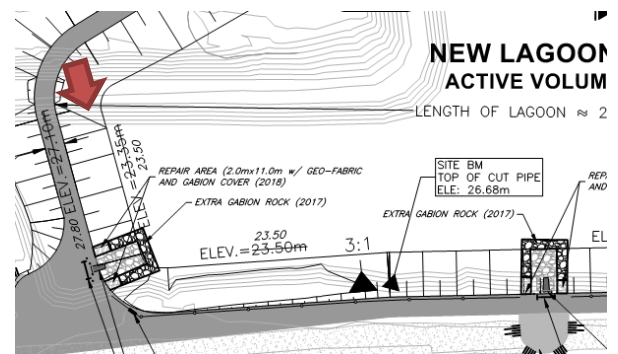
FIGURE
A21

Attributes	
Photograph	B – US –West Berm
Description	View of upstream slope
Observations	Sign of minor erosion, noting coarser particles at upstream slope. No visible soil steps or benches. No sign of GCL exposure.
Remarks	There are signs of minor erosion.

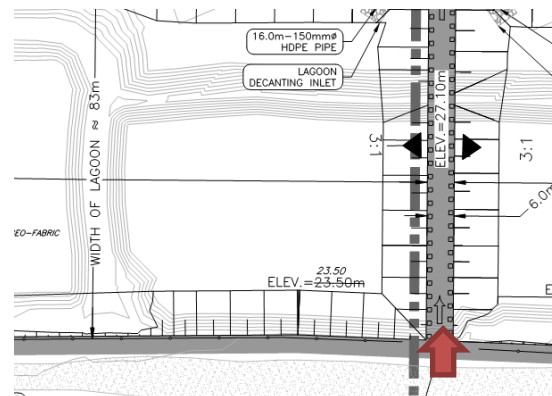
Crest generally in a good condition.

Photograph	C – Crest – West Berm
Description	View of crest
Observations	No signs of settlement, erosion, cracks. Minor ponding water after rainfalls. The bollards at the crest were in a good condition with no sign of settlement and deflection
Remarks	The crest is in a good condition.

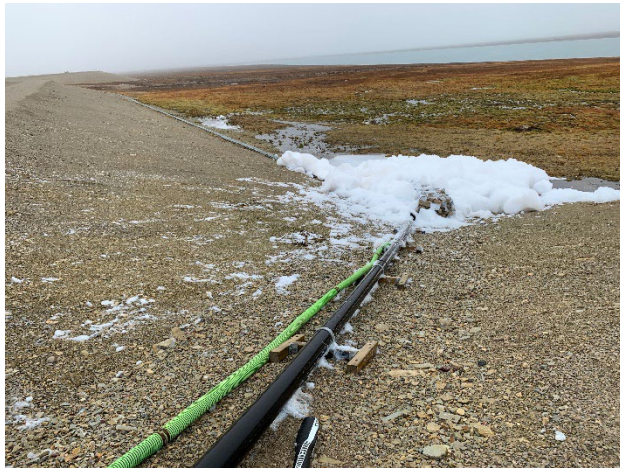
Decanting pump in operation
Downstream - Outlet

Photograph	B – Decanting Pump
Description	View of decanting in operation
Observations	Decanting in operation using 3" pump.
Remarks	Decanting operation lasts about 5 days for Cell B

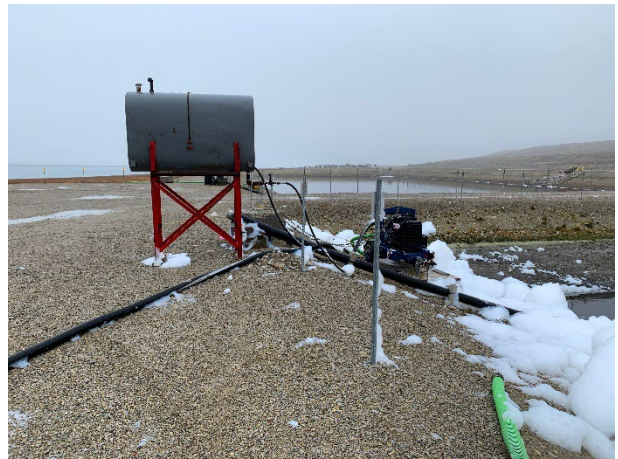
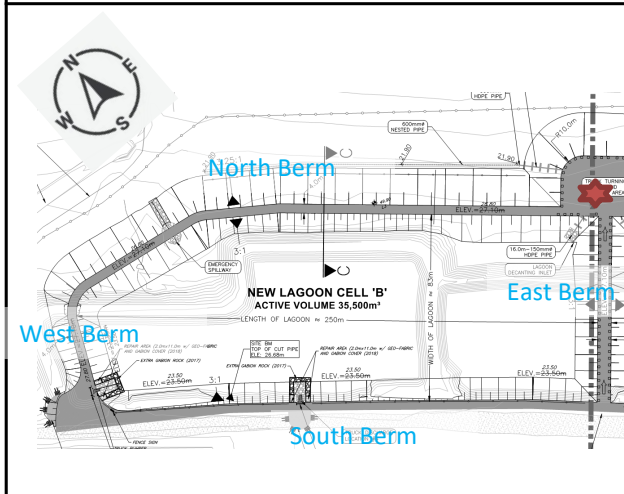
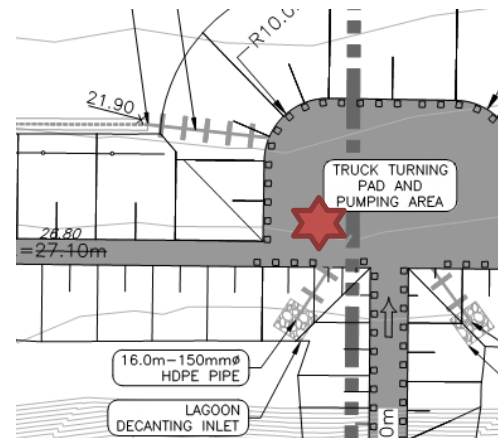
Decanting pump in operation
Upstream - Inlet

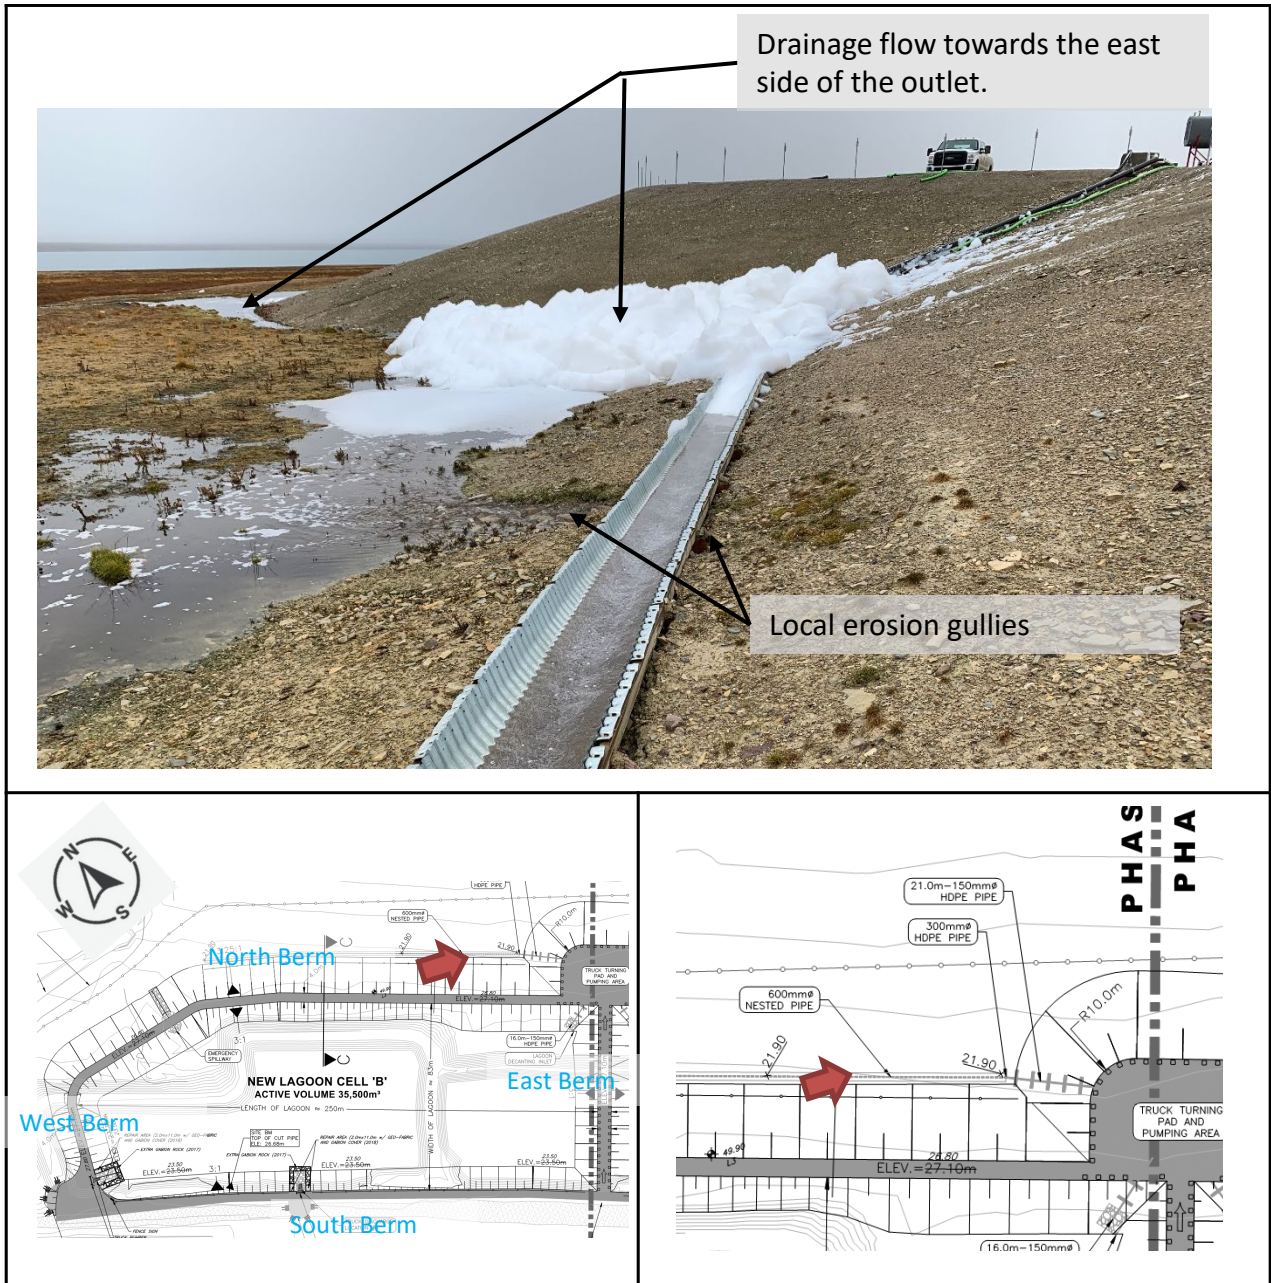
Attributes	
Photograph	B – Trough
Description	View of drainage flow
Observations	Some drainage flow towards east along the toe of berm. Some erosion gullies below and near the trough. Water level in trough is well below the side wall.
Remarks	The trough appears function well to direct the drainage flow as per the design intent.

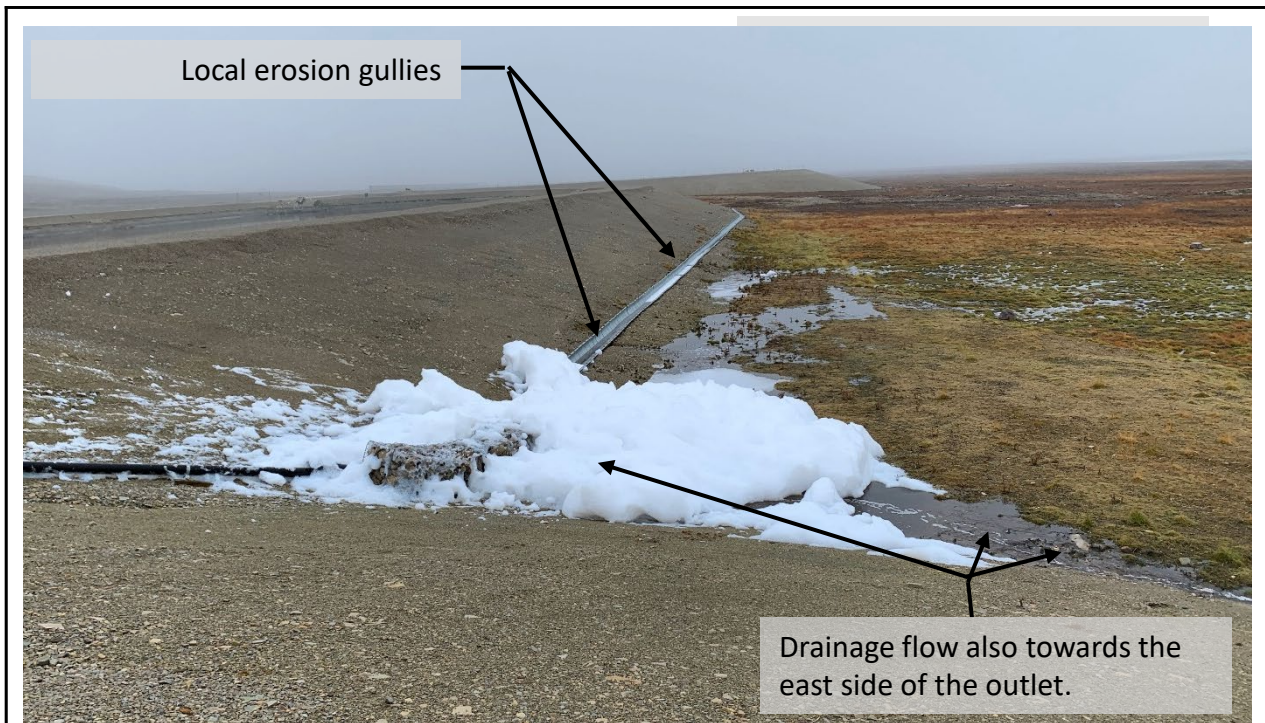
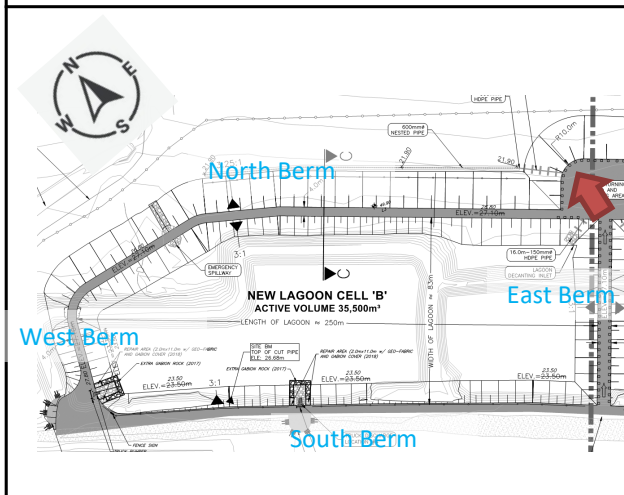
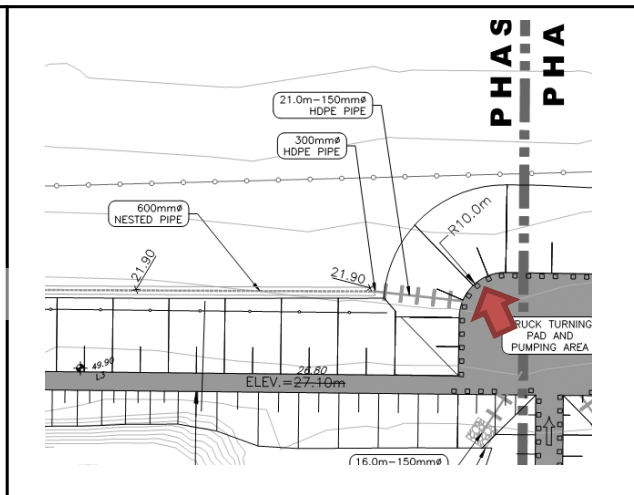
Attributes	
Photograph	B – Trough
Description	View of drainage flow
Observations	Some drainage flow towards east along the toe of berm. Some erosion gullies below and near the trough.
Remarks	The tie-in between the trough and outlet pipe may be improved to direct the drainage flow to the trough.

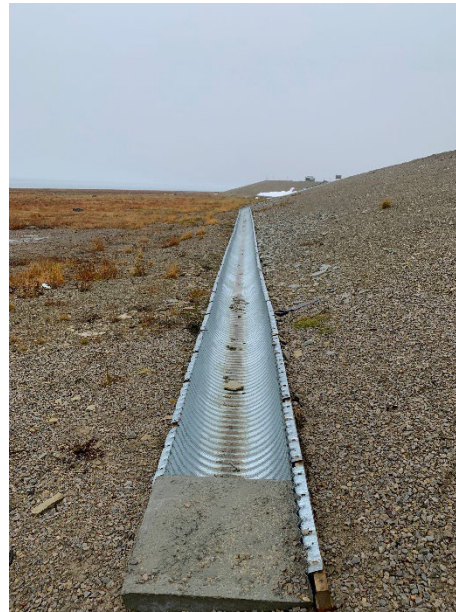
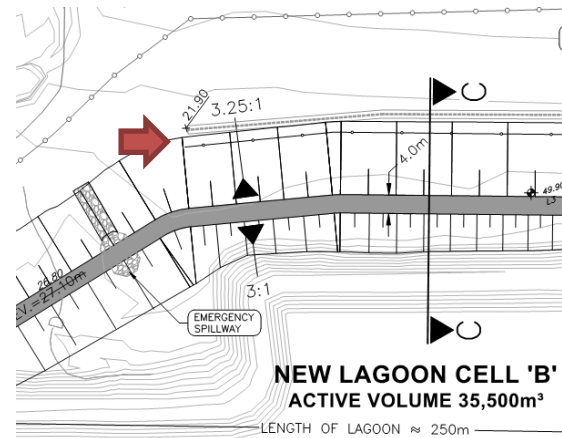
Dry condition at the end of the drainage trough.

Photograph	B –Trough - North Berm
Description	View of trough
Observations	Dry condition was encountered along the westerly one third of the trough.
Remarks	The site grading may cause the dry condition of the trough during decanting.

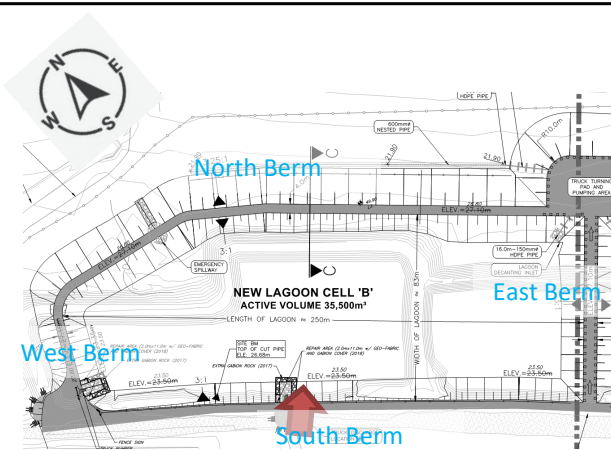
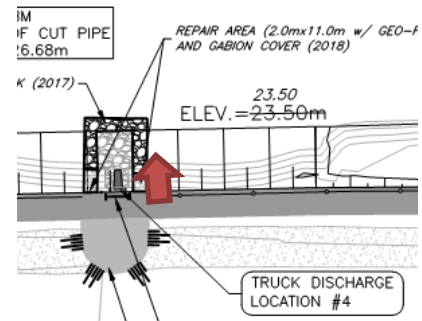
Local riprap damage

Photograph	B – US –East Truck Discharge Facility (#4) - Local Riprap Damage
Description	View of local riprap damage at upstream slope
Observations	Sign of riprap damage from waste-water dumping. The operation staff indicated that the riprap damage was due to the truck dumping away from the designed location.
Remarks	There are signs of local riprap damage from truck dumping slightly off the designed discharge location.

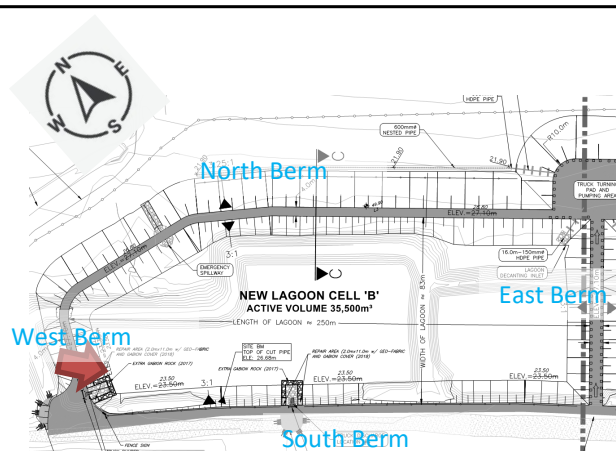
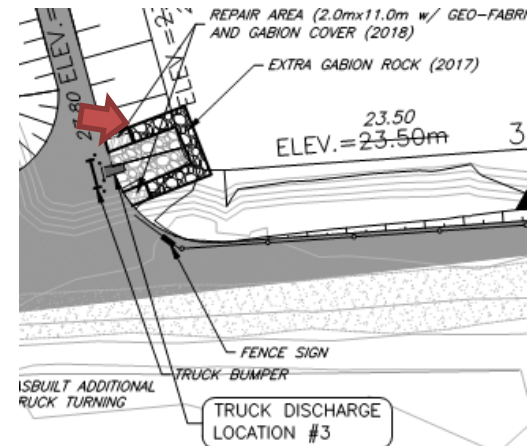
Attributes	
Photograph	B – US –West Truck Discharge Facility (#3) -Local Riprap Damage
Description	View of local riprap damage at upstream slope
Observations	Sign of riprap damage from waste-water dumping. The operation staff indicated that the riprap damage was due to the truck dumping away from the designed location.
Remarks	There are signs of local riprap damage from truck dumping slightly off the designed discharge location.
