IGLOOLIK WASTEWATER TREATMENT FACILITY

SEWAGE LAGOON BERM 2022 DAM SAFETY INSPECTION, IGLOOLIK, NUNAVUT

PROJECT NO.: TE0223017
DATE: OCTOBER 2022

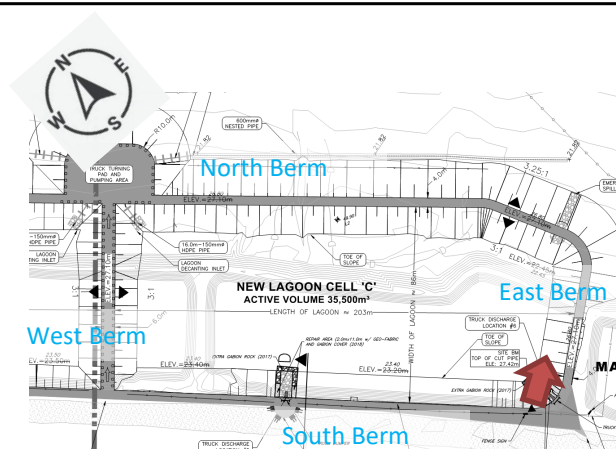
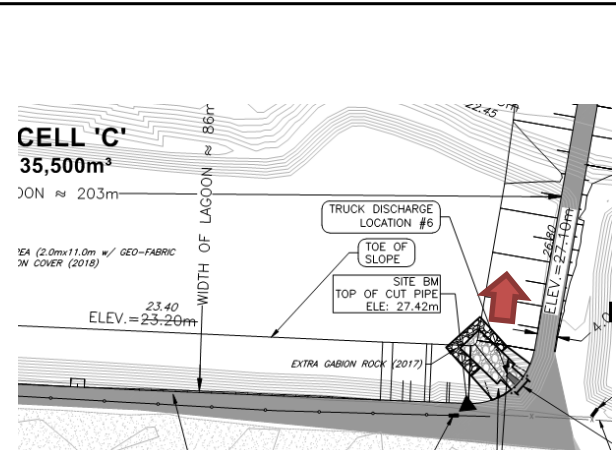
Generally good condition.
Sign of minor washout, noting
the coarser particles

Sign of minor washout,
noting the coarser particles

Attributes	
Photograph	C – US – East Berm
Description	View of upstream slope
Observations	No visible signs of significant erosion such as soil steps or benches. Sign of minor washout, noting the coarser particles.
Remarks	The slope is in a good condition

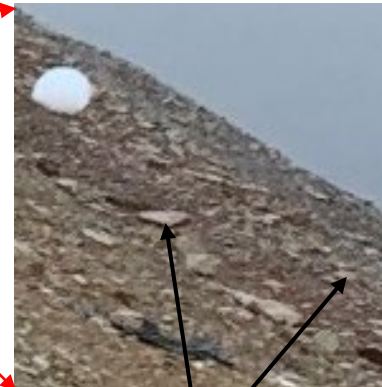
Generally good condition.

Photograph	C – US – West Berm
Description	View of upstream slope
Observations	No visible signs of significant erosion such as soil steps or benches. Sign of minor washout, noting the coarser particles.
Remarks	The slope is in a good condition

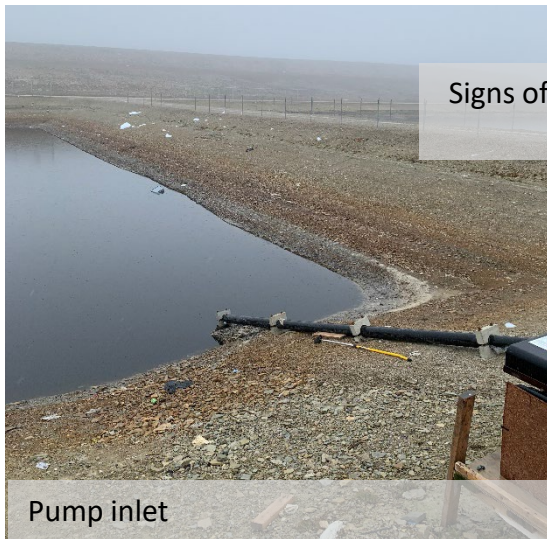
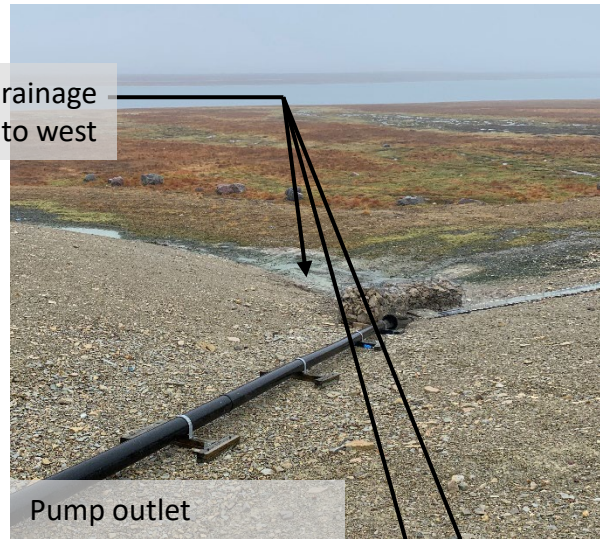
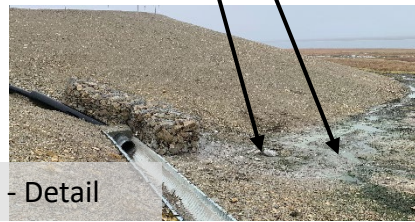
Signs of drainage
to west

Photograph	C – Pump – Inlet and outlet at North Berm
Description	View of Inlet and outlet
Observations	Equipment not in operation. Sign of drainage towards west side.
Remarks	The pump equipment appears in a good condition. It indicates that some drainage may flow to west instead following the trough as designed.

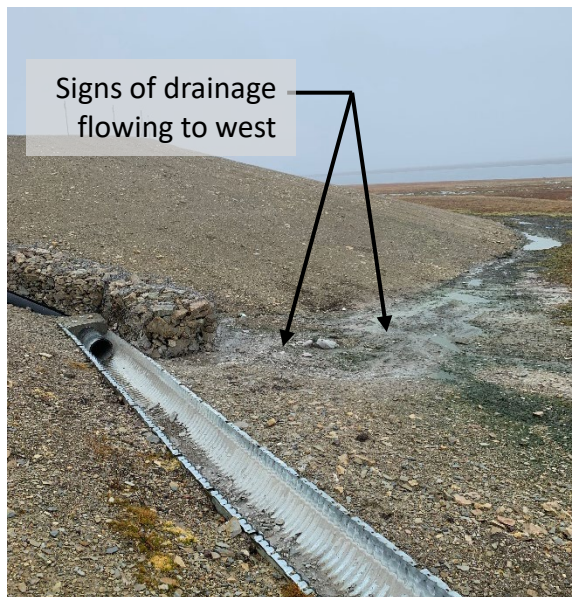
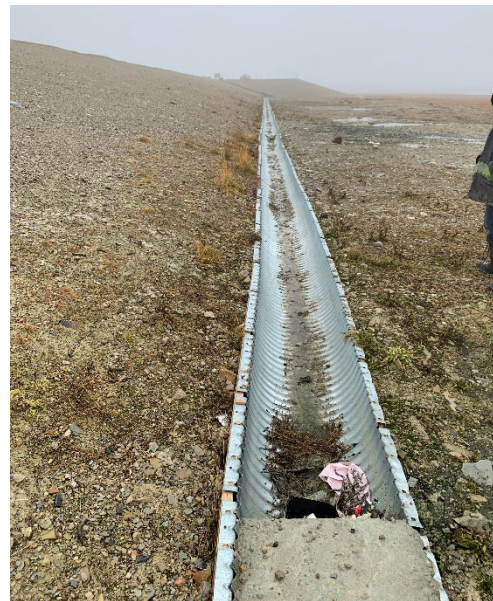
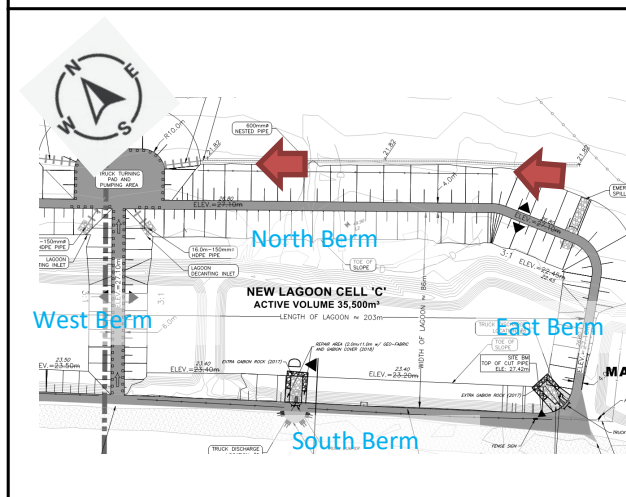
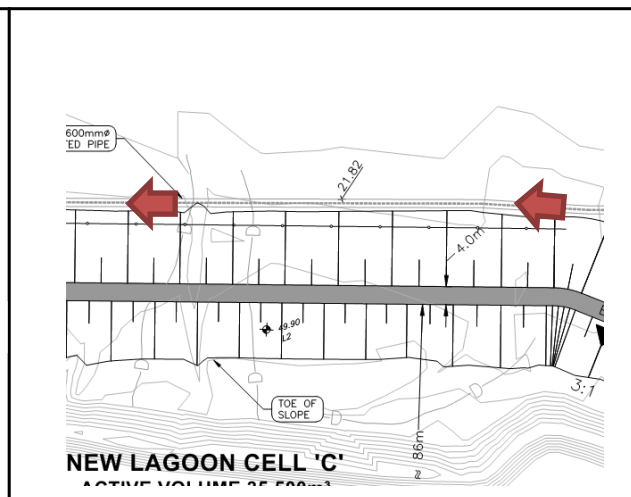
Attributes	
Photograph	C – Trough – North Berm
Description	View of trough
Observations	Trough was dry and was not in operation. Some debris in trough. Signs of drainage to west.
Remarks	Some drainage had flowed to west, not following the trough. Debris in trough should be removed during regular maintenance.

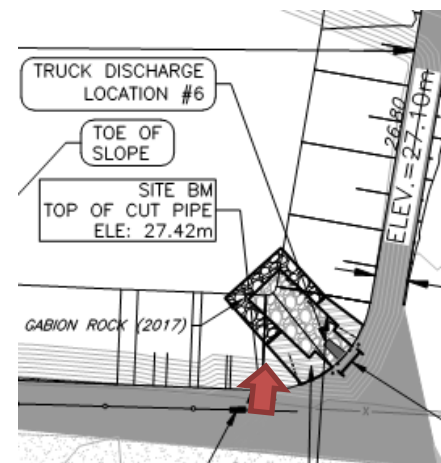
Photograph	C – Truck Discharge Facility (#6)
Description	View of truck discharge area
Observations	Riprap in a good condition. Discharge equipment in a good condition.
Remarks	The area is in a good condition

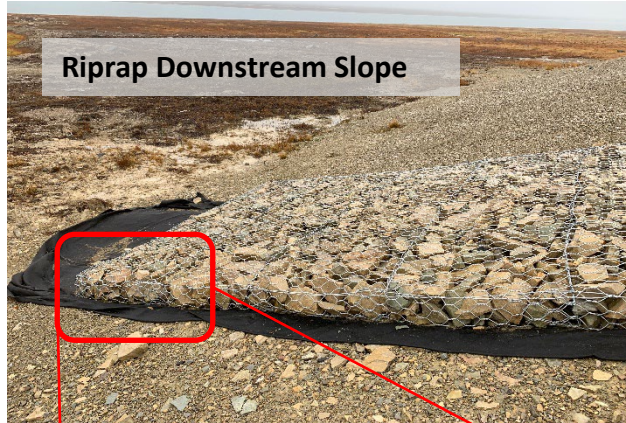
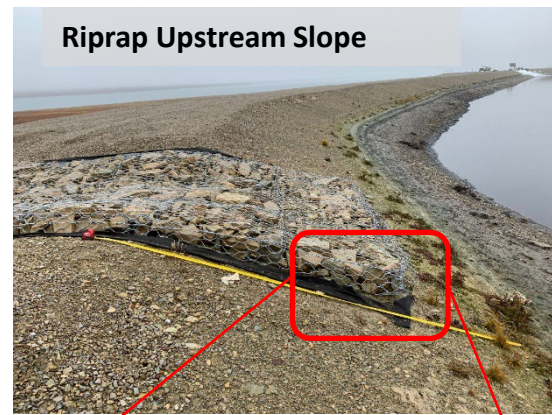
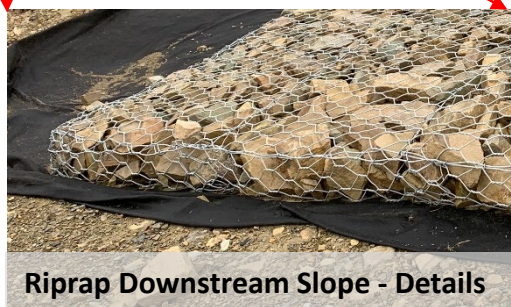
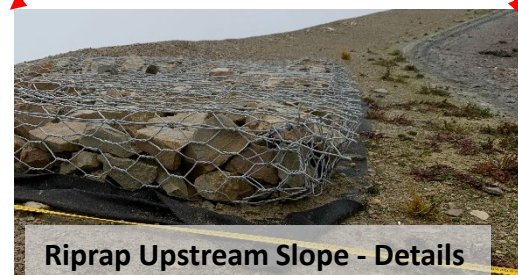
FIGURE
A44

Photograph	A – Spillway
Description	View of spillway
Observations	Riprap at spillway is in good condition. No sign of riprap damage. Riprap baskets are likely placed above the slope. The thickness of riprap is about 200 to 250 mm.
Remarks	The riprap was placed above the slope surface at both upstream and downstream. In this way, the riprap may not prevent soil erosion during emergent use of spillway. Similar configuration of spillway with Cell B and Cell C.

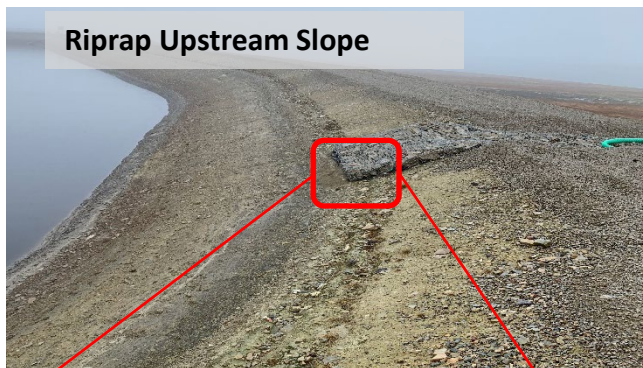
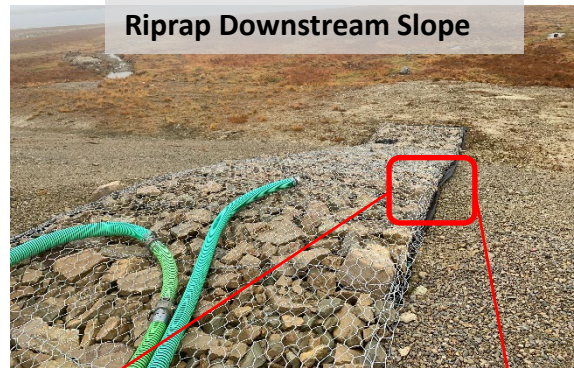
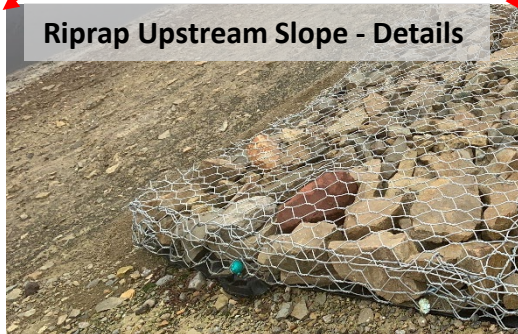
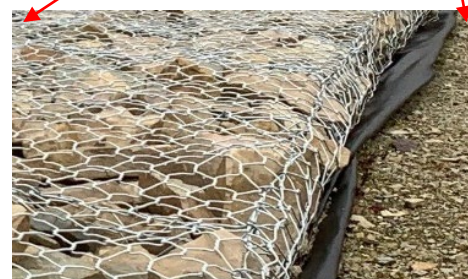
FIGURE
A45

Photograph	B – Spillway
Description	View of spillway – riprap
Observations	Riprap at spillway is in good condition. No sign of riprap damage. Riprap baskets were placed <u>above</u> the slope. Riprap at downstream slope does not extend to the toe.
Remarks	Similar configuration of spillway with Cell A and Cell C.

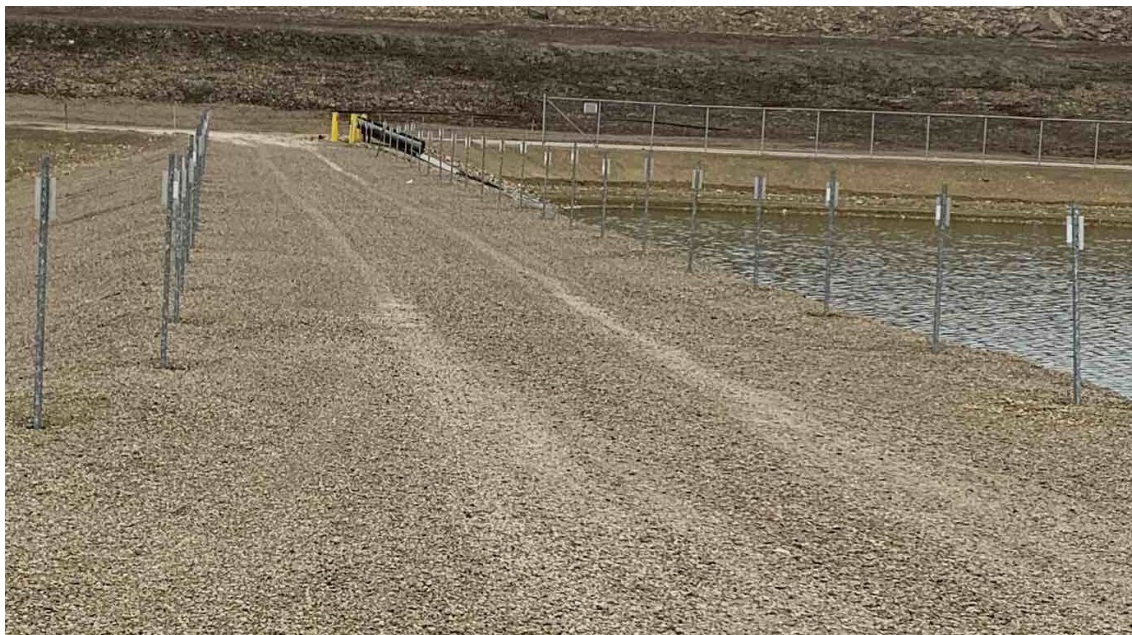
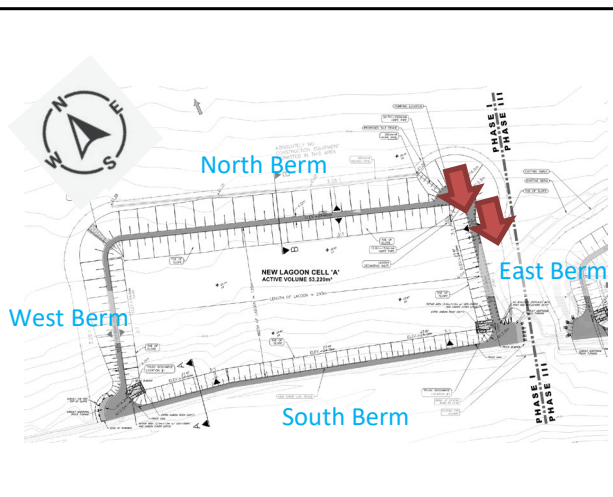
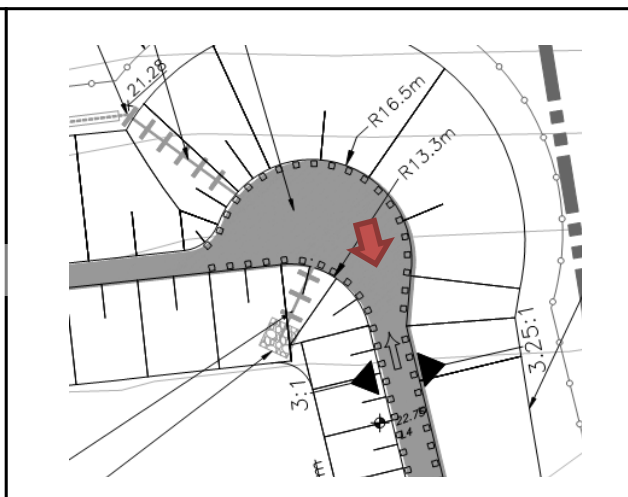
Photograph	A – Crest of East Berm
Description	View of crest
Observations	The posts aligned with each other well at crest. No sign of movement, deflection or settlement.
Remarks	No sign of settlement or lateral movement

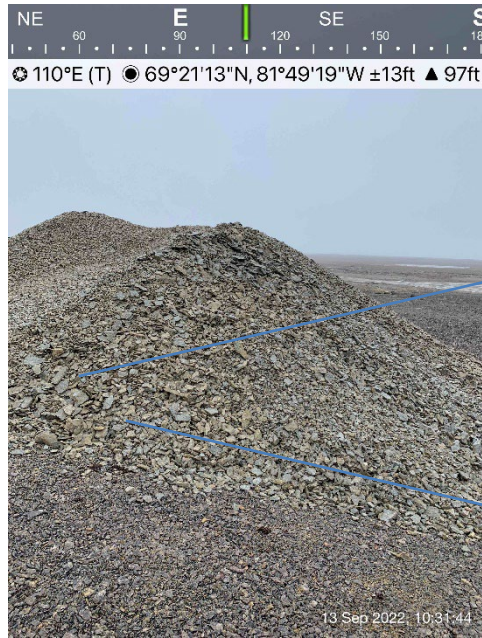
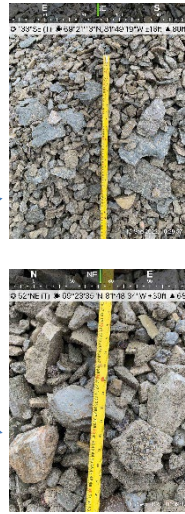
Potential Source for Riprap – Site A

Photograph	Screened (over-sized) stockpile
Description	Material for potential use as riprap prospection materials
Observations	
Remarks

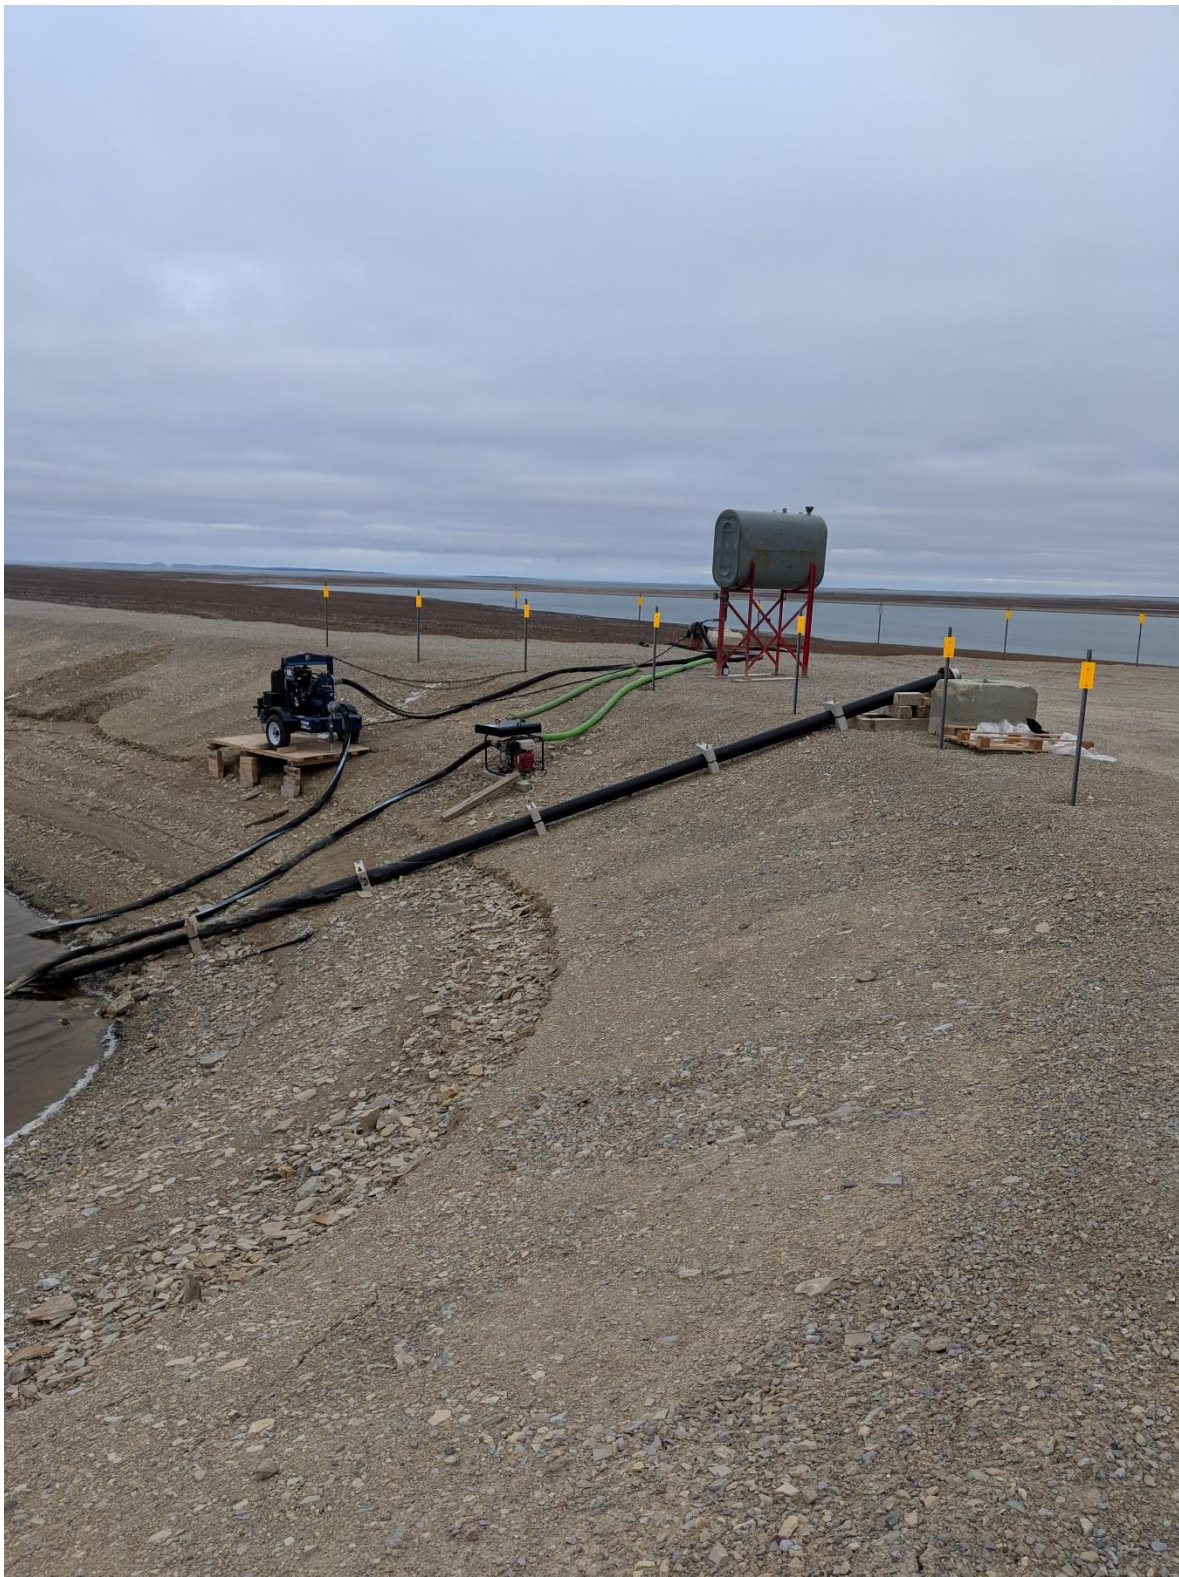
2. The soil around the lagoon cells presents some cracking suggesting settlement during freeze-thaw cycles. This is not expected to impact the lagoon's function. See picture 1

Photograph #1: Settlement Cracking of the soil around the lagoon.

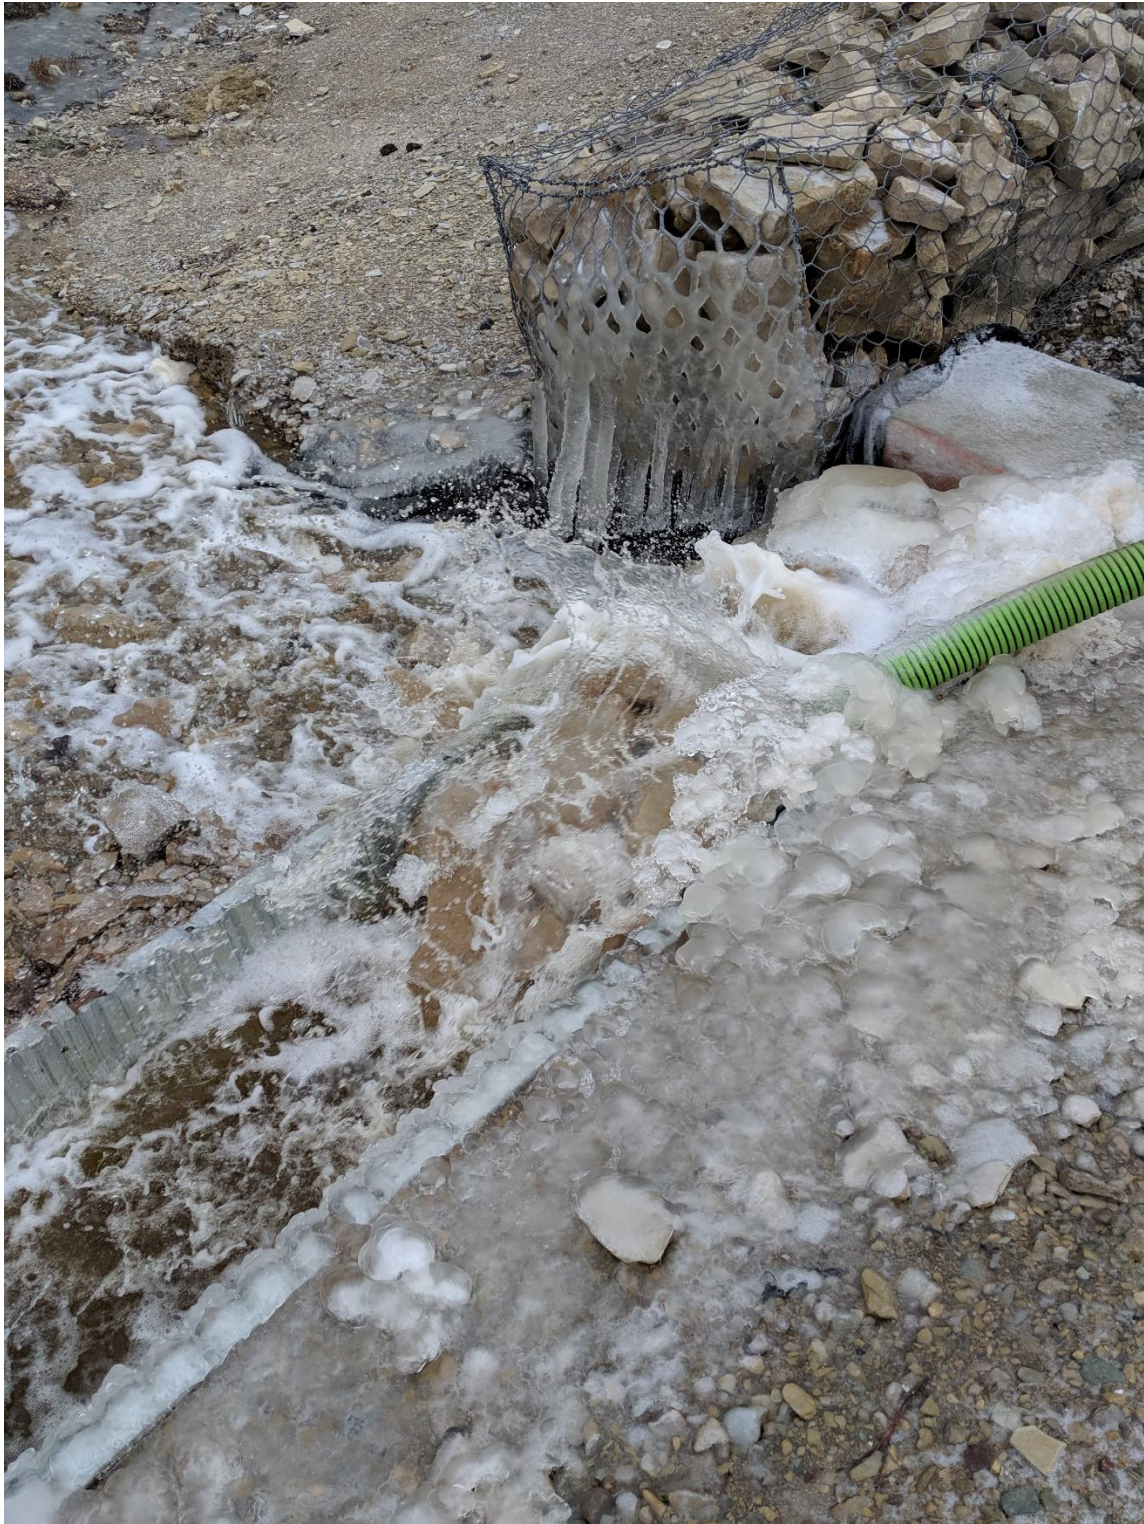
3. The wastewater within one cell of the lagoon was being pumped into the troughs located on the north side of the cell. From there, the water was decanting into the natural wetland and flowing across the wetland before making its way to the ocean. See picture 2 for pumping setup.

Photograph #2: Pumping operations.

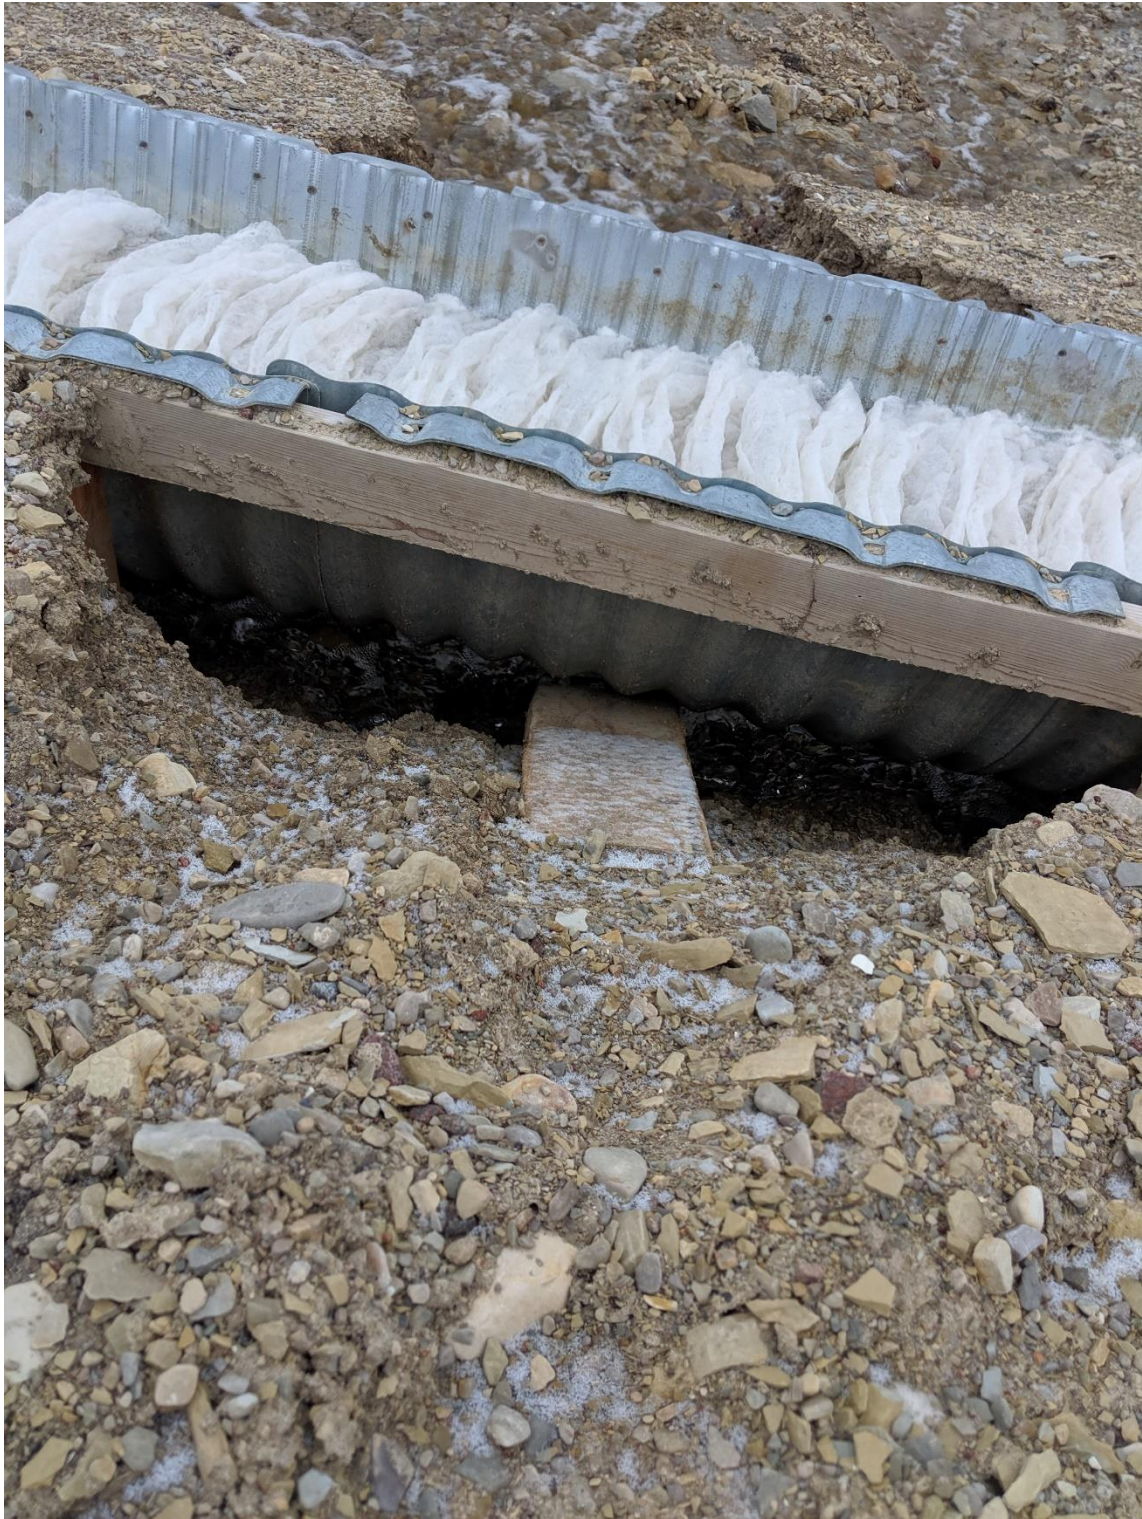
6. During the walkthrough, it was observed that the water being pumped out of the lagoon was causing some erosion. See picture 3. This is not a construction issue, but caused some concern, especially as washouts seem to have occurred in other areas along the trough as well. See picture 4. The pumping setup also does not conform to the intended setup. It is recommended that the Operation Manual be reviewed and operation procedures be amended as required.

Photograph #3: Pump outlet.

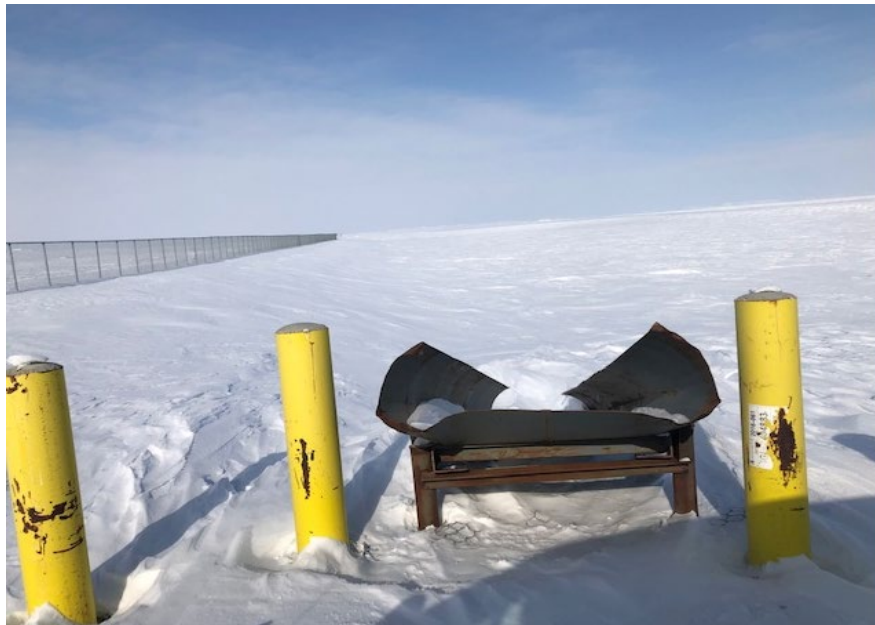
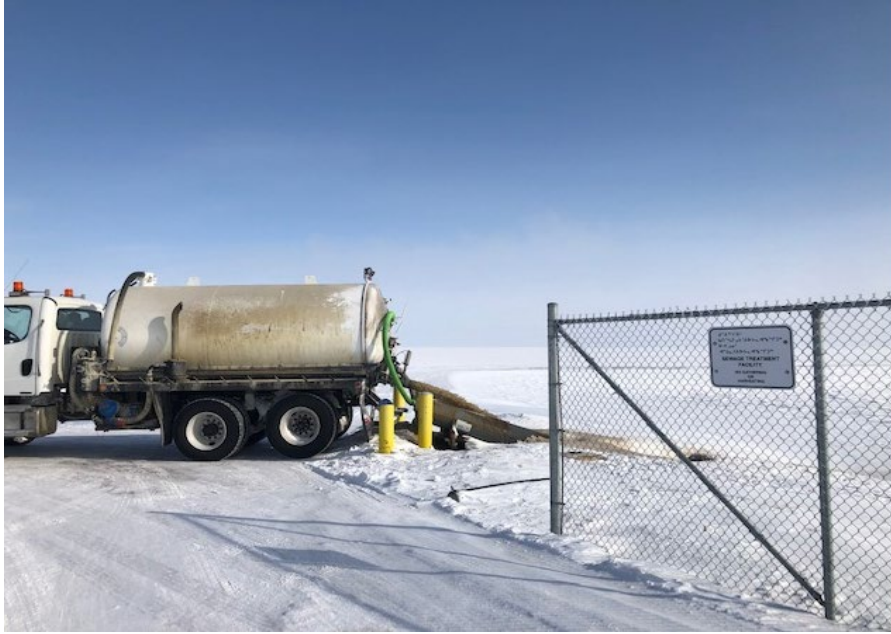
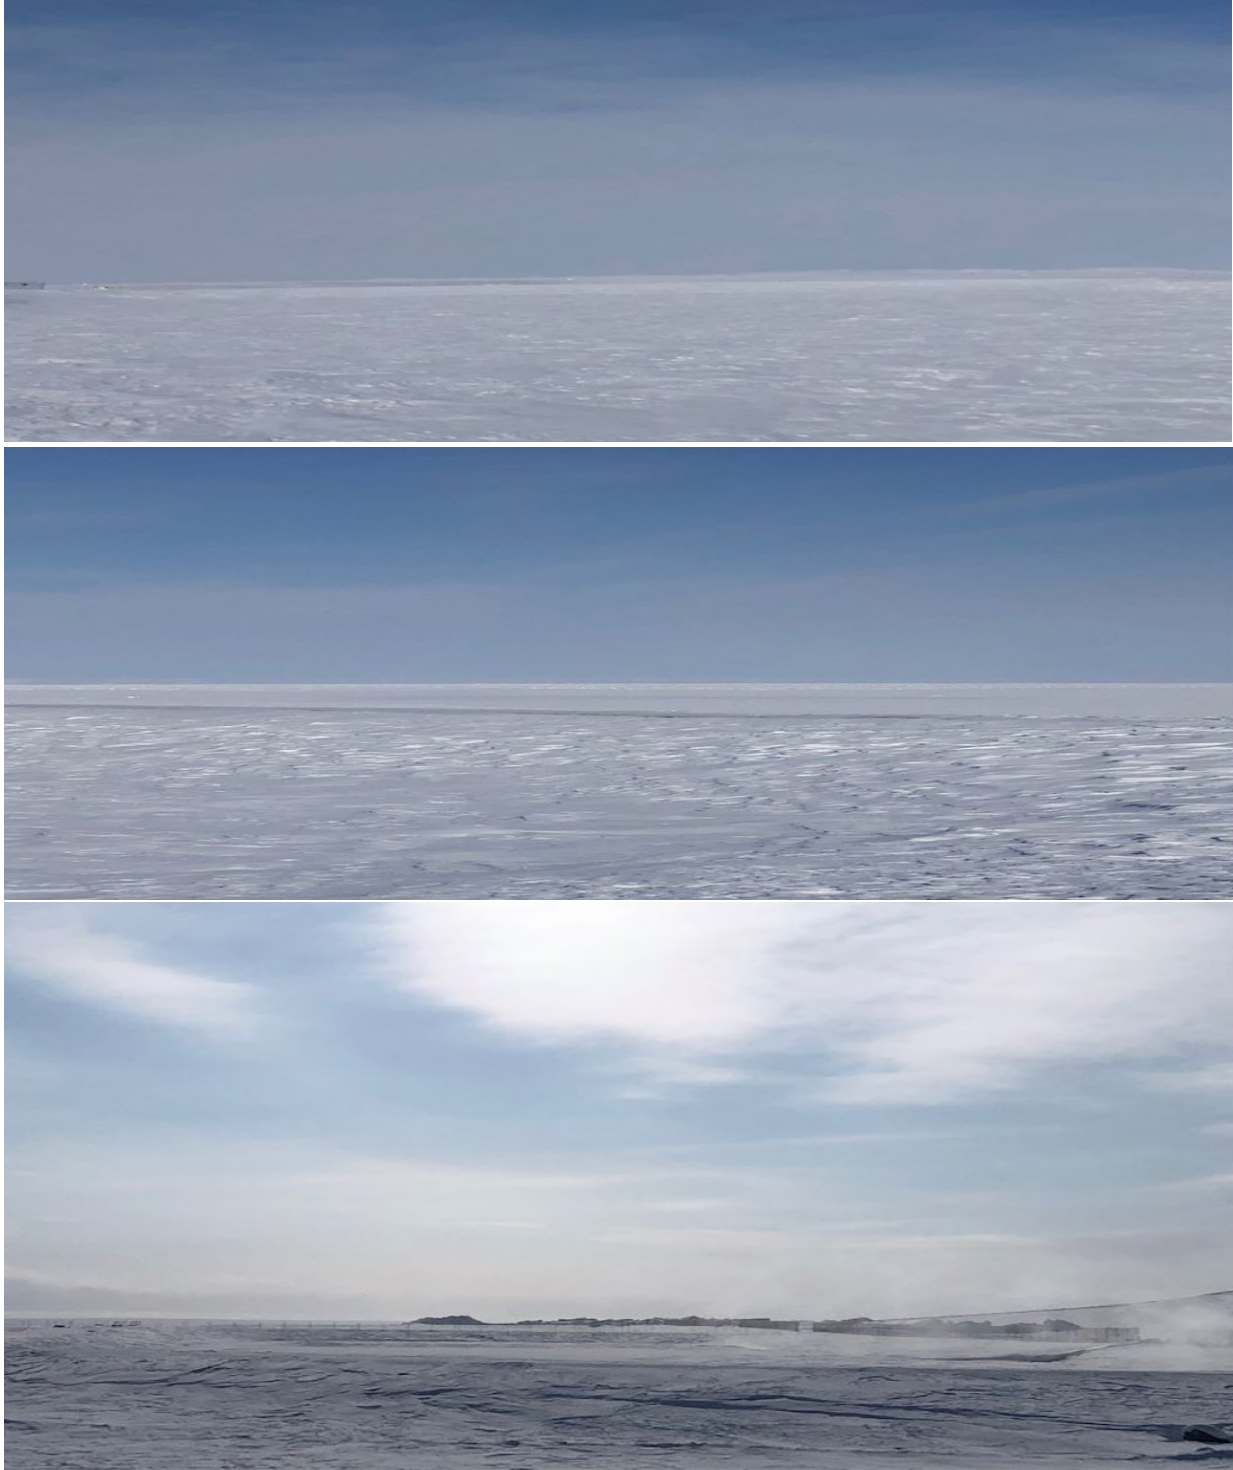
April 20th 2022.

Upon visiting the sewage lagoon location, and visually inspecting cells A,B and C, attached photos are witnessing there was no visible sewage exfiltrating/seeping/or overflowing the lagoon cells.

As per pictures taken, and visual inspection completed, CGS stuff could not identify or confirm any faulty or concerning issues on either of 3 sewage lagoon cells. CGS rep and Municipality Director of Public Works agreed that summer inspection would be a must to:
