**Preliminary Design Report
Expansion of City of Iqaluit
Raw Water Storage,
City of Iqaluit, Nunavut**

Draft Report

Trow Associates Inc.

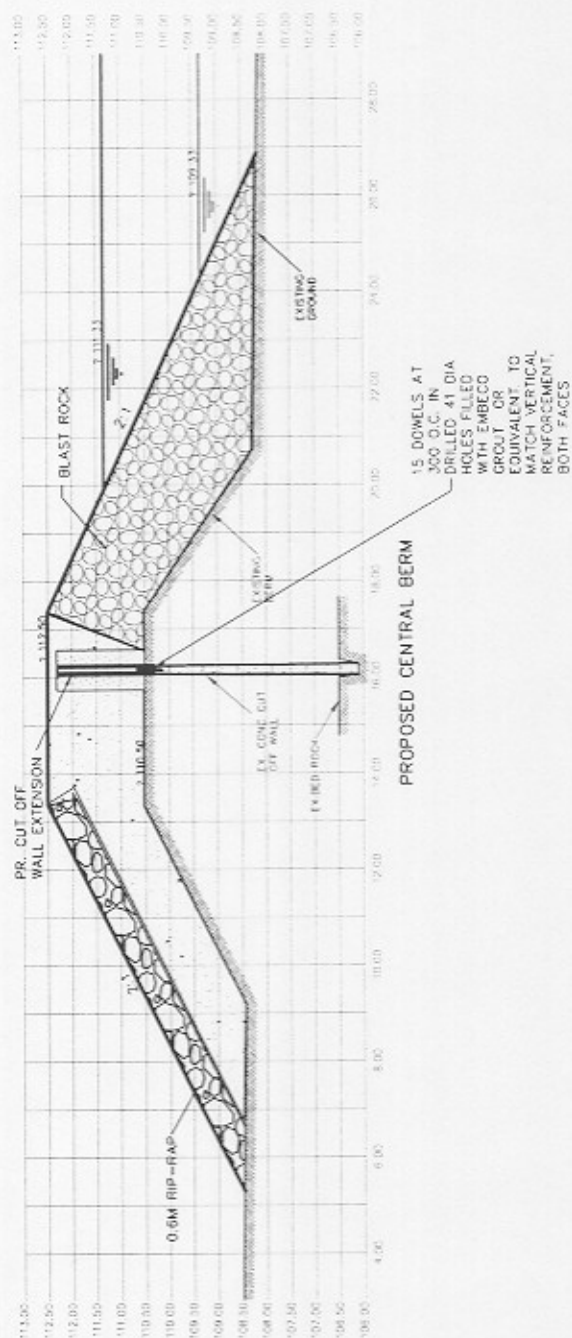
| DRAWN: MMR | | | SK-7 |

The concrete cut-off wall in both the north and central berm will be raised 2.0 metres. It should be noted that the concrete cut-off walls within the earth berms are intended to prevent seepage through the soil materials. The cut-off wall does not act as a gravity dam.
