### **Lake Geraldine Intake Replacement Conceptual Design**

# LONG-TERM WATER PROJECT OWNERS ENGINEER

LAKE GERALDINE INTAKE ACCESS VAULT  
TECHNICAL REPORT

FINAL REPORT

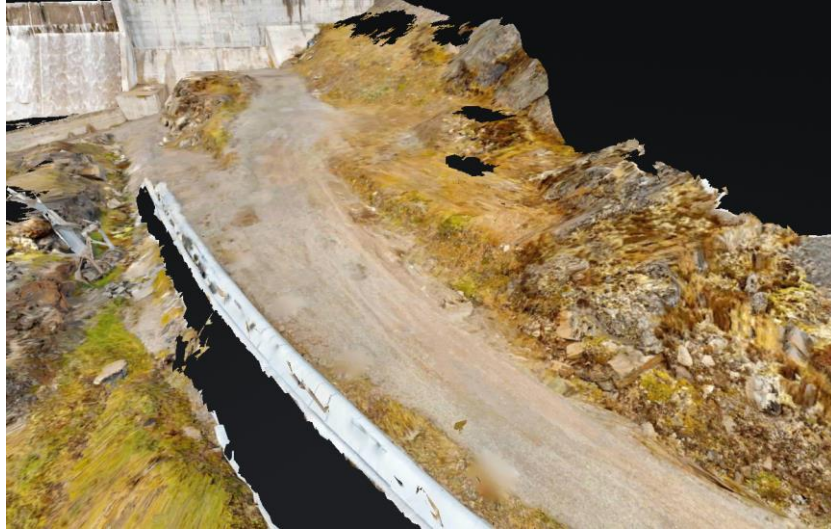
**Figure 6: Matterport Aerial Rendering of Access Road approaching Lake Geraldine Dam (2023)**

The access road mildly expands in approach of the Dam ([Figure 6](#)). The gravel portion of the roadway widens to as much as 9.1 m (30 ft) and may be able to facilitate vehicle turn-around and additional vehicular parking at the Project site.

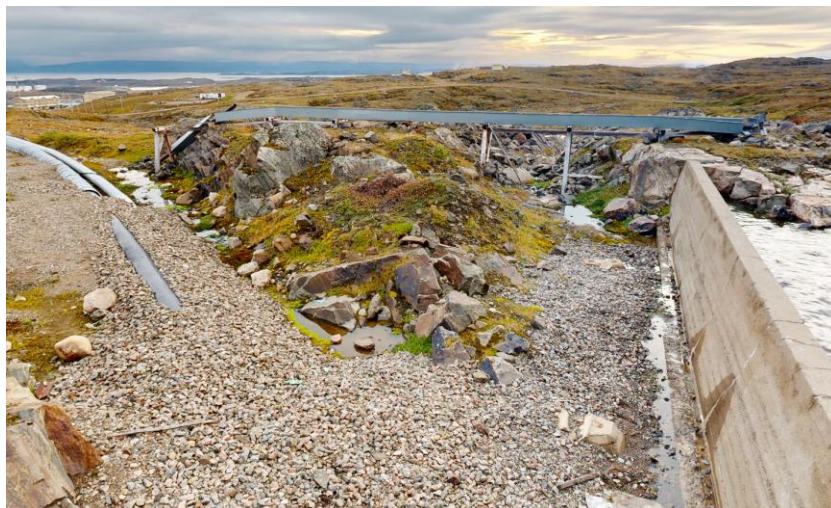
**Figure 7: Existing site features near the Lake Geraldine Dam, as viewed from atop the Access Vault**

The access roadway appears to be relatively level across the full length, with a minor grading to the west in approach of the Dam (Figure 6 above). Large Canadian Shield outcrops are present on the east side of the access road and small brook is present to the immediate west of the intake piping (Figure 7). Water over the Dam’s spillway is diverted to the west via a large concrete wall. An unknown metal structure, possibly a weir, is located to the immediate south of the spillway, is not connected to anything on either end, and is not believed to serve any current functional purpose.

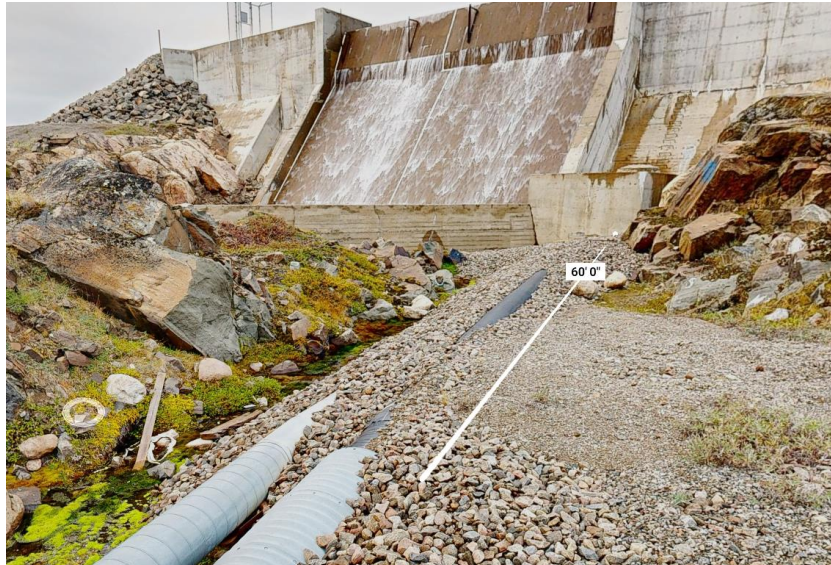
**Figure 8: Intake Piping from Access Vault**

The insulated intake piping appears to be shallow-buried from the Access Vault for approximately 18.3 m (60 ft) to the corrugated metal casing.

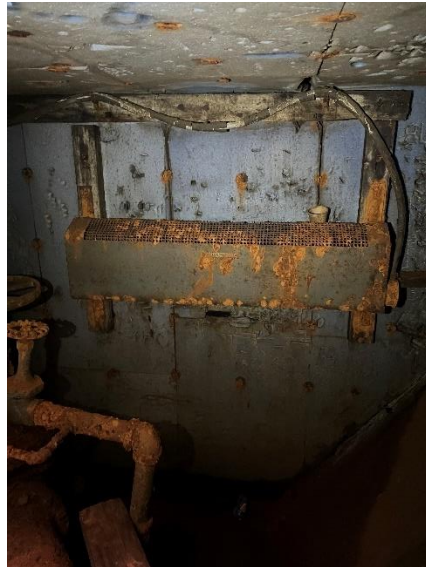
Electrical services, including switches and disconnects are mounted on the wall of the chamber and are also heavily damaged by corrosion. There is an electric heater mounted on the wall. It is not known whether this unit still functions.

Photo 2.2.1: existing electrical radiant heater

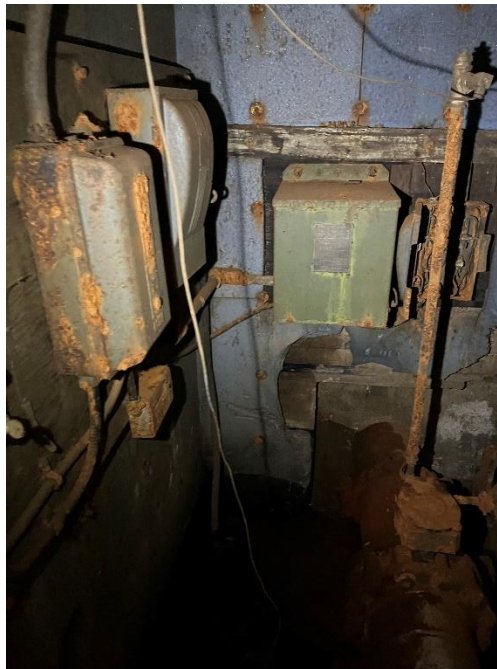
It is unknown whether the electrical service is connected to the water treatment plant, what size the cabling is and what capacity the breaker(s) have.

Photo 2.1.2: overall view of existing electrical services

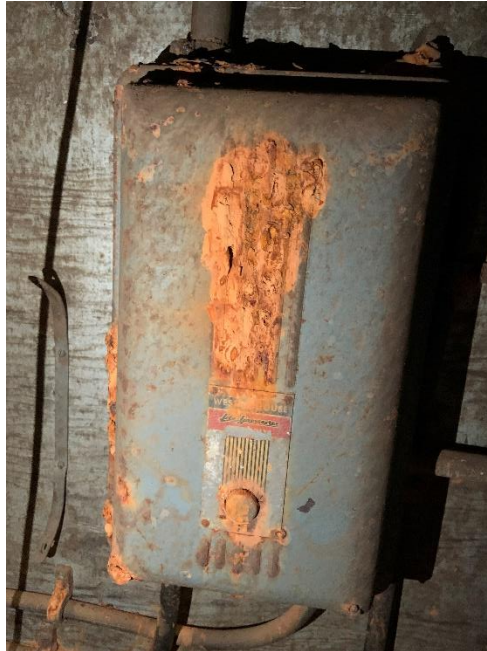
Photo 2.1.3: motor starter, assumed to be wired to sump pump

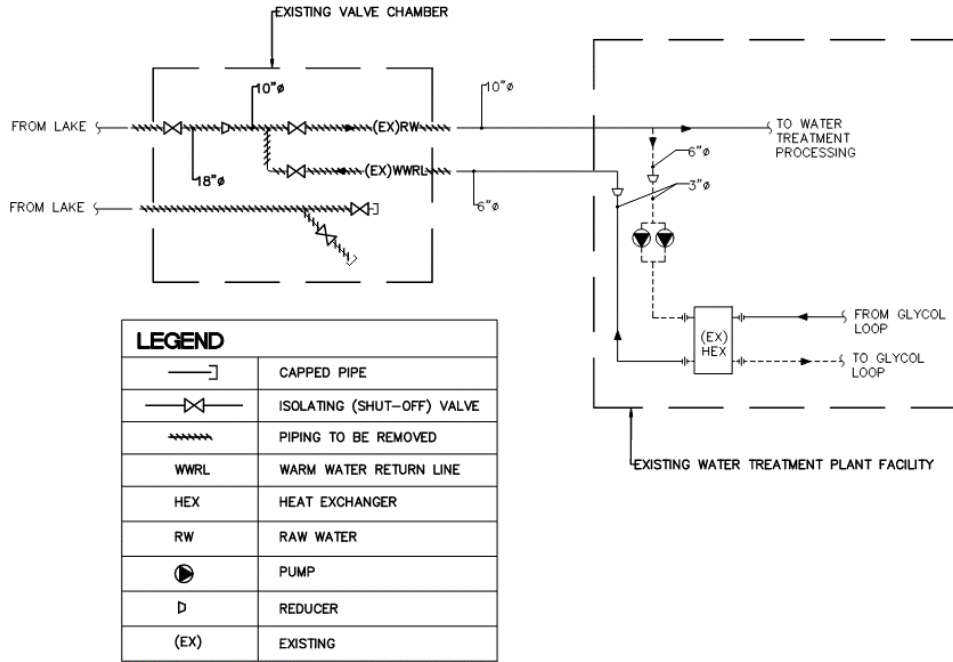
Figure 3.1: Schematic of existing piping to be removed

Once the temporary bypass is in place, the remainder of the work can be carried out. Refer to Appendix for configuration options. Gate valves or butterfly valves may be used. Gate valves, although larger than butterfly, are recommended for this application as they do not obstruct flow in the pipe when open.

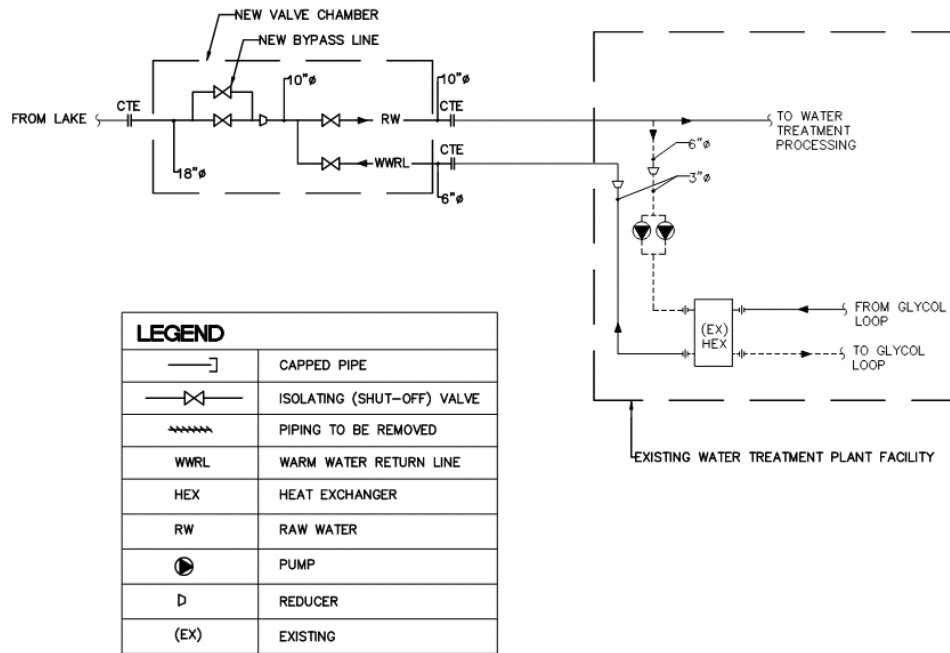
Figure 3.2: Schematic of new piping

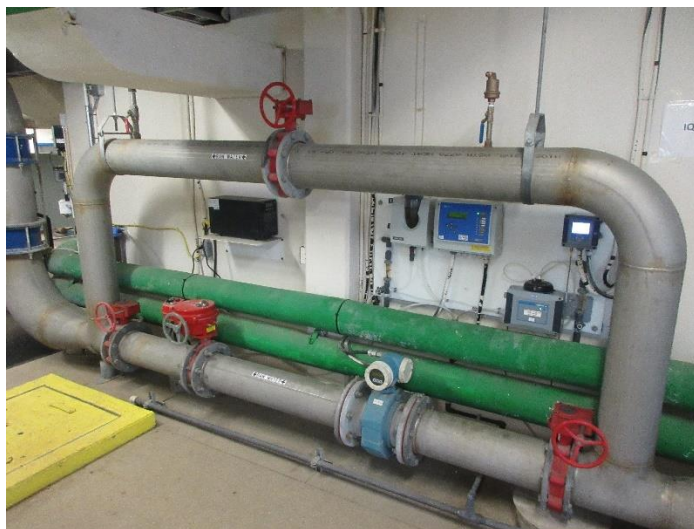
Photo 3.1: Proposed location for new RP backflow preventer

Since water treatment plants are considered a severe hazard application under CSA B64.10, a reduced pressure (RP) zone assembly backflow preventer should be installed on the intake piping; however, CSA indicates that RP assemblies cannot be installed in a vault. Backflow prevention should be installed within the water treatment plant.
