# DEVELOPMENT OF A MASTER DRAINAGE PLAN – FINAL SUBMISSION

City of Iqaluit

Nunami Stantec Ltd.  
1088C Noble House, PO Box 1779,  
Iqaluit NU X0A 0H0

144902610  
May 3, 2019

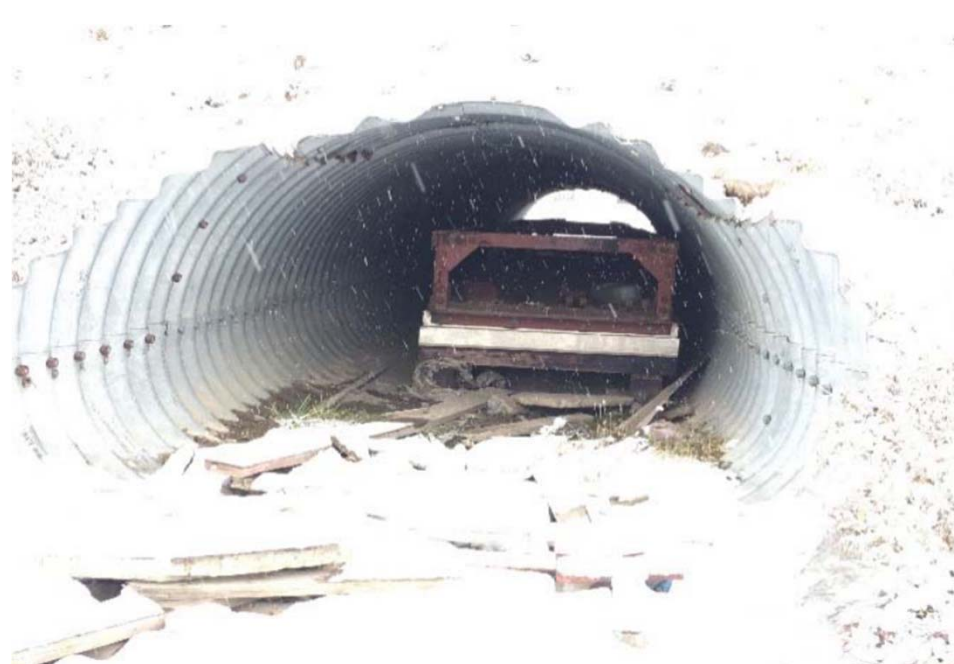
East of Crossing 9 (2100 mm dia.) looking  
Upstream

X9	NE	SW	2100	Corrugated Steel	Circular	Projected	N	Torn out edges, significant amount of debris deposited at the upstream end. A furniture was identified in the Culvert	
X10a	NW	SE	3100	Corrugated Steel	Arch	Projected	N	Garbage deposits at the upstream end	
X10b	NW	SE	1600	Corrugated Steel	Circular	Projected	N		
X12a	N	S	1000	Corrugated Steel	Circular	Projected	N	Deformed Culvert, elliptical in shape, surface corrosion on floor	
X12b	N	S	1000	Corrugated Steel	Circular	Projected	N	Worn Out Edges, surface corrosion on floor	
X12c	N	S	1000	Corrugated Steel	Circular	Projected	N	Surface corrosion on floor	
X12d	N	S	2100	Corrugated Steel	Circular	Projected	N	Deformed Culvert, deflected sidewall at 2 O'clock, at the downstream end.	
X13	NW	SE	1600	Corrugated Steel	Circular	Projected	N	Deteriorated Edges at the downstream end
