City of Iqaluit

Drinking Water Management Program

Development of Drinking Water Program

OTT-00246002-B0

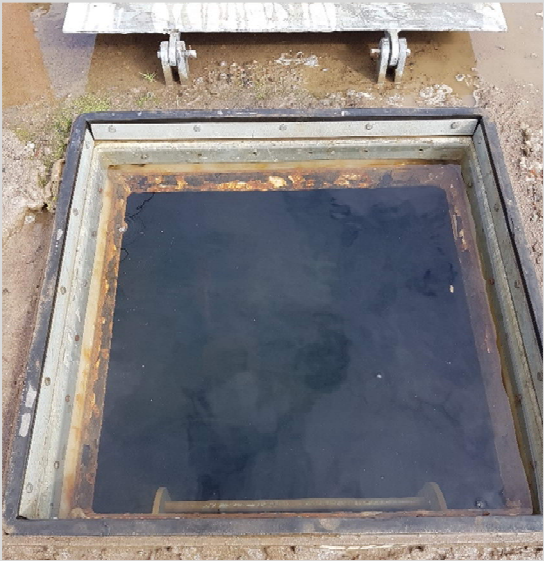
<u>AV #</u>	<u>Comment</u>	<u>Photo</u>	<u>Corrective Action</u>
AV 326	<ul style="list-style-type: none"> Pump out and inspect Critical structure for Booster Station No. 1 and Road to Nowhere Loop

Yes – pump out and inspect
AV 327	<ul style="list-style-type: none"> Incorrect AV numbering on sign, structure is AV 327 not AV 213 Protective coating inside structure failing, probably due to high moisture from standing water.

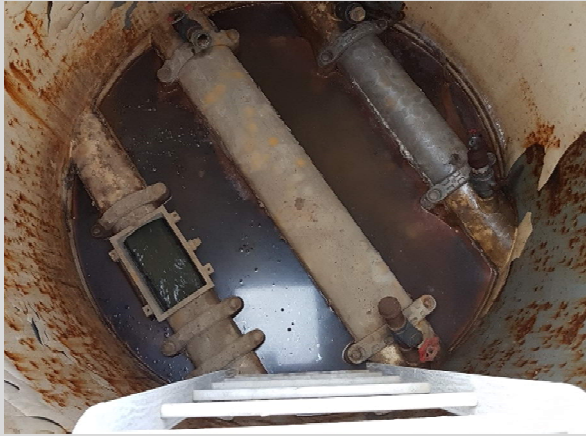
AV 328	<ul style="list-style-type: none"> Protective coating inside structure failing, probably due to high moisture from standing water. Sanitary cleanout cover not installed

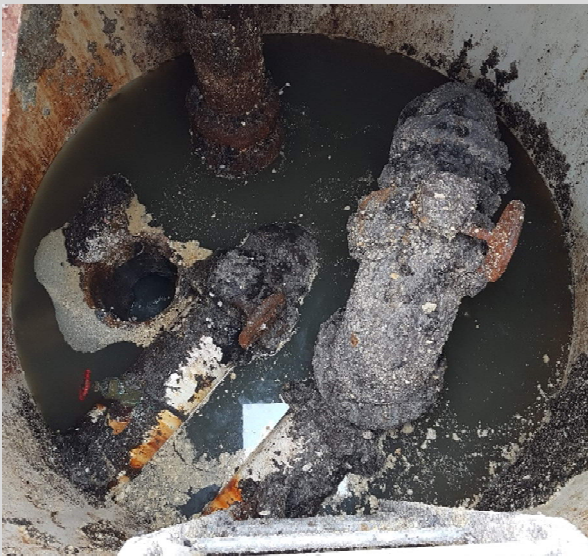
No
AV 331	<ul style="list-style-type: none">• Sanitary cleanout cover not installed• Evidence of serious sewer backups within structure• Limited visibility, pump out, clean and re-investigate

Yes – pump out and reinvestigate

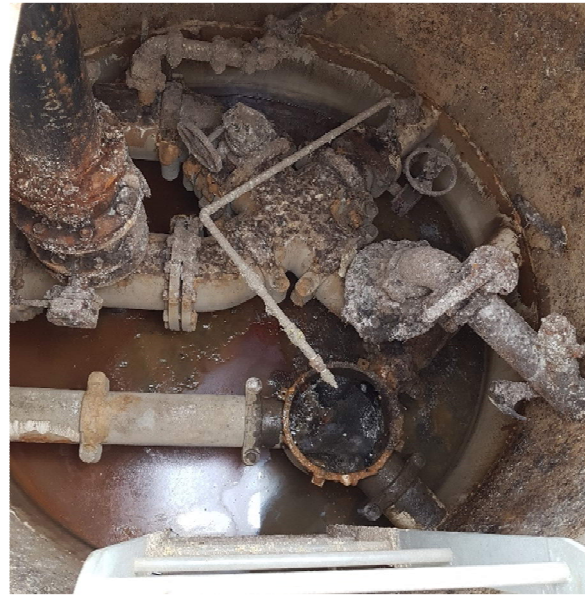
AV 332

- Photo was taken prior to completion of Joamie Court
- Bleed was eliminated as part of Joamie construction
- Evidence of sewer backups within structure

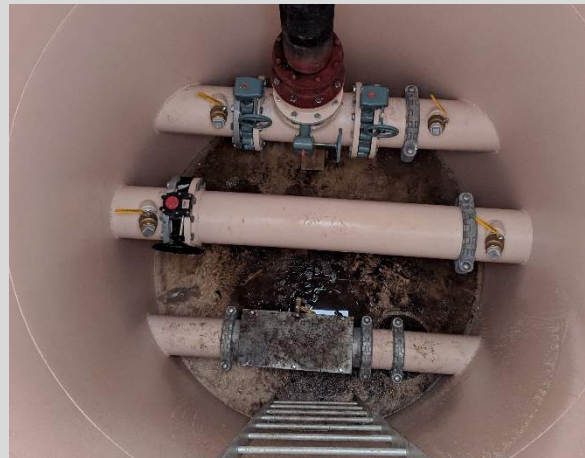
AV A

- No exceptions noted

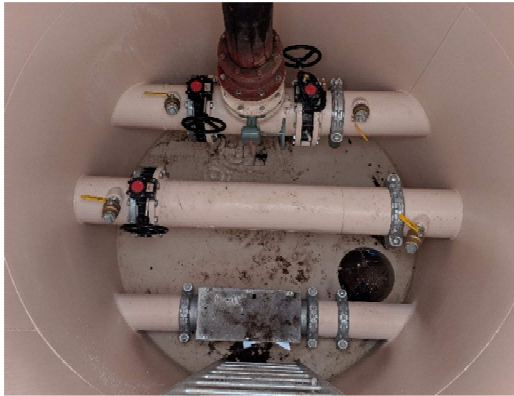
AV B	<ul style="list-style-type: none">• No exceptions noted

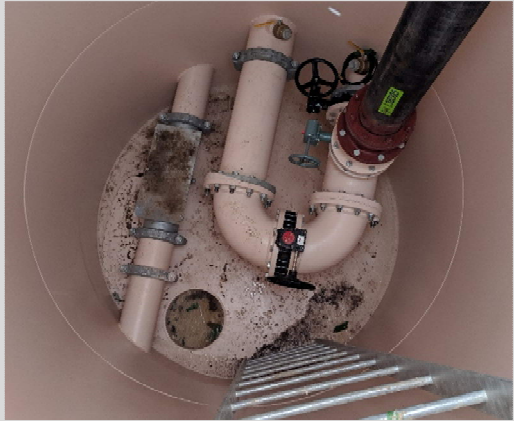
No
AV C	<ul style="list-style-type: none">• No exceptions noted

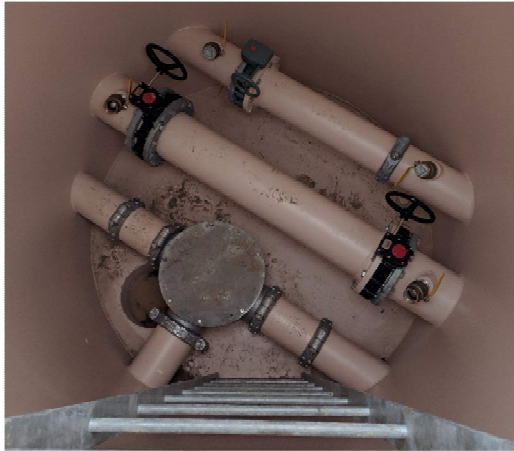
No
AV D	<ul style="list-style-type: none">• No exceptions noted

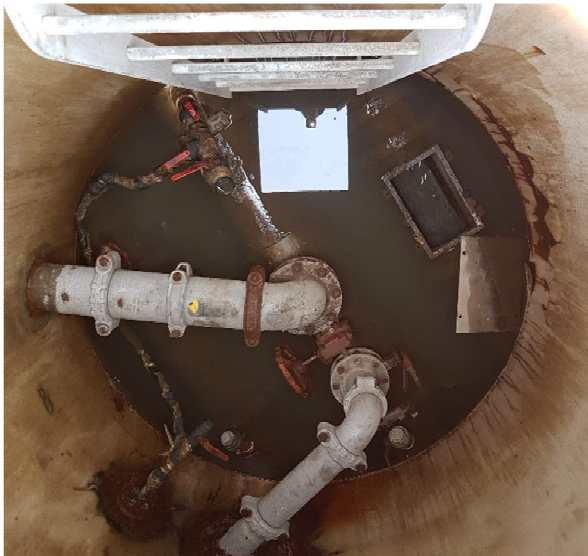
AV C	Previously reviewed, see above		
AV B	Previously reviewed, see above		
AV A	Previously reviewed, see above		
AV 332	Previously reviewed, see above		
AV 331	Previously reviewed, see above		
AV 333	<ul style="list-style-type: none"> Multiple large services connected to the supply main Service return connected to laterolet, it is the correct watermain pipe Return piping for the larger service cannot be seen, it is assumed to be done outside the structure <ul style="list-style-type: none"> there is a possibility of a short circuit as the service return piping would need to crossover the return main and connect to the supply main (same pipe the service supply is connected to). Need more information. Sanitary cleanout not installed Protective coating within the structure is starting to fail, probably due to high moisture. Evidence of sewer backups

Yes – investigate second service connections return piping

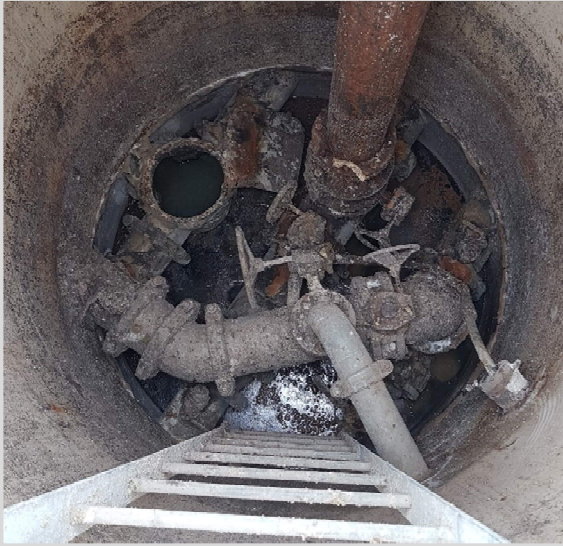
<p>AV 334</p>	<ul style="list-style-type: none"> • Connection of return piping for the larger service cannot be seen, which watermain it connects to cannot be determined • there is a possibility of a short circuit if the service's return is connected to a different main then the service's supply is connected to. Need more information. • Sanitary cleanout cover not installed • Evidence of sewer backups

<p>Yes – clean and investigate service return connection inside the vault</p>
<p>AV 335</p>	<ul style="list-style-type: none"> • Above ground sanitary quick connect access <ul style="list-style-type: none"> • Cap missing, and should be locked • Recirculation piping should be abandoned • Protective coating within the structure has failed, probably due to high moisture • Sanitary cleanout cover not installed

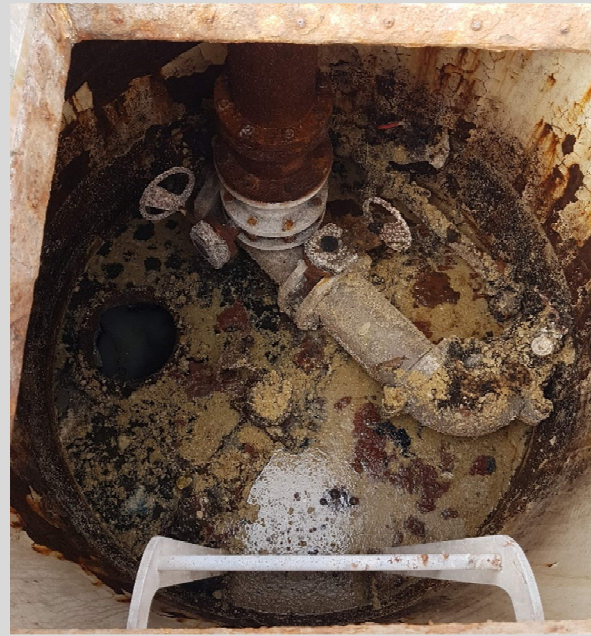
AV 338

- Visibility low, requires significant cleaning
- Recirculation piping is out of service
- Evidence of sewage backups
- Sanitary cleanout cover not installed

Yes – clean and investigate

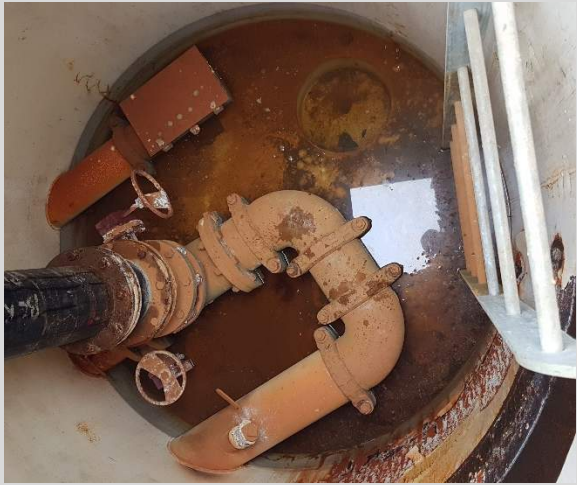
AV 336	<ul style="list-style-type: none"> Structures protective coating has failed

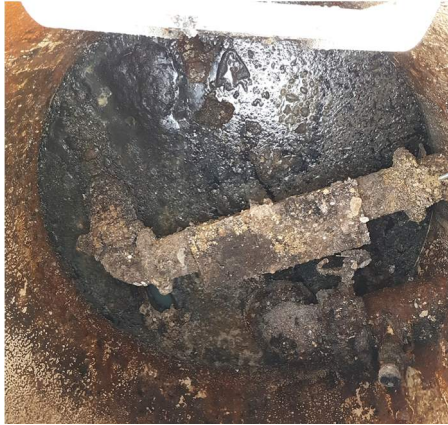
No
AV 337	Previously Reviewed, see above		
AV 338	Previously Reviewed, see above		
AV 339	<ul style="list-style-type: none"> Visibility low, requires significant cleaning Key structure in loop, water supply splits to separate areas Recirculation piping is out of service Evidence of serious sewage backups Sanitary cleanout cover not installed

Yes – clean and reinvestigate

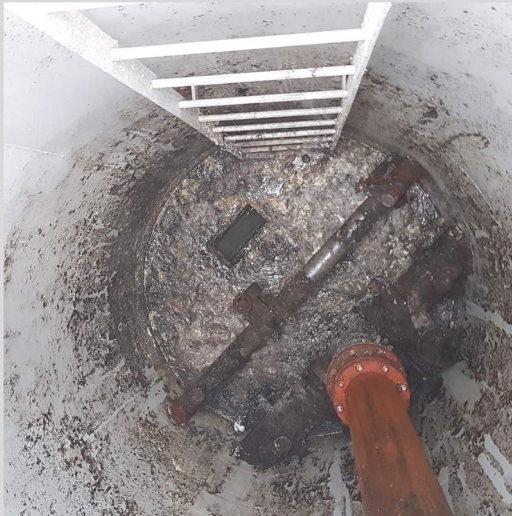
AV 342	<ul style="list-style-type: none">• Recirculation piping is out of service• Evidence of sewer backups• Sanitary cleanout cover not installed

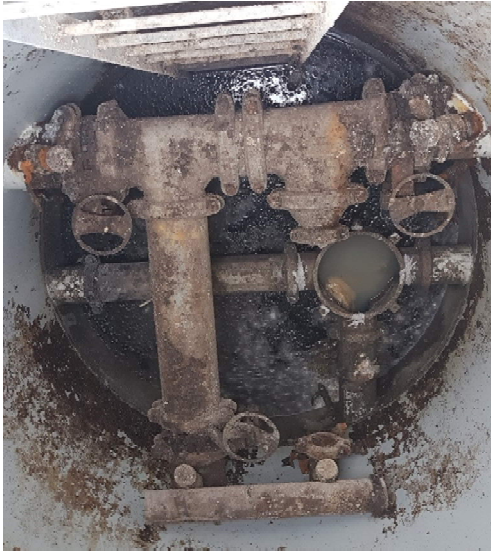
No
AV 343	<ul style="list-style-type: none">• Connections available for future development.• Recirculation piping not in service• Evidence of sewer backups• Sanitary cleanout cover not installed

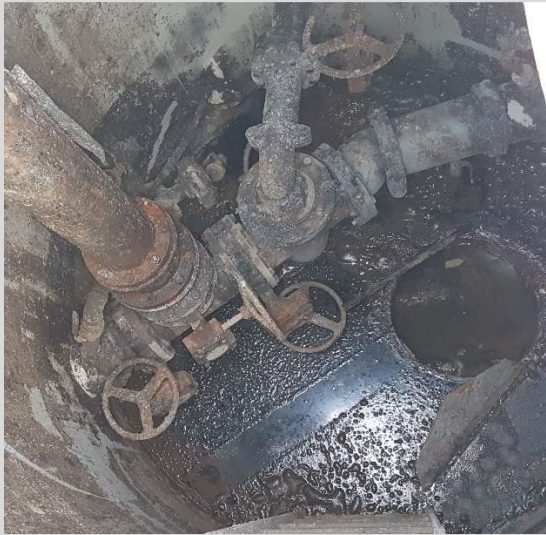
AV 351	<ul style="list-style-type: none">• Key structure in loop supplying arena and school• Valve on right side of hydrant should be closed, confirmation required• Jumpers present on laterolet, unsure of other connection point• Evidence of sewer backups• Cleanout cover not installed

Yes – confirm valve closure, and jumper connection point
AV 356	<ul style="list-style-type: none">• Evidence of sewer backups• Sanitary cleanout cover not installed• No other exceptions noted

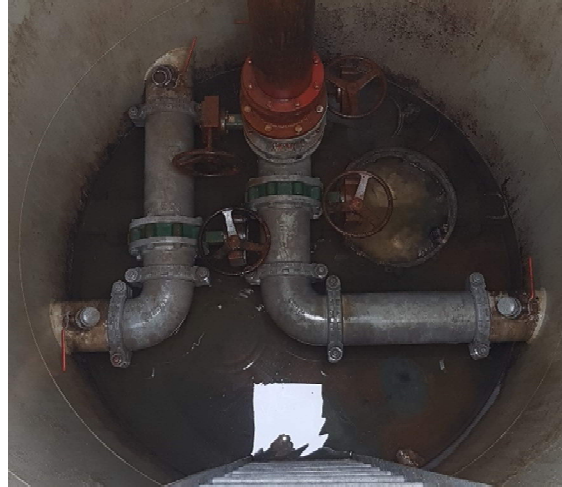
No
AV 353	<ul style="list-style-type: none"> • Watermain diverts to service a cul de sac • Evidence of sewer backups • Sanitary cleanout not installed • No other exceptions noted

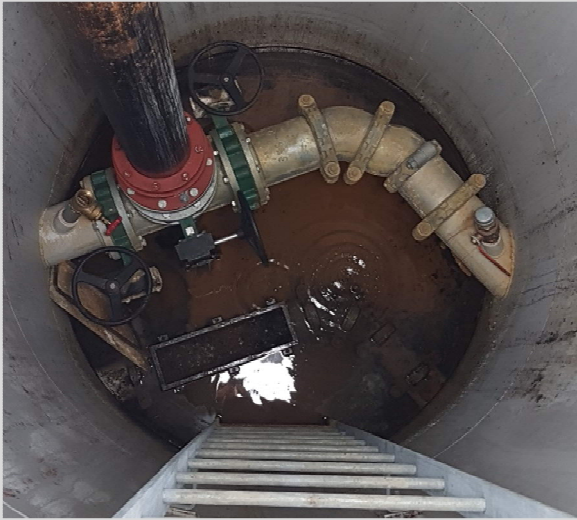
No
AV 353	Previously reviewed, see above		
AV 355	<ul style="list-style-type: none"> • Laterolet on left side has been modified and is missing the cap • Evidence of sewer backups • Sanitary cleanout not installed • No other exceptions noted

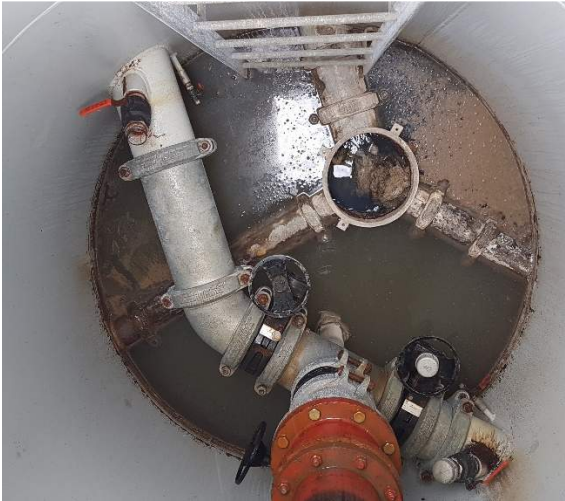
<p>Yes – very minor leak at laterolet</p>
<p>AV 346</p>	<p>Previously reviewed, see above</p>		
<p>AV 348</p>	<ul style="list-style-type: none"> • Evidence of sewer backups • Sanitary cleanout not installed • No other exceptions noted

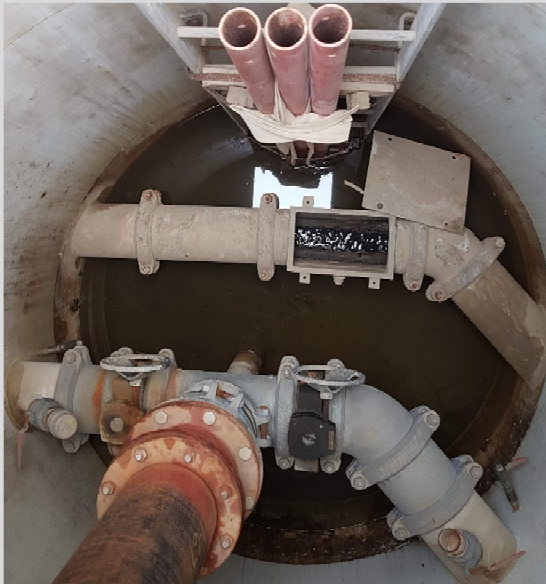
AV 349	<ul style="list-style-type: none"> • Miscellaneous piping on structure access ladder • Sanitary cleanout not installed • No other exceptions noted

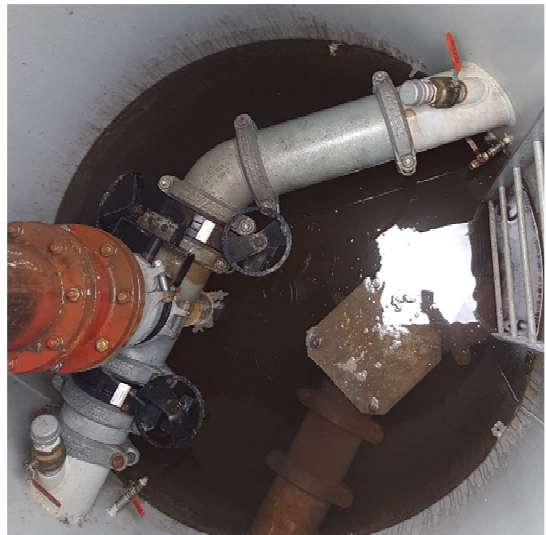
No
AV 350	<ul style="list-style-type: none"> • Water should be pumped out of structure • No exceptions noted

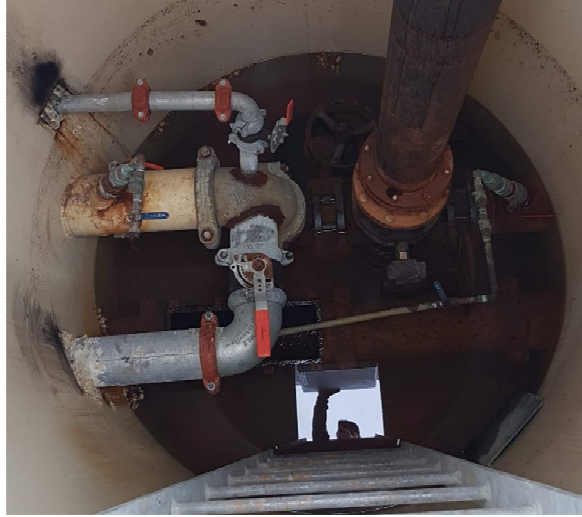
AV 331	Previously reviewed, see above		
AV 330	Previously reviewed, see above		
AV 329	Previously reviewed, see above		
AV 500	Previously reviewed, see above		
AV 327	Previously reviewed, see above		
AV 326	Previously reviewed, see above		
Booster Station No 1			
AV 523	<ul style="list-style-type: none"> Two bleeds are utilized within structure, probable circulation issues Appears to have a large service connection welded onto the 90° bend, not typical configuration <ul style="list-style-type: none"> Assuming smaller pipe is the service return piping Sanitary cleanout cover not installed

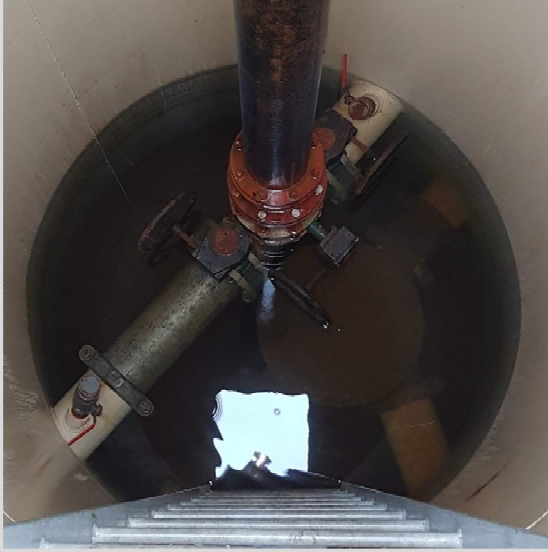
<p>AV 520</p>	<ul style="list-style-type: none"> • Water in structure is clear, possible ground water infiltration or potable water, investigate to confirm • No other exceptions noted

<p>Yes – investigate water source</p>
<p>AV 518</p>	<ul style="list-style-type: none"> • Large service connection, both supply and return for service are within structure, small leak noted from service supply • Unused penetrations present, for future use • Sanitary cleanout not installed • Evidence of sewer backups • Pressure gauge installed on laterolet • Laterolet appears to be used as a bleed, no backflow preventer

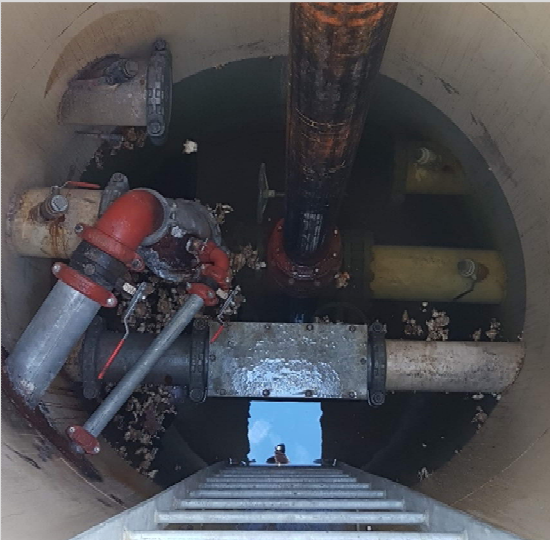
AV 517	<ul style="list-style-type: none">• Appears to have a large service connection welded onto the 90° bend, not typical configuration• Possibly leak on service connections, investigate• Evidence of sewer backups, cleanout cover may not be properly installed

Yes – investigate service connections for a leak
AV 516	<ul style="list-style-type: none">• Pump out and inspect

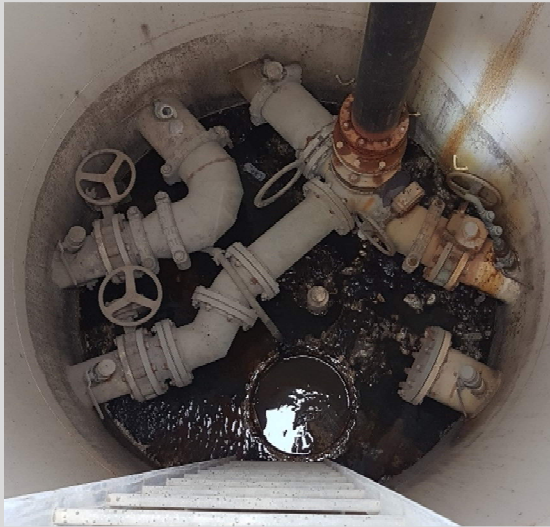
AV 503	<ul style="list-style-type: none">• Key structure for water network• Pending the configuration in AV 516, the valve above the hydrant would need to be in the closed position. The hollow ring left of the hydrant may be a spade which would serve the same purpose of blanking the line• Watermain reduced from a 250mm to a 200mm• Bleed used within structure, not directed to cleanout• Evidence of sewer backups

Yes – investigate AV 516 and then check valve configurations within AV 503.
AV 504	<ul style="list-style-type: none">• Leak at bleed• Corrosion on wall indicates it's the bleed has been broken for a period of time• Sanitary cleanout not installed• Evidence of sewer backups

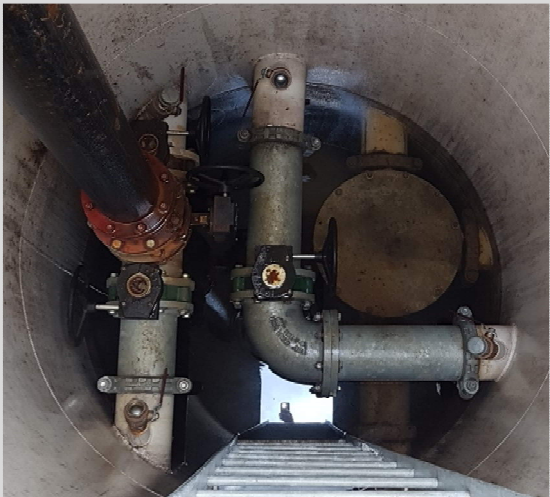
AV 505	<ul style="list-style-type: none">• Water in structure is clear, possible ground water infiltration or potable water, investigate to confirm• No other exceptions noted

A photograph showing a large, dark-colored industrial pipe with a red-handled valve. A smaller, lighter-colored pipe is connected to it. The pipes are located inside a large, circular concrete structure. A metal ladder is visible in the foreground.	Yes – investigate source of water
AV 506	<ul style="list-style-type: none">• No exceptions noted	  A photograph showing a horizontal industrial pipe with a black-handled valve. A smaller, lighter-colored pipe is connected to it. The pipes are located inside a large, circular concrete structure. A metal ladder is visible in the foreground.

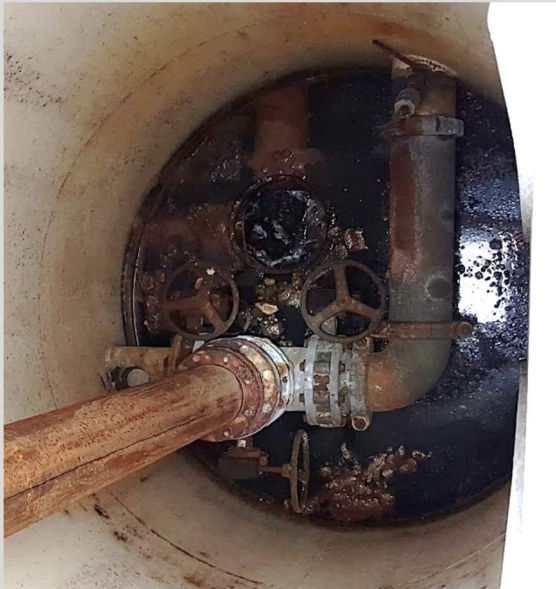
AV 509	<ul style="list-style-type: none">• Sanitary cleanout not installed• Evidence of sewer backups

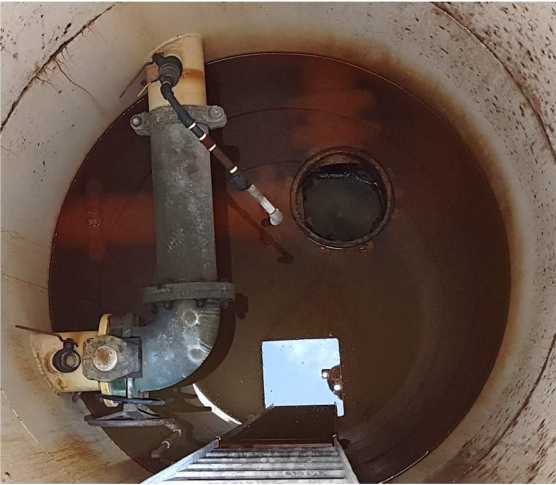
No
AV 510	<ul style="list-style-type: none">• Two bleeds utilized within the structure, possible circulation issues in the area• Sanitary cleanout not installed• Evidence of sewer backups

Yes – ensure backflow preventers are utilized

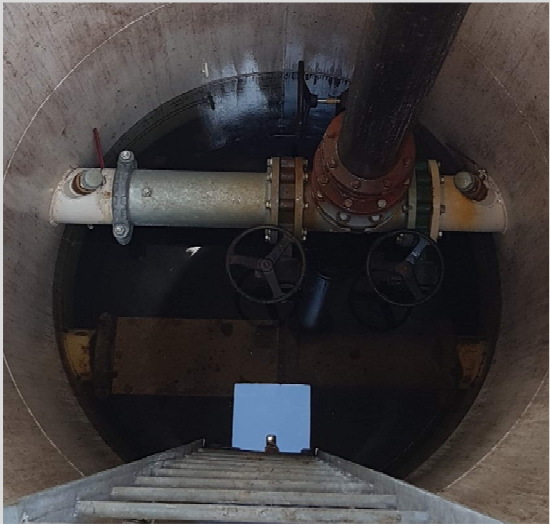
AV 511	<ul style="list-style-type: none">• Water in structure is clear, possible ground water infiltration or potable water, investigate to confirm• No other exceptions noted

Yes – investigate water source, probably ground water
AV 512	<ul style="list-style-type: none">• No exceptions noted	 	No

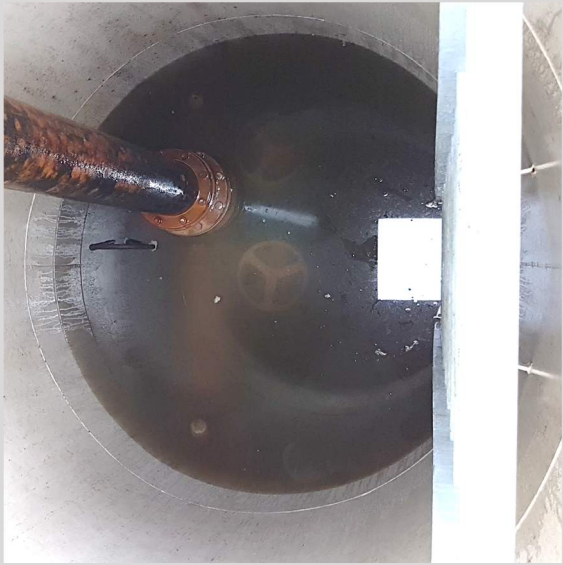
AV 513	<ul style="list-style-type: none"> • Low visibility, noticeable sheen on the water • Investigate water source

Yes – investigate water source
AV 514	<ul style="list-style-type: none"> • No exceptions noted

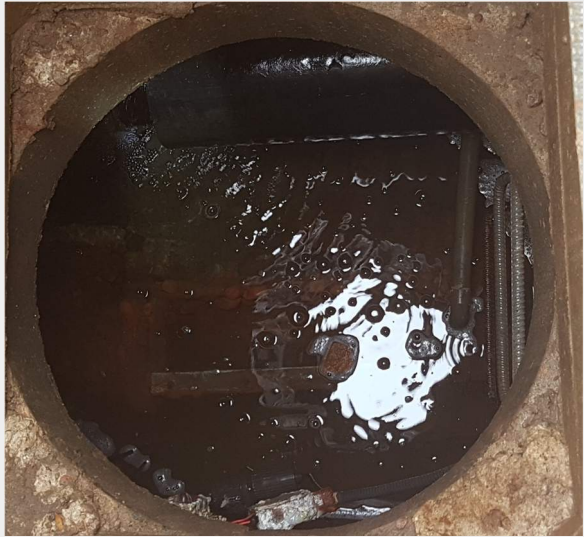
MH 95 – *see image in Table 1.1* – There is a significant leak that appears to be coming from the base of the hydrant. Once leak has been repaired and the structure has been drained, re-inspection of internal components will need to be completed.

Yes – modify structure access
95	<ul style="list-style-type: none"> • Large leak from hydrant base • Depth of standing water suggests downstream sewer problems • Once fixed, pump and take photos of the interior. • Cleanout cover not installed • Inadequate structure access

Yes – major leak, repair structure access and pump out and investigate

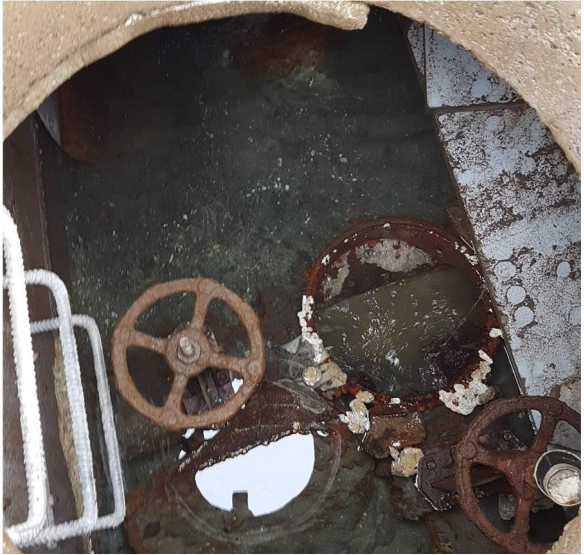
MH 68 - *see image in Table 1.1* – There is a significant leak that appears to be coming from the base of the hydrant. Once leak has been repaired and the structure has been drained, re-inspection of internal components will need to be completed.

68	<ul style="list-style-type: none"> • Watermain location appears to outside of photo frame • Water in chamber appears clear, notes indicate noticeable leak • Cleanout cover not installed

Yes – repair leak
69	<ul style="list-style-type: none"> • Manhole appears to be buried as it cannot be located 		Yes – need to find this critical structure
70	<ul style="list-style-type: none"> • Dirty; requires cleaning and disinfection • Bleed into sewer • Cleanout cover not installed

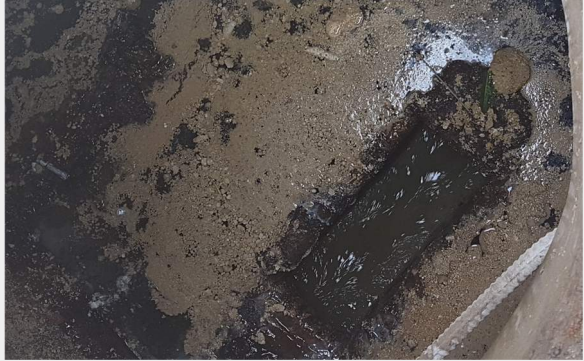
71	<ul style="list-style-type: none">• Dirty; requires cleaning and disinfection• Watermain not visible• Structure access inadequate• Cleanout cover not installed

Yes – modify structure access, pump out and re-inspect.
72	<ul style="list-style-type: none">• Full of water, pump out and inspect• Structure access inadequate• Booster station No. 1 ties into this structure

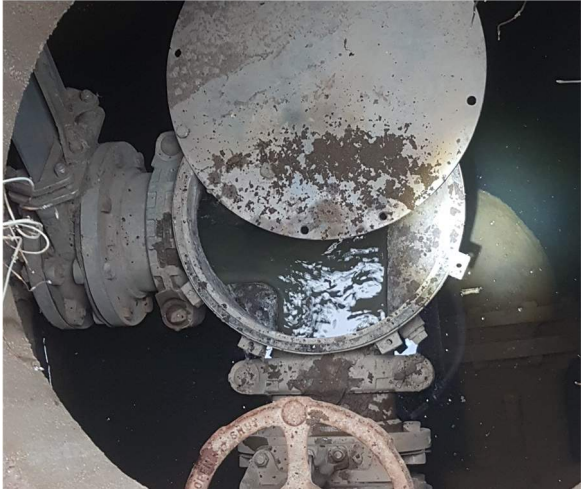
No
100	<ul style="list-style-type: none"> • Knife gate valves for direction of sewage flow • Clarity of water suggests infiltration or a leak • Watermain not clearly visible • Watermain is lower in elevation then sewer • Cleanout cover not installed

Yes – pump out and inspect for leaks

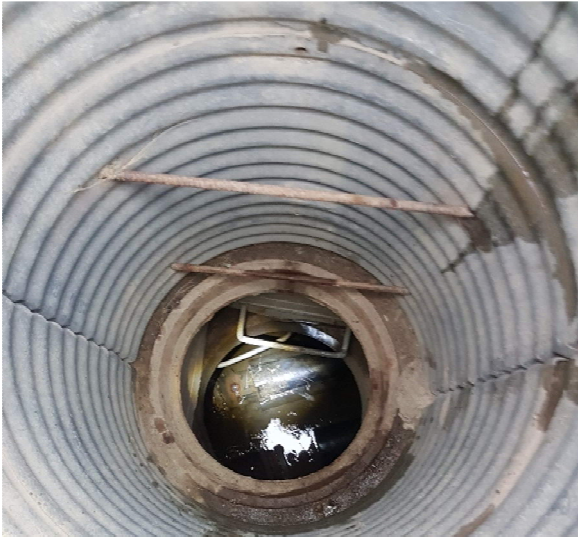
99	<ul style="list-style-type: none">• Clarity of water suggests infiltration or possibly a leak• Access challenging and inadequate due to unusual access tube• Cleanout cover not installed

Yes – modify access
98	<ul style="list-style-type: none">• Clarity of water suggests infiltration or possibly a leak.• Access challenging and inadequate due to unusual wooden access box

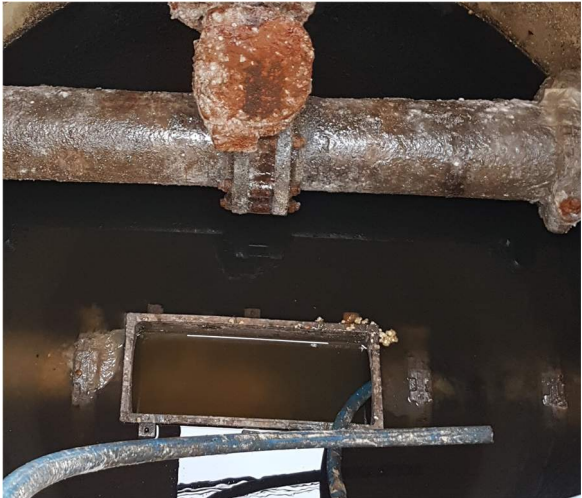
Yes – pump out and inspect for leak
96	Manhole is not visible; could not locate		Yes – need to find this critical structure
216	<ul style="list-style-type: none"> • Heavy corrosion on valve • High level in sewer suggests downstream issues (collapsed pipe?) • Hose in AV suggests ongoing thawing required • Requires cleaning and disinfection • Cleanout cover not installed

Yes – test valve, probably replace. Repair sewer.

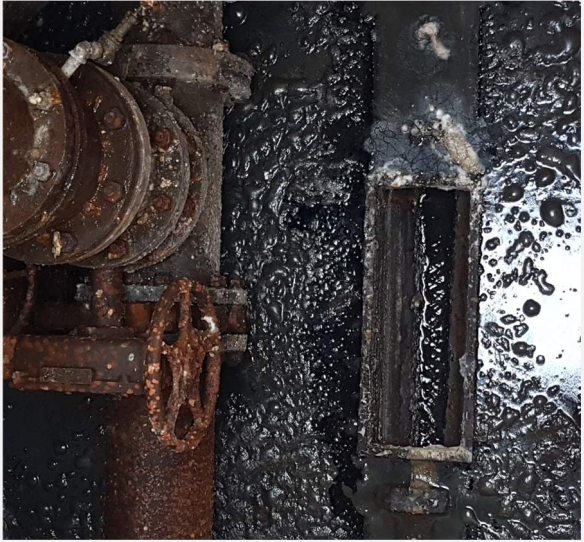
217	<ul style="list-style-type: none"> • Dirty; requires cleaning and disinfection • Accumulation suggests sewer backups • Cleanout cover not installed

Yes – clean and repair sewer
237	<ul style="list-style-type: none"> • Standing water suggest previous backup • Requires pump out • No unusual water observations • Cleanout cover not installed

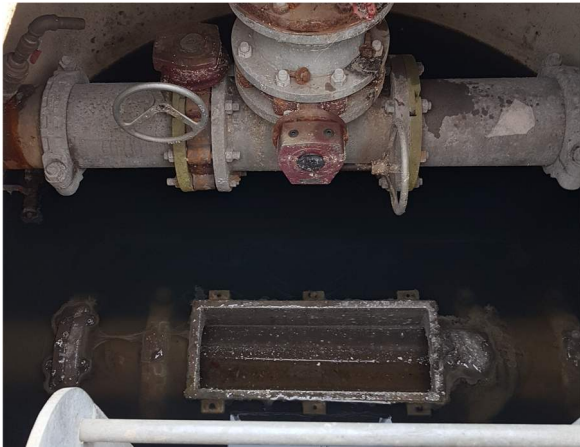
238	<ul style="list-style-type: none"> • Requires pump out • Fitting on laterolet suggests usage as a bleed, no backflow preventer • Cleanout cover not installed

Yes – install backflow preventer
227	<ul style="list-style-type: none"> • Access tube due to AV depth • Cover almost buried due to upslope erosion • Appears to have a bleed present • Need confirmation that valve is closed or open • Internally complex due to watermain from AV 228 <ul style="list-style-type: none"> • Internal not visible • Valve on piping that goes to AV 226 should be closed to prevent short circuit

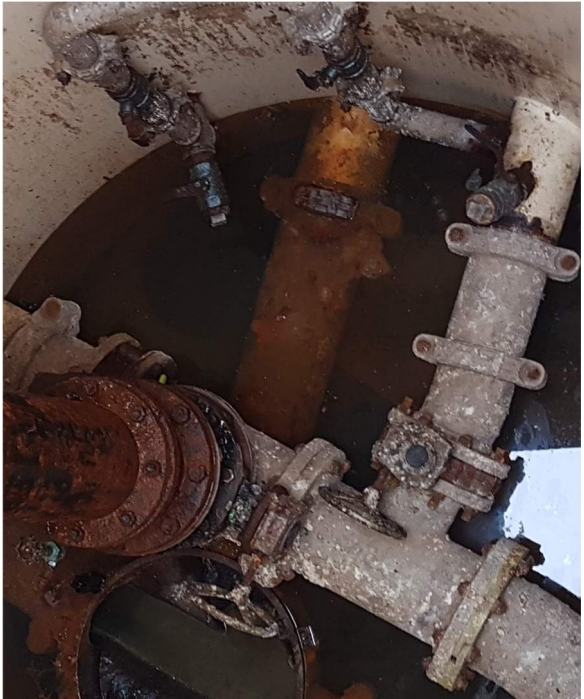
AV 229	<ul style="list-style-type: none">• Return for watermain from AV 232 (not in service)• Valve should be closed to prevent short circuit (piping directed to AV 232)<ul style="list-style-type: none">• Cannot confirm valve position• Cleanout cover not installed

Yes – confirm valve is closed

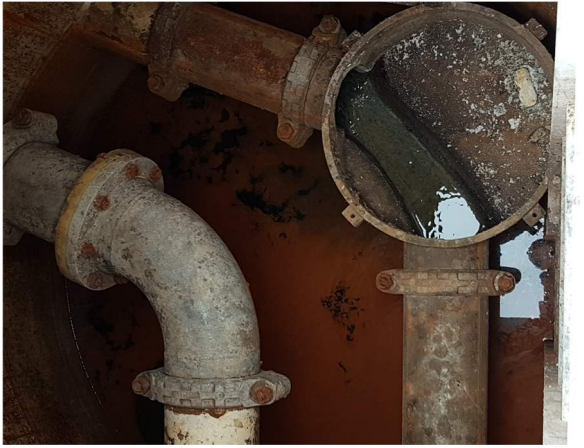
230	<ul style="list-style-type: none">• Heavy corrosion around laterolet, possible leak• Cleanout cover not installed

Yes – investigate laterolet
231	<ul style="list-style-type: none">• No watermain exceptions noted• Cleanout cover not installed	 	No

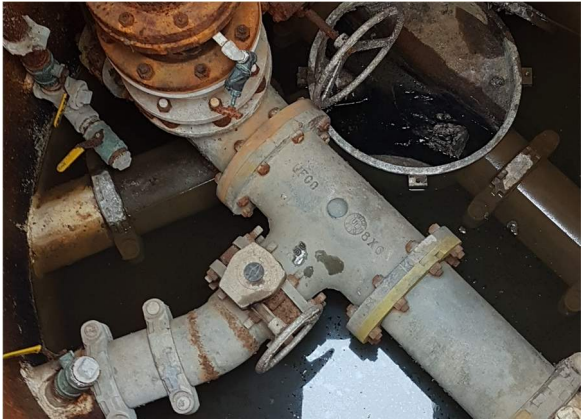
232	<ul style="list-style-type: none"> • Contains recirculation line from AV 229 • Valves appear closed, supposed to be closed at it appears lots between AV 232 and AV 229 are on trucked service • Recirculation piping from AV 229 out of service • Supply valve to AV 229 appears to be open, should be closed • Cleanout cover not installed

Yes – confirm valve positioning
AV 233	<ul style="list-style-type: none"> • Leak on laterolet • Large service connection • Service valve appears to be in half open configuration • Service return not present inside AV, assume it's outside AV • Recirculation piping should be out of service • Cleanout cover not installed

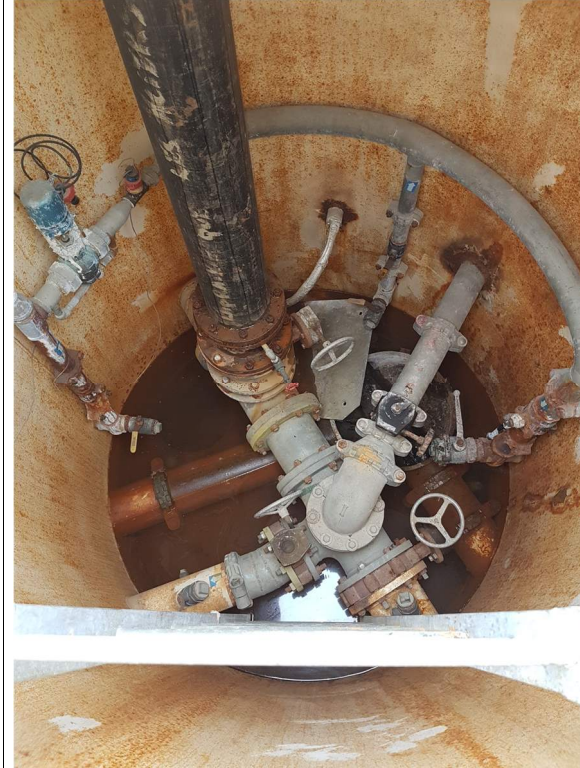
AV 234

- Large service connection
- Location where recirculation should be active from AV 235
 - Self-powered regulator probably not functional/salvageable
 - Flow meter removed
 - Valves appear to be open
- Cleanout cover not installed

Yes – Significant level of effort required to get recirculation system functioning as originally designed

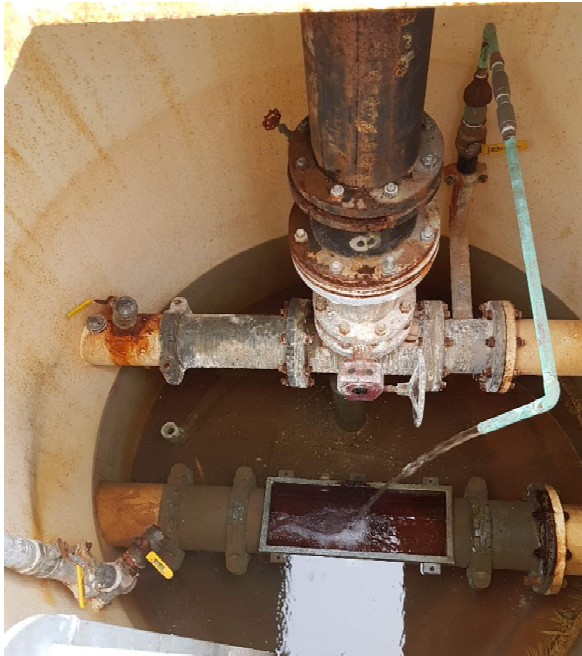
<p>AV 235</p>	<ul style="list-style-type: none"> • Recirculation piping has been removed, piping is underwater sitting on the bottom of vault. • Recirculation piping was replaced with a bleed, currently active with heavy flow rate (appears to have backflow preventer) • Recirculation piping clearly out of service <ul style="list-style-type: none"> • Fitting for flow meter is open • Recirculation piping from AV 235 to 234 is probably frozen • Cleanout cover not installed

<p>Yes – Significant level of effort required to get recirculation system functioning as originally designed</p>
<p>AV 226</p>	<ul style="list-style-type: none"> • Supply to AV 227 • Multiple bleeds installed, some missing backflow preventers • Laterolet valve does not appear to be holding, small leak <ul style="list-style-type: none"> • Fitting suggests laterolet was used as a bleed, again without backflow preventer • Multiple bleed from piping to AV 227 <ul style="list-style-type: none"> • Is watermain currently fed from AV 227? • Recirculation piping out of service <ul style="list-style-type: none"> • Fitting for flow meter is open • Self-powered regulator probably not functional/salvageable • Cleanout cover not installed

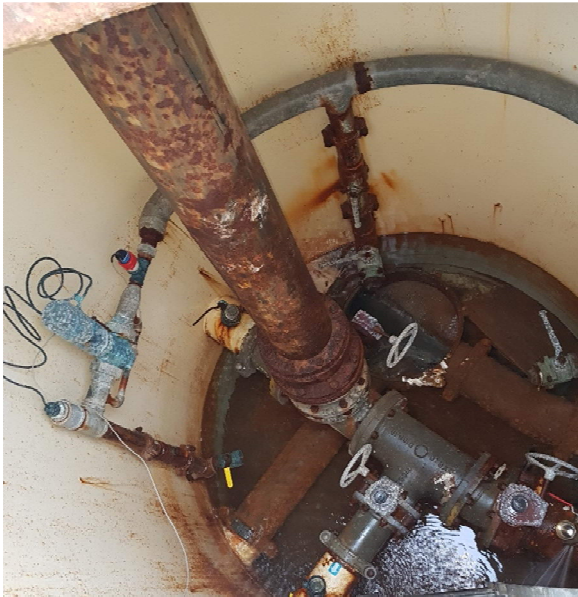
AV 225 - *see image in Table 1.1* – There is a leak on the laterolet that should be repaired. The recirculation piping appears in tact inside this structure, but the key appurtenances do not appear functional or salvageable (ie- self powered regulators). Based on the state of this and all other recirculation components, it is probable that recirculation lines are frozen and not functional nor salvageable. A very significant level of effort will be required to bring this system back to intended design.

225	<ul style="list-style-type: none"> • Clean-out cover missing • Recirculation from AV 239 <ul style="list-style-type: none"> • Probably not in service • Self-powered regulator probably not functional/salvageable • Supply valve to AV 239 open • Leak on laterolet

<p>Yes – fix leak. Significant level of effort required to get recirculation system functioning as originally designed</p>
239	<ul style="list-style-type: none"> • Circulation piping still present, but not as per typical piping configuration • Heavy flow at the bleed • Leak on bleed

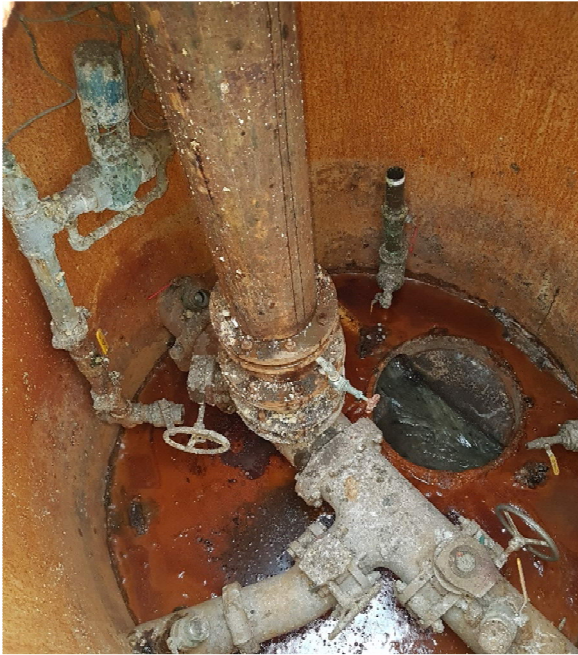
224	<ul style="list-style-type: none"> • Supply to AV 240 • Recirculation piping missing • Self-powered regulator probably not functional/salvageable • Cleanout cover not installed

<p>Yes - Significant level of effort required to get recirculation system functioning as originally designed</p>
240	<ul style="list-style-type: none"> • Recirculation piping removed • Would expect to see a bleed here, possibly using the laterolet. <ul style="list-style-type: none"> • Needs a backflow preventer • Cleanout cover not installed 	 	<p>Yes – Significant level of effort required to get recirculation system functioning as originally designed</p>

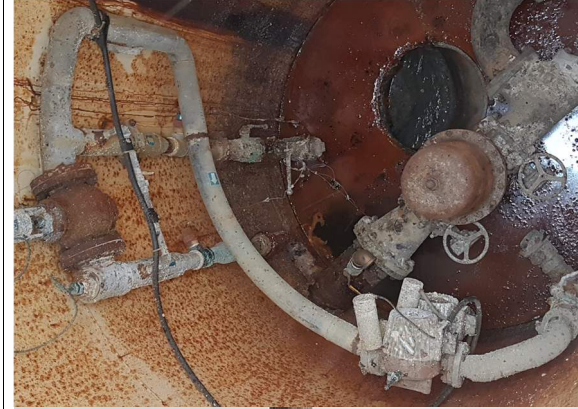
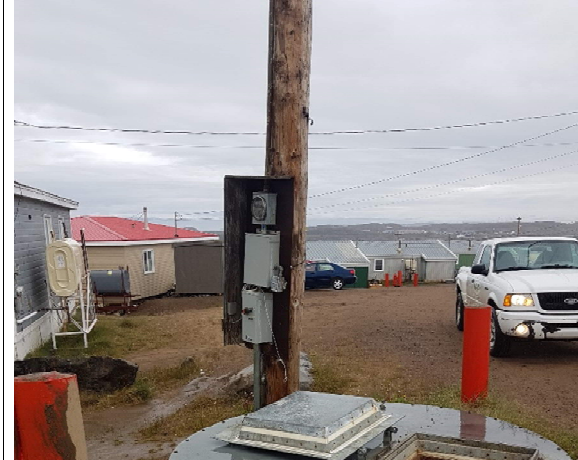
223

- Dirty; requires cleaning
- Pressure reducing valve on main, should be normally closed
- Recirculation
 - 2 pumps in AV, probably not functional or serviceable
 - Piping at the main appears to be removed
 - Automated valve may no longer be serviceable
 - Recirculation piping goes to MH 96, probably all froze
- No meter on electrical service. Is there power?
- Appears that laterolet has been used as a bleed without backflow preventer
- Cleanout cover not installed

Yes – install
backflow preventer

Confirm valve
configuration

Significant level of
effort required to
get recirculation
system functioning
as originally
designed

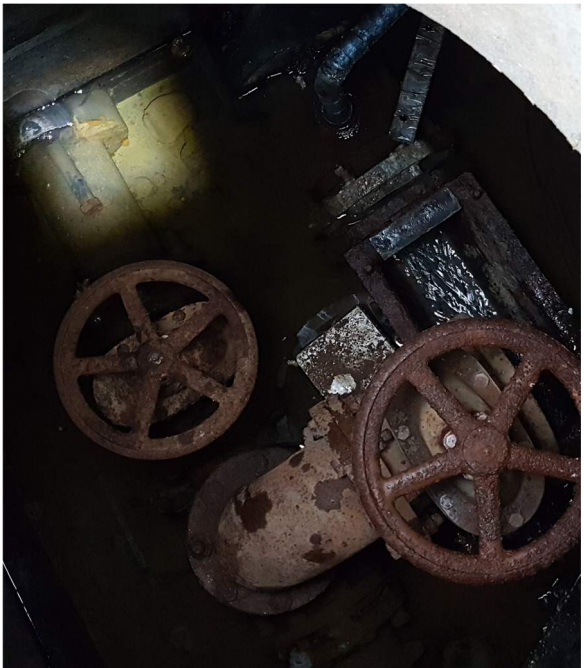
No
92	<ul style="list-style-type: none"> • Sump pump may still be in place, probably not functional • Purpose of valved connection uncertain <ul style="list-style-type: none"> • High contamination risk • Cleanout cover not installed

Yes – properly blank 'T' on the watermain

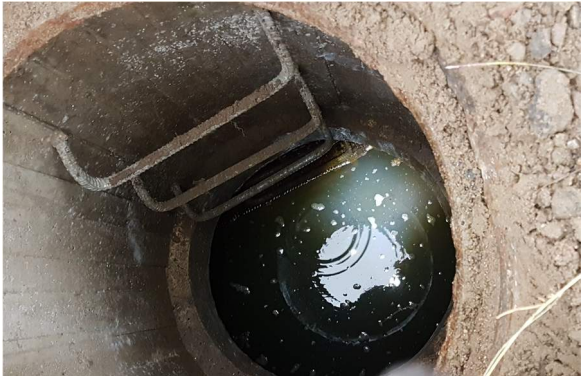
91	<ul style="list-style-type: none">• Cover buried• Chamber filled with water; no observations possible• Possibly downstream sewer issues?

Yes – pump out and investigate
89	<ul style="list-style-type: none">• Sump pump appears to still be in place, probably not functional• Infiltration or possibly a leak• Cleanout cover not installed

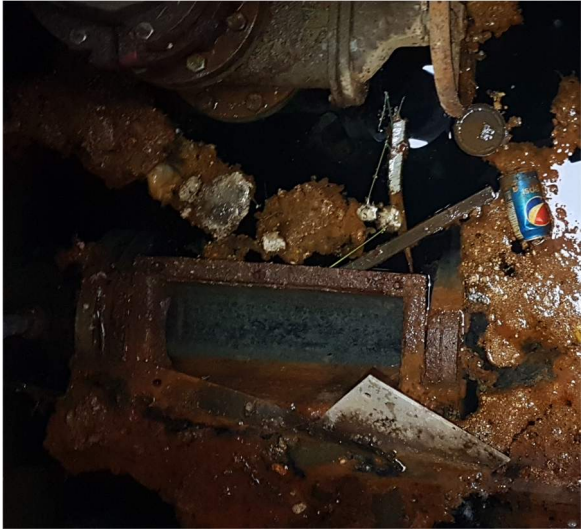
88	<ul style="list-style-type: none">• Watermain is lower than the sewer• Sump pump appears to be in place, probably not functional• Evidence of previous backups• Possibly infiltration or leak• Cleanout cover not installed

A photograph taken from inside a sewer pipe. It shows a sump pump unit at the top, partially obscured by thick, orange-brown sludge. A small blue and red object, possibly a can or a piece of debris, is visible near the pump. The surrounding area is dark and filled with sludge.	Yes – pump out and investigate
87	<ul style="list-style-type: none">• Evidence of previous backups• Watermain is lower than the sewer• Debris, including rocks; requires cleaning• Possibly infiltration or leak• Cleanout cover not installed

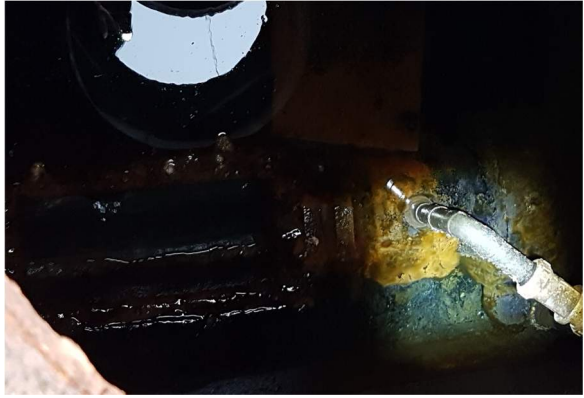
86	<ul style="list-style-type: none">• Infiltration or possibly a leak• Sump pump appears to be in place, probably not functional• Cleanout cover not installed

Yes – pump out and investigate
85	<ul style="list-style-type: none">• Infiltration or leak• Sewer is higher in elevation than watermain• Sump pump appears to be in place, probably not functional• Cleanout cover not installed

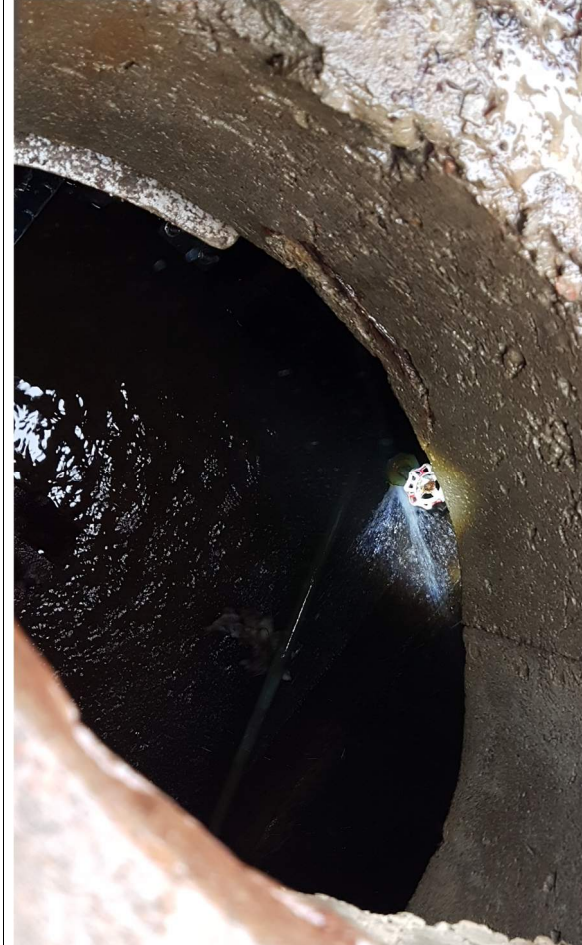
MH 73 - see image in Table 1.1 – This structure had very limited visibility due to the structures collar being shifted, but it appears there was a leak within. Adjust access to structure, install backflow preventer on bleed, and repair leak.

- Frame and cover shifted, very limited internal view
- Active bleed with no backflow preventer
- Cleanout cover not installed

Yes – fix access
and install
backflow preventer

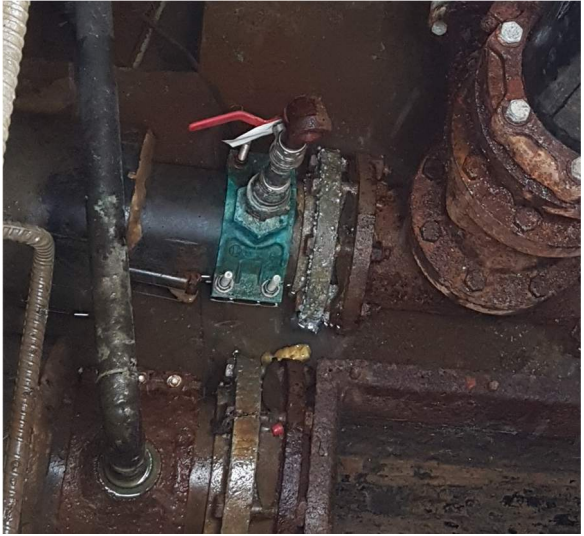
74	<ul style="list-style-type: none"> • Sump pump in place, probably not functional • Service saddle on watermain probably used as a bleed with no backflow preventer present • Cleanout cover not installed

Yes – install backflow preventer
75	<ul style="list-style-type: none"> • Manhole could not be located, probably buried 	N/A	Yes – find this structure
90	<ul style="list-style-type: none"> • Largely filled with debris; internal observations not possible

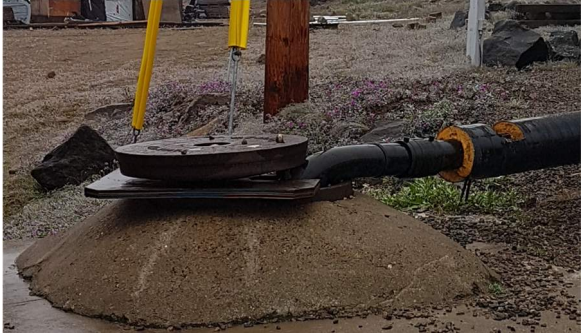
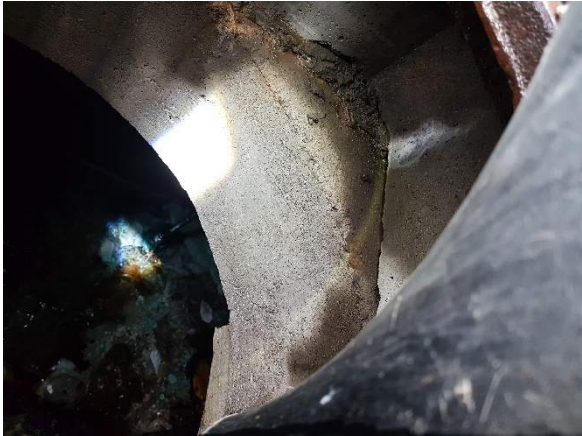
76	<ul style="list-style-type: none"> • Sewer dropping through cover <ul style="list-style-type: none"> • Public safety issues • Very limited internal examination due to sewer • Internal water appears to be relatively clear <ul style="list-style-type: none"> • Objects below water level appear visible • Appears to be a significant internal water leak (audible)

Yes – fix leak and re-arrange the sewer
69	<ul style="list-style-type: none"> • Can't find structure 	N/A	Yes – find it, very important structure
68	<ul style="list-style-type: none"> • Already reviewed 		
95	<ul style="list-style-type: none"> • Already Reviewed 		
103	<ul style="list-style-type: none"> • Already Reviewed

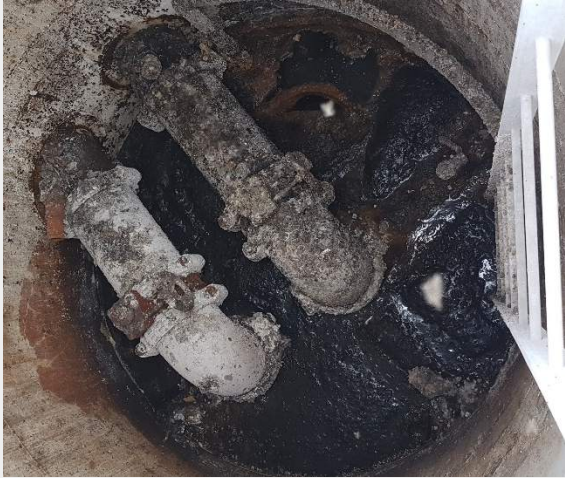
Structure	Comment	Photo	Action Required
AV 305	<ul style="list-style-type: none"> • Sewer Cleanout not installed • Evidence of previous backups and surcharges • Requires cleaning and pumping
