City of Iqaluit

Drinking Water Management Program

Development of Drinking Water Program

OTT-00246002-B0

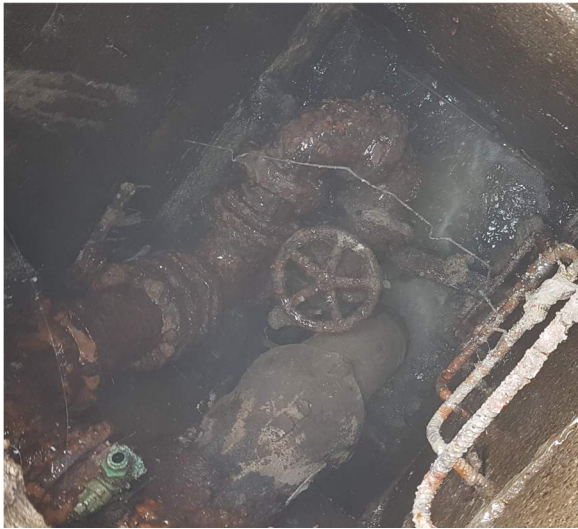
No
MH 9	<ul style="list-style-type: none"> • Water servicing removed from MH 9 in 1985 (approx.) and was replaced with AV 9A • Sewage dropping into structure at very high flow rate • Appears to have extensive corrosion, potential that mechanical components don't operate as intended

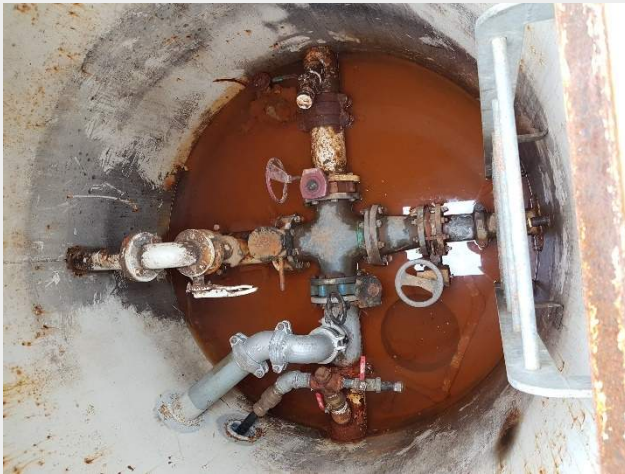
AV 9A	<ul style="list-style-type: none"> • Piping under ladder is believed to be a service, no recirculation piping visible, may be outside structure. • Piping going to MH 84 (going up, vertically in the photo) is supposed to be abandoned. Cannot tell configuration of valve. • Large service connection visible, return piping installed on laterolet

Yes – confirm valve going to MH 84 is closed
MH 8	<ul style="list-style-type: none"> • Key structure in Lower Iqaluit network as the water supply loops back and ties into the structure, thus completing the loop • Originally constructed with open sewer benching • Requires pumping and cleaning • Water level suggests possible downstream sewage issues • Access does not appear adequate • Piping from MH 8 to AV 11 is supposed to have been abandoned • Electrical equipment (heater and sump pump) still in place but probably not functional

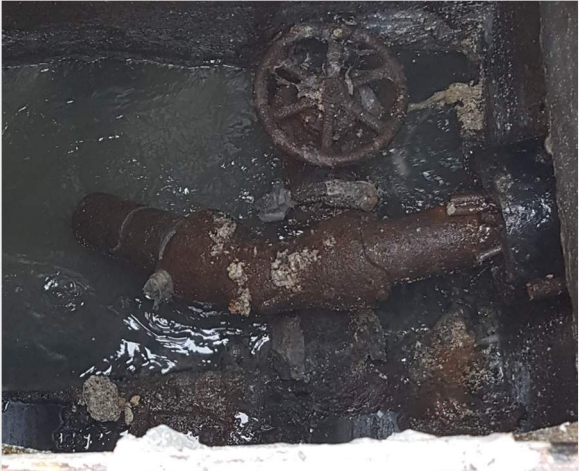
MH 7	<ul style="list-style-type: none"> • Originally constructed with open sewer benching • Appears to have extensive corrosion, potential that mechanical components don't operate as intended • Requires pumping and cleaning • Water level suggests downstream sewage issues • Upper pipe appears to be sewer from AV 10, water line coming from AV 10 was previously abandoned

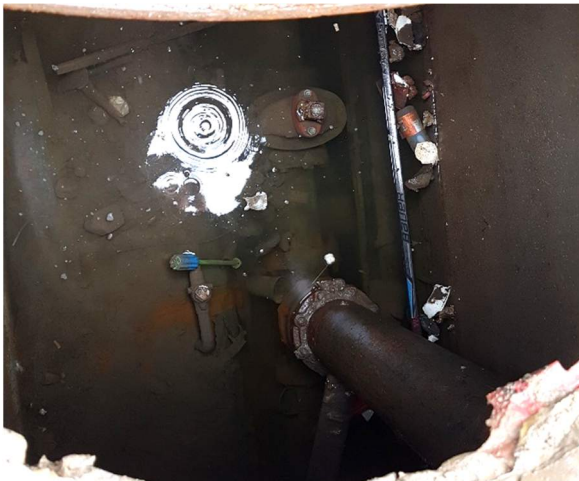
No
PT A2	<ul style="list-style-type: none"> • Low visibility • Requires cleaning and draining

Yes – determine source of water, leak or infiltration

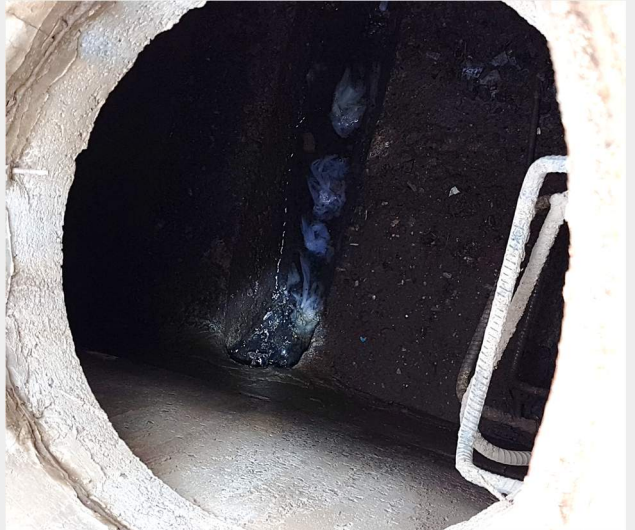
AV 400	<ul style="list-style-type: none"> • Sewage backup issues present • Cleanout cover not installed • Appears to have various jumpers installed • Furthest Valve to the right appears to be closed, this valve should be open as the supply for Lower Iqaluit is supposed to come through this piping • Bleed present but not active, appears to have backflow preventer 	 	<p>Yes, confirm that the valve is in the closed position. If closed, discuss with Public Works why this was shut, frozen pipes? Or?</p>
MH 6	Could not locate structure, possibly buried		Locate and investigate
MH 14	<ul style="list-style-type: none"> • Open sewer benching • Little information can be gathered without entry into structure

<p>Yes – determine source of water, leak or infiltration</p>

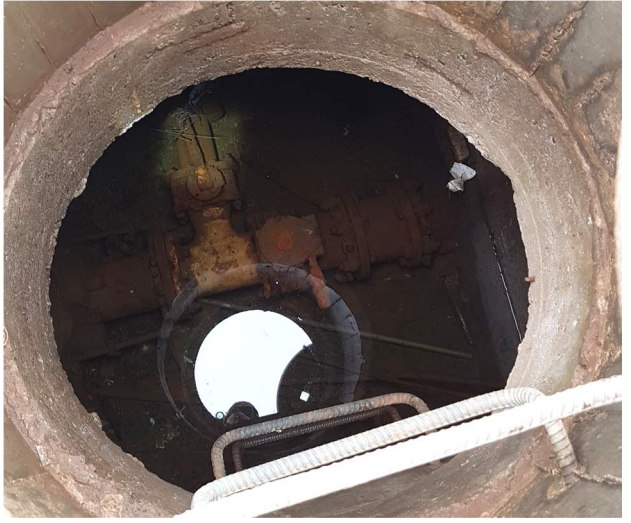
<p>MH 15</p>	<ul style="list-style-type: none"> • Requires pumping • Clear water inside structure, probably groundwater but possibly potable • Low visibility, further information not obtainable without pumping

<p>Yes – determine source of water, leak or infiltration</p>
<p>MH 13</p>	<ul style="list-style-type: none"> • Contains valving to control water flow direction • Requires pumping and cleaning as none of the internals visible • Internal condition suggests sewage back-up to substantial depth

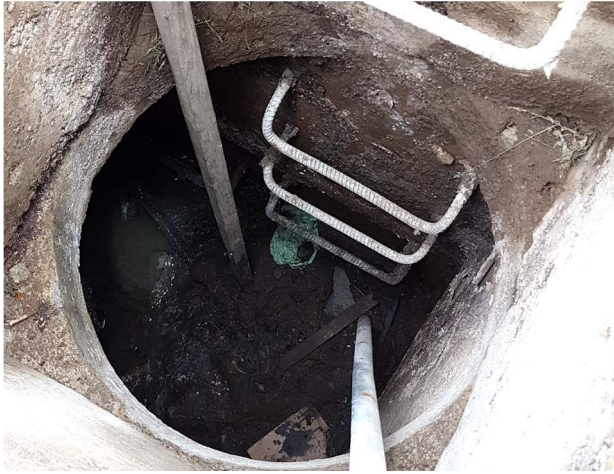
MH 22 – see image in Table 1.1 – During the investigation, it was noted, that audible sounds were observed that seemed to be representative of a leak. Structure requires cleaning and further investigation to confirm the cause of the noise. If a leak is identified, repair.

MH 13	Previously reviewed, see above		
MH 22	<ul style="list-style-type: none"> • Requires pumping and cleaning • Audible sounds suggest water flow present • Further internal observations required

Yes – access to determine causes of noise and repair
MH 21	Could not open, frame and cover seized together.		Yes – Fix access issue and gather information
MH 20	<ul style="list-style-type: none"> • Requires pumping and cleaning • Open sewer benching • Structure access damaged • Internal conditions could not be observed • Requires internal access and re-inspection

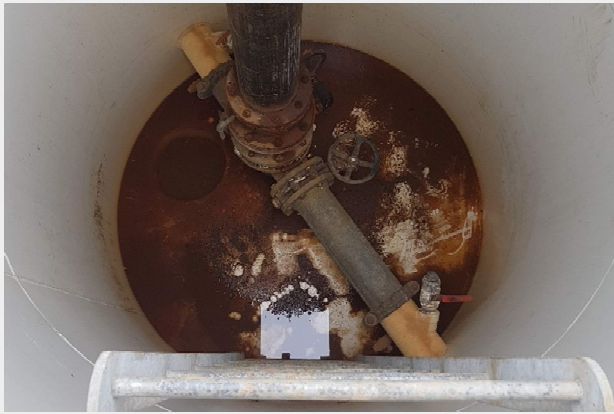
AV 19A	<ul style="list-style-type: none"> • No exceptions noted

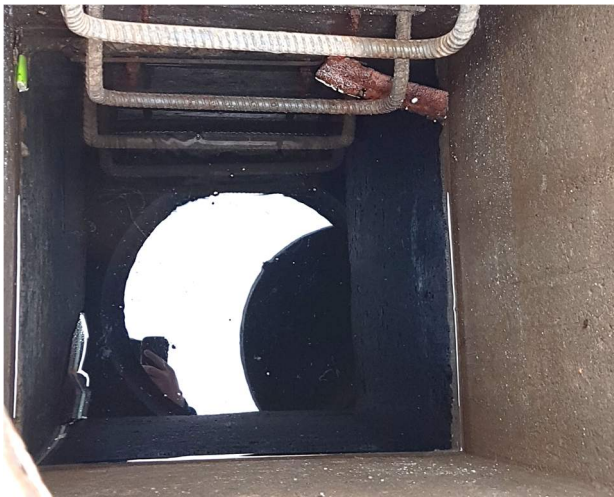
No
MH 23B	<ul style="list-style-type: none"> • Requires pumping and cleaning • Internal conditions could not be evaluated due to internal water

Yes –Investigate structure after cleaning and pumping, determine source of water

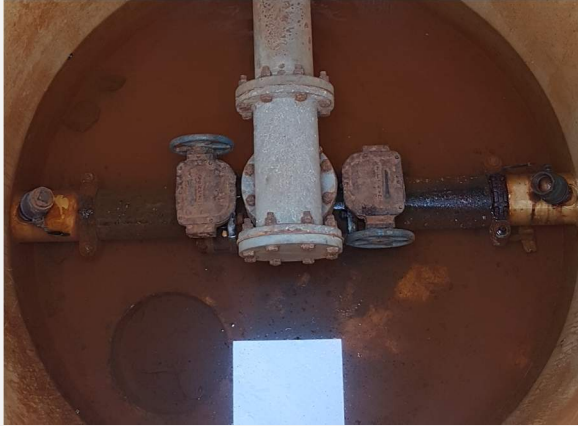
AV 23A	<ul style="list-style-type: none"> • Requires pumping • Installed to separate water from sewer • High humidity due to standing water is damaging coatings • Piping going to MH 33 is to have been abandoned.

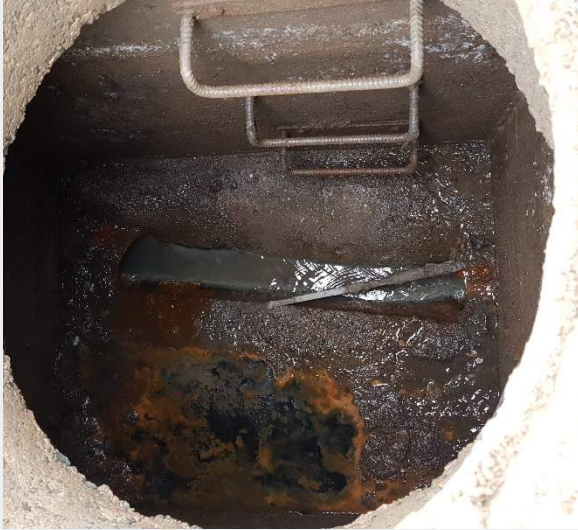
No
MH 30	Could not locate; probably buried		Locate and investigate
MH 31	<ul style="list-style-type: none"> • Requires cleaning and disinfection • Open sewer benching • Indications of sewage back-up to near surface elevation • Watermain is not visible, supposed to be a 150mm ductile iron pipe

Yes – investigate water piping after cleaning

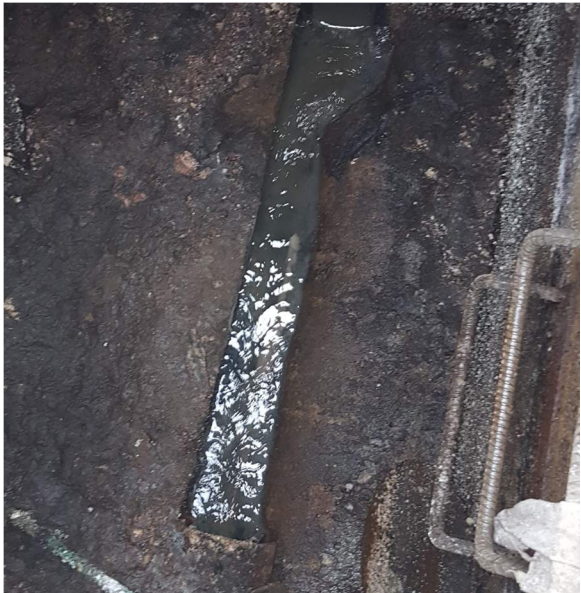
MH 32	<ul style="list-style-type: none"> • Requires cleaning and disinfection • Open benching • Indications of sewage back-up to near surface elevation • Watermain is not visible, supposed to be a 150mm ductile iron pipe

Yes – investigate water piping after cleaning
MH 32A	<ul style="list-style-type: none"> • Requires pumping and cleaning • Clean-out cover missing • Copper piping probably for sump pump that is no longer in service

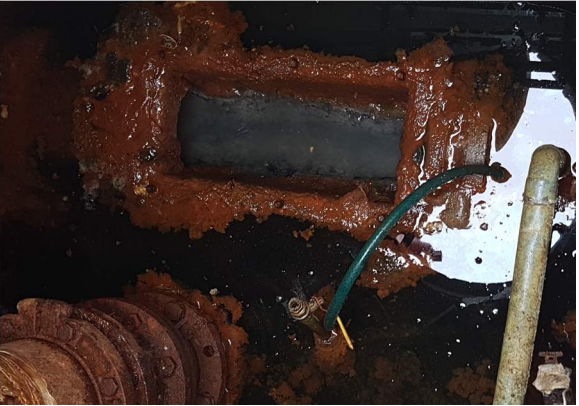
MH 32B	<ul style="list-style-type: none"> • Requires pumping and cleaning • Clean-out cover missing • Appears to previously have used garden hose for bleed; currently broken from nozzle. • Does not appear to have back flow prevention • Copper piping for sump pump; not in service

<p>Yes – if bleed is utilized, backflow preventer required. After pump out investigate watermain</p>
MH 63A	<ul style="list-style-type: none"> • Clean-out cover missing • Water and Sewer both drop vertically • Insulation added for additional freeze protection • Water present at bottom of structure, probably groundwater but could be potable • Bleed installed with missing backflow preventer • Minor leak from end of bleed, structure has water in it upto top of clean out

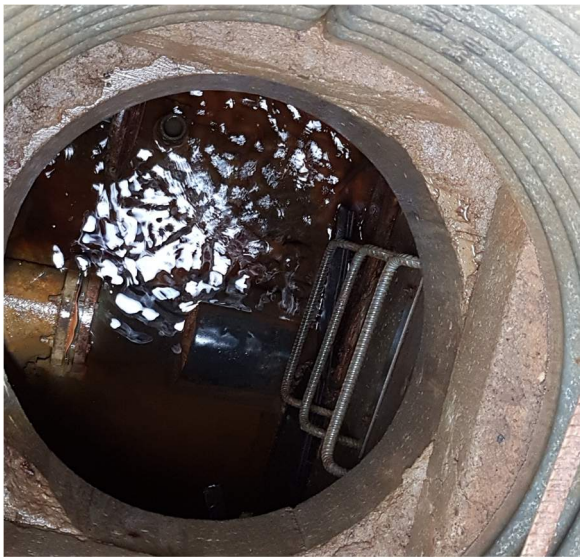
<p>MH 63</p>	<ul style="list-style-type: none"> • Requires pumping water at bottom • Frame and cover raised using a combination of CSP and concrete collar. • Inadequate structure access • This is an important junction/structure within Lower Iqaluit loop. • Structure has quite a bit of water that appears transparent, possible leak or groundwater.

<p>Yes – repair access, investigate source of water in structure.</p>
<p>MH 65</p>	<ul style="list-style-type: none"> • Structure access appears inadequate • Structure has water that appears transparent, possible leak or groundwater • Cleanout cover not installed

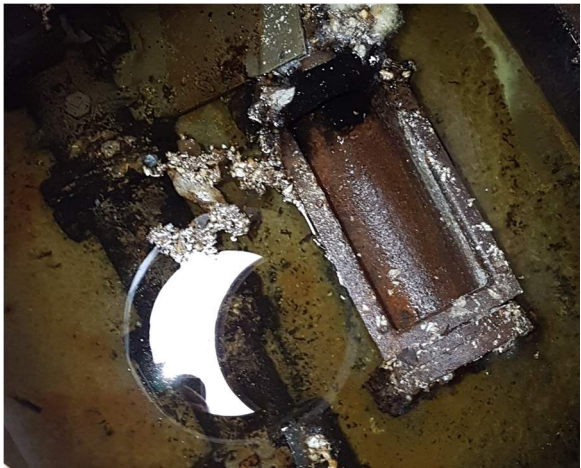
MH 66	<ul style="list-style-type: none"> • Transparent water within structure, appears to be ground water infiltration but could possibly be a leak • Pumping and cleaning required • Appears to be top of sewer run

Yes – investigate source of water in structure.
MH 39	<ul style="list-style-type: none"> • Large structure with 2 access points • Significant leak at valve • Water pipe going to MH 48 should be out of service • Electrical equipment still present but probably not functional

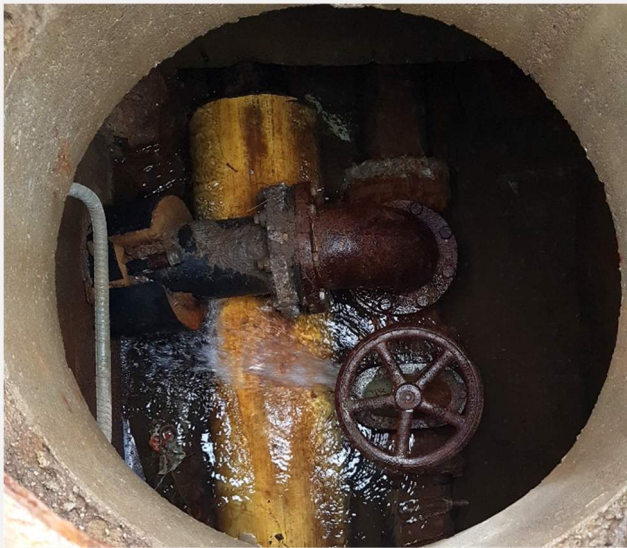
MH 39 – see image in Table 1.1 – Major leak identified at the valve, repair the leak.

Yes – repair major leak

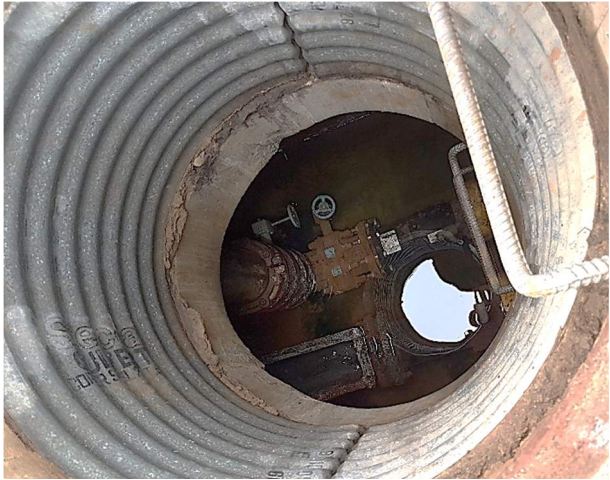
MH 38	<ul style="list-style-type: none"> • Requires pumping • Frame and cover raised using a combination of CSP and concrete collar. • Clean-out cover missing • Appears to contain groundwater

Yes – investigate water source within structure

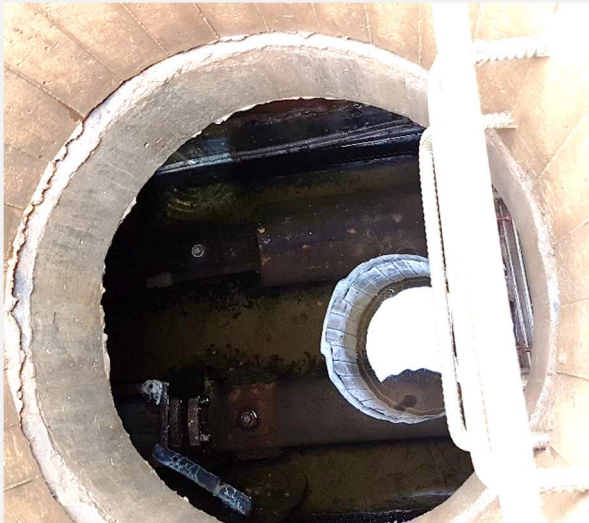
MH 37	<ul style="list-style-type: none"> • Requires pumping and cleaning • Structure appears to have relatively clear water, possible leak or groundwater

Yes – investigate water source within structure
MH 36	<ul style="list-style-type: none"> • Requires pumping, removal of debris and cleaning • Clean-out cover missing • Sewer appears to have previous backups • Sump pump and heater present but probably not functional

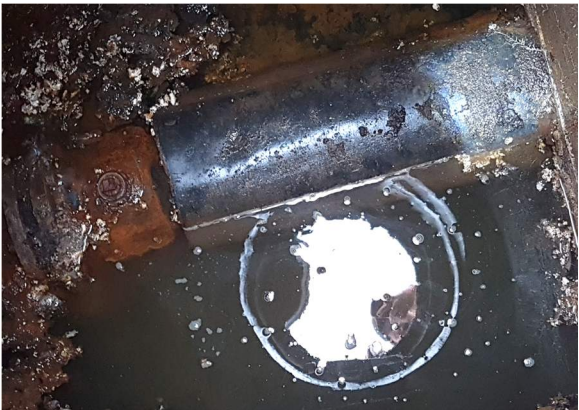
MH 35	<ul style="list-style-type: none"> • Requires pumping and cleaning • Clean-out cover missing 	 	Yes – investigate water source within structure
MH 62	<ul style="list-style-type: none"> • Requires pumping and cleaning • Further comments require pump out

Yes – investigate water source within structure

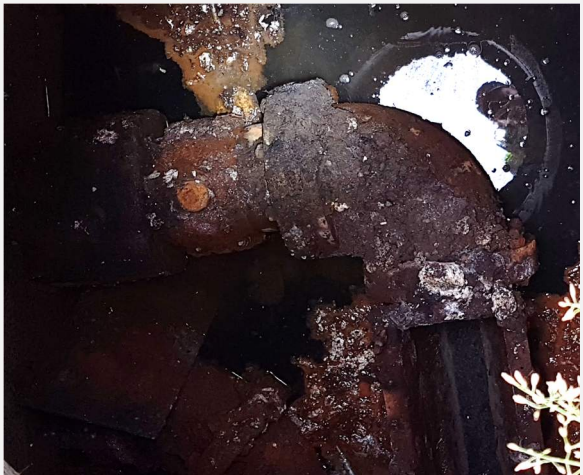
MH 61	<ul style="list-style-type: none"> • Requires pumping and cleaning • Significant corrosion, indicative of long standing water issues • Appears to have experienced sewage back-up and surcharge • Further comment requires cleaning and re-inspection

Yes – investigate water source within structure
MH 60	<ul style="list-style-type: none"> • Access appears to be buried • Internal inspection not possible • Important junction in water network

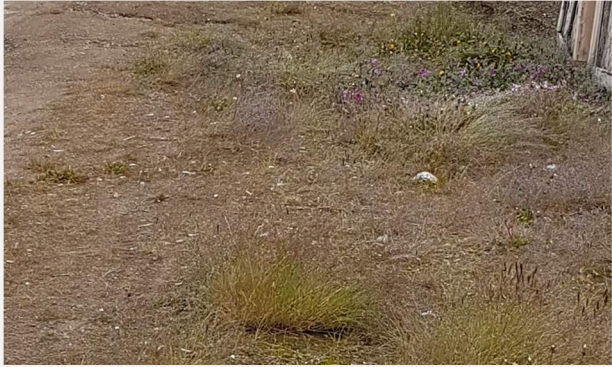
MH 59	<ul style="list-style-type: none"> • Structure appears to be buried • Internal inspection not possible

Yes – Uncover access and investigate
MH 48	<ul style="list-style-type: none"> • Large structure with 2 access points • Sump pump installed but probably not functional • Piping to MH 39 should have a valve that is in the closed position • Cleanout cover not installed • Relatively clear water present, possible leak or infiltration

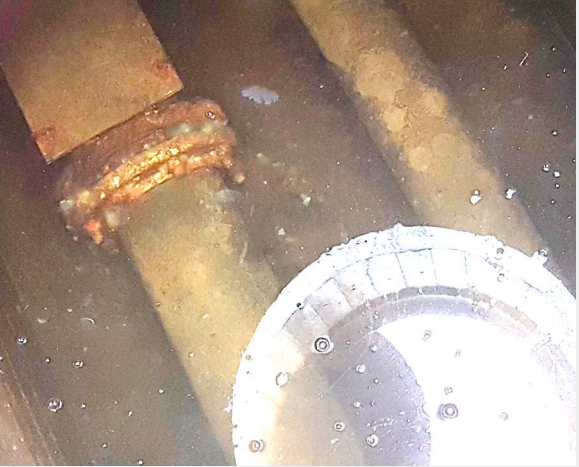
MH 47	<ul style="list-style-type: none">• Requires pumping• Clean-out cover in place

Yes – investigate water source within structure
MH 46	<ul style="list-style-type: none">• Requires pumping• Clean-out open• Piping in place for a bleed, not operating during inspection• Structure needs to be accessed to see other piping which connects to watermain

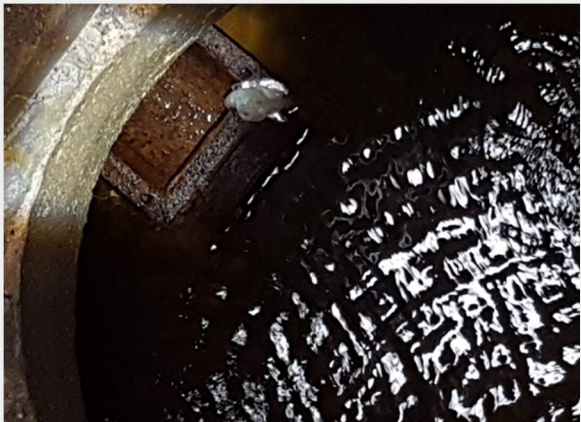
MH 58	<ul style="list-style-type: none"> • Requires pumping • CSP riser installed over concrete structure • Clean-out open, water inside structure is filled to rim of clean-out; draining into sewer • Watermain not visible

Yes – Investigate water source, groundwater or leak
MH 46B	<ul style="list-style-type: none"> • Unused electrical equipment remains in place <ul style="list-style-type: none"> • Sump pump, electric heater, connection to thaw tube • Clean-out cover missing, start of sanitary run • Requires cleaning • Structure generally dry • Newer ball valve installed, assuming it was used as a bleed.

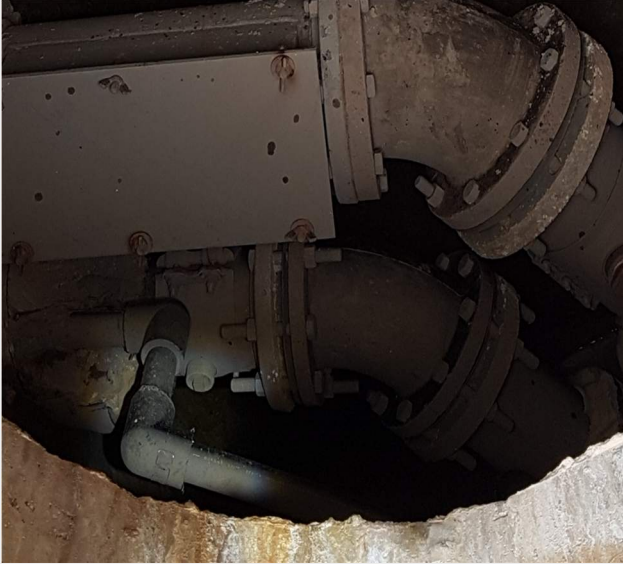
MH 46A	<ul style="list-style-type: none"> • Clean-out cover appears to be in place <ul style="list-style-type: none"> • Appears to be a retro-fitted cover • Thaw tube still in place • Requires pumping

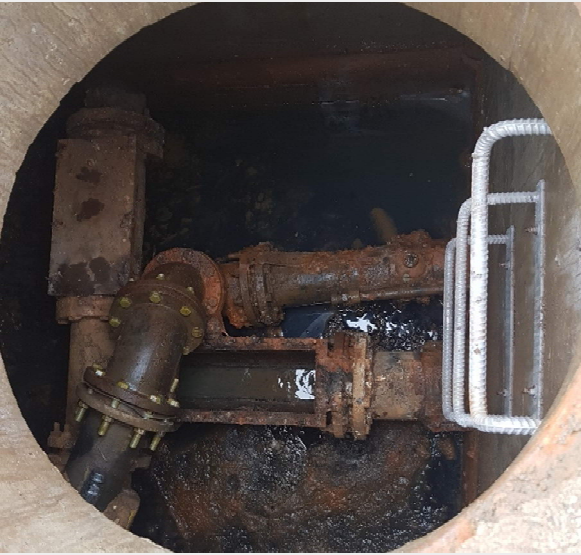
No
MH 45	Structure not visible; probably buried		Yes – Locate and uncover
MH 43	<ul style="list-style-type: none"> • Requires pumping and cleaning • Clean out cover removed • Watermain crosses over sewer main • Evidence of previous backup and surcharges

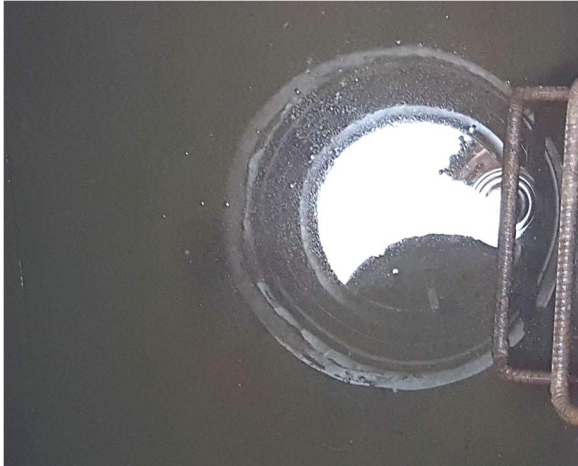
MH 42	<ul style="list-style-type: none"> • Requires pumping and cleaning • Important junction in watermain network • No internal observations possible

Yes – clean and investigate
PT A	<ul style="list-style-type: none"> • Could not open wooden box; inspection not possible

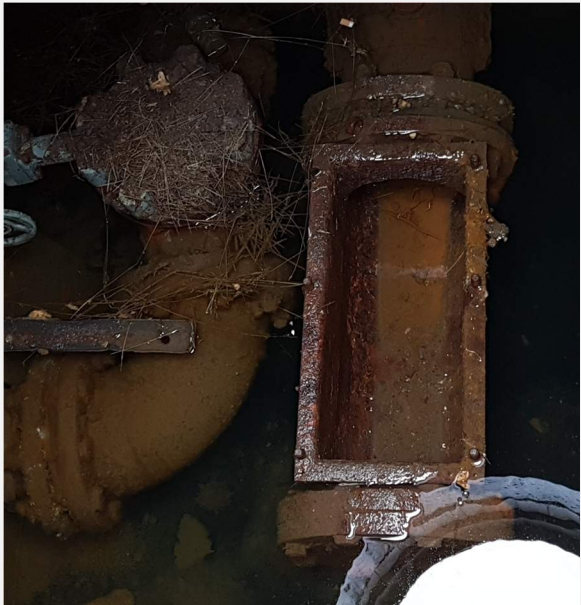
MH 41	<ul style="list-style-type: none"> • Requires pumping and removal of debris • Clean-out cover missing • Appears filled with groundwater to clean-out rim • Top end of sewer system • No evidence of sewage back-up

Yes – investigate water source
MH 40	<ul style="list-style-type: none"> • Requires pumping • Lower sewer piping not visible • Upper piping appears more recent (thaw laterolets) • Valve on lower piping between newer piping is supposed to be in closed position

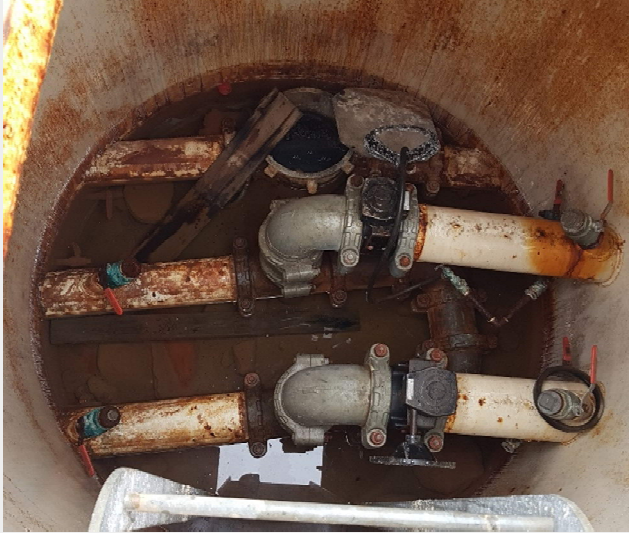
AV 40A	<ul style="list-style-type: none"> • Requires pumping • Cleanout not installed • Original configuration had water entering and returning within the structure, appears to have been extended. • Where (structure) the water returns, unknown • Piping for a bleed present, doesn't appear active • Corrosion around laterolet indicates minor leak

Yes – investigate water source, repair laterolet
MH 40	Previously reviewed, see above		
MH 24A	<ul style="list-style-type: none"> • Leak at 45° bends flanged connection • Requires pumping and cleaning, contamination risk is high with leak present • Electrical components are present but probably not functioning

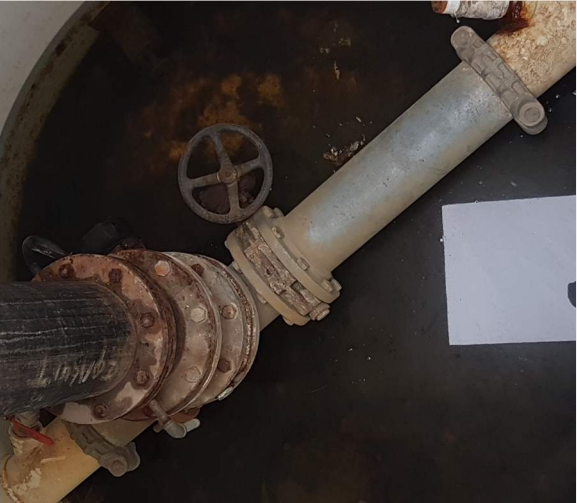
AV 25A	<ul style="list-style-type: none"> • Appears to have been provided to separate water from sewage (MH 25) • Requires pumping • Corrosion around laterolet indicates a minor leak

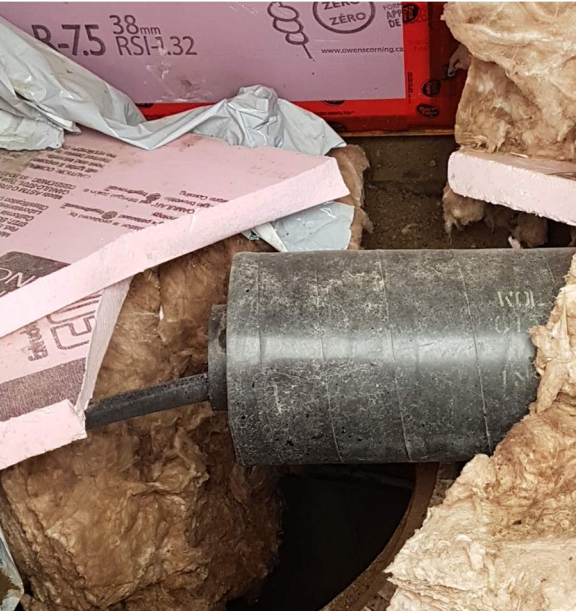
No
MH 26	<ul style="list-style-type: none"> • Wooden box has been constructed above the structure • Limited visibility • Appears to have ½ piping either acting as a service or as a bleed into the structure

Yes – Correct odd configuration and investigate internal components

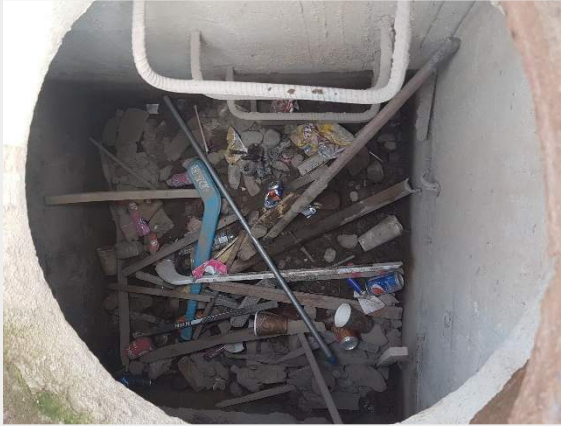
MH 27	<ul style="list-style-type: none"> Filled with debris, cleaning required

Yes – clean and insepct
MH 8	Previously reviewed, see above

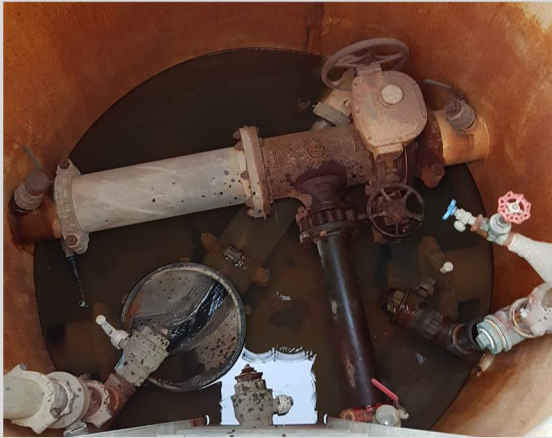
<u>AV #</u>	<u>Comment</u>	<u>Photo</u>	<u>Corrective Action</u>
AV 200	<ul style="list-style-type: none"> • Heated water returning into the supply from the Trigram building through 4" piping • Recirculation piping that feeds into the Trigram building (recirculation from Lower Base and Airport Loop are combined) • Install cleanout cover

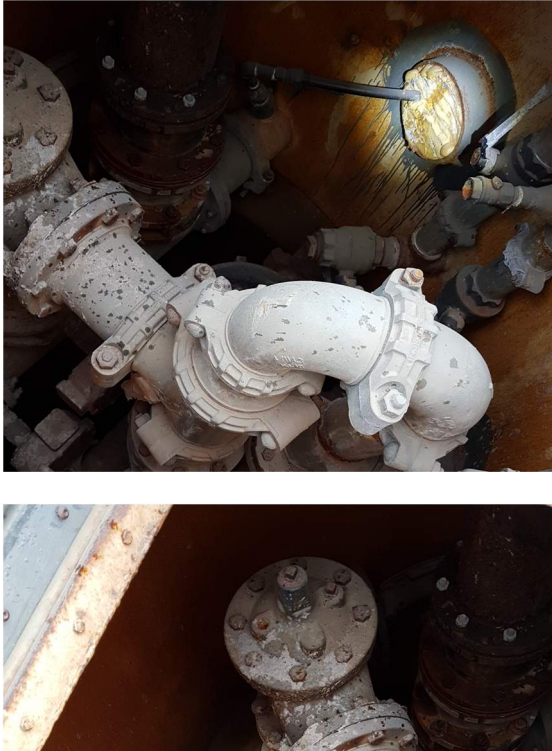
AV 201 – *see image in Table 1.1* – This is a very critical AV as part of the Lower Base network as well as for the Airport loop. The recirculation line from Lower Base as well as the returning supply from Airport are combined into one recirculation line within this AV and are then directed towards the Trigram building to have heat added. There is also a pressure reducing valve installed within this AV on the supply line for Lower Base and Airport Loop. Under normal conditions it is in the closed configuration. In a low-pressure event the valve opens, and additional water is added in both directions of the Airport loop to provide additional water and pressure for fire conditions. We believe the current state of this valve is open and thus the circulation pattern is not per design conditions.

No
AV 201	<ul style="list-style-type: none"> • CLA-VAL pressure reducing valve, model 100-20 for high (fire) flow conditions • Here is where Lower Base and Airport Loop recirculation lines are combined and head to trigram building in 1 recirculation line to have heat added • Internal appurtenances configuration appears similar to design • Piping for CLA-VAL Pressure reducing valve is missing pilot controls. In current condition it appears the valve is in full open configuration which should only occur during fire conditions. If correct, then reverse feed of airport loop and lower base on a constant basis. • Appears a service connection was made on the laterolet, not sure where the service return is. Or this could be the return from the 4" service at bottom of the 2- 90-degree bends

<p>YES</p> <p>Pilot piping needs to be re-installed. Could be a major issue as Lower Base and Airport would need to function as intended. All piping would need to be operational and thawed.</p>

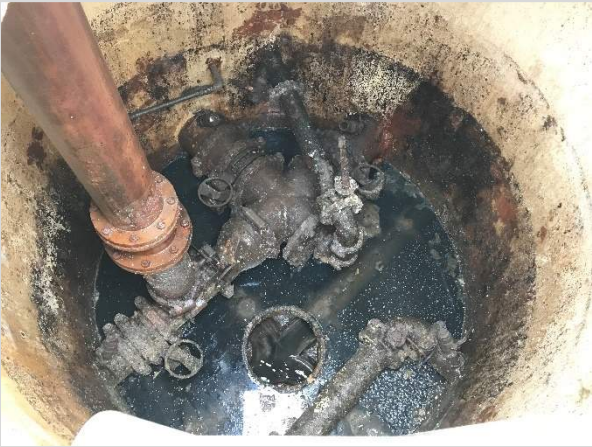
AV 414	<ul style="list-style-type: none"> • Requires cleaning • 4" service to government of Canada building • Connection of service re-circulation pipe not clear, appears there's a 1" return just discharging into vault • Supply splits to feed Airport Loop and Lower Base here • Install cleanout cover

<p>YES</p> <p>Verify that the small pipe is connected. Please send photos.</p> <p>Connection should be made for the small diameter piping if it is a service recirculation or atleast install a backflow preventer</p>
AV 415	<ul style="list-style-type: none"> • 2 – large services (8" and 6") for large buildings • Not sure where the 8" watermain and sewer heading south go (direction towards the ladder) • Water is supposed to do a 180 loop here and go to feed Lower Base • Install cleanout cover

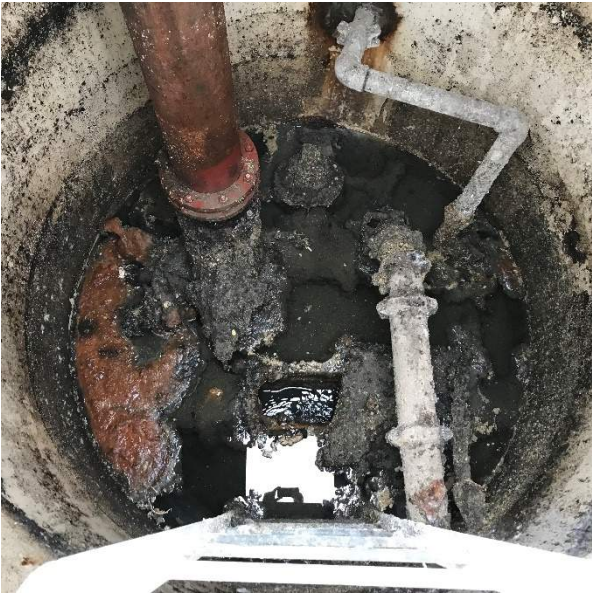
AV 413	<ul style="list-style-type: none">• Appears to be 2 – services and re-circulations pipes, configuration appears correct• Install cleanout cover

YES Needs cleaning and another photo to properly assess
AV 205	<ul style="list-style-type: none">• Watermains cross, but do not interconnect• Jumpers in place, but laterolet valves appear to be closed. If these jumpers are activated, the flow patterns for both the Airport Loop and Lower Base are affected and the 2 separate loops would be interconnected.• Circulation is supposed to be in service for Lower Base, but pumps not operating.• Install cleanout cover

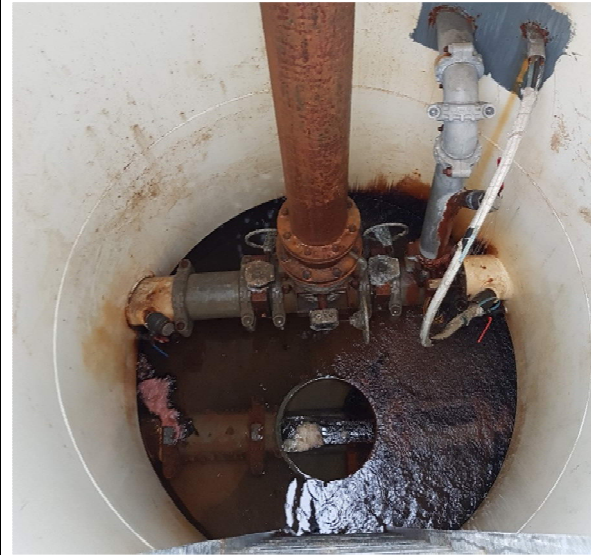
AV 405 - *see image in Table 1.1* – There is a significant leak coming from the return line on the service within this structure. There also appears to be a leak at the laterolet of the service supply. Both should be repaired.

- Service return piping has a significant leak
- Interesting to see a laterolet on service supply, evidence of leak around laterolet as well due to corrosion.
- Evidence of sewage backups
- Sanitary cleanout cover not installed

Yes
Repair leaks (x2)

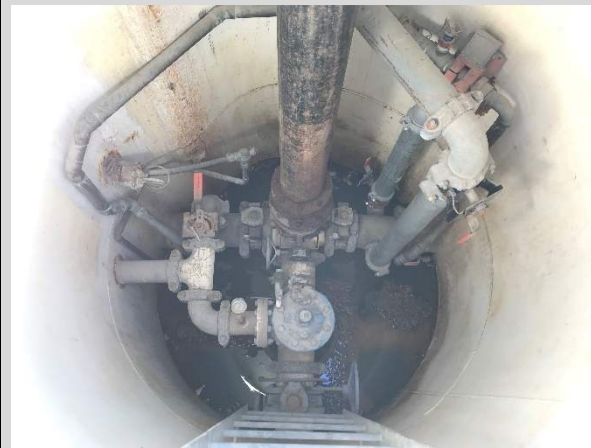
AV 404

- Structure appears to be bowed out of shape, structural failure possibly
- Jumper connected has a flow regulator and flow meter, condition unknown
- Pressure reducing valve present, appears to be in working order
- Large service connection, return piping appears to be located on other side of valving
- Sanitary cleanout cover not installed
- Evidence of sewer backups

Yes
Investigate structure further, piping configuration as well as structural assessment

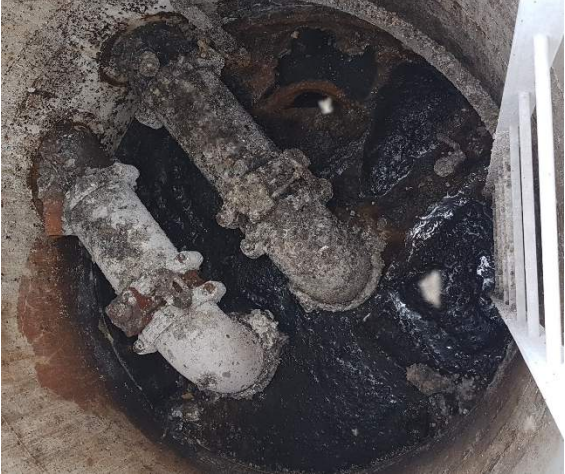
AV 305	<ul style="list-style-type: none">• Sewer Cleanout not installed• Evidence of previous backups and surcharges• Requires cleaning and pumping

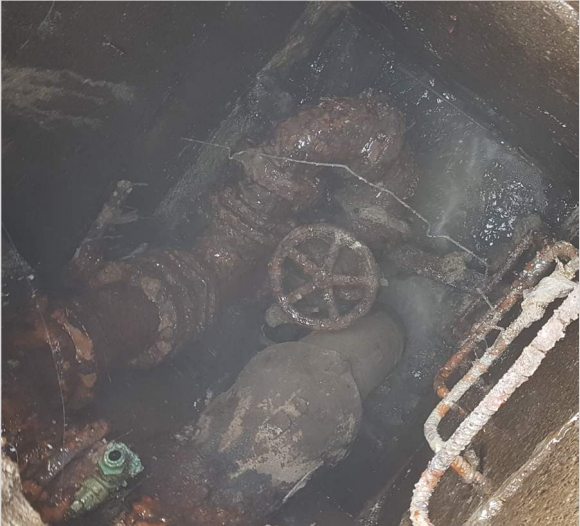
No
MH 9	<ul style="list-style-type: none">• Water servicing removed from MH 9 in 1985 (approx.) and was replaced with AV 9A• Sewage dropping into structure at very high flow rate• Appears to have extensive corrosion, potential that mechanical components don't operate as intended

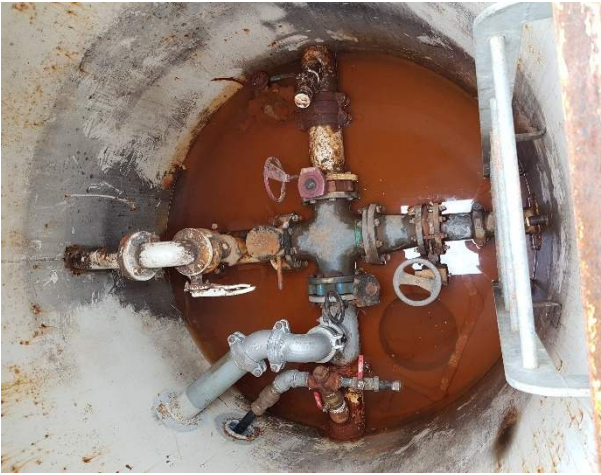
<p>AV 9A</p>	<ul style="list-style-type: none"> • Piping under ladder is believed to be a service, no recirculation piping visible, may be outside structure. • Piping going to MH 84 (going up, vertically in the photo) is supposed to be abandoned. Cannot tell configuration of valve. • Large service connection visible, return piping installed on laterolet

<p>Yes – confirm valve going to MH 84 is closed</p>
<p>MH 8</p>	<ul style="list-style-type: none"> • Key structure in Lower Iqaluit network as the water supply loops back and ties into the structure, thus completing the loop • Originally constructed with open sewer benching • Requires pumping and cleaning • Water level suggests possible downstream sewage issues • Access does not appear adequate • Piping from MH 8 to AV 11 is supposed to have been abandoned • Electrical equipment (heater and sump pump) still in place but probably not functional

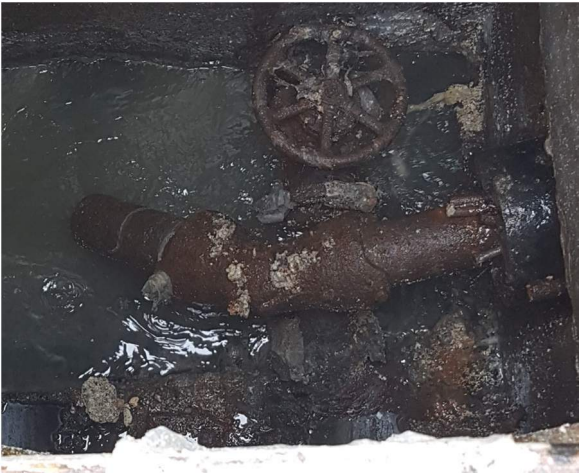
<p>MH 7</p>	<ul style="list-style-type: none"> • Originally constructed with open sewer benching • Appears to have extensive corrosion, potential that mechanical components don't operate as intended • Requires pumping and cleaning • Water level suggests downstream sewage issues • Upper pipe appears to be sewer from AV 10, water line coming from AV 10 was previously abandoned

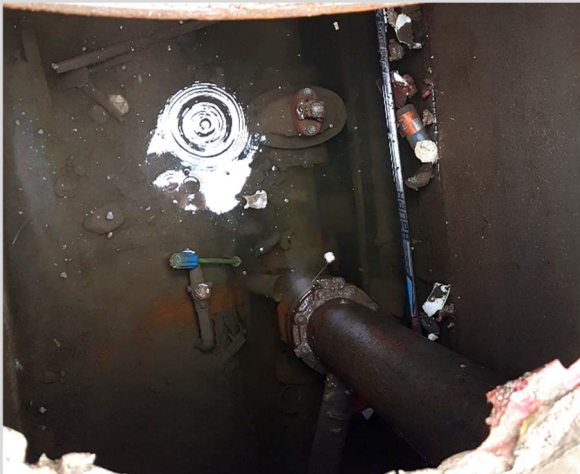
<p>No</p>
<p>PT A2</p>	<ul style="list-style-type: none"> • Low visibility • Requires cleaning and draining

<p>Yes – determine source of water, leak or infiltration</p>

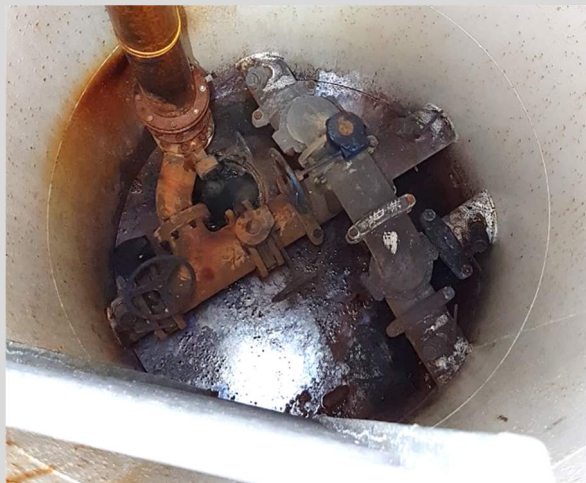
AV 411	<ul style="list-style-type: none">• Evidence of corrosion on back side of hydrant• Structure's protective coating appears to be failing, pitting evident• Watermain crosses over other main, not interconnected• Sanitary cleanout cover not installed• Evidence of sewer backup

Yes Investigate around hydrant barrel and connections, minor leak possible
AV 431	<ul style="list-style-type: none">• Sanitary clean out cover not installed• Evidence of sewer backups

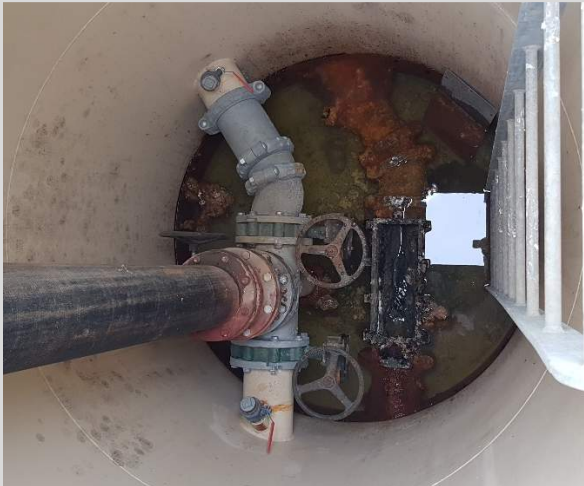
AV 432	<ul style="list-style-type: none">• Extensive corrosion on sanitary piping• Sanitary clean out cover not installed• Evidence of Sewer backups

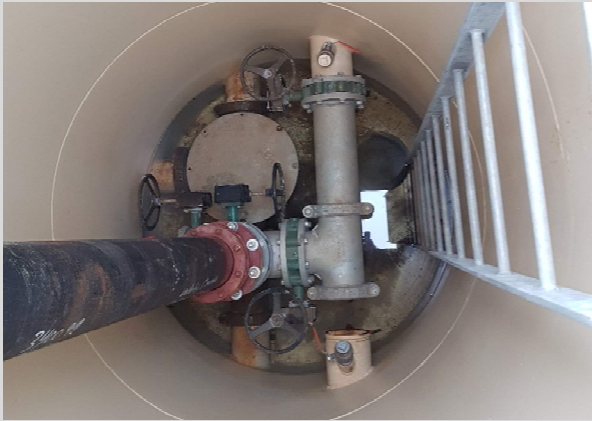
AV 434	<ul style="list-style-type: none"> • Future water connection not utilized, also not capped • Sanitary cleanout lid isn't bolted • Standing water in structure

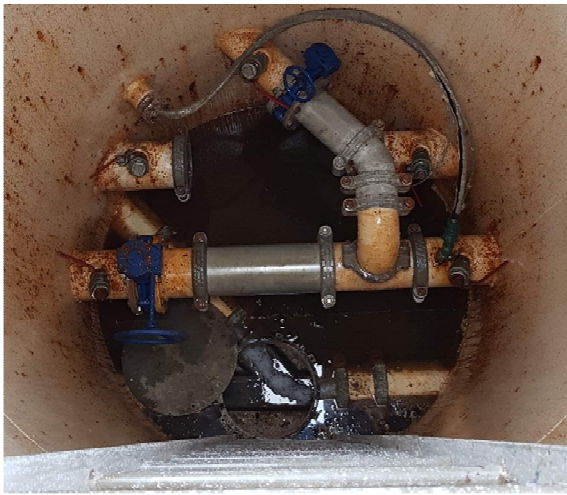
AV 435 - *see image in Table 1.1* – There is a leak at the laterolet, this should be repaired. Also investigate as another leak is possible, picture shows water on the piping.

No
AV 435	<ul style="list-style-type: none"> • Laterolet appears to be leaking • Piping is wet, which indicates another leak, investigate • Large service connection present • Sanitary cleanout cover not installed • Protective coating within structure is failing, pitting evident

<p>Yes</p> <p>Repair leak at laterolet and investigate for further leaks within structure</p>
AV 411	Previously reviewed, see above

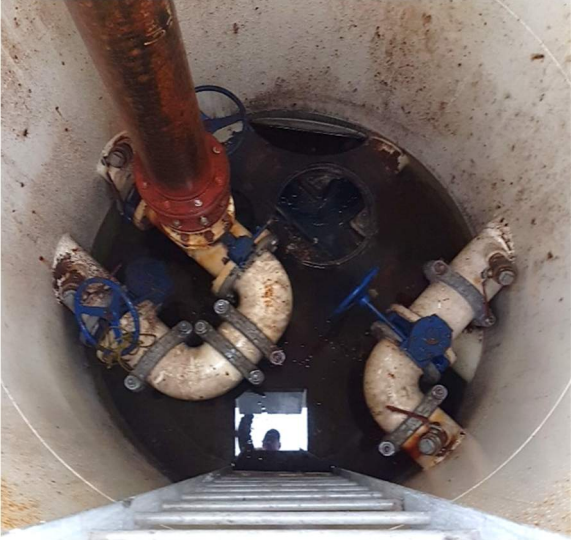
<p>AV 410</p>	<ul style="list-style-type: none"> • Corrosion around laterolet indicates minor leak • Corrosion around hydrant, possible leak at flanged connections • Sanitary cleanout cover not installed • Evidence of sewer backups • AV protective coating is pitting

<p>Yes</p> <p>Repair minor leak at laterolet, investigate hydrant</p>
<p>AV 440</p>	<ul style="list-style-type: none"> • Gasket of sanitary cleanout has been removed • No other exceptions noted

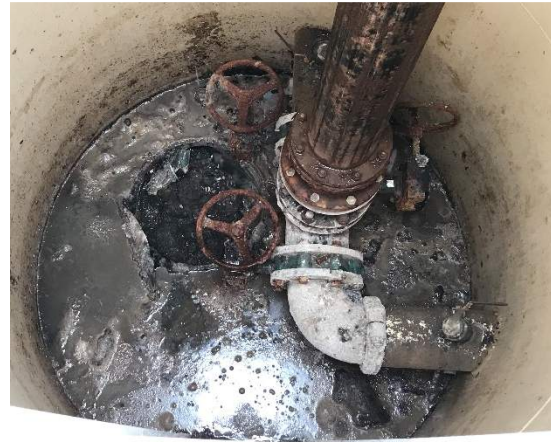
AV 439

- Sanitary cleanout cover removed
- Evidence of sewer backup downstream

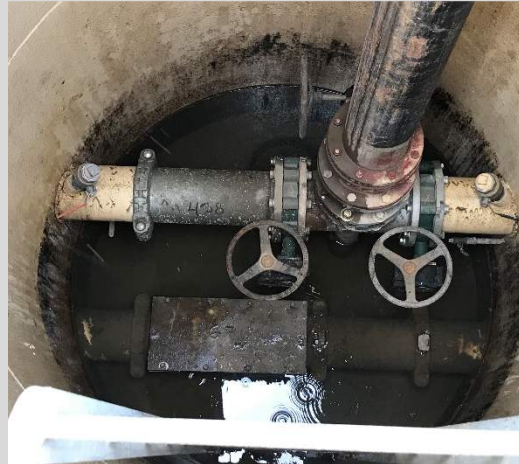
AV 438

- Evidence of sewer backup downstream
- Cleanout cover may be missing bolts or gasket

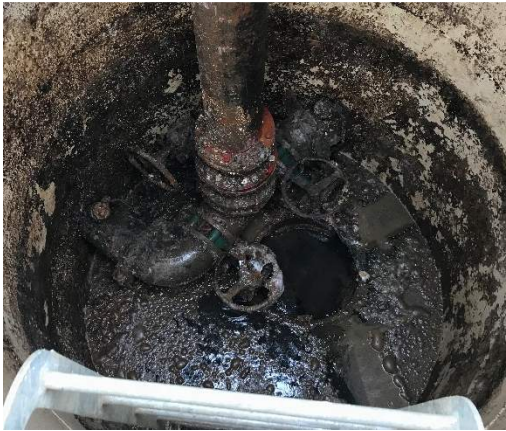
AV 437	<ul style="list-style-type: none"> • Sanitary cleanout cover is not installed • Evidence of major sewer backups • Watermain appears okay, visibility limited

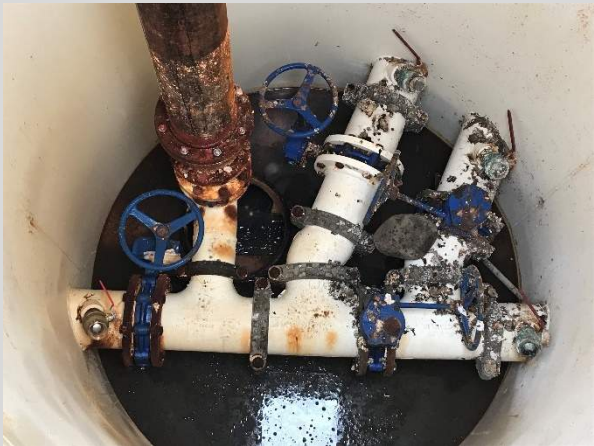
No
AV 409	<ul style="list-style-type: none"> • Large boulder on piping • Corrosion around hydrant flanges, may be a minor leak • Valve between the two T's should be in the closed position • Sanitary cleanout not installed • Evidence of previous sewer backup

<p>Yes</p> <p>Investigate hydrant and remove debris. Also confirm valve configuration</p>
AV 410	Previously reviewed, see above		
AV 409	Previously reviewed, see above

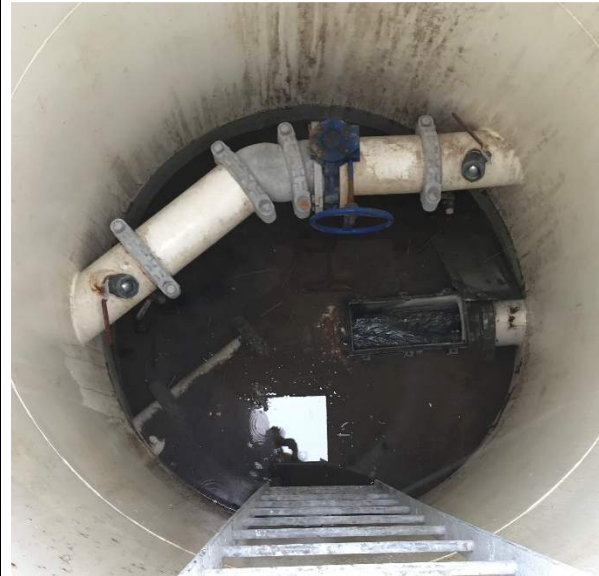
AV 408

- Sanitary cleanout not installed
- Evidence of previous sewer backup

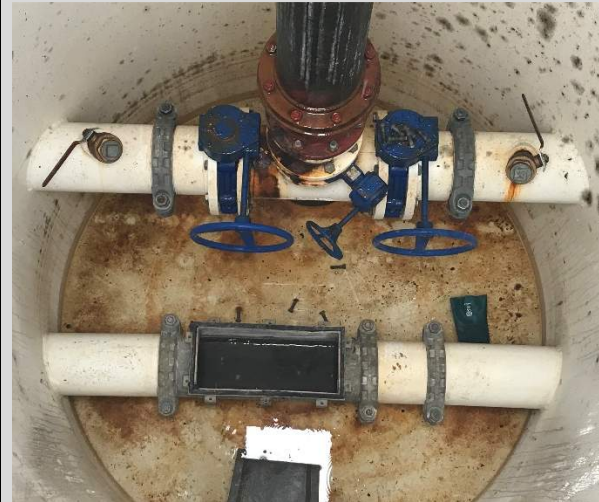
AV 407

- Odd corrosion on hydrant T, probably a leak
- Sanitary cleanout not installed

Investigate hydrant as a
minor leak is probably
present

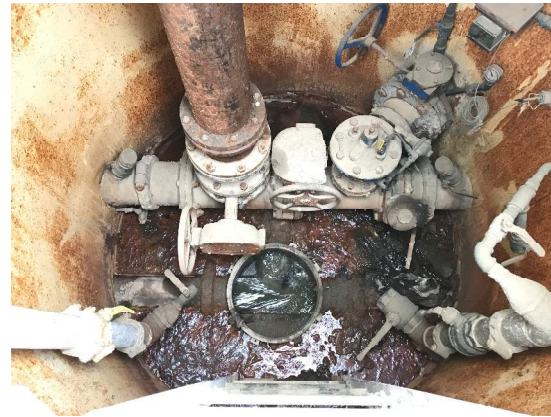
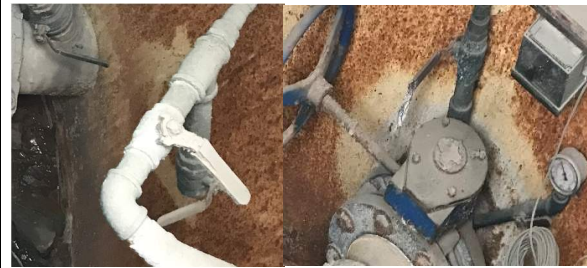
AV 207

- Automatic valve to supply AV 407 under high pressure sensed by low pressure on outlet side
- Recirculation main to provide circulation from Lower Base
- Very key AV, start of recirc from Lower Base that goes to Trigram
- Appears the valves for recirculation from Lower Base are in closed configuration
- Install cleanout cover

Investigate recirculation loop to confirm if valves are closed or not

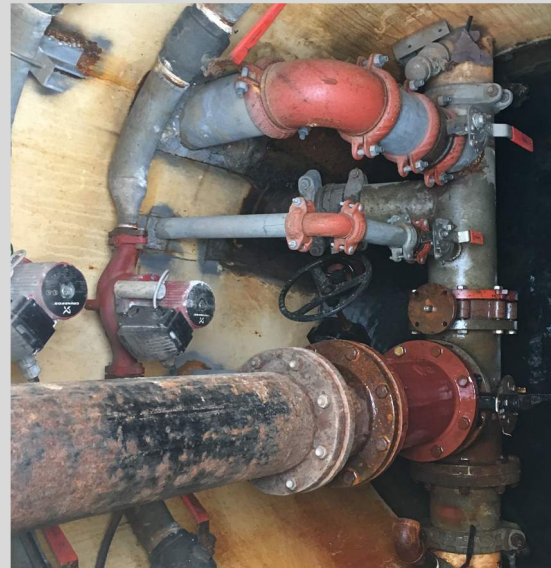
AV 206

- Circulation pumps for Lower Base
 - Reported not in service
- Hydrant leaking
- 2 Service connections
 - 1 connection appears to be good
 - 1 connections return appears to tie into hydrant barrel
- Valve before hydrant is missing the spin wheel
- Fix exterior, damage to structure at surface
- Install cleanout cover

Confirm if pumps are functional

Fix damage to exterior

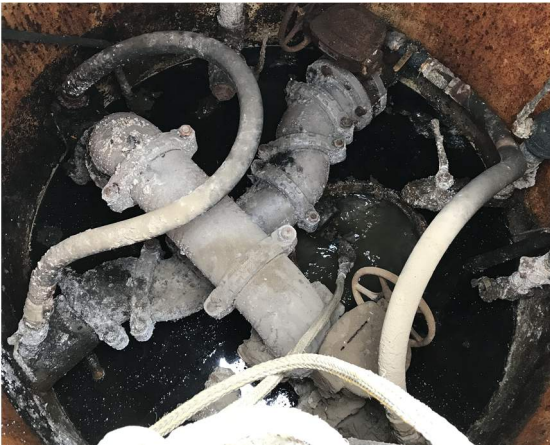
AV 205	<ul style="list-style-type: none"> • Watermains hard piping crosses, but does not interconnect • Jumpers in place, but valves appear to be closed. Jump on the 2 mains changes flow intents. If jumper is active, then Airport Loop and Lower Base loop interconnected. • Recirculation supposed to be in service for Lower Base, but pumps not operating. • Install cleanout cover

<p>Yes</p> <p>Confirm if jumpers are operational</p>
