City of Iqaluit

Drinking Water Management Program

Development of Drinking Water Program

OTT-00246002-B0

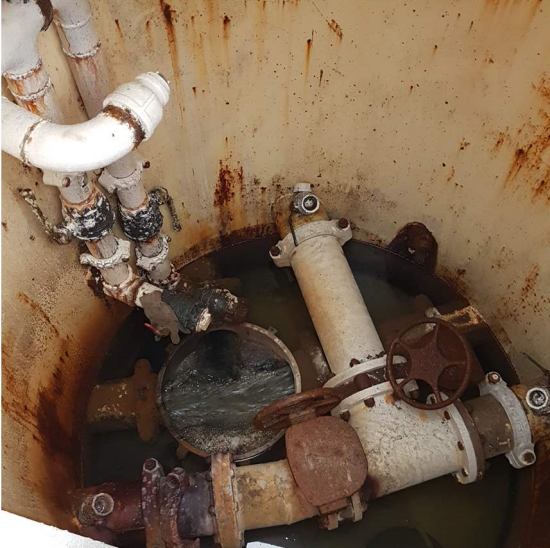
<p>AV 204</p>	<ul style="list-style-type: none"> • Large service connection present • Return appears to be outside of AV • Circulation supposed to be in service for Lower Base, but pumps not operating. • Purpose for electrical cable unknown (or is it a 1" service?) • Install cleanout cover 	 	<p>YES</p> <p>Confirm if that is in fact an electrical cable or if it is a service return</p>
<p>AV 203</p>	<ul style="list-style-type: none"> • Piping that is returning form airport loop splits and goes to Trigram building and to supply Uivaaq Loop • Recirculation supposed to be in service from Lower Base • Install cleanout cover

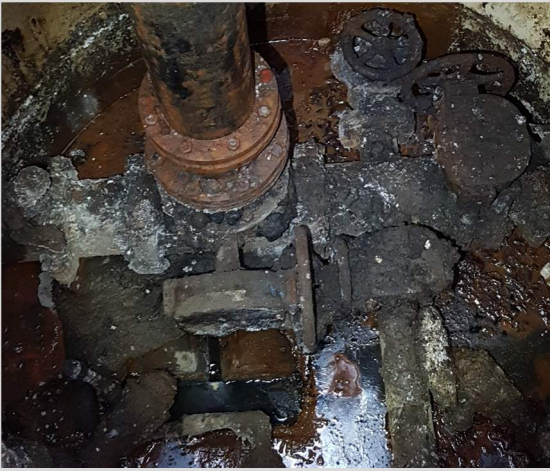
AV 202	<ul style="list-style-type: none"> • 3” return for circulation of Lower Base • Appears to have 2 service connections

<p>YES</p> <p>Needs cleaning and another photo to properly assess</p>
AV 201	Previously reviewed, see above.		
AV 200	<p>Previously reviewed, see above.</p> <p>Lower Base loop now complete. Water has returned to Trigram for heat to be added</p>

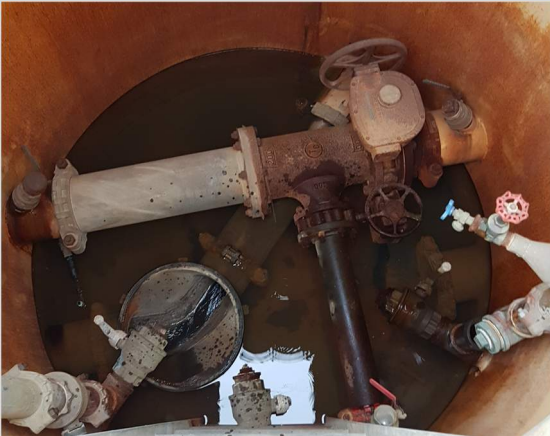
<u>AV #</u>	<u>Comment</u>	<u>Photo</u>	<u>Corrective Action</u>
AV 200	<ul style="list-style-type: none"> • Heated water returning into the supply from the Trigram building through 4" piping • Recirculation piping that feeds into the Trigram building (re-circulation from Lower Base and Airport Loop are combined) • Install cleanout cover

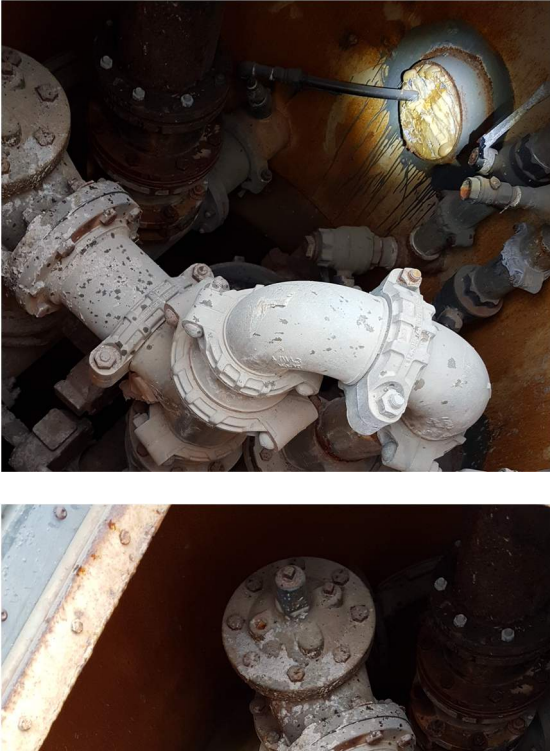
AV 201 – *see image in Table 1.1* – This is a very critical AV as part of Airport Loop as well as for the Lower Base loop. The recirculation line from Lower Base and the returning supply from Airport are combined into one recirculation line within this AV and are then directed towards the Trigram building to have heat added. There is also a pressure reducing valve installed within this AV that under normal conditions is be in the closed configuration. In a low-pressure event the valve opens and therefore additional water is added in both directions of the loop to provide additional water and pressure for fire conditions. We believe the current state of this valve is open and thus the circulation pattern is not per design conditions.

No
AV 201	<ul style="list-style-type: none"> • CLA-VAL pressure reducing valve, model 100-20 for high (fire) flow conditions • Here is where Lower Base and Airport Loop recirculation lines are combined and head to trigram building in 1 recirculation line to have heat added • Internal appurtenances configuration appear similar to design • Piping for CLA-VAL Pressure reducing valve is missing pilot controls. In current condition it appears the valve is in full open configuration which should only occur during fire conditions. If correct, then reverse feed of airport loop and lower base on a constant basis. • Appears a service connection was made on the laterolet, not sure where the service return is. Or this could be the return from the 4" service at bottom of the 2- 90 degree bends

YES Pilot piping needs to be re-installed. Could be a major issue as Lower Base and Airport would need to function as intended. All piping would need to be operational and thawed.

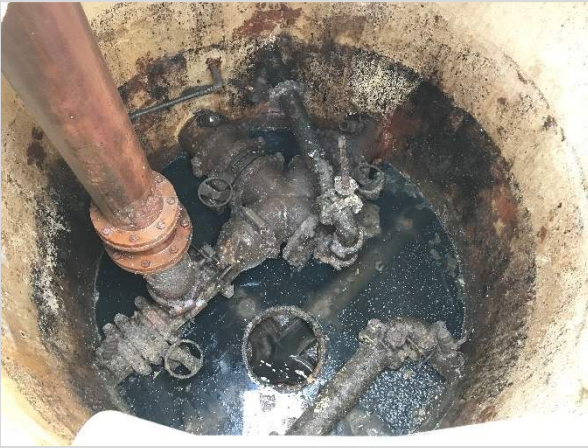
AV 414	<ul style="list-style-type: none"> • Requires cleaning • 4" service to government of Canada building • Connection of service re-circulation pipe not clear, appears there's a 1" return just discharging into vault • Supply splits to feed Airport Loop and Lower Base here • Install cleanout cover

<p>YES</p> <p>Verify that the small pipe is connected. Please send photos.</p> <p>Connection should be made for the small diameter piping if it is a service recirculation or atleast install a backflow preventer</p>
AV 415	<ul style="list-style-type: none"> • 2 – large services (8" and 6") for large buildings • Not sure where the 8" watermain and sewer heading south go (direction towards the ladder) • Water is supposed to do a 180 loop here and go to feed Lower Base • Install cleanout cover

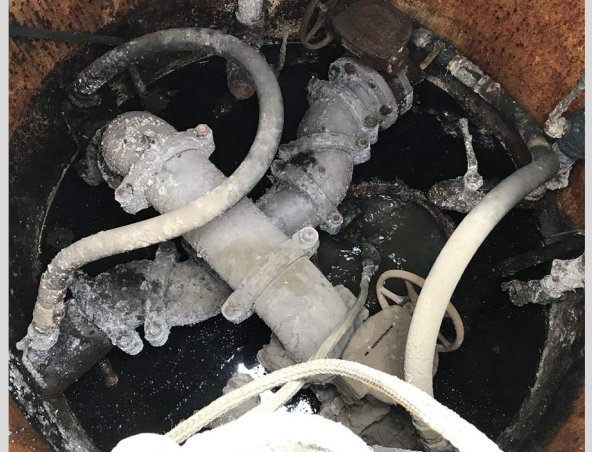
<p>YES</p> <p>Needs cleaning and another photo to properly assess</p>
AV 205	<ul style="list-style-type: none">• Watermains cross, but do not interconnect• Jumpers in place, but laterolet valves appear to be closed. If these jumpers are activated, the flow patterns for both the Airport Loop and Lower Base are affected and the 2 separate loops would be interconnected.• Circulation supposed to be in service for Lower Base, but pumps not operating.• Install cleanout cover

<p>No</p> <p>Ensure the jumpers are not activated</p>

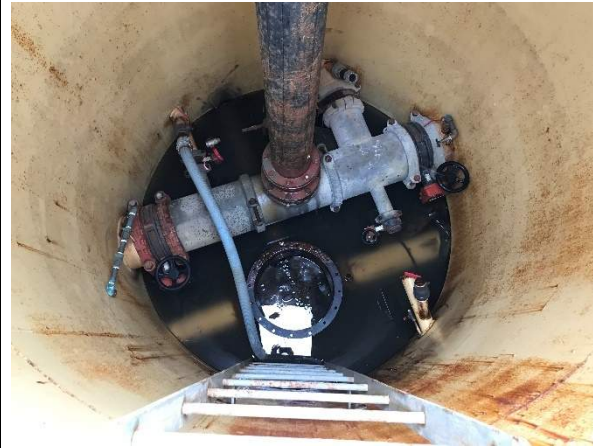
AV 416

- There are 3 visible bleeds here
- Possible that with the number of bleeds present might indicate that the building circulation pump is not functioning. We believe this service is for the RCMP building.
- Install cleanout cover

There is frozen pipe somewhere here.

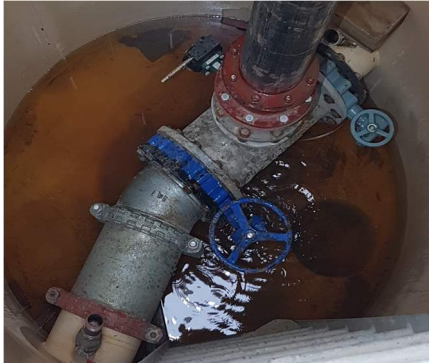
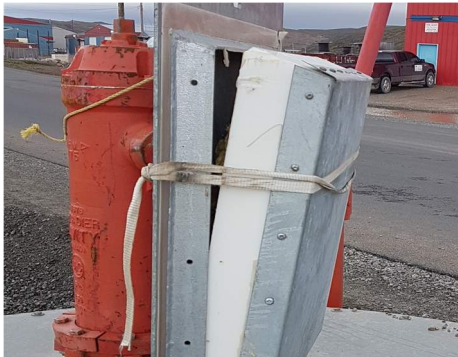
No
AV 422	<ul style="list-style-type: none">• Nothing unusual with internals• Cover insulation should be re-secured

YES Repair cover

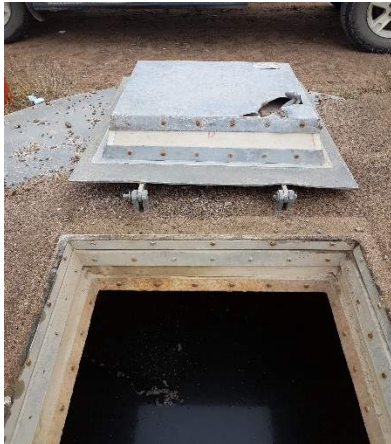
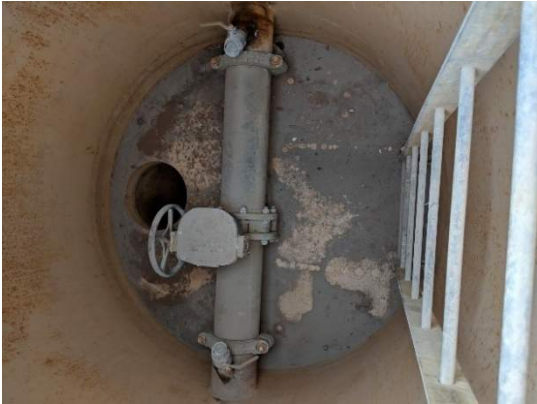
No
AV 1	<ul style="list-style-type: none"> Filled with water (initial investigation, Aug 2018) Reviewed again in Sept 2018 and Vault has drained itself. Corrosion around laterolet indicates possible leak

<p>YES</p> <p>Investigate laterolet</p> <p>Repair Cover</p>

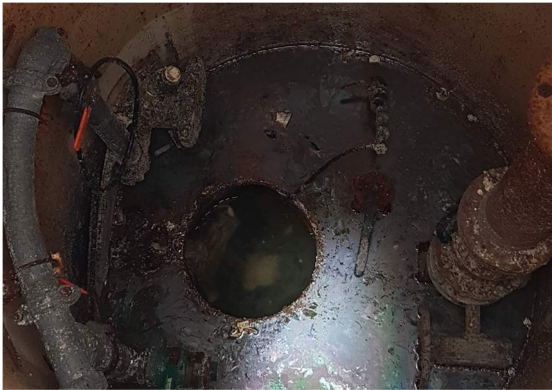
No
AV 3	<ul style="list-style-type: none"> Recirculation piping out of service Bleed on laterolet doesn't have a backflow preventer Replace clean-out cover Valve to piping to AV 264 appears to be open. This should be closed Watermain piping from AV 3 to AV 264 should not be in service now that airport extension has completed another loop connecting AV 5 back to AV 264. If AV 3 to AV 264 is still operational then this creates another short circuit. Install cleanout cover

<p>YES</p> <p>Clean to get better assessment, send pictures</p> <p>Bleed needs backflow preventer</p> <p>Valve should be closed</p>
AV 4	<ul style="list-style-type: none"> Rusting indicates long term high water level Install cleanout cover

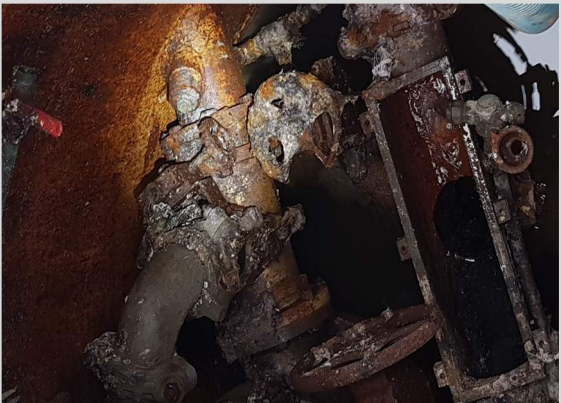
<p>No</p>
<p>AV 5</p>	<ul style="list-style-type: none"> • Rusting indicates long term high water level • Purpose for various hoses unknown • Service connection • Bleed is active, cannot see backflow preventer • Recirculation piping probably inactive • Install cleanout cover

<p>YES</p> <p>Ensure backflow preventer on bleed</p>
<p>ATB-04</p>	<ul style="list-style-type: none"> • No exceptions noted

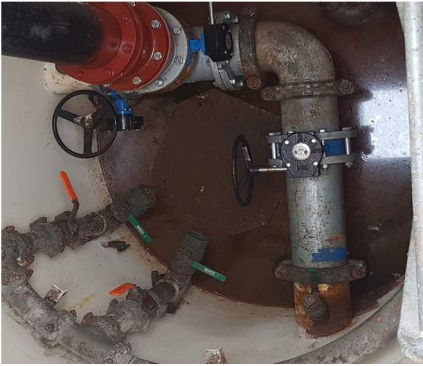
<p>No</p>
<p>AV 262</p>	<ul style="list-style-type: none"> • Piping not unusual • Recirculation piping out of service • Laterolet valve appears to be open?

<p>YES</p> <p>Check laterolet valve configuration</p>

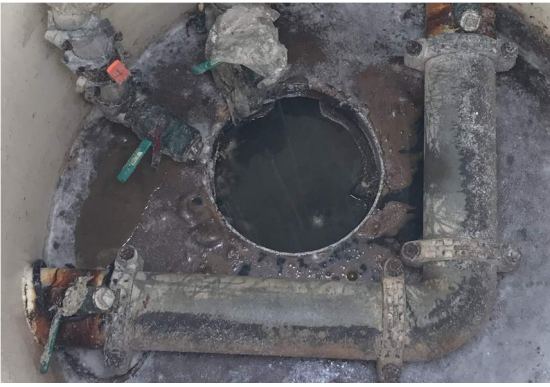
<p>No</p>
<p>AV 260</p>	<ul style="list-style-type: none"> • Piping not unusual • Recirculation piping out of service • Install cleanout cover • Corrosion around laterolets indicates possible leaking

<p>YES</p> <p>Investigate corrosion around laterolets</p>
<p>AV 259</p>	<ul style="list-style-type: none"> • Internal piping in good order • Supply to new airport service building • Service return appears to connect behind hydrant, probably on laterolet • Purpose of second (2"?) pipe uncertain. Requires further review • Recirculation to right in photos out of service, spoke with Kudlik about when they installed this AV and they confirmed recirculation piping was not in use

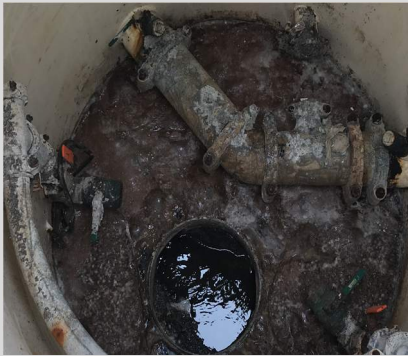
<p>No</p>
<p>AV 257</p>	<ul style="list-style-type: none"> • Recirculation piping out of service • Un-used connection (4"), spool piece appears to be missing. • Install cleanout cover

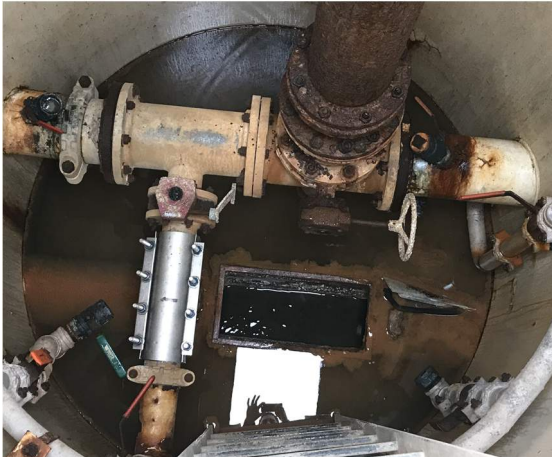
AV 256 - see image in Table 1.1 – From the photos taken it is evident that a repair has been made to one of the existing spool pieces. This repair was made by utilizing a robar, this should be a prefabricated spool piece. Also, the main appears to have odd corrosion on the main that could indicate failure is near. May need to also replace this spool piece.

<p>No</p>
<p>AV 256</p>	<ul style="list-style-type: none"> • Dirty, requires cleaning • Service connection <ul style="list-style-type: none"> • Repair sleeve suggests previous failure of piping for service connection supply • Recirculation appears connected to main • Corrosion of internal painted piping • Install clean-out cover

<p>YES</p> <p>Investigate corrosion around laterolet</p> <p>Proper repair of service connection</p>

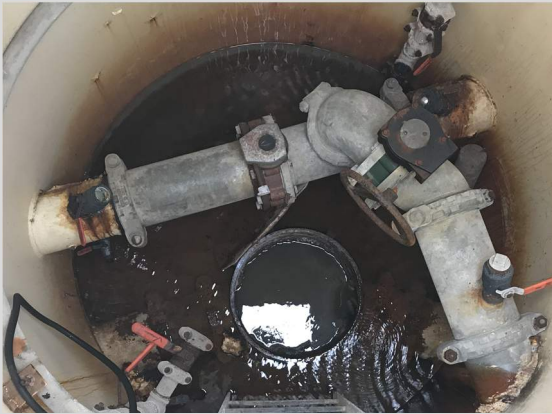
<p>AV 255</p>	<ul style="list-style-type: none"> • Recirculation out of service • Corrosion of painted piping • Large diameter service connection • Return appears to be external to AV • Replace clean-out cover • Corrosion around laterolet and service penetration may indicate possible leaks

<p>YES</p> <p>Investigate laterolets and service connection penetration</p>
<p>AV 215</p>	<ul style="list-style-type: none"> • Internal piping not unusual • Recirculation out of service

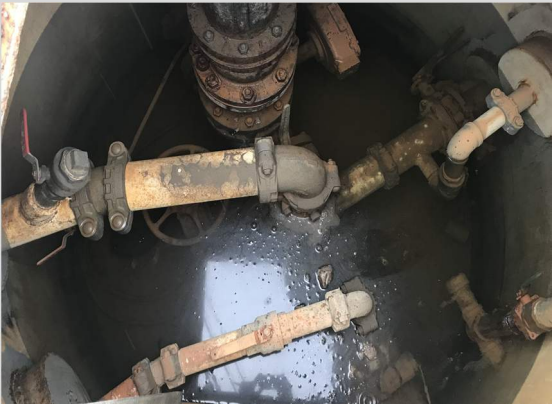
AV 214 - see image in Table 1.1 – It appears the return piping from a service connection is connected to its own supply. This should be repaired and connected to the main directly.

<p>No</p>
<p>Av 214</p>	<ul style="list-style-type: none"> • Requires pump out to fully confirm • Recirculation piping seems to be used for service connections <ul style="list-style-type: none"> • Appear to be 2 services • 1 services' re-circulation appears to be connected to its own supply and not the main • Recirculation should be out of service.

<p>Yes</p> <p>Cleanout for further investigation</p> <p>Service return should be connected to main</p>

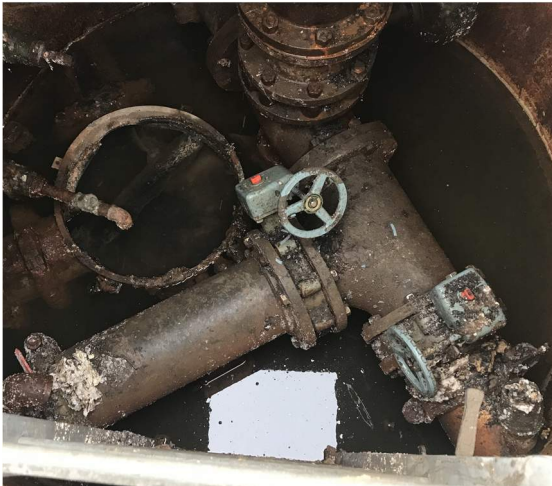
<p>AV 213</p>	<ul style="list-style-type: none"> • 2 Bleeds present • Supply towards AV 271 • Recirculation appears to be bleed piping into clean-out <ul style="list-style-type: none"> • Connected to recirculation piping • Recirculation is supposed to be out of service • Install cleanout cover

<p>YES</p> <p>Investigate if the bleeds can have water (confirm backflow preventer present)</p> <p>Pending above, look at connecting to main instead of bleeding</p>
<p>AV 270</p>	<ul style="list-style-type: none"> • No irregularities • 3" re-circulation line • Large service present, configuration is correct • Install cleanout cover

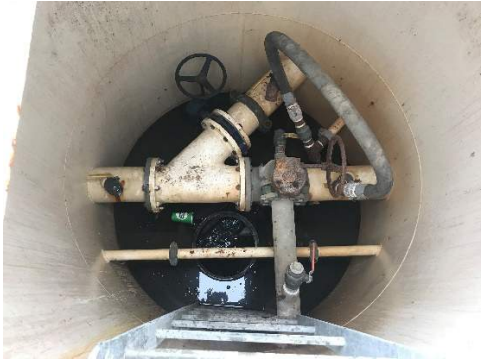
<p>AV 271</p>	<ul style="list-style-type: none"> • Bleed installed on laterolet • Odd corrosion on spool piece adjacent to bleed • Need to know if re-circulation piping is connected, hard to visualize but does not appear to be (by ladder). • Install cleanout cover • The watermain heads to Government of Nunavut Building, apparently there is a re-circulation pump in the building and that's where the supply turns to the return.

<p>YES</p> <p>Need to know if re-circulation piping is connected.</p> <p>Need access to GN building to find re-circ pump and determine if active or not</p> <p>Probably replace corroded spool piece</p>
<p>AV 212</p>	<ul style="list-style-type: none"> • Install cleanout cover • Recirculation piping should be out of service • 2 service connections <ul style="list-style-type: none"> • Return piping appears to be external to AV for both services • Strap-on style outlet for 1 service connection <ul style="list-style-type: none"> • Higher cross contamination risk

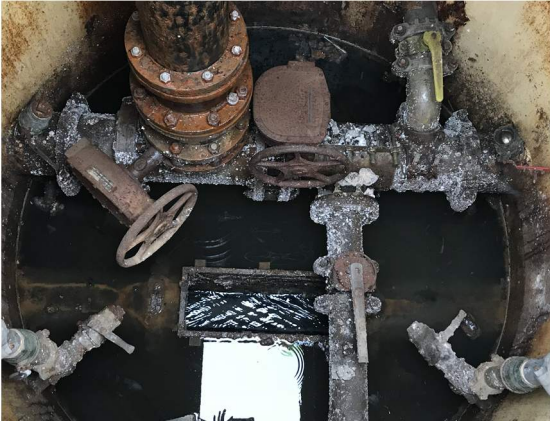
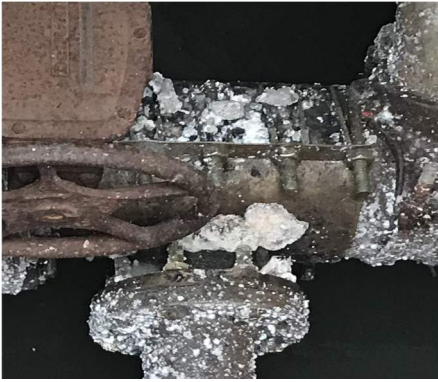
<p>AV 208</p>	<ul style="list-style-type: none"> • Requires cleaning, clean-out cover replacement • Has the recirculation piping been used as a bleed? • Recirculation piping returning from AV 210 and 209 ties back into the supply going to AV 207. • Install cleanout cover

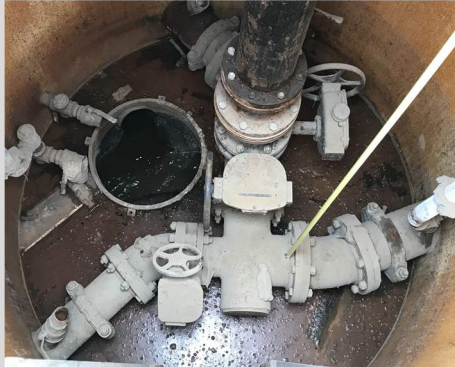
<p>No</p>
<p>AV 209</p>	<ul style="list-style-type: none"> • Re-circulation piping should be in service • Appears to have electrical wiring • Supposed to have re-circulation pumps, appear to be missing • Install cleanout cover

<p>YES</p> <p>Want to confirm that recirculation lines aren't frozen from AV 208 to 210</p> <p>Once above is confirmed, installation or recirculation pumps</p>
<p>AV 210</p>	<ul style="list-style-type: none"> • Watermain dead ends here, just passed hydrant • Recirculation piping should be connected to watermain supply to complete a 180 turn, can't confirm due to no visibility. • Install cleanout cover

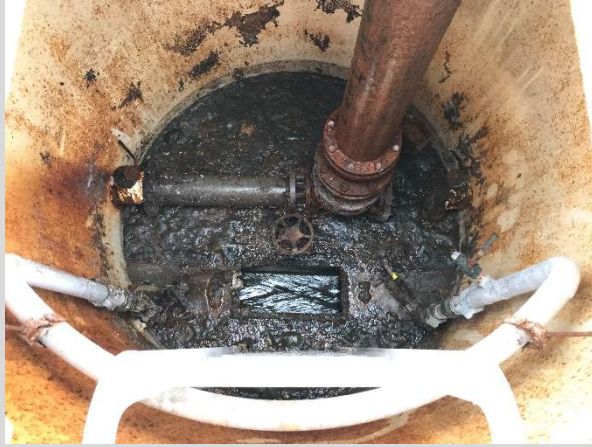
AV 207

- Automatic valve to supply AV 407 under high pressure sensed by low pressure on outlet side
- Recirculation main to provide circulation from Lower Base
- Very key AV, start of recirc from lower base that goes to Trigram
- Appears the valves for recirculation from Lower Base are in closed configuration
- Install cleanout cover

Need photos of recirculation loop to confirm if valves are closed or not

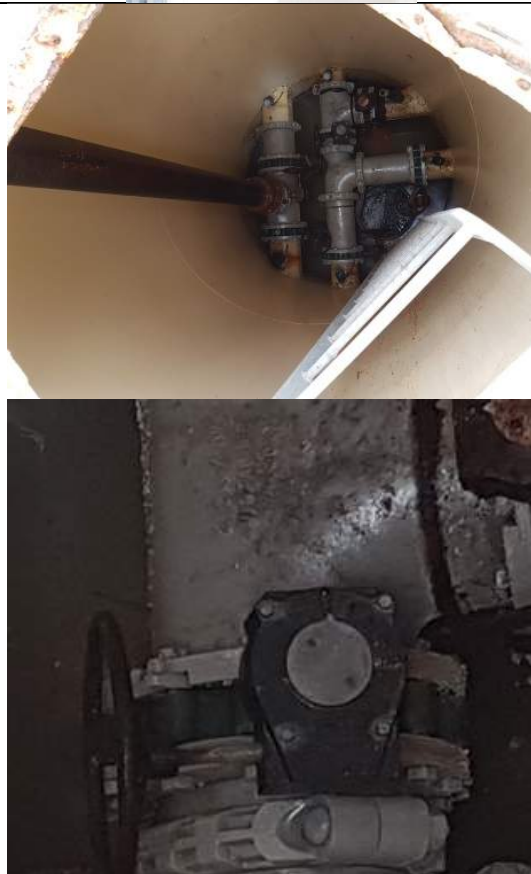
AV 602 – *see image in Table 1.1* - The supply watermain (with the fire hydrant) appears to be in good working order with no evident issues other than minor corrosion staining at the laterolet. This could be indicative of a very minor leak at the laterolet. On the recirculation watermain, it appears the current configuration of the middle valve (between the 2 – T's) is not as per intended functionality. When the photo is enhanced (see image in table, very pixilated) it appears this valve is in the open position. As per the intended design, this valve is supposed to be in the closed position. With the valve in the closed position, all the water that is flowing through the re-circulation main is forced to become the supply for Plateau Phase 4.

No
AV 602	<ul style="list-style-type: none">• The Re-circulation main should loop AV 612• Valve on re-circulation should be closed, which would force circulation to AV 612.• Valve appears to be open and allows water to pass straight through. No effect on upper part of plateau, only effects Phase 4

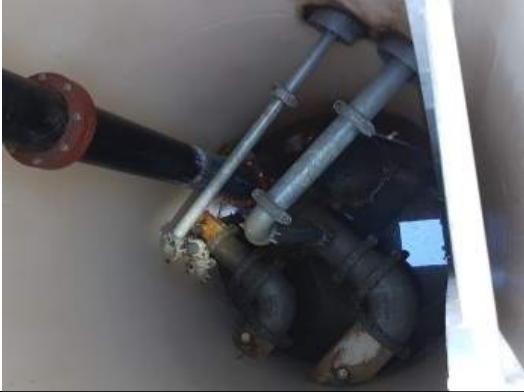
AV 603	<ul style="list-style-type: none"> • Service connection connected to Supply • Service return connected to Re-circulation • Short Circuit created by this connection • Both service connections need to be on the same main (either supply or re-circ) • No valves on the service connections

With the findings noted above, AV 603 has been identified as an initial action required prior to correcting the Plateau's system. The service connection within AV 603 must be fixed before any major efforts are made within the Plateau's distribution network. The service's return and supply piping must be connected to the same watermain to discontinue the short circuit. From the photos taken, it appears there are no valves on the service pipes and thus the watermain (both supply and recirculation) will probably need to be shutdown to complete this repair. With the unknowns of this distribution network there is the risk that the current configuration is working as a jumper and providing service to other residences whom do not have water supply due to frozen pipe(s). Therefore, a plan based on the current state will need to be in place prior to starting this work so that once the service is corrected, if need be, service can be provided to any other users who are unintentionally affected.

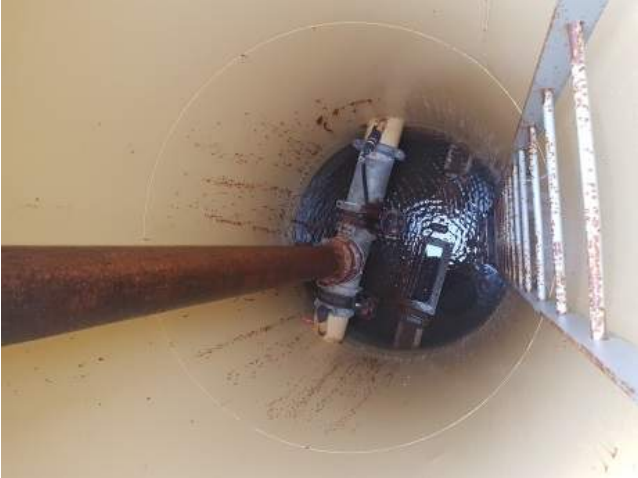
AV 616	<ul style="list-style-type: none"> • Bleed installed on 2" laterolet, • No backflow preventer installed on bleed

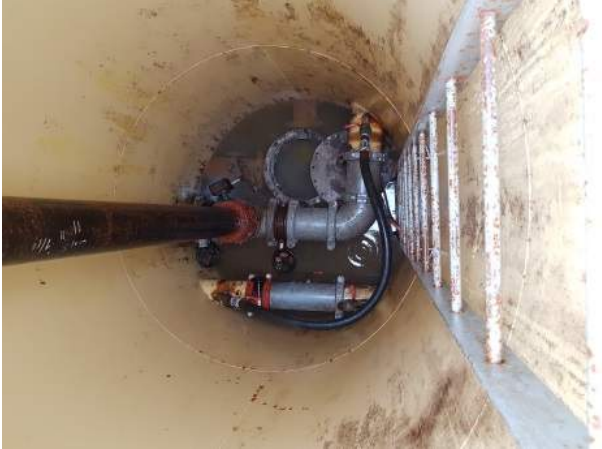
AV 615	<ul style="list-style-type: none"> • Jumper installed from supply to return • Probably installed to provide service due to frozen pipes

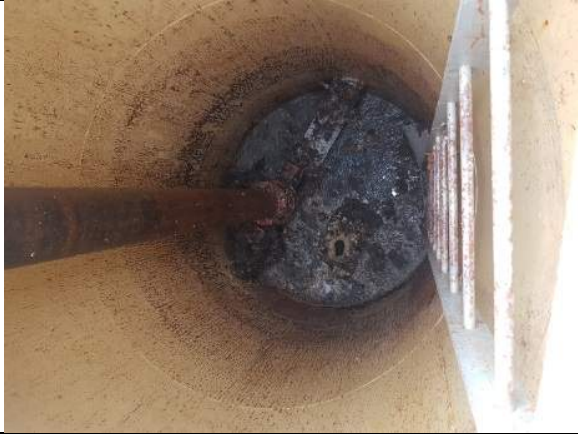
AV 615	Already reviewed – See above		
AV 618	<ul style="list-style-type: none"> • Very dirty, can't review

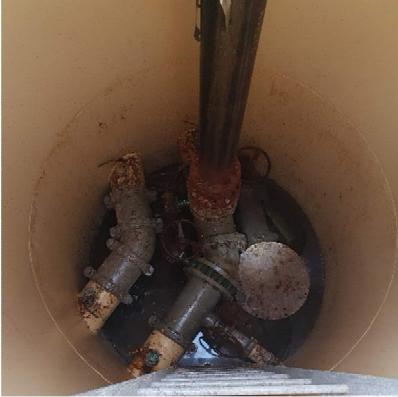
AV 612A	<ul style="list-style-type: none"> • Assuming service return is installed on the same water main outside the AV • Corrosion around laterolet indicates possibly small leak • No other exceptions noted

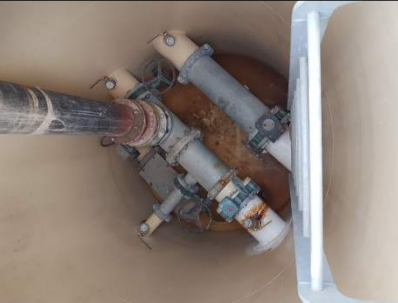
No
AV 613A	<ul style="list-style-type: none"> • Assuming service return is installed on the same water main outside the AV • Corrosion around laterolet indicates possibly small leak • No other exceptions noted

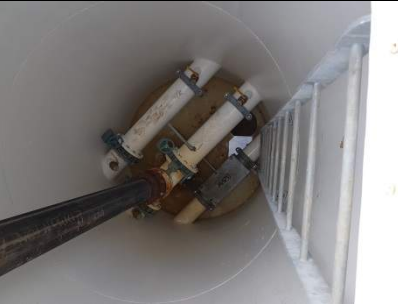
No
AV 631	<ul style="list-style-type: none"> • Bleed to sewer installed • Does not appear to have a backflow preventer installed • No other exceptions noted

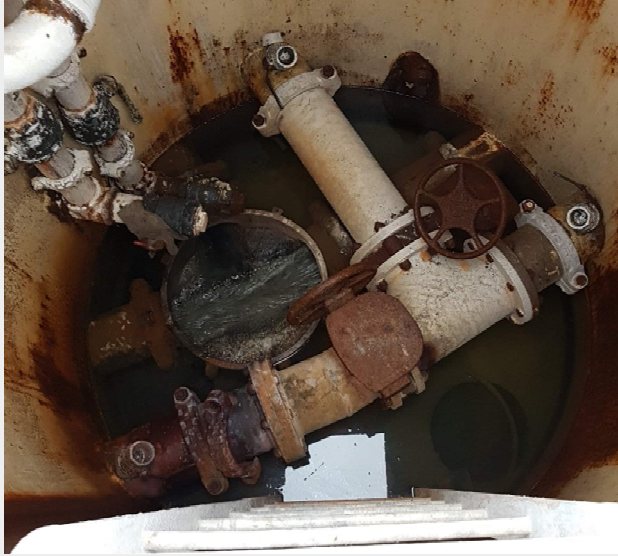
Structure	Comment	Photo	Action Required
AV 203	<ul style="list-style-type: none"> • Supply from Federal road splits, 1 pipe is returning to Trigram building which completes the Federal loop, the other is the supply source for Uivvaq Loop • Recirculation piping is from Lower base, probably frozen • Sanitary cleanout cover not installed

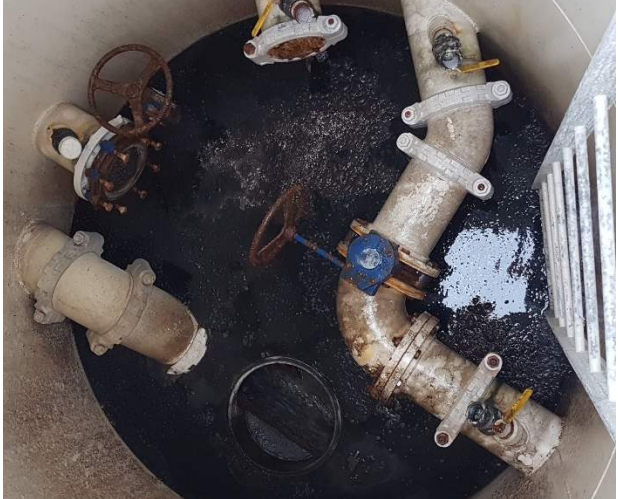
No
AV 450	<ul style="list-style-type: none"> • Penetrations in place for future connections for final configuration of the water system • Penetrations in place for future connections for final configuration of the water system • Sanitary cleanout cover not installed • Evidence of sewer backups

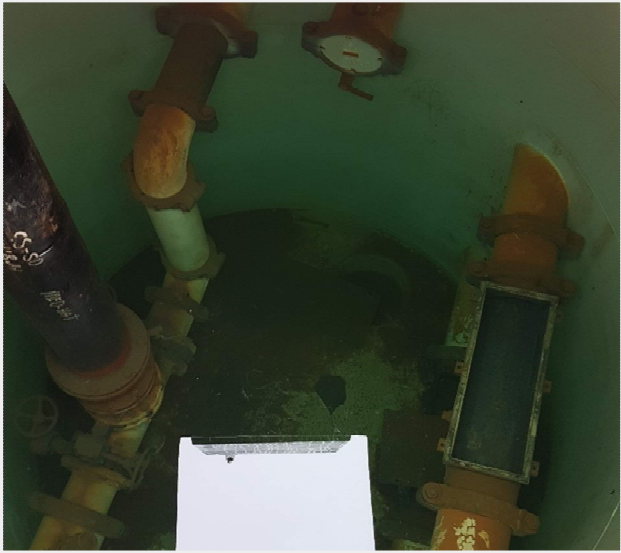
AV 451 – *see image in Table 1.1* – Structure is full of clear water, it is probable that there is a leak within the structure. Pump out, investigate and repair as needed.

<p>AV 451</p>	<ul style="list-style-type: none"> • Structure full of clear water, investigate water source • Piping inside structure appears to be smaller than manufactured penetrations. Piping appears to be 6" and penetrations are sized for 8" penetrations • Penetrations in place for future connections for final configuration of the water system • Sanitary cleanout not installed

<p>Yes – pump out and investigate water source</p>
<p>AV 452</p>	<ul style="list-style-type: none"> • Penetrations in place for future connections for final configuration of the water loop • Sanitary cleanout not installed • No other exceptions noted

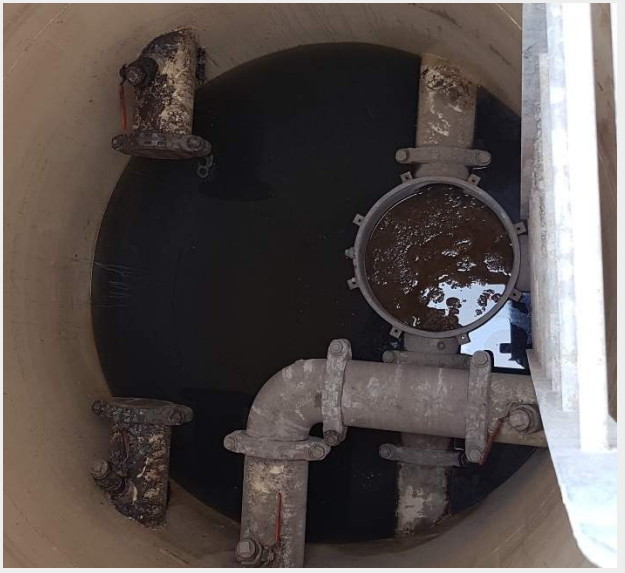
AV 447	<ul style="list-style-type: none"> • Penetrations in place for future connections for final configuration of the water loop • Sanitary cleanout not installed • No valve installed in structure • No other exceptions noted

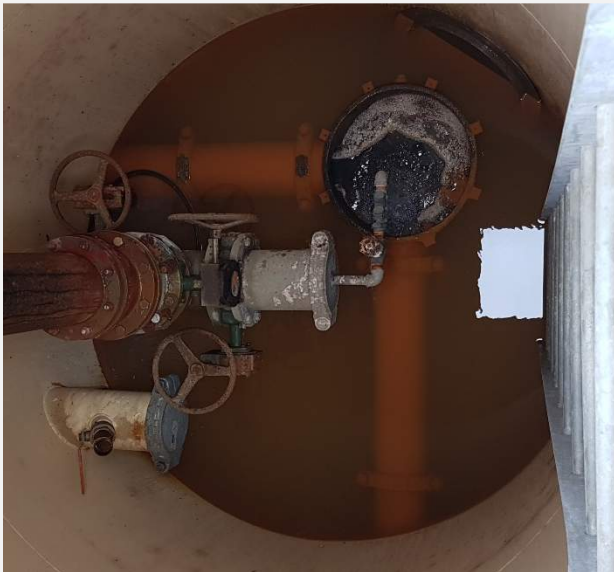
AV 445	<ul style="list-style-type: none"> • Penetrations in place for future connections for final configuration of the water loop • Active bleed utilized as final configuration is not complete and no recirculation is occurring • Sanitary cleanout not installed • No other exceptions noted

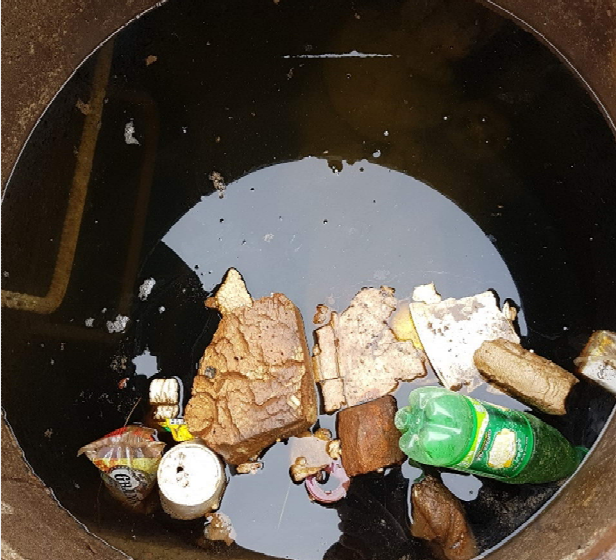
MH 54 – *see image in Table 1.1* – Structure is full of clear water, it is probable that there is a leak within the structure. Pump out, investigate and repair as needed.

<p>MH 54</p>	<ul style="list-style-type: none"> • Water and debris inside structure, limited visibility • Clean out and re-inspect

<p>Yes – pump out and re-inspect</p>
<p>AV 53</p>	<ul style="list-style-type: none"> • Evidence of serious sewer backups, sewage on top ladder rung • Downstream sewer issues • Sanitary cleanout cover not installed

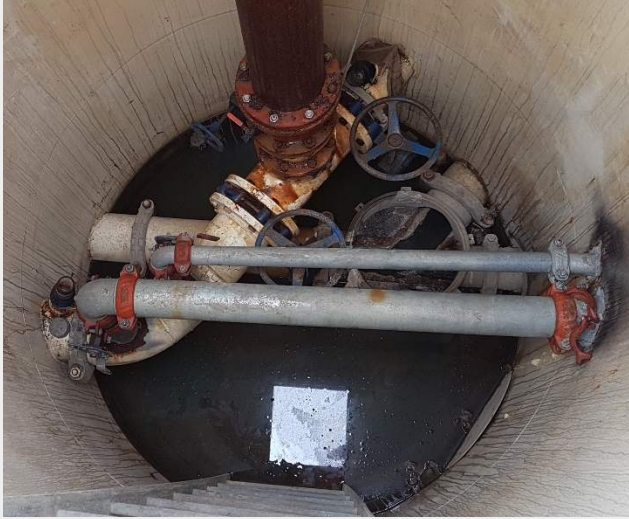
AV 52	<ul style="list-style-type: none"> • Watermain crosses over sewer • Large service connection installed • Sanitary cleanout cover not installed

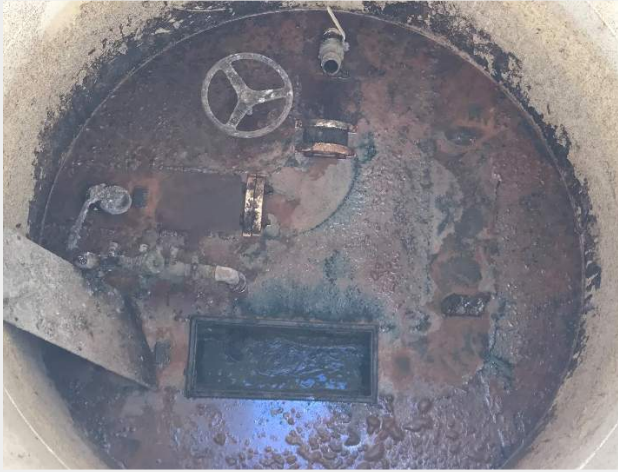
No
AV 11	Lock needs to be cut on structure for access		Yes – gain access and inspect
AV 10	<ul style="list-style-type: none"> • Bleed utilized in structure as no recirculation is occurring • Records shows that watermain from AV 10 to MH 7 is not in service, however the final completion of this water network plans to flow water from AV 10 to MH 7 • Caps not installed on laterolet • Evidence of serious sewer backups, sewage on top ladder rung • Sanitary cleanout cover not installed
