Map V-2: Upper Base

2. Results of Previous Studies

3. Current Sampling Program

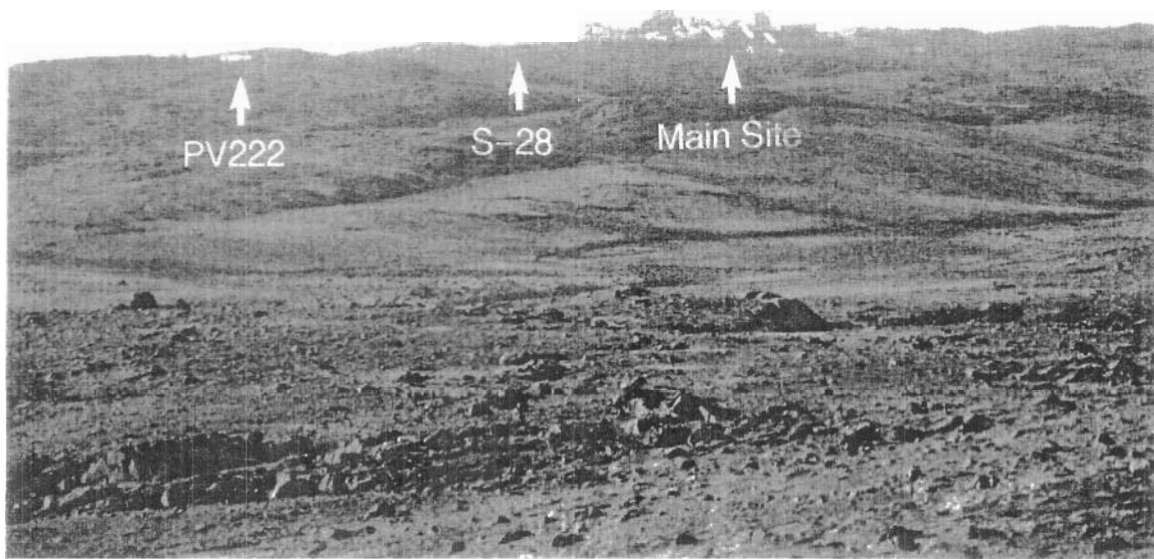
Photograph V-3: View from the east of the Upper Base including Pole Vault Building 222, Communications Building S-28 and the Main Site.

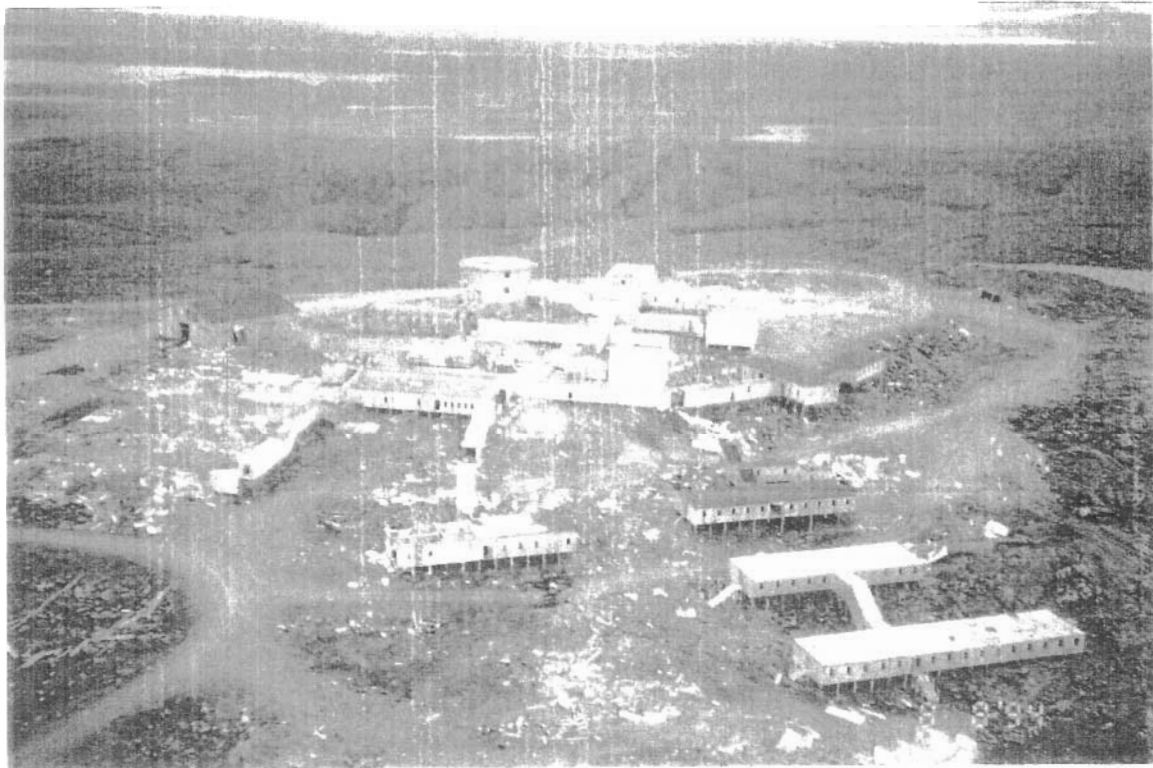
Photograph V-4: Aerial view of the Main Site at the Upper Base. Long-range radar were housed in geodesic domes formerly situated atop the rectangular towers.
