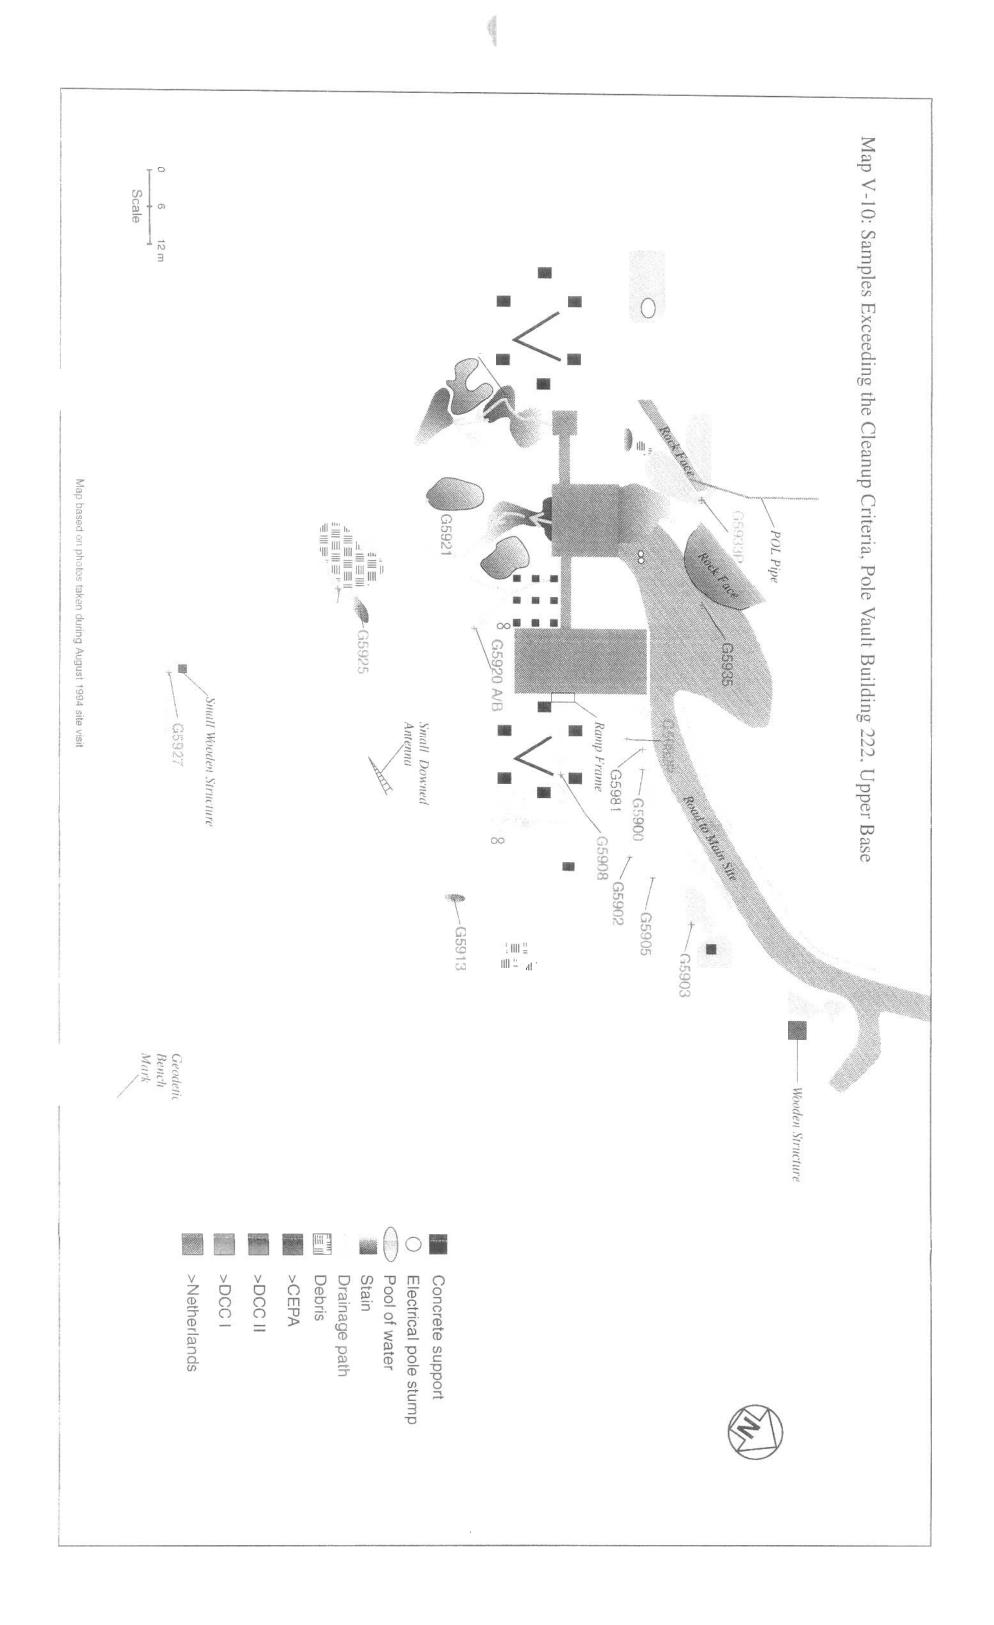
PV222, contained copper (128 ppm) and lead (354 ppm) in excess of DCC Tier II and Tier I, respectively. Cadmium (10.4 ppm) was detected at levels exceeding the DCC in soil collected near the east side of the building, below the communications dish (G5908). A sample of soil and ash (G5913), collected from within a pile of burned debris approximately 35 m from the southeast corner of Building PV222, contained copper (2500 ppm), lead (9860 ppm) and zinc (1080 ppm) at concentrations which were greatly elevated above DCC Tier II (Photograph V-14).

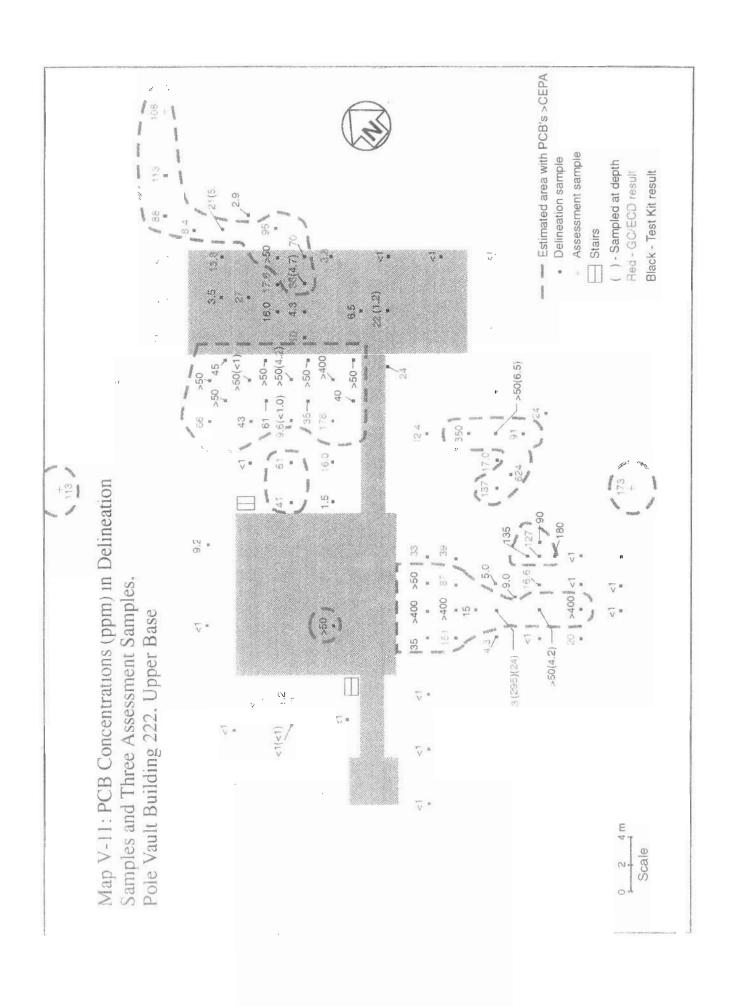
Four areas on the south side of Building PV222 were found to contain PCBs at concentrations exceeding CEPA. The largest affected area is immediately south of the westernmost half of the building and is delineated by a very dark stain (Photograph V-15). A second location where soil PCB concentrations exceed the CEPA level is also evidenced by the presence of staining on the surface of the soil. This "Y" shaped stain has resulted

from the migration of the black oil along two drainage paths which converge and flow toward a rock that prevents the migration of the staining compound past its northern edge (see Map V-10). Finally, two smaller areas of CEPA level contaminated soil were detected between the two larger affected areas on the south side of Building PV222, and east approximately 10 m from the largest stained area, respectively. The soil sample from the easternmost of the two smaller affected areas was collected as part of the assessment sampling program (Map V-10).
