Map V-15: Samples Exceeding the Cleanup Criteria, North 40 Dump

## **D. Dump Site #1: Sylvia Grinnell Park Dump**

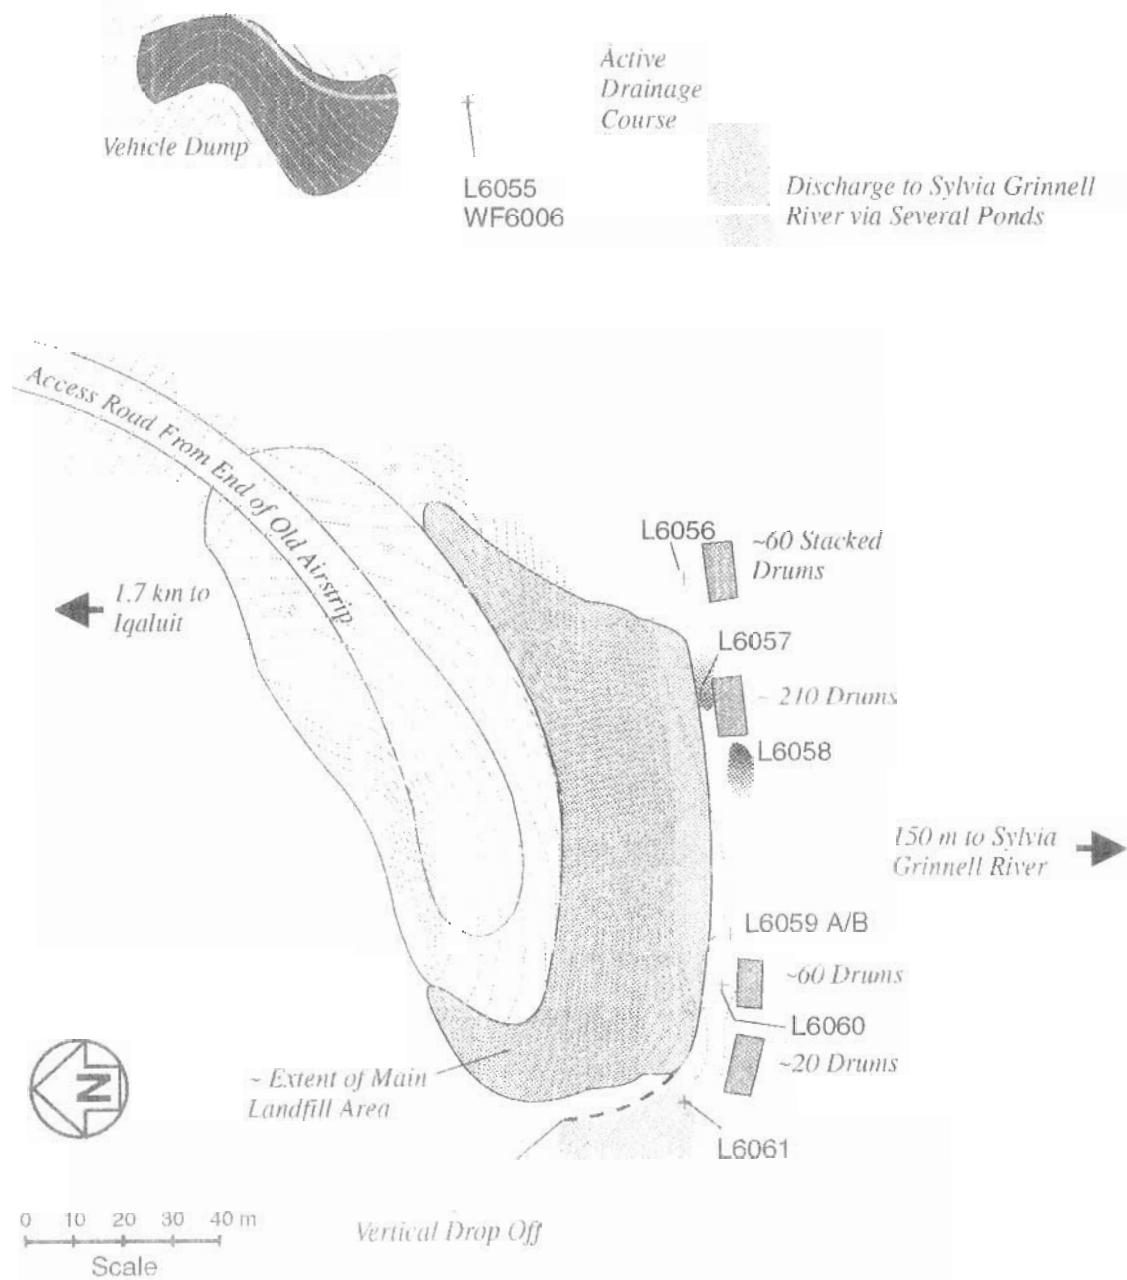
Map V-16: Sample Locations at Dump Site #1, the Sylvia Grinnell Park Dump

The ESG undertook field sampling at Dump Site #1, as part of the current investigation, on August 15th, 1995. The potential for contaminant migration out of the dump and south towards Sylvia Grinnell River made the collection of samples at the toe of the dump the primary focus of the sampling program. As obvious sites of potential contamination, stained areas formed a second focus of the sampling program. A total of eight soil samples, including one field duplicate, were collected in Dump Site #1; one in the drainage channel flowing through the vehicle pile east of the main area of the dump, and seven from the toe of the main slope of the dump, including two from stained areas

As part of the concurrently conducted Historical Ocean Disposal study, three sediment samples were collected from Sylvia Grinnell River in the vicinity of the dump (SG004-006, Bright et al. 1995).
