Map V-17: Samples Exceeding the Cleanup Criteria, Dump Site #1

## **E. Dump Site #2: Summer Camp Dump**

## **F. Dump Site #3: Site of the New Municipal Landfill**

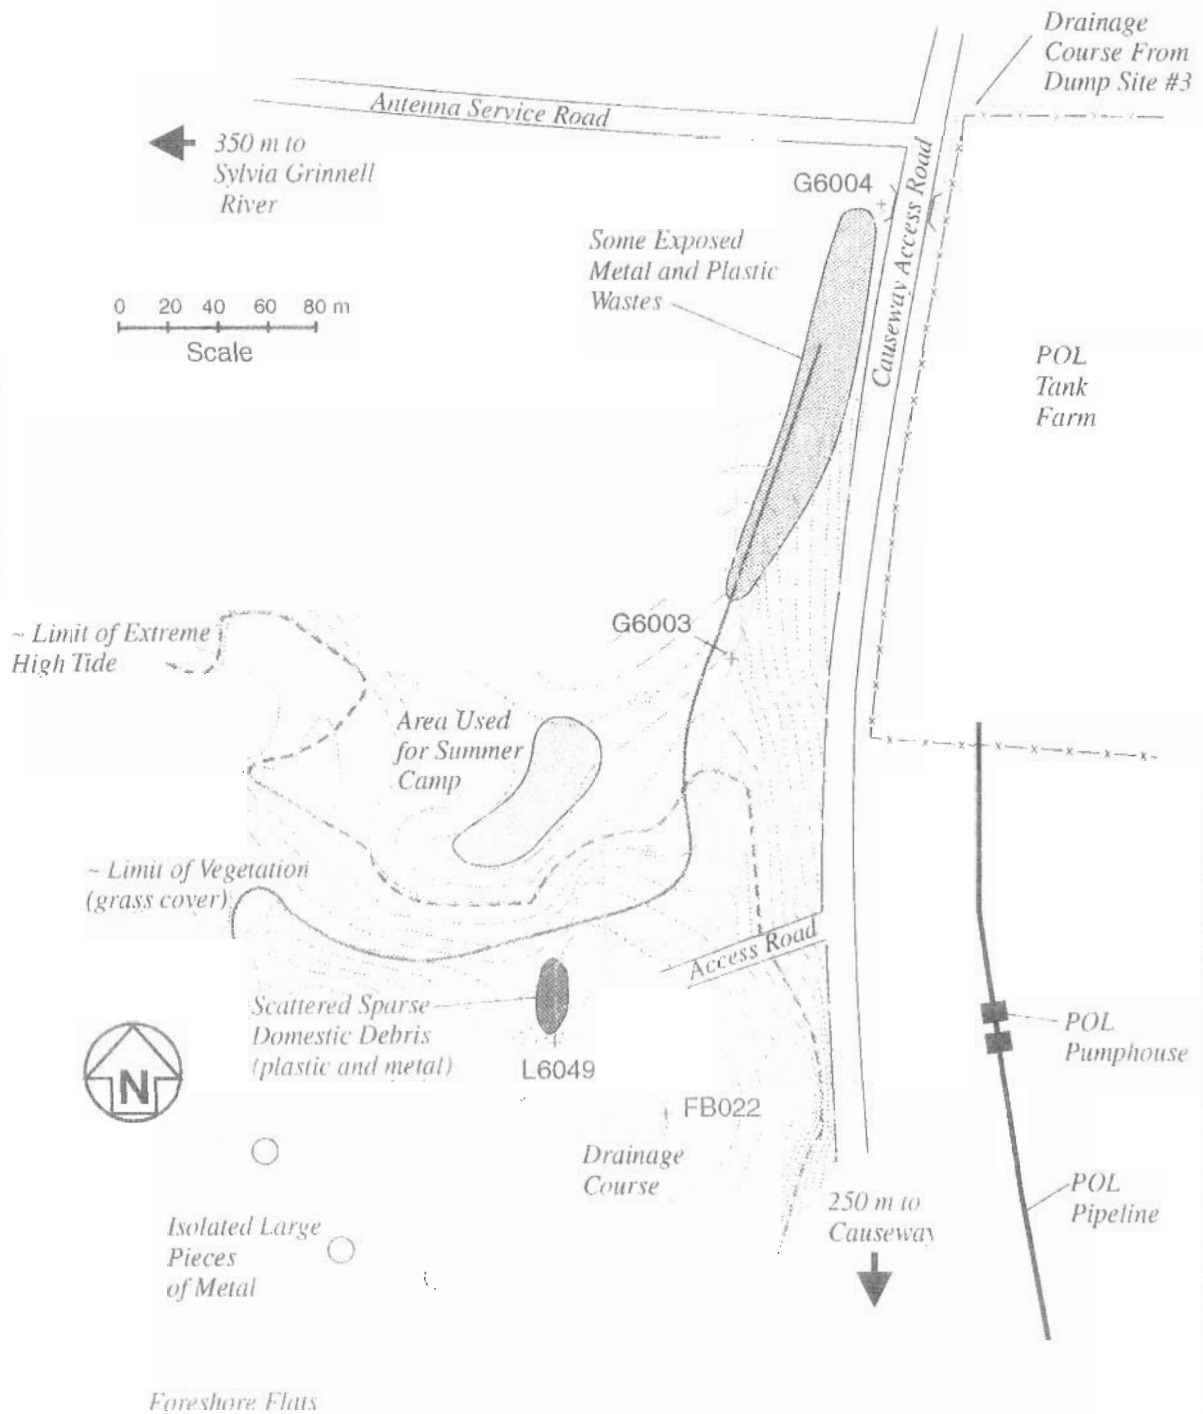
Map V-18: Sample Locations at Dump Site #2,  
West 40 Summer Camp Area

As part of the concurrently conducted Historical Ocean Disposal study, one sample of marine sediment was collected in the high intertidal zone of the embayed area, adjacent to the dump (FB022, Bright et al. 1995).

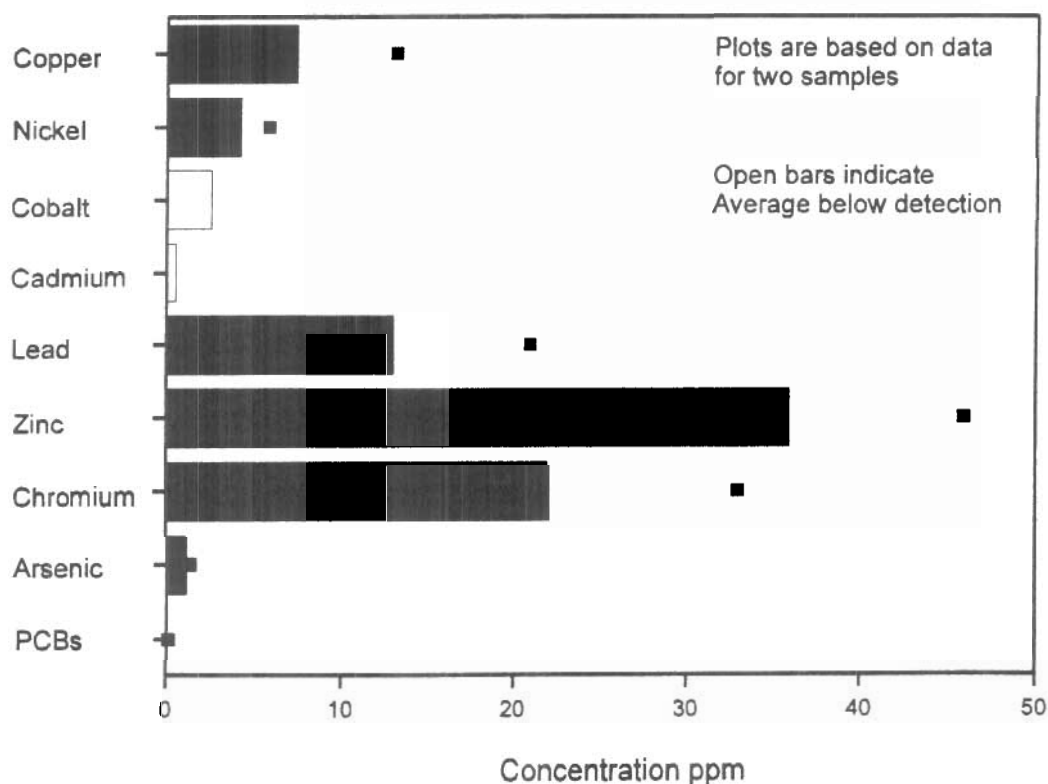
**Figure V-12: Mean and Maximum Inorganic Element and PCB Concentrations in Soils Collected at Dump Site #2.**

Two of the three soil samples collected at Dump Site #2 were analyzed for inorganic elements. Mean and maximum levels of all elements investigated were well below the DCC (Figure V-12). Concentrations of all inorganic analytes, except lead and arsenic in one of the sample, were comparable to concentrations in background soils. Lead and arsenic concentrations were four and three times the background soil concentration, respectively, in L6049.

The levels of contamination present in soils at Dump Site #2 are generally comparable to background concentrations. The low concentrations of PCBs and pesticides present in soils at this site could have been transported to the site in leachate from Dump Site #3. All but one of the pesticides detected at Dump Site #2 were detected at higher concentrations in soil from Dump Site #3. The one compound detected in Dump Site #2 soil which was not found in site #3 soils was present at the limits of detection (0.00004 ppb). In previous studies (Avati 1993a), copper and lead have been detected in water collected from the site at levels exceeding the CCME FAL Remediation Criteria, suggesting that contaminants may be leaching from the area of buried waste. The fact that these contaminants were not found to be elevated in soils from the area does not support the idea that they originate from within the dump, however. **Therefore, chemical contamination in the area occupied by Dump Site #2 does not represent a threat to the surrounding environment.**

Erosion of the areas where wastes are buried does pose a risk, however, as exposed wastes could be transported into the ocean by tidal action should it continue. The practice of burning materials before burial while the site was active indicates that a significant portion of the buried materials may be ash which is considered hazardous under the DLCU Protocol. Permitting any hazardous materials to enter fish bearing waters constitutes a potential violation of the Fisheries Act (Section 36). Any debris present on top of the substrate should therefore be removed, and erosion reduced with the addition of an appropriate amount of fill over the area most affected by the drainage channel which runs through the site. Exposed materials not readily removed from the substrate should be left undisturbed to avoid decreasing the stability of the filled areas. Rerouting the drainage channel under the access road by installing a culvert, as suggested by UMA (1994), is a possible further measure for the reduction of erosion.
