2. Results of Previous Studies

3. Current Sampling Program

5. Cleanup Recommendations

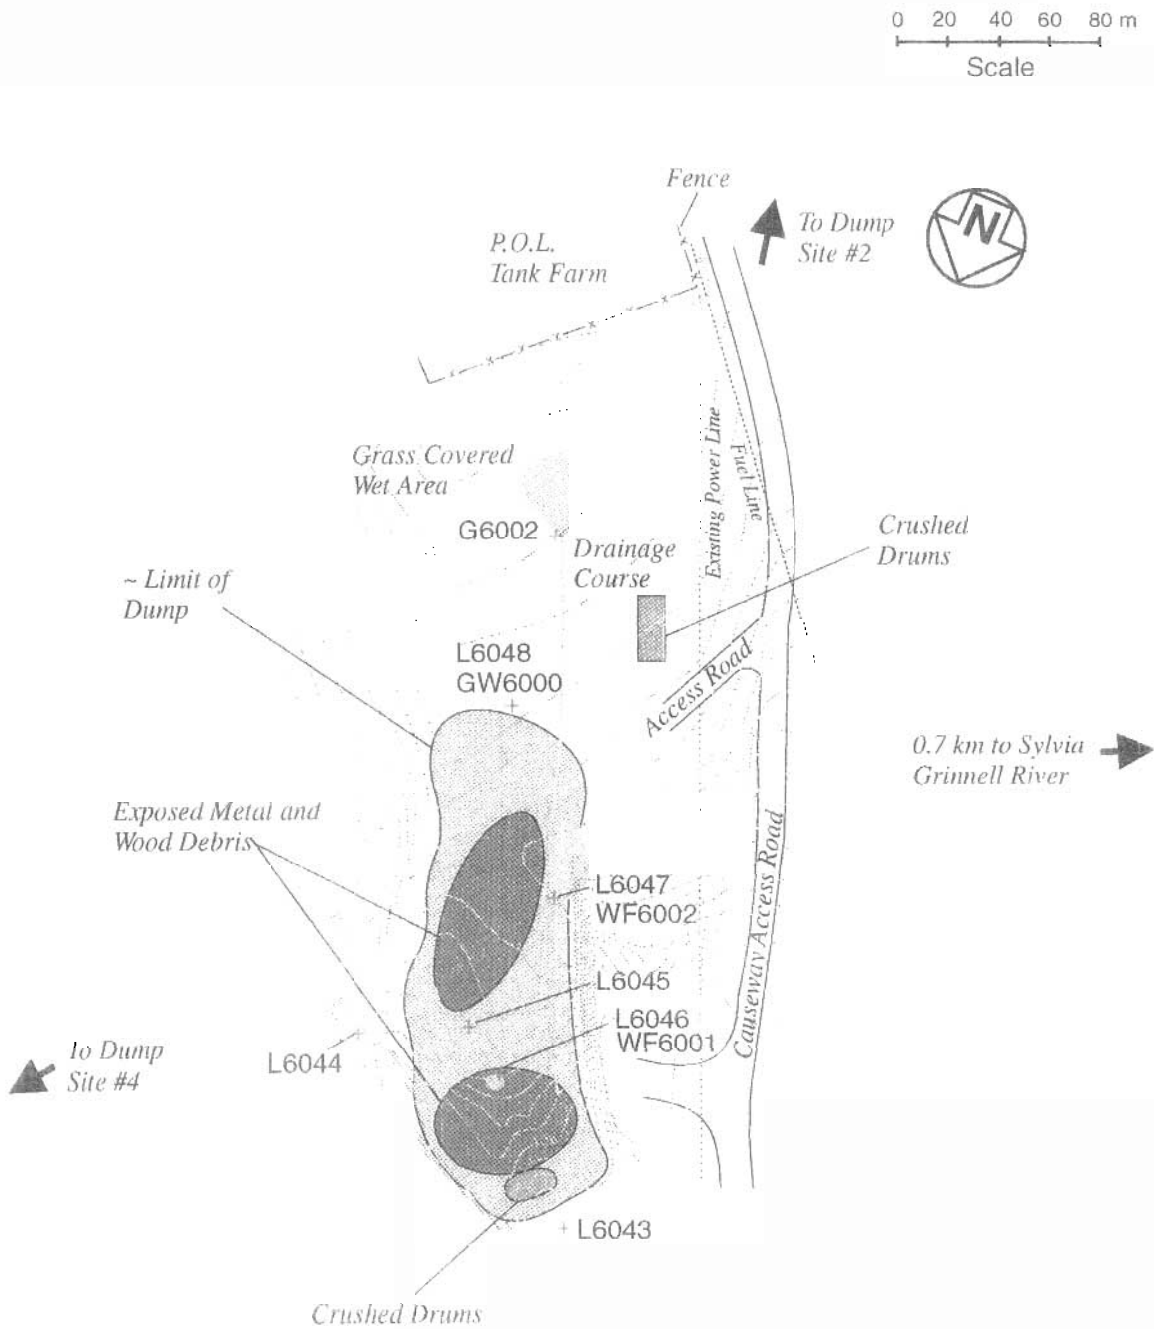
Map V-21: Sample Locations at Dump Site #3, Site of the New Municipal Landfill

The ESG conducted its sampling program at Dump Site #3 on August 14th, 1995, before construction of the new landfill commenced. In view of the analytical results obtained from twenty boreholes drilled as part of the UMA work (1991), the current sampling program focused on drainage channels and catchment areas into which the migration of contaminants was possible. A total of seven soil samples were collected, five from the north and two from the southern end of the site (Map V-21). Two samples of vegetation were collected from two different sampling locations. Two freshwater samples were collected from pools of standing water in the northern half of the site, and a single water sample was obtained from a borehole at the southern end of the largest area of concentrated wastes. Detailed descriptions of individual sampling locations and vegetation collected and surveyed are provided in Section F, Chapter IV of the Appendices.

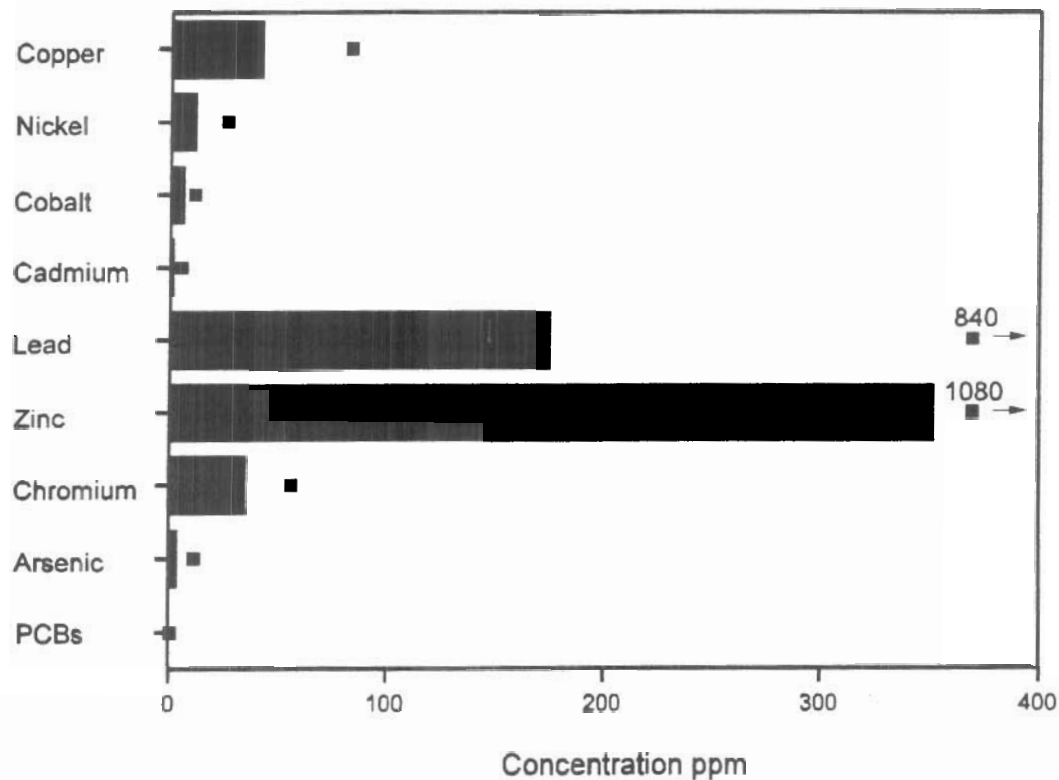
Figure V-13: Mean and Maximum Inorganic Element and PCB Concentrations in Soils Collected at Dump Site #3.

Six of the seven soil samples collected at Dump Site #3 were analyzed for inorganic elements. Mean levels of all elements investigated were below the DCC (Figure V-13). However, the maximum concentrations of cadmium (5.2 ppm), lead (840 ppm) and zinc (1080 ppm) exceeded the DCC Tier II for those elements.

Contaminants at concentrations exceeding the DCC were found in only one sample, L6046, collected from the bottom of a small drainage catchment on the south side of the northernmost debris pile (Photograph V-40).
