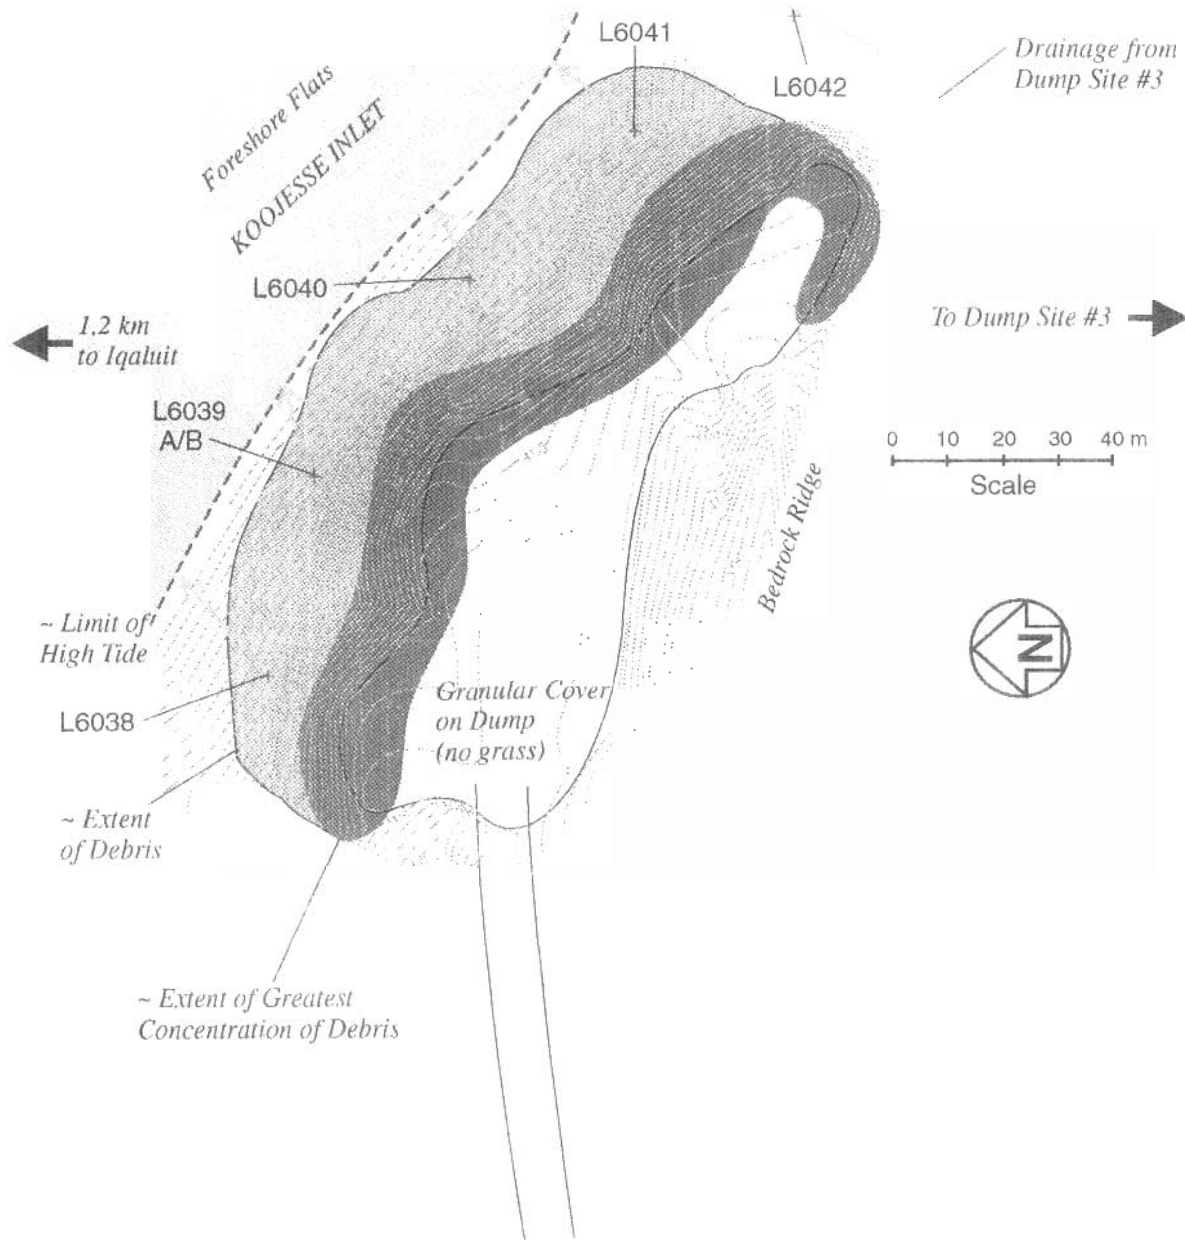
Map V-23: Sample Locations at Dump Site #4,
the Iqaluit Municipal Dump

The analytical results for samples from this and all other sites can be found in Chapter V of the Appendices. One sample collected in the municipal dump (Dump Site #4) contained inorganic elements in excess of the DCC (Map V-24).

One of the three plant samples collected was analyzed for inorganic contaminants. The plant sample collected at the same location as soil sample L6041 had a concentration of zinc (600 ppm) which was 2.4 times the mean background concentration in plants (252 ppm). Levels of all other analytes in the same plant sample (L6041P) were not significantly higher than those observed in background vegetation.

Copper and zinc concentrations in soil from Dump Site #4 were found to be elevated. Copper concentrations exceeded the DCC. Impact on vegetation in the dump by contamination in the soils was detected.

Hazardous and non-hazardous loose debris should be removed from the site. Hazardous materials should be shipped south for disposal; however, non-hazardous materials should be buried in the engineered landfill proposed for construction at the North 40 (see Implementation section, Chapter II). Metallic debris could be shredded and shipped South for recycling.

Control of leachate production within the dump requires implementation of the following measures: pulling back the top accumulated debris from the edge of the slope and depositing it as far to the south as possible within the area currently occupied by the dump; capping it with sufficient clean fill to promote permafrost infiltration of the waste-containing layer; and diverting drainage, which could potentially infiltrate the waste, away from the slope. Further mediation of leachate production within the dump could be accomplished by the placement of a synthetic membrane or amended soils over the regraded area. Revegetation of the area should be encouraged by reseeding with endemic early successional species, as outlined for Dump Site #1.

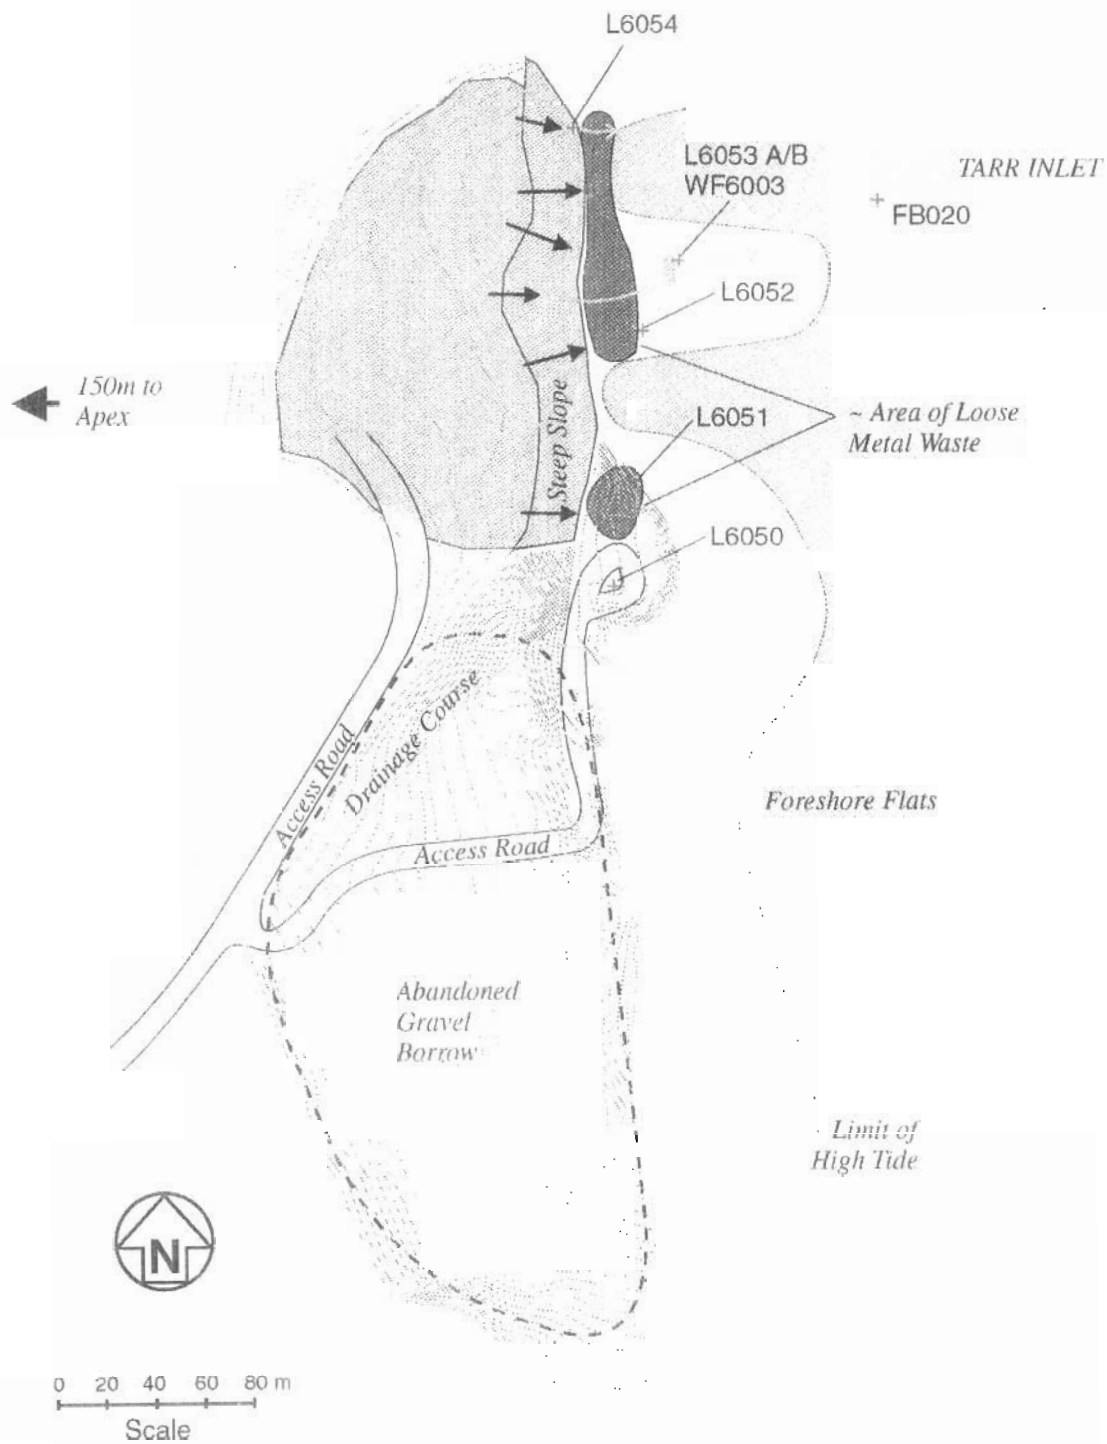
Map V-25: Sample Locations at Dump Site #5, the Apex Dump

The ESG conducted its sampling program at Dump Site #5 on August 14th, 1994. Leachate migration from Dump Site #5 into Tarr Inlet may represent a threat to marine organisms including fish and hence is in direct conflict with Section 36 of the Fisheries Act. Therefore, potential pathways of contaminant migration into the marine environment formed the focus of the ESG sampling program. Six soil samples, including one field duplicate, were collected in drainage paths from the south toe of the dump (Map V-25). Two samples of vegetation were collected from each of two different sampling locations where sufficient plant material was available. A single water sample was obtained from a pool of water collecting drainage from the middle of the dump. Detailed descriptions of individual sampling locations and vegetation collected and surveyed are provided in Section H, Chapter IV of the Appendices.
