WATER LICENCE INSPECTION FORM

Licensee	Licensee Representative
Hamlet of Pangnirtung	Gord Marinic
Licence No. / Expiry	Representative's Title
3AM-PAN1828	Municipal Engineer
Land / Other Authorizations	Land / Other Authorizations
1BW-DUV2025	
Date of Inspection	Inspector
June 22, 2022	Joseph Monteith
Activities Inspected	
<div><input type="checkbox"/> Camp<input type="checkbox"/> Drilling<input type="checkbox"/> Mining<input type="checkbox"/> Construction<input type="checkbox"/> Reclamation<input type="checkbox"/> Fuel Storage</div> <div><input type="checkbox"/> Fuel Storage<input type="checkbox"/> Other:<input type="checkbox"/> Other: Water Use &amp; Waste Disposal</div>

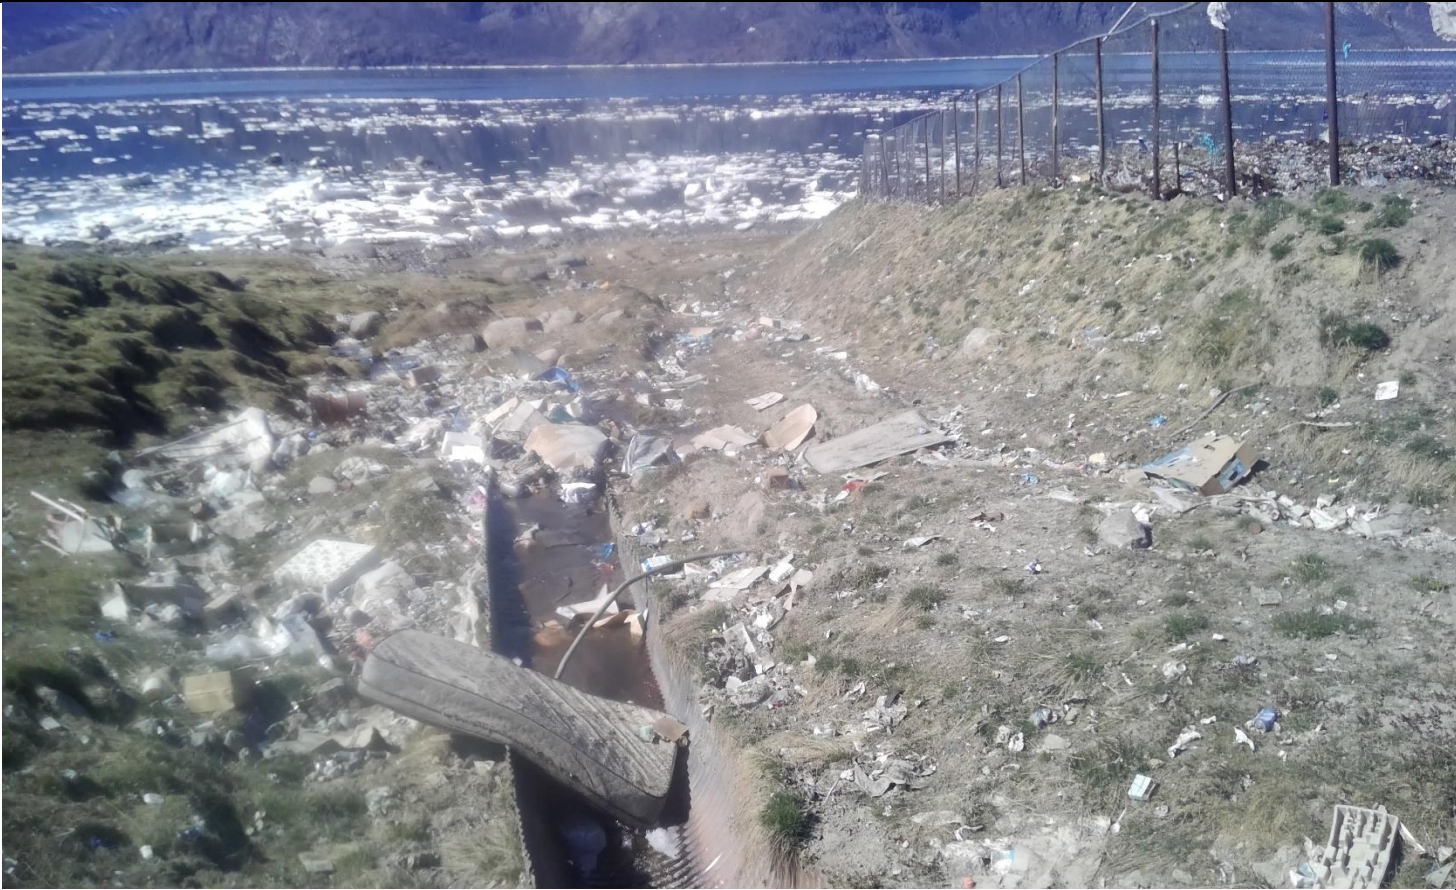
Photo 9

12. The burn and cap is fenced, and also has two drainage culverts at the base of the landfill. A drainage basing on East side of the burn and cap has large amounts of wind blown debris and bulk wood deposits (photo 9).

Description: The drainage ditch next to the fenced in burn and cap facility. Littered with domestic wind blown debris.
