Project Title: Pangnirtung WWTF

Project No.: FRE-00232735-A5

Aftercare Service – Site Visit #16 (SUMMARY REPORT)

Site Visit: Sept 19-28, 2023

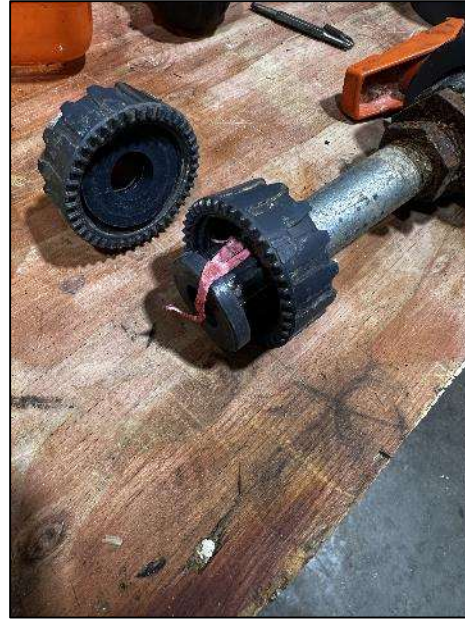
Figure 12: 1 1/2" PVC Valve for Wash Bar
Figure 13: 1 1/2" PVC Fittings for Wash Bar
