Leak Repair Program Resolute Bay October 2010

Prepared For:
Department of Community and Government Services
Government of Nunavut

Project No: OTT00020430A
Report date: October, 2010

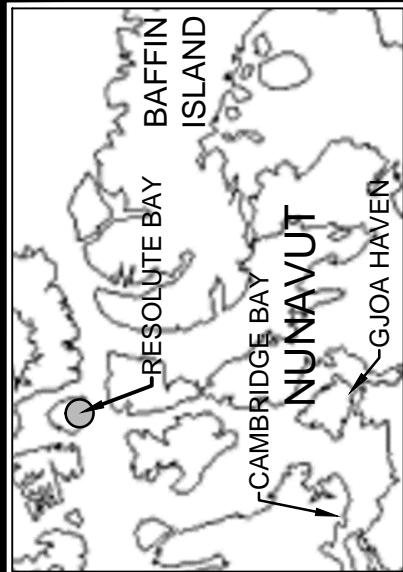
scale 1:2000		CLIENT: GOVERNMENT OF NUNAVUT	project no. OTCD00020430A
date 20/09/10			
drawn by C.ROACH		TITLE: LEAK DETECTION DEFICIENCIES	D1

11m North of AV10
@ SECTION, 1-3gpm
POINT OF INTEREST

5m North of AV10
@ SVC (possible),
1-3gpm
POINT OF INTEREST
