Sewage and Water Works Technical Evaluation – Phase 1

**Hamlet of Resolute Bay, Nunavut
CGSHQ-09023-01**

Project No: OTCD00020312A
Report date: March, 2010

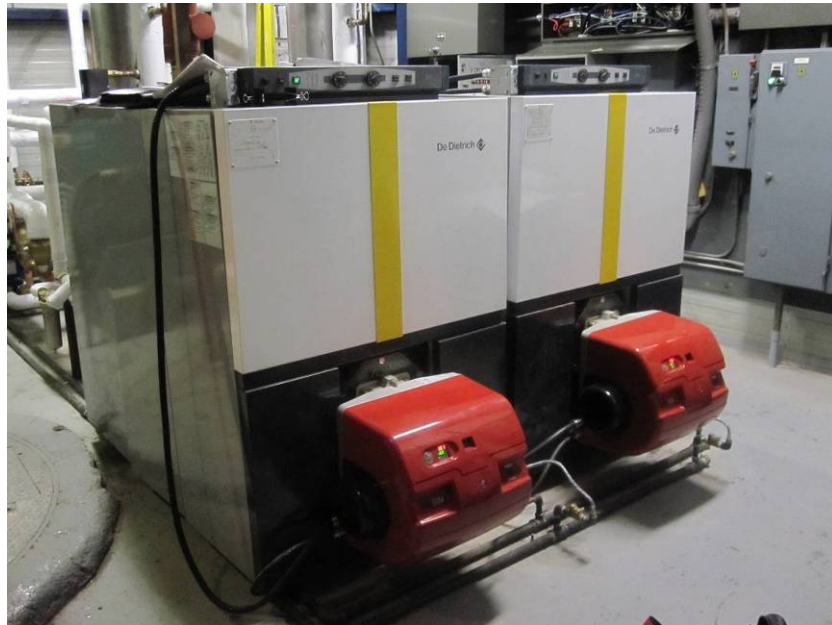
Two oil fired cast iron boilers, using Riello fully modulating burners with UV scanner for flame detection were installed in 2009. The boilers are used to provide part of the heating necessary for the building and to heat the potable water that is injected in the well and to the water line at the discharge of the potable water pumps. The boilers operate to maintain the hot water supply temperature setpoint. There is no controller to allow sequential operation and no means to control the potable temperature in the well or in the piping between Char Lake pump house and the Signal Hill water treatment plant. Both boilers were operating at the time of site review. (refer to Photo 6.1.4.1.a)

Picture 6.1.4.1.a – Char Lake boilers

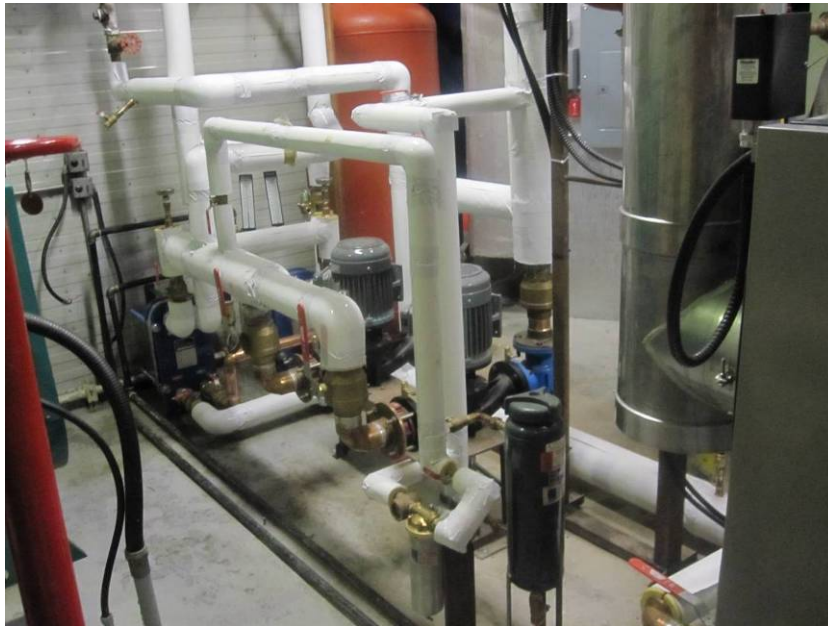
Two stainless steel plate and frame heat exchangers are installed to transfer heat from the heating water to the domestic water. The heat exchangers were installed in 2009. (refer to Photo 6.1.4.3.a)

Picture 6.1.4.3.a – Char Lake hot water pumps and heat exchangers

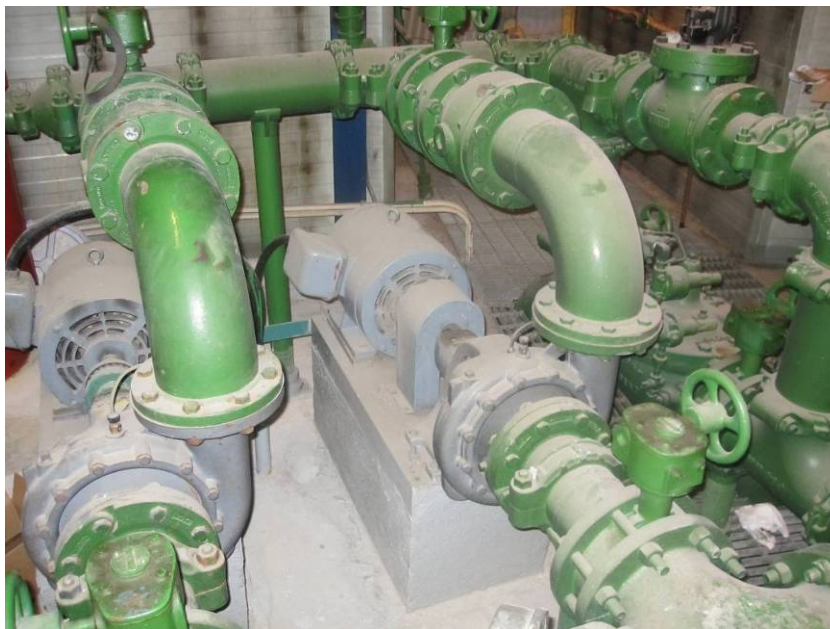
The water pressure for the flows to town is boosted by a pair of pumps that are rated at 28 L/s (444 usgpm) at 209 kPa (70 feet H₂O) of head. These pumps operate on the basis of one duty pump and one in standby, with alternation of the duty pump. The pressure boost provided by the pumps is intended to ensure circulation through town of the water supply and return flow to the water treatment plant. (refer to Photo 6.2.2.1.a)

Picture 6.2.2.1.a – Water Treatment Plant circulating pumps

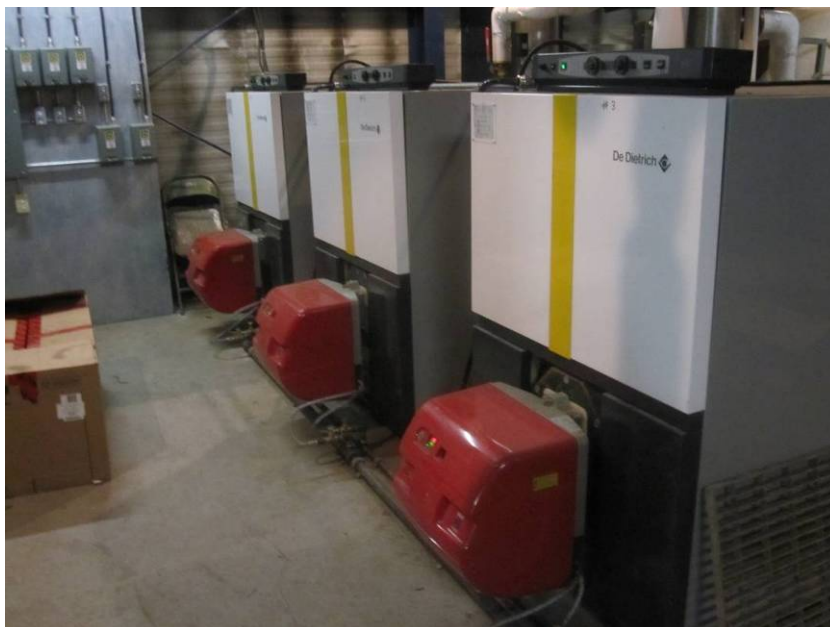
Three oil fired cast iron boilers, using Riello fully modulating burners with UV scanner for flame detection have been installed in 2009. The boilers are used for building heating and to heat the potable water. The boilers operate to maintain the hot water supply temperature setpoint. (refer to Photo 6.2.4.1.a)

Picture 6.2.4.1.a – Water Treatment Plant boilers

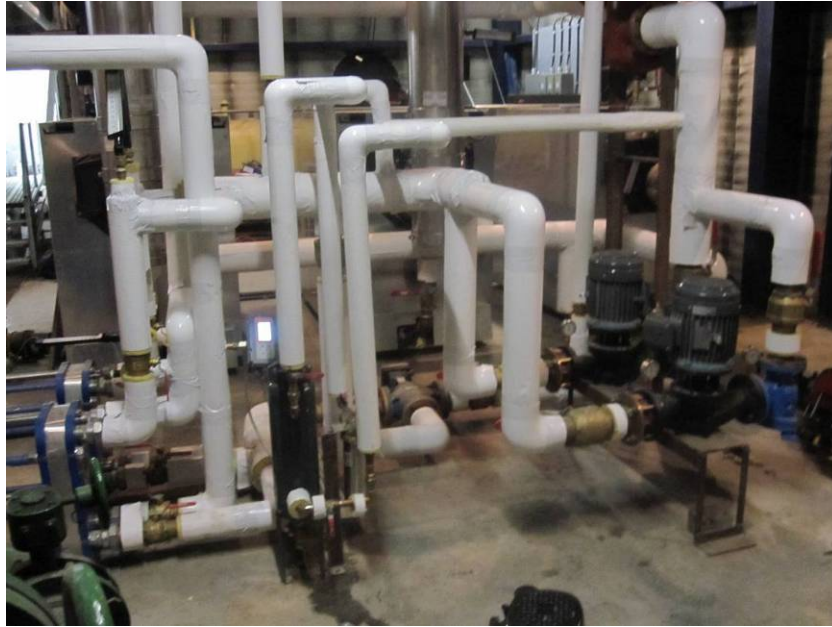
Two primary pumps installed in parallel ensure flow through two of the boilers and to the heat exchangers. The pumps operate at constant volume and only one pump operates at a time in a lead/lag configuration. The capacity of one pump is sufficient to operate two boilers and both heat exchangers. The pumps were installed in 2009. (refer to Photo 6.2.4.2.a)

Picture 6.2.4.2.a – Water Treatment Plant hot water pumps and heat exchangers

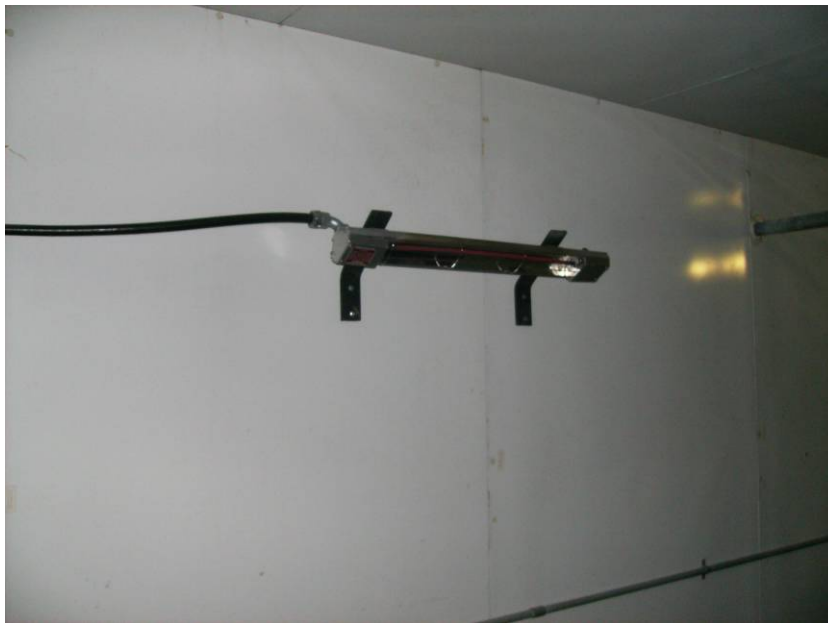
Heating is provided by a low density electrical radiant heater that keeps the surface of the macerator warm. (refer to Photo 6.3.3.a)

Picture 6.3.3.a – Macerator radiant heater
