- **Government of Nunavut**

## **Dam Safety Review**

Dam Safety Review  
Sewage Lagoons and Water Reservoir  
Cape Dorset, Nunavut

OTT-00209248-A0

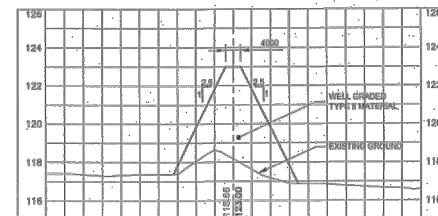
6 WEST BERM SECTION 0+140  
SCALE 1:2000

- 1.) The west berm is approximately 4 m wide and with side slopes of 2.5H:1V. It has been constructed with sand and gravel fill in accordance with the project specifications. The upstream and downstream slopes of the berm have been provided with rip rap.
- 2.) At the time of the visit, the west berm of the lagoon was leaking from an area south of the emergency overflow weir. The leak was observed to take place at the interface of the berm and the natural ground. However, a representative of the Government of Nunavut indicated that

during the spring melt, water was also observed to seep through the berm in this area. The representative also indicated that during construction, the design of the berm was modified and that the bentonite liner was not installed vertically in the centre of the cross section of the berm but along the downstream slope of the berm. Currently, it is not known whether the liner was sealed into the bedrock.

- a.) The liner has been damaged during construction since the rip rap contains sharp edges;
- b.) The liner was not sealed into the bedrock; and
- c.) Joints in the liner may be defective or may have opened subsequent to installation of the liner since the joints of a bentonite liner are not sealed but are merely overlapped with bentonite beads placed in the overlap.

It is recommended that the liner should be replaced as soon as possible since side slopes of 2.5H:1V for a seepage berm are not considered stable. The downstream slope of the berm is susceptible to failure. It is recommended that the bentofix liner should be replaced as it cannot be repaired.
