July 29-30/12 Cape Dorset: Inspection of license number 3BM-CAP0810 – *Expired*

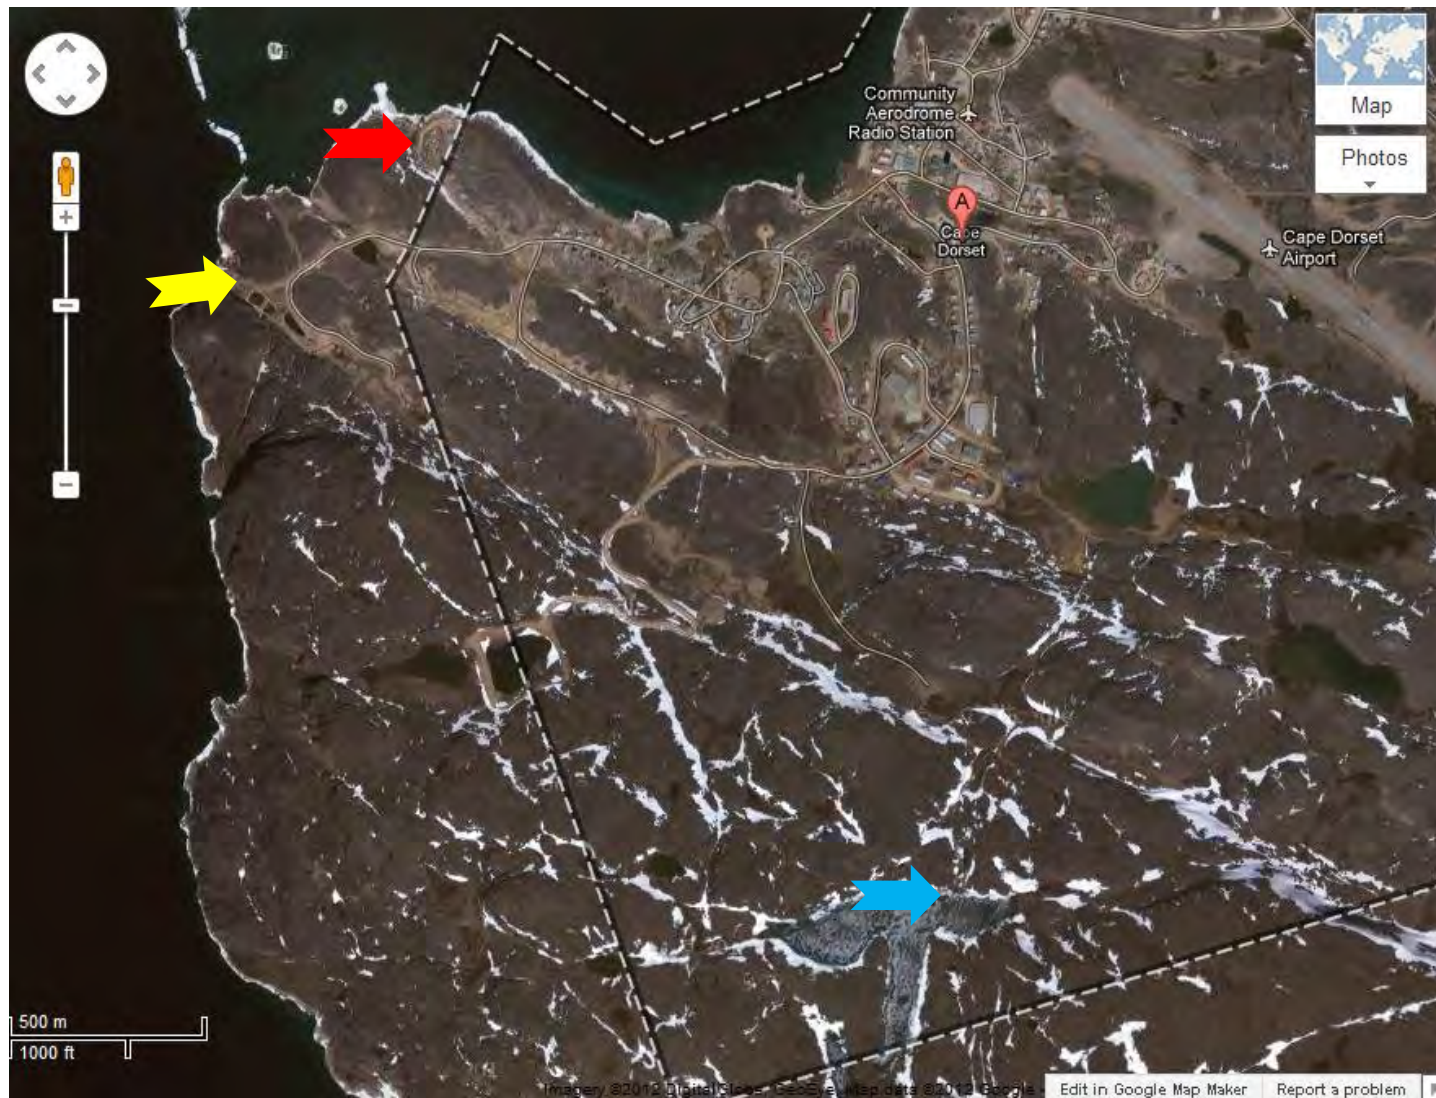
Samples taken near the water intake system at Tee Lake (blue arrow), effluent outfall (yellow arrow) and small pond near the metal dump (red arrow).
