Inspection Report

License #: 3BM-CLY

RE: August 18th, 2008 Municipal Water Licence 3BM-CLY0909

Water License Inspection photos Clyde River August 18, 2008: CIDM 268991

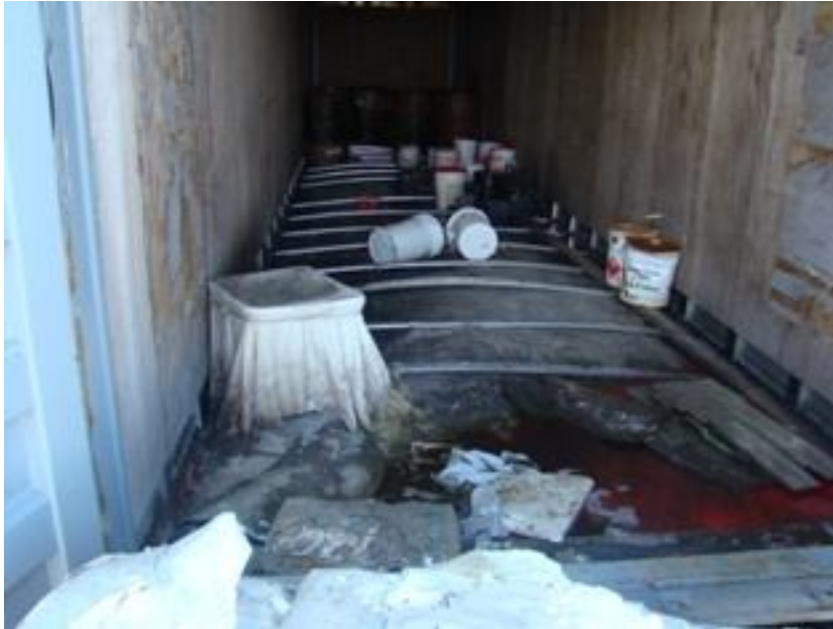
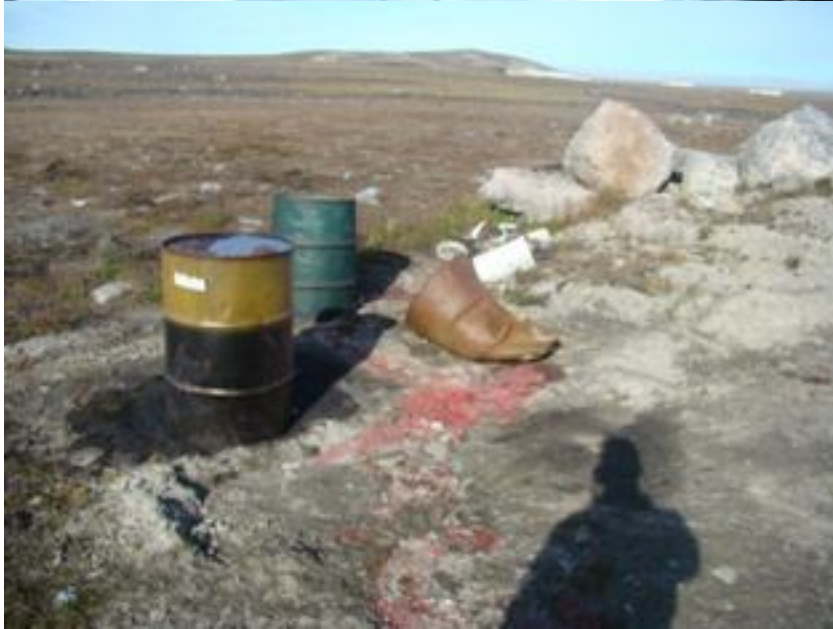
Unknown Red power in Municipal waste area

The Municipality (Mr. David Arreak) was provided a verbal direction to consolidate and remediate the area. It was suggested that some form of secondary containment was required to ensure these spills were not migrating into the environment and water was necessary and that the consolidation of the batteries found to be scattered throughout the area was also necessary.
