**Ref: INAC File No. 3BM-CLY0308, CIDM # 216017:
Clyde River Sewage Lagoon Failure May 23rd, '08**

Reference: OTCD00019055A

Sewage Lagoon Failure Clyde River, Nunavut

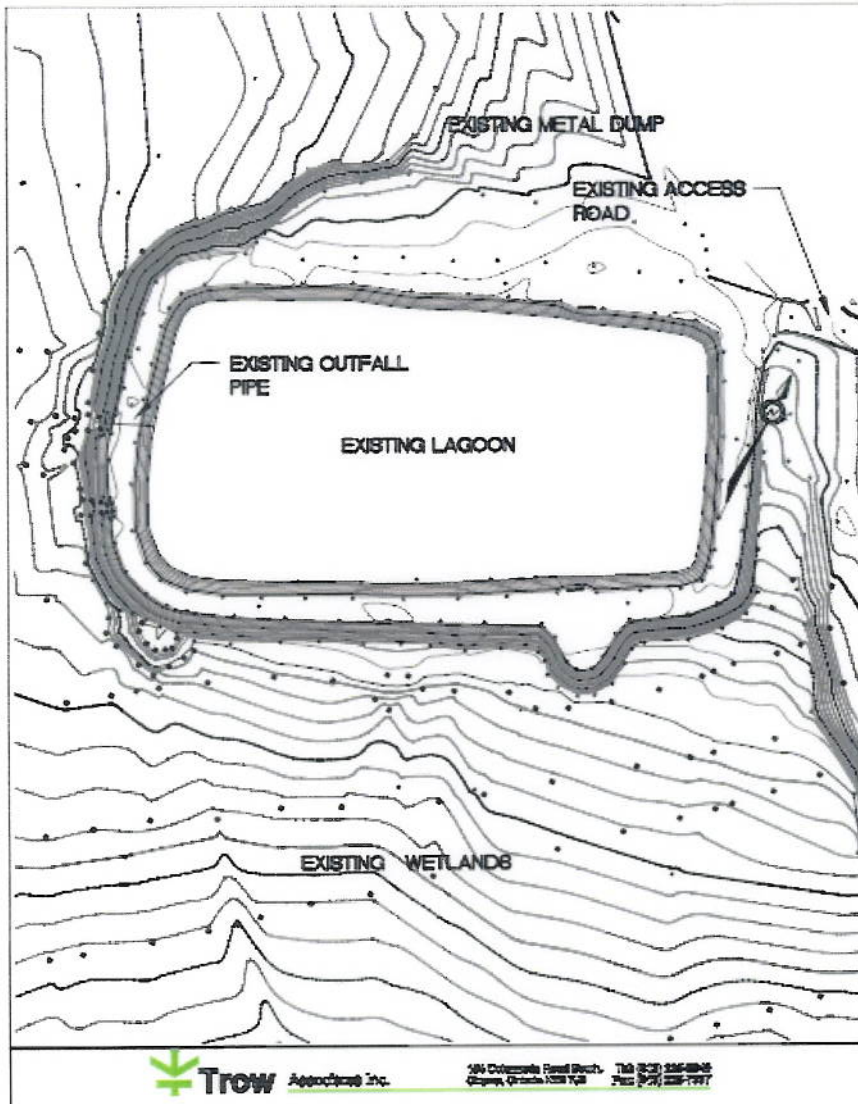
Figure 3

- I engaged hamlet residents and 5,000 sand bags were filled and placed to reinforce the existing berm (see Appendix A, Figures 2 and 3 and the five pictures at the end). This was necessary in order to maintain berm integrity until planned civil works occur.
