## **Design Brief**

**Project Name**  
Coral Harbour Pump House Upgrades

**Project Number**  
OTT-00203694-A0

**Date Submitted**  
July 2012

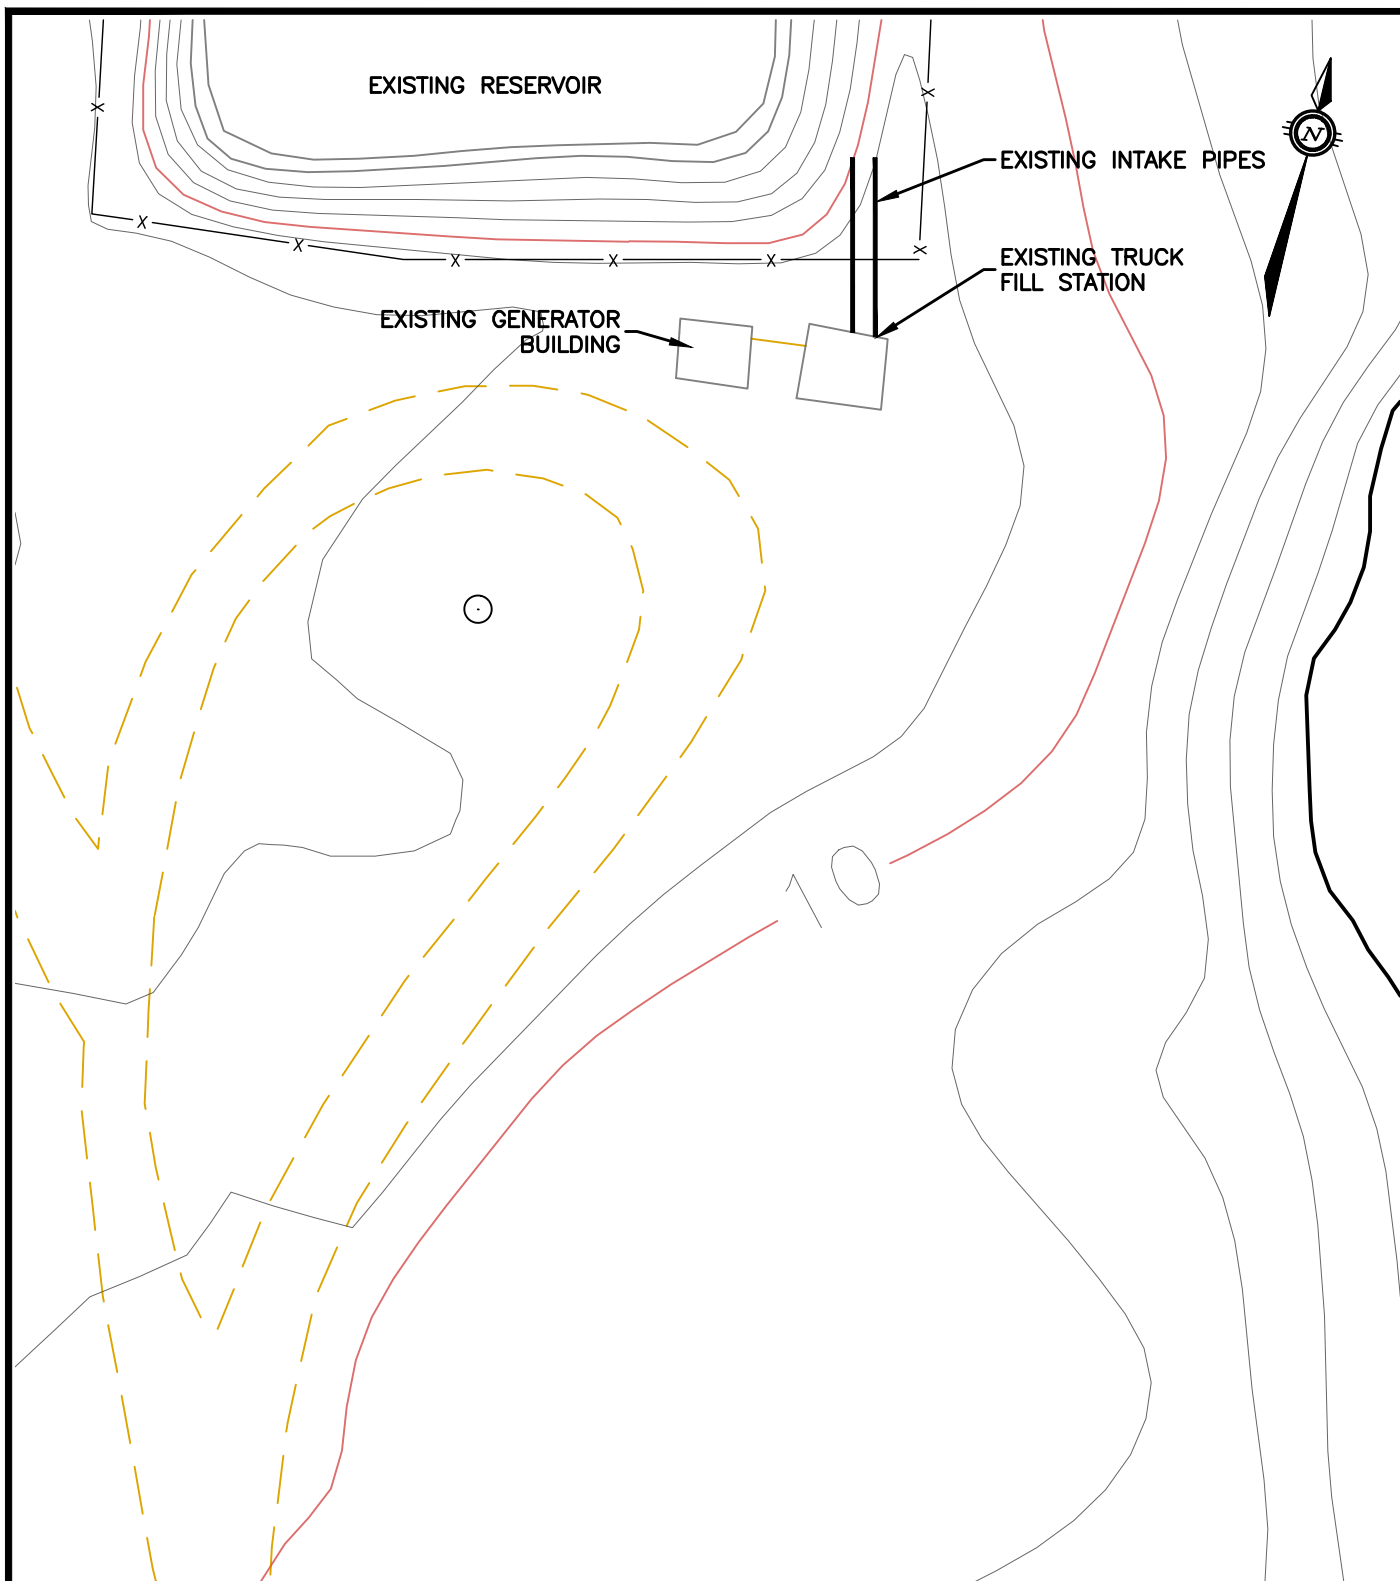
scale 1:500	CLIENT: <b>GOVERNMENT OF NUNAVUT</b>	project no. OTT00203694A
date 30/04/12		FIG1
drawn by S.BUTLER

The truck-fill station is accessed via a turn-around loop that extends from the road connecting the station to the Hamlet as shown on Figure 1. Water service vehicles were observed to easily manage this access to the site. The turn-around loop does not provide direct access by the truck to the loading arm. The truck must advance from the turn-around loop, parallel to the building face, to a point where the loading port on the truck is aligned with the loading arm. This places the front of the truck in close proximity to an unprotected and abrupt drop off. Due to winter conditions during the site visit, the condition of the road could not be observed.

In the short term, protection from the drop-off should be provided. This will require the placement of some fill material, together with a substantial barrier. Large rocks might be suitable as a barrier.

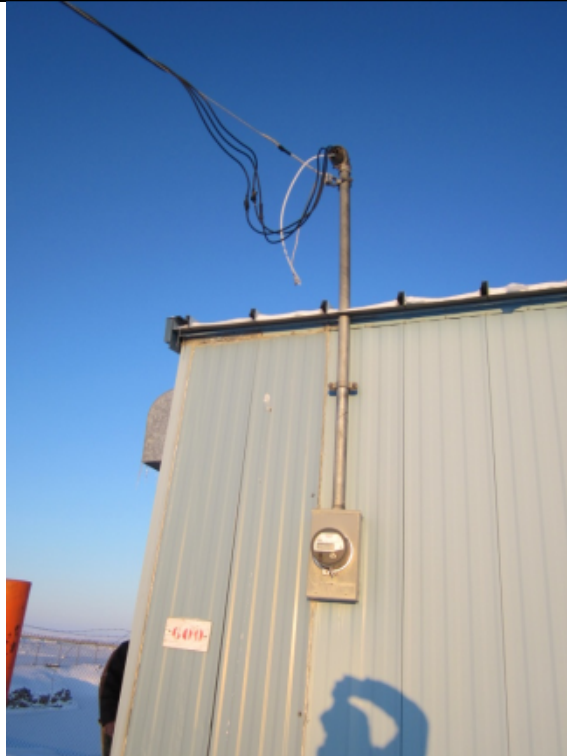
Photo 3 – Generator Building Electrical Supply

Electrical service to the site is provided by the local utility at 100A, 120/208V via a service mast mounted on the southwest corner of the generator enclosure. A utility meter is mounted on the exterior of the enclosure in front of any disconnecting means. Refer to Photo 3 in Appendix A.

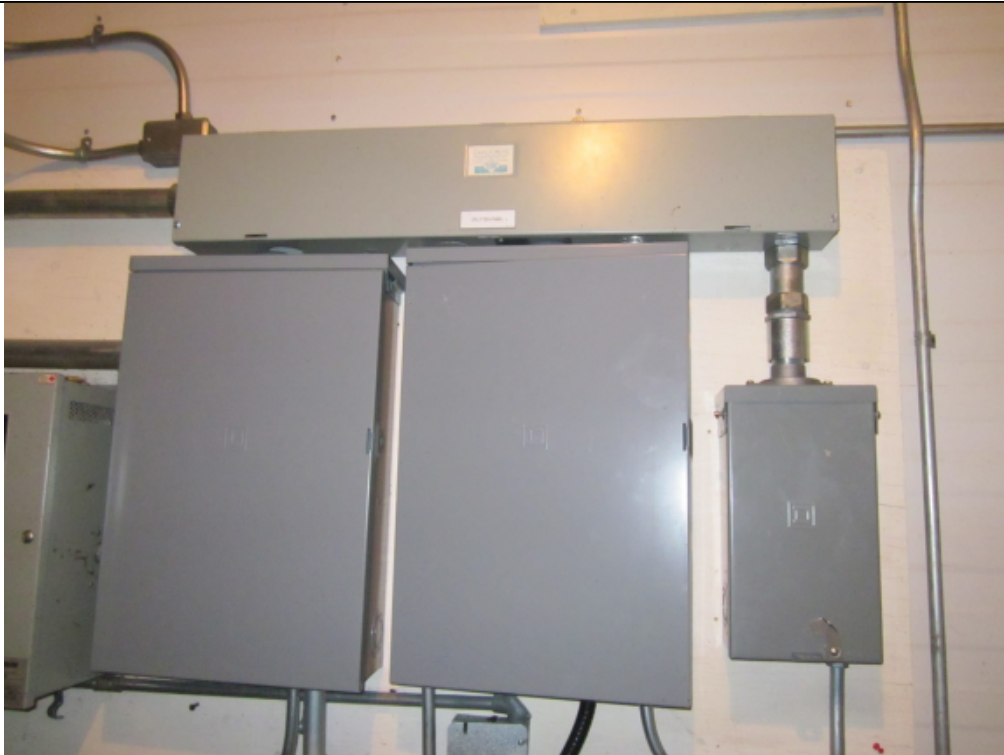
Photo 4 – Main Disconnect, Splitter and Panels

The Hydro service enters the building via a 100A, 120/208V Square D self-enclosed main breaker. The breaker supplies a splitter which feeds the building's ATS and heating panels. The breaker cover does not feature a gasket and the type 3R enclosure is not air tight. The main breaker is still fully operational and appears to be in good condition. Refer to Photo 4 in Appendix A.

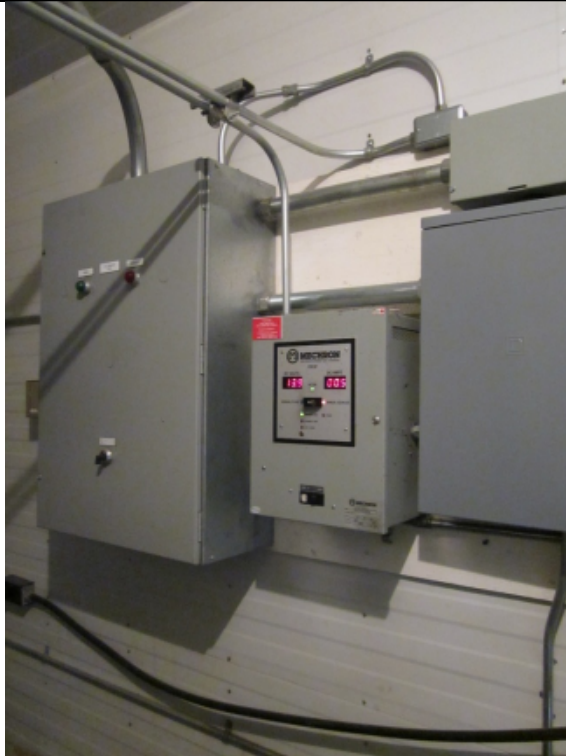
Photo 5 – Automatic Transfer Switch and Battery Charger

The emergency power transfer switch supplies power to the Subfeed and Lighting Panel from the normal power or the generator. The automatic transfer switch (ATS) in the generator enclosure is rated at 100A, 208V. It is a Cutler Hammer LRO Robonic breaker-style ATS and is part of the original installation. The enclosure does not have a gasket and is not liquid or air tight. There are signs of infestation from flies during the summer. Refer to Photos 5 and 7 in Appendix A.

The generator battery is non-operational and will not carry a charge. It must be boosted in order to start the generator. The battery charger is original to the installation. It is a Mechtron charger; model CR2F120-012-110B. It is rated for 120V AC input and 12V DC output. It is currently operating on DC equalize mode with 0.4A DC charging at 14V DC. It could not be determined if the battery charger was operating properly on site since the battery is dead. Refer to Photos 5 and 10 in Appendix A.

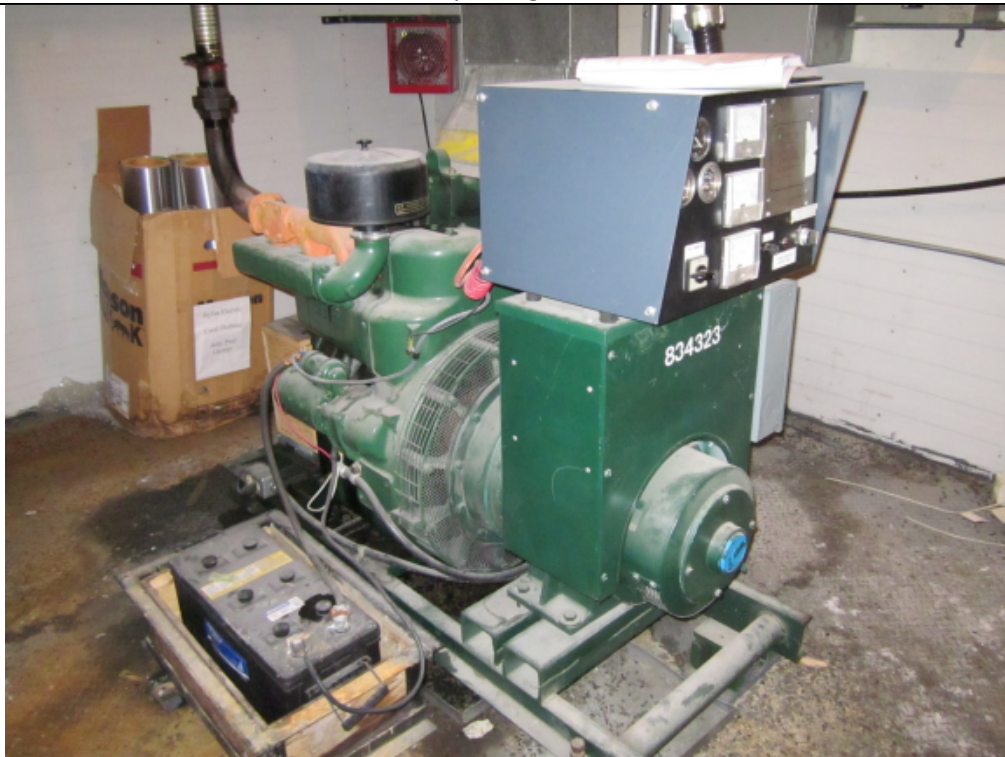
Photo 6 – Generator Building Generator

Emergency power is supplied to the truck lift station from a 25 kW, 120/208V emergency generator installed within the generator enclosure. The generator is the original unit installed in 1984. The generator is powered by a Lister HR3 diesel engine. The alternator is a LIMA SER 208V, 3 phase model. It has a runtime of 1840 hours. Refer to Photo 6 in Appendix A.

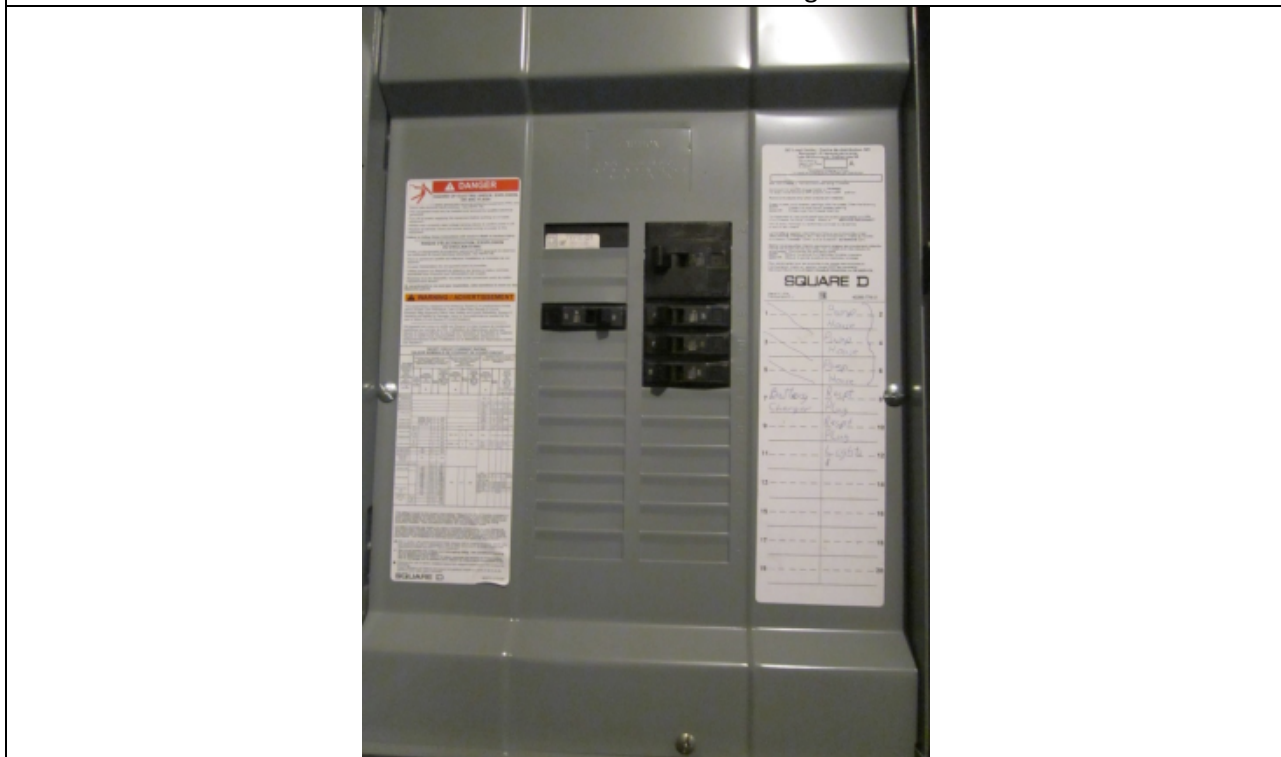
Photo 8 – Generator Building Subfeed Panel to Truck Fill Station

The Subfeed Panel is original to the generator enclosure installation based on the original O&M manuals and information provided by staff. We did not open the Subfeed Panel since it was in operation, but the exterior of the panel appears to be in good condition and there is very limited electrical damage in the generator enclosure. The panel cover does not feature a gasket and the type 3R enclosure is not air tight. The panel and all breakers are still fully operational. Refer to Photos 4 and 8 in Appendix A

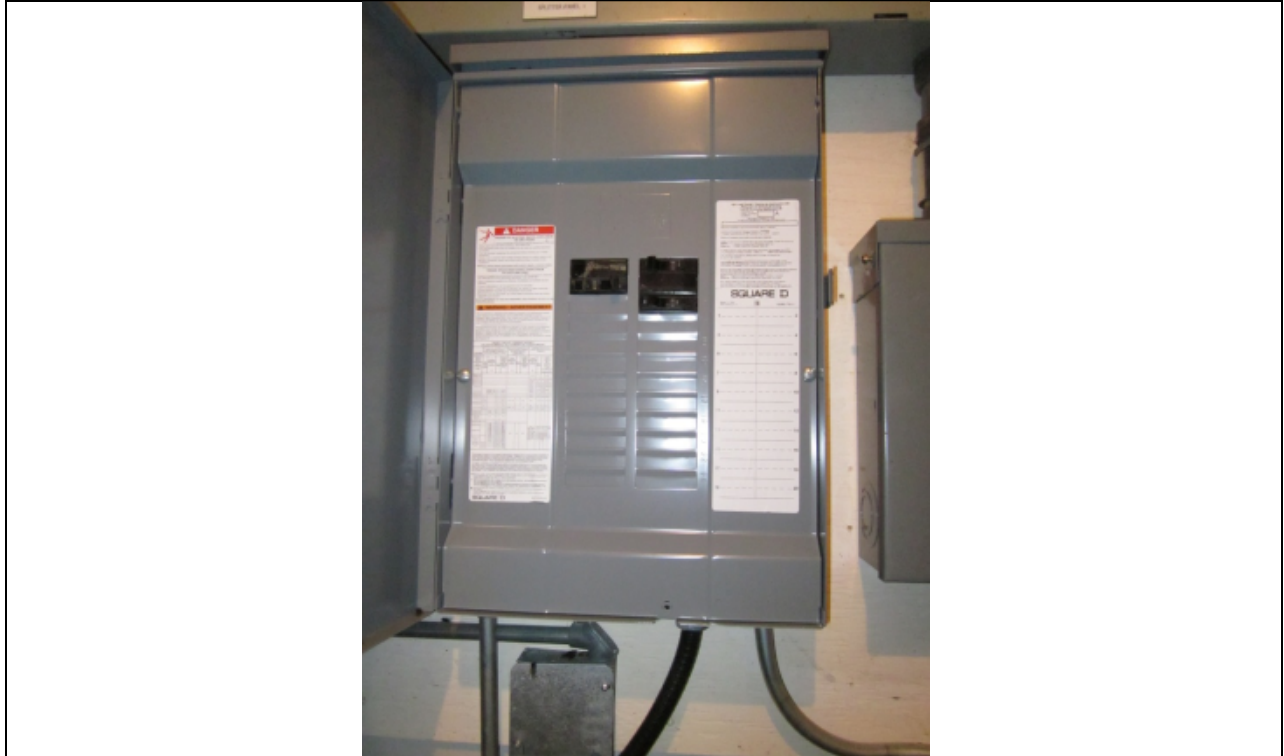
Photo 9 – Generator Building Heating Panel

The Heating Panel is also original to the generator enclosure installation. We did not open the heating panel although its exterior appears to be in good condition. The panel cover does not feature a gasket and the type 3R enclosure is air tight. The panel and all breakers are still fully operational. Refer to Photos 4 and 9 in Appendix A

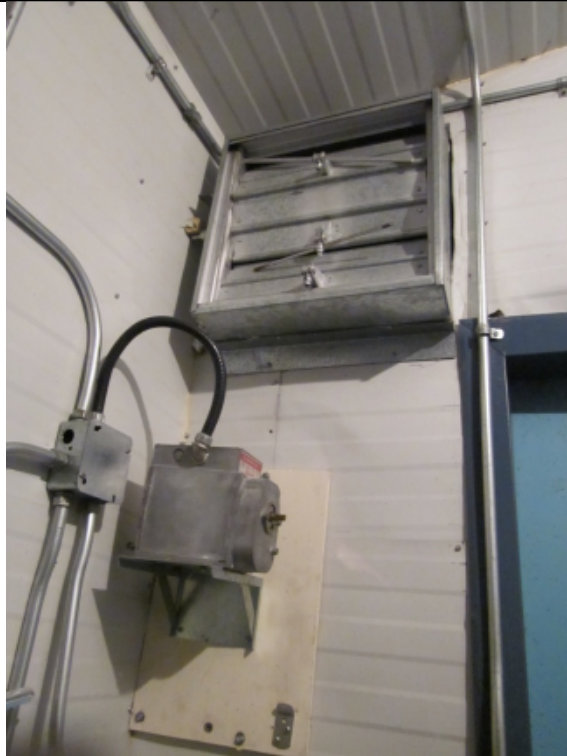
Photo 11 – Generator Air Intake Damper

There is only 1 air intake in the room. The outside air damper is permanently shut and the crank arm connecting the damper leafs to the actuator has been removed. There is currently no combustion air provided to the generator. Refer to Photo 11 in Appendix A.

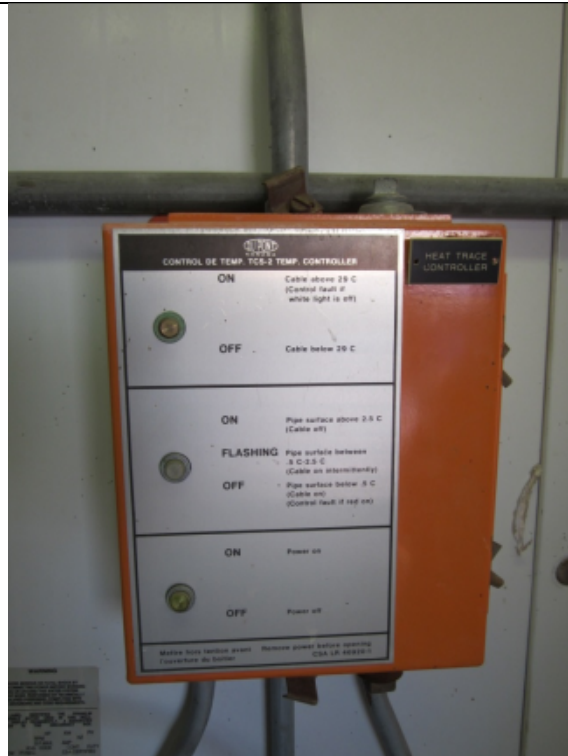
Photo 31 – Heat Trace Controller Enclosure

The heat trace for pump P2 is supplied by a 30A, 2 pole breaker in Panel B. The heat trace controller is mounted directly above the piping entrance on the North side of the building. Pump P2 is no longer in operation and the heat tracing for pump P2 is not plugged in. The controller for the heat trace is in the same condition as for pump P1 and the system is in extremely poor condition. The fuse has been bypassed and there are no longer any control or high limit temperature thermistors installed in the pipe. There is a single heat trace cable (no spare) which is not plugged in. Its plug appears to be damaged and when we resistance tested the tracing cable there was infinite resistance across the phases. The heat tracing does not appear to be functional. Refer to Photos 30 – 32 for details of the heat trace controller and its connections.
