Dam Safety Review

Dam Safety Review
Sewage Lagoons and Water Reservoir
Gjoa Haven, Nunavut

OTT-00209248-A0

October 16, 2013

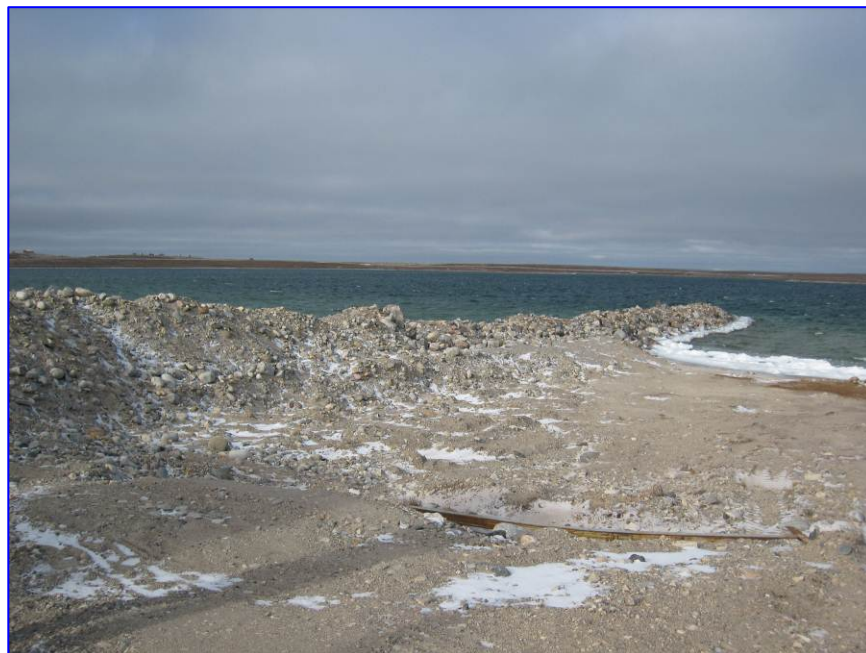
The Hamlet of Gjoa Haven draws its water supply from Swan Lake located approximately 2.3 kms northwest of the Community (Photos 14 and 15). It is reported that a sufficient quantity of water is available from Swan Lake to satisfy the Community needs and that the water quality is also good. Water is drawn from the lake via a 150 mm diameter pipe by pumps located in the pumping station (Photo 16). The water is heated to 15 degrees Celsius and pumped into the pipeline to the water treatment plant and truck fill station (Photo 17) located approximately 2.3 km southeast of Swan Lake. The pumping station is also equipped with an emergency truck fill station. During transmission of the water from the pumping station to the water treatment plant, it is heated twice at heating stations located along the pipeline approximately 1 km apart.

Photograph No. 14
View of Swan Lake (source of water supply).

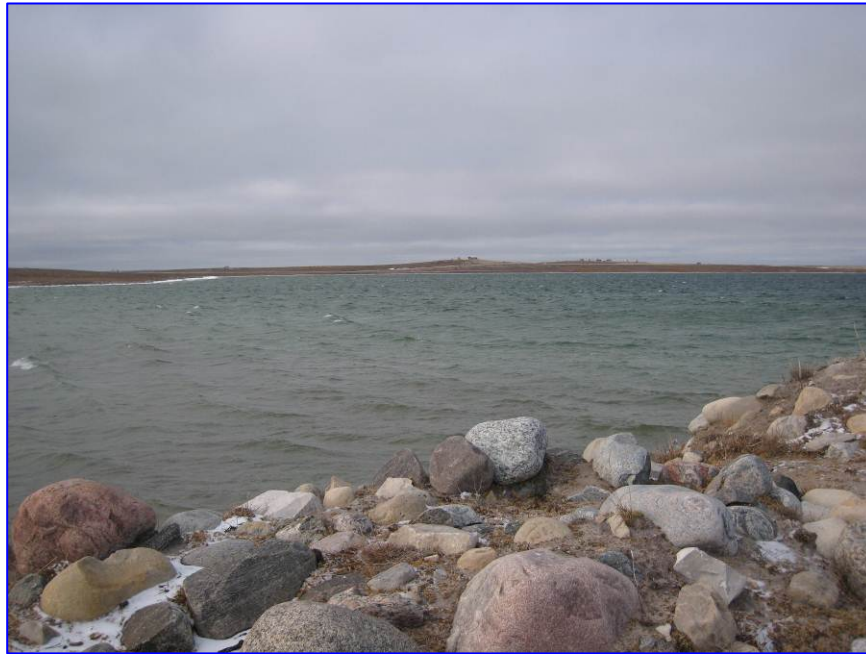
Photograph No. 15
Another view of Swan Lake.

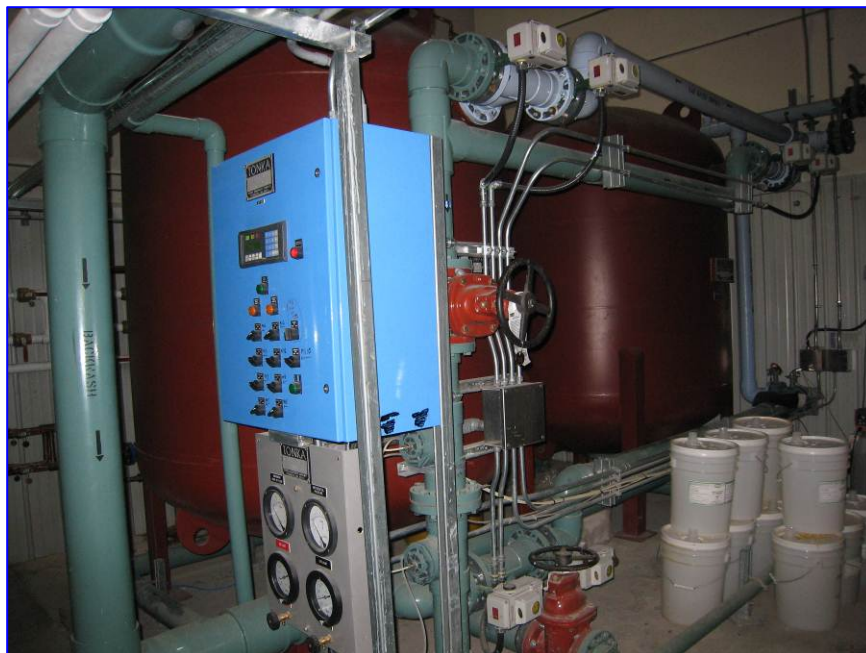
The water at the water treatment plant is chlorinated. It is then filtered through anthracite sand and fine sand filters (Photo 18). Subsequently to filtration, it is re-chlorinated (Photo 19) and stored in the storage tank (Photo 20). The storage tank has a capacity of 385,000 litres, which is reported to be sufficient to meet the community's demands for approximately one to two days in case of any plant malfunction. During the normal operation of the plant, the intake pump runs daily to keep the water flowing through the buried pipeline.

Photograph No. 18
Filtration Plant.

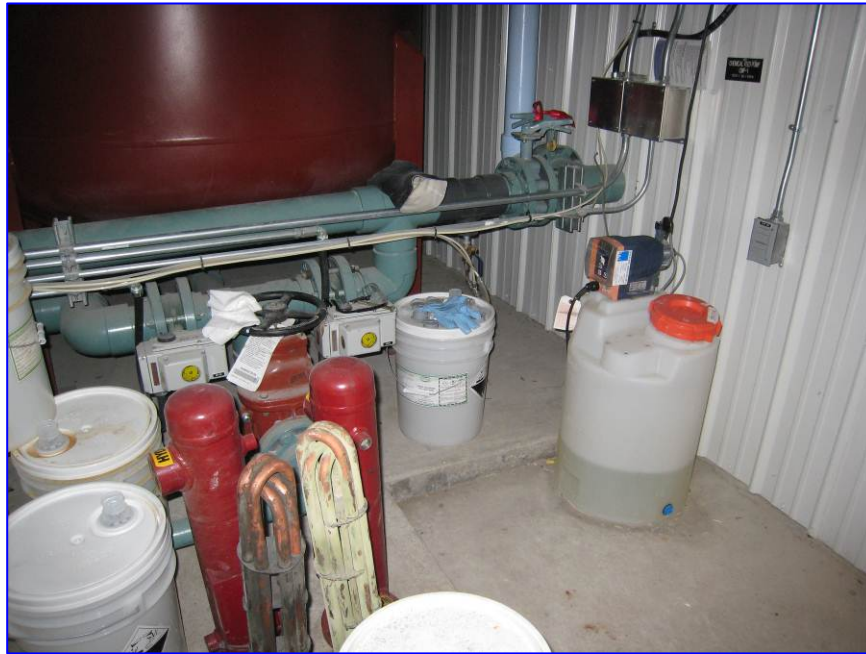
Photograph No. 19
Chlorination station.

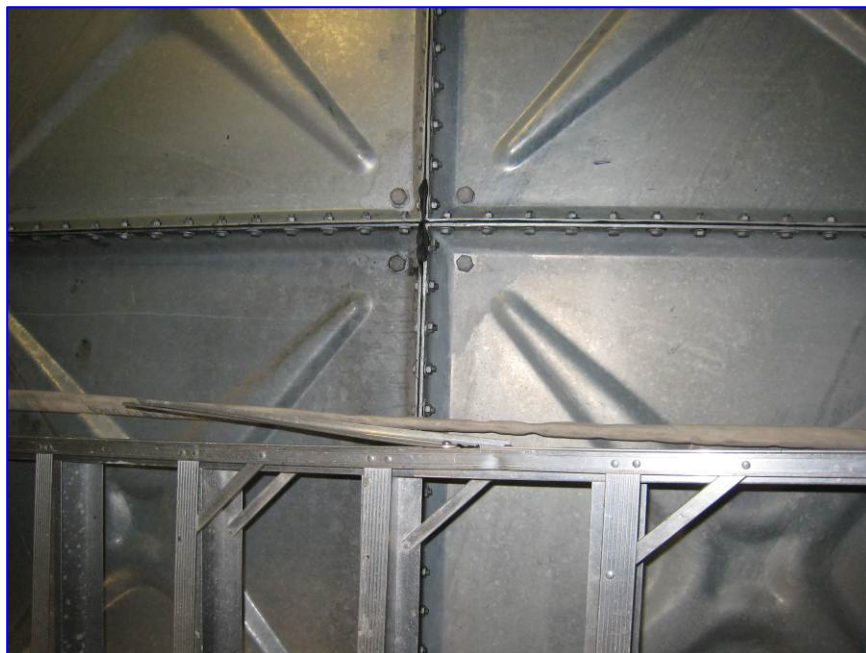
Photograph No. 20
Partial view of water storage tank.

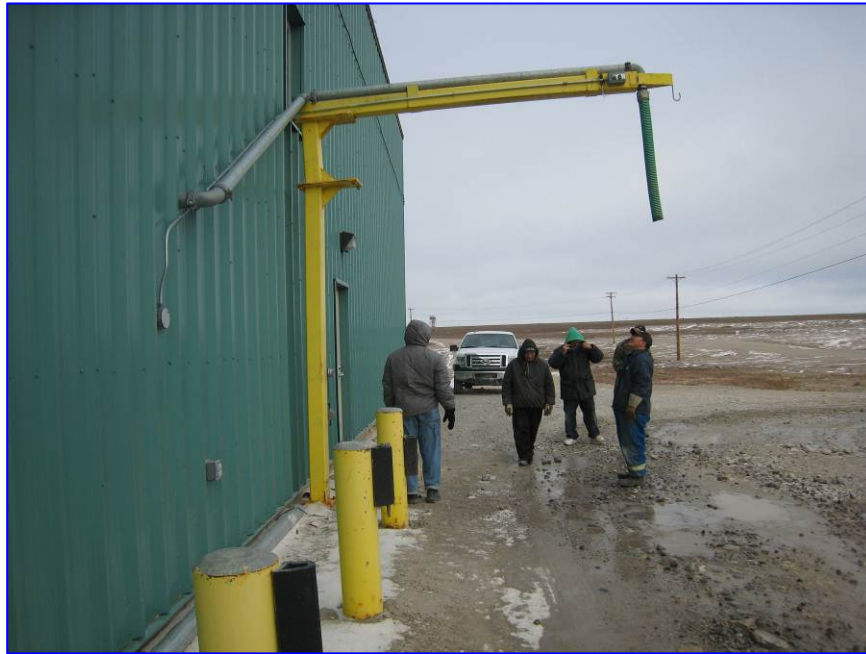
The water from the storage tank is used to fill the water trucks at the truck fill station (Photo 21) for transportation to the community.

Photograph No. 21
Truck fill station.
