Gjoa Haven August 24, 2012

Sewage Lagoon and Solid Waste Management Area

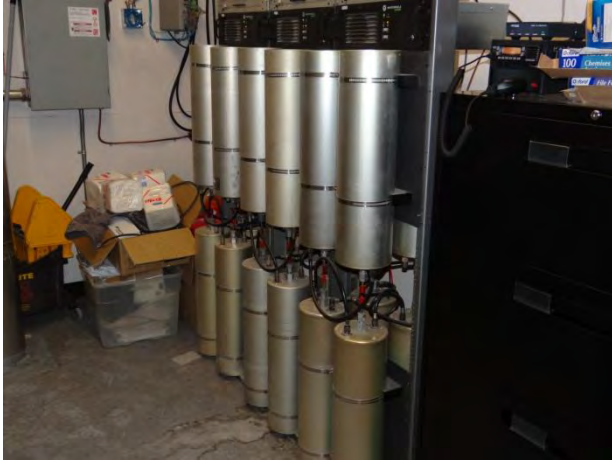
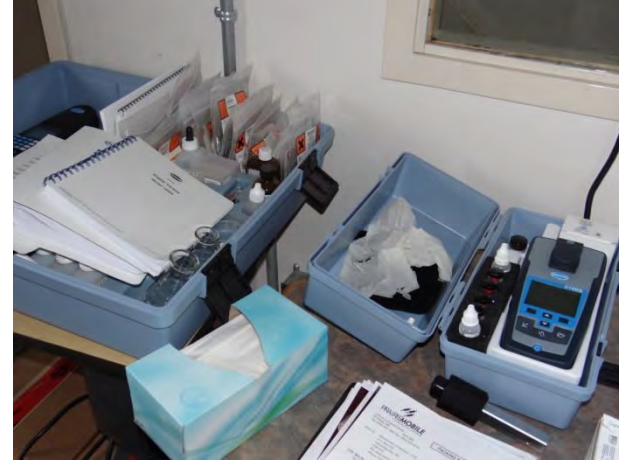
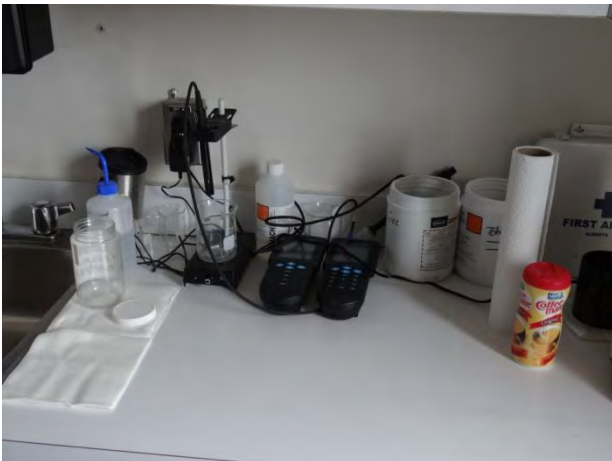
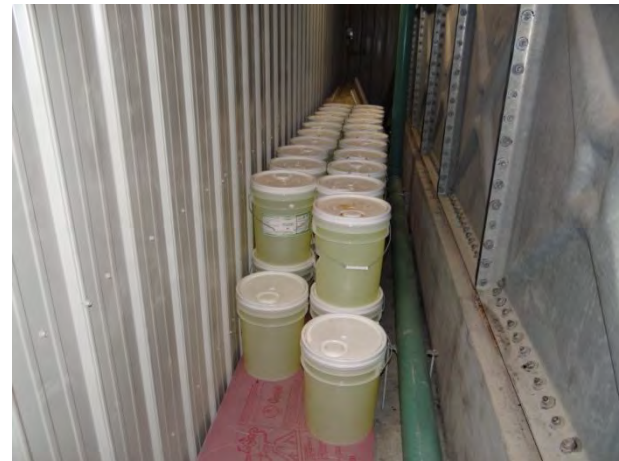
- Water Treatment Facility
- House keeping issues including the secure and safe storage of chemicals and hazardous materials should be addressed by the Licensee.

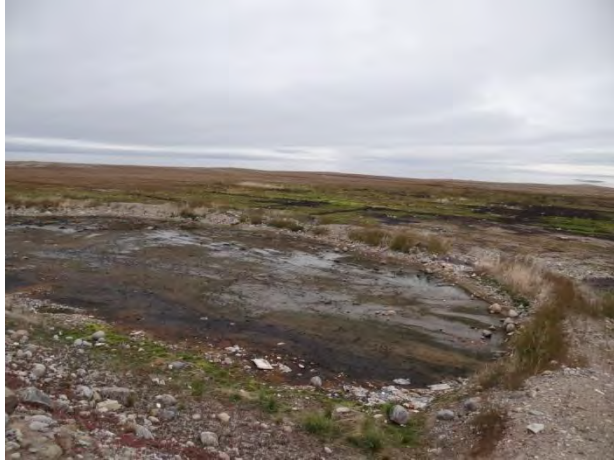
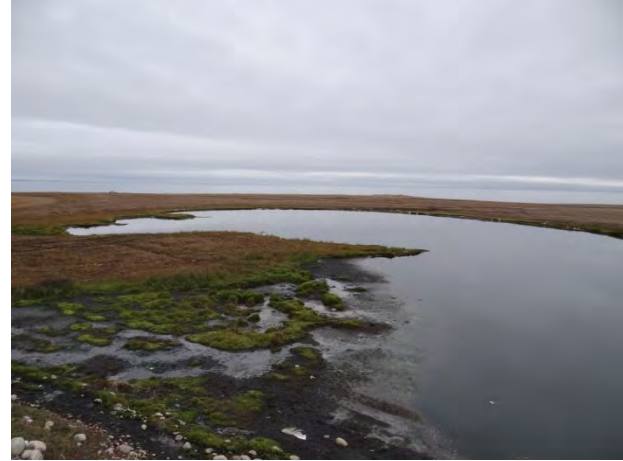
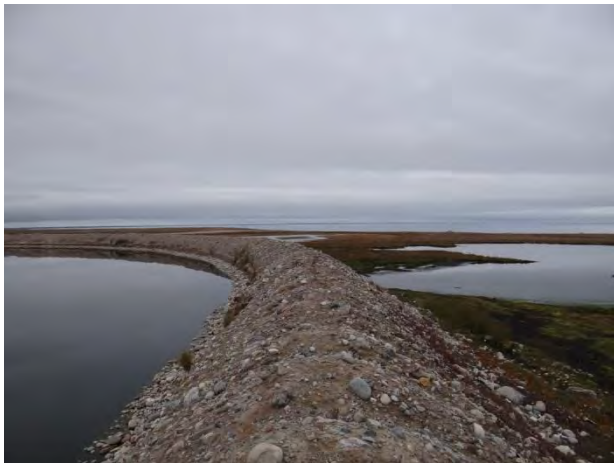
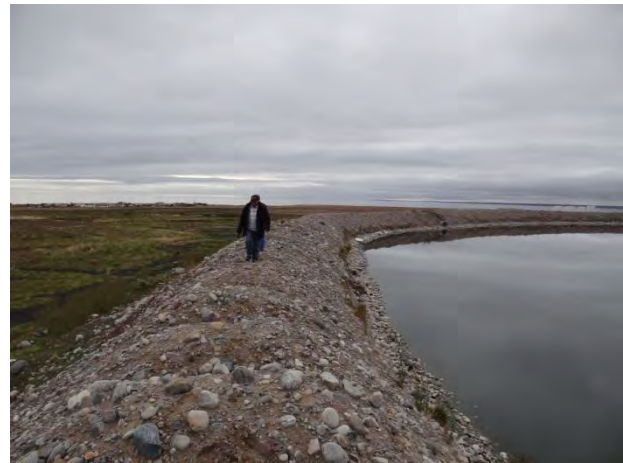
- Sewage lagoon

- Effluent is trucked to community lagoon.
- On average 10 truck loads per day
- 1 meter freeboard is maintained by culvert at the back of the lagoon.
- Effluent flows via installed pipe to secondary cell
- There is an obvious flow seen exiting the secondary cell and proceeding down gradient to the Municipal Solid Waste Management Area.
- Two ponds adjacent to the lagoon showed signs of nutrient loading. It is suspected that effluent has infiltrated these ponds.
