## **Dam Safety Review**

Dam Safety Review  
Sewage Lagoons and Water Reservoir  
Gjoa Haven, Nunavut

OTT-00209248-A0

October 16, 2013

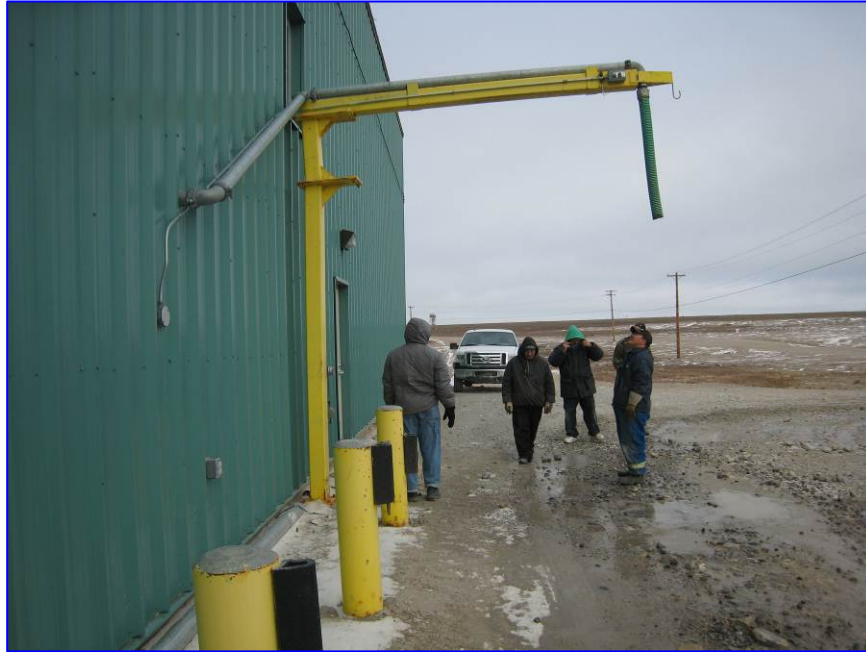
The water from the storage tank is used to fill the water trucks at the truck fill station (Photo 21) for transportation to the community.

**Photograph No. 21**  
Truck fill station.
