Summary of Work – Hall Beach 2020 Field Season

Final Report

Hall Beach Sewage Lagoon
Change Order No. 5 & Leak Detection/Resolution

OTT-220382

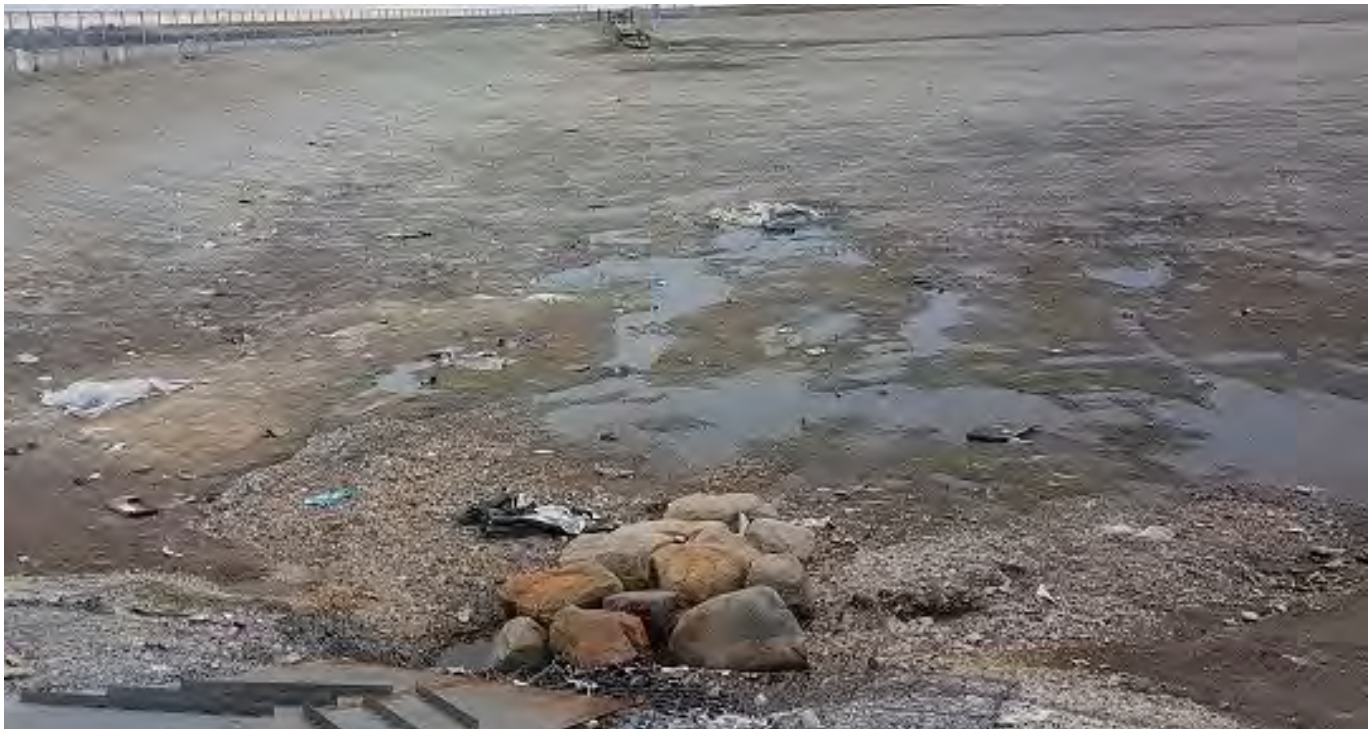
Photo 1: View of western side of the lagoon from the south discharge location. Hamlet had been using this cell for disposal, as evidenced by the liquid at the surface at both discharge locations.

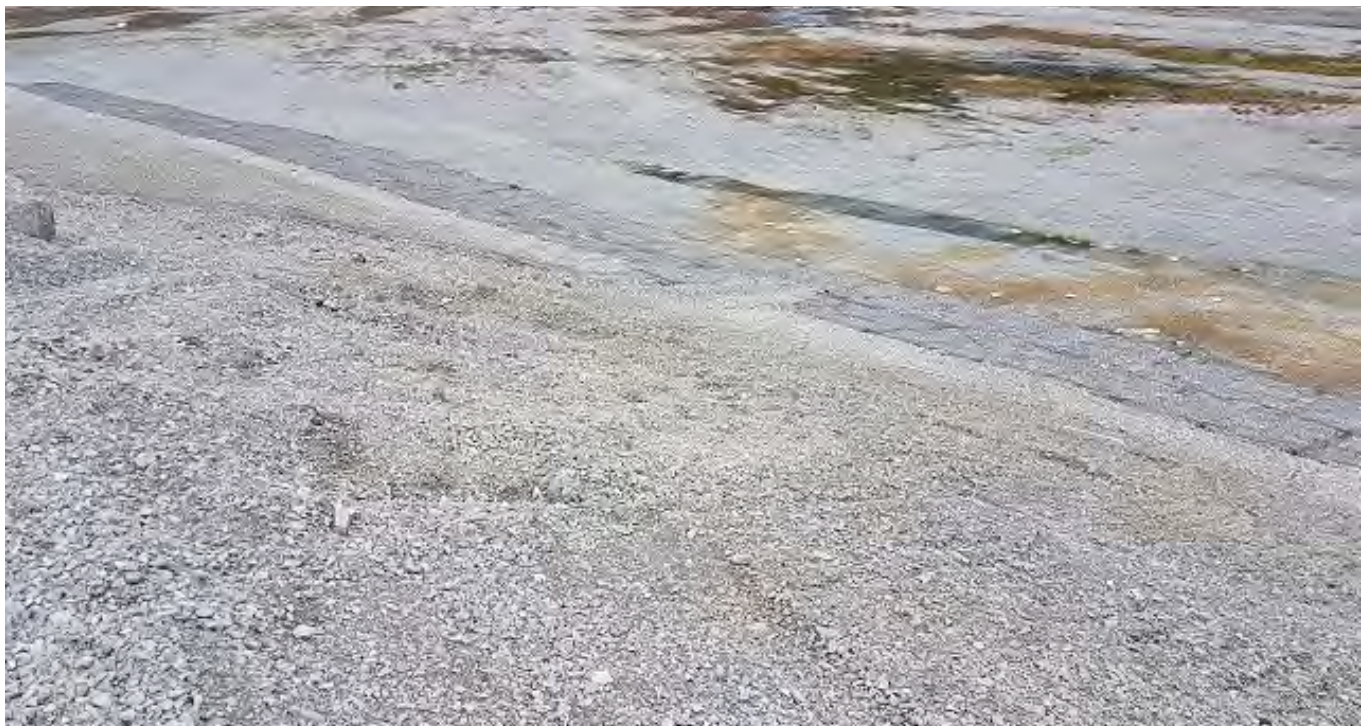
Photo 2: View of the eastern berm of Cell 1, where seepage has occurred.

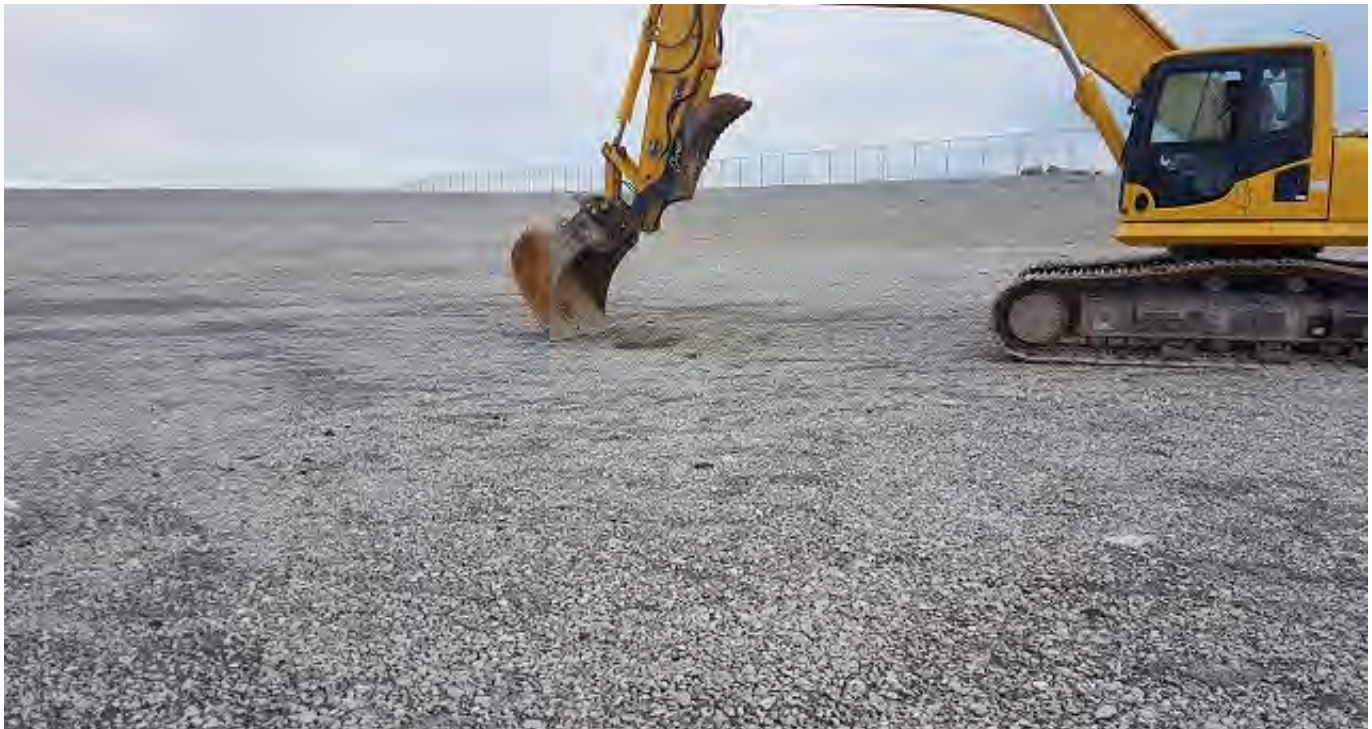
Photo 1: Excavator onsite at Area 1.

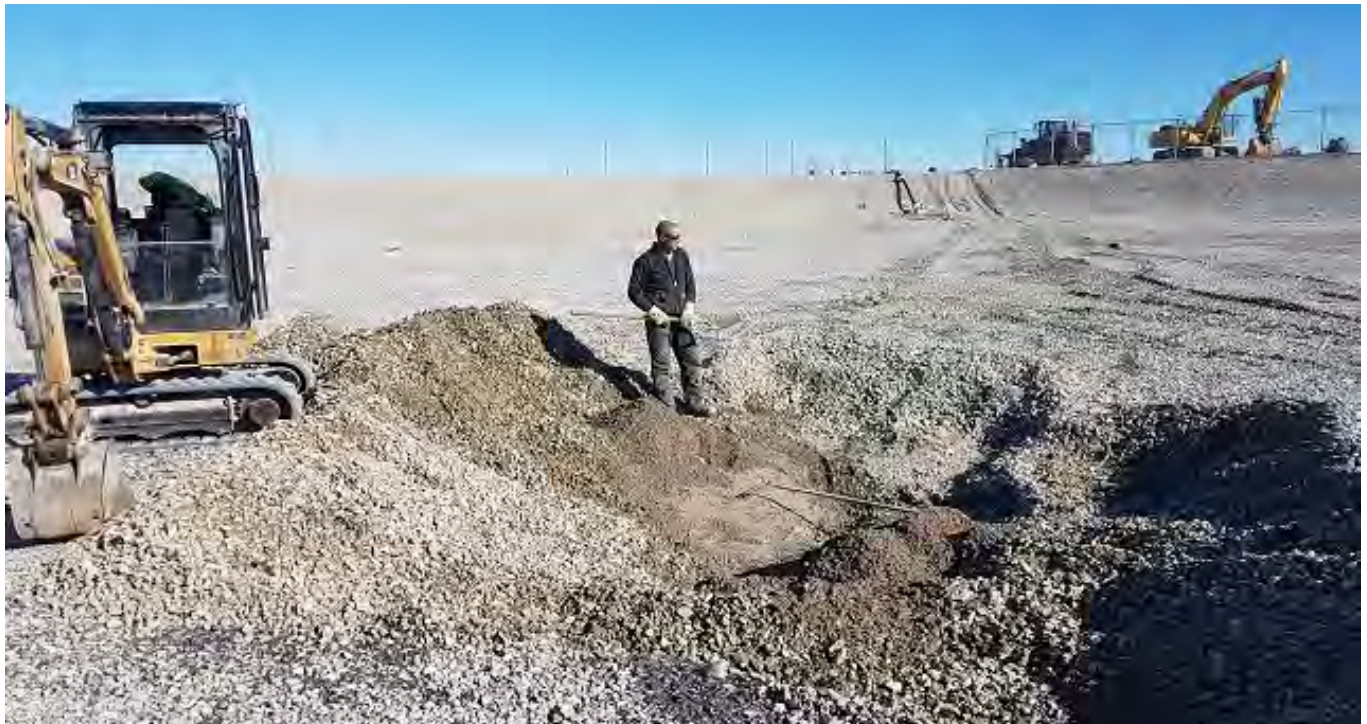
Photo 2: Mini mobilized in to complete the removal. All equipment for August 26 in view.

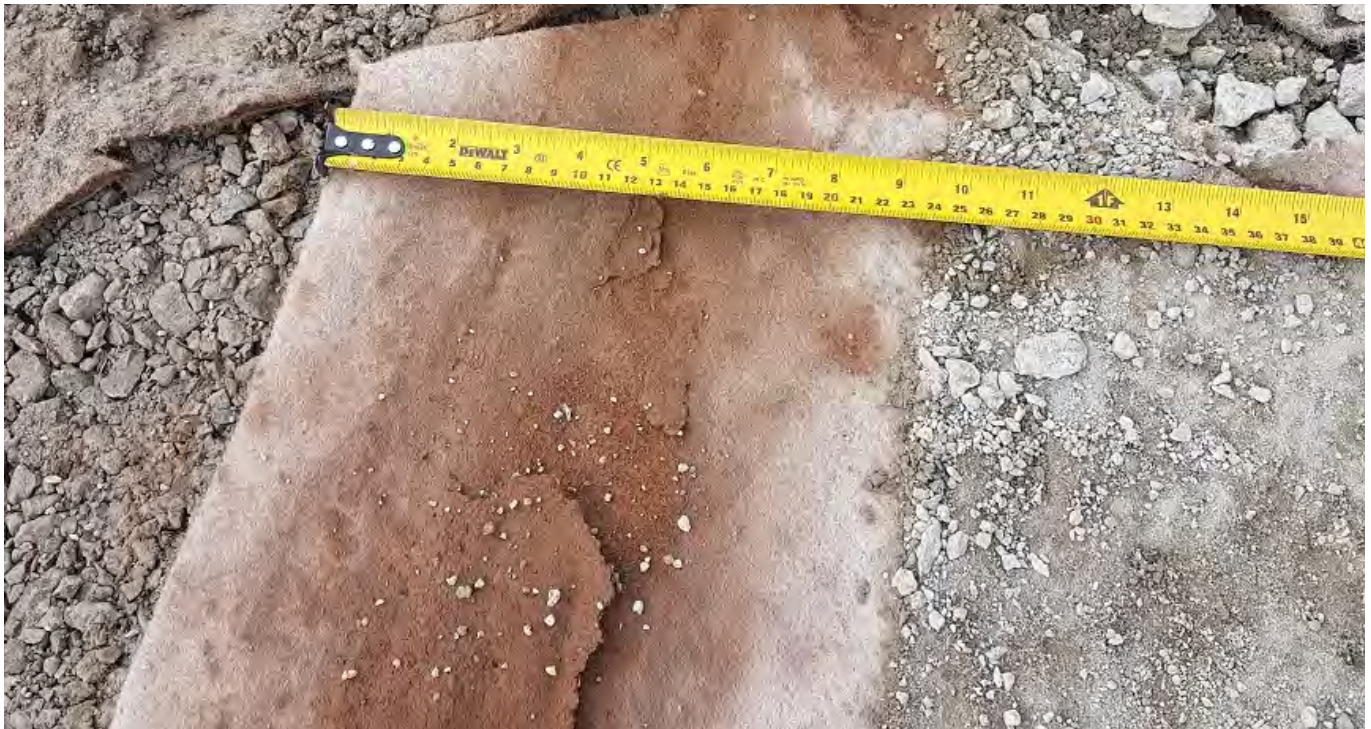
Photo 1: Evidence of overlap and bentonite at GCL seam at Area 1.

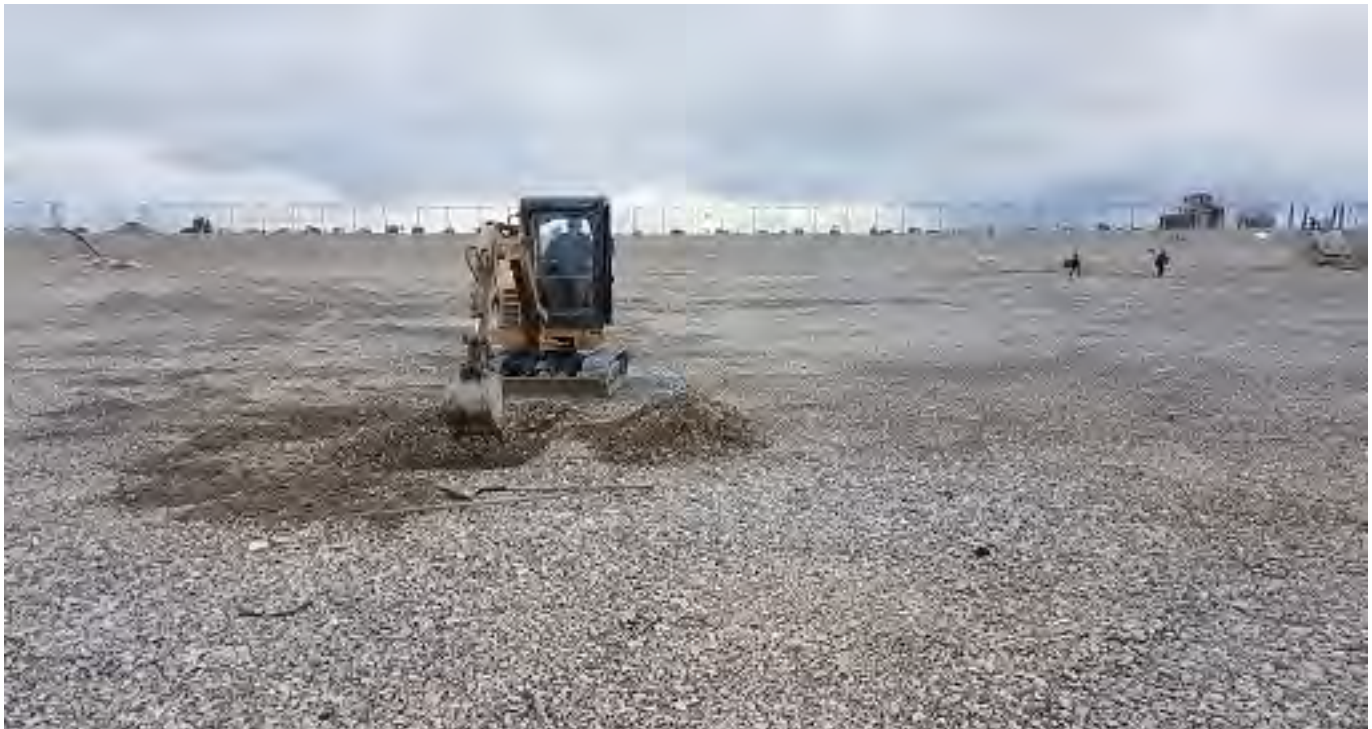
Photo 3: Excavation effort at Area 2.

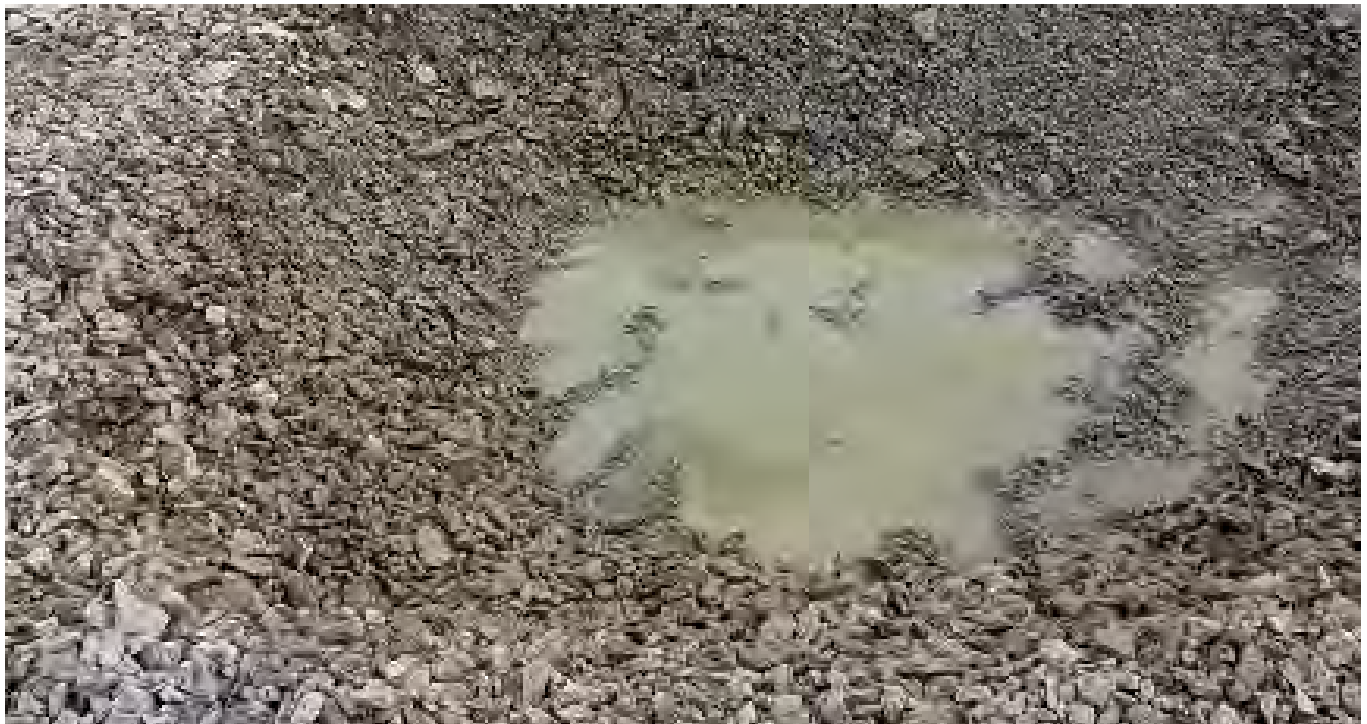
Photo 4: Area 4 during excavation. Cover material underlain by a coarse sand, with about 100mm of liquid before the GCL.

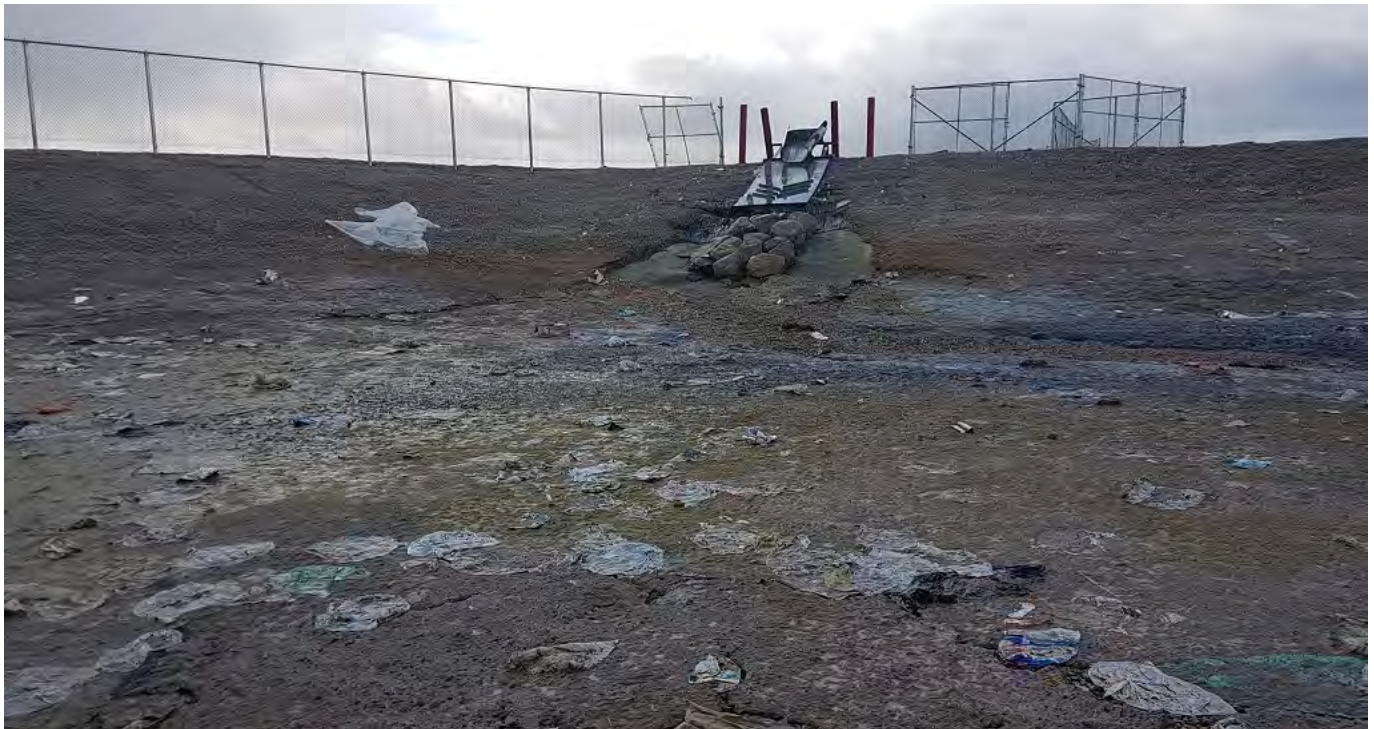
Photo 5: North discharge area. GCL exposed around the larger stone. Gabion baskets highly eroded.

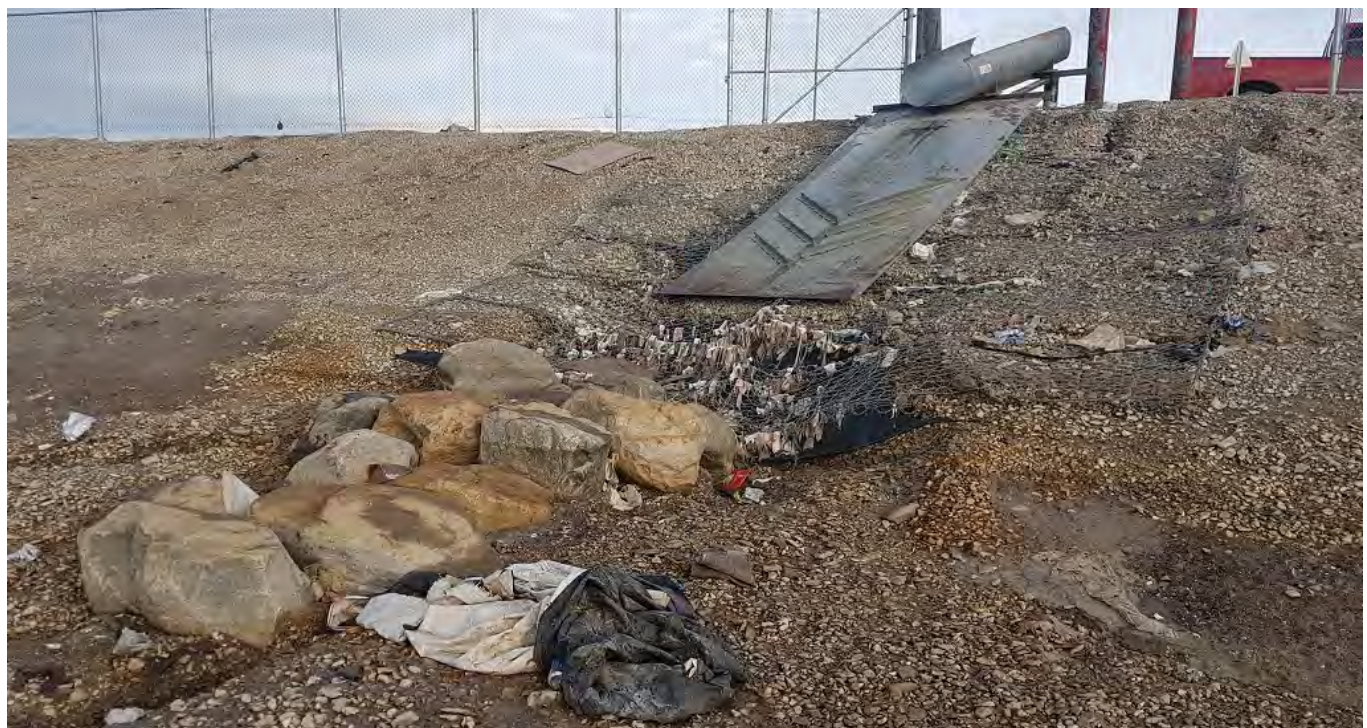
Photo 6: South discharge area. Areas of localized erosion to expose GCL. Gabion baskets eroded at bottom of discharge.

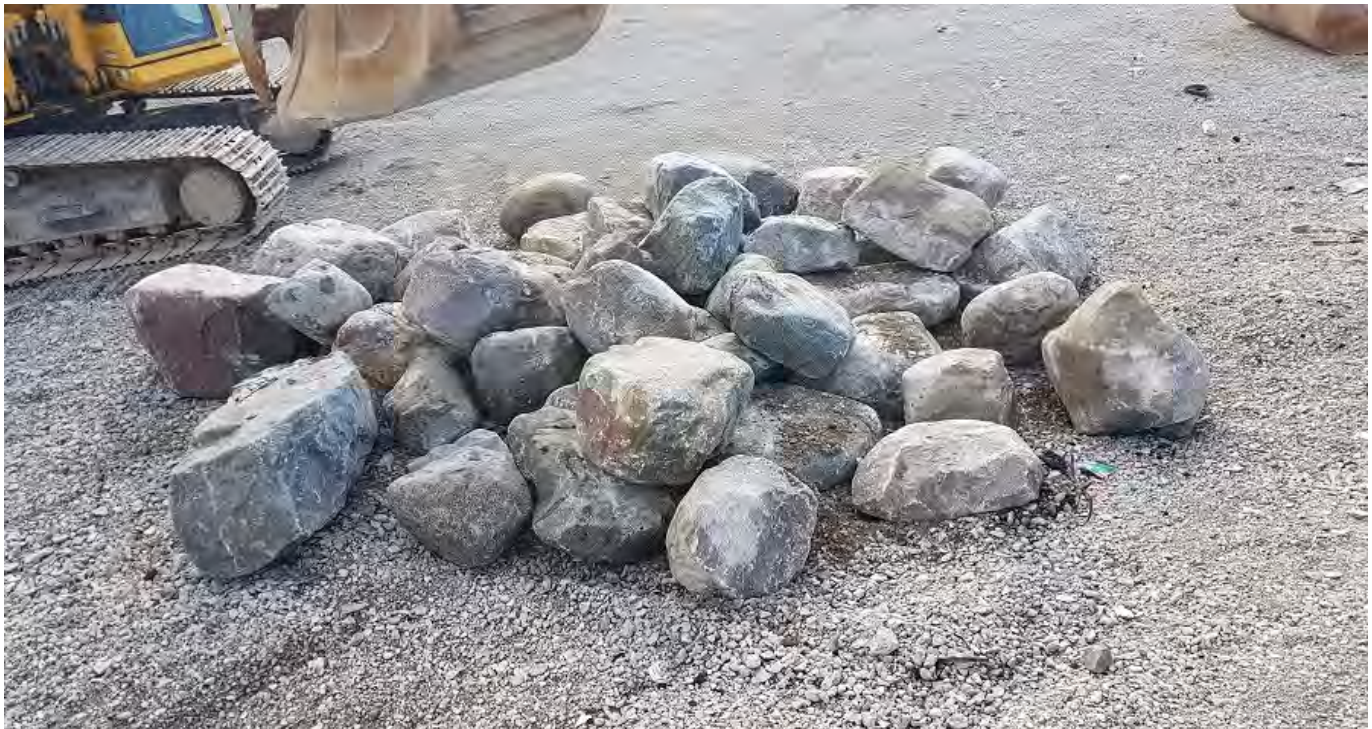
Photo 1: Larger rock that the contractor was able to collect for the south discharge repair.

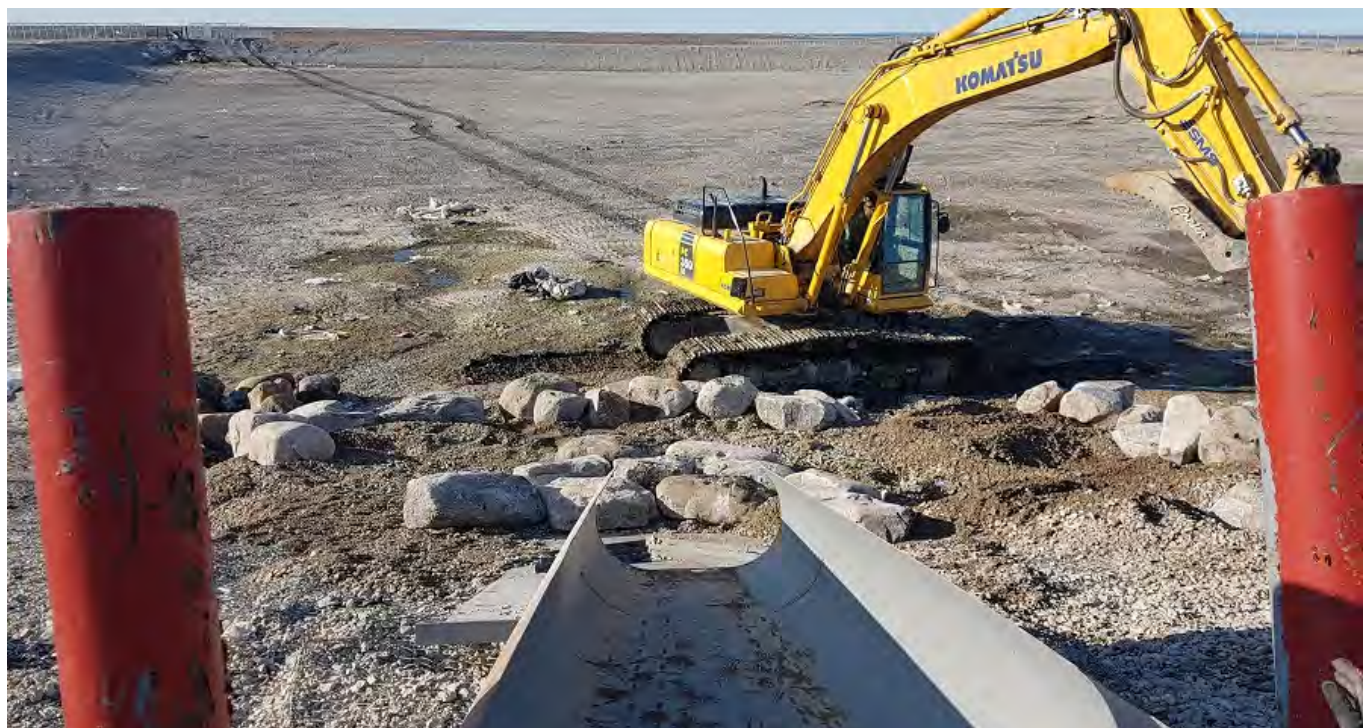
Photo 2: Progress of the south discharge repair. Placed granular material to raise grades, followed by larger stone to reduce erosion.

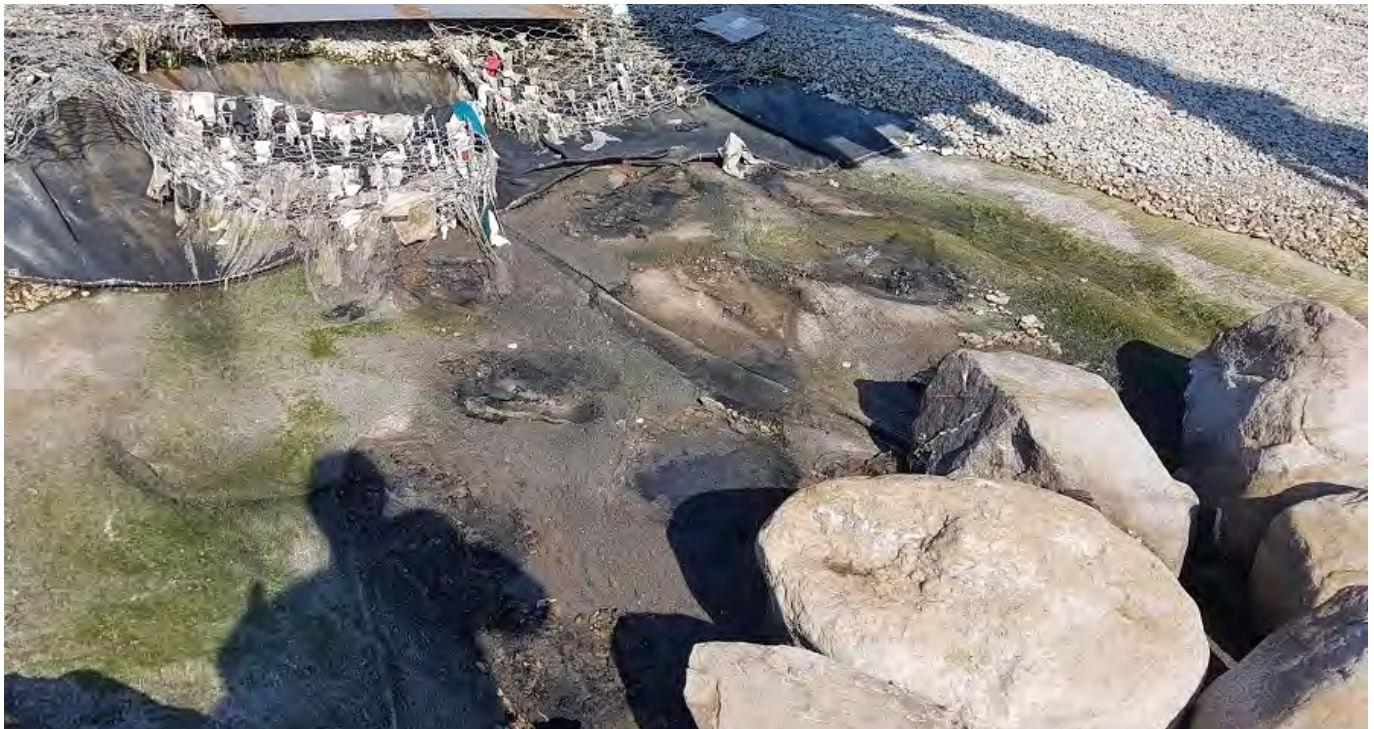
Photo 1: Large stone removed to reveal holes in GCL. Gabion baskets have had all stone eroded out.

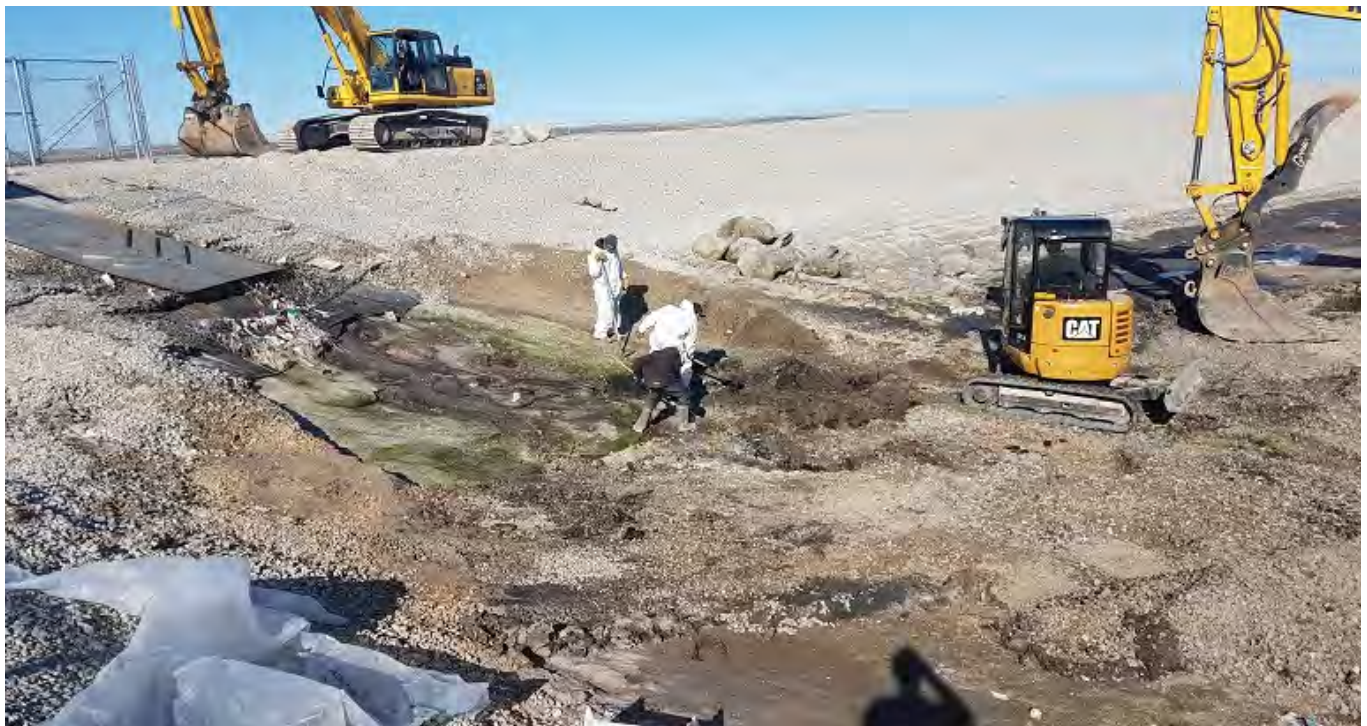
Photo 2: Mini Excavator and labourers removing the cover material above the GCL in the discharge area.

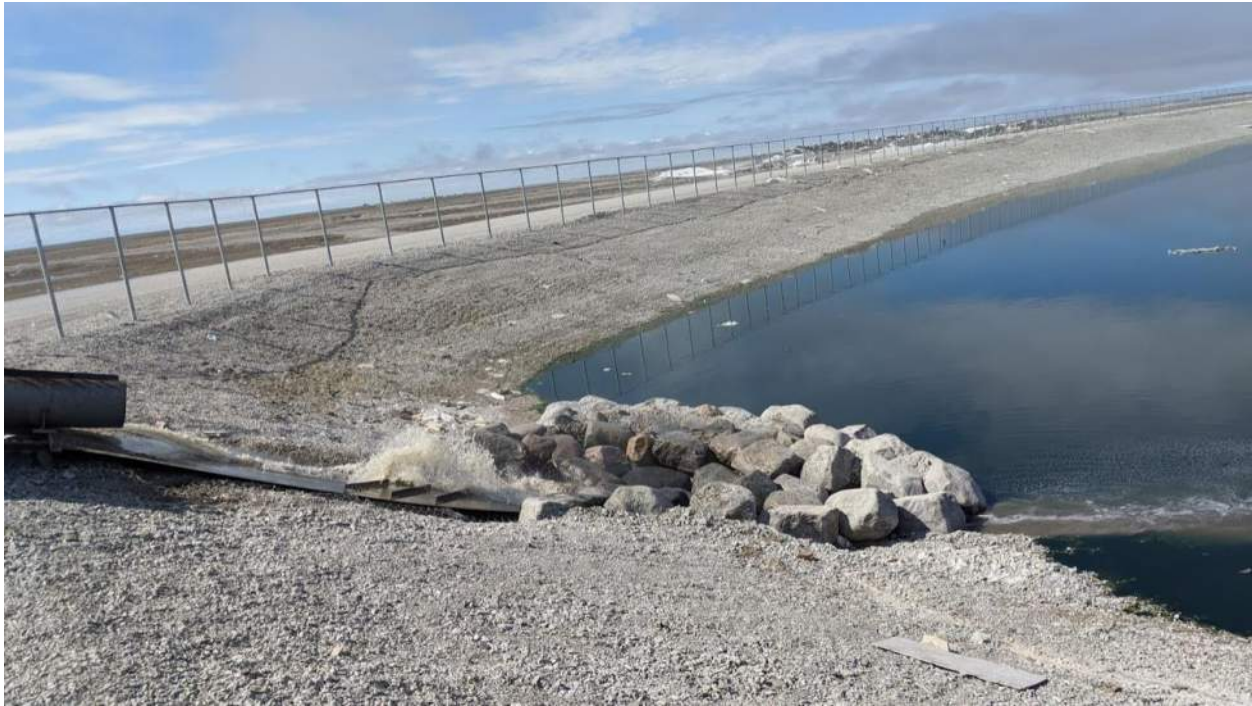
Photograph #3: South discharge station, discharge in progress. Note concentrated plume of sewage entering lagoon through rocks.

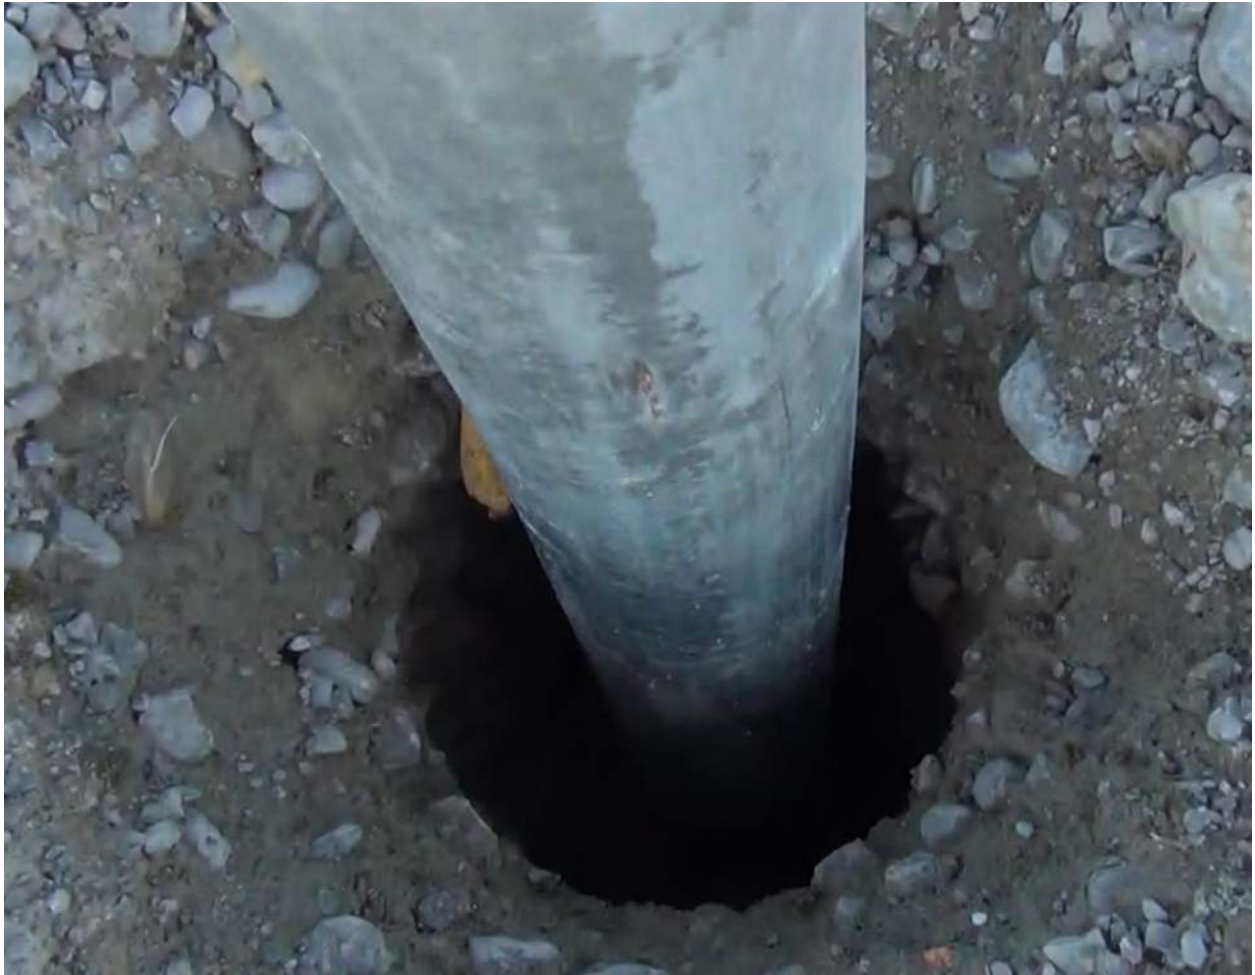
Photograph #4: Significant settlement around fence post, northeast corner of north cell.

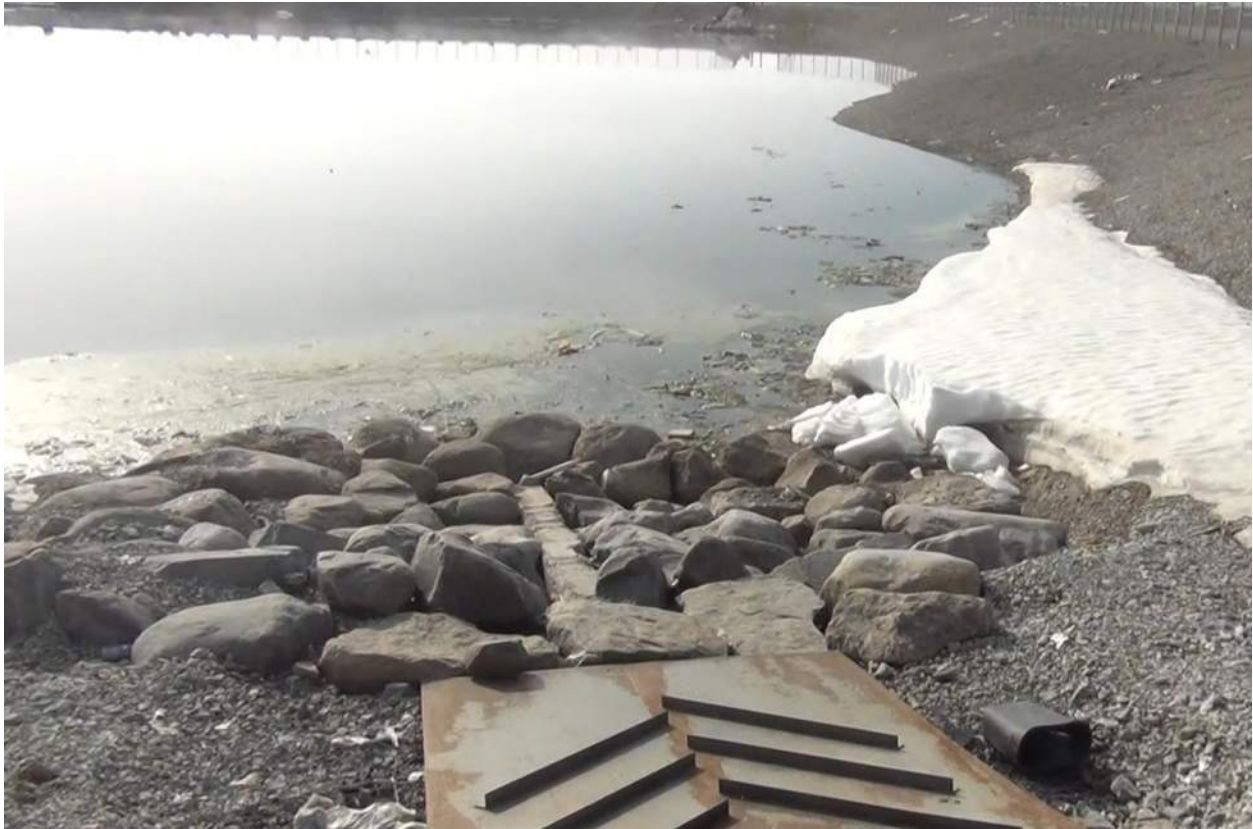
Photograph #5: North discharge station. Very few fines between large rocks, concrete slab running down centerline of discharge path quite apparent.

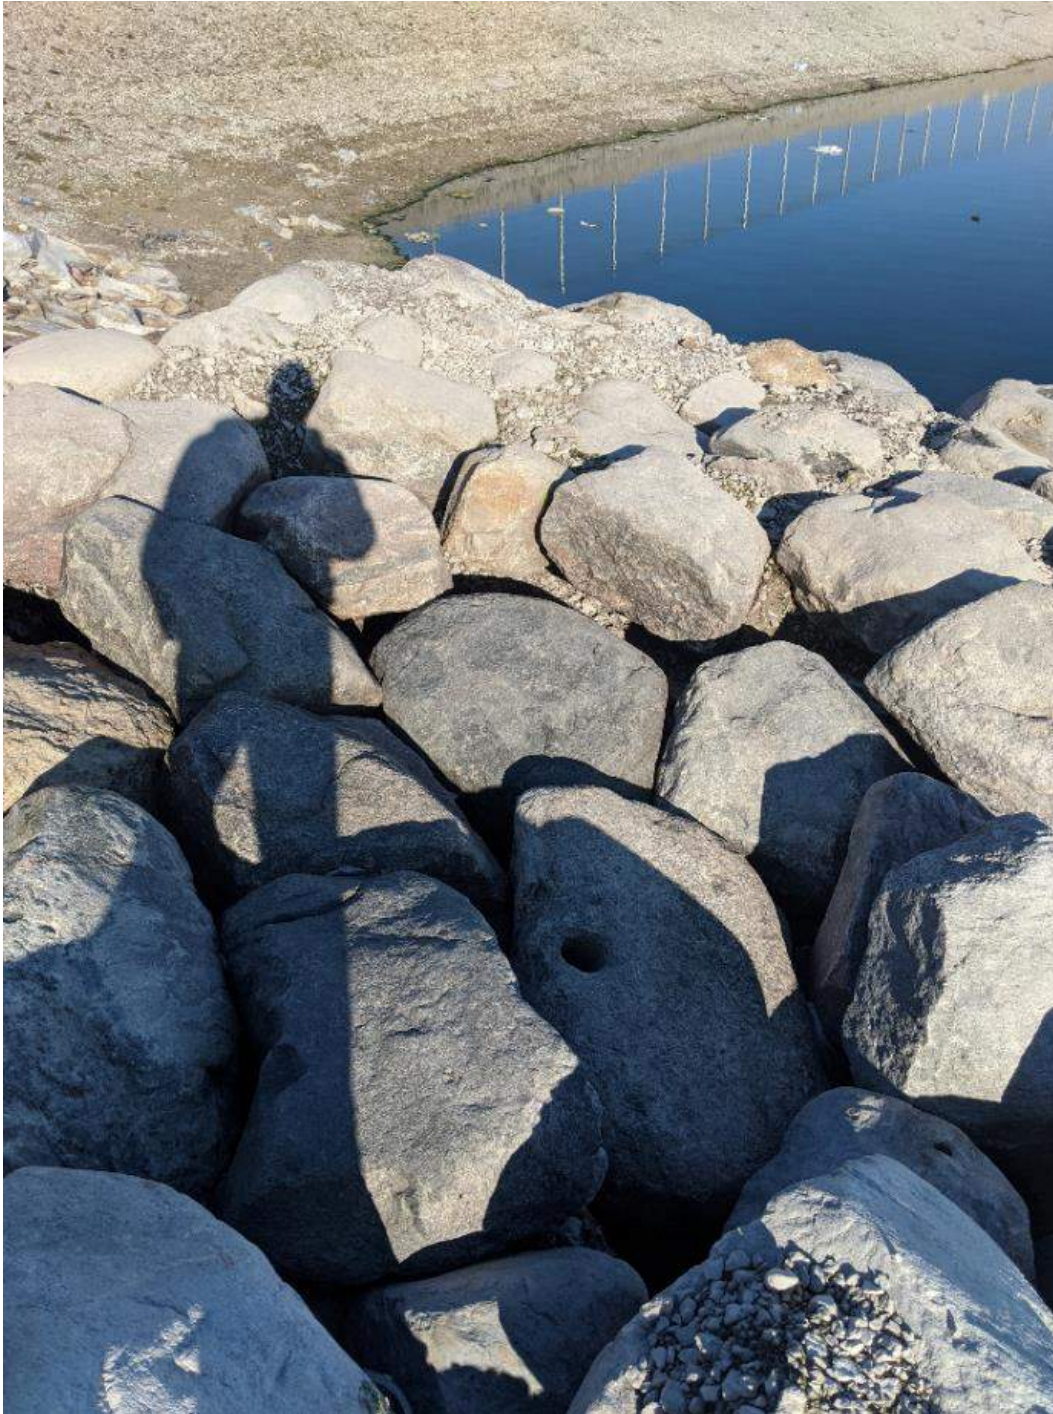
Photograph #1: Boulders at the base of south discharge station. Note the erosion of fines from between rocks in foreground as opposed to background.

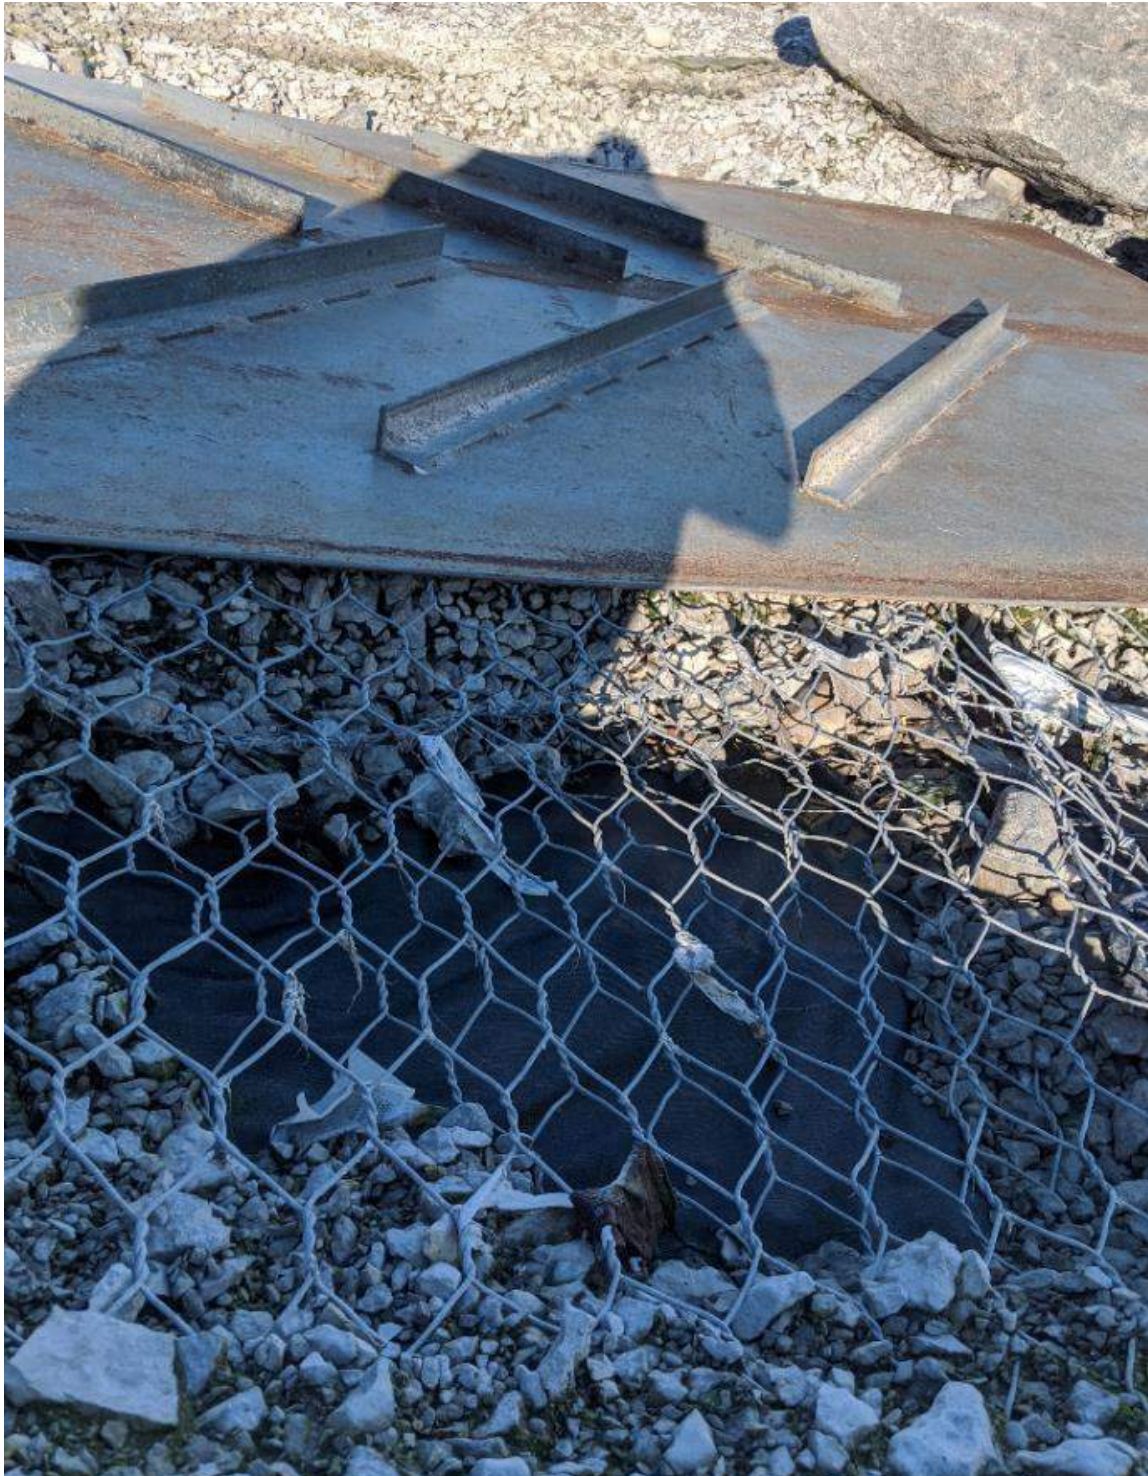
Photograph #2: Gabion baskets have a tendency to empty themselves over time owing to the small diameter of gravel contained within.

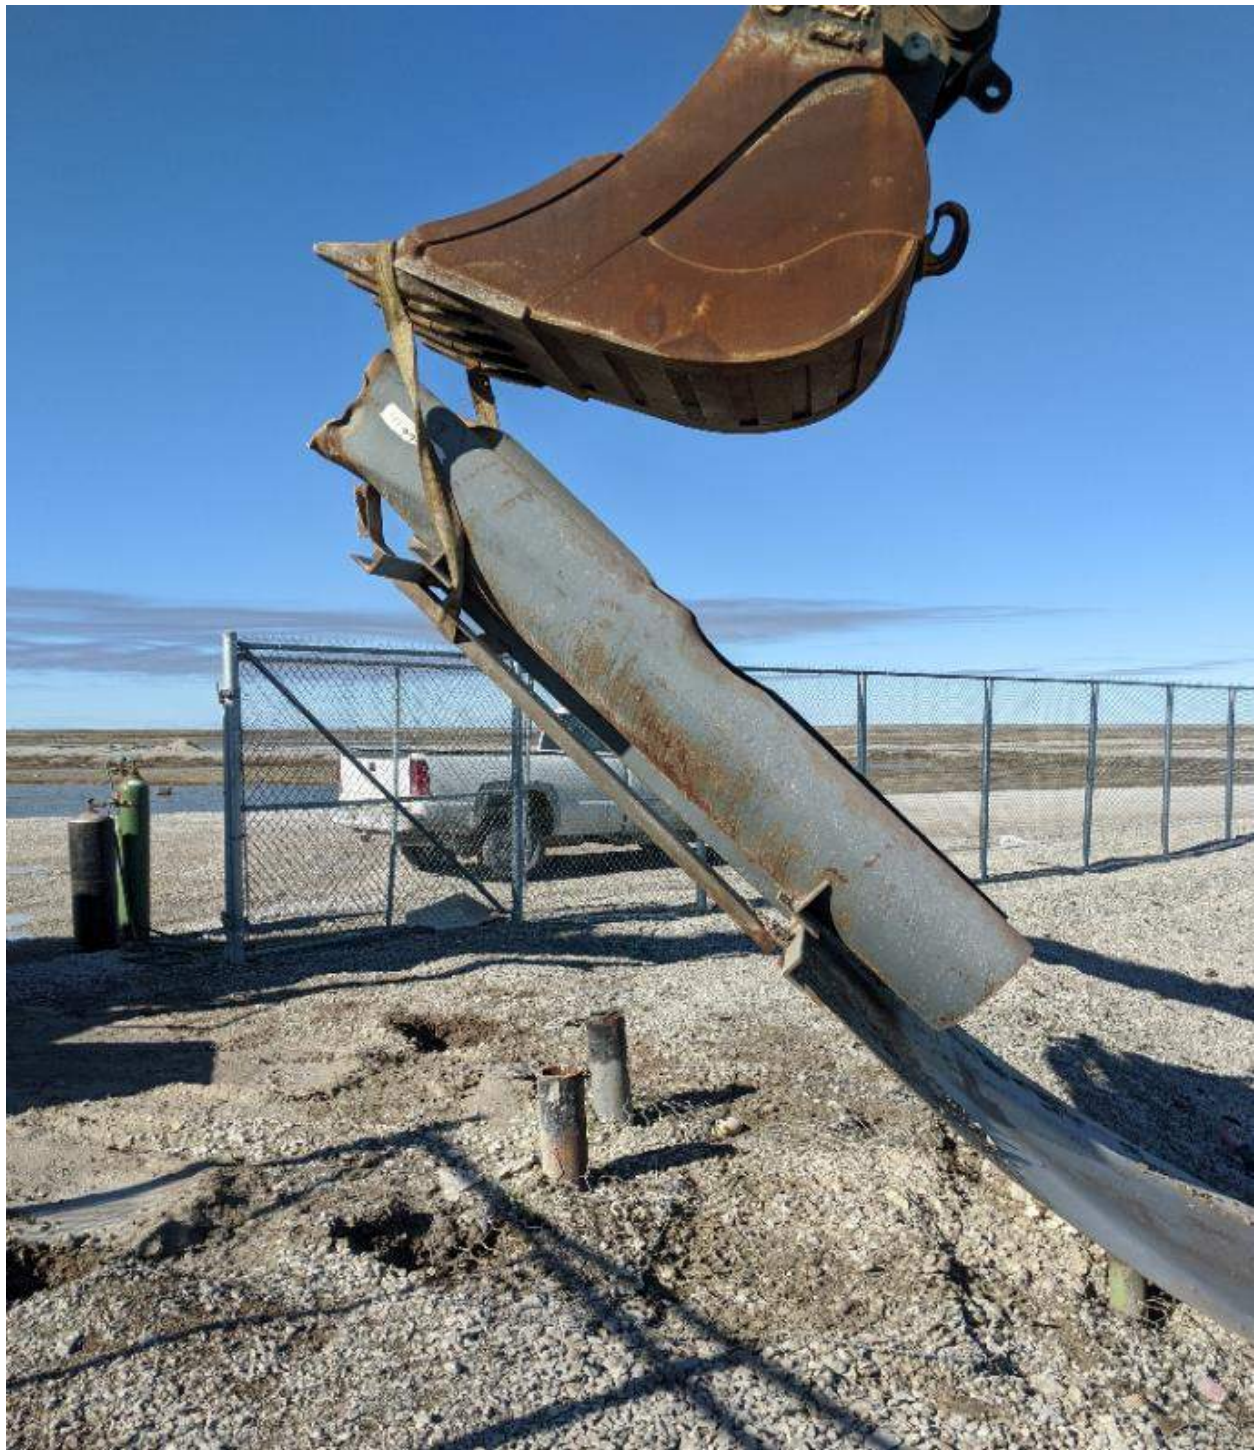
Photograph #3: After being cut off its piles, chute was removed with excavator.

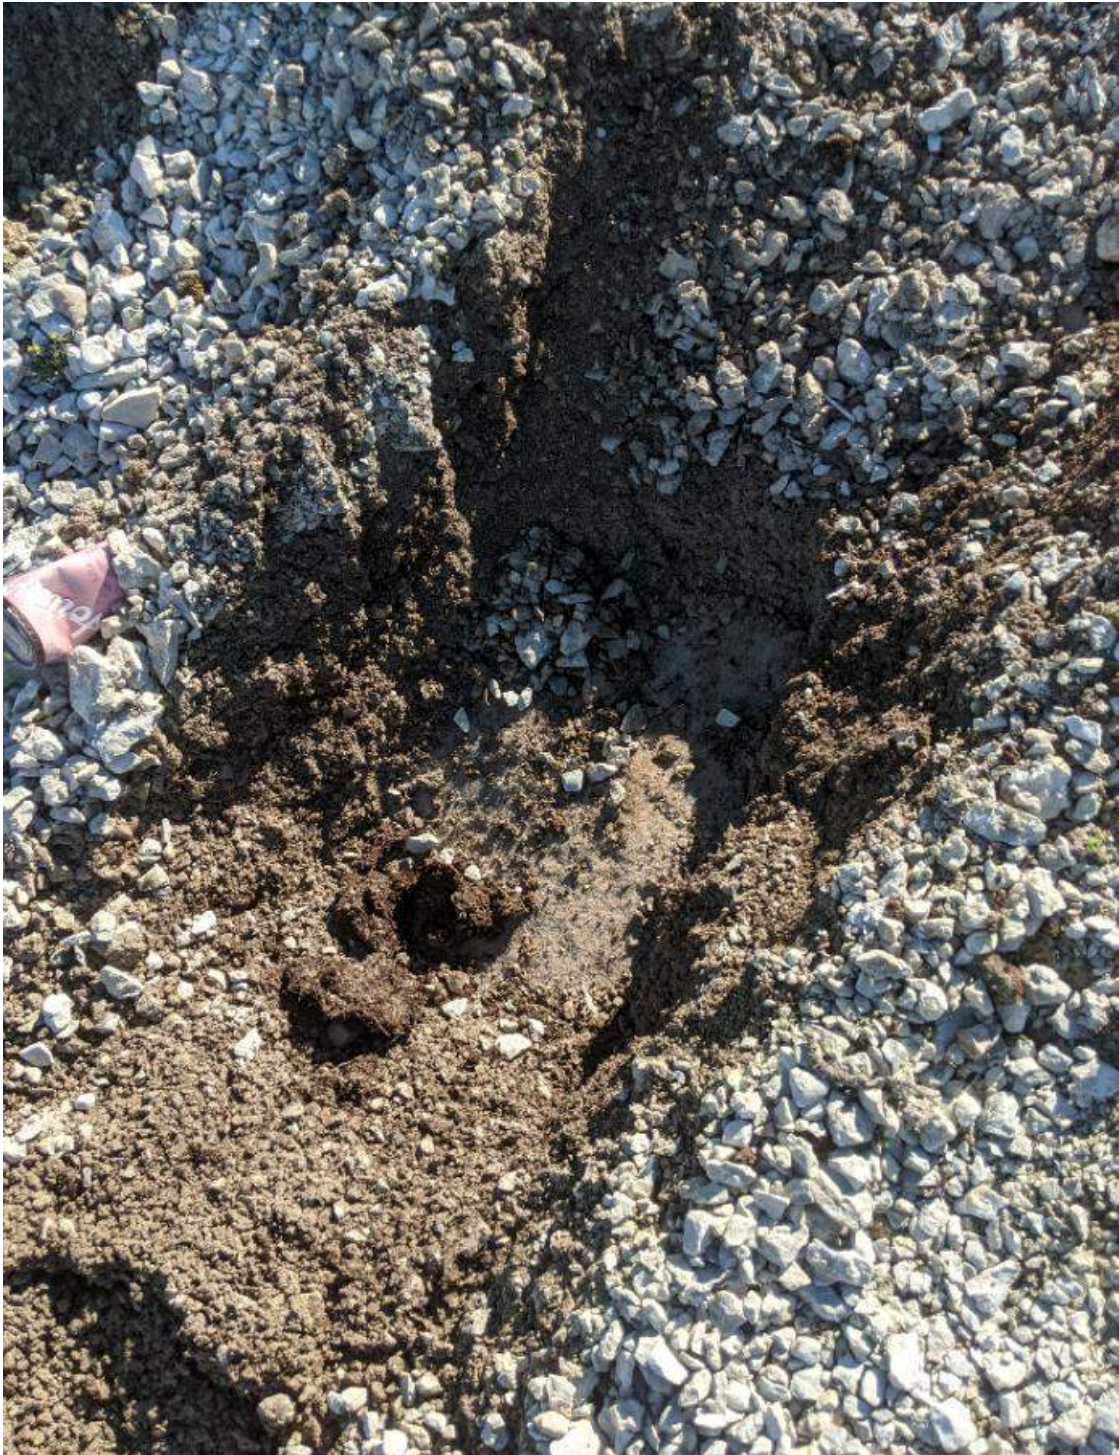
Photograph #4: Liner was exposed by hand to gauge depth. There appears to be approx. 0.4m of material left over liner, as a general average.
