Summary of Work – Hall Beach 2020 Field Season

Final Report

Hall Beach Sewage Lagoon
Change Order No. 5 & Leak Detection/Resolution

OTT-220382

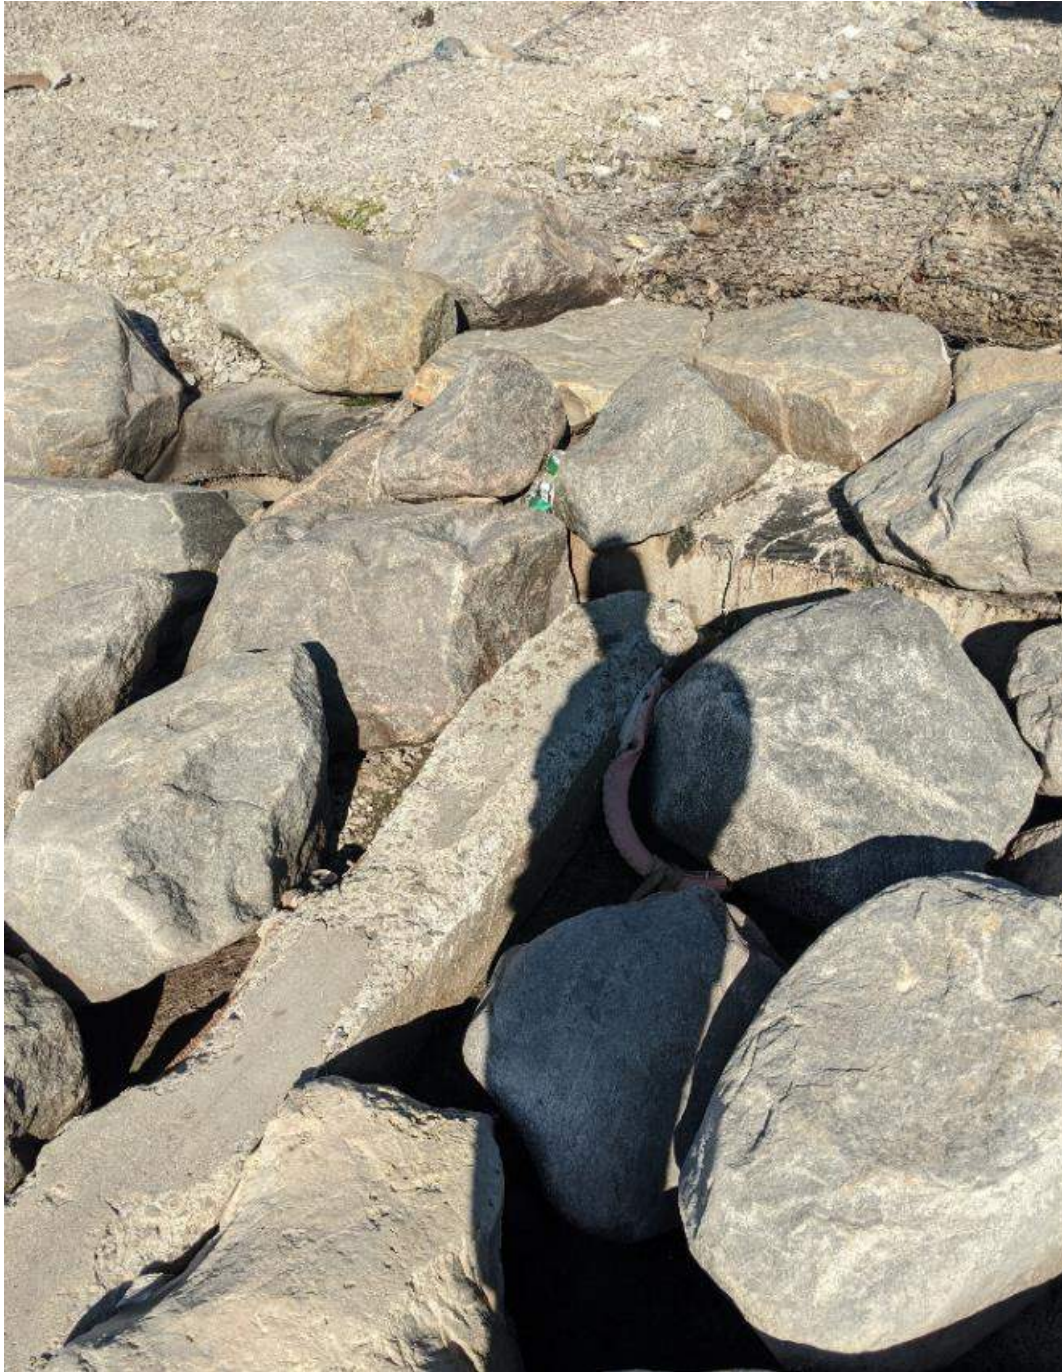
Photograph #1: Fines are largely eroded from between the large rocks at the base of the chute.

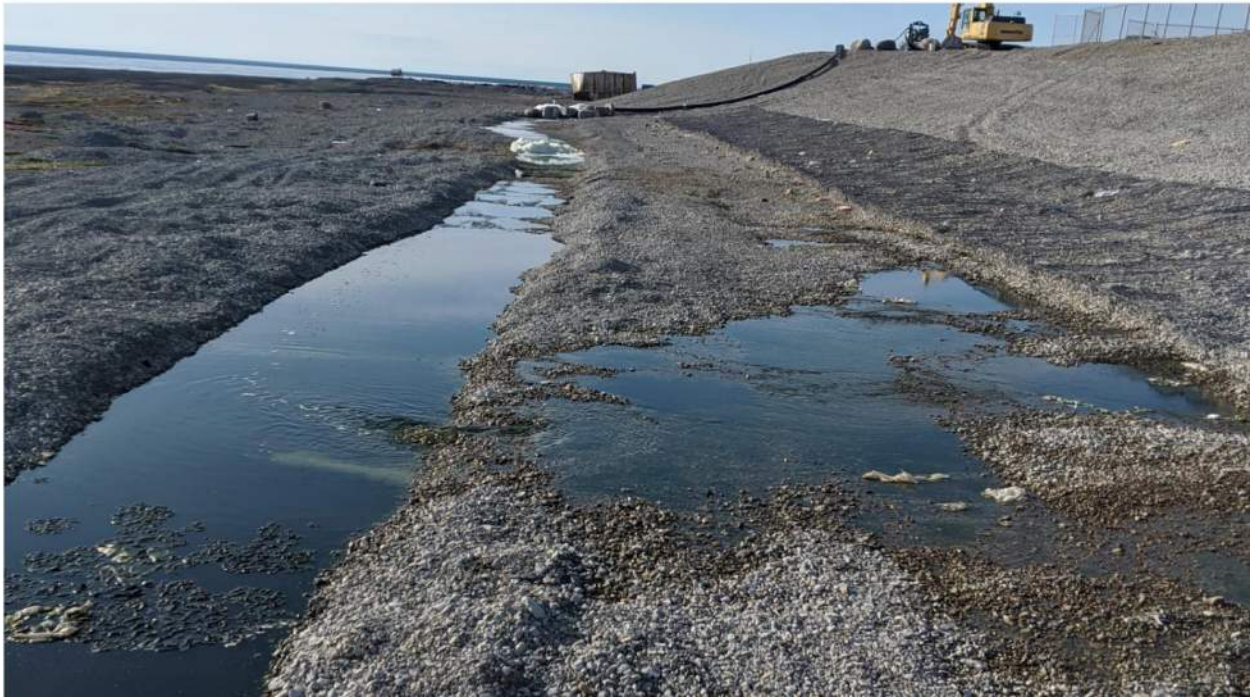
Photograph #1: Significant amount of water is leaking from the east side of the lagoon.

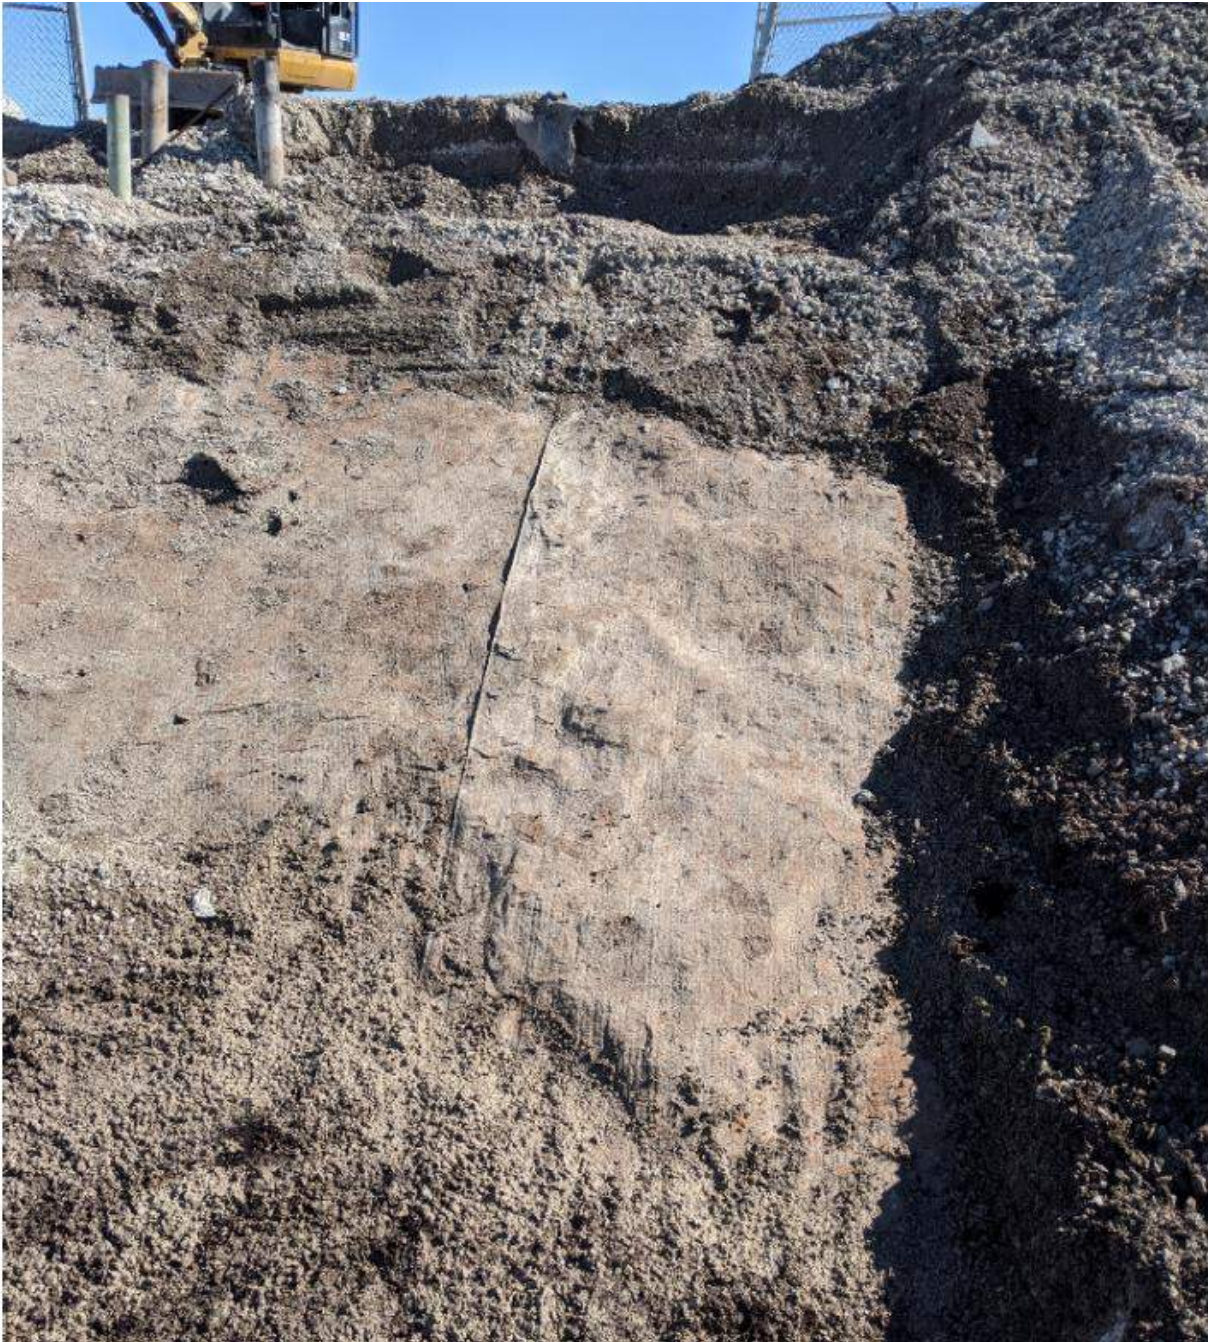
Photograph #3: Seam within existing liner. New liner will be glued to existing liner using bentonite as per manufacturer's instructions. Existing liner will be cleaned off with broom at location of seam prior to applying bentonite.

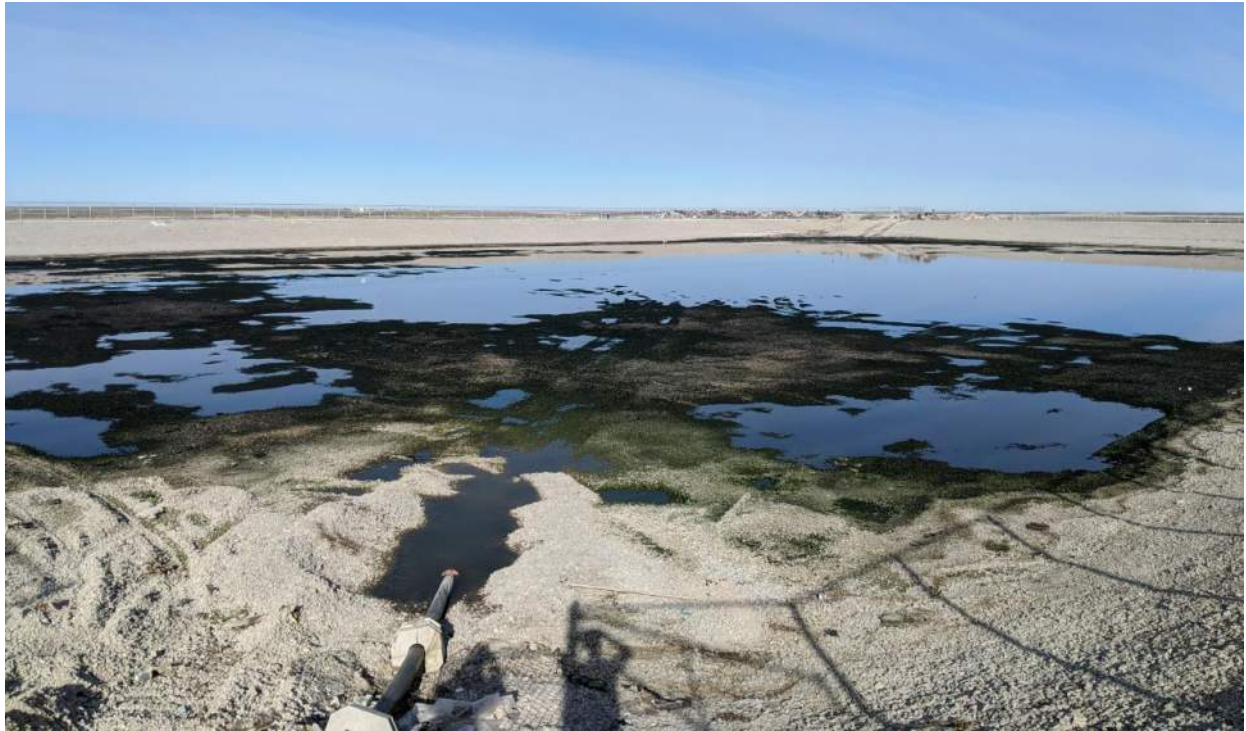
Photograph #2: Lagoon in the morning.

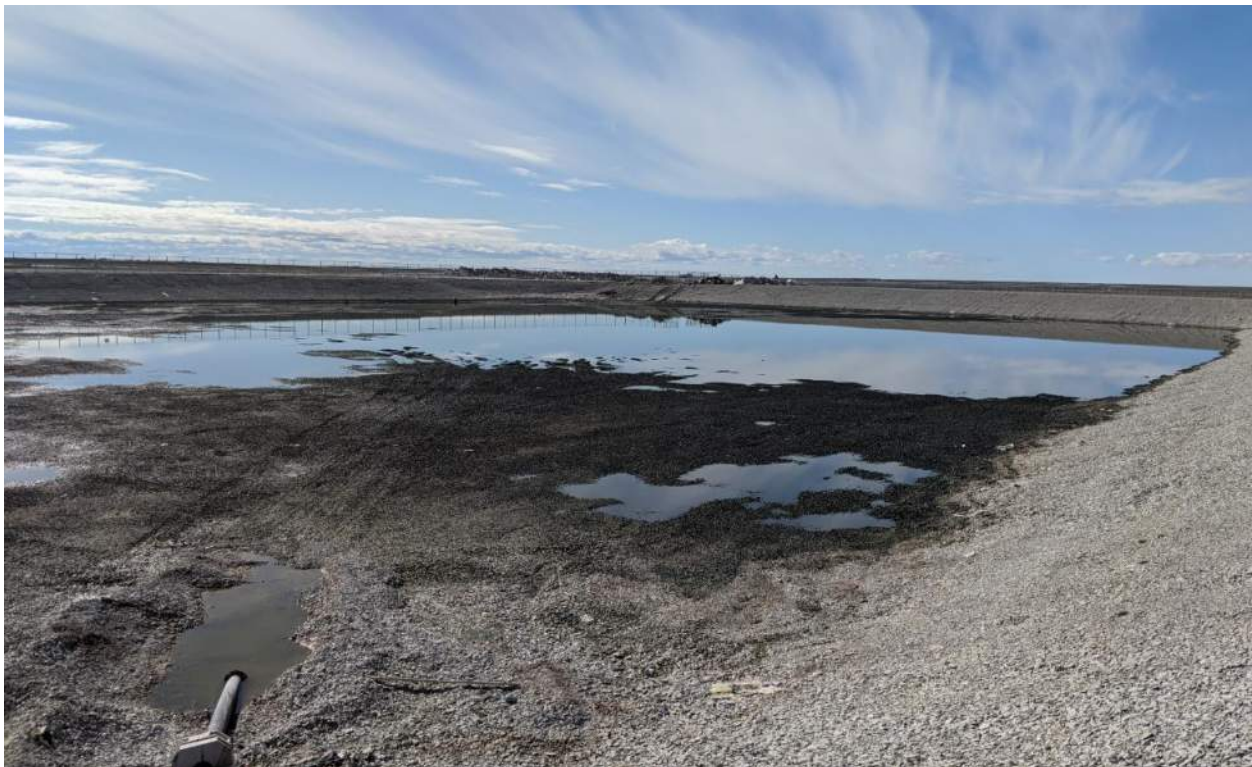
Photograph #3: Lagoon in late afternoon. Note the ponding in the right foreground has gotten much smaller, and to the left several ponds have disappeared.

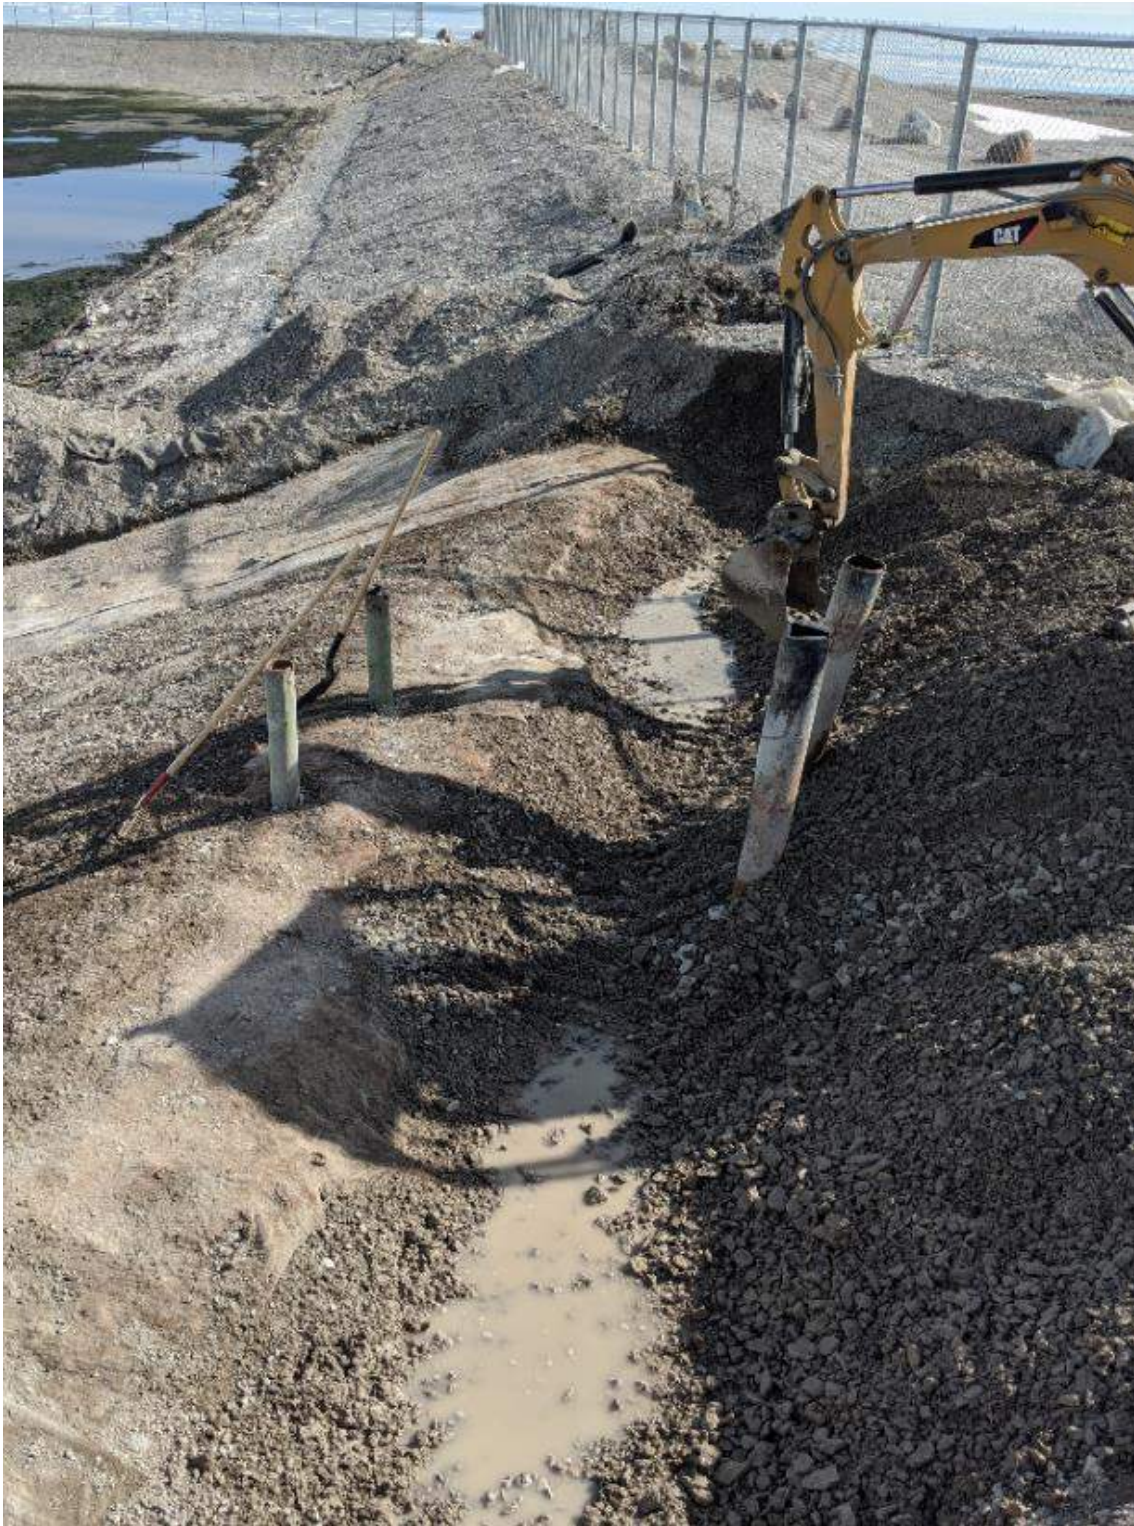
Photograph #4: Anchor trench for new liner is being dug behind existing anchor trench.

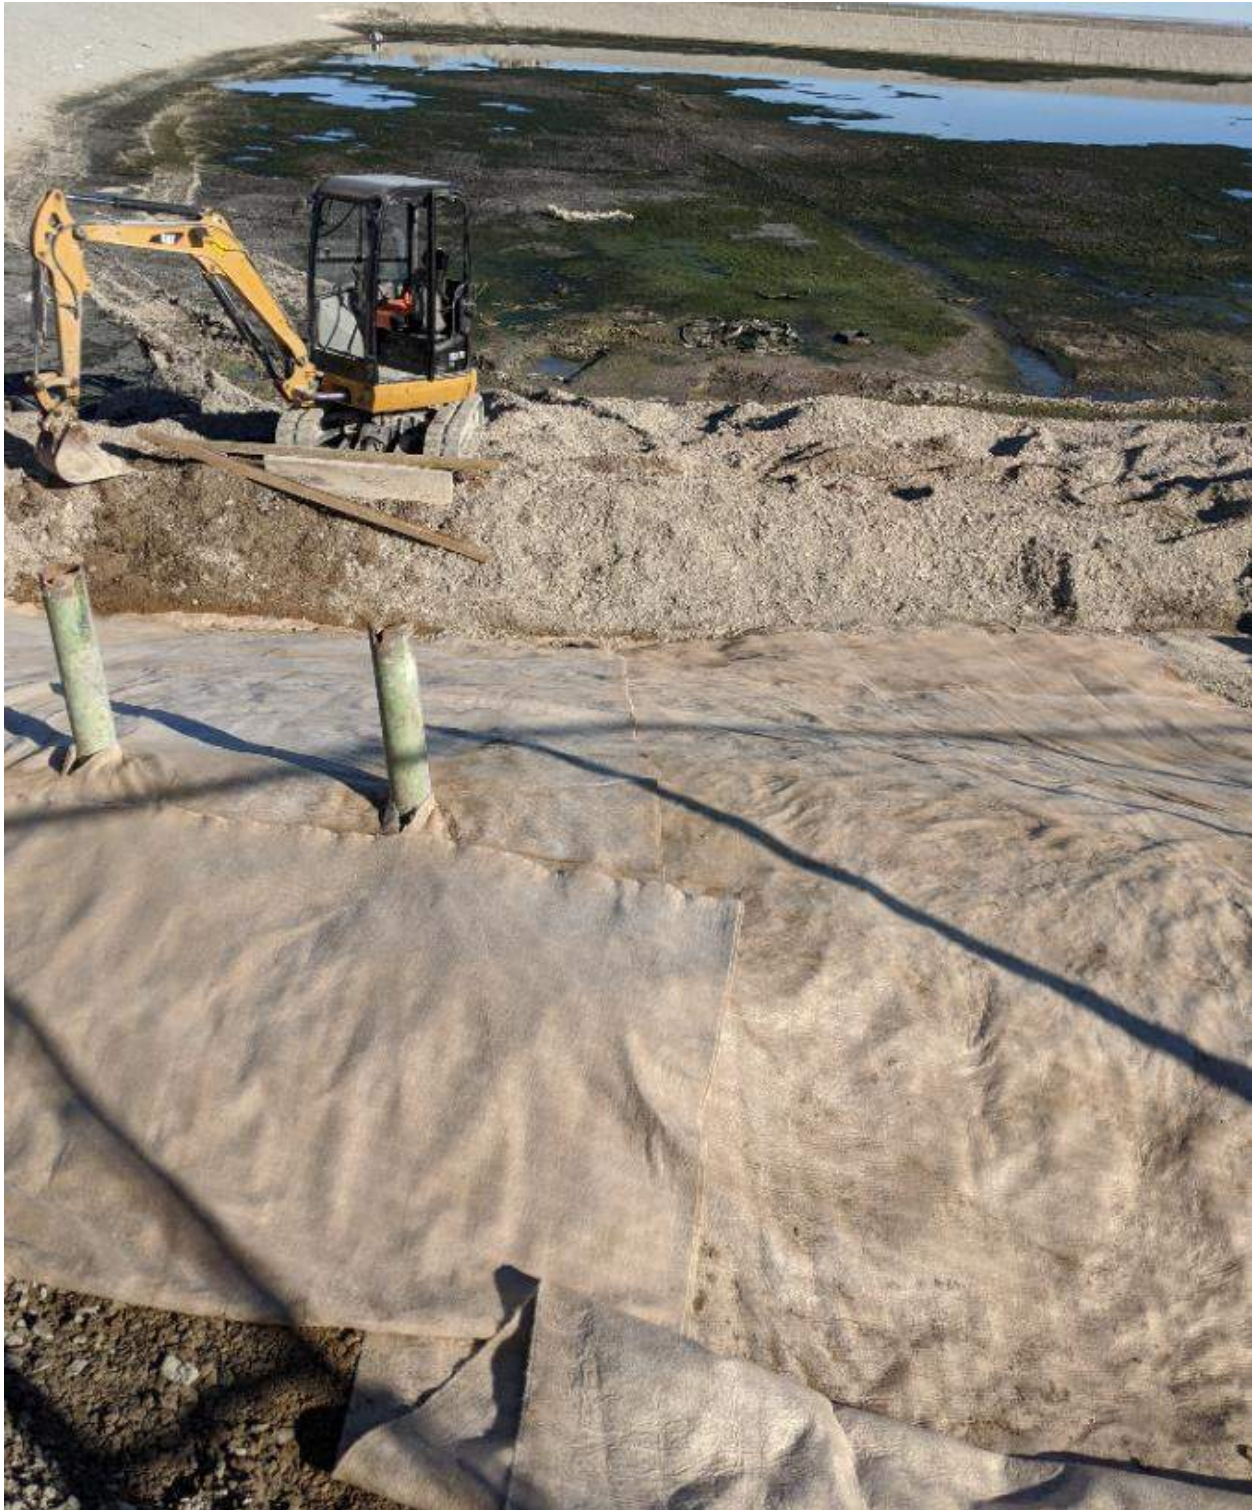
Photograph #1: Liner was placed on embankment and tucked into anchor trench. Excess material was trimmed before burial.

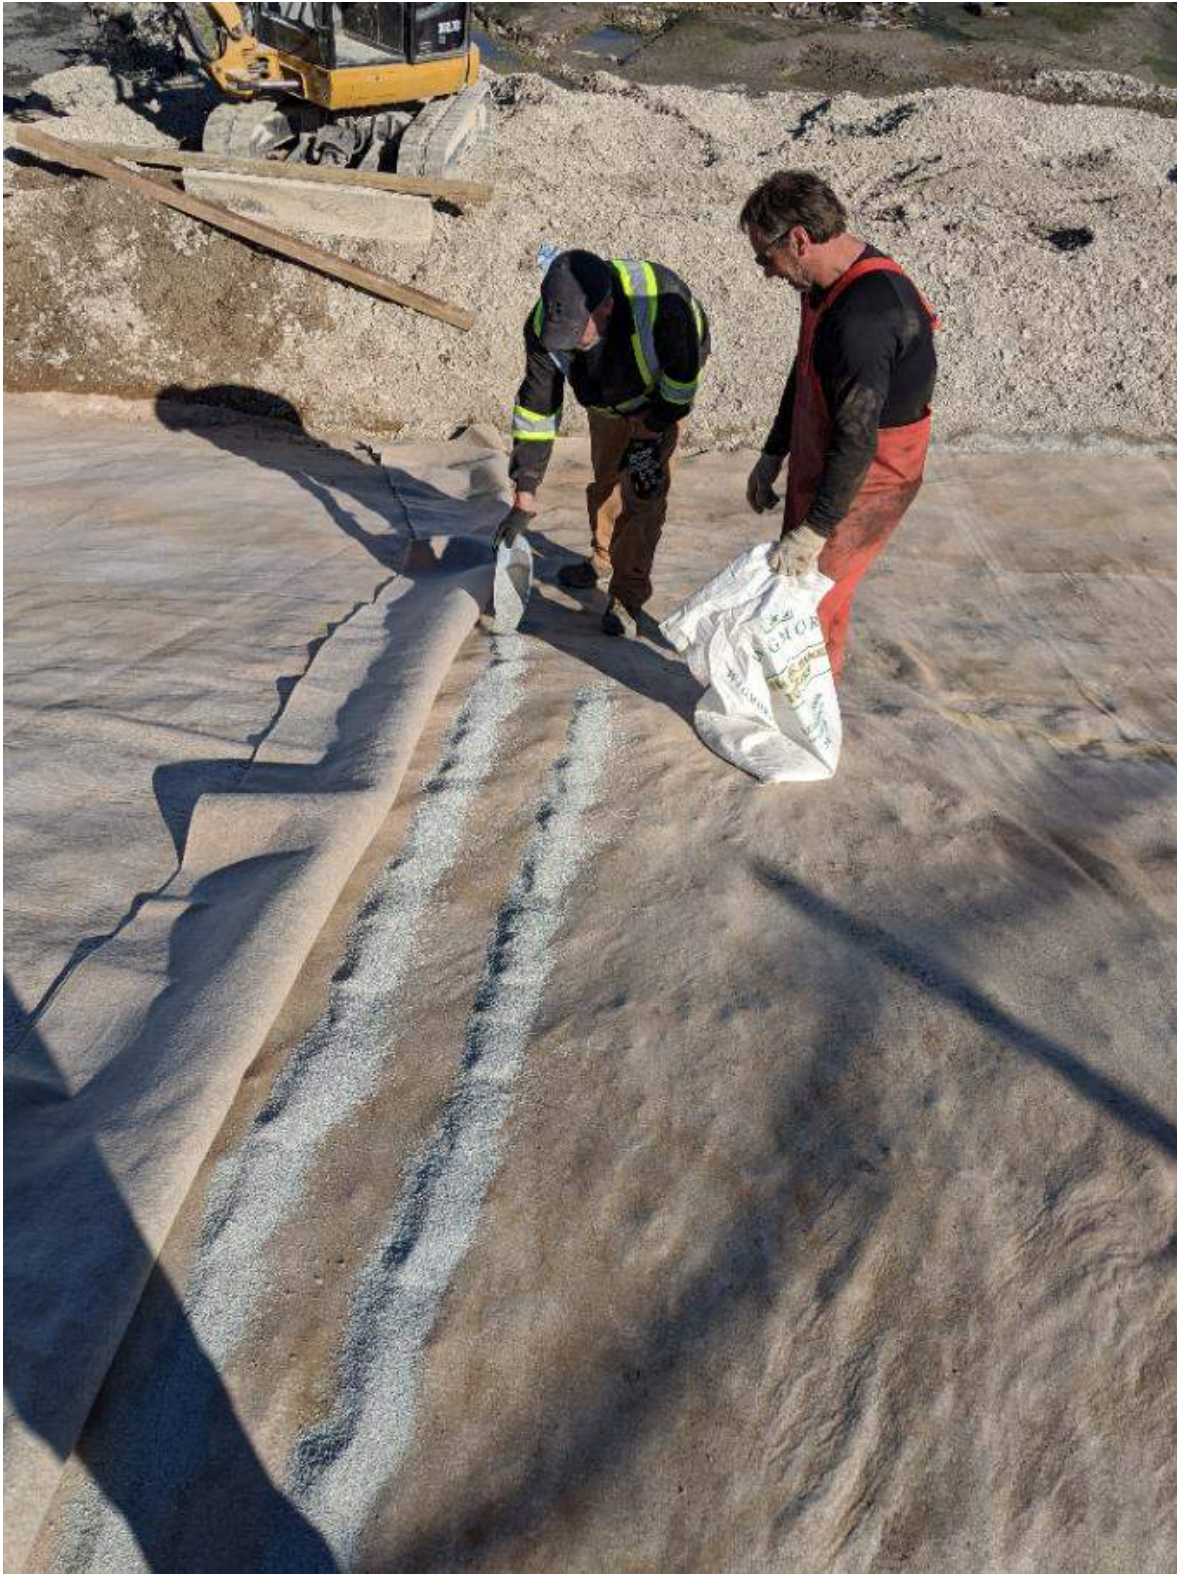
Photograph #2: A double line of bentonite was used to seal liner at the edges.

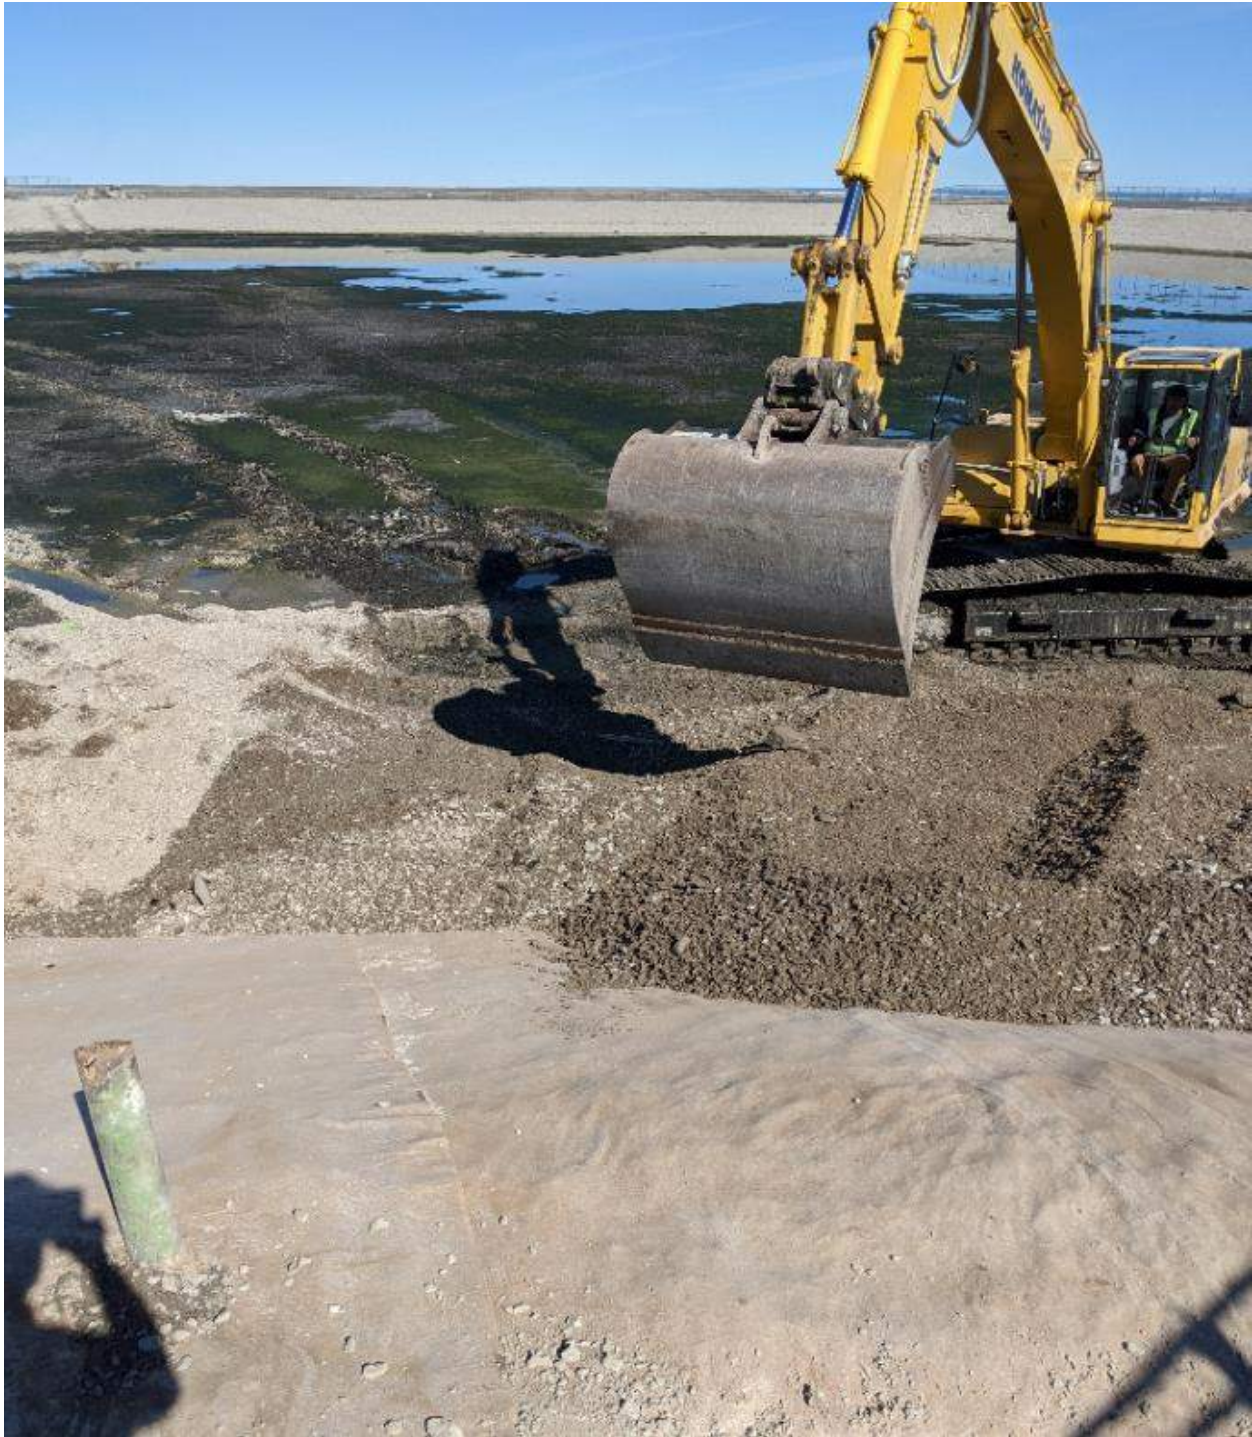
Photograph #3: Liner was covered with granular material.

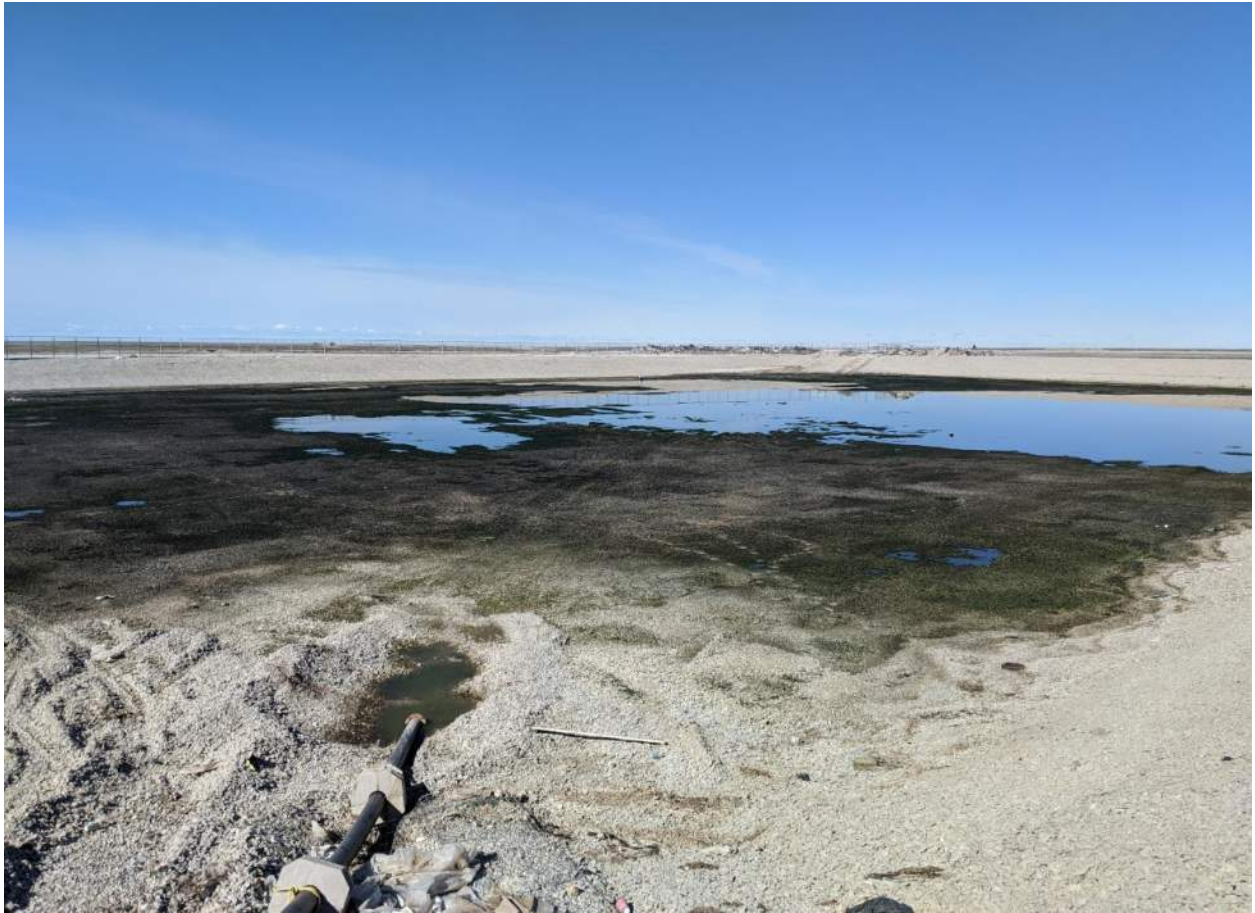
The leak at the east side of the lagoon is still similar in size, shape, location and volume as yesterday. The water level in the lagoon is still dropping.

Photograph #4: Water level in lagoon is still dropping.

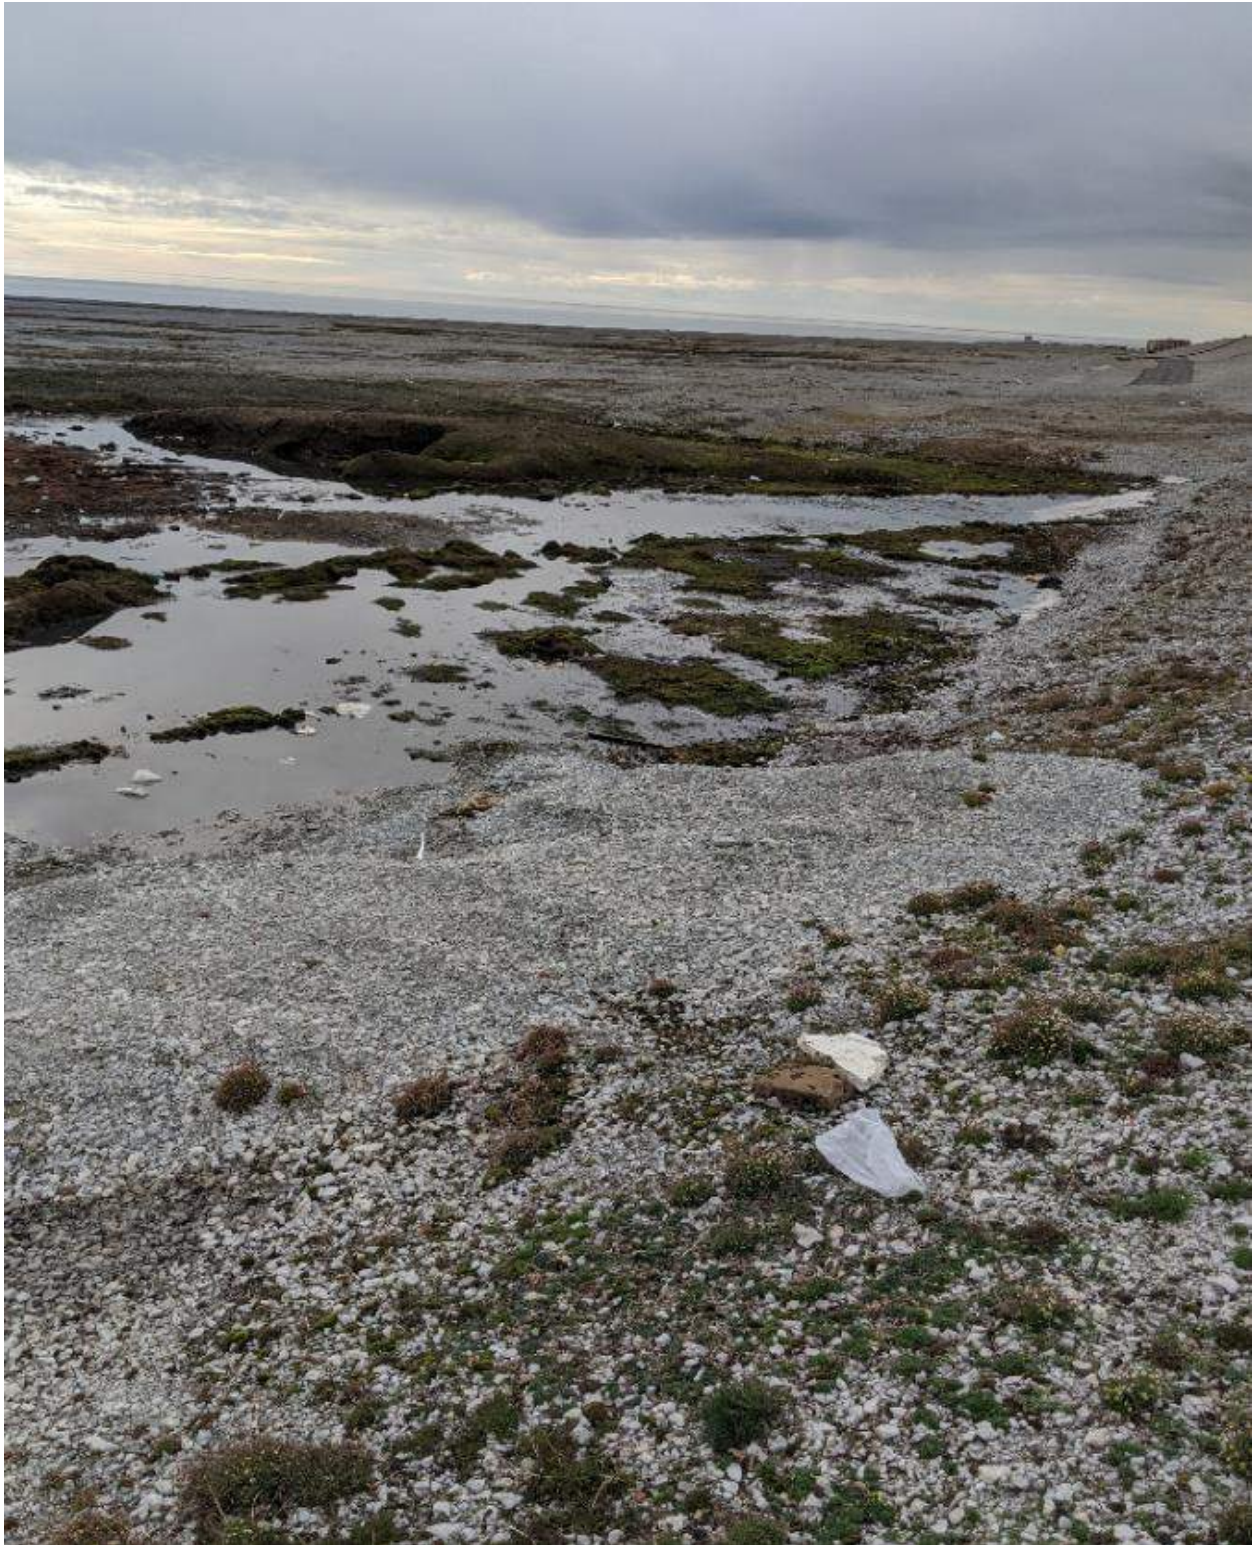
Water was observed to be coming out of the lagoon berm near the northeast corner of the north cell. Pictures were taken and this area will be monitored as well, with the water treated as a leak for observation purposes, until its origin can be determined.

Photograph #3: Another view of the new potential leak. This picture was taken at the northeast corner of the north cell, at the bottom of the berm looking south along the berm.

After discussion with the hamlet, it was determined that the water coming from the northeast corner of the north cell is intended, as part of the lagoon's automatic decanting process. Thus this area will no longer be considered a potential leak.

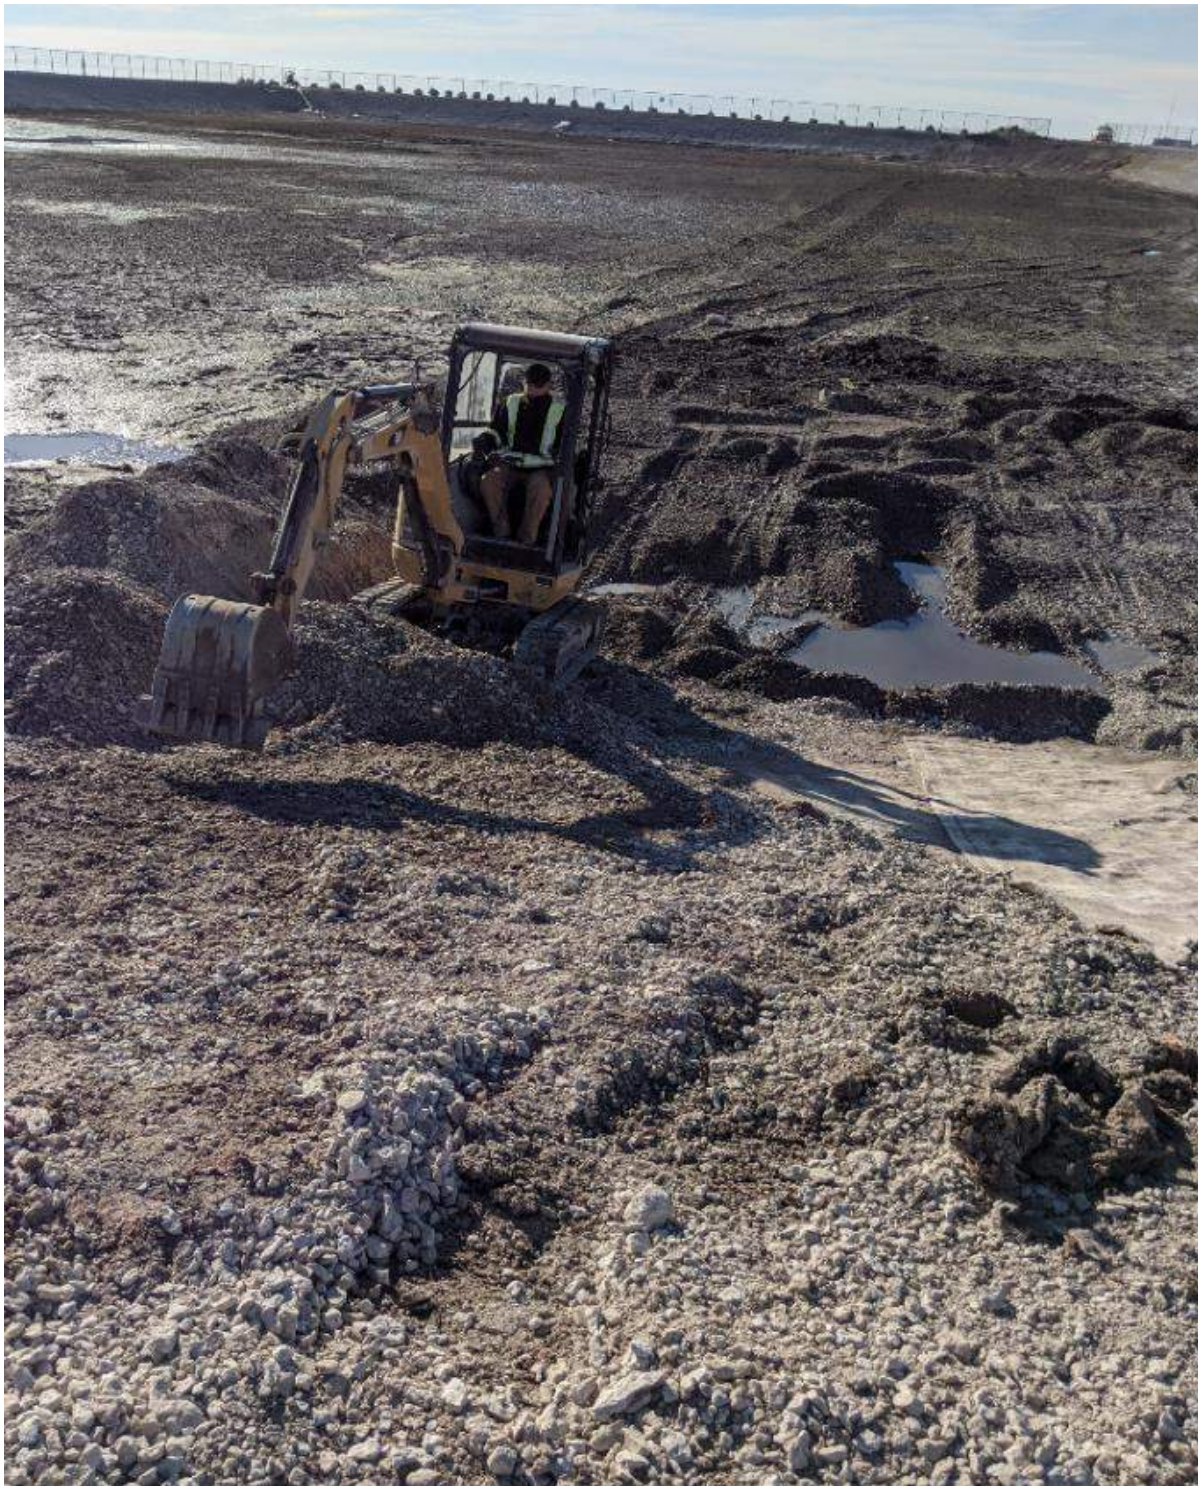
Photograph #1: A thin layer of granular material was left on the liner until dried. This allowed the liner to recover some of its structural strength before being exposed.

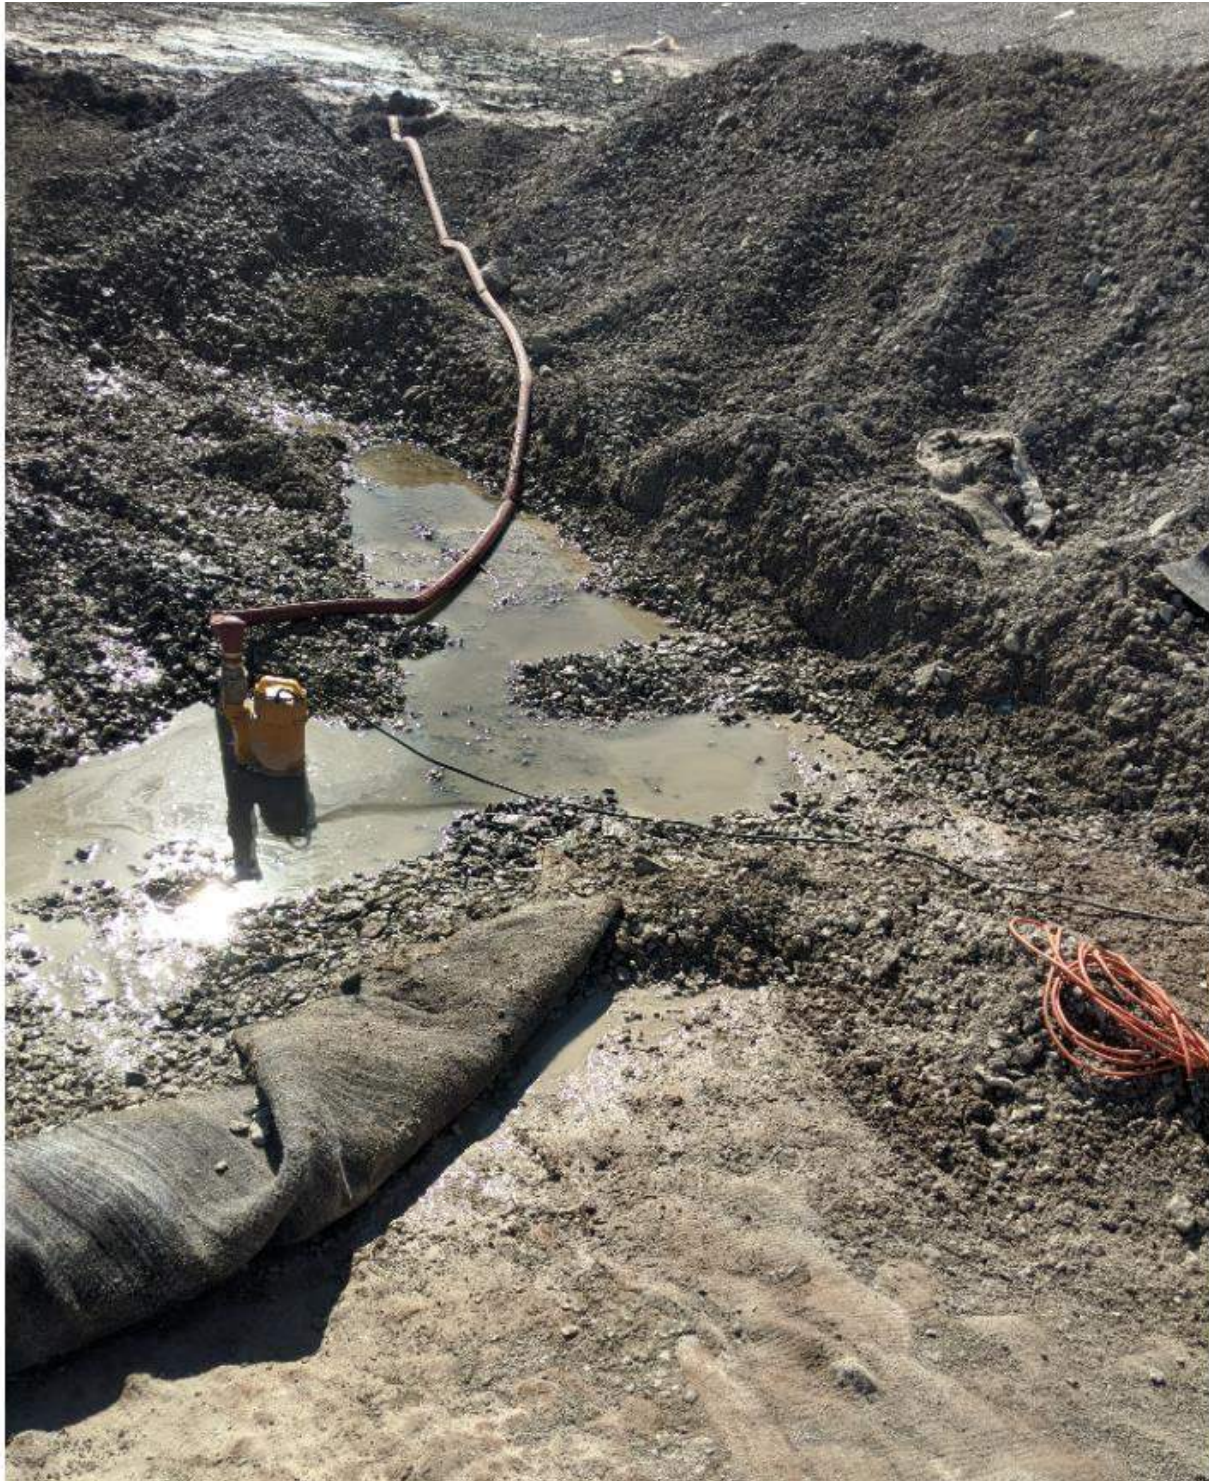
Photograph #2: A pump was used to drain the water at the bottom of the embankment, but had difficulty keeping up. The soil to the right of the picture still needs to be removed in order to prepare a clean dry joint for the new liner.

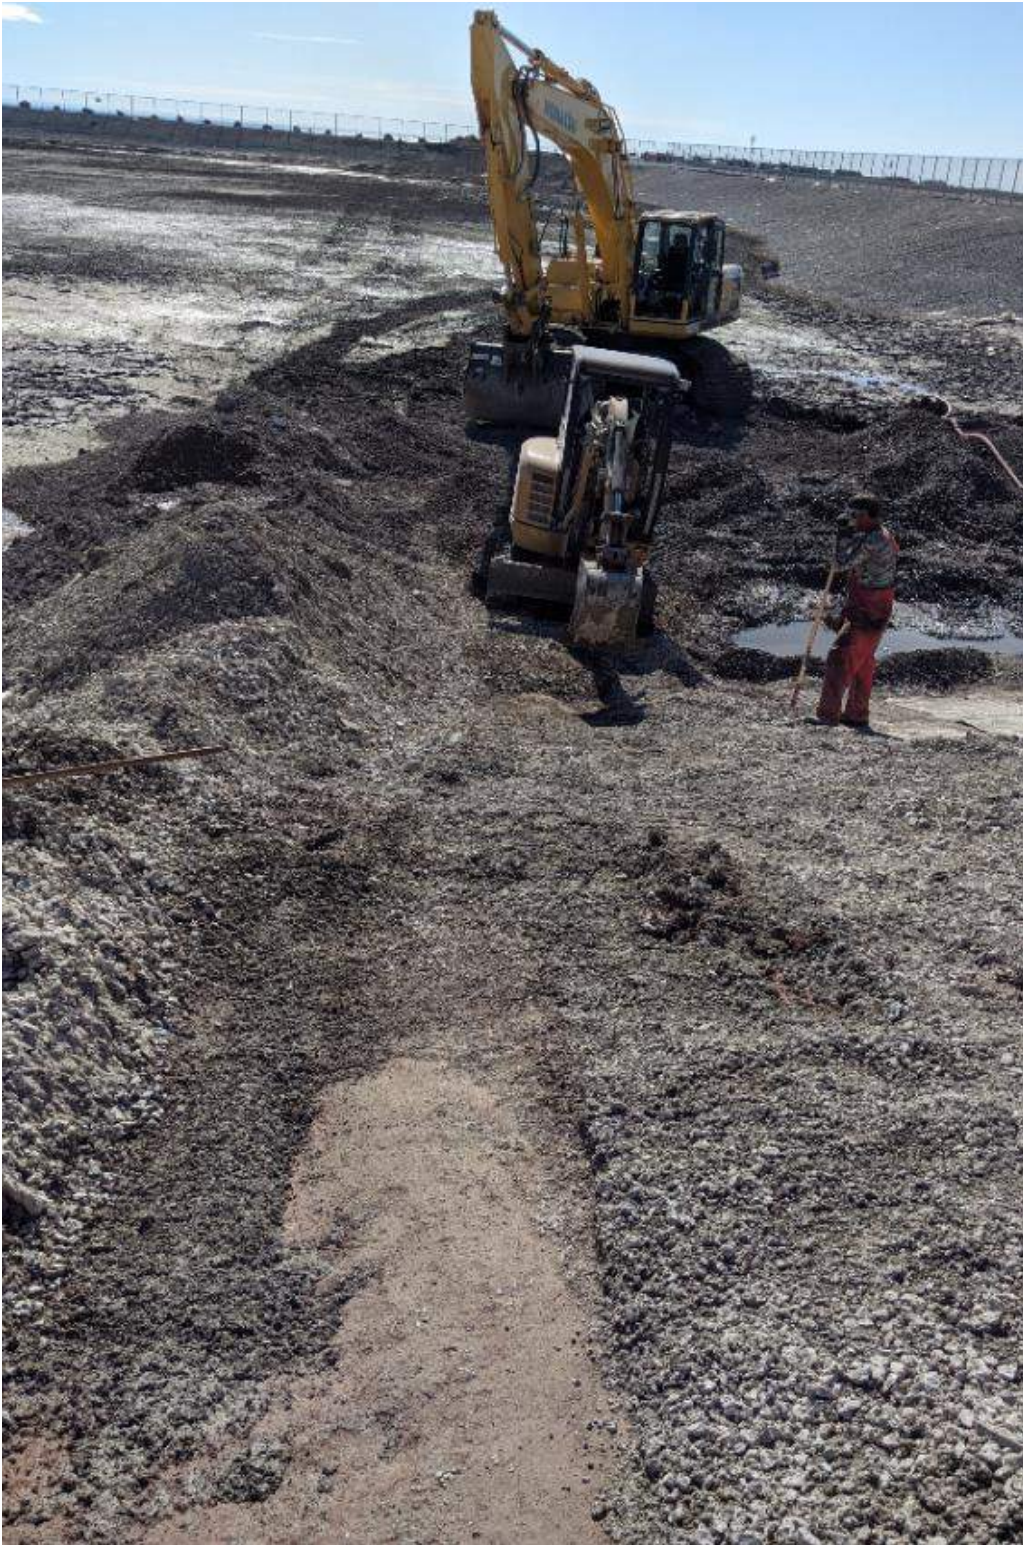
Liner was exposed further along the embankment to the east of the discharge station, in an attempt to find competent liner onto which the new liner can be sealed. Competent liner was found approximately 5m further along the embankment. Allowing the liner to dry appears to restore some of its structural strength, so the granulars above the liner were removed down to the final 20 to 30mm, which will be allowed to dry in place before being removed to fully expose the liner.

Photograph #3: Competent liner was found approximately five meters further than originally exposed. This is where the new liner will seal onto the existing liner once the latter is cleaned.
