Summary of Work – Hall Beach 2020 Field Season

Final Report

Hall Beach Sewage Lagoon
Change Order No. 5 & Leak Detection/Resolution

OTT-220382

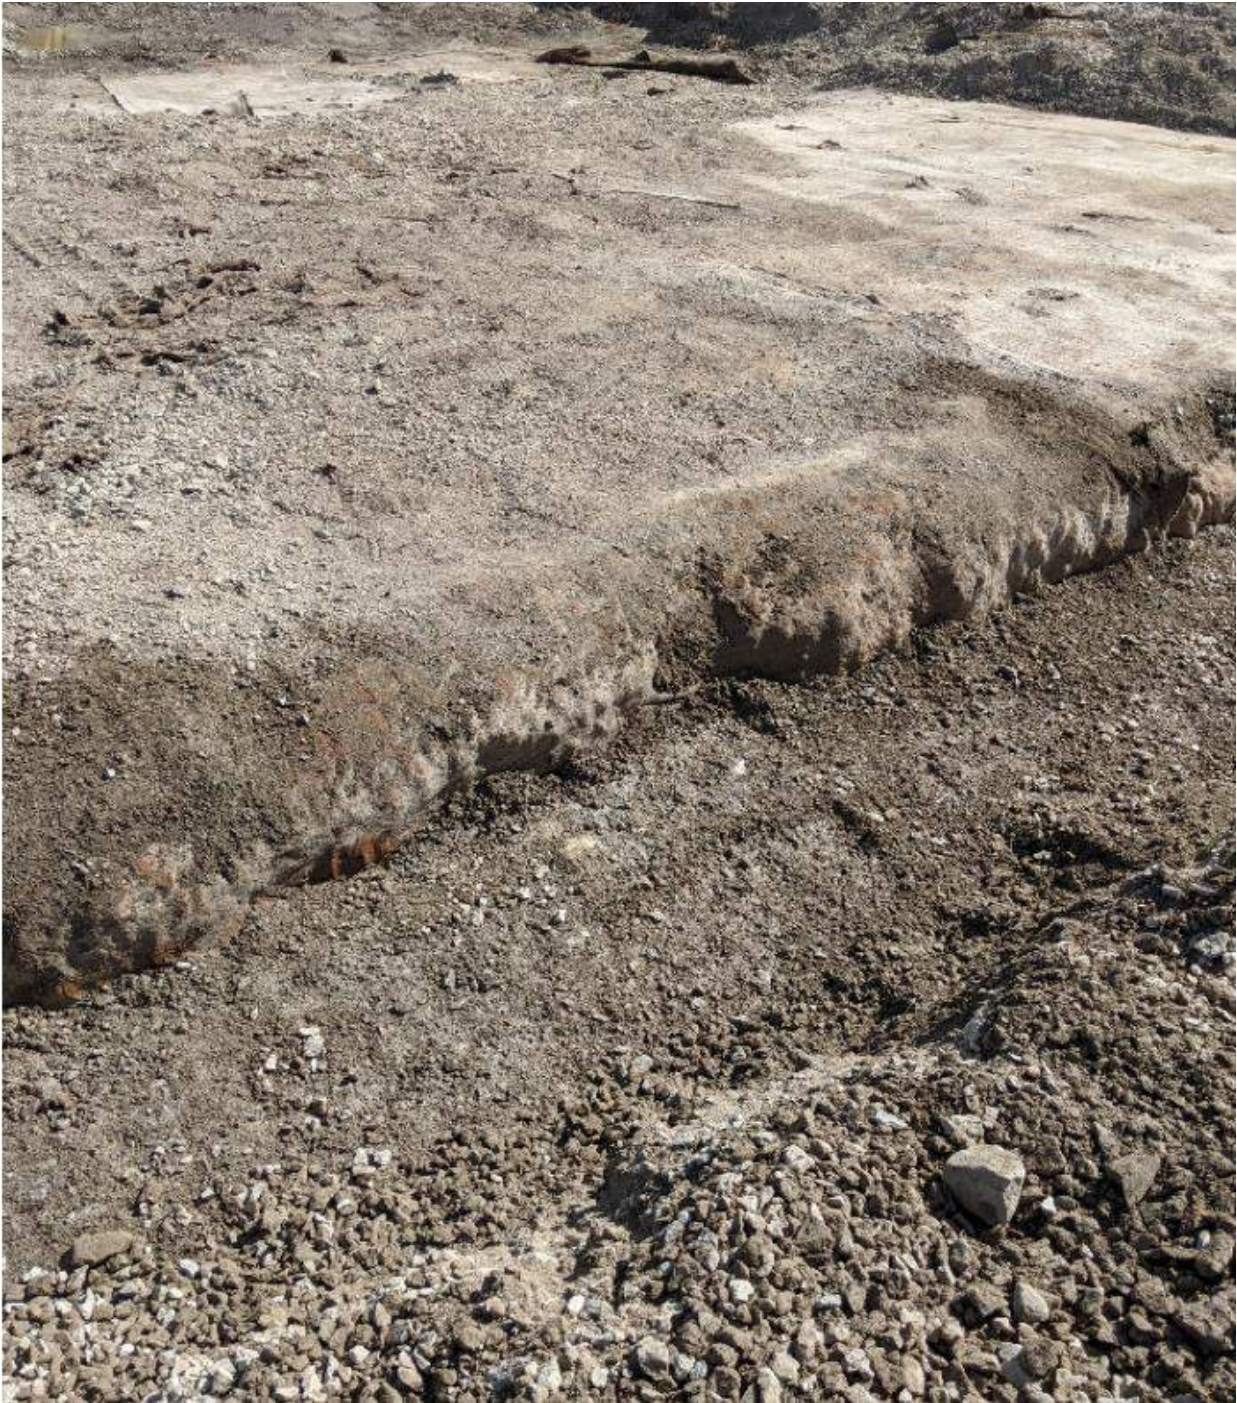
Photograph #4: The anchor trench for the new liner, located immediately behind the existing liner's anchor point, was dug.

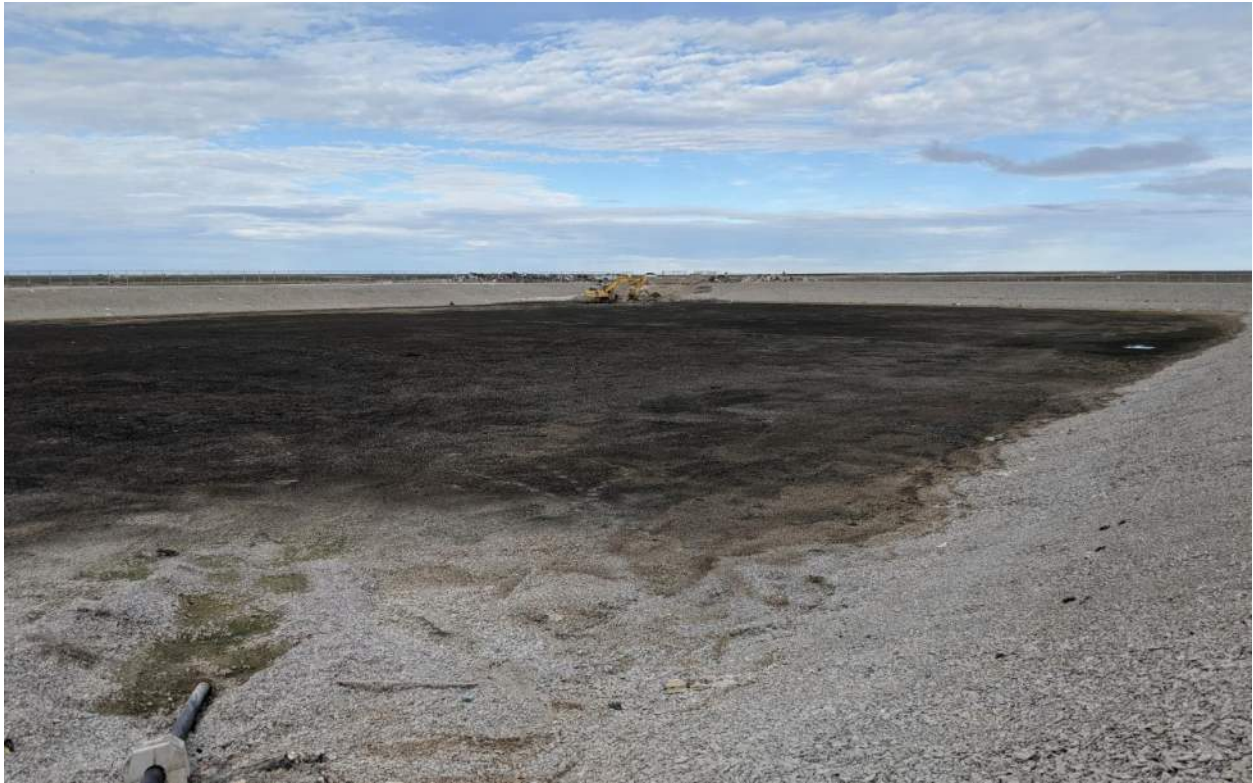
Photograph #1: Apart from a very small puddle, the lagoon cell is now completely empty. Note that there is still >300mm of water in much of the cell, above the liner but below final grade.

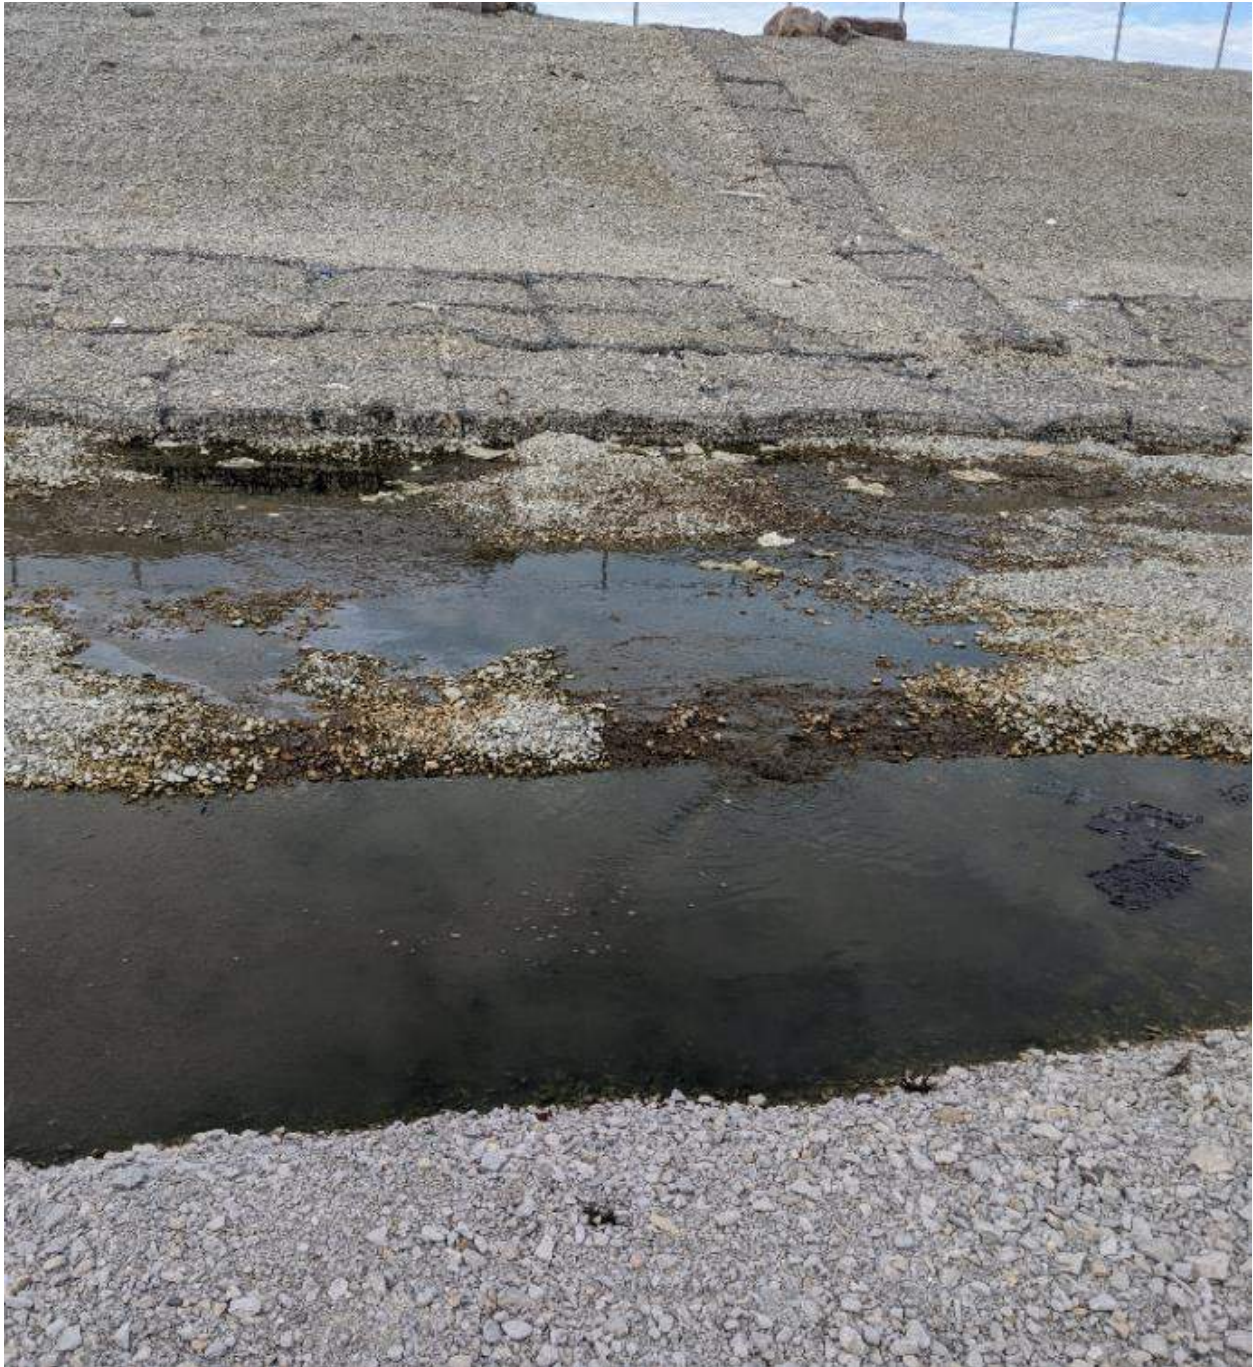
The leak on the east side of the lagoon seems to have a slightly lower discharge than in previous days. While it is still of the same order of magnitude, as well as similar general shape and location, the depth of the flow seems slightly lower. The leak will continue to be monitored on a daily basis. The water level in the lagoon is now below grade, but above liner, everywhere in the south cell.

Photograph #2: The leak is still flowing, but its volume may be starting to diminish.

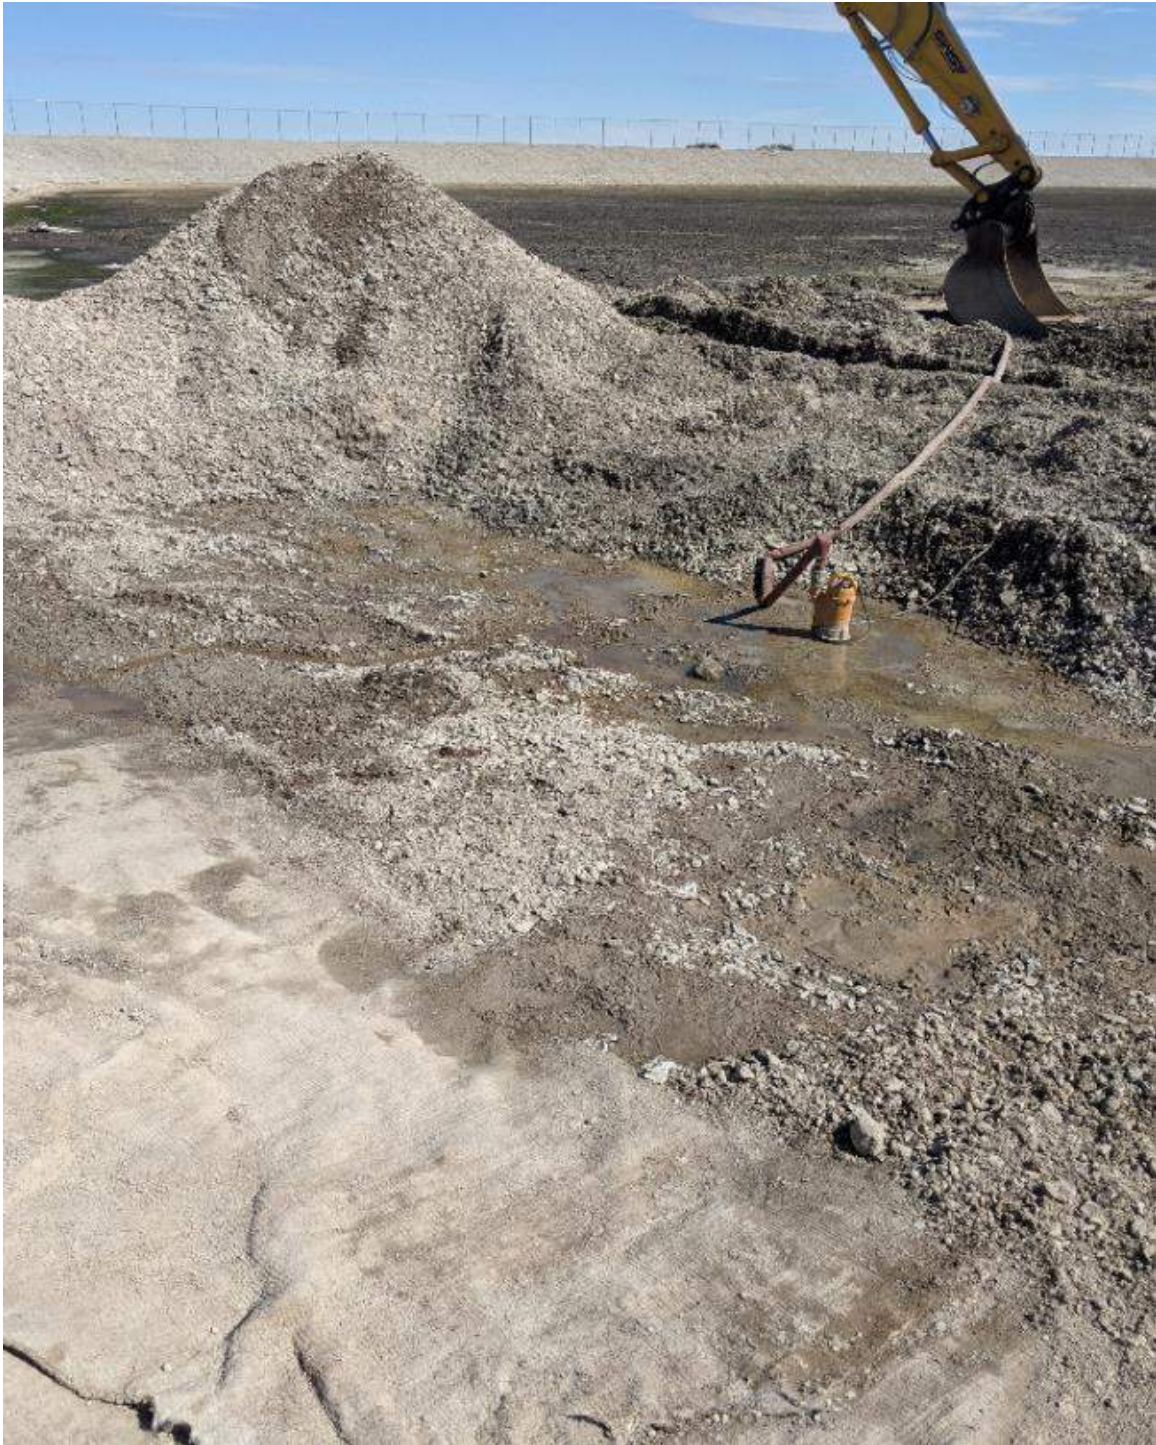
Water bubbles were also noted under the existing liner. As the existing liner at the bottom of the lagoon is exposed, the removal of the granular material is allowing the liner to lift approximately 50 to 70mm, effectively floating on the underlying water. The bottom of the excavation was left exposed and will be monitored over the next few days to see if the situation improves.

Photograph #3: The bottom of the embankment at the north discharge station is starting to dry. It will be allowed to dry further in order to ensure a proper seal of the new liner to the existing, as well as to help mitigate the issue of water bubbles under the liner.

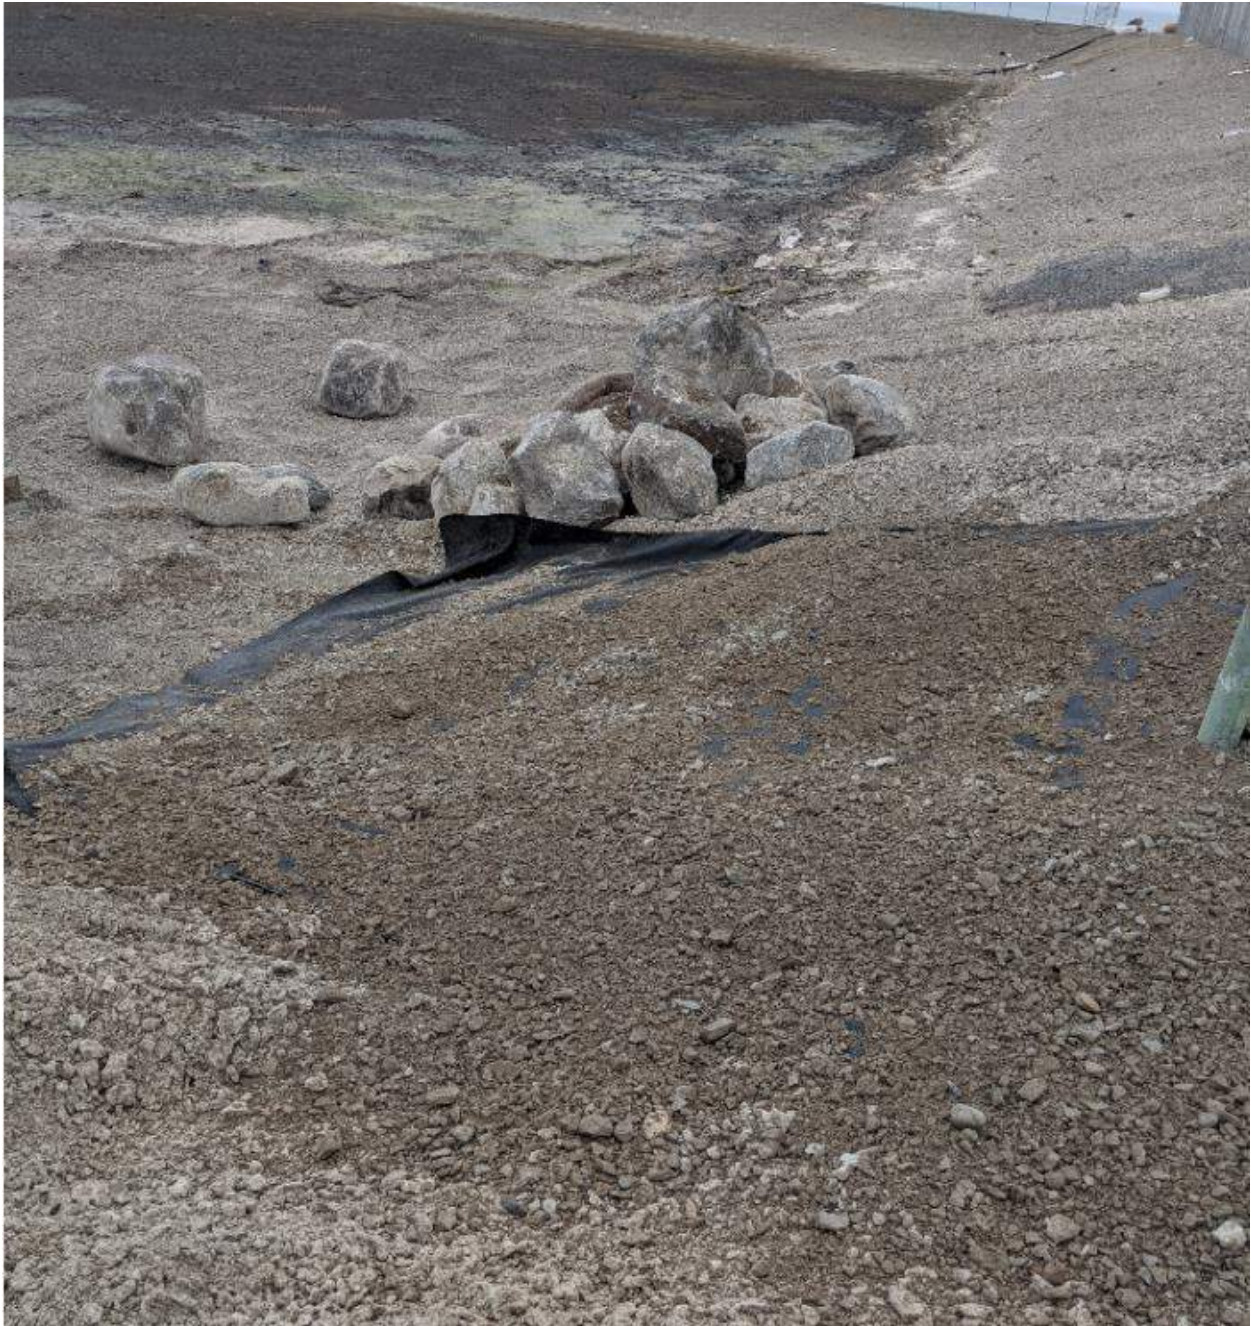
Photograph #1: Geotextile installed at south discharge station.

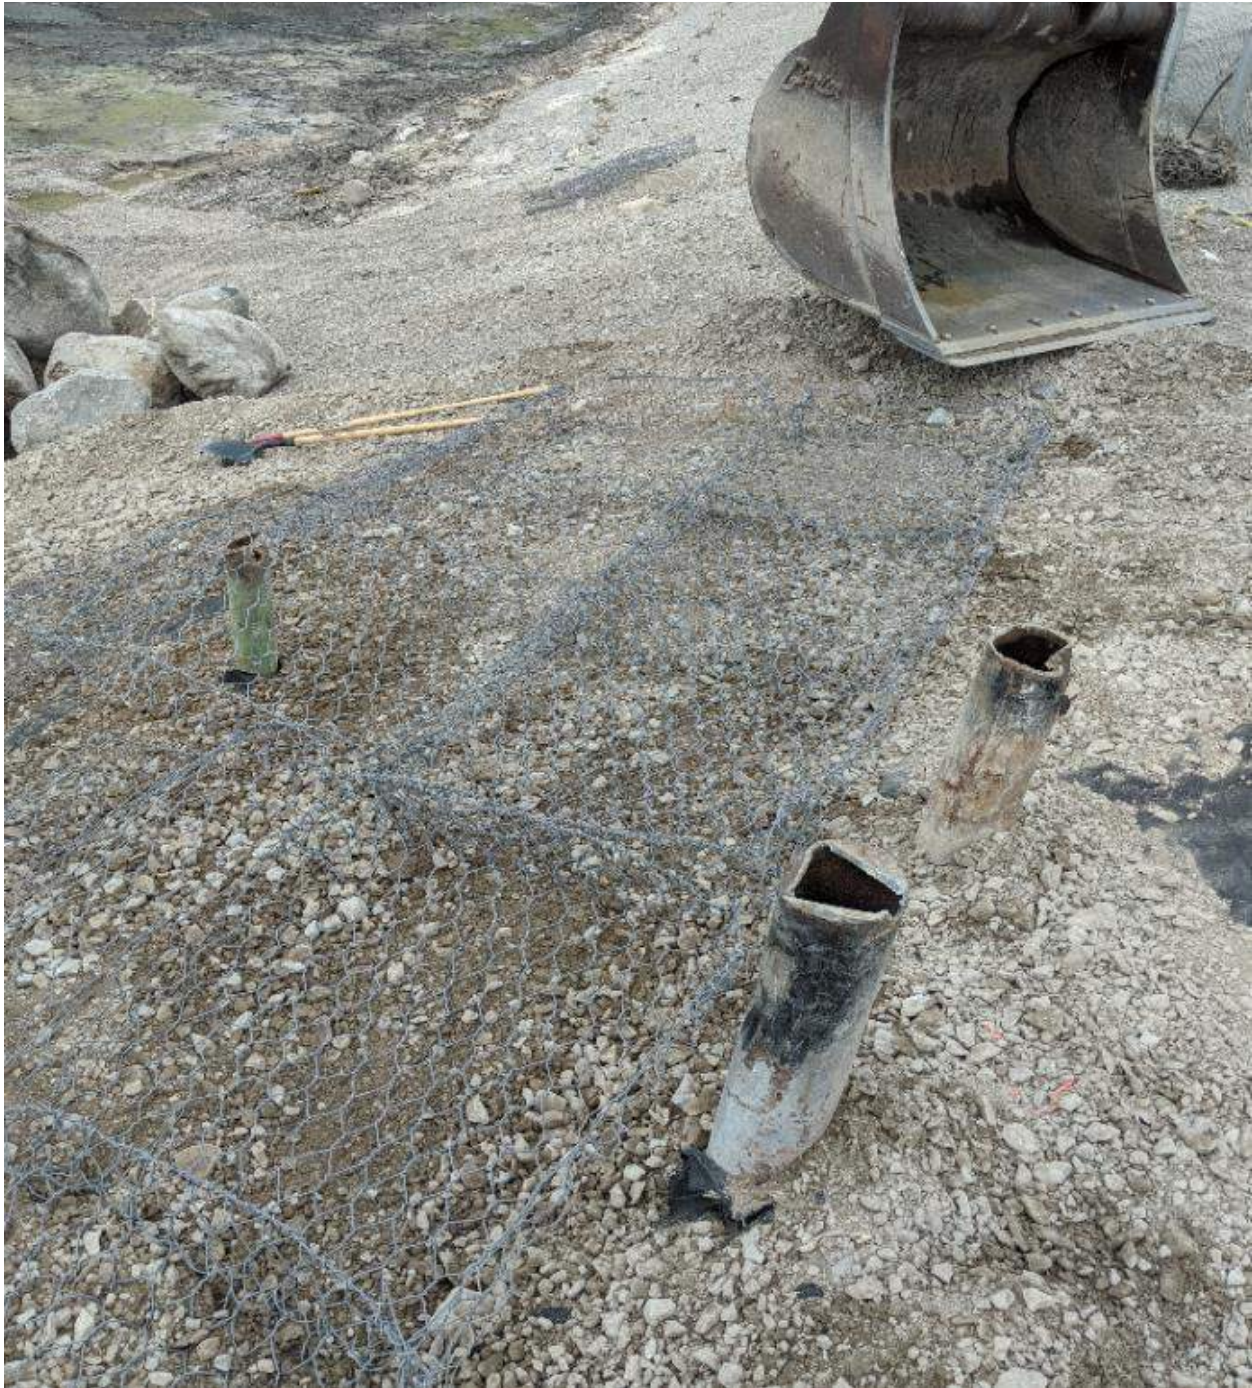
Photograph #2: Installation of gabion cages. The discharge station's lower piles pass through the second row of cages, anchoring the entire gabion mat in place.

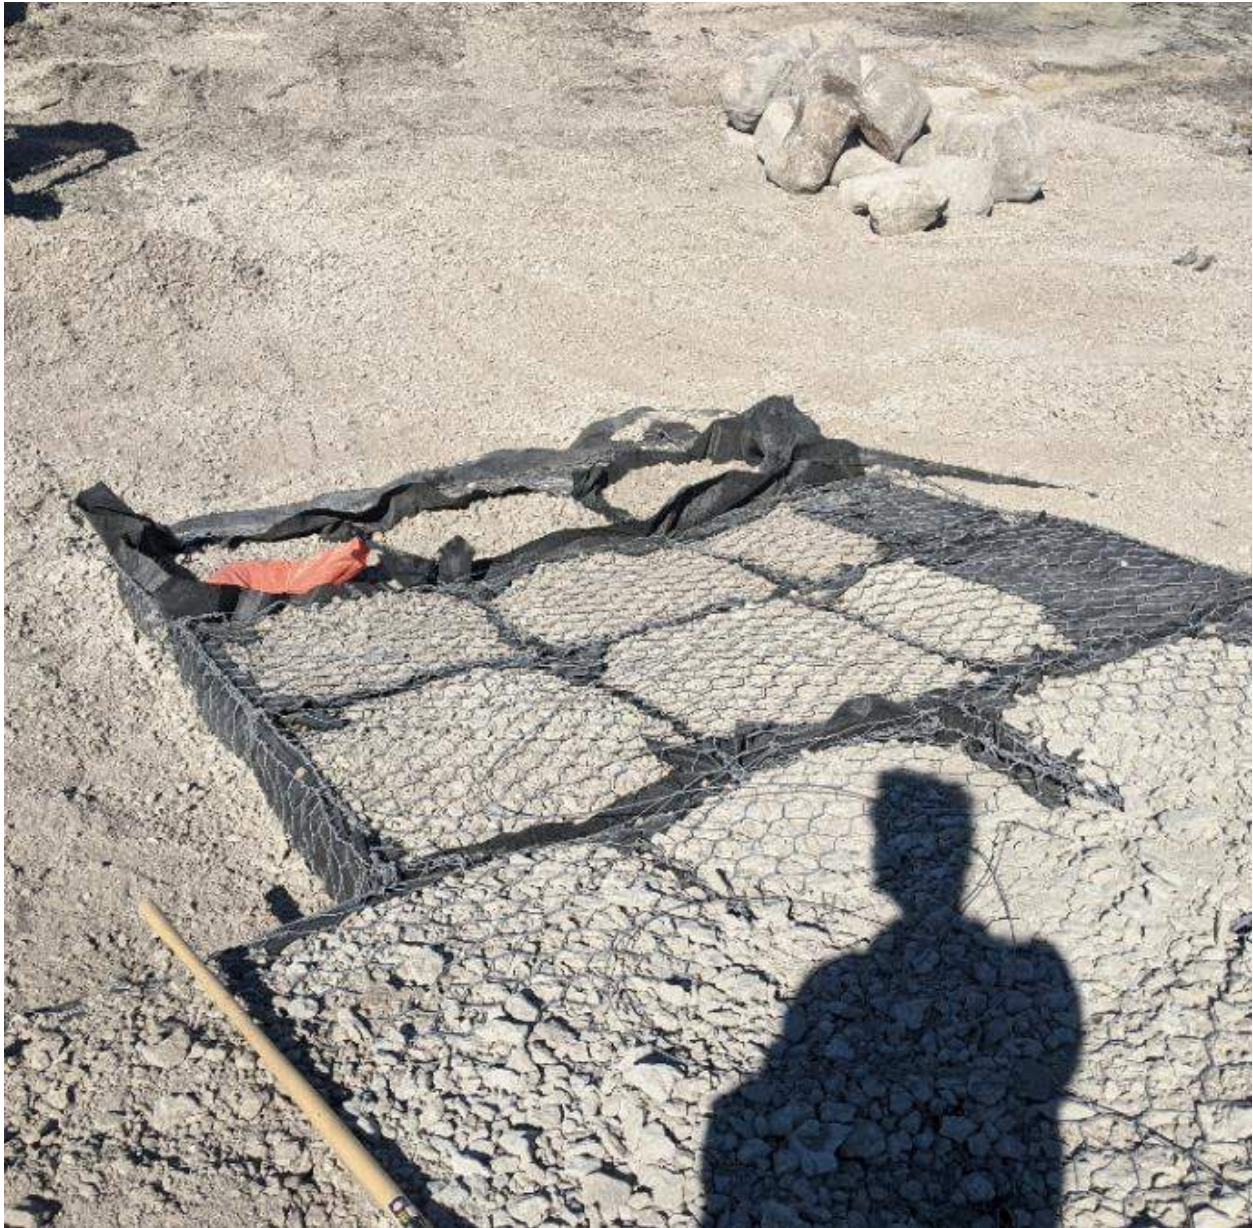
Photograph #3: This photo taken on July 14 demonstrates the geotextile used to prevent the granular material from falling out of the cages.

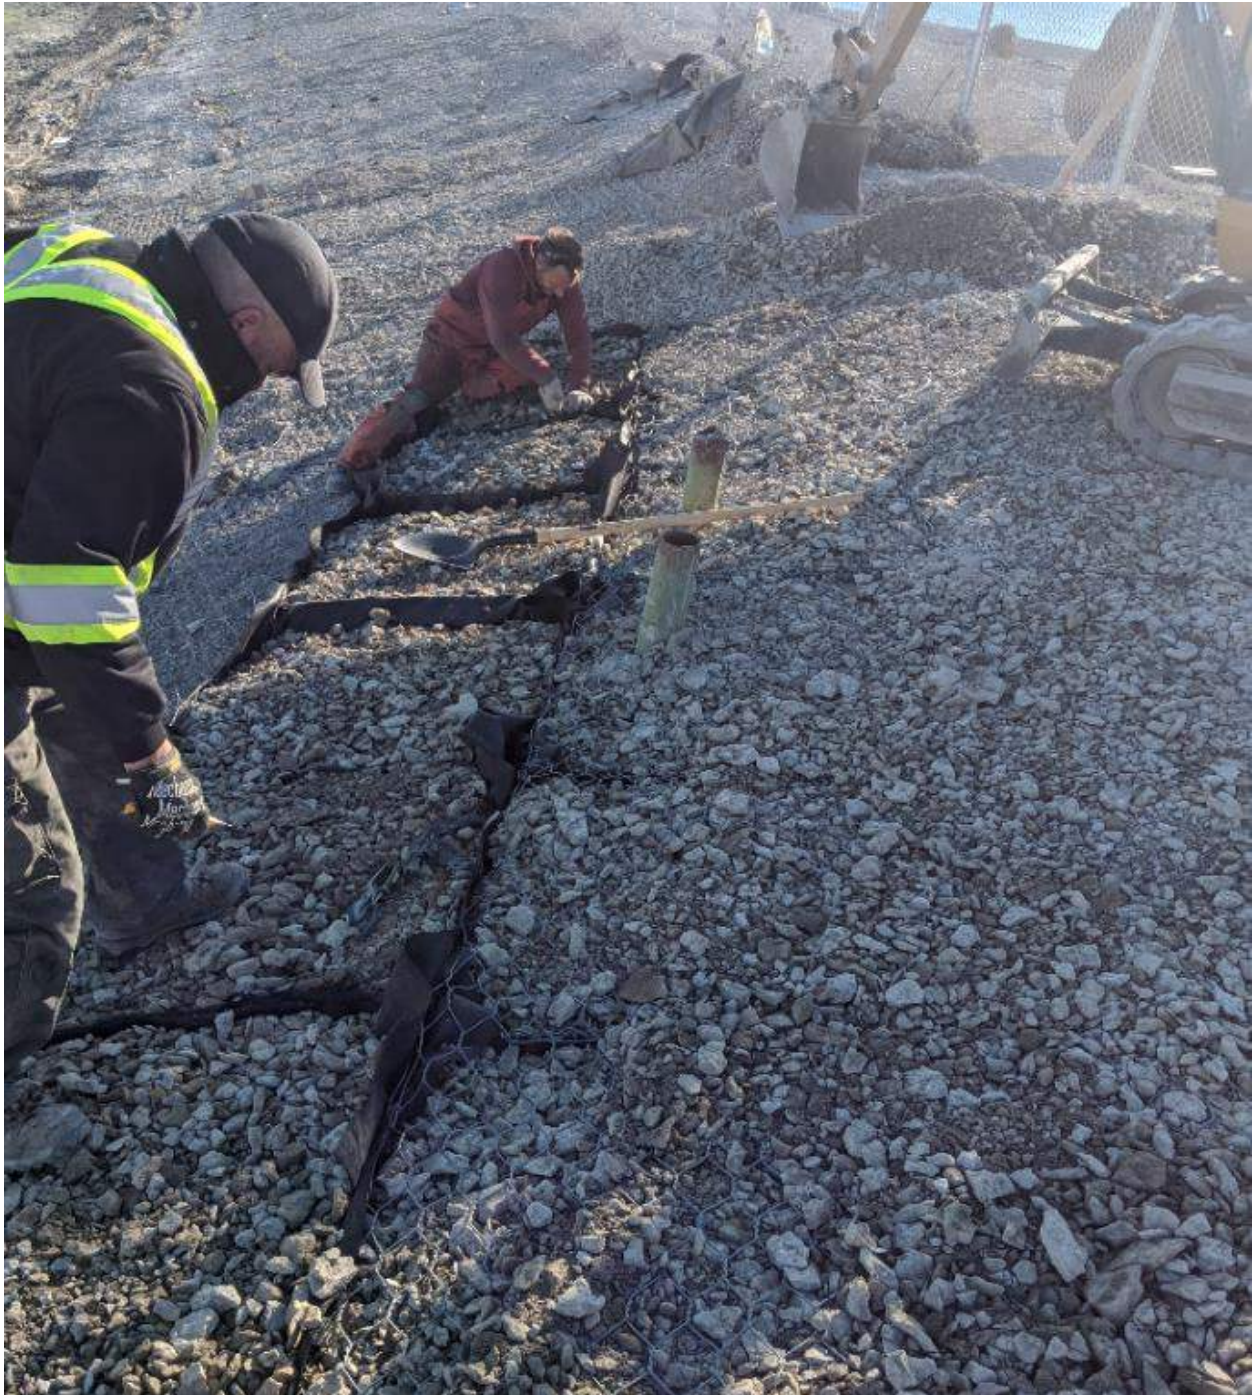
Photograph #1: The gabion cages, once filled, were wired shut as well as wired to the previous row of cages to form a complete mat.

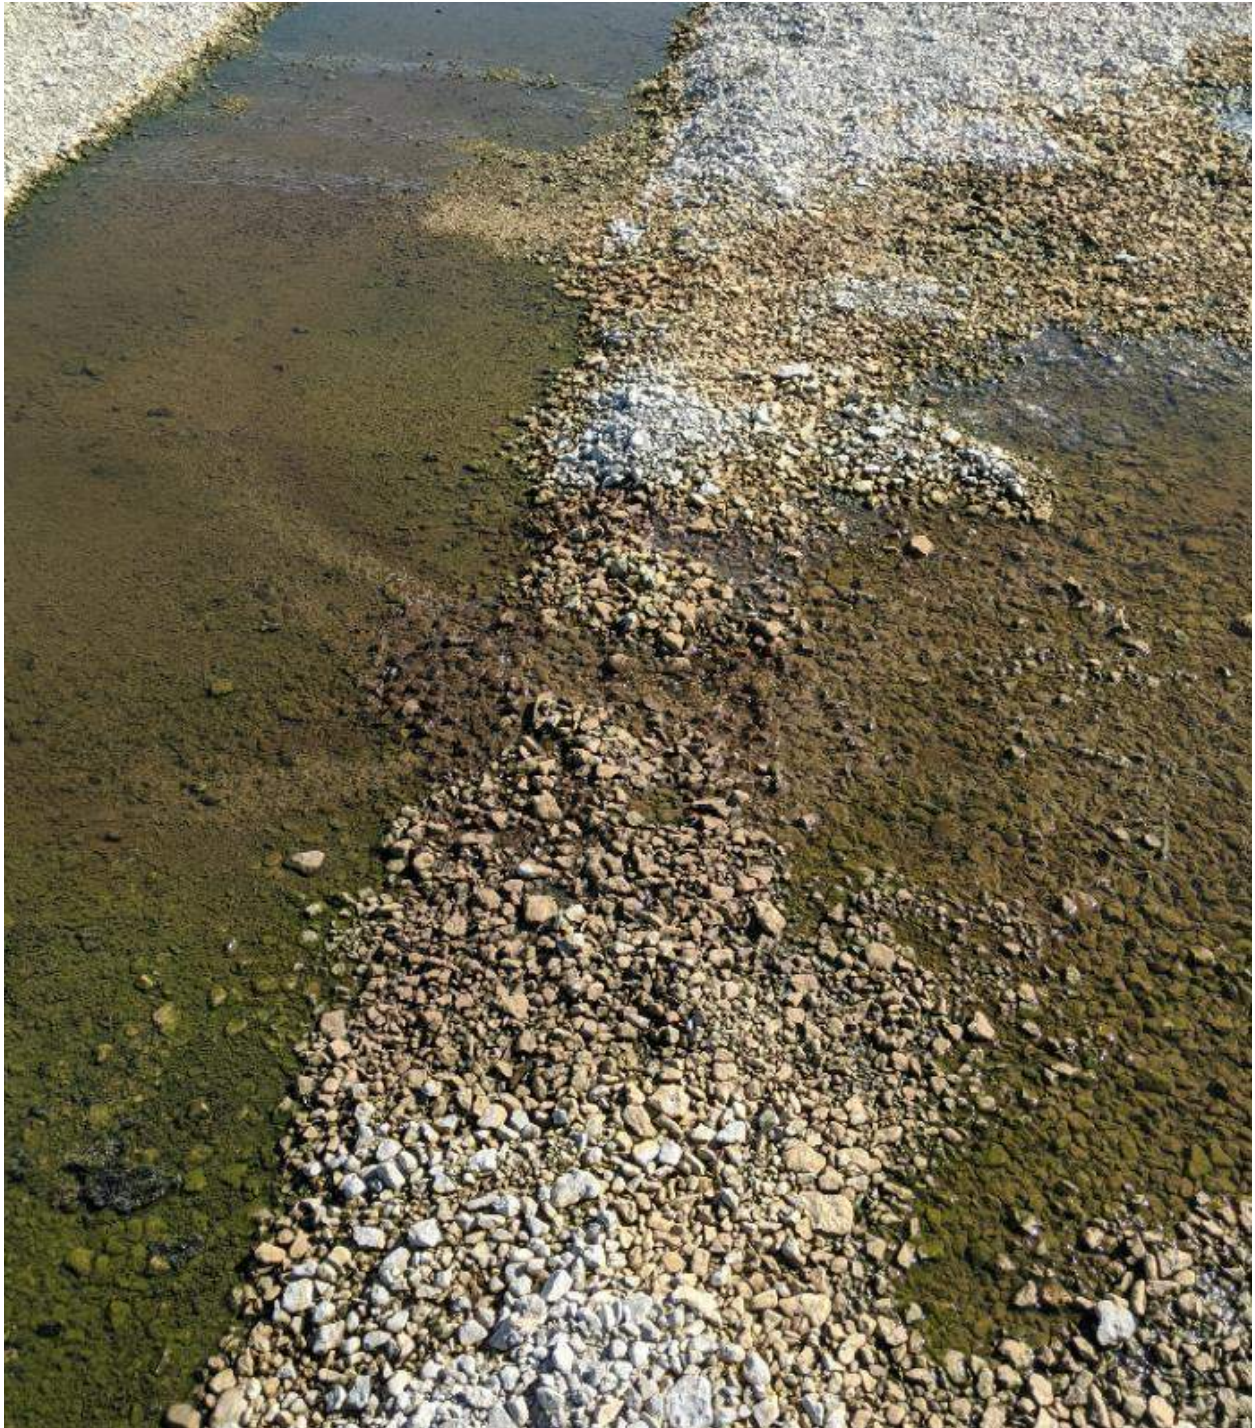
The leak along the east side of the lagoon is significantly smaller than it was at its peak. It is beginning to diminish not only in volume but also in area.

Photograph #2: The leak is beginning to recede significantly in area. The orange discolored region represents the area formerly covered by flowing water.

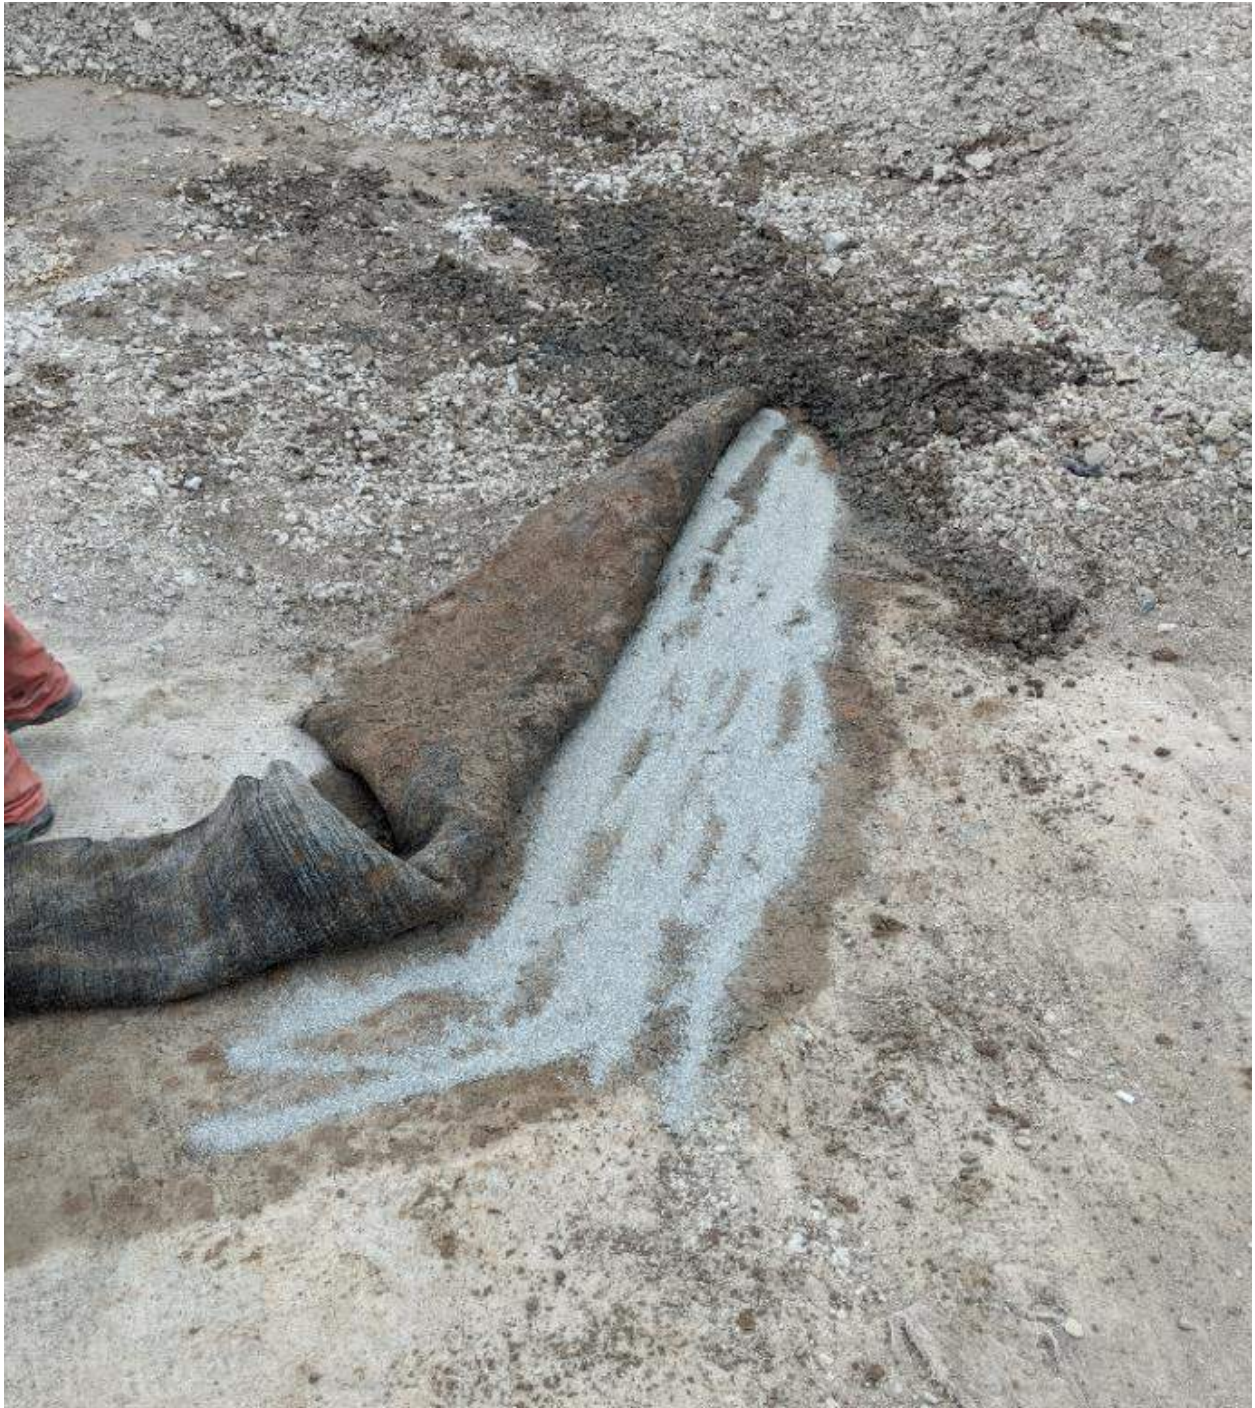
The existing seams near the edge of the excavation were cleaned out and resealed with new bentonite. The depressions in the existing liner were filled and worn out pieces were removed to obtain an even surface on which to place the new liner.

Photograph #1: Seams in existing liner were cleaned out and sealed with additional bentonite.

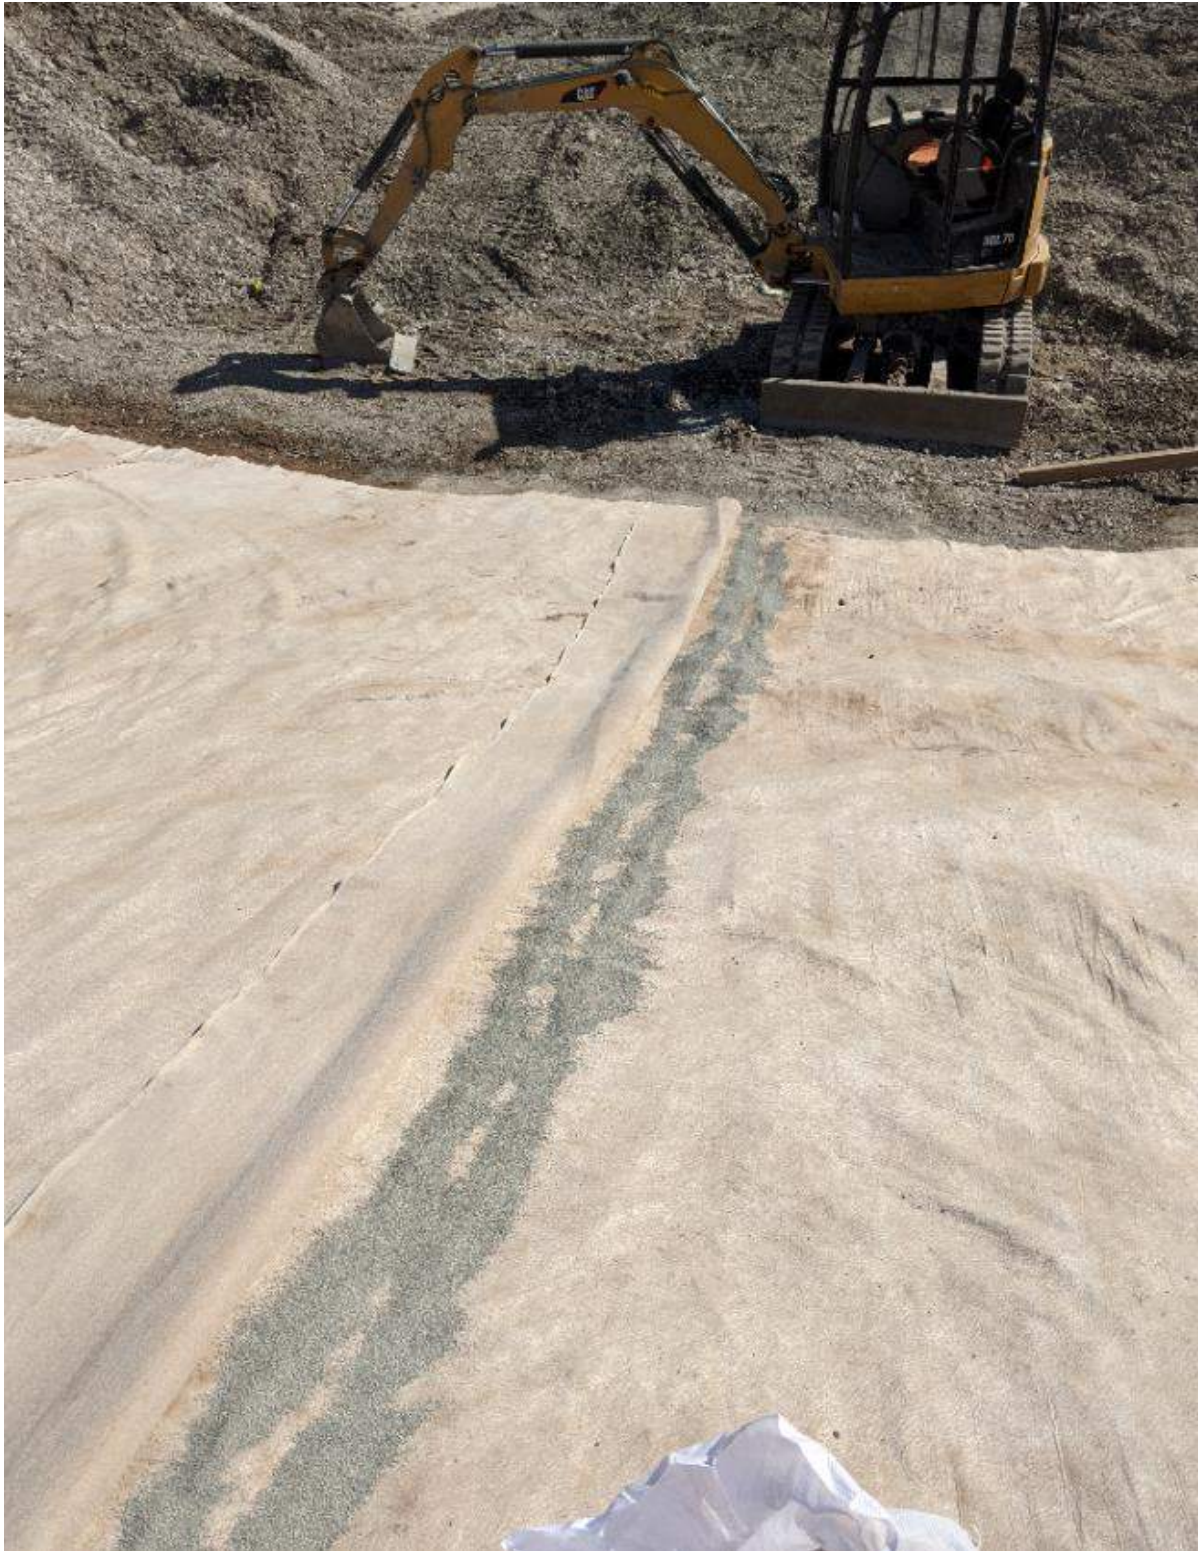
The new liner was anchored at the top of the embankment in a trench as recommended by the manufacturer. Seams were sealed with a double row of bentonite. The new liner panels extend down the entire embankment down to the existing liner panels at the bottom of the lagoon, completely covering the damaged existing liner. The new liner covers an area just over 15m wide at the top of the embankment, and 12m wide at the bottom. The difference is due to the liner turning the corner of the lagoon.

Photograph #2: A double row of bentonite was used to seal the seams of the new liner.

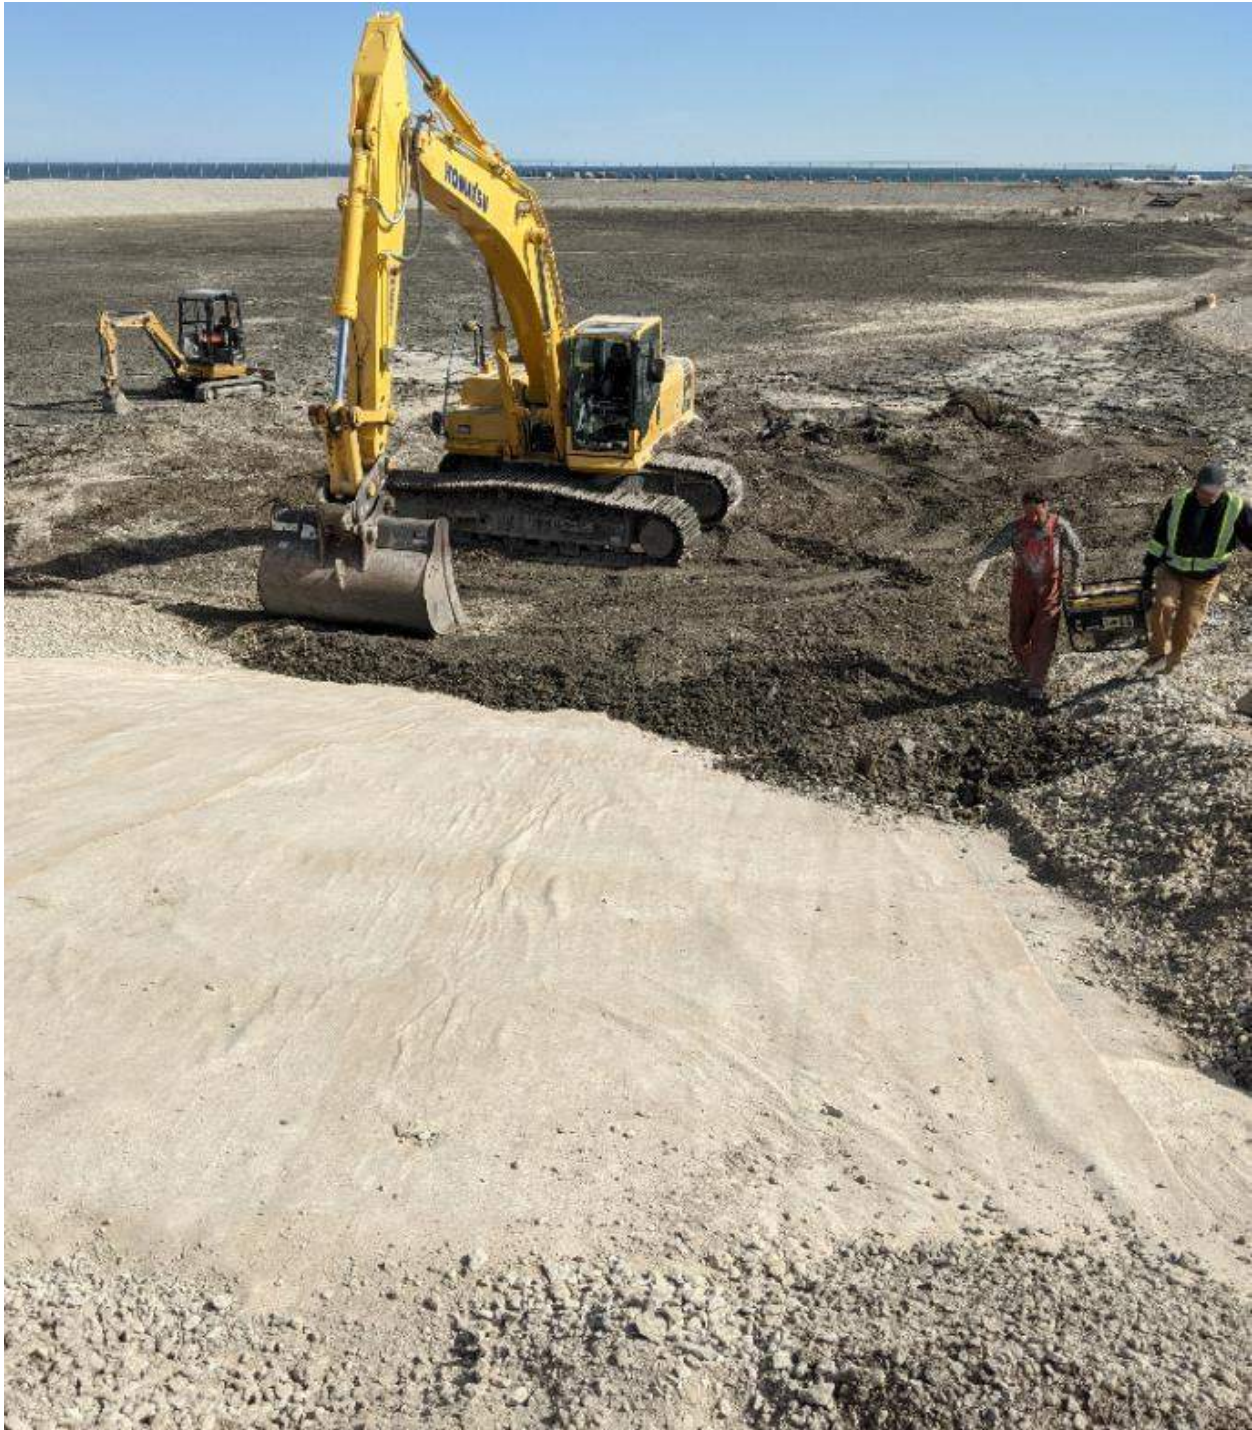
Photograph #3: The liner was covered with approximately 0.5m of granular material.

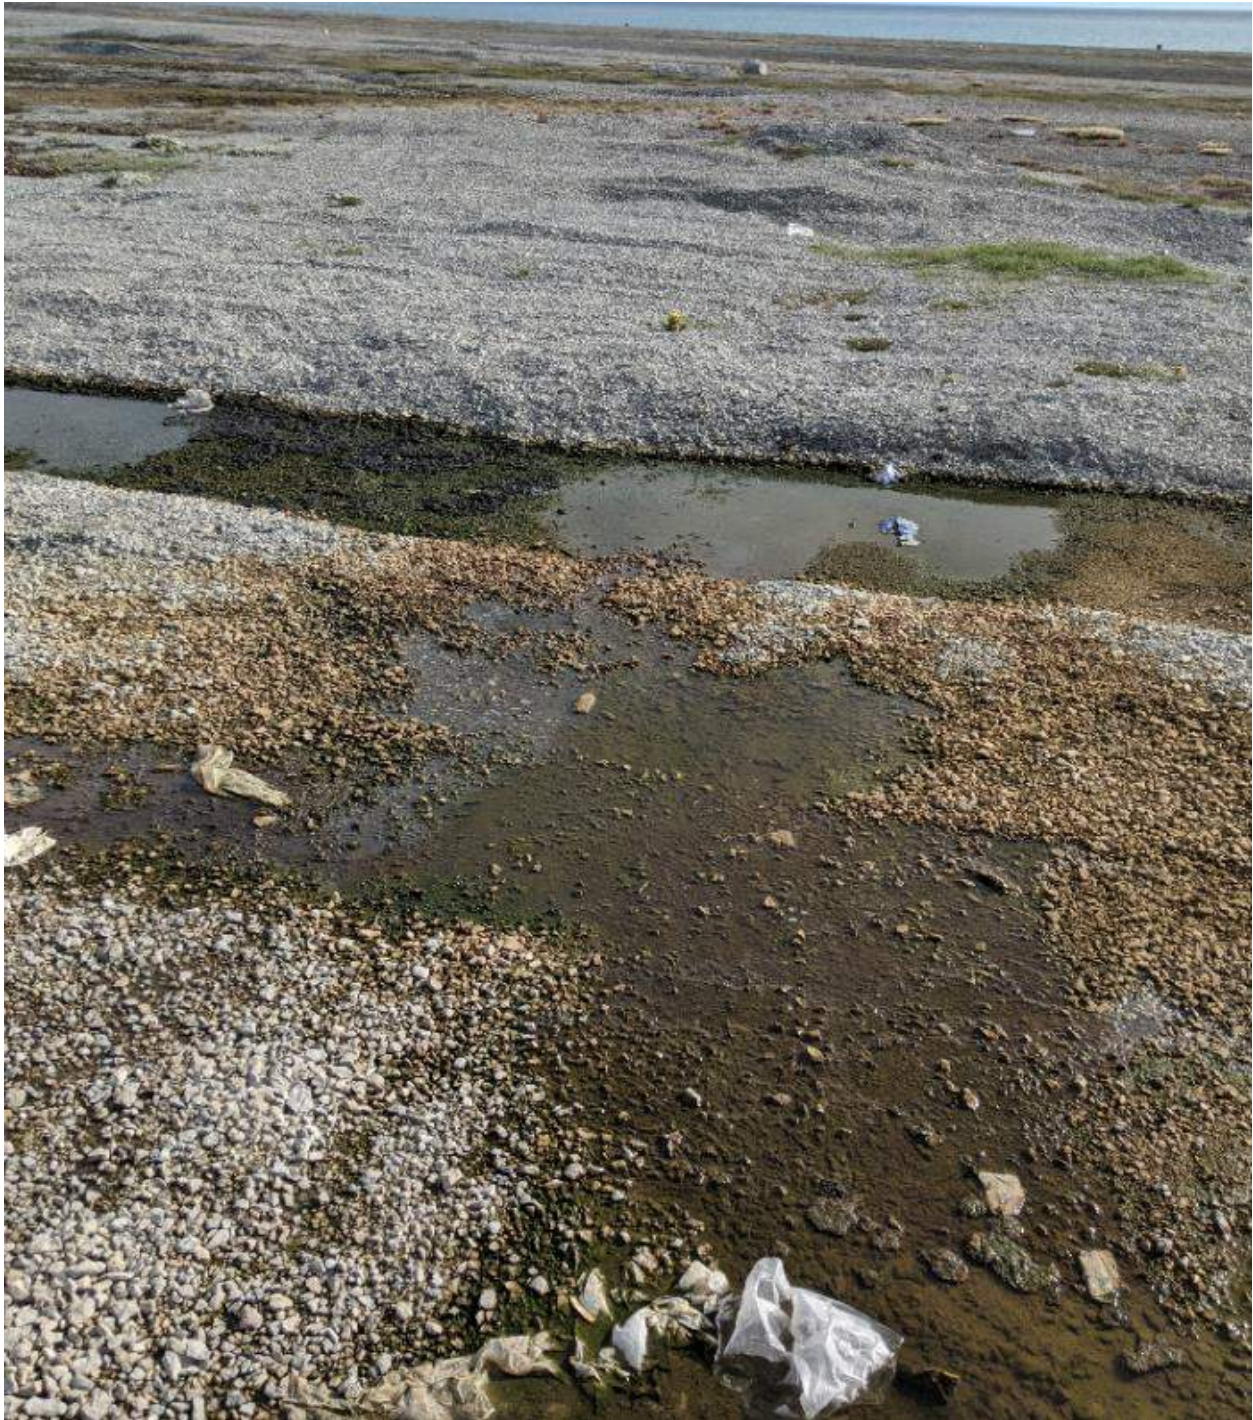
The east side leak is significantly diminished, and the swale into which it has been discharging is drying up significantly.

Photograph #1: The leak at the east side of the lagoon is significantly diminished, and the swale is starting to dry up.
