Summary of Work – Hall Beach 2020 Field Season

Final Report

Hall Beach Sewage Lagoon
Change Order No. 5 & Leak Detection/Resolution

OTT-220382

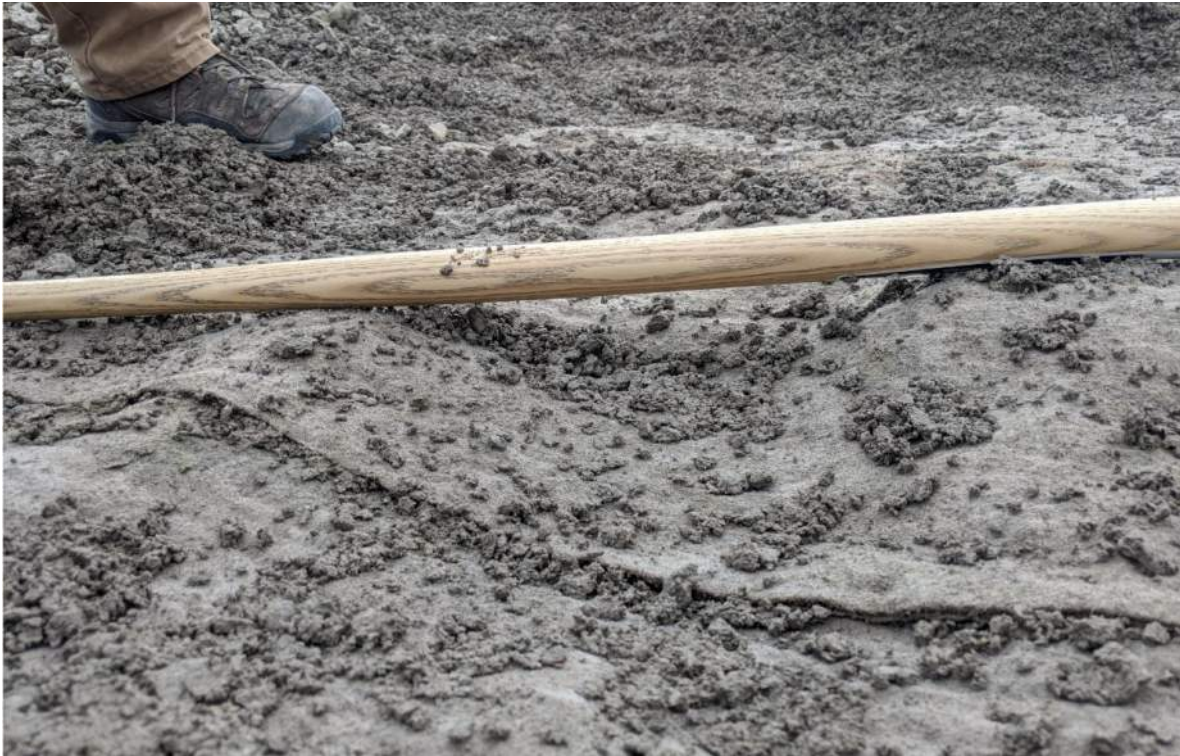
The liner was exposed at a seam. During exposure, the liner was damaged and will need a patch, so an area approximately 2m by 2m was exposed. The liner was found to be very uneven, with depressions of up to 50mm over 300mm being quite common in this particular area.

Photograph #3: The liner at the bottom of the lagoon is not even. Significant local depressions are commonplace.

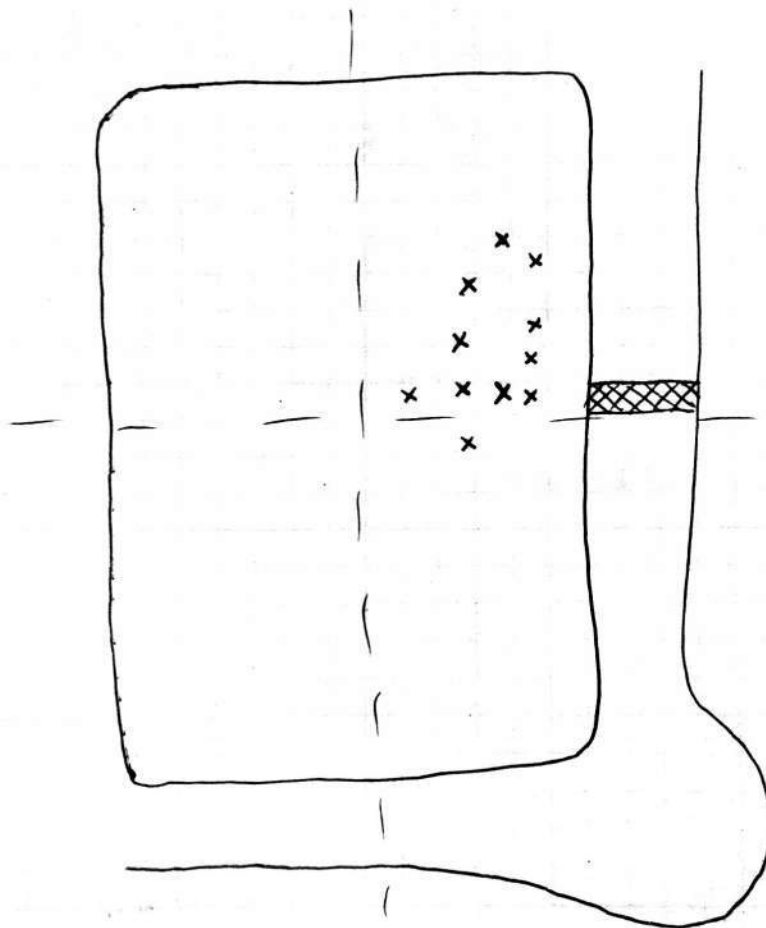
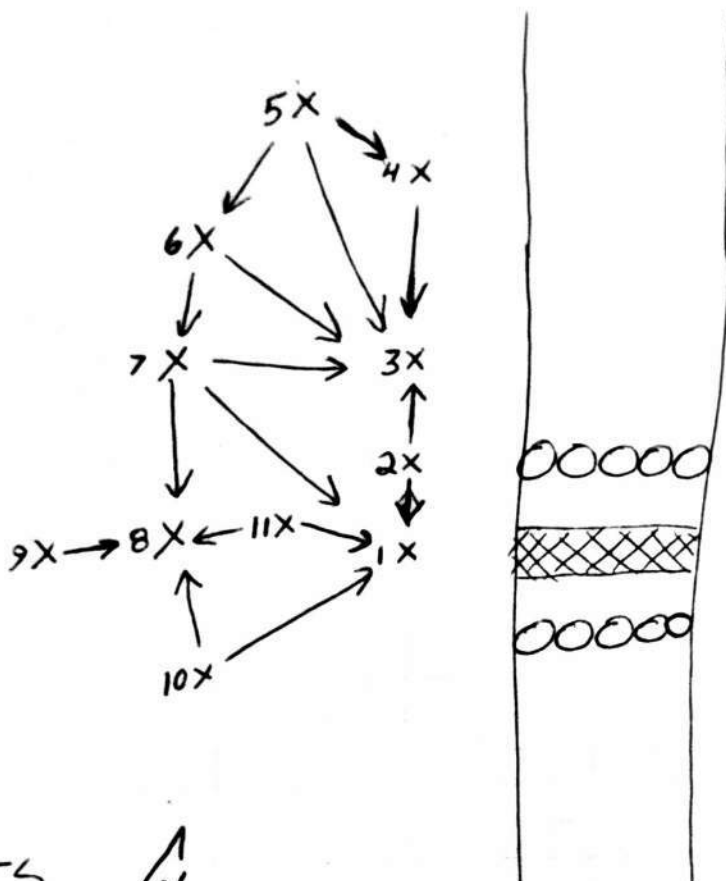
Project: Hall Beach Lagoon	Project No: OTT-220382
Description: Elevation shots on liner - July 16, 2020	Prepared By: MB
	Date: July 16, 2020
	Other: Page 112

In order to determine with more accuracy the low point of the lagoon, a series of exploratory holes were then dug around the area. A level was used to determine the liner elevation. A total of 11 measurements were taken, which demonstrate that the lagoon liner is generally sloped towards the east berm. This is consistent with visual observation of the general shape of the granular material in the bottom of the lagoon, and the recession of the water during the draining of the lagoon. Work on the leak stopped at 1500, so would total 3.25h for an operator and a labourer, and 2h for a mini-excavator (1.5h taken for lunch, and time was spent going to get the level borrowed from Inukshuk).

Point	Elev
1	0.146
2	0.200
3	0.087
4	0.264
5	0.312
6	0.283
7	0.231
8	0.195
9	0.270
10	0.227
11	0.212

No water observed pooling on liner in any
of the excavations.

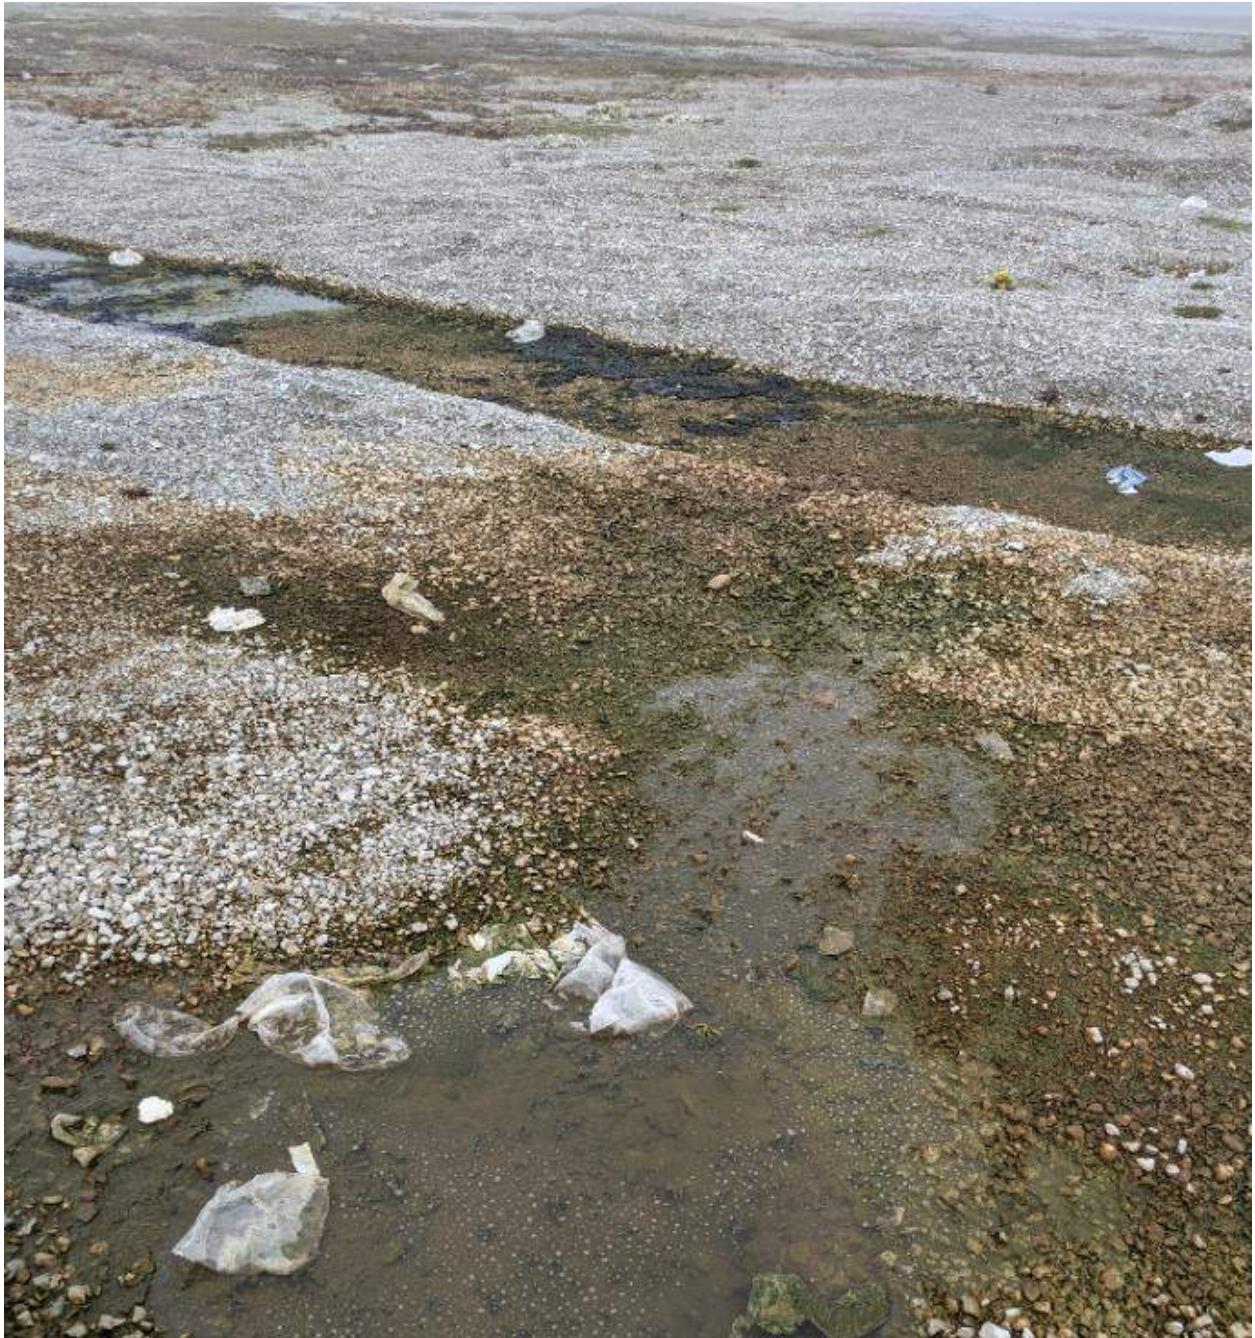
The leak at the east side of the lagoon is now completely stopped. Some puddles of stagnant water remain in the area where the leak used to be.

Photograph #1: The leak at the east side of the south cell is no longer flowing, and the remaining water is stagnant.

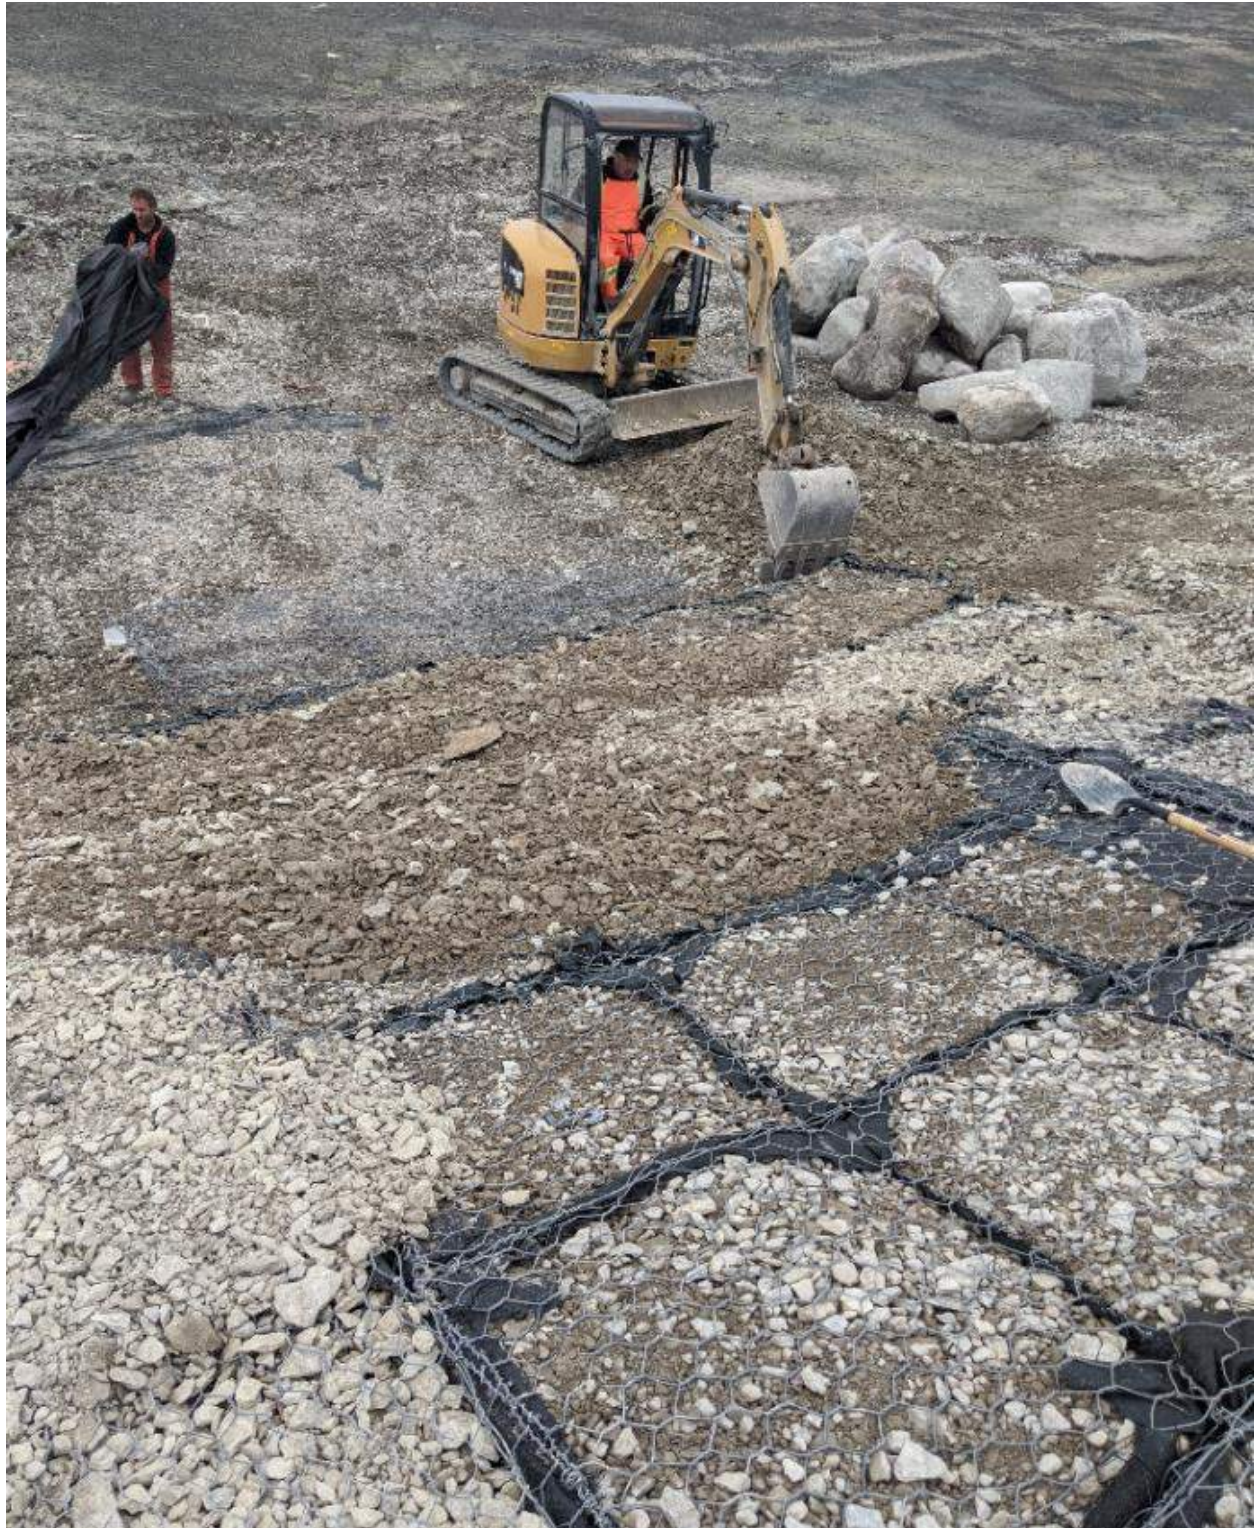
Photograph #2:The day was spent installing gabion cages at the south discharge station.

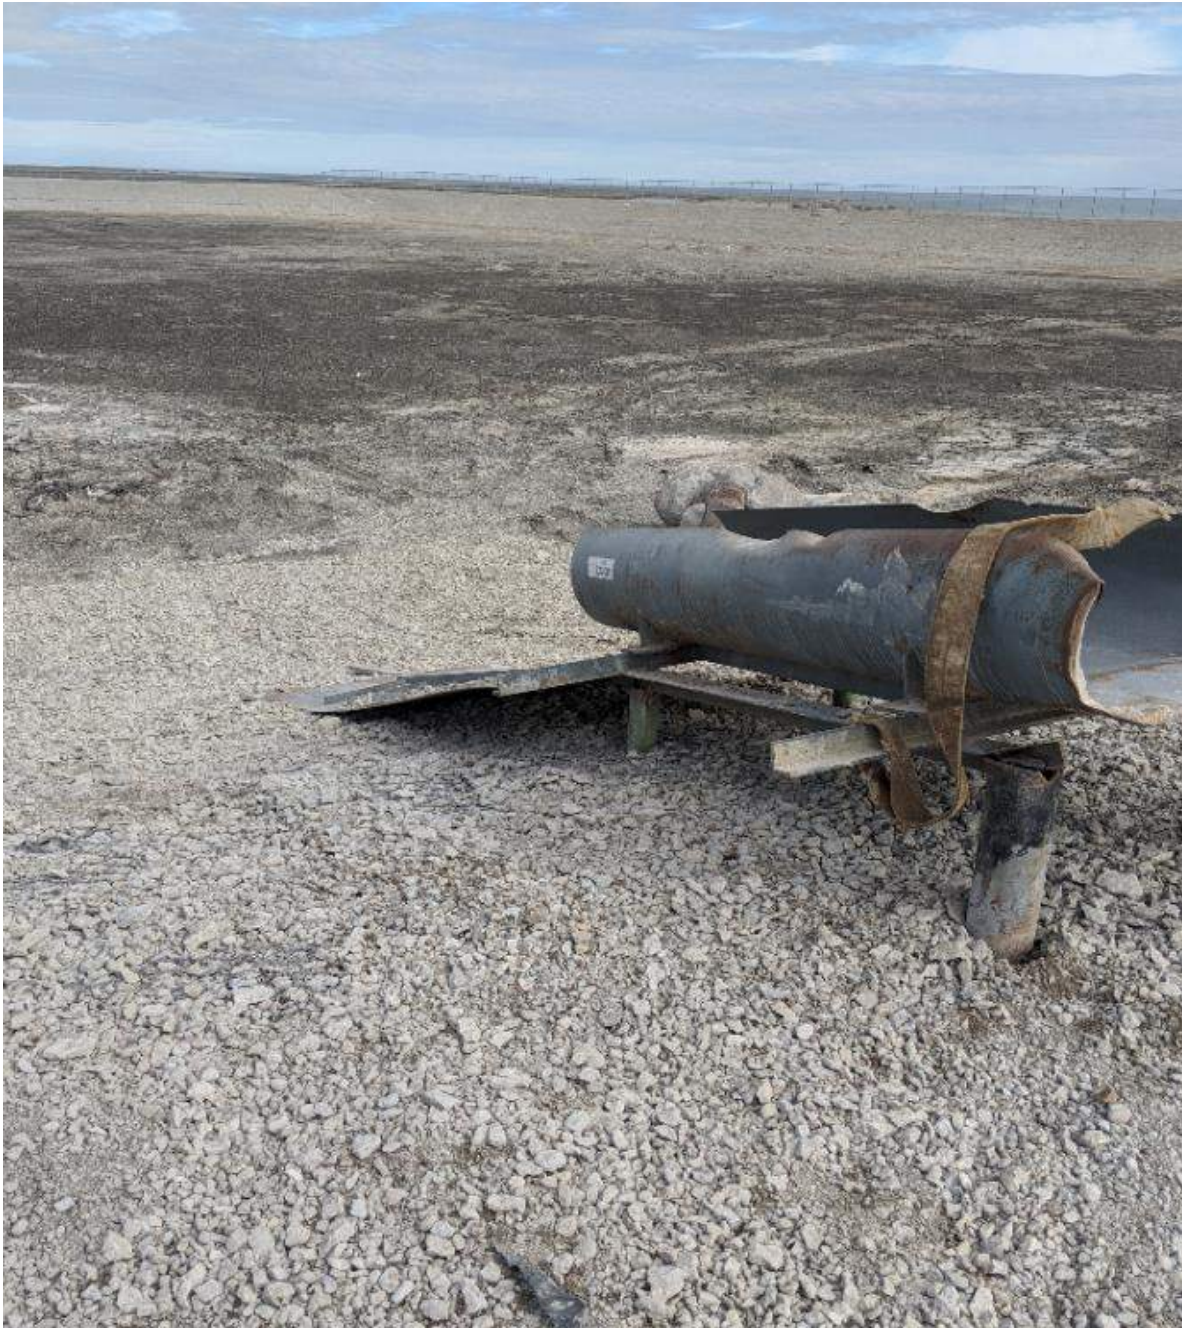
Photograph #1: The south discharge station's chute was placed onto its piles, but. The granular material is shaped over the gabion cages, and the riprap at the bottom of the chute will be installed once the chute is welded in place.

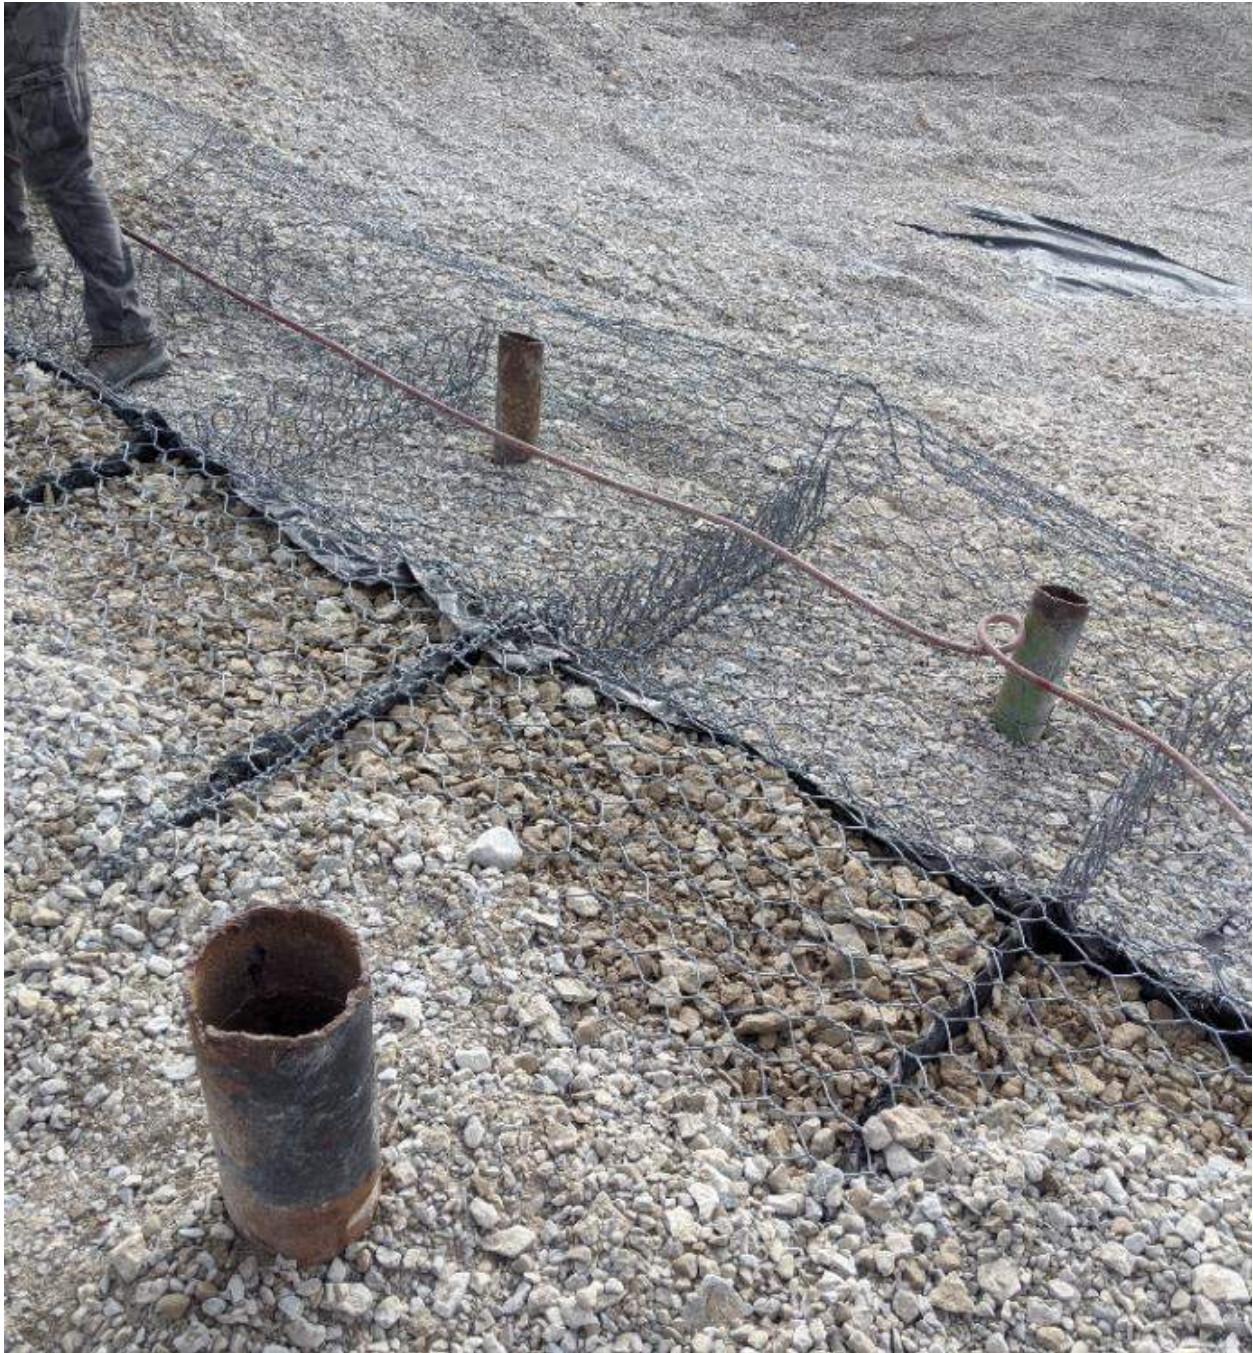
Photograph #1: Gabion cages installation at north discharge station.

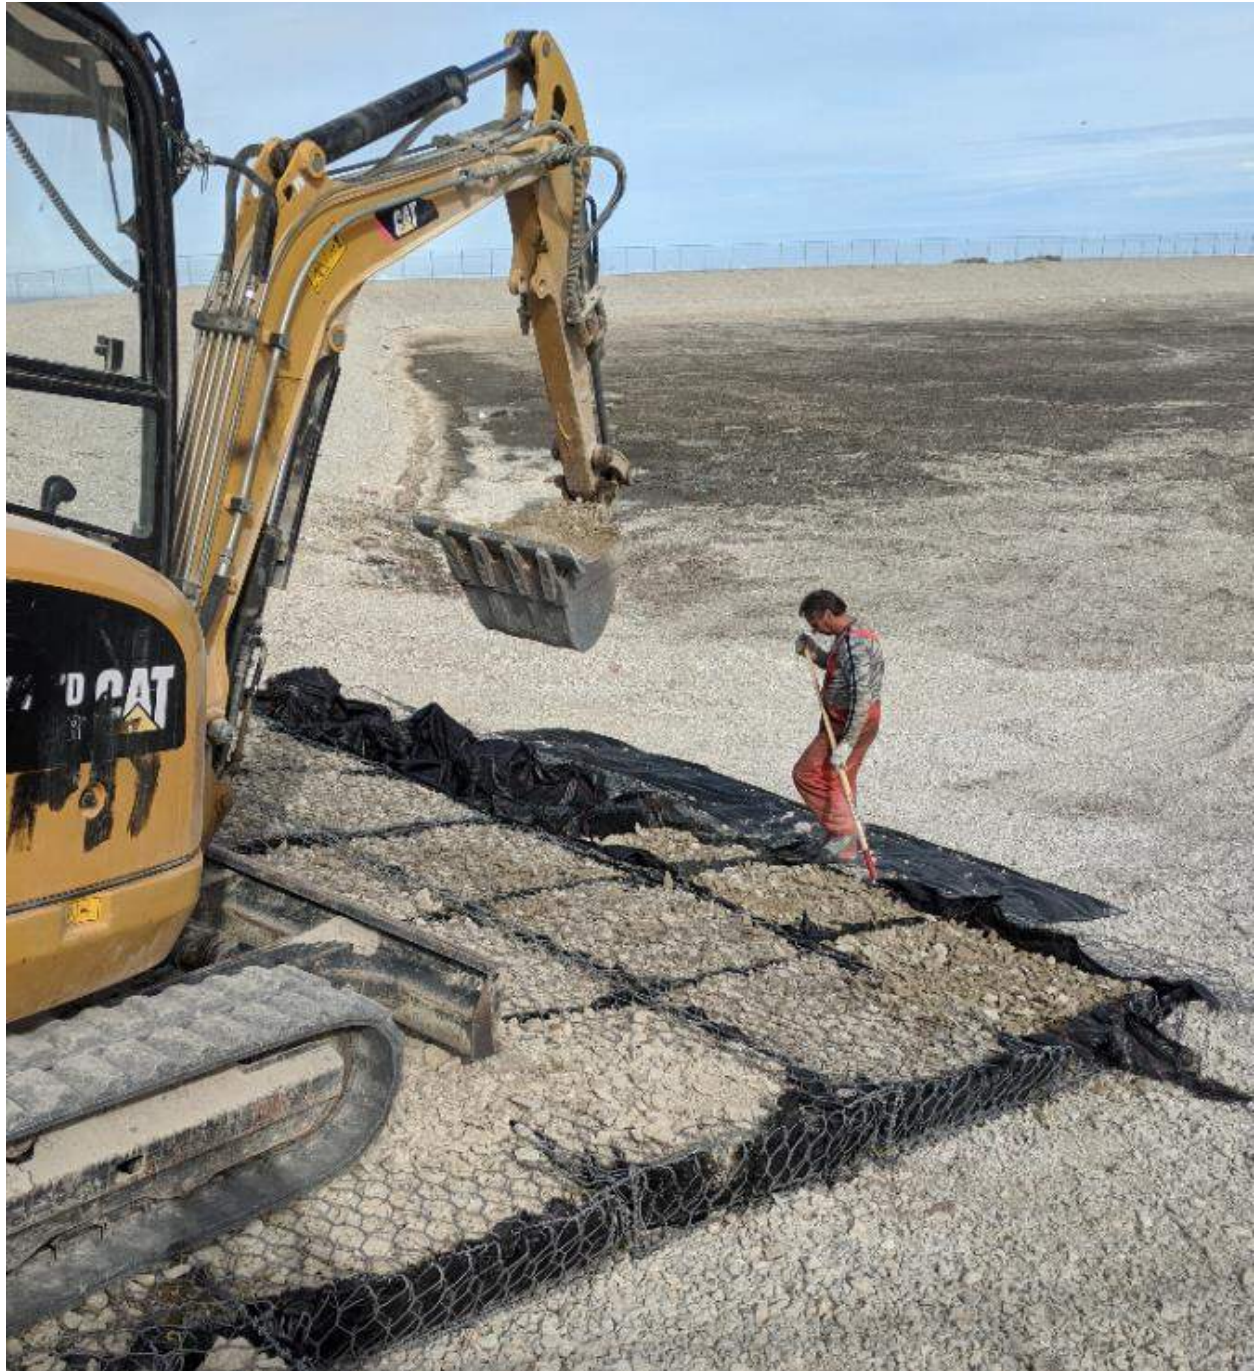
Photograph #2: Filling of lined gabion cages with granular material.

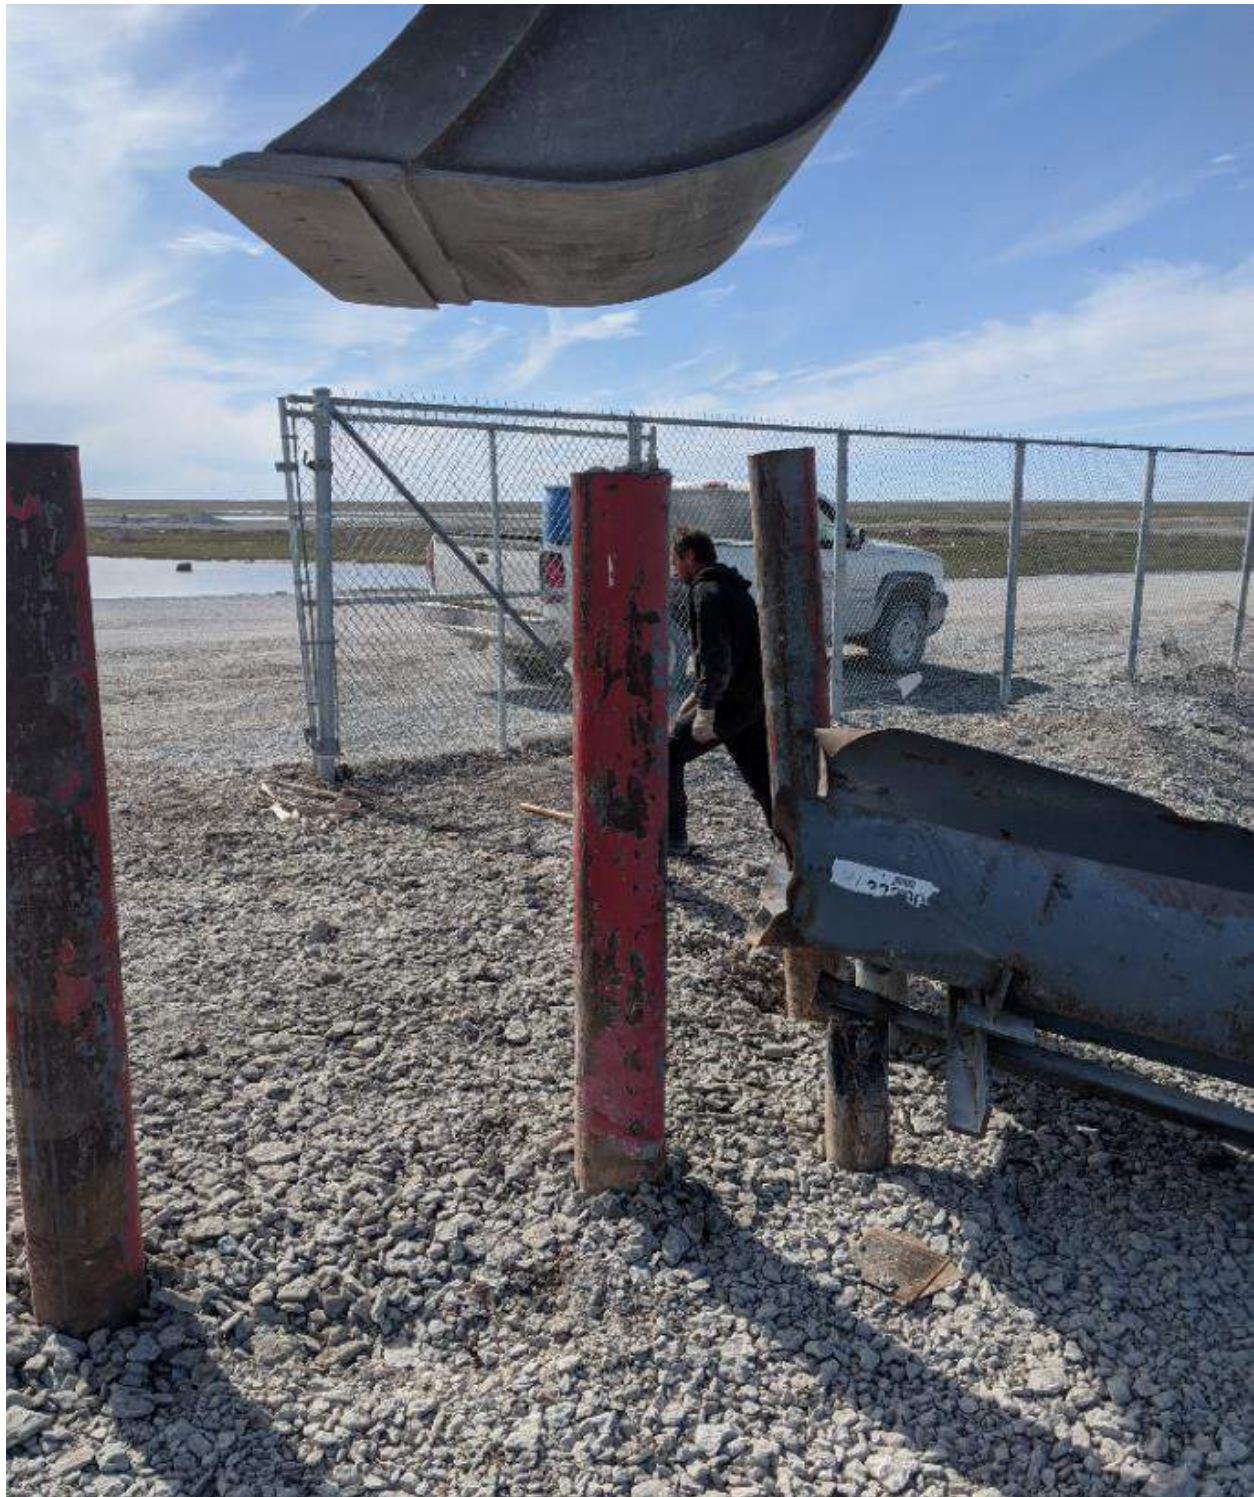
Photograph #1: Installation of the bollards.

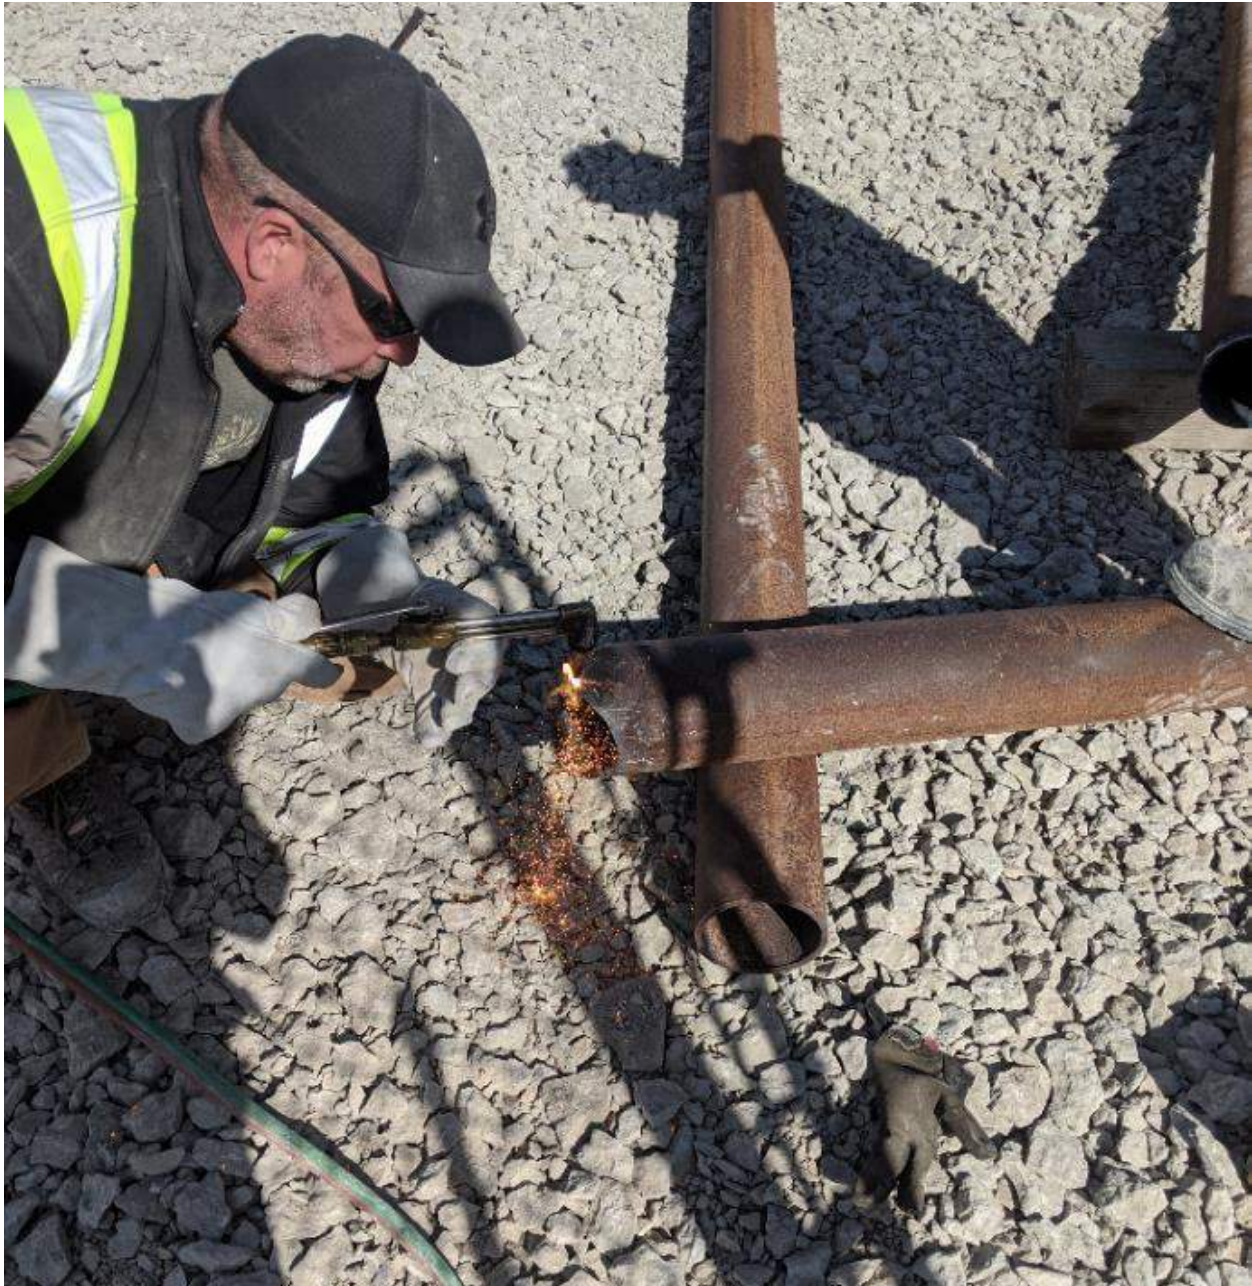
Photograph #2: Torch cutting of the pieces for the truck bumper at the south discharge station.

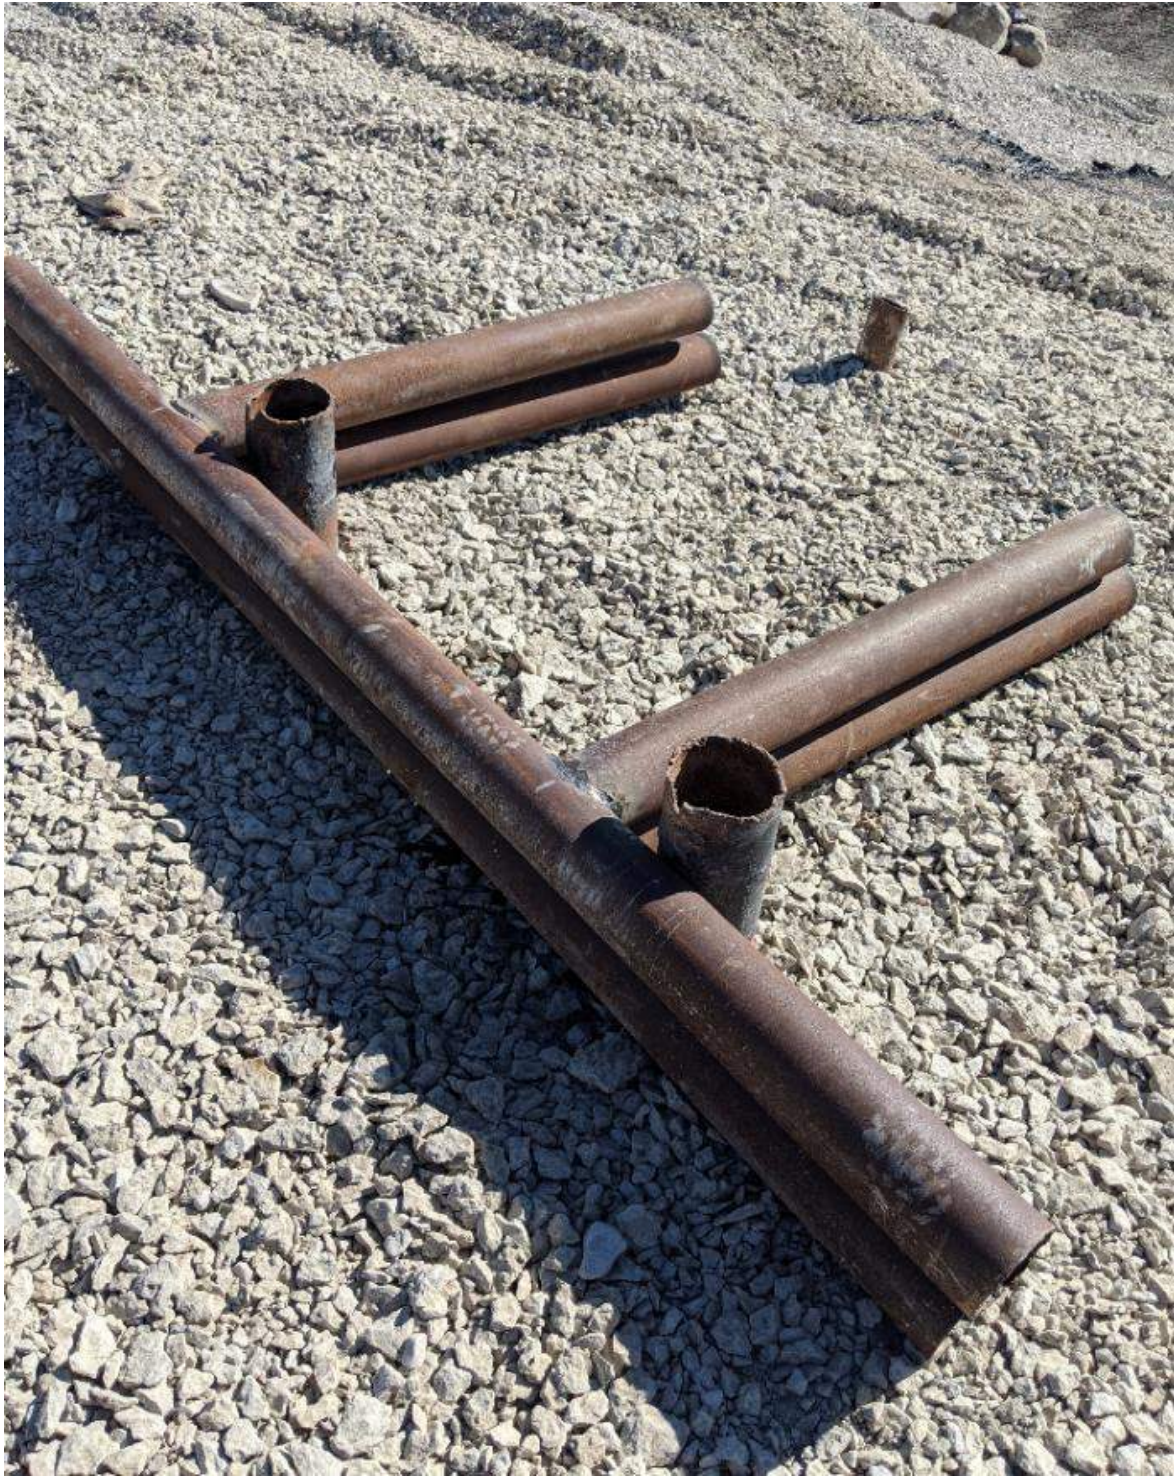
Photograph #1: Final design of the truck bumper (north station). The structure will eventually be moved so that the back end of the truck bumper, to the right in this picture, is against the front piles of the discharge station.

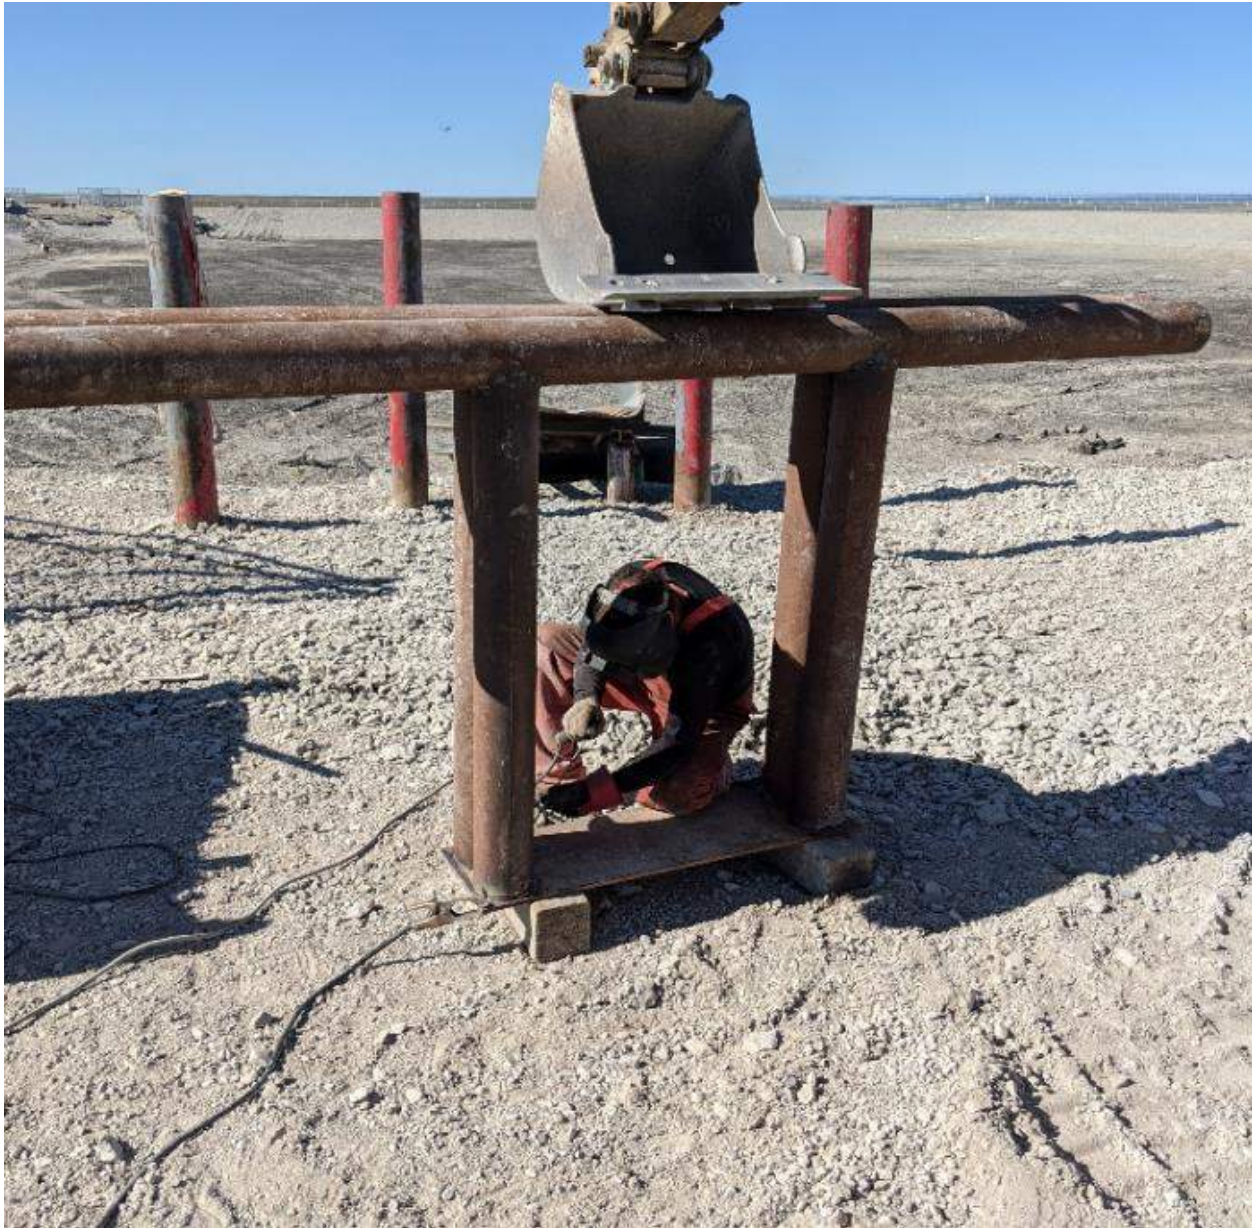
Photograph #2: Welding the truck bumper onto the 12 mm steel plate that will in turn connect to the discharge station piles.

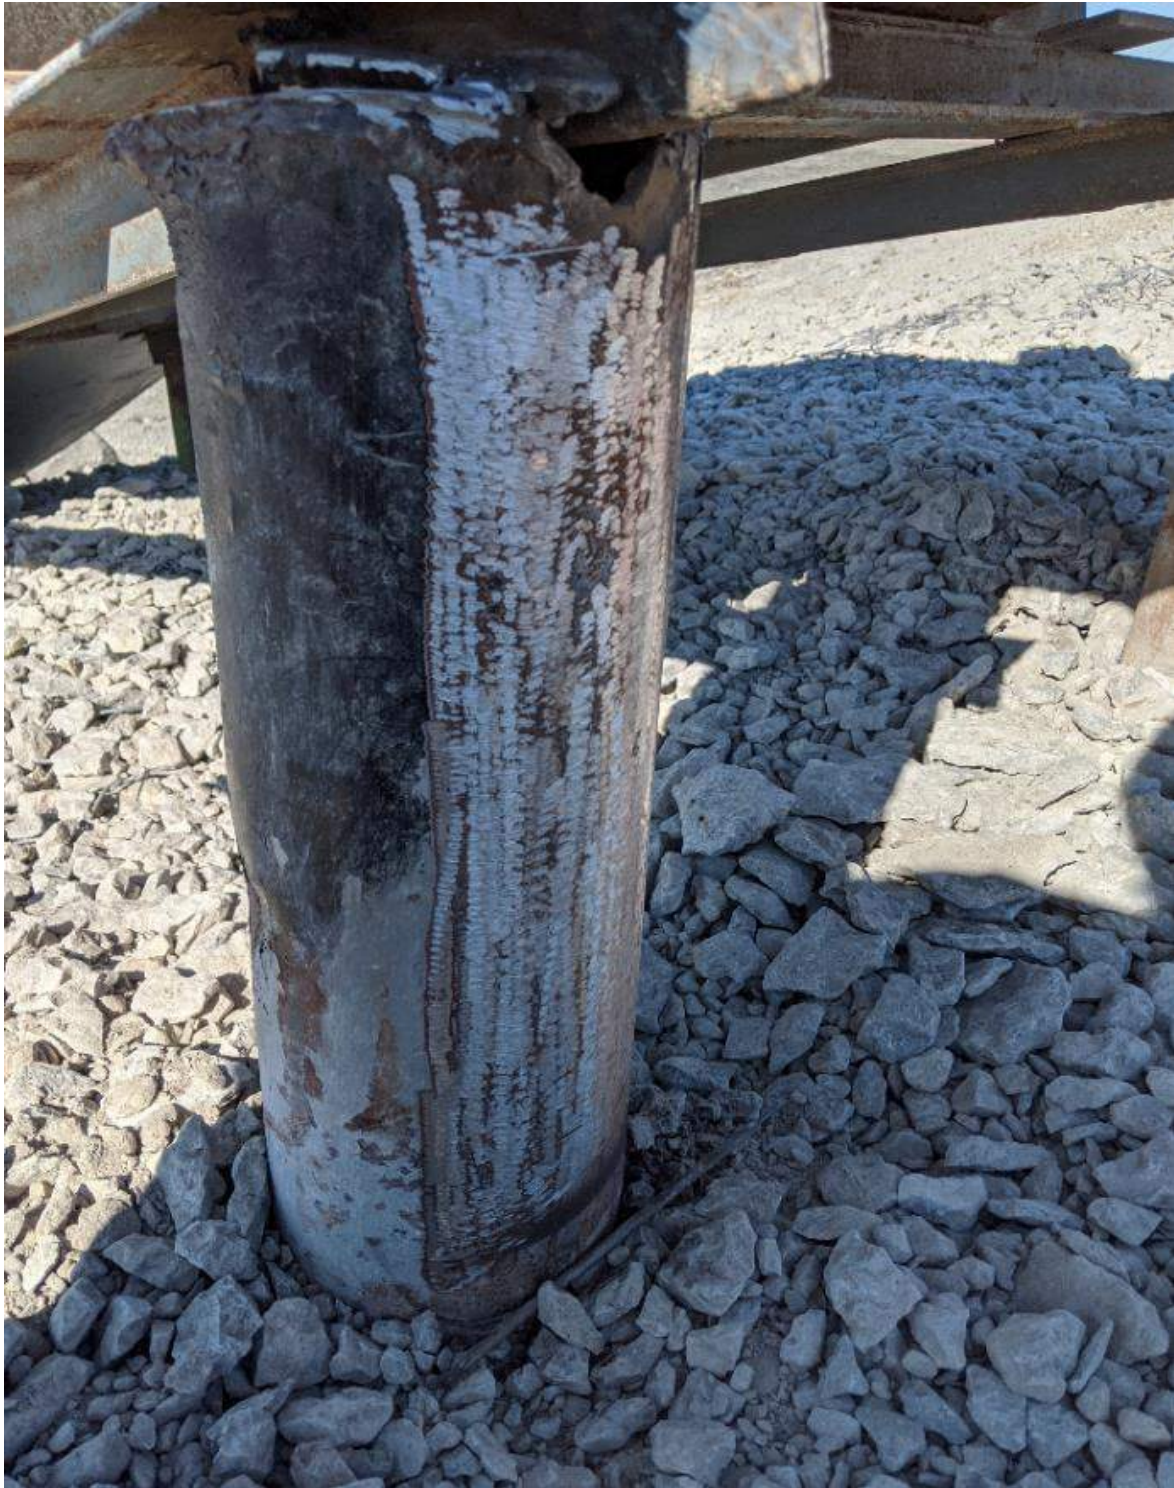
Photograph #3: The front o the piles was lightly grinded to remove paint and rust in preparation for the weld.

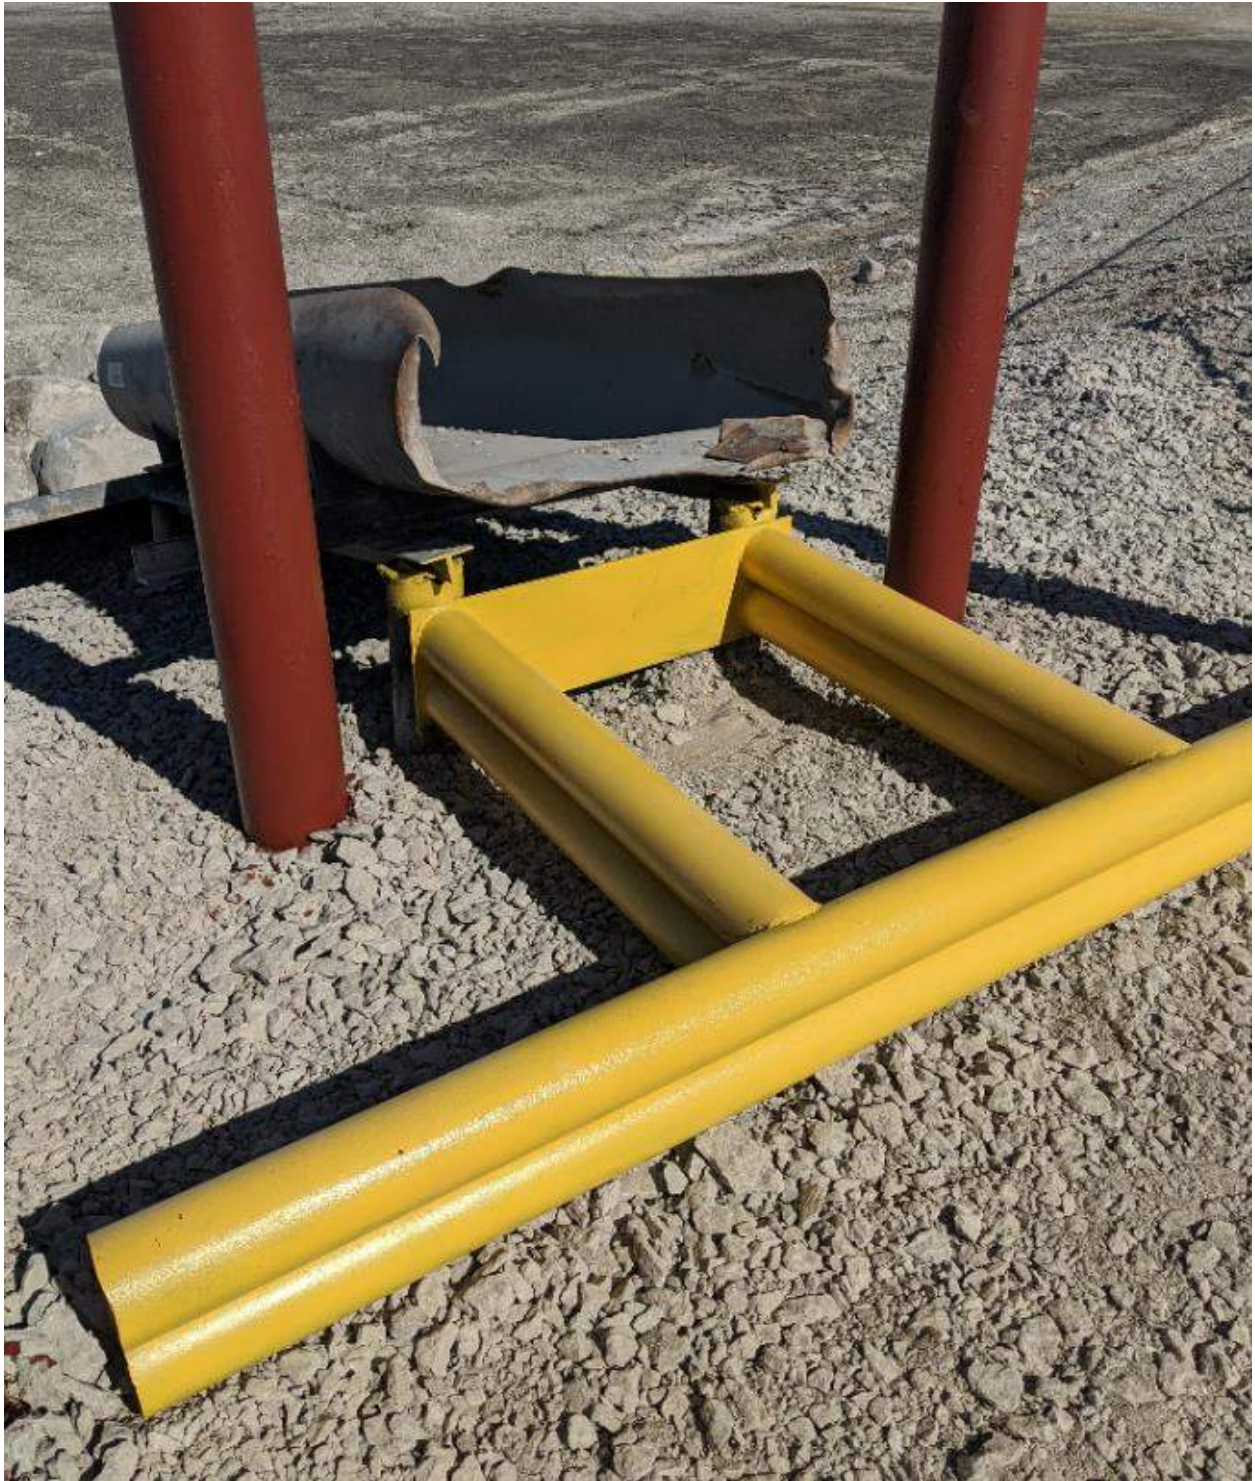
Photograph #1: The bumper at the south discharge station, installed and painted. Preference would have been for red paint to match the bollards, but the contractor could only obtain enough red paint to touch up the bollards themselves.
