Summary of Work – Hall Beach 2020 Field Season

Final Report

Hall Beach Sewage Lagoon
Change Order No. 5 & Leak Detection/Resolution

OTT-220382

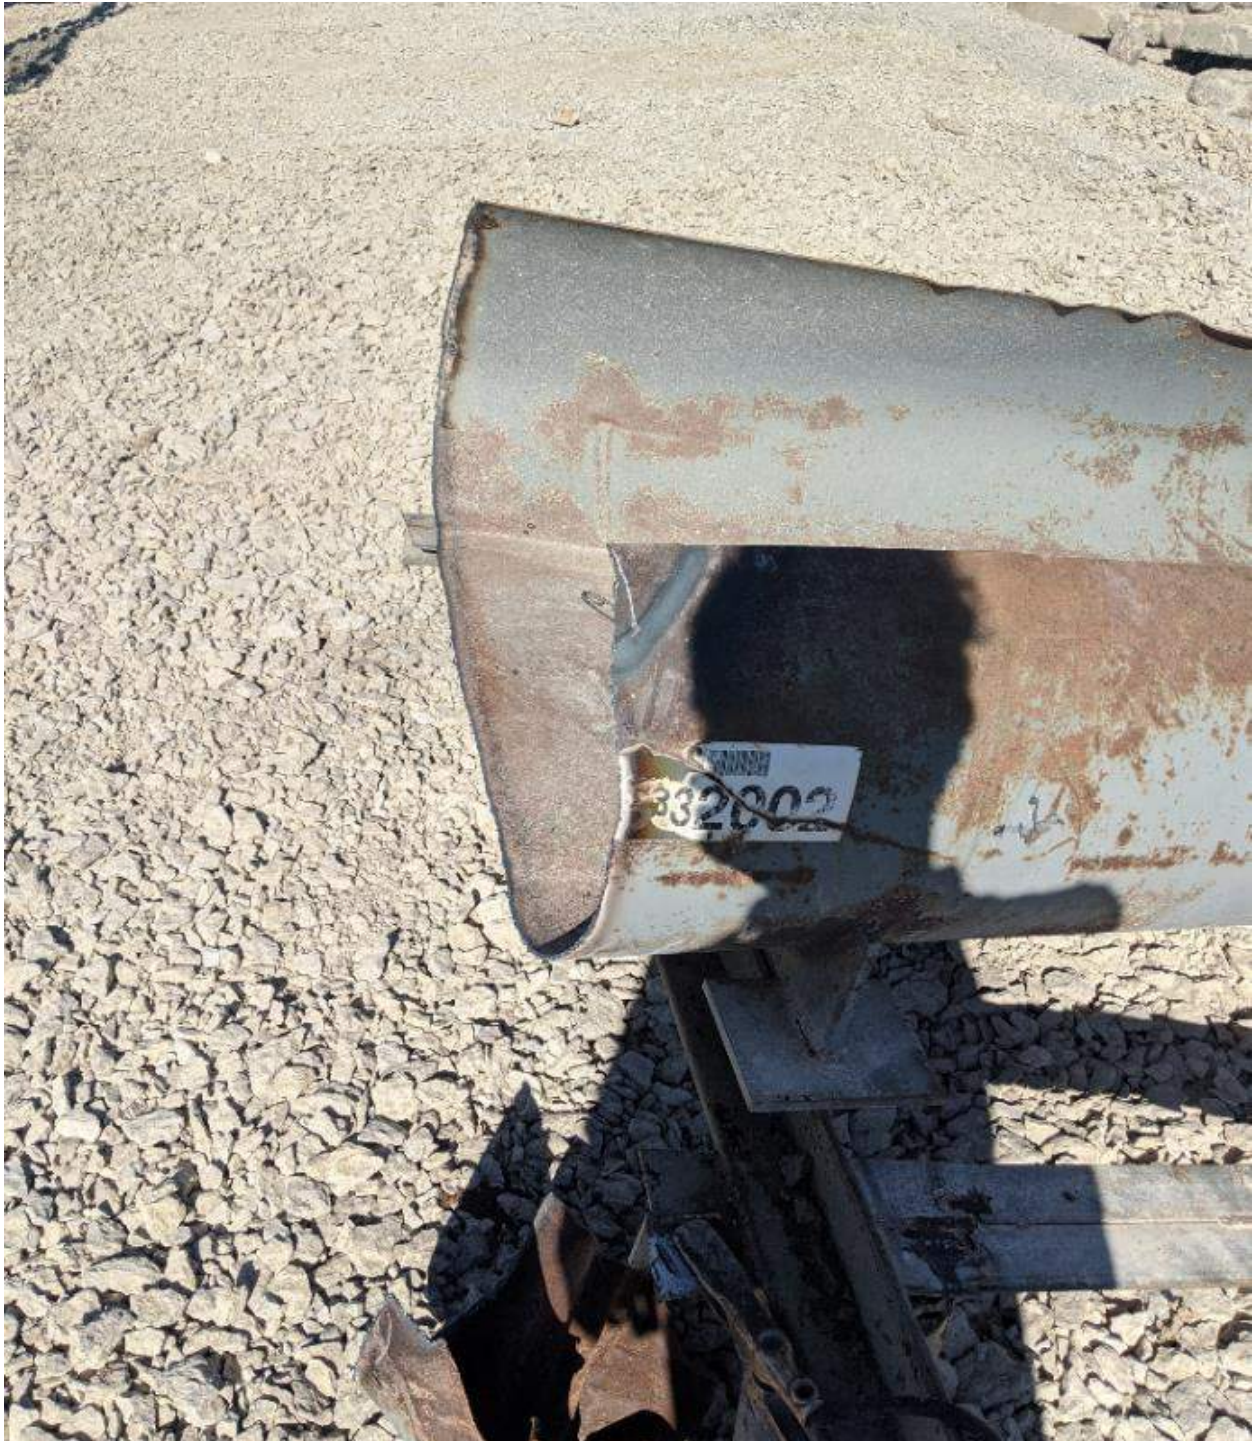
Photograph #2: The crumpled metal at the front of the chute at the north discharge station was cut off, leaving a straight edge.

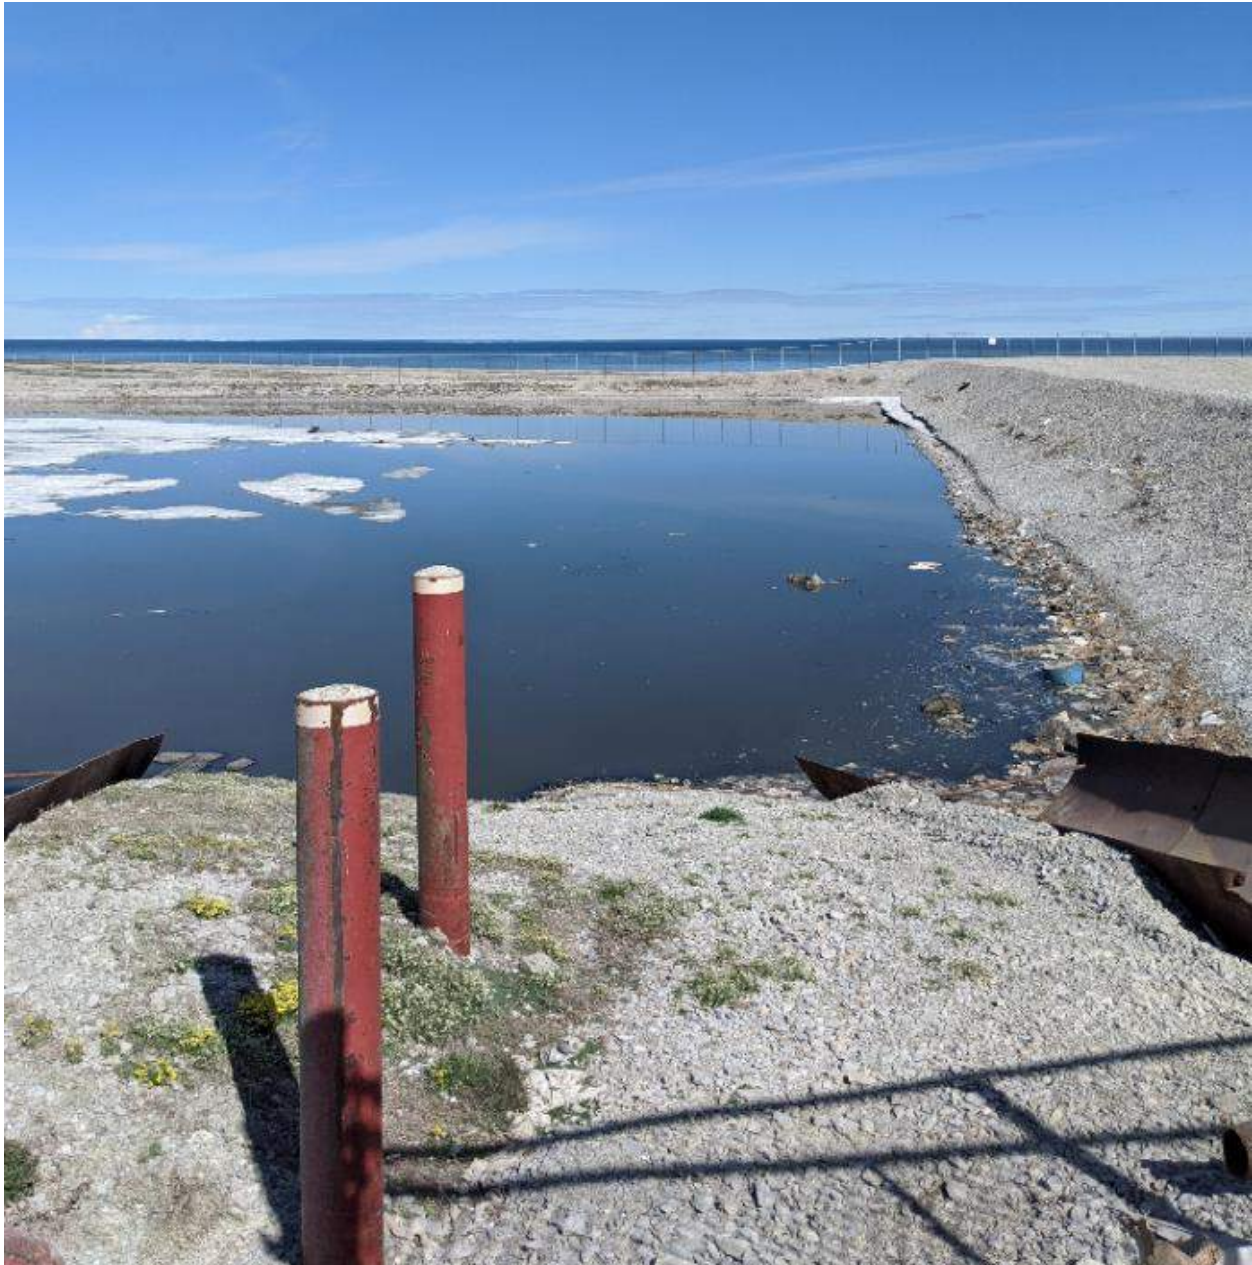
Photograph #3: While the angle is not ideal, this picture shows the water level in the north cell on July 11th.

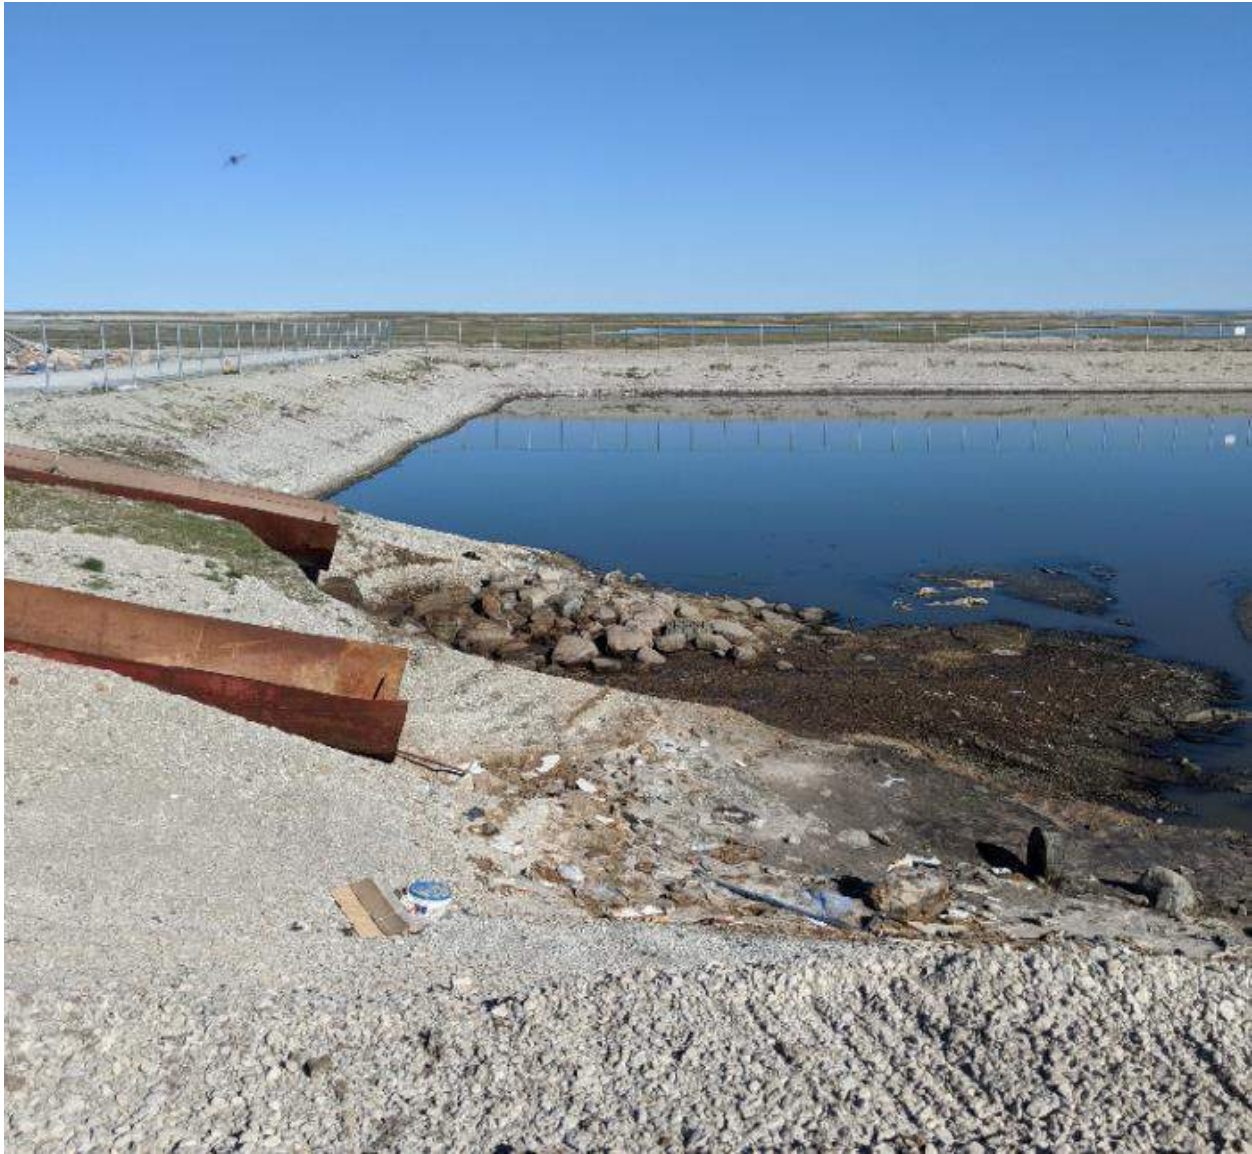
The north cell of the lagoon, which is expected to become the source of water for leak testing of the south cell, was noted to have a water level far below what was observed previously. While some drop in the water level is expected as part of the cell's normal operation, the significant drop raises concerns as to whether there will be enough water in the cell to draw from during the testing process.

Photograph #4: The north cell's water level has dropped significantly. This picture was taken July 24th, 13 days after Photograph #3. The water level has dropped by about a meter.

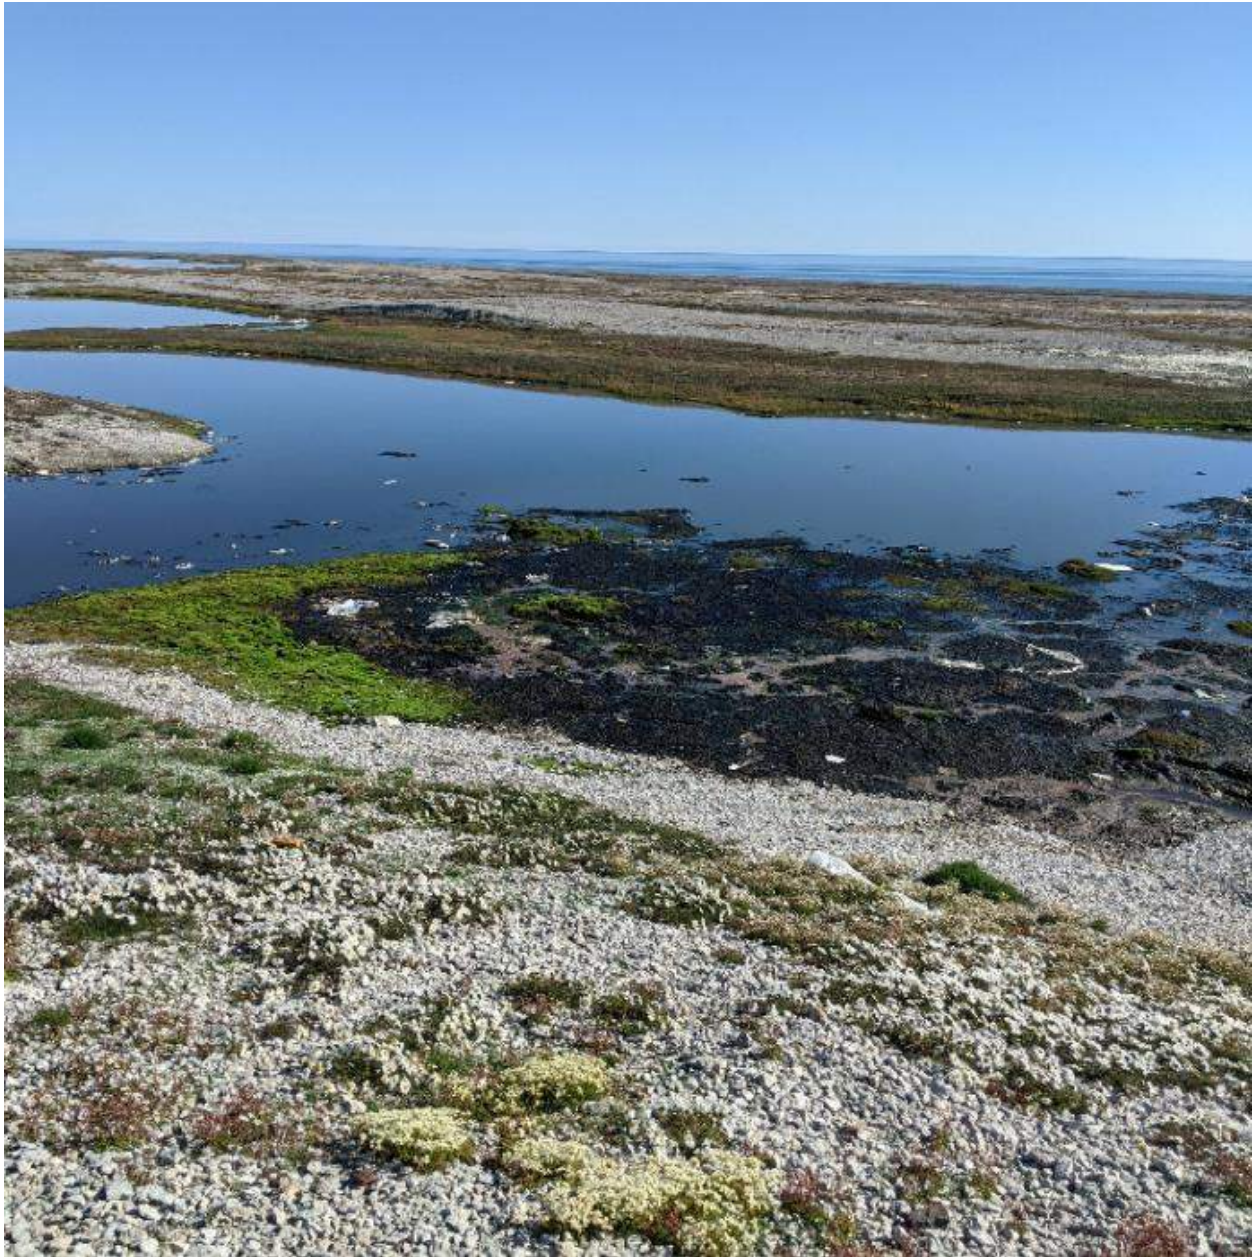
Photograph #5: There is an accumulatio of black matter outside the north cell's northeast corner. The water level in the area is also at or higher than the level where the water was coming out of the ground in this area. It is difficult to tell whether there is still water coming from the ground, and in what quantity.

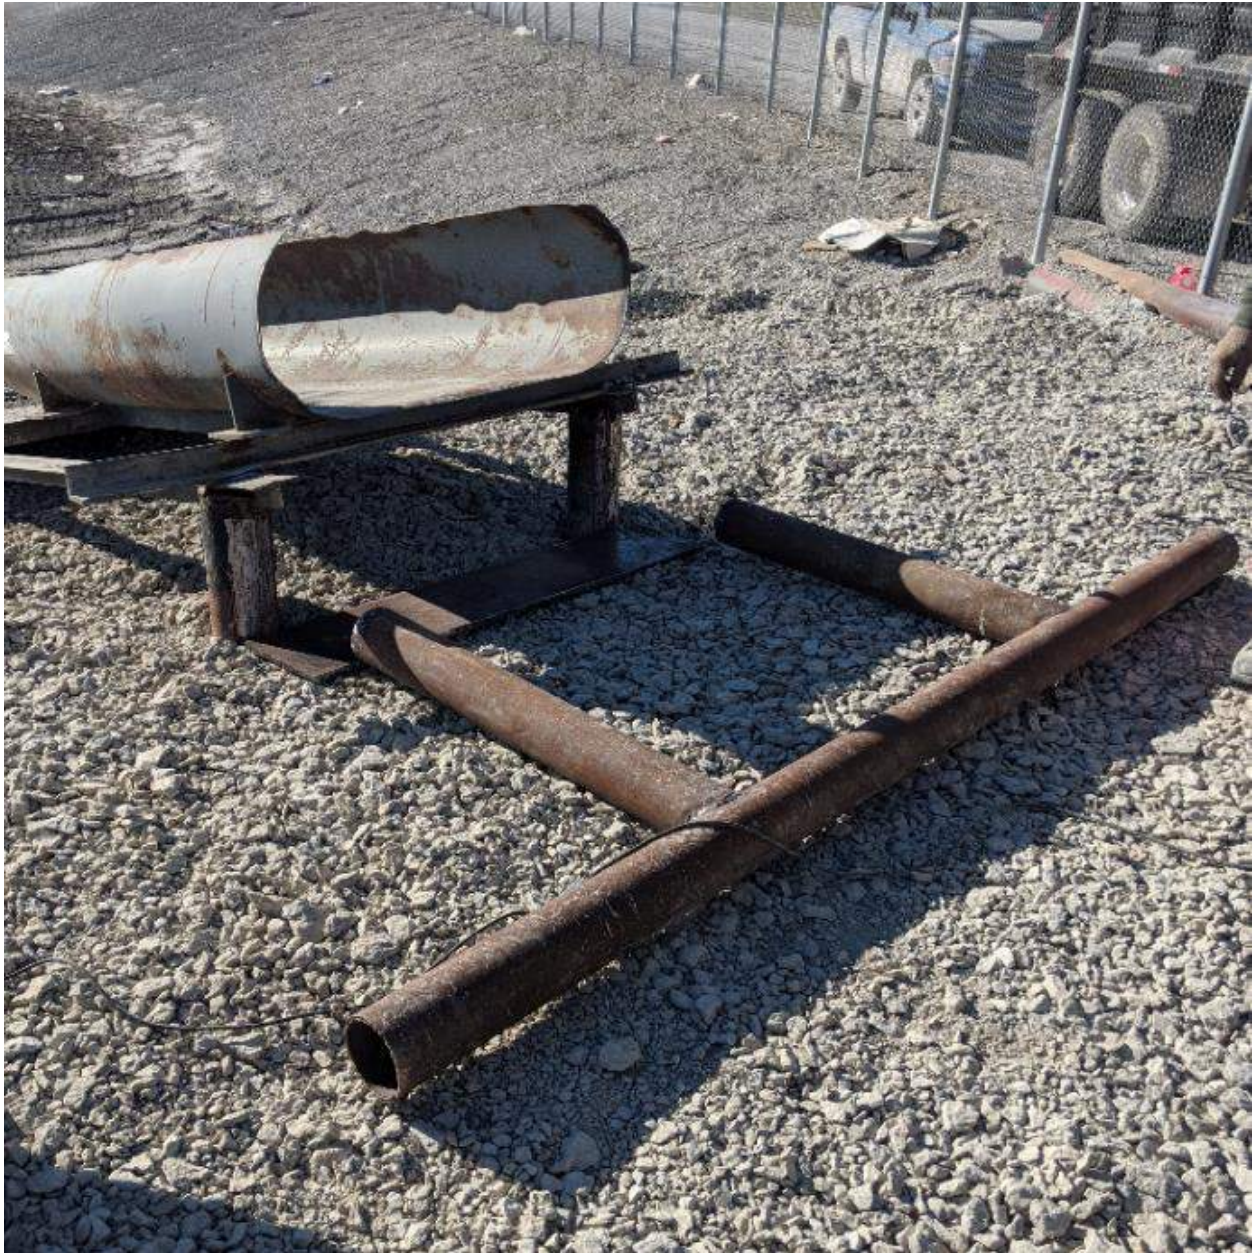
Photograph #1: Various pieces of the truck bumper prior to assembly onto the discharge station piles.

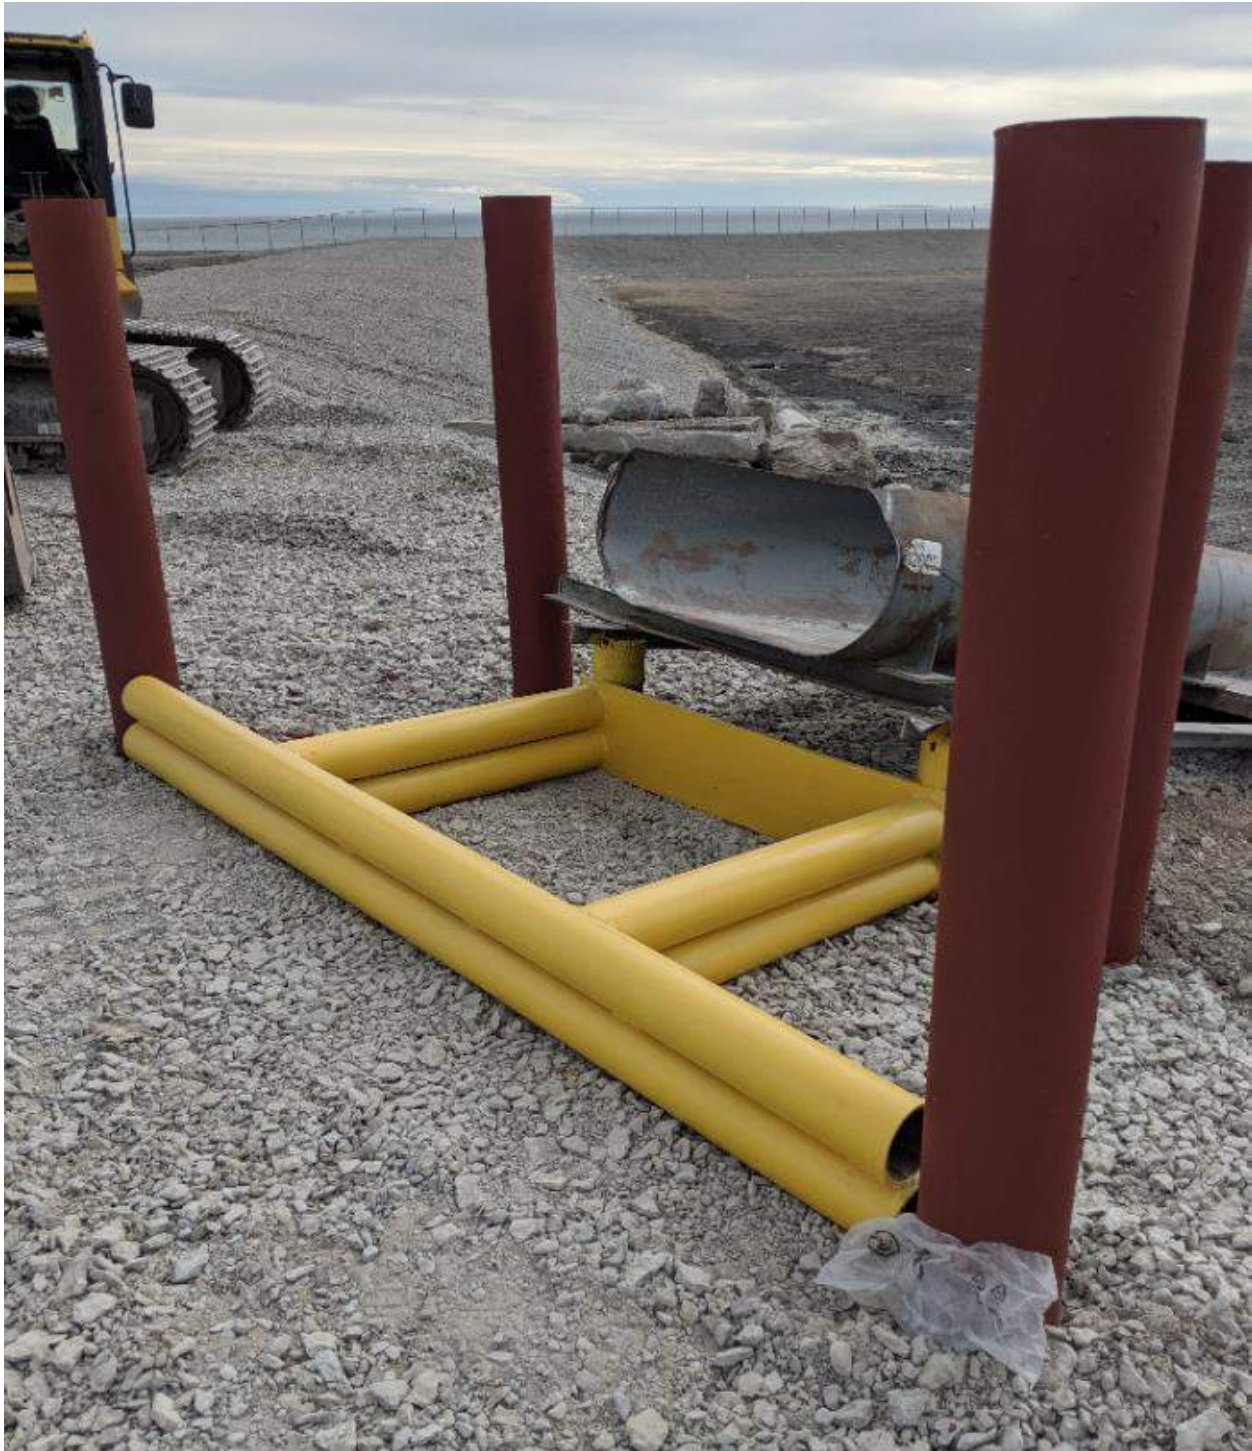
Photograph #2: Final configuration of discharge station, with bollards and truck bumper installed and painted.

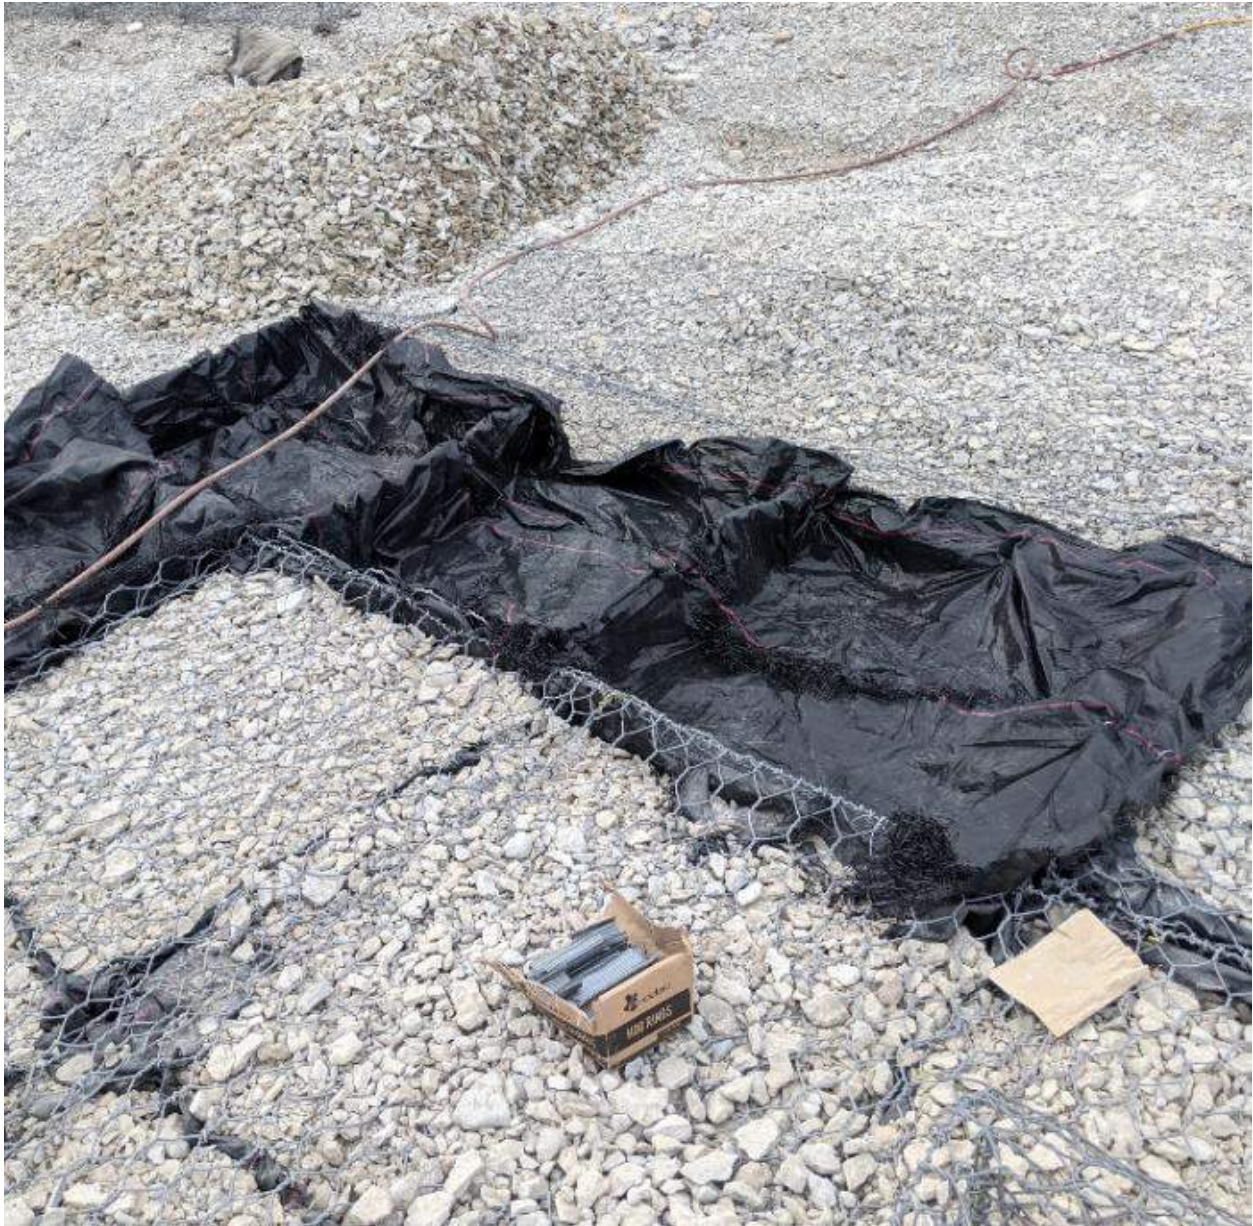
Photograph #1: Lined cages ready to be filled.

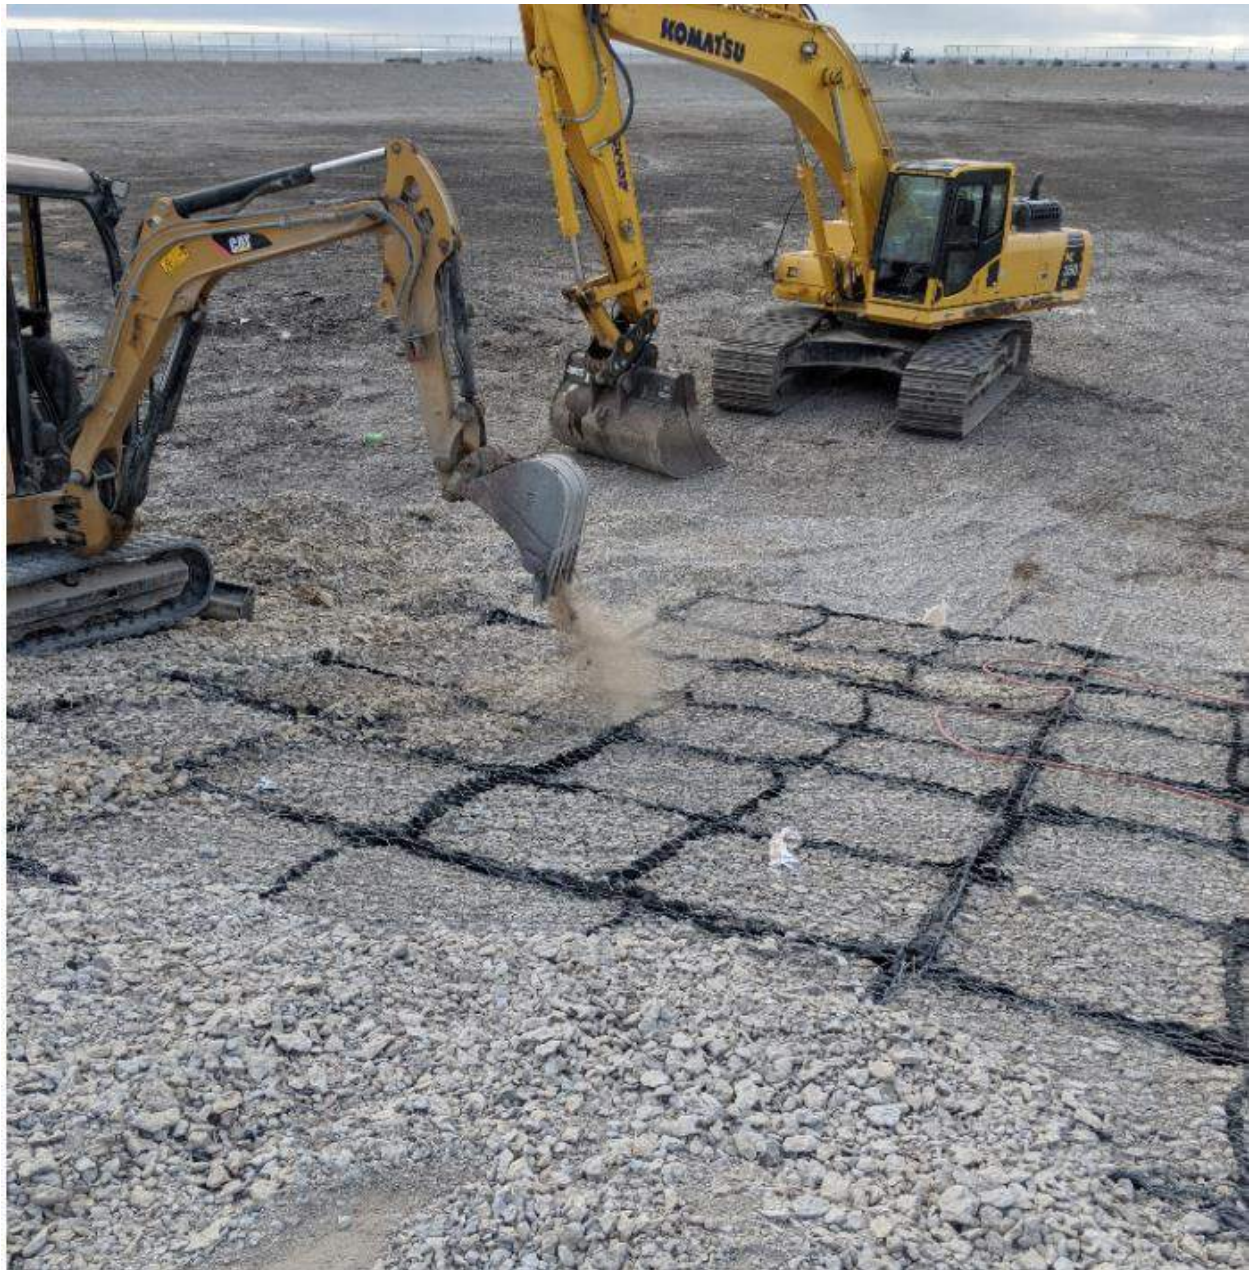
Photograph #1: Covering the newly installed gabion mat with a thin layer of aggregates.

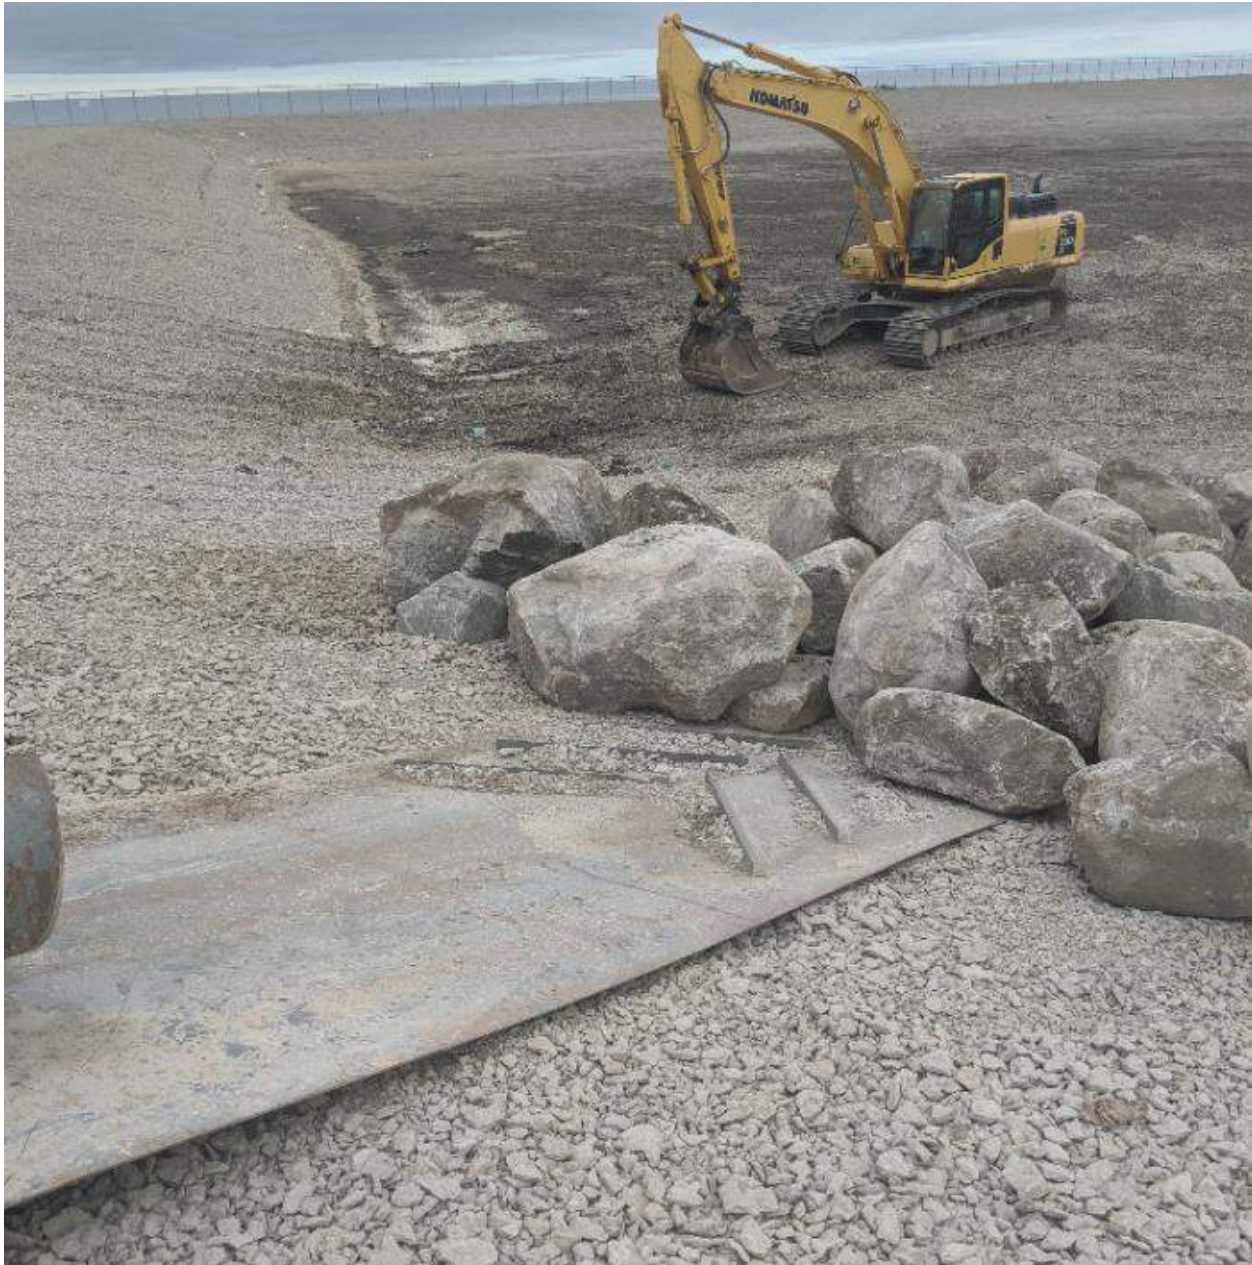
Photograph #2: Riprap placed at the bottom of the chute.

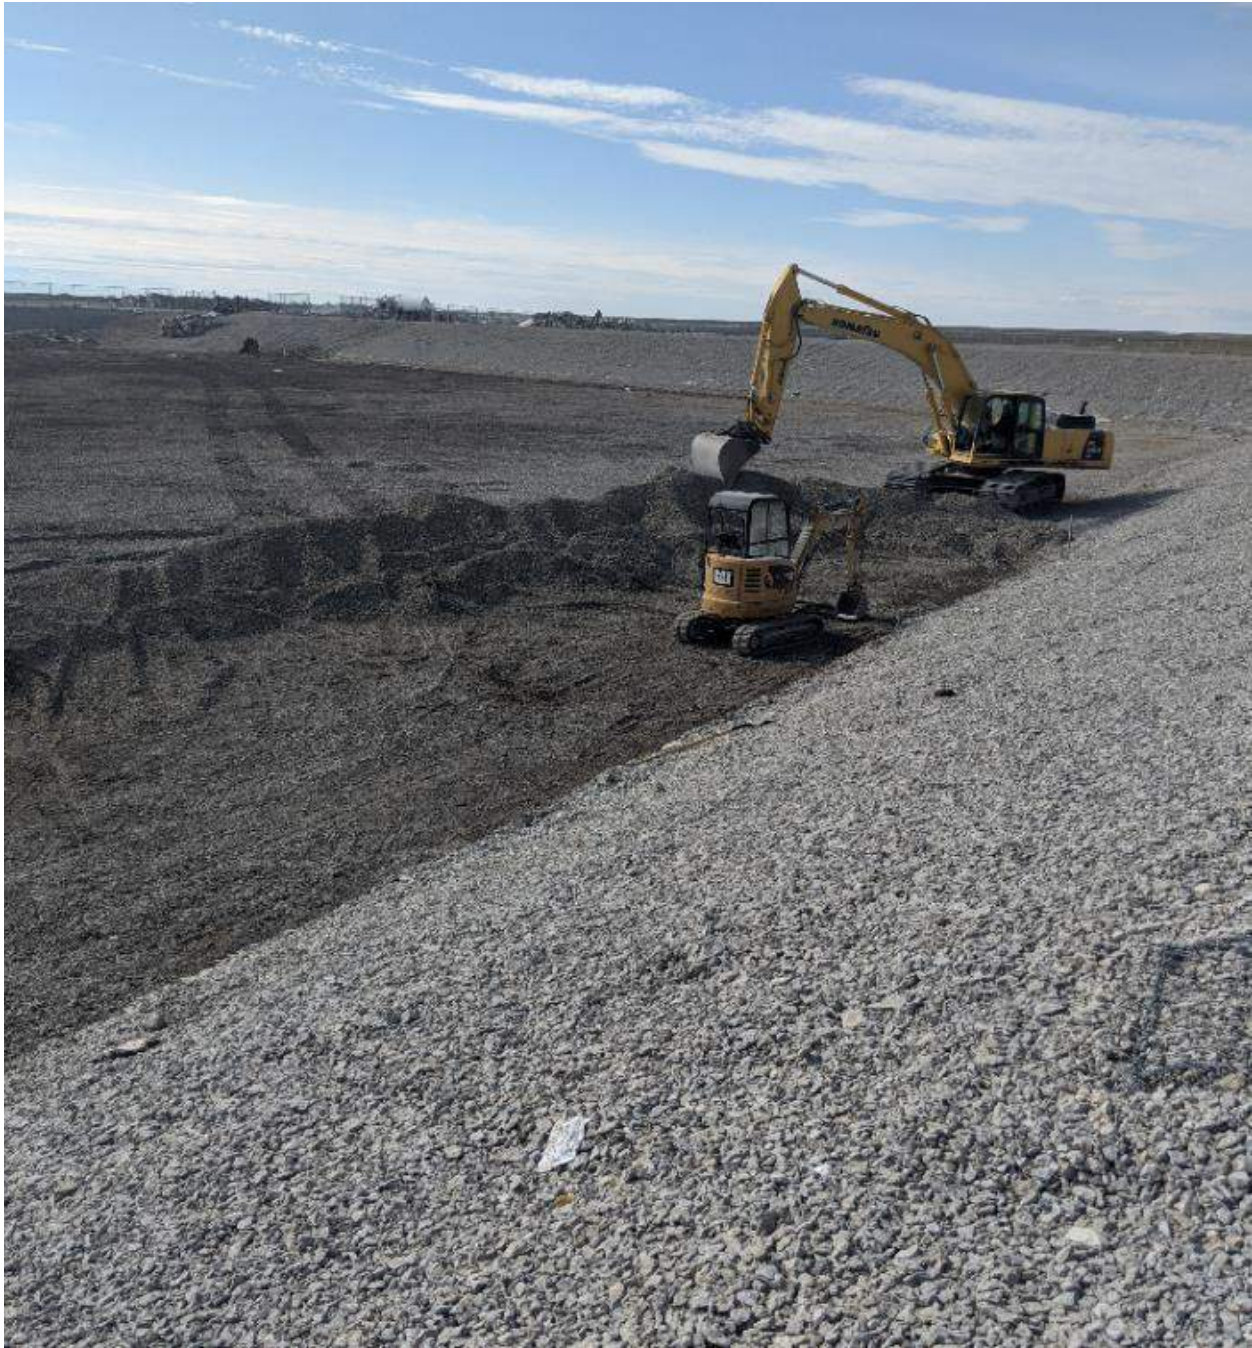
Photograph #2: Clearing aggregate from along the East berm of the south cell.

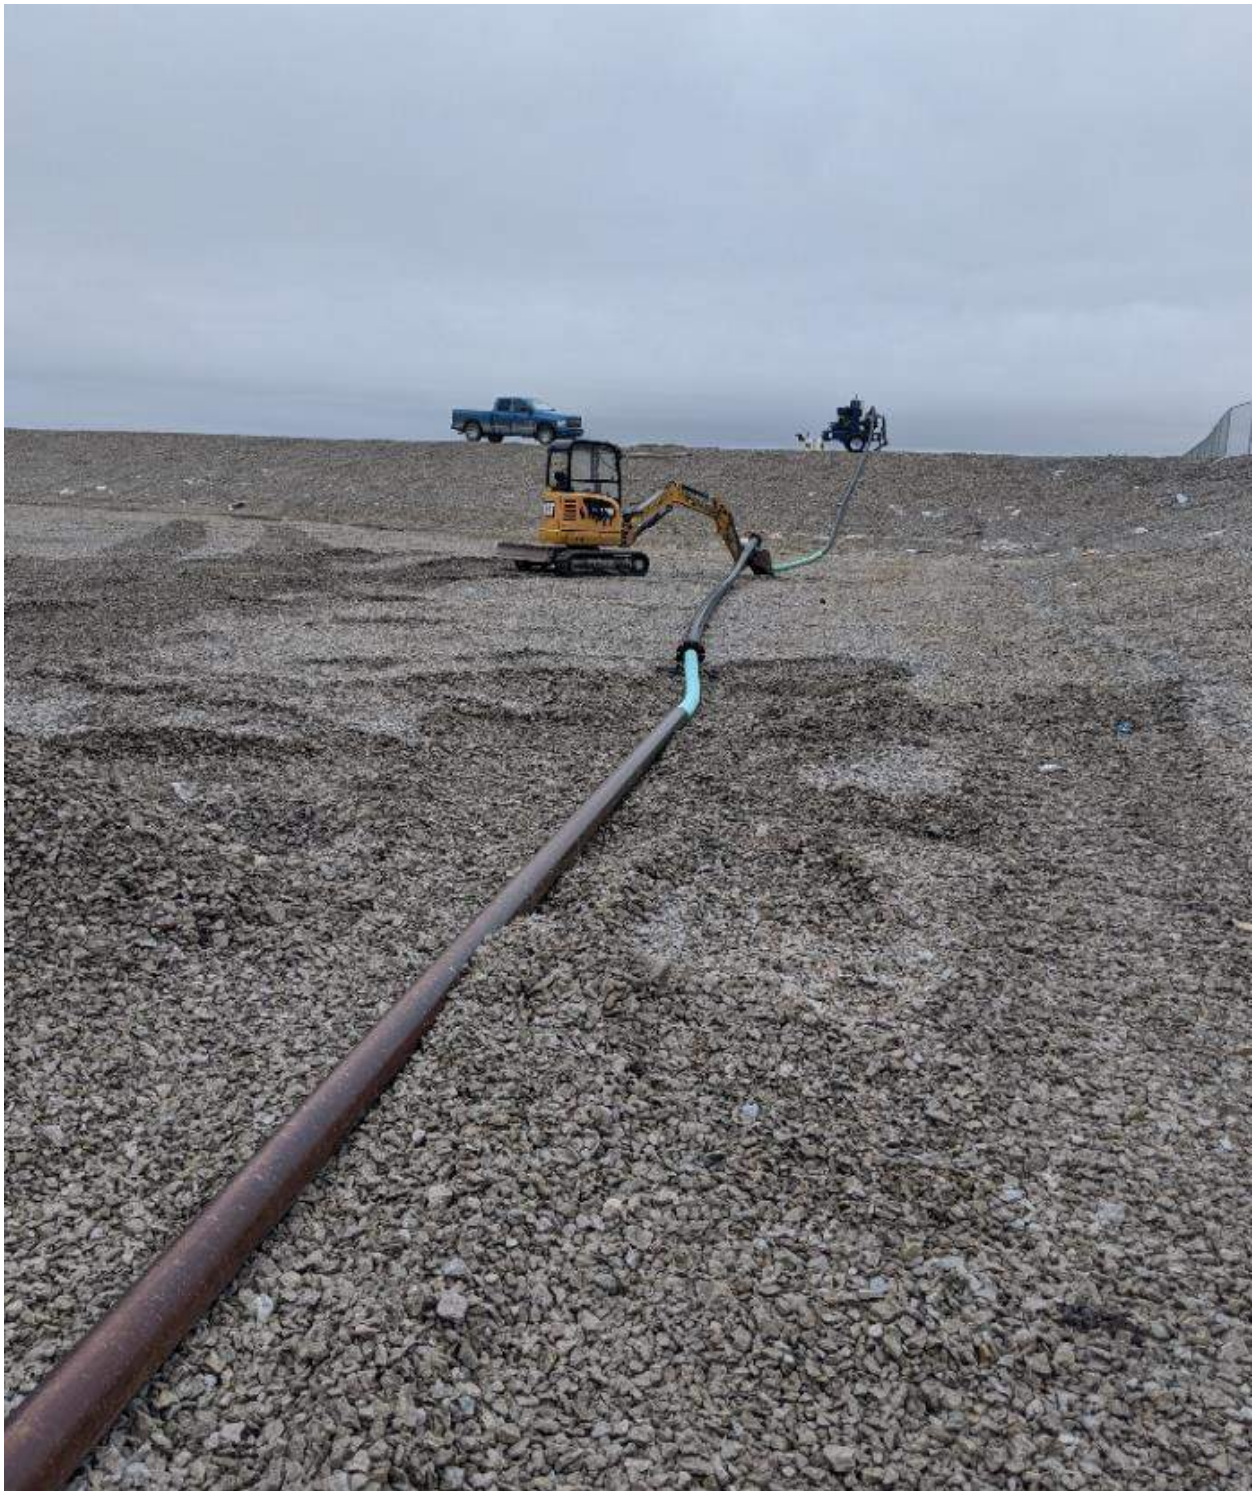
Photograph #1: Pump, with series of hoses leading to the area to be flooded.

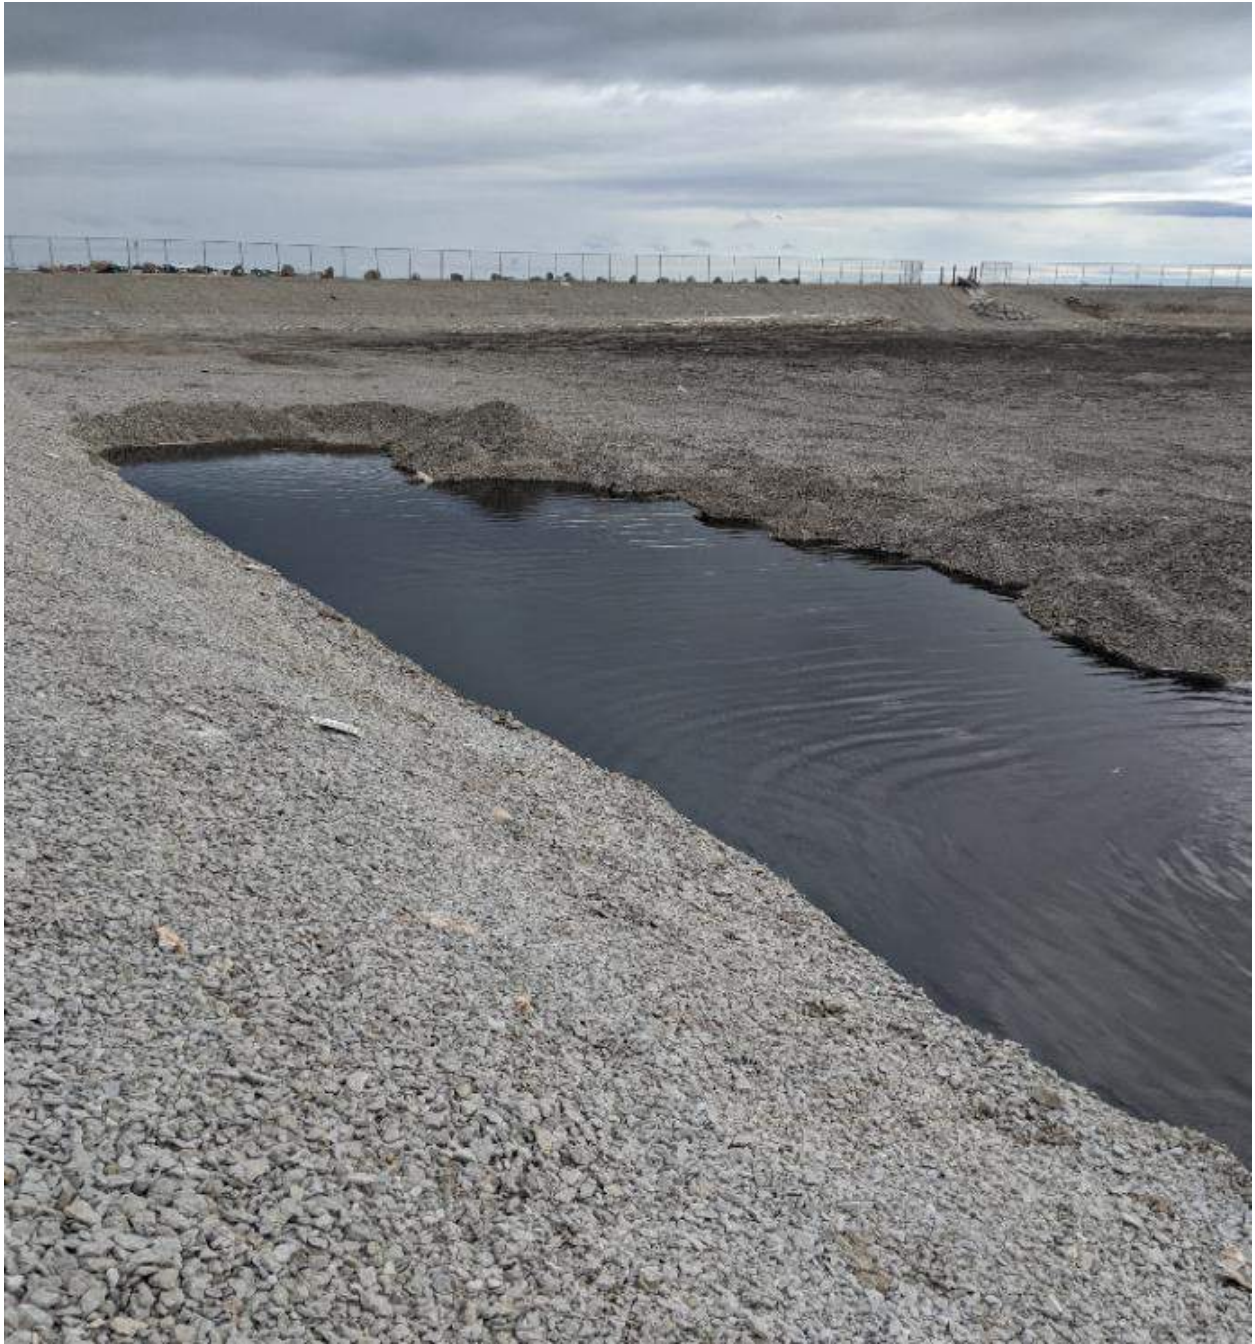
Photograph #3: Flooded lagoon as of the end of the day. Water depth is approximately 0.6m at the deepest.

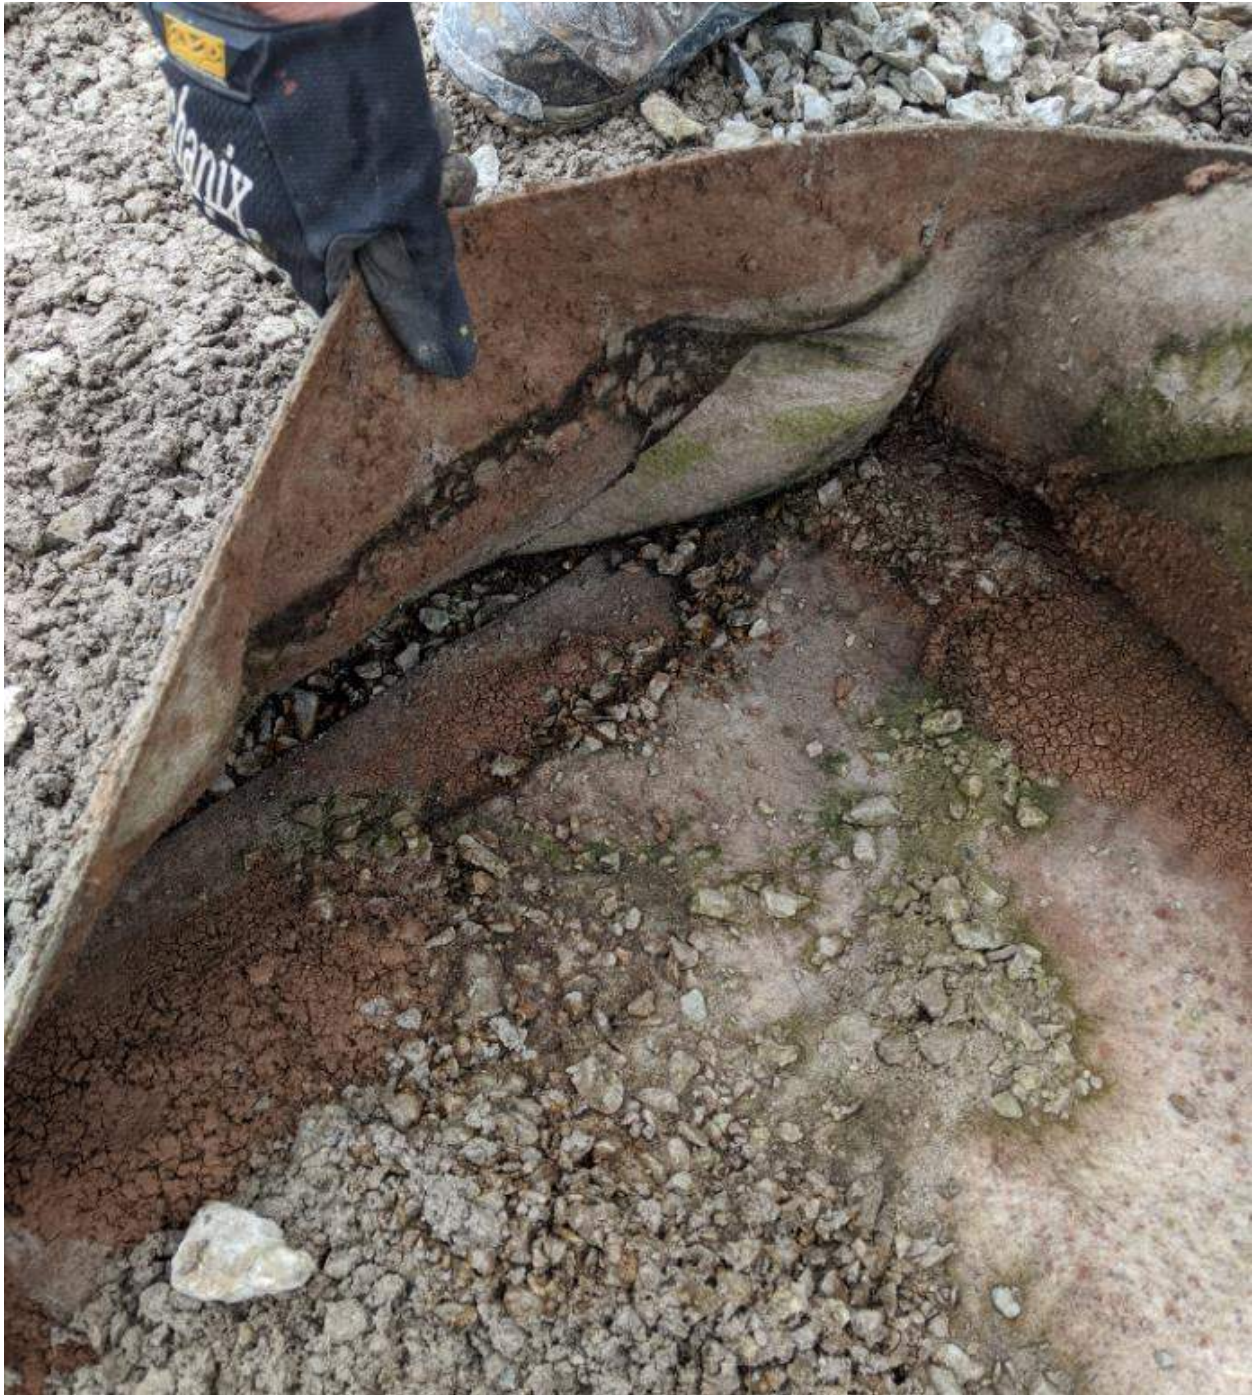
Photograph #6: Evidence of significant water flow under the liner, with algal growth suggesting this area was quite wet and nutrient-rich.
