Summary of Work – Hall Beach 2020 Field Season

Final Report

Hall Beach Sewage Lagoon
Change Order No. 5 & Leak Detection/Resolution

OTT-220382

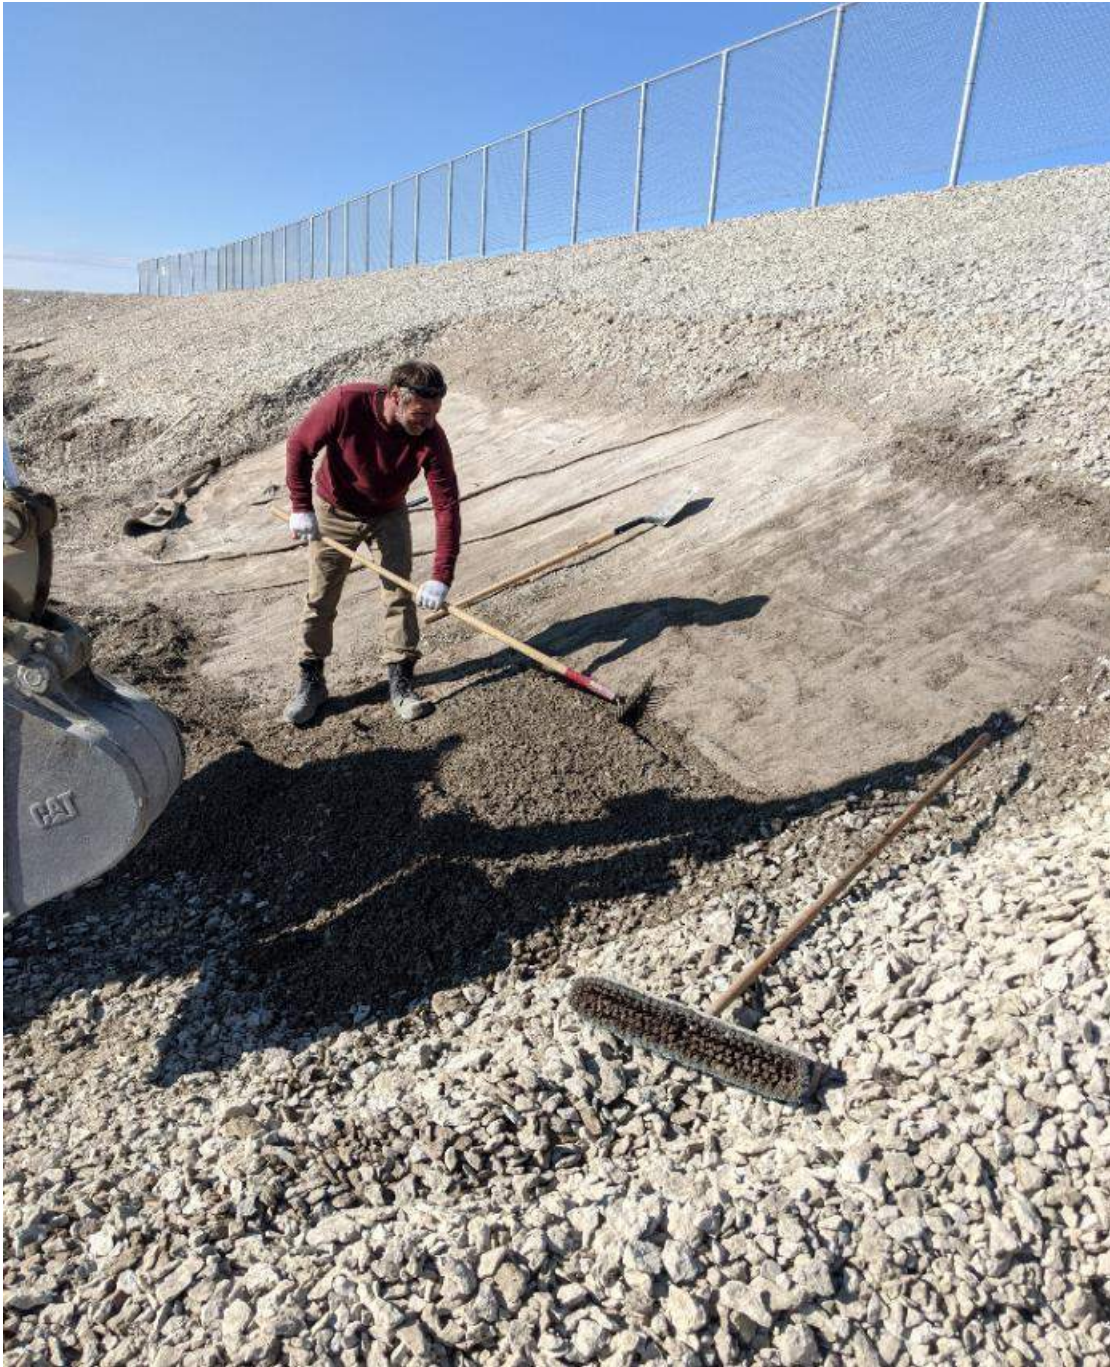
Photograph #3: Area exposed by end of day.

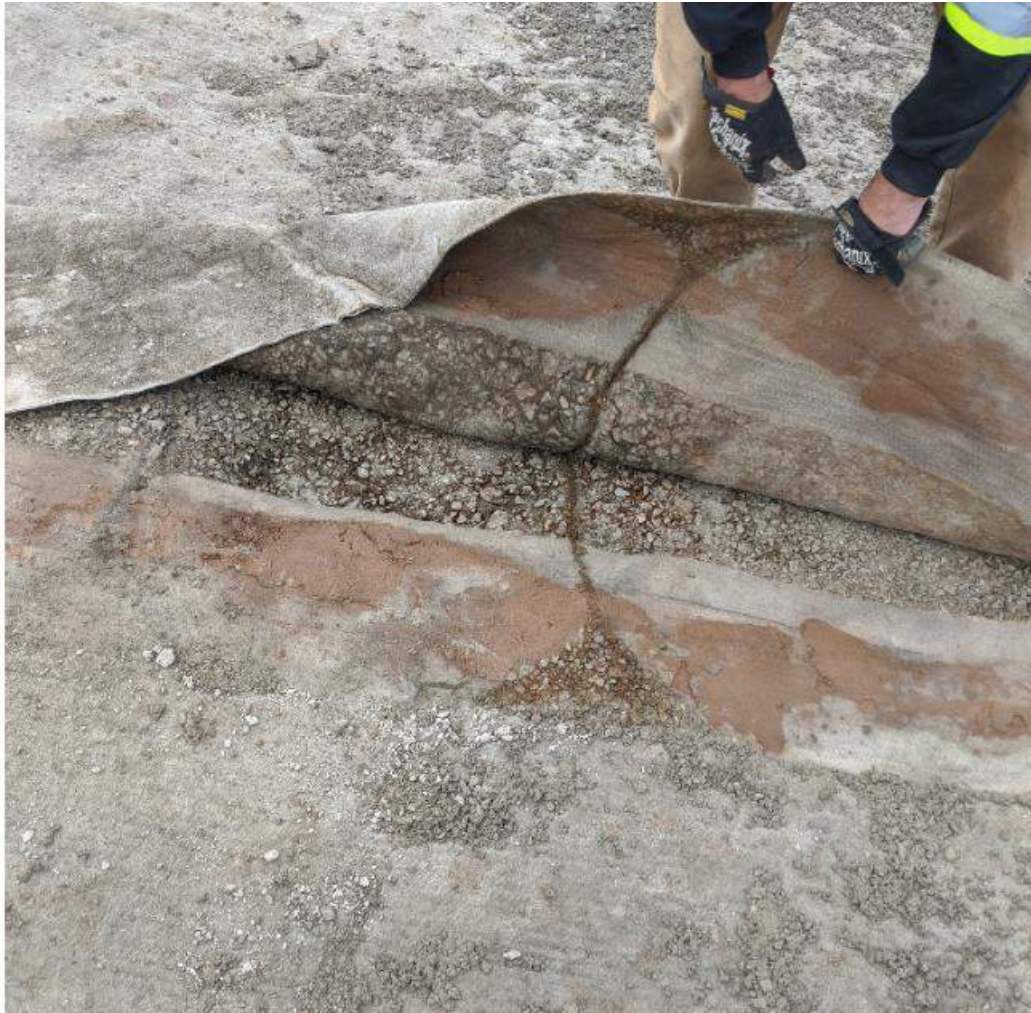
Photograph #1: Evidence of water travelling through a seam. The edge of the seam is held open by gravel.

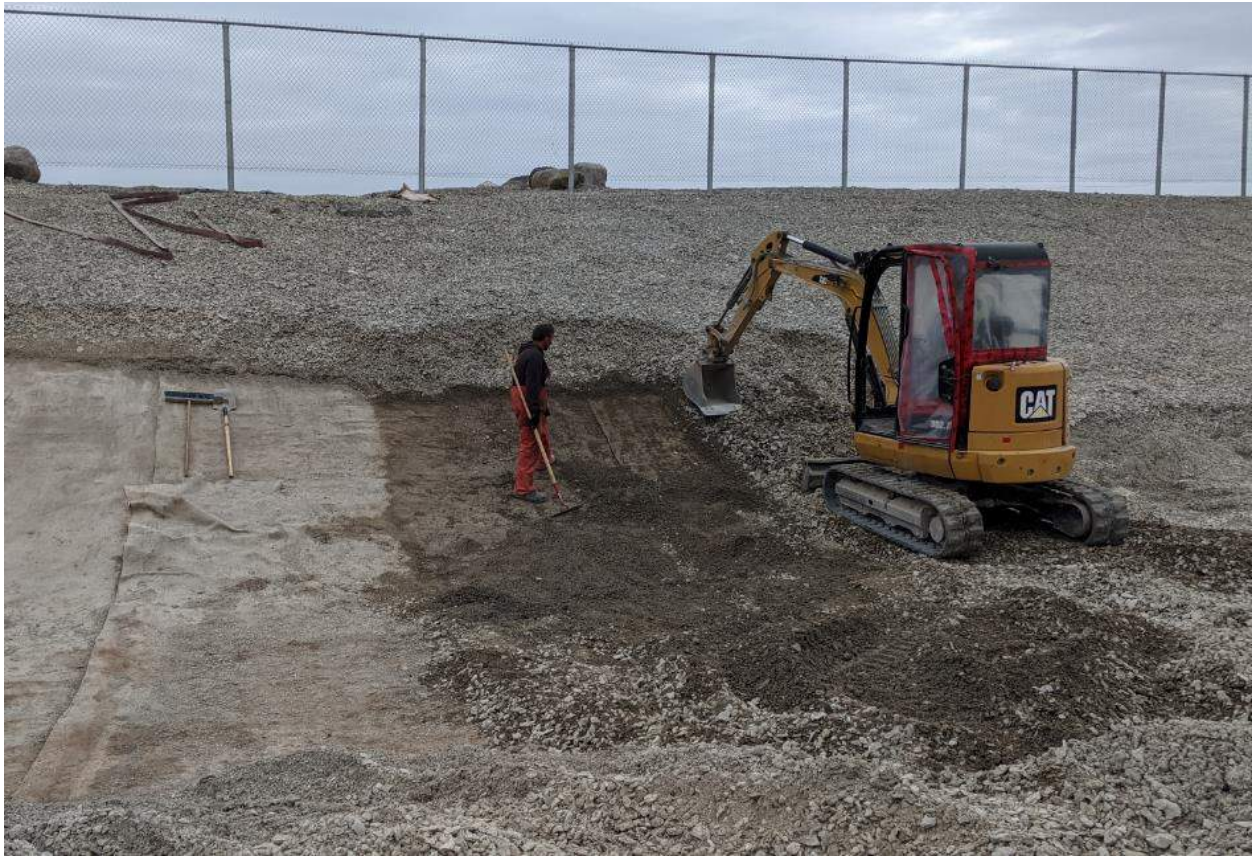
Photograph #1: Liner exposure operations continue along the east bank.

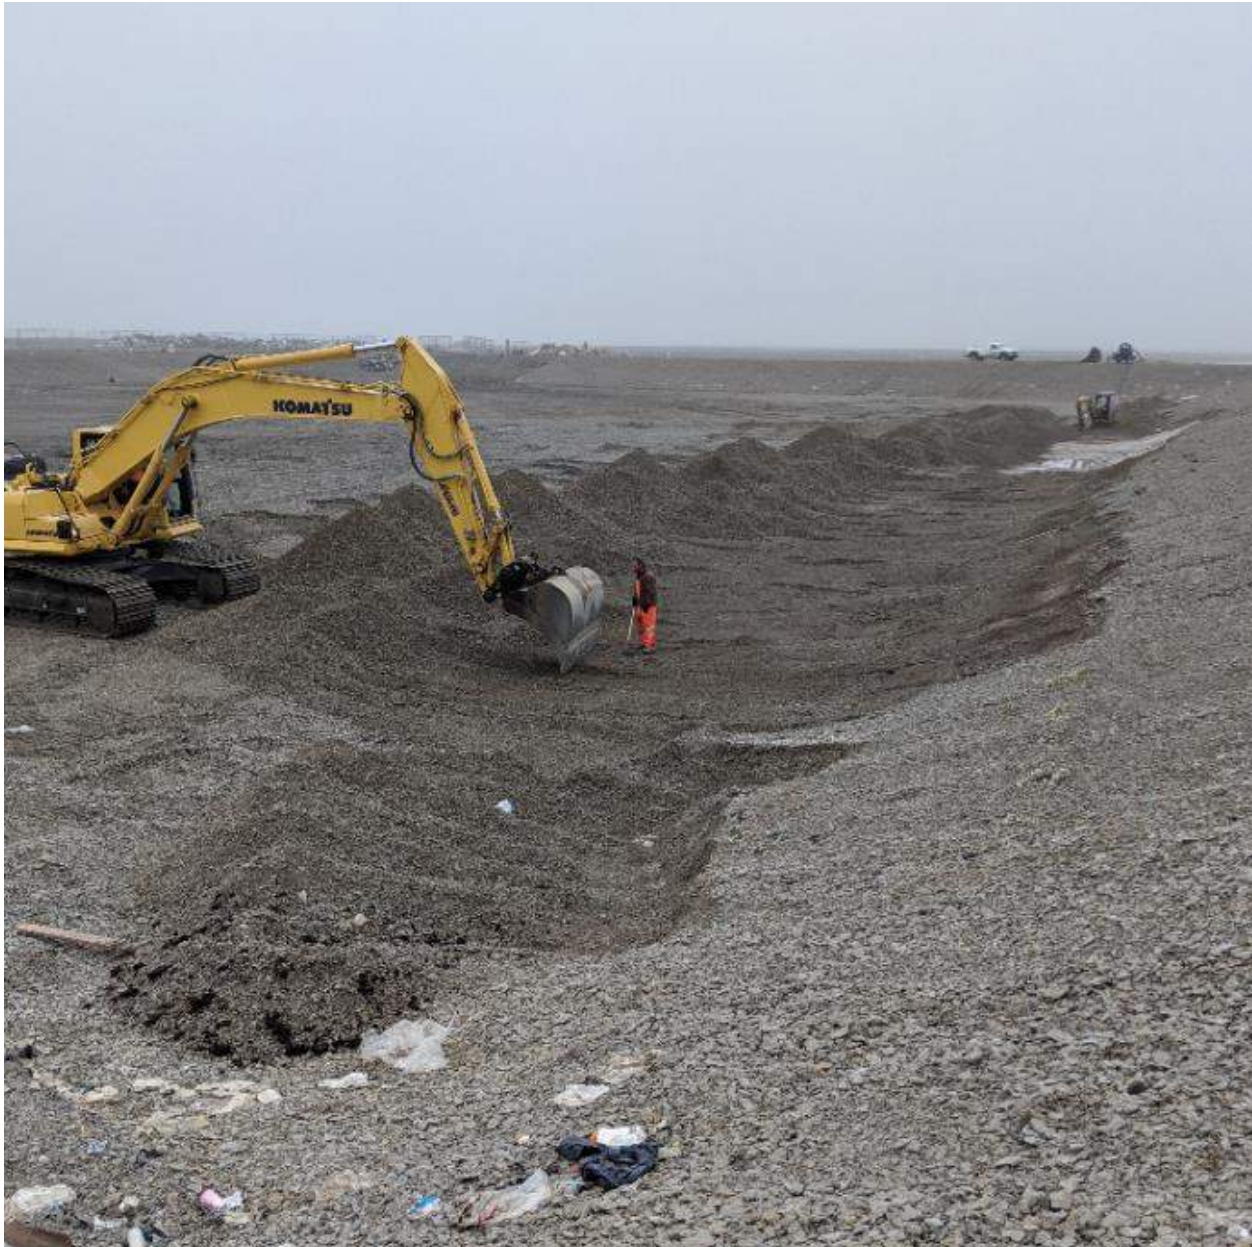
Photograph #1: Using the Komatsu to remove the top layer of aggregate. The final 100 to 150mm of sand will be removed using the mini-ex and hand tools for more accuracy and lower likelihood of damaging the liner.

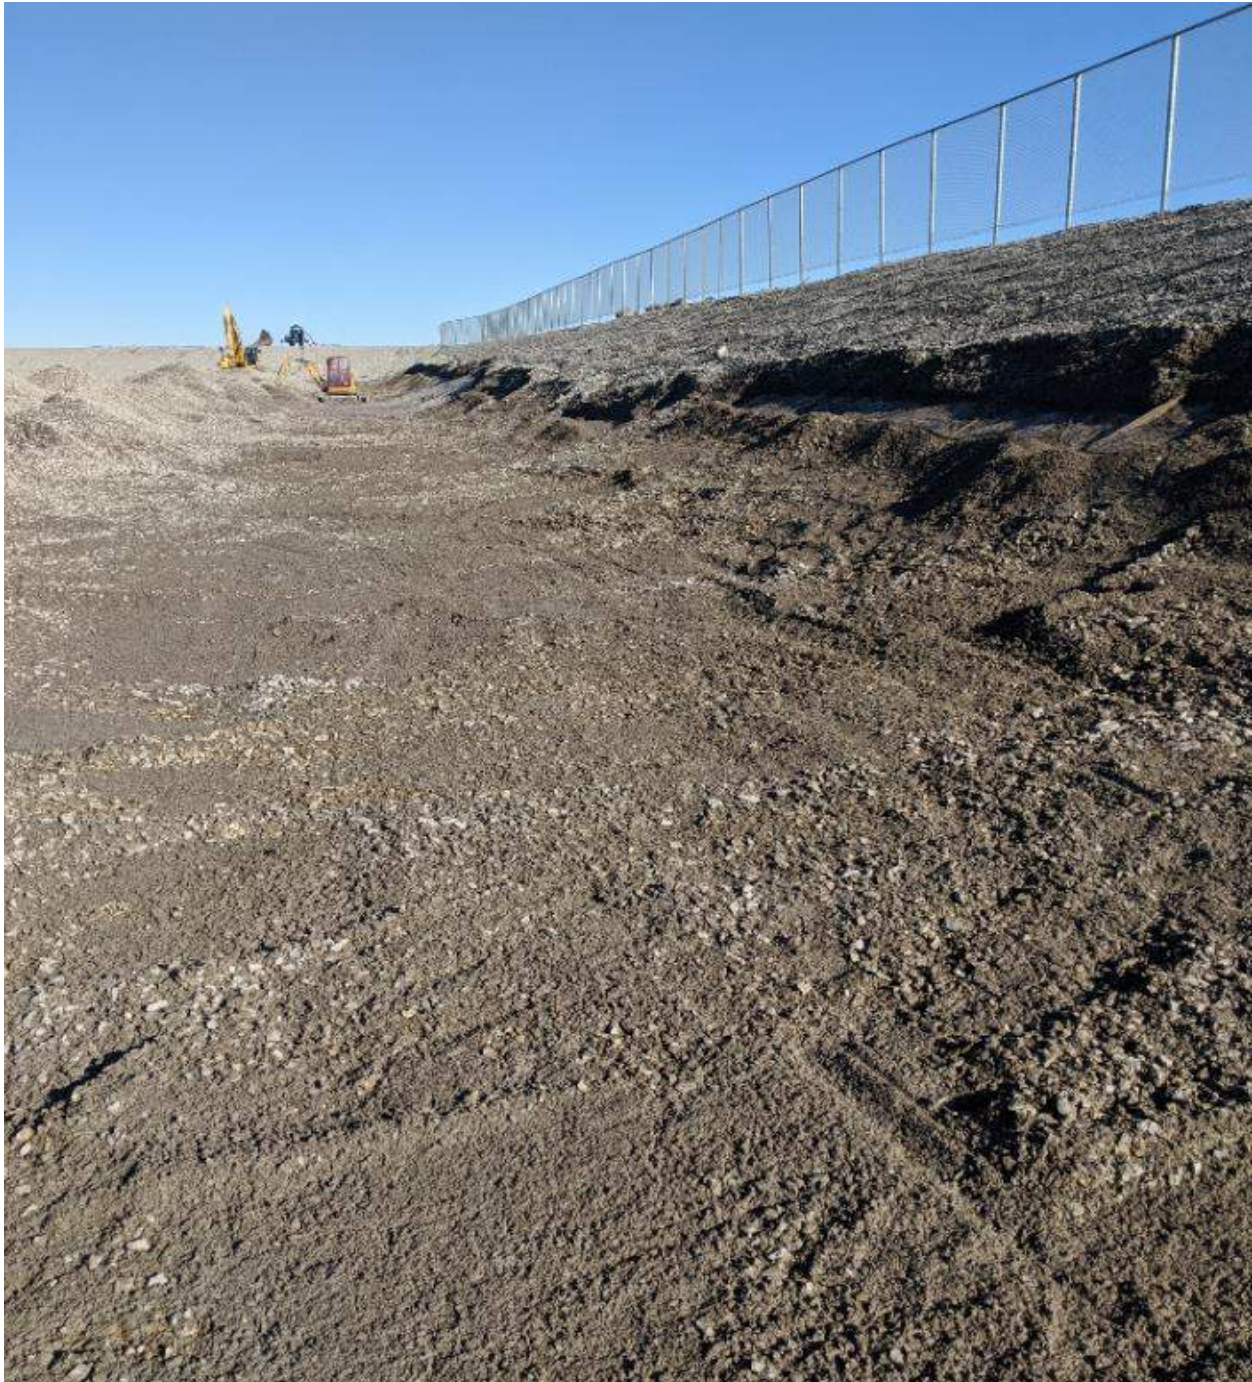
Photograph #2: Picture taken on Aug 5 showing final result of aggregate removal with excavator.

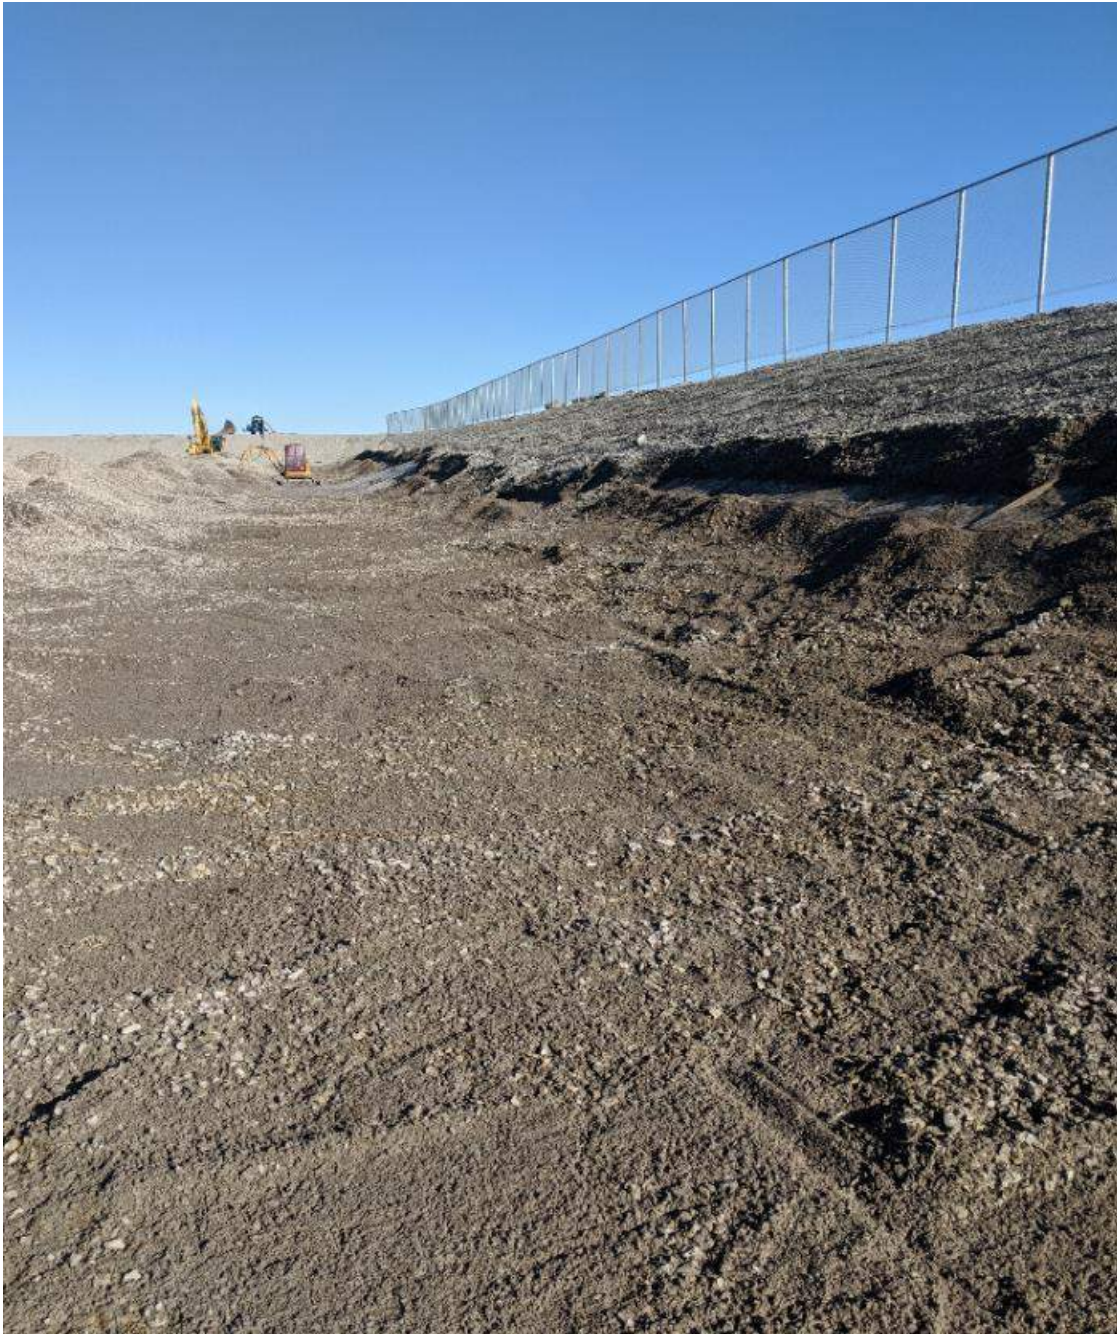
Photograph #1: East bank, with most of the aggregate layer removed, leaving only the sand layer.

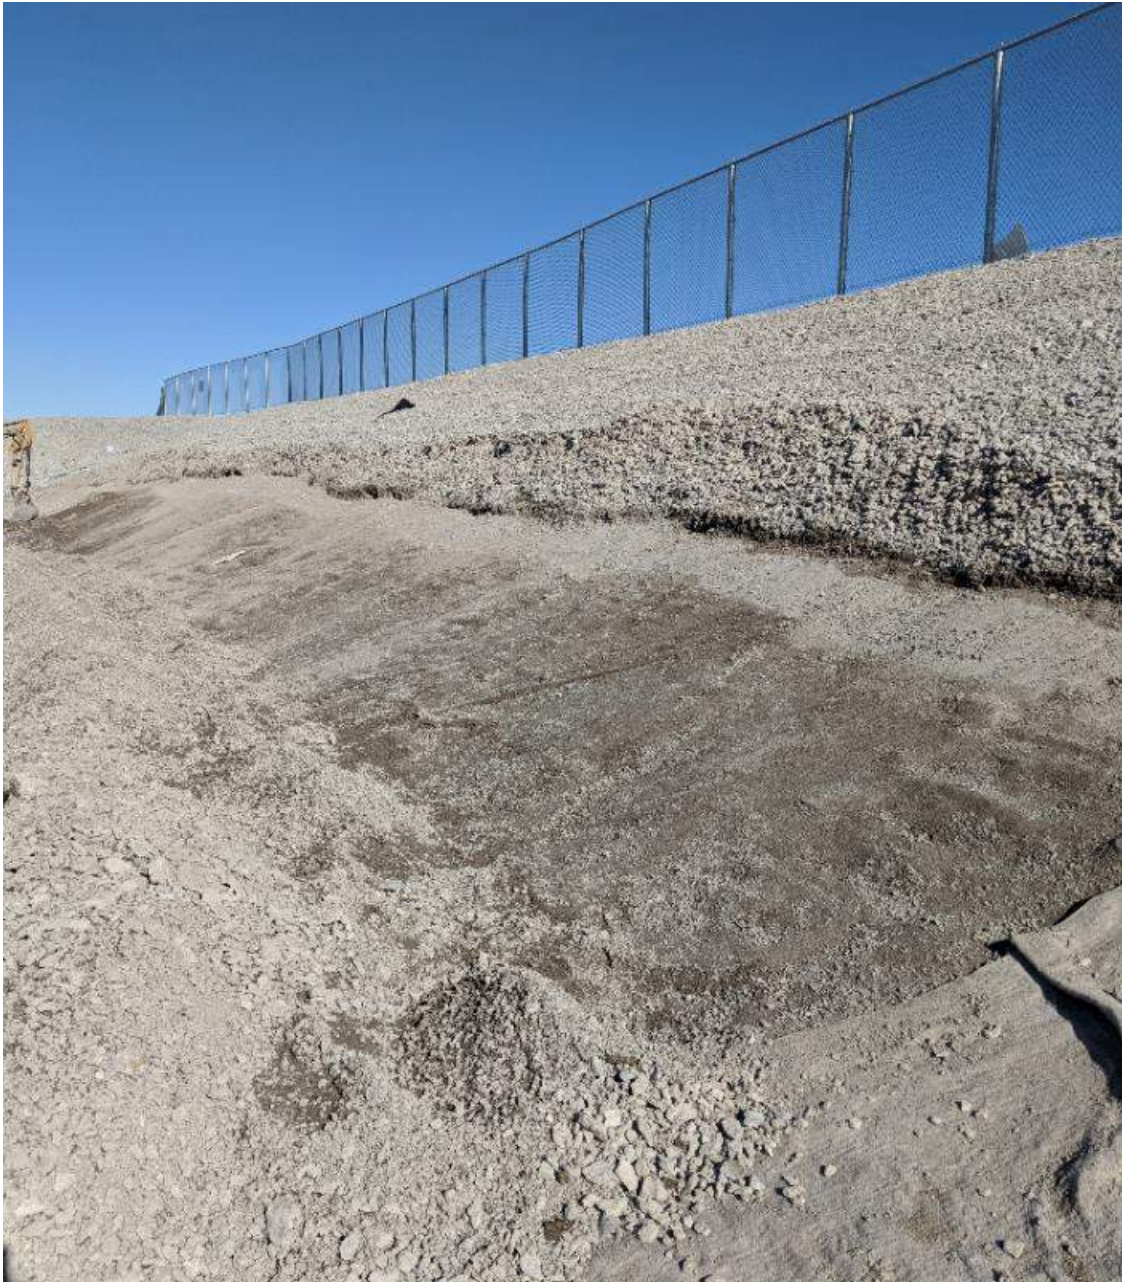
Photograph #1: Clearing of the existing liner along the east embankment, towards the north end of the cell.

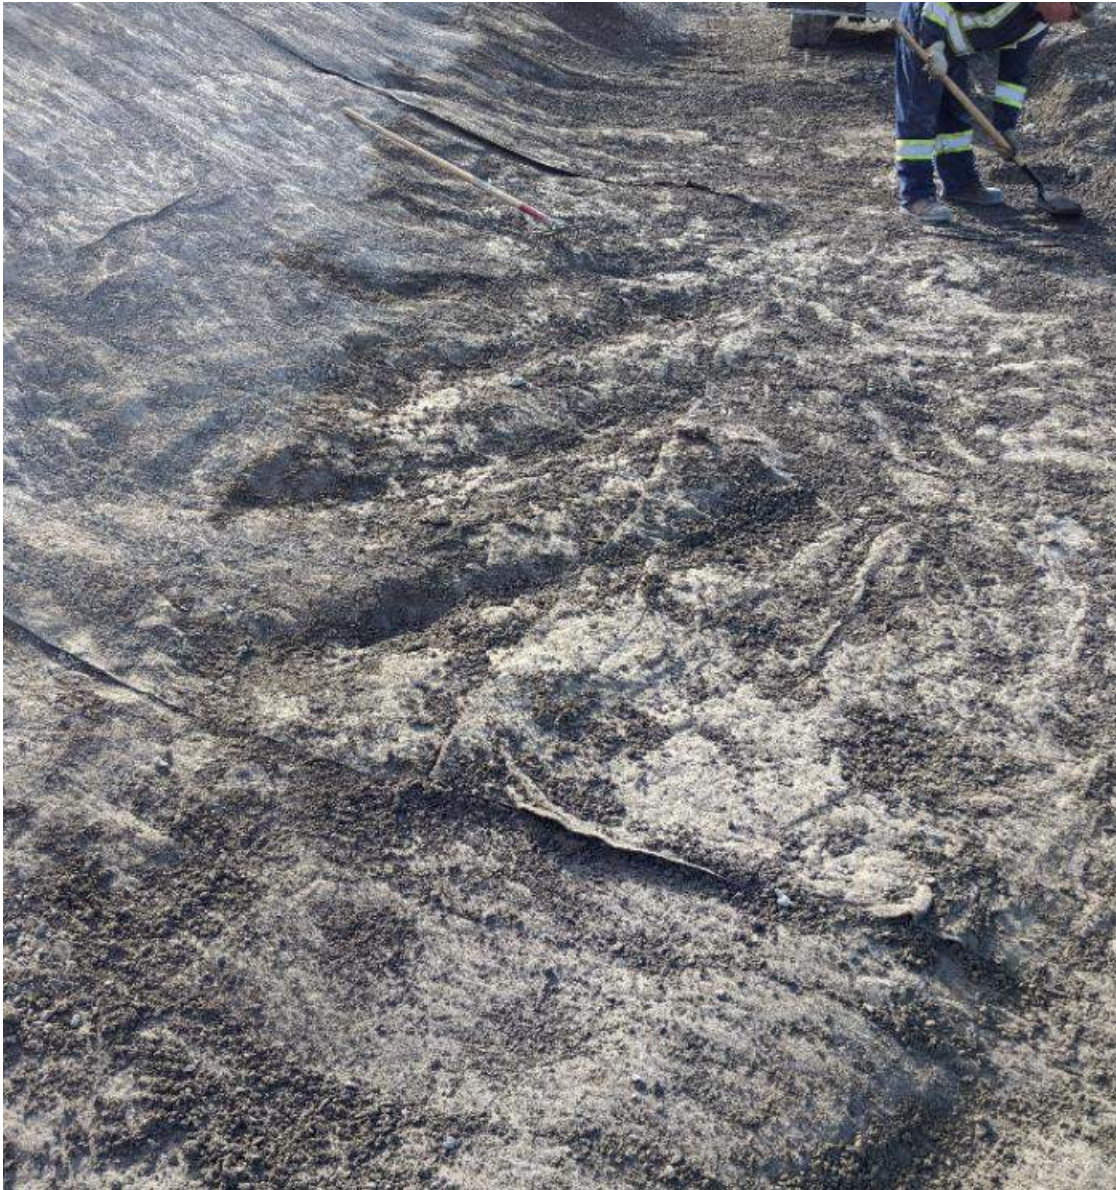
Photograph #1: Subgrade forming a wave pattern along the bottom of the cell.

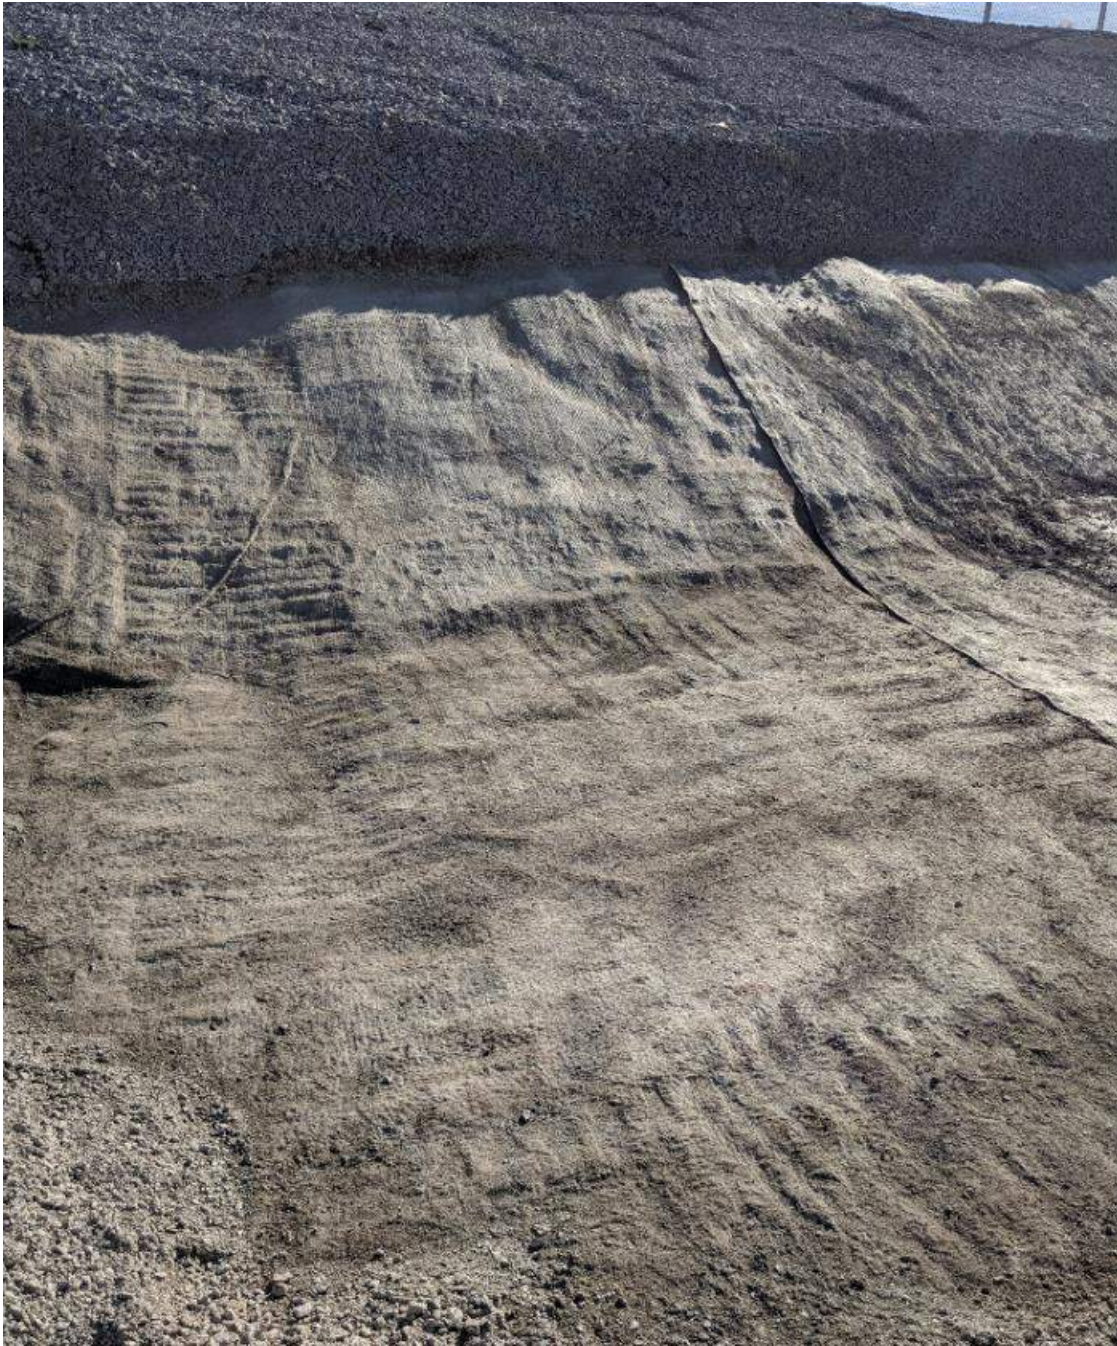
Photograph #2: Evidence of equipment having travelled on the liner. By the shape and width of the imprints, it is suspected to have been an excavator.

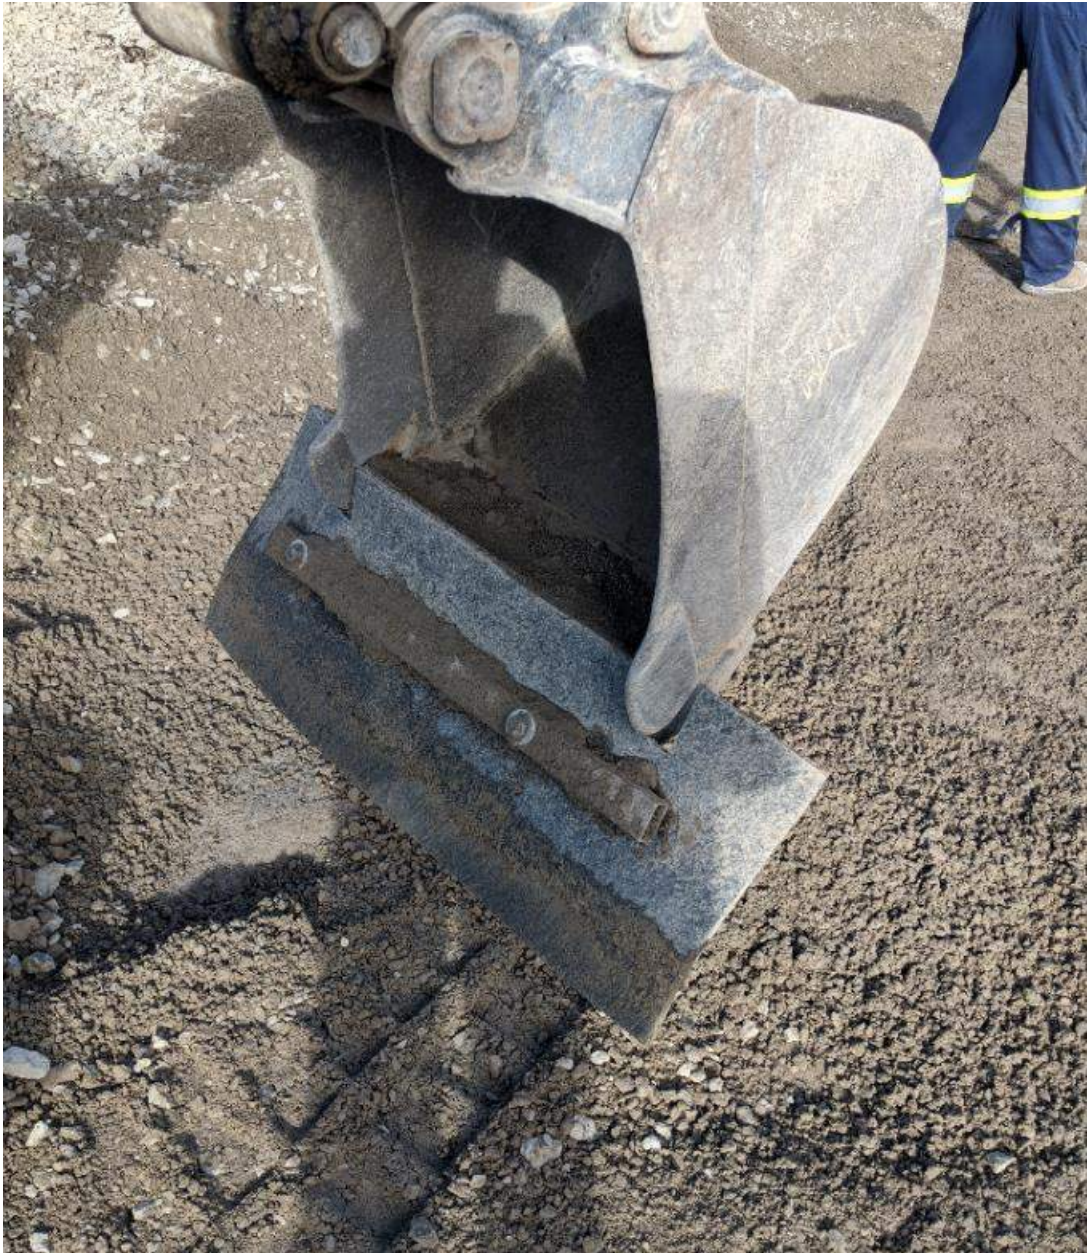
Photograph #3: Attaching a piece of 15mm thick flexible rubber to the front of the mini-excavator's bucket greatly sped up work by allowing the operator to scrape much closer to the liner, leaving less work to be done by hand. It also greatly reduced the incidence of accidental tearing of the liner by the excavator.

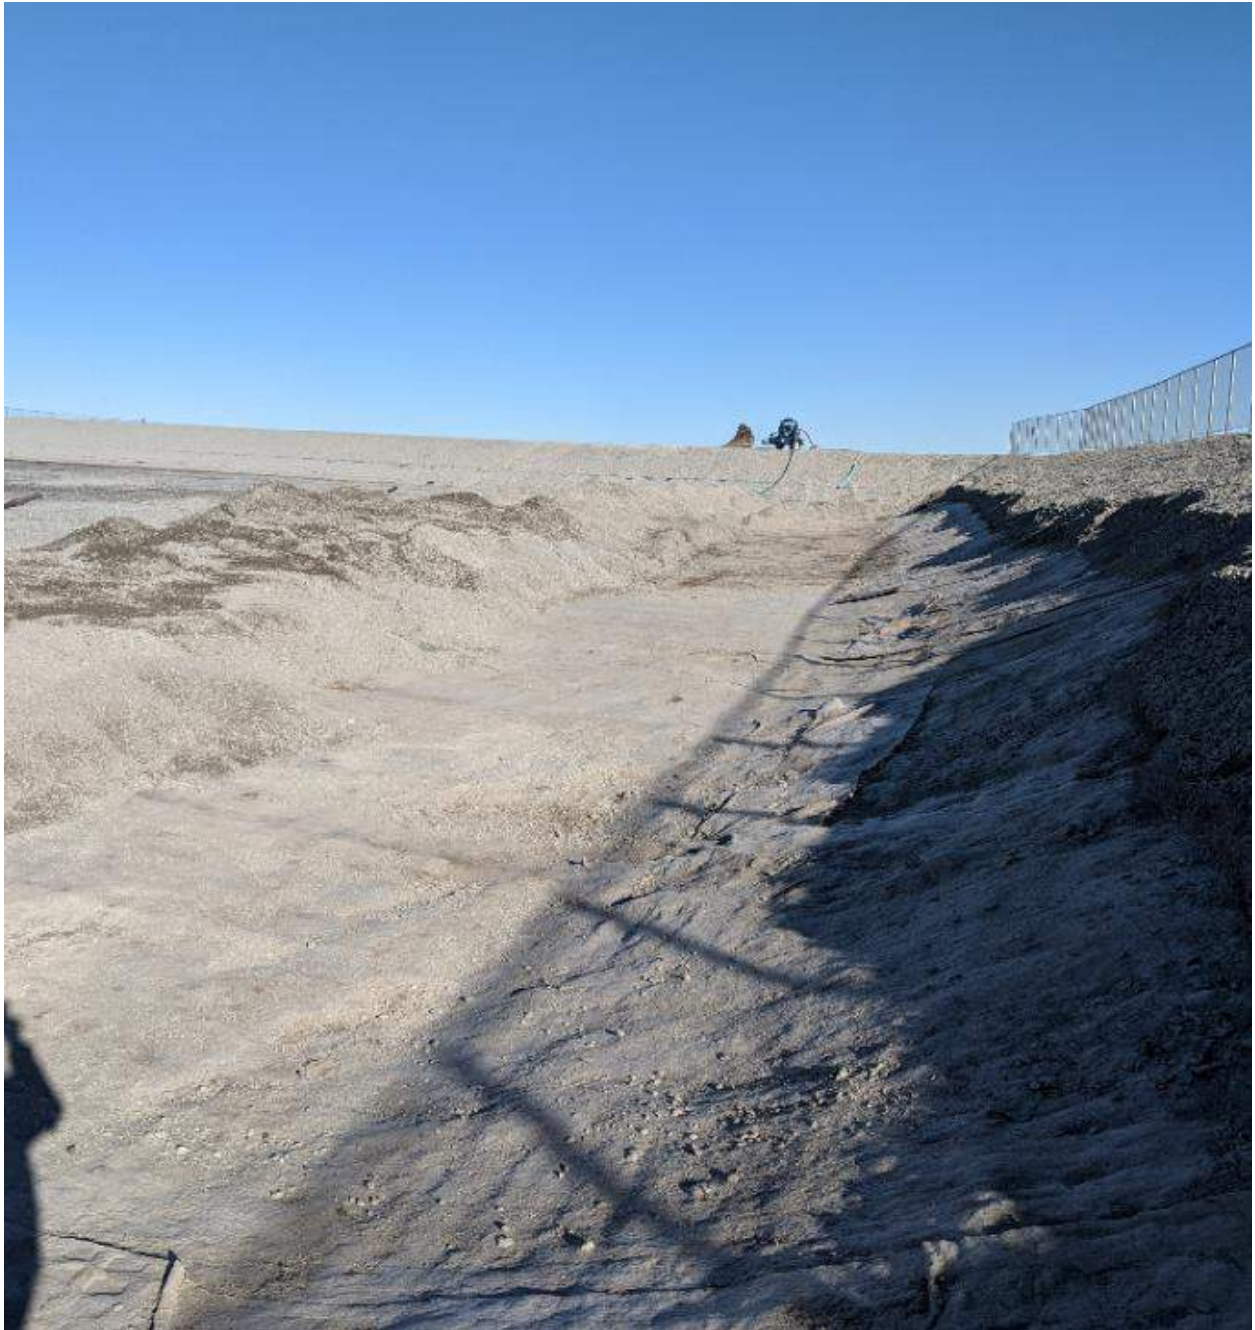
Photograph #1: The result. Existing liner exposed along the bottom of the lagoon. Some wrinkles and rolls present, which will be smoothed out prior to placing the new liner down.

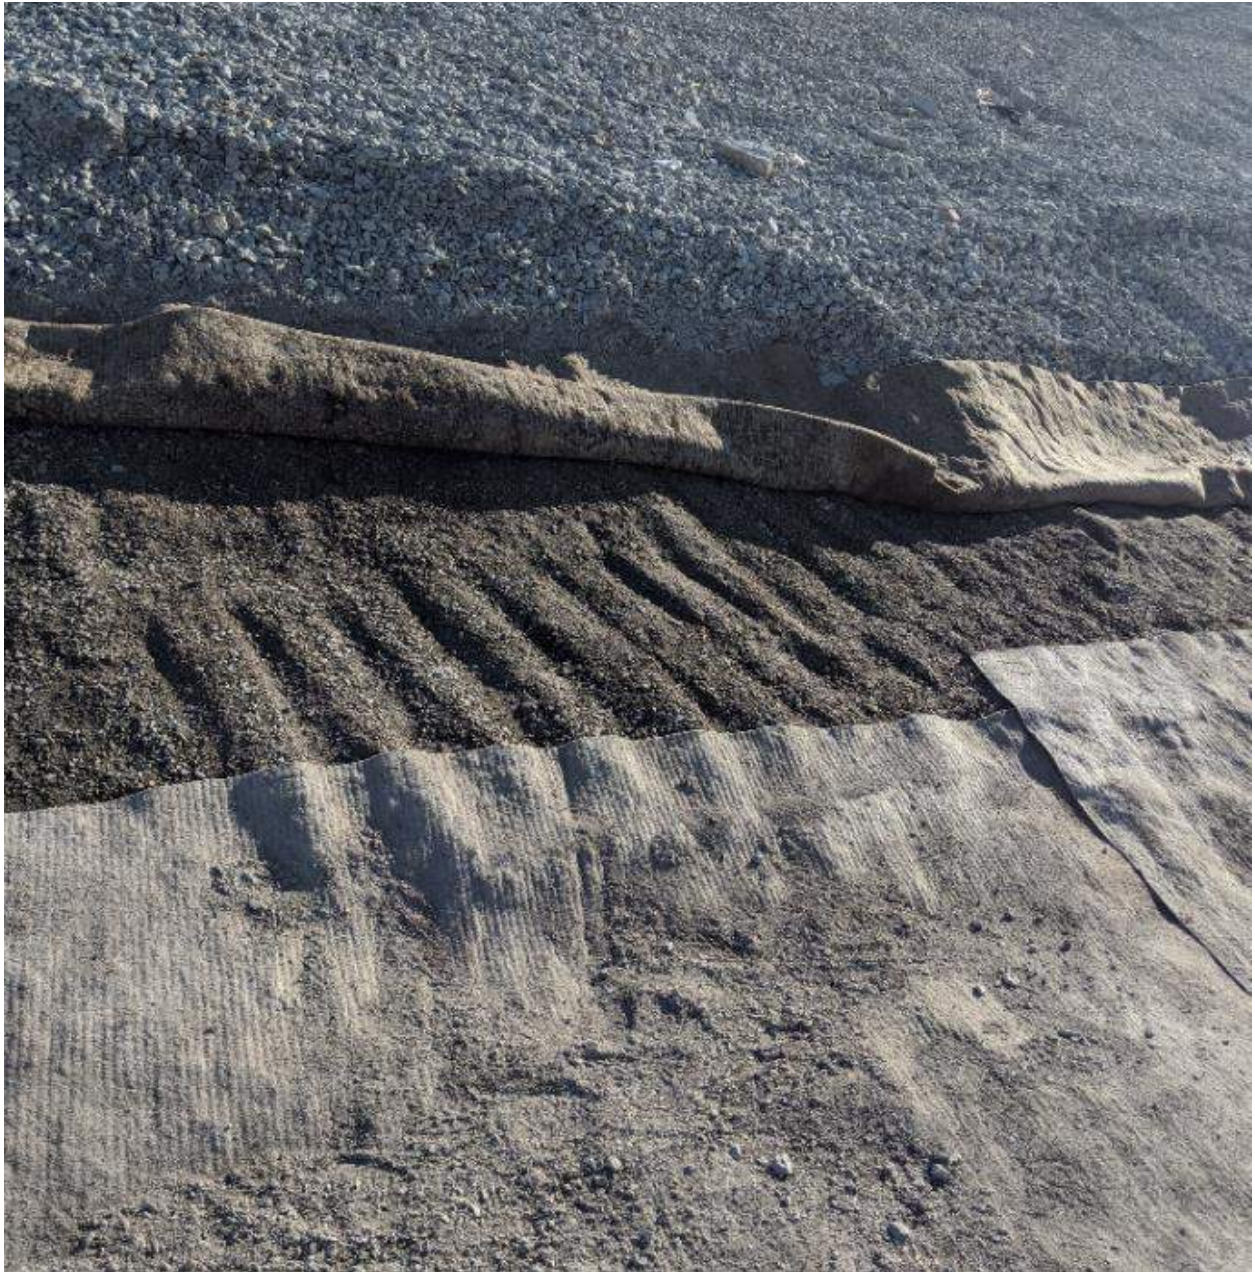
Photograph #1: The existing liner was cut and the top part rolled back to expose the soil underneath. In some parts, the soil showed patterns of having been driven over with a vehicle with cleated tracks.

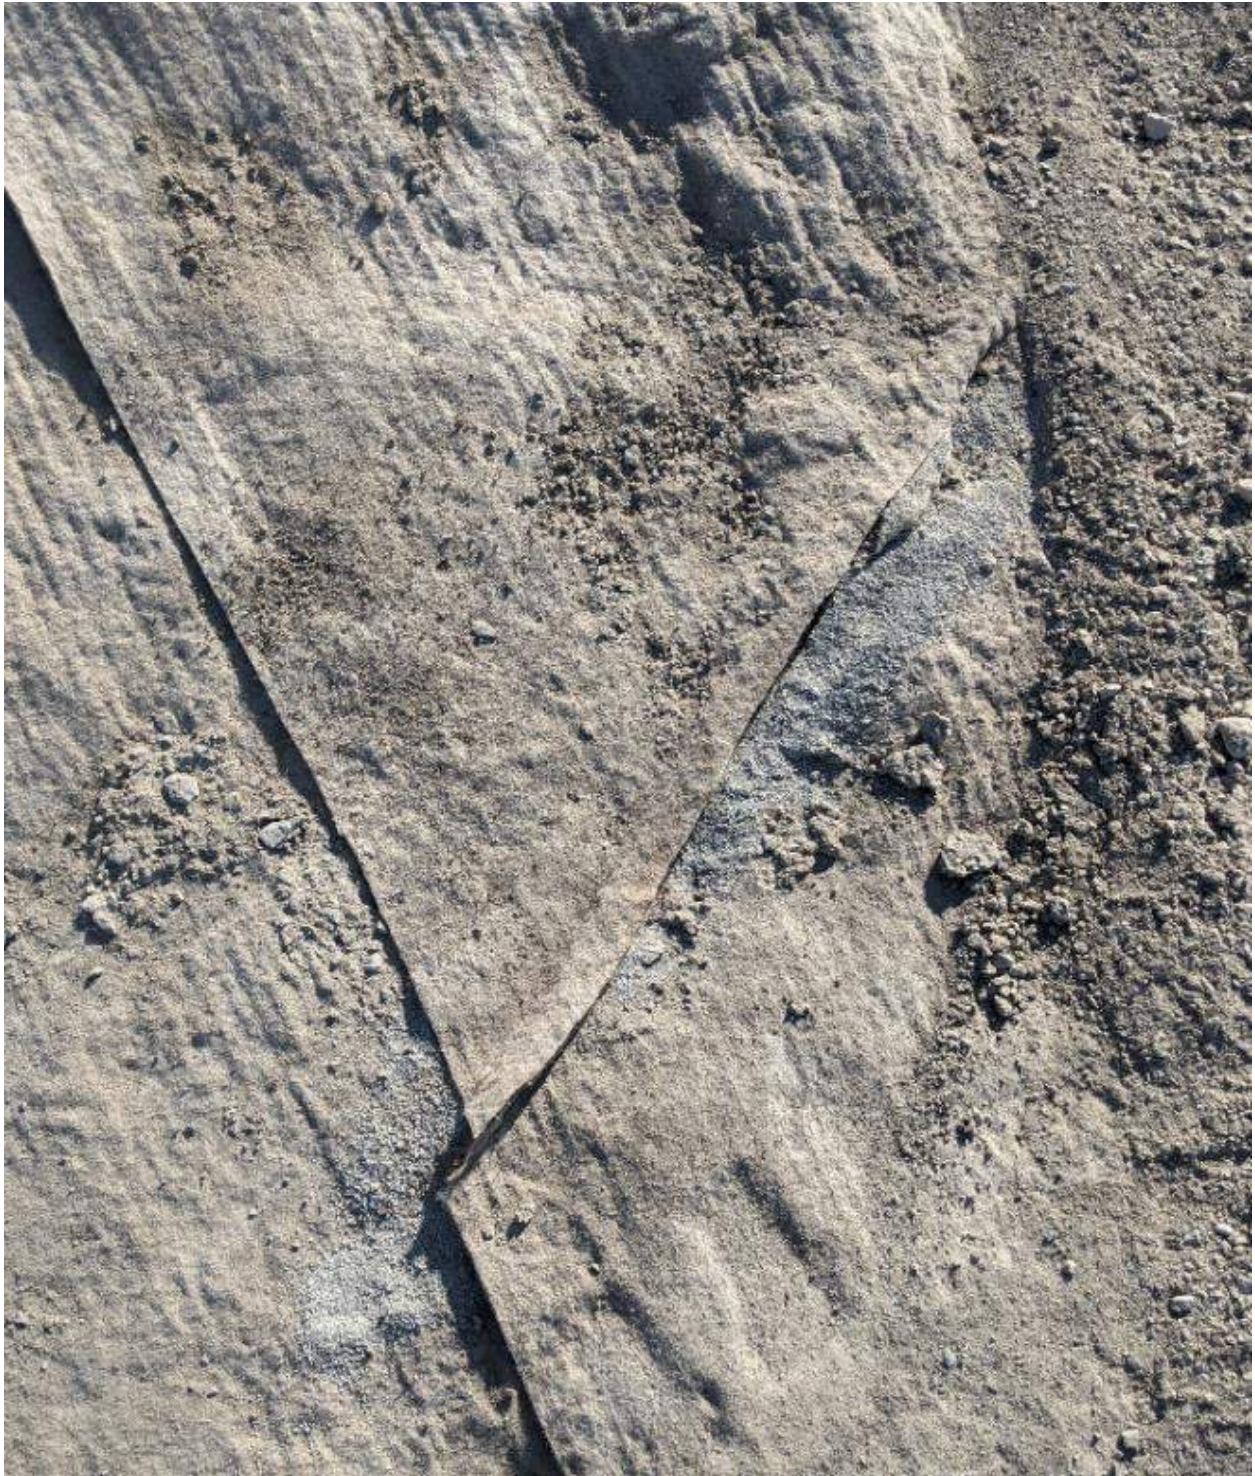
Photograph #3: Some wrinkles and folds were cut out in order to allow the liner to sit flat. The new liner will completely cover these cuts.

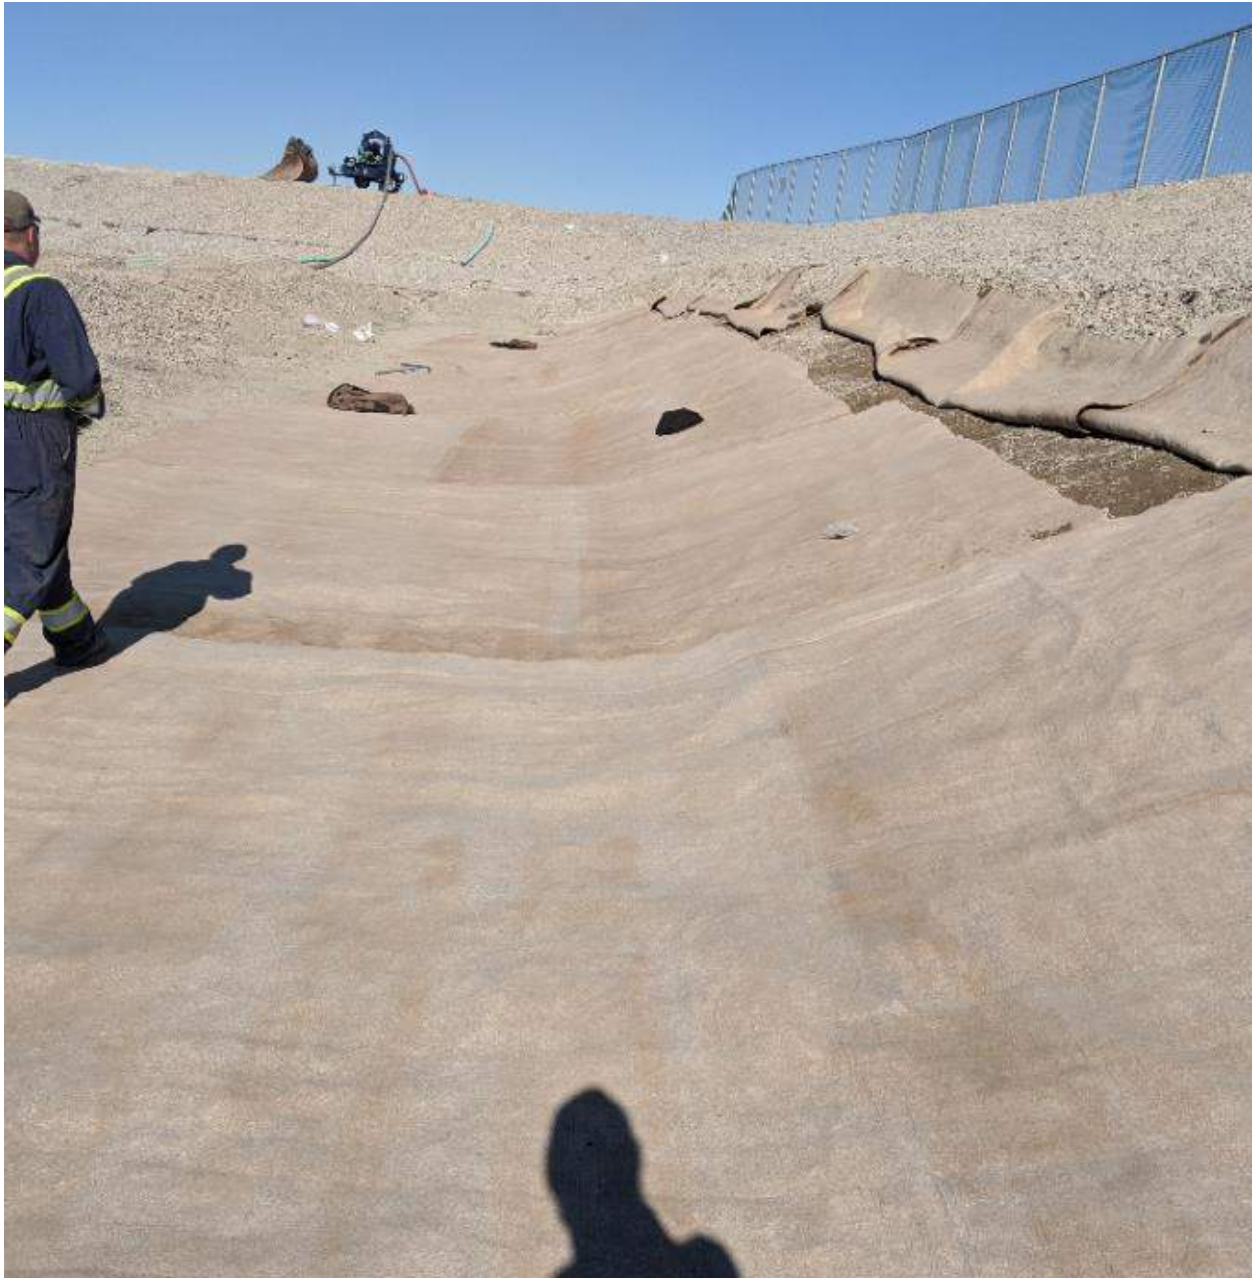
Photograph #4: New liner installed. The top flap of the existing liner will be rolled down once the seams are properly sealed with bentonite.

New liner panels were then installed over the exposed area, ensuring proper lap between new panels and between new and existing liner at the top of the new liner. The rolled-over top part of the existing liner will be rolled back onto the new liner and sealed in place. Overlap at the top of the new liner panels is approximately 1m. This was done to ensure that even if the new panels slip a bit, the top joint would not leak. In addition, the seams on the new liner were offset by half a panel relative to those of the existing liner, so that the seams within both liners do not align.
