Summary of Work – Hall Beach 2020 Field Season

Final Report

Hall Beach Sewage Lagoon
Change Order No. 5 & Leak Detection/Resolution

OTT-220382

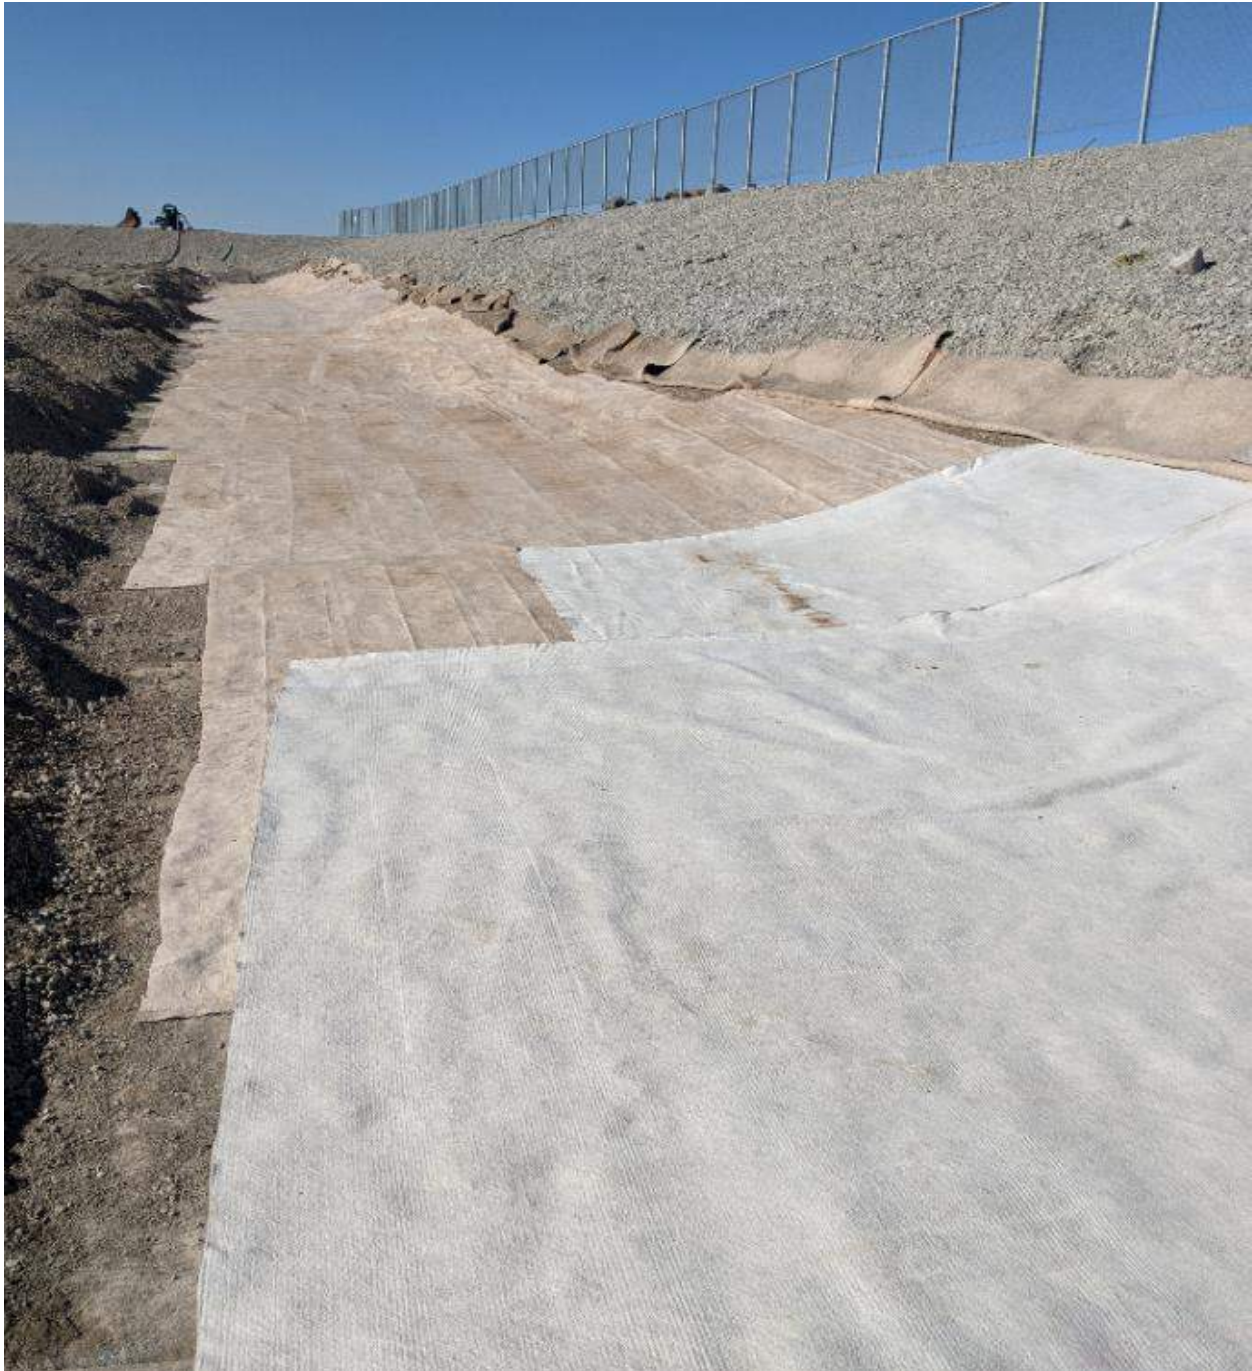
The last few panels at the south end of the existing berm are a different type of liner (Bentomat DN-SFT). This liner is left over from the original lagoon construction, as opposed to the liner used so far in these repairs, which is left over from CO5 and was sent up in 2019. According to Nunavut Excavating, the two types of liner are compatible, and installation method is the same for both, according to information received from the manufacturer.

Photograph #5: The final panels of the new liner are a different material than the rest of the panels. The new material is from a different shipment, and is approximately twice as thick as the rest of the liner.

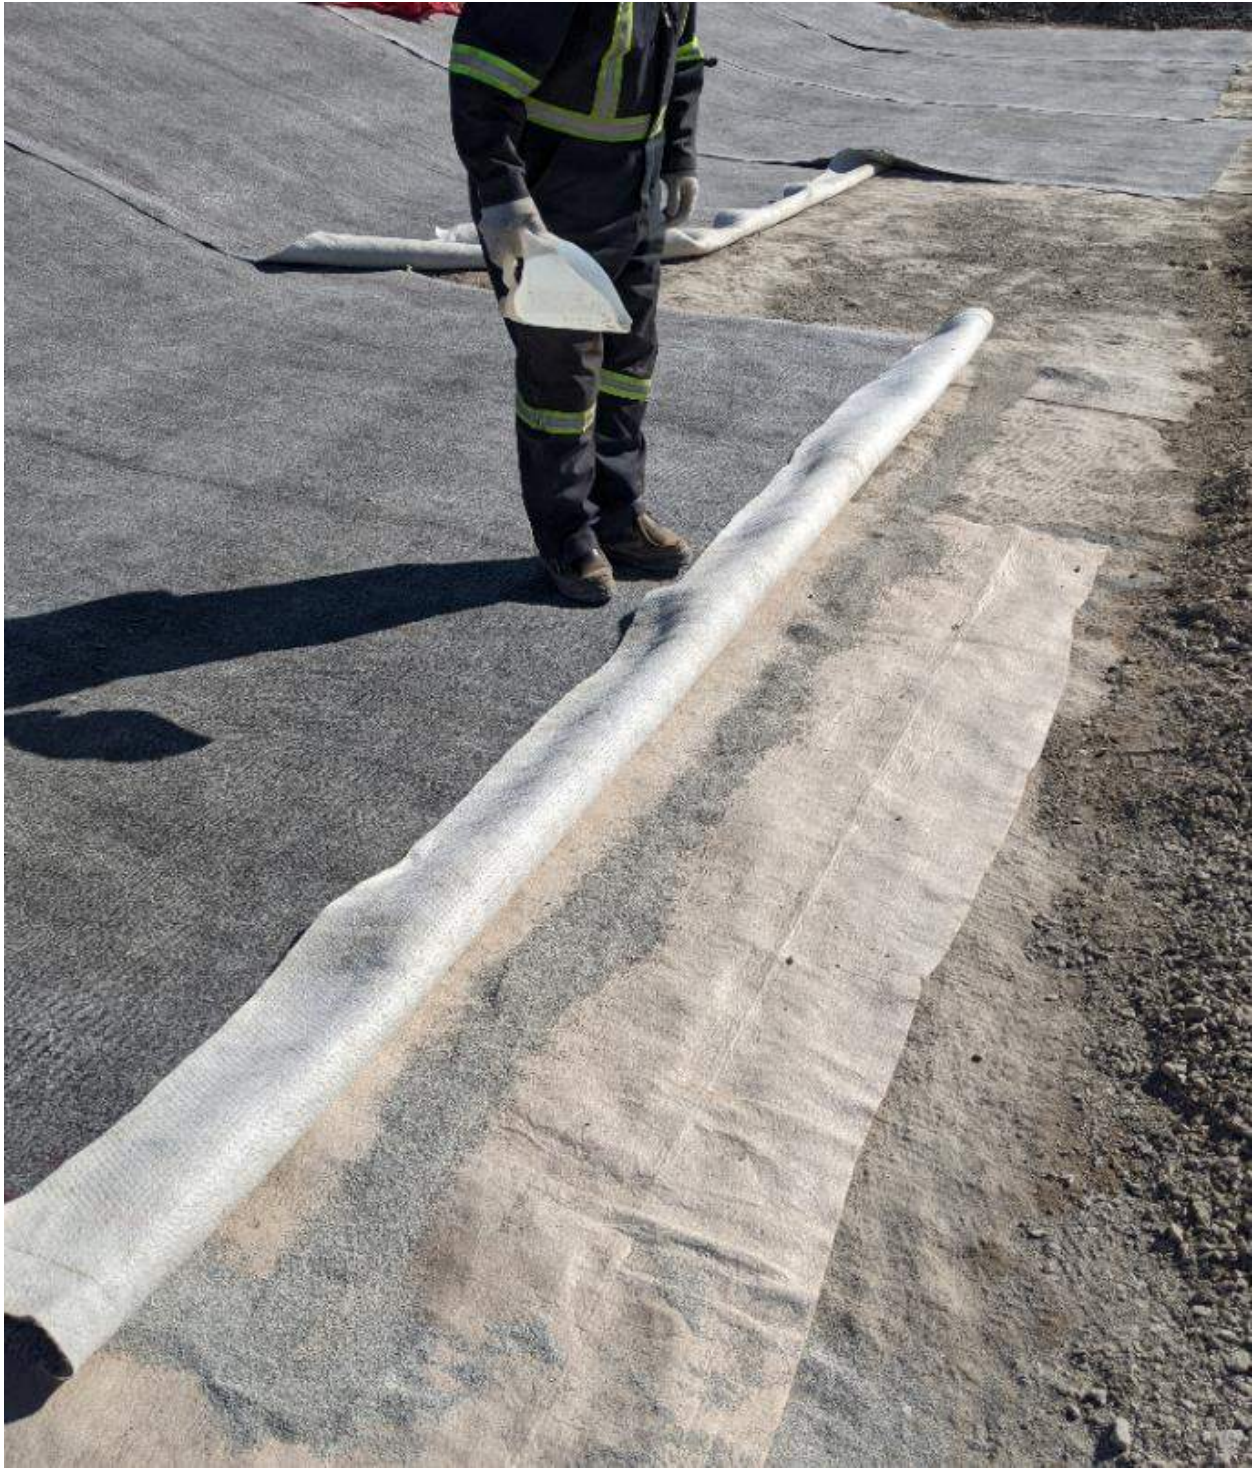
Photograph #1: Sealing the liner seams with bentonite.

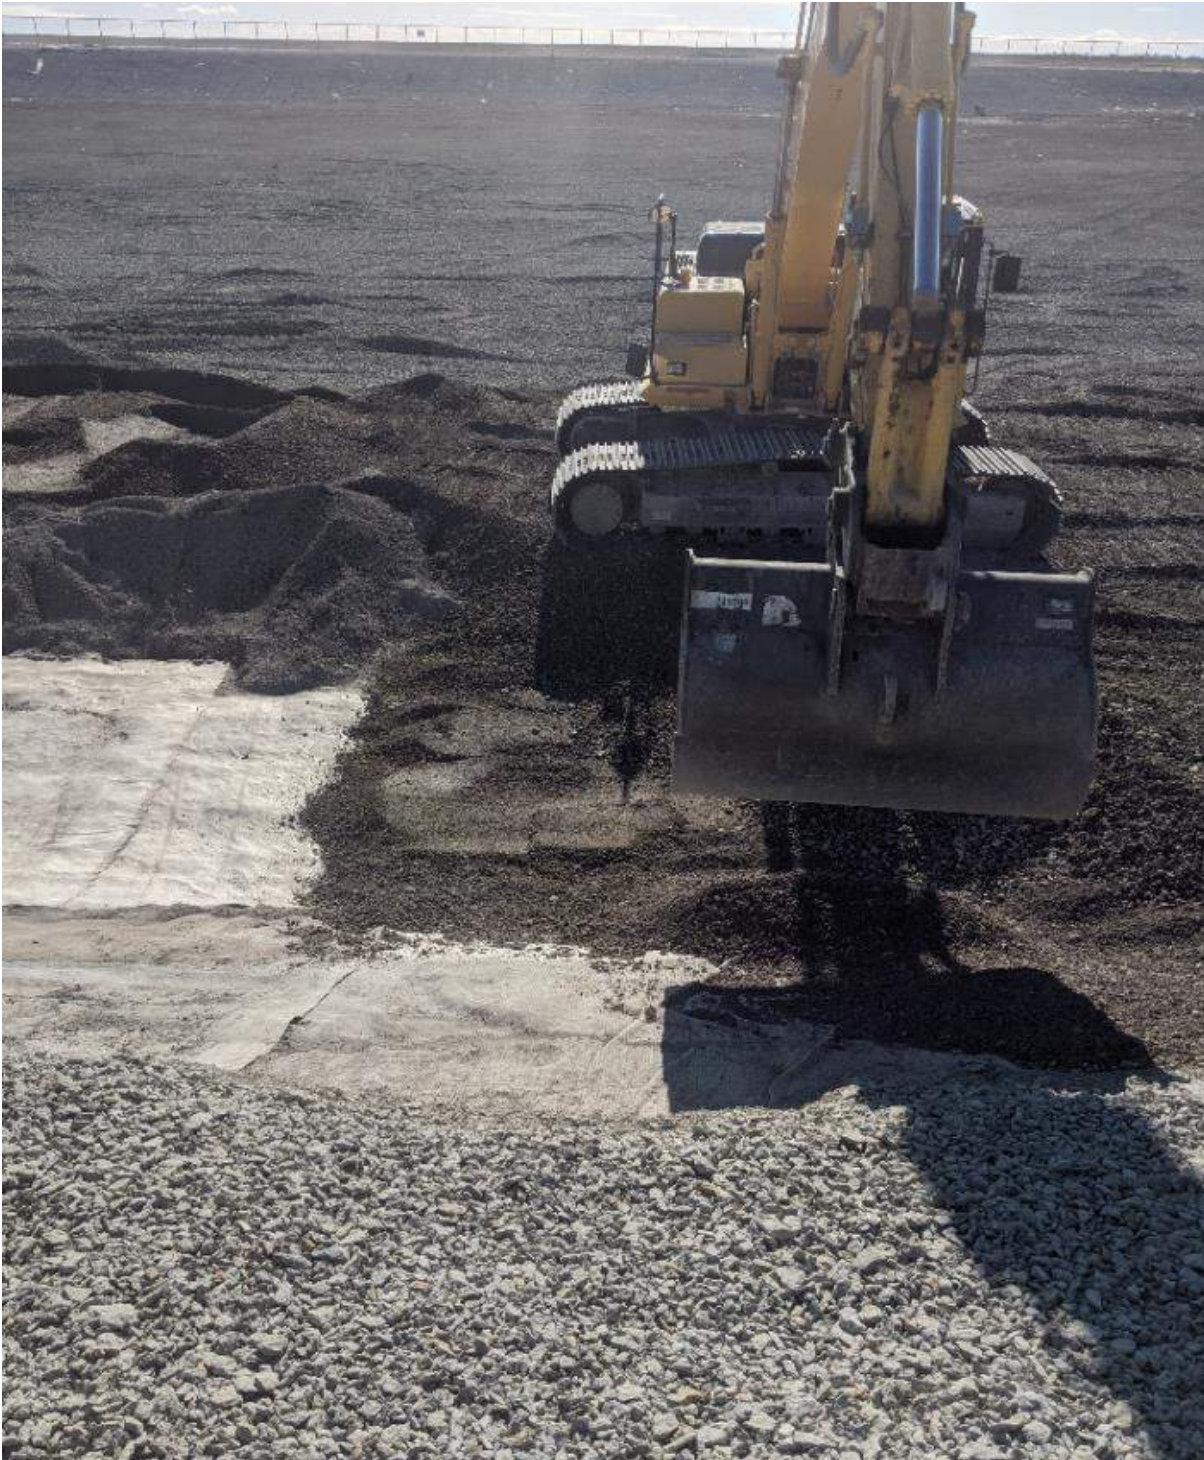
Photograph #2: Sand was placed onto the liner using the excavator. The excavator did not travel onto the liner or the sand layer and did not travel onto the embankment even once the aggregates had been placed down.

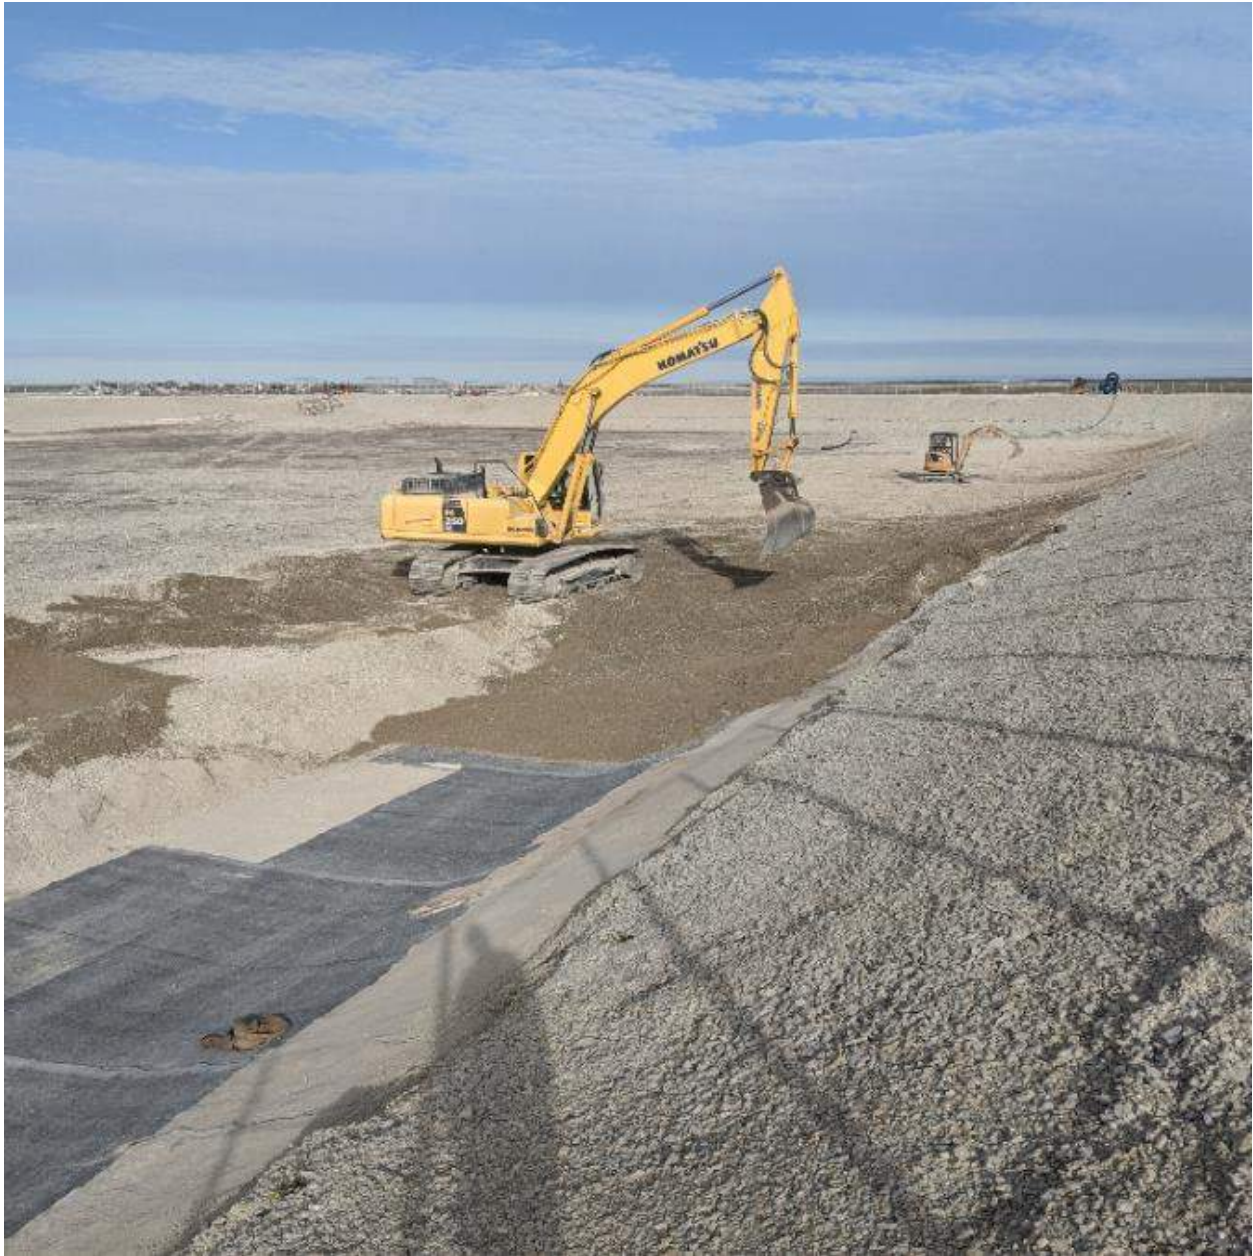
Photograph #1: Covering the newly installed liner with sand, then aggregates.

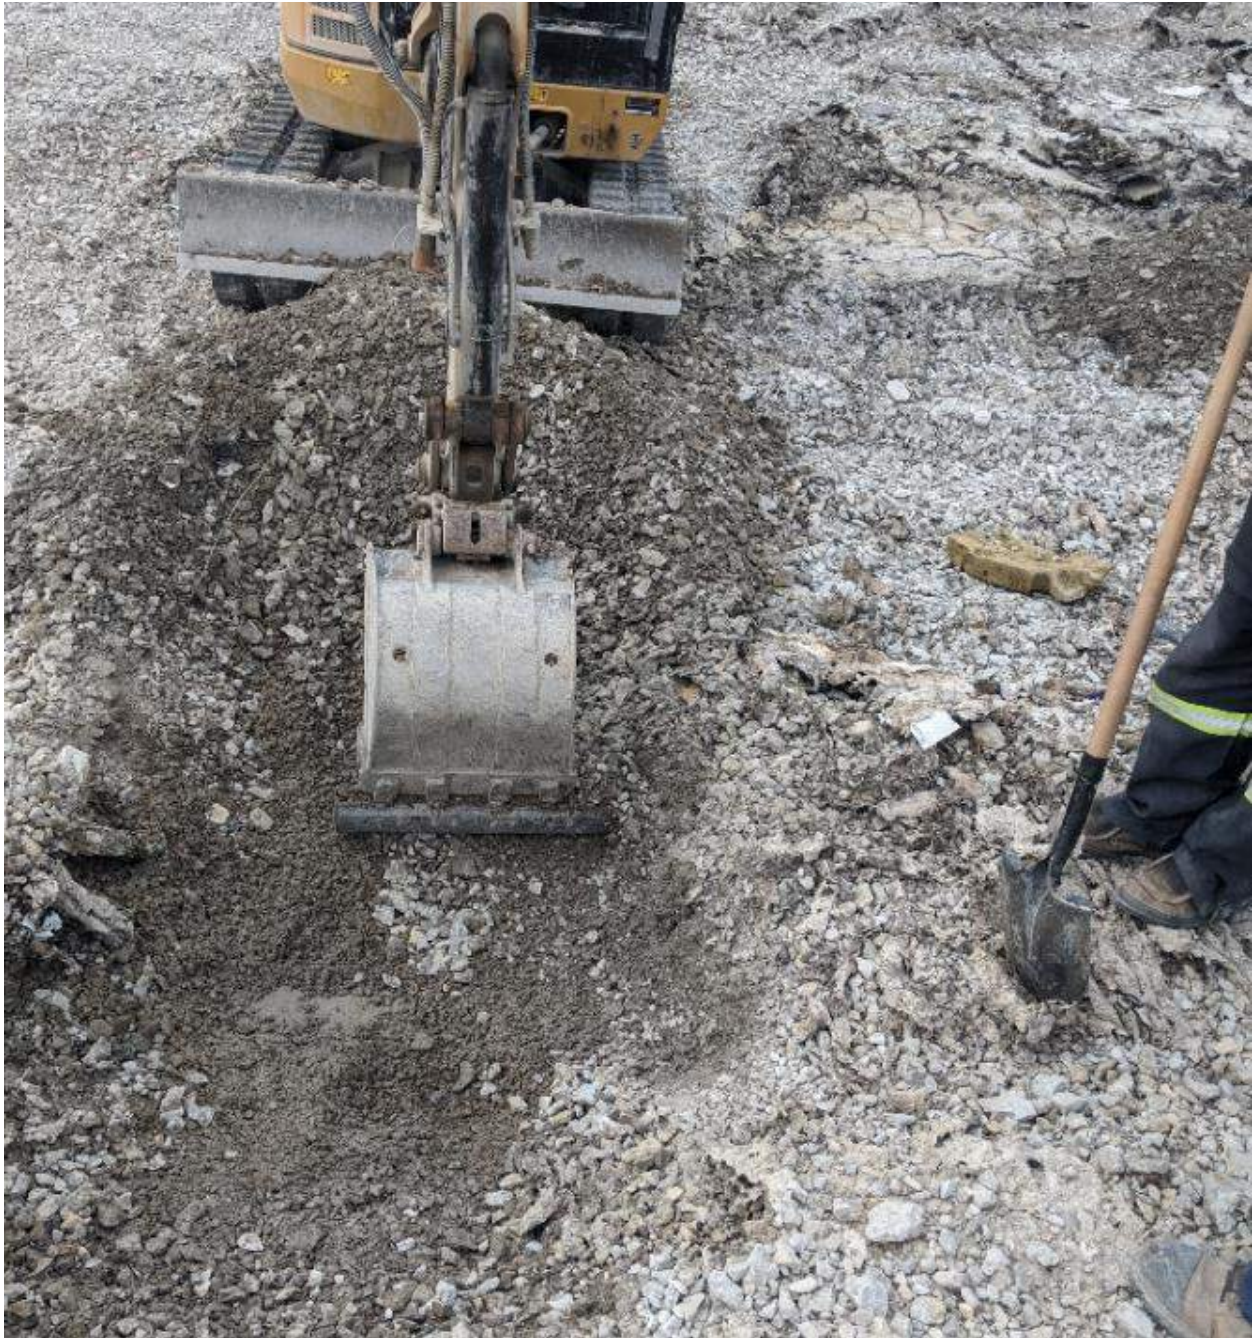
The contractor used the mini-excavator to expose the liner seams on the south side of the lagoon. The seams were deemed most likely to show signs of failure in the event that the south side of the lagoon suffered from the same issues as the east side. All 14 seams were exposed, for a length of approximately 3m, starting at the interface between the lagoon floor and the embankment and going up the embankment. No issues were observed in any of the seams. All seams appeared properly sealed.

Photograph #2: Exposing the liner seams on the south berm of the south cell. No defects were found in any of the seams on the south berm.

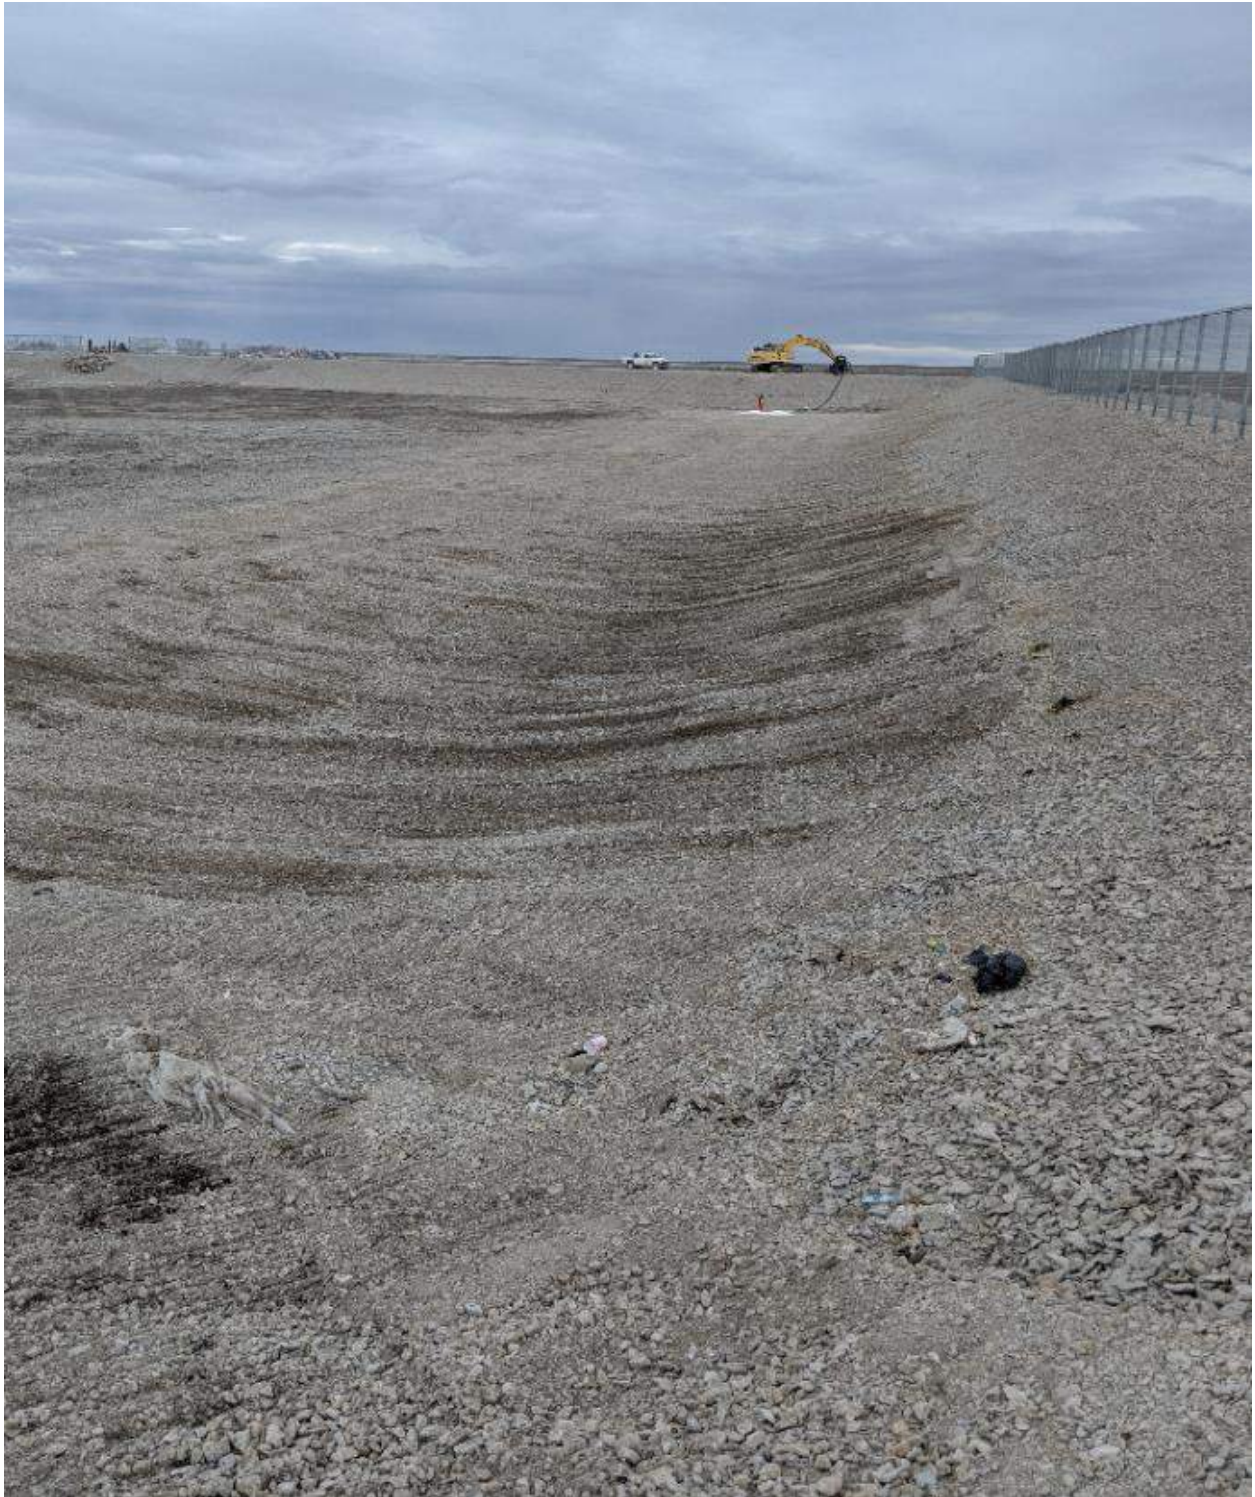
Photograph #1: Completed backfill of new liner along east berm.

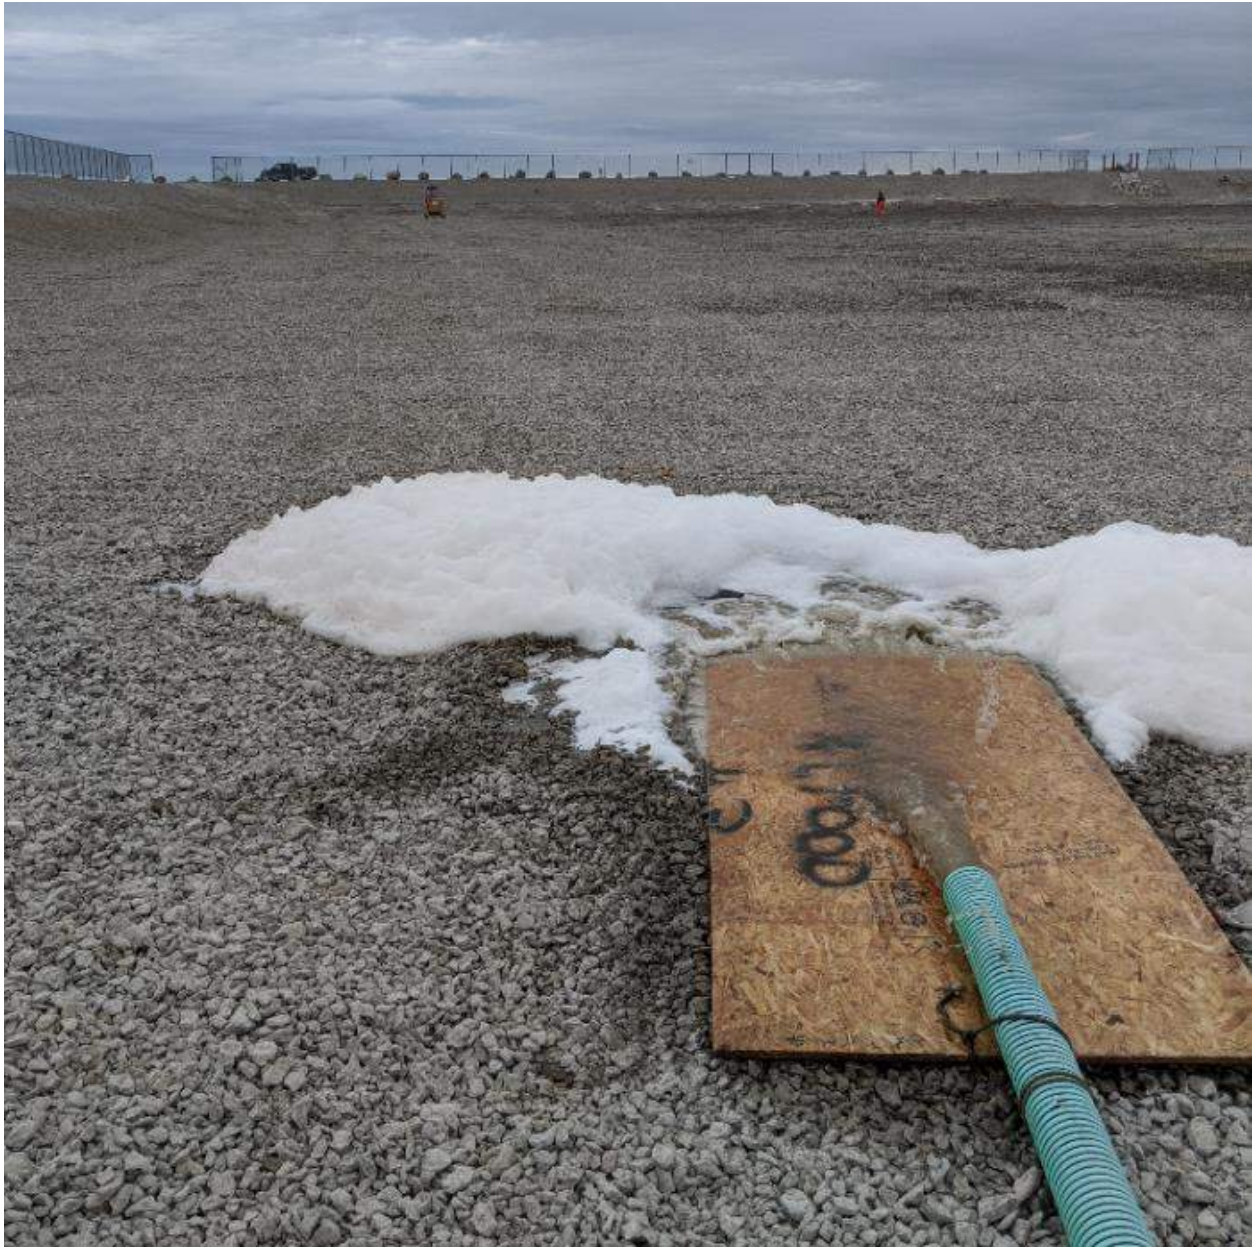
Photograph #2: Water being pumped form the North cell into the South cell.

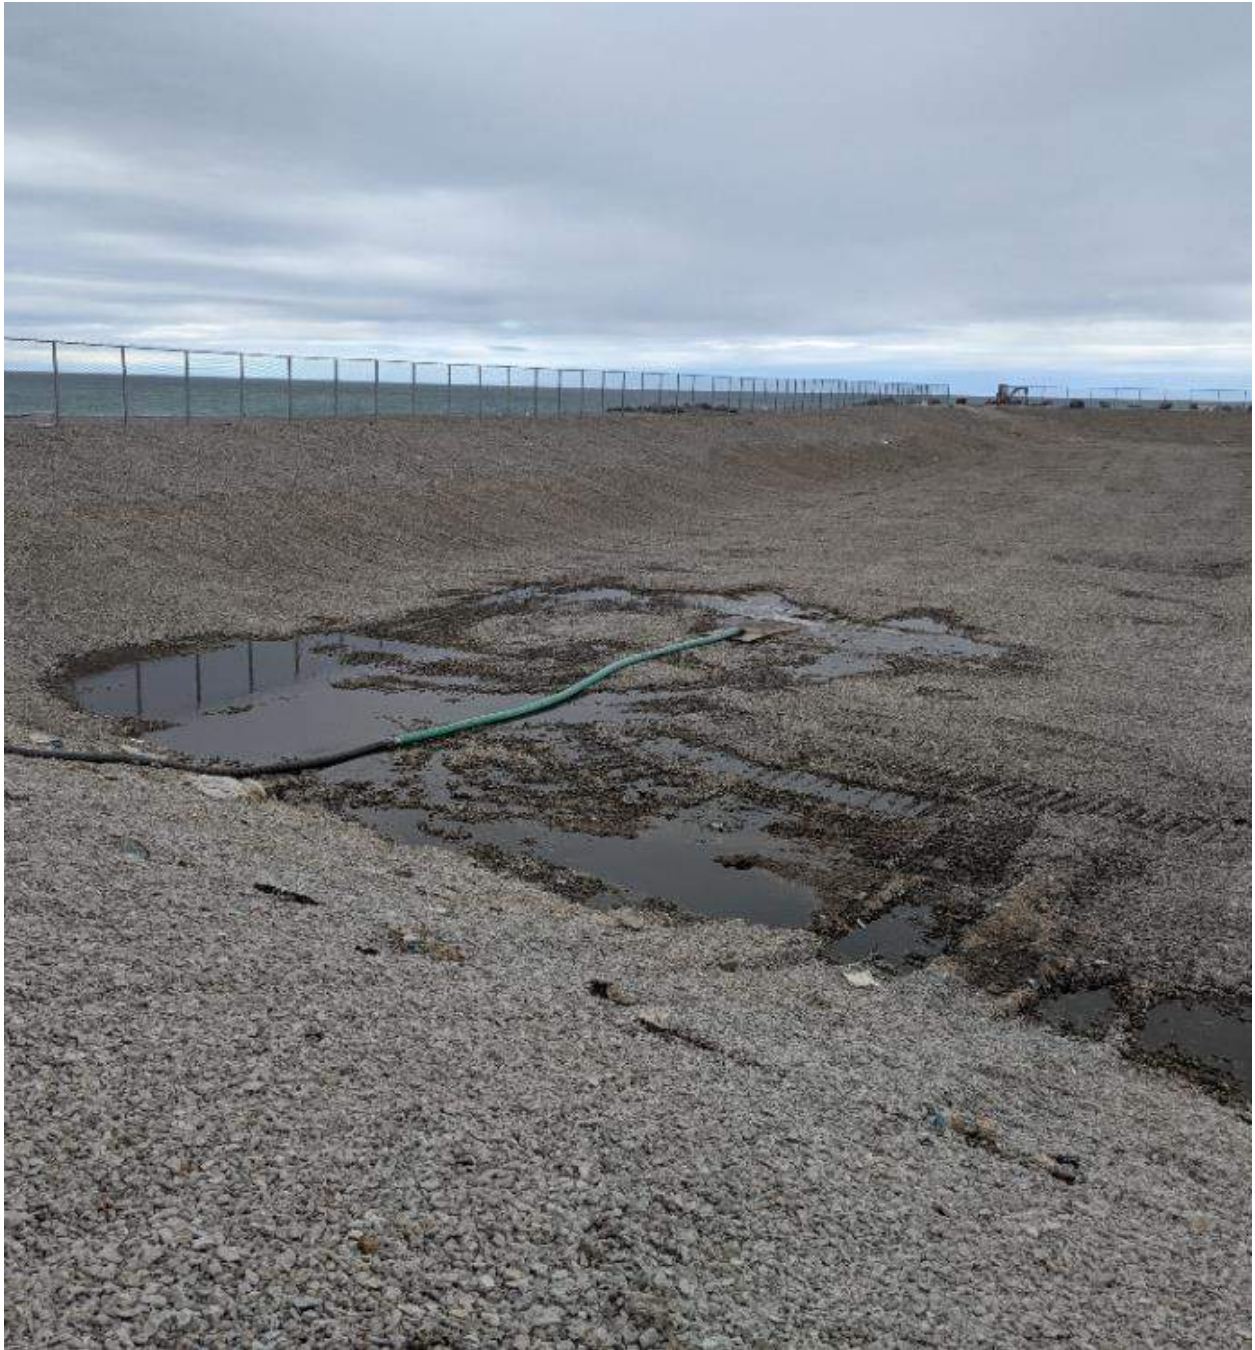
Photograph #3: Water pooling into the northeast corner of the south cell.

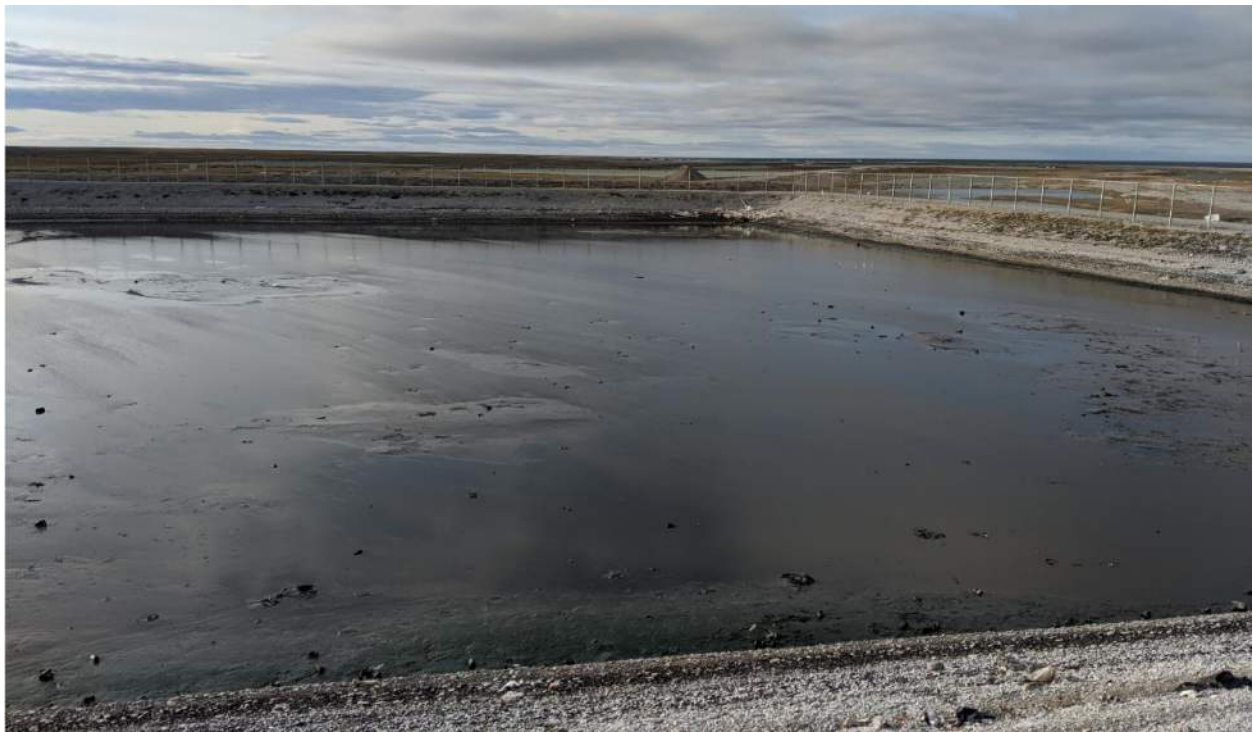
Around 1600, it was noted that the water level in the north cell had dropped significantly, and that the bottom of the cell was showing in several locations within the cell. Alternate sources of water are being considered, but a permit will be required for any source outside the north cell.

Photograph #4: The North cell is rapidly depleting, and the bottom is visible in most of the cell.

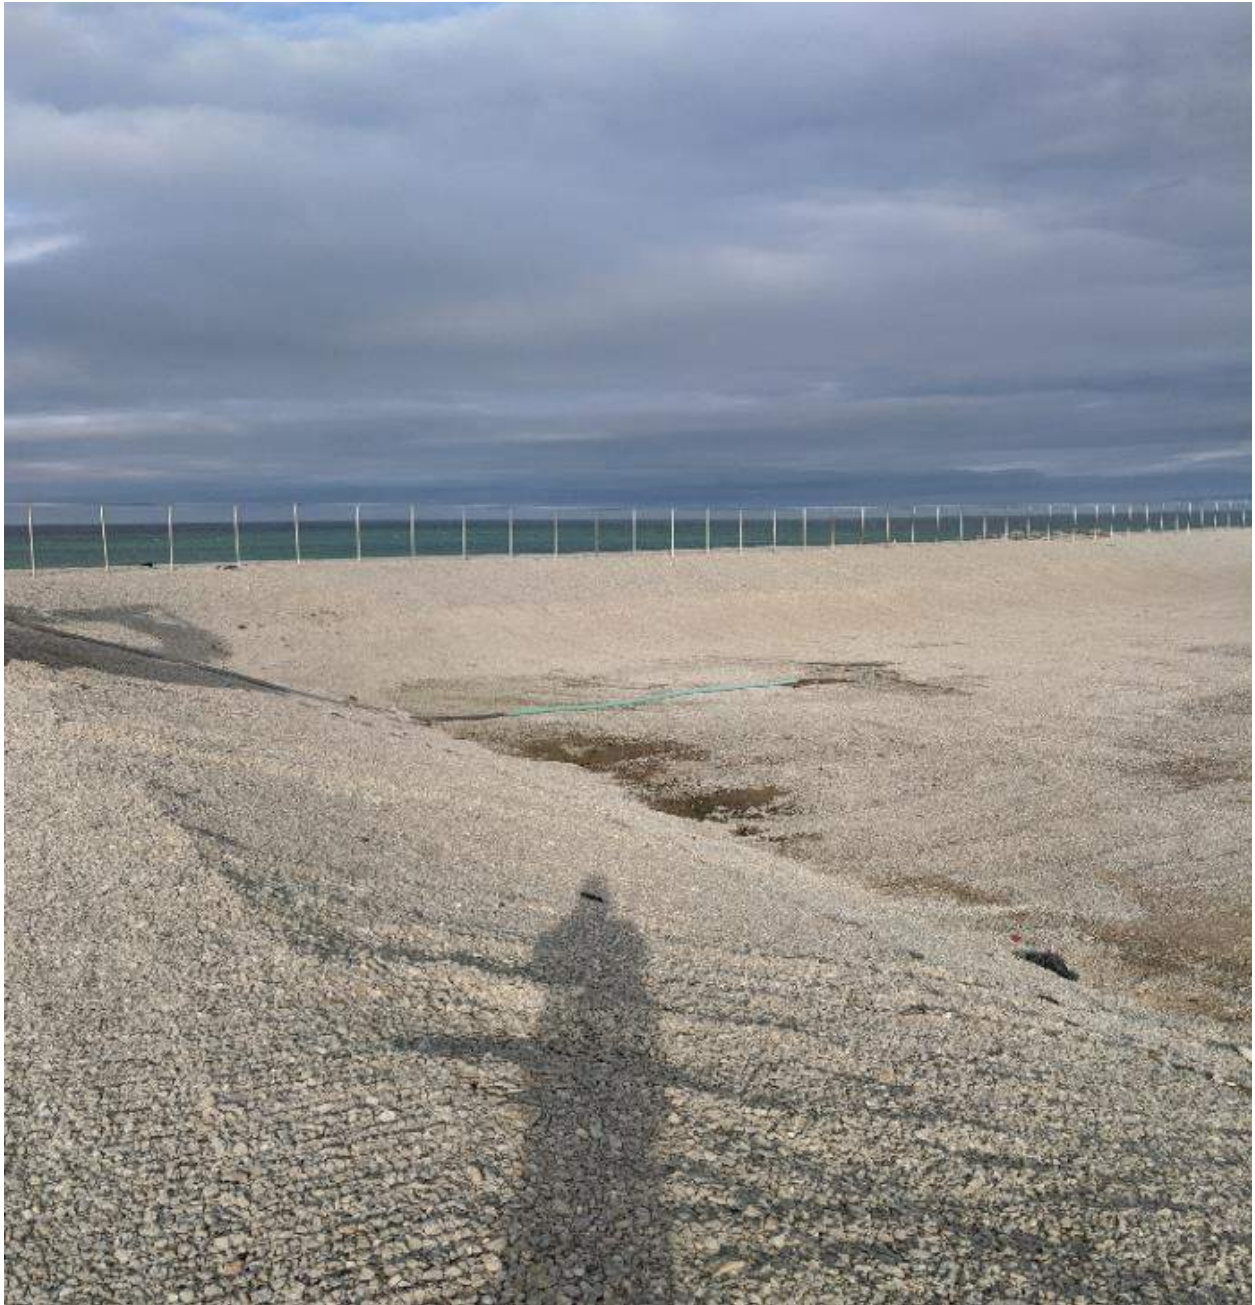
The water pumped into the south cell had initially pooled around the area where the pump's outlet is located but receded into the aggregates shortly after the pump was turned off. No evidence of any leak was observed on the outside of the cell.

Photograph #5: Shortly after shutting down the pump, the water had receded into the aggregates.

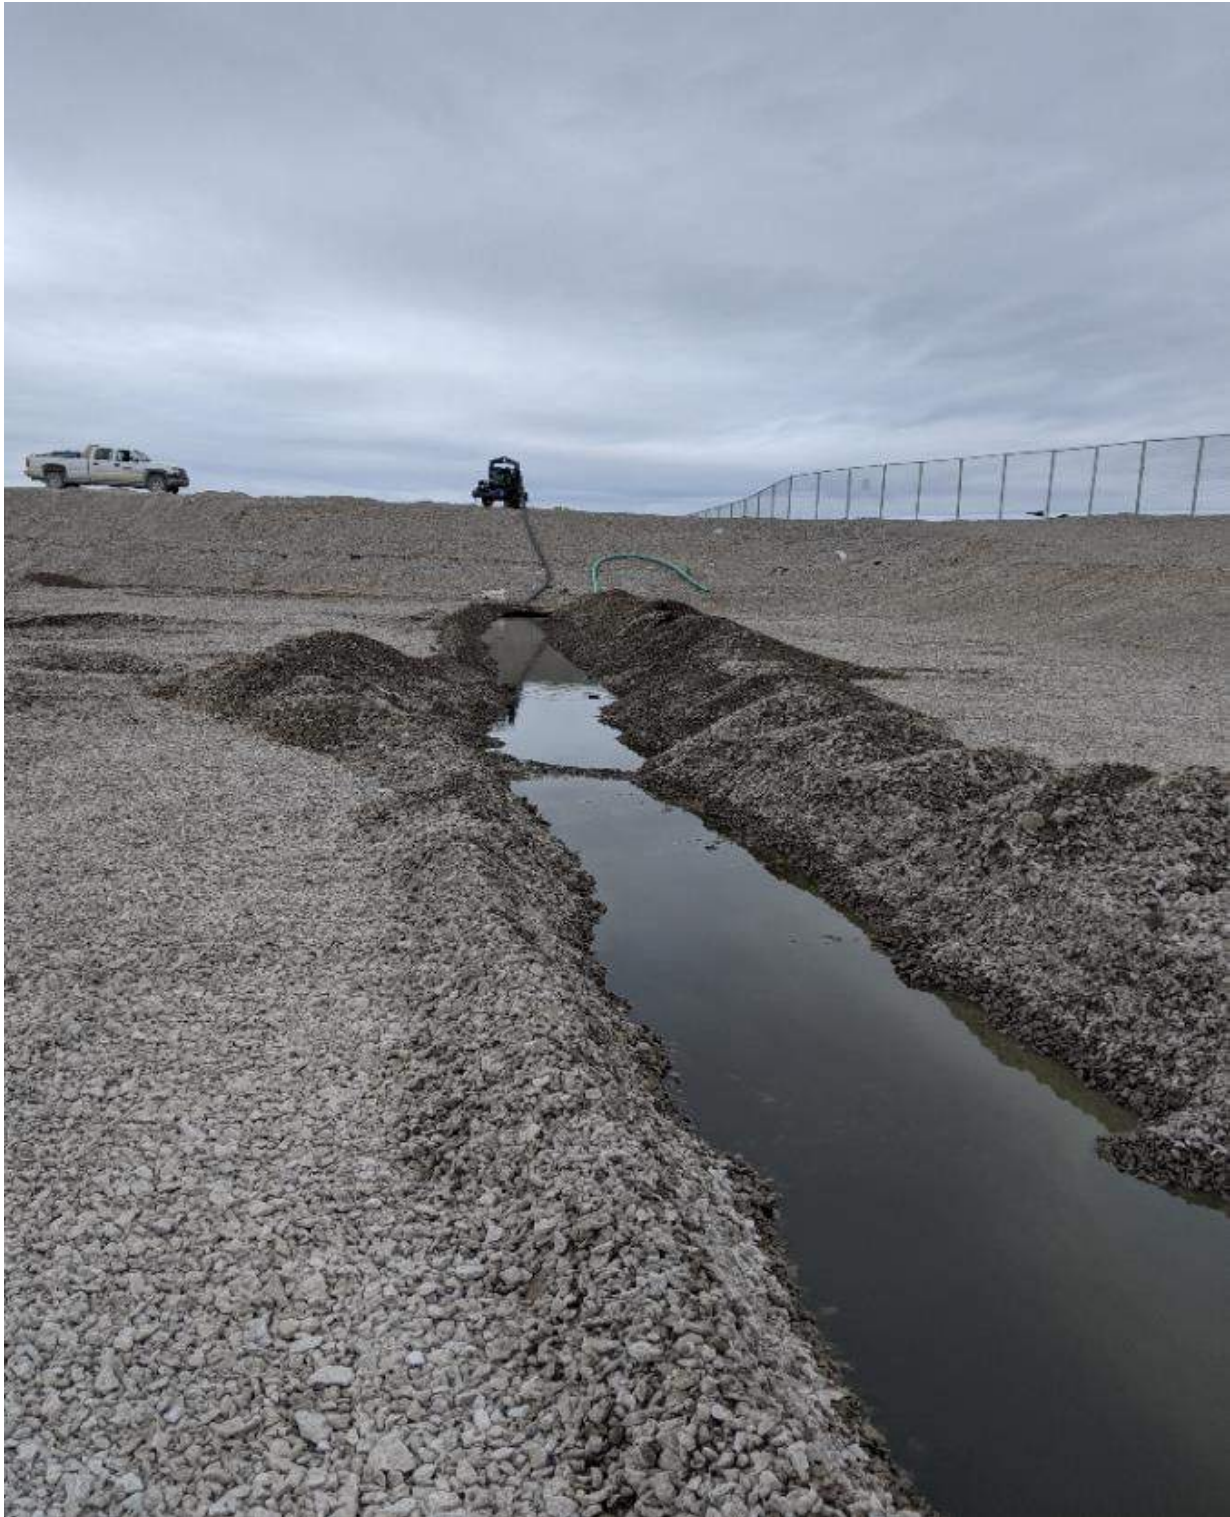
Photograph #2: Single channel dug to delimit the extent of the pool created yesterday. By digging until dry material was encountered, the area to be searched for leaks can be restricted to within the wet area.

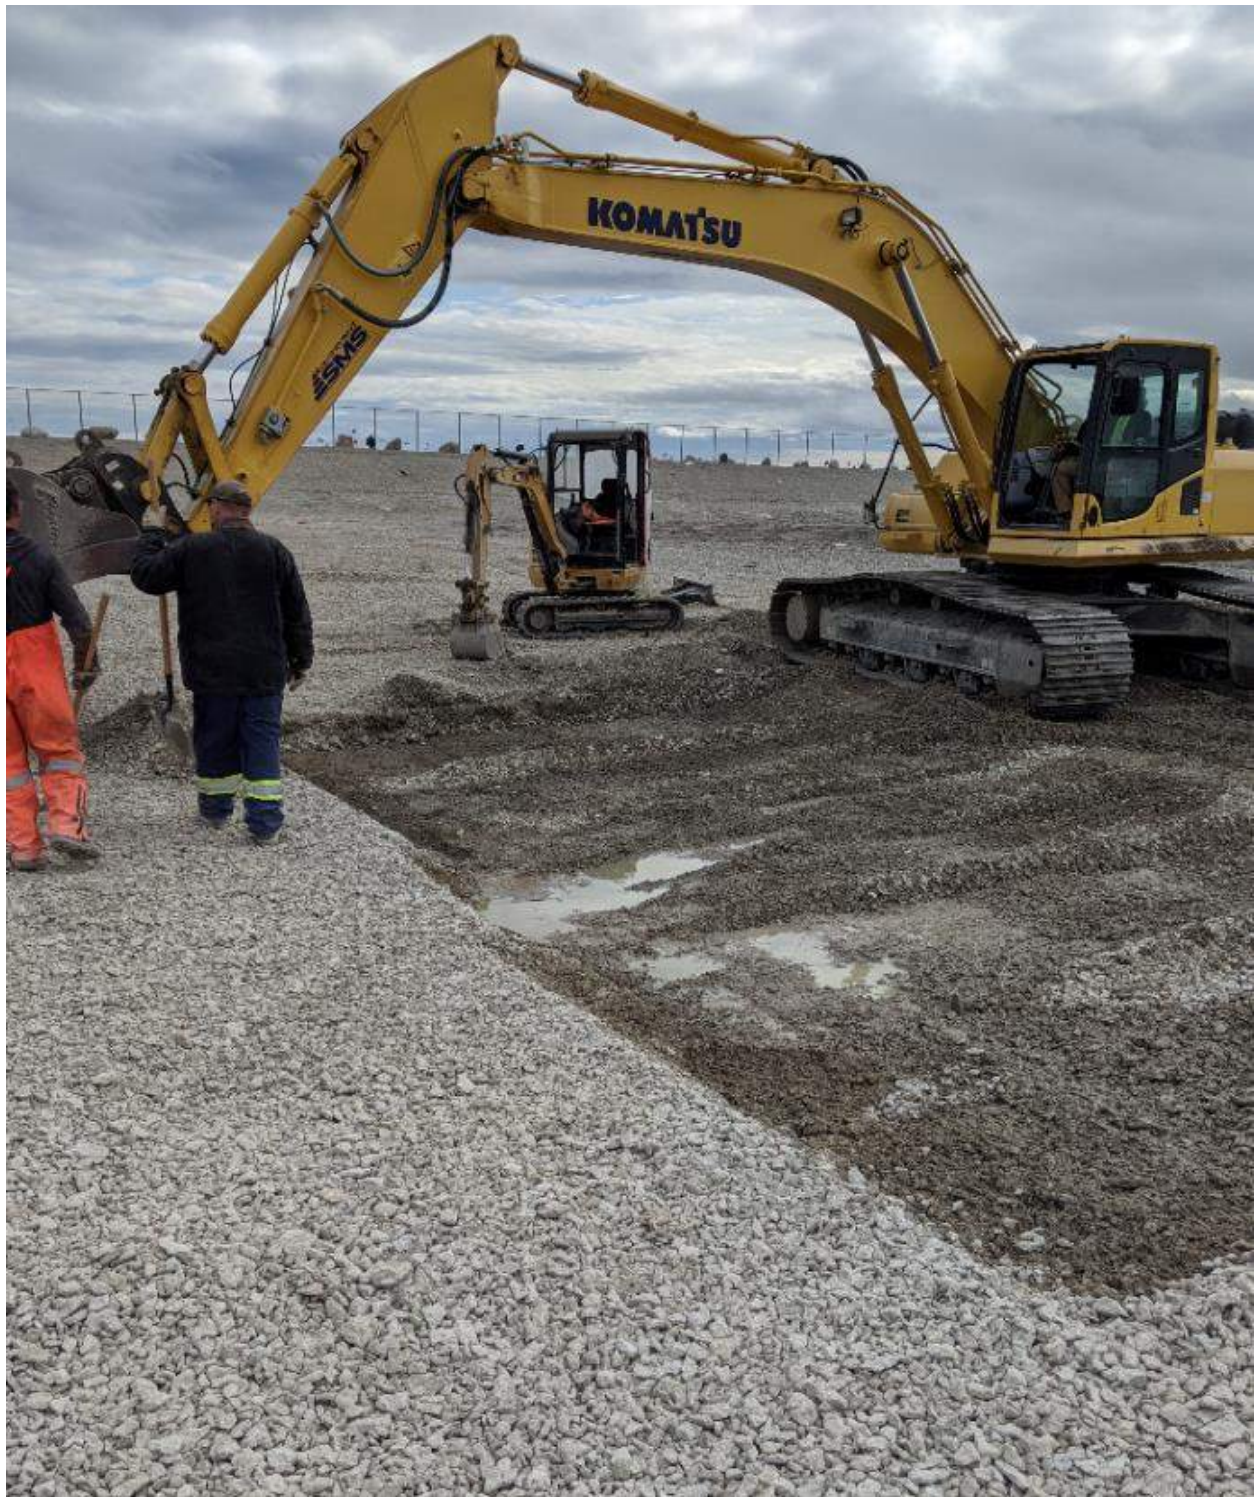
Photograph #3: Exposing liner to check for leaks.

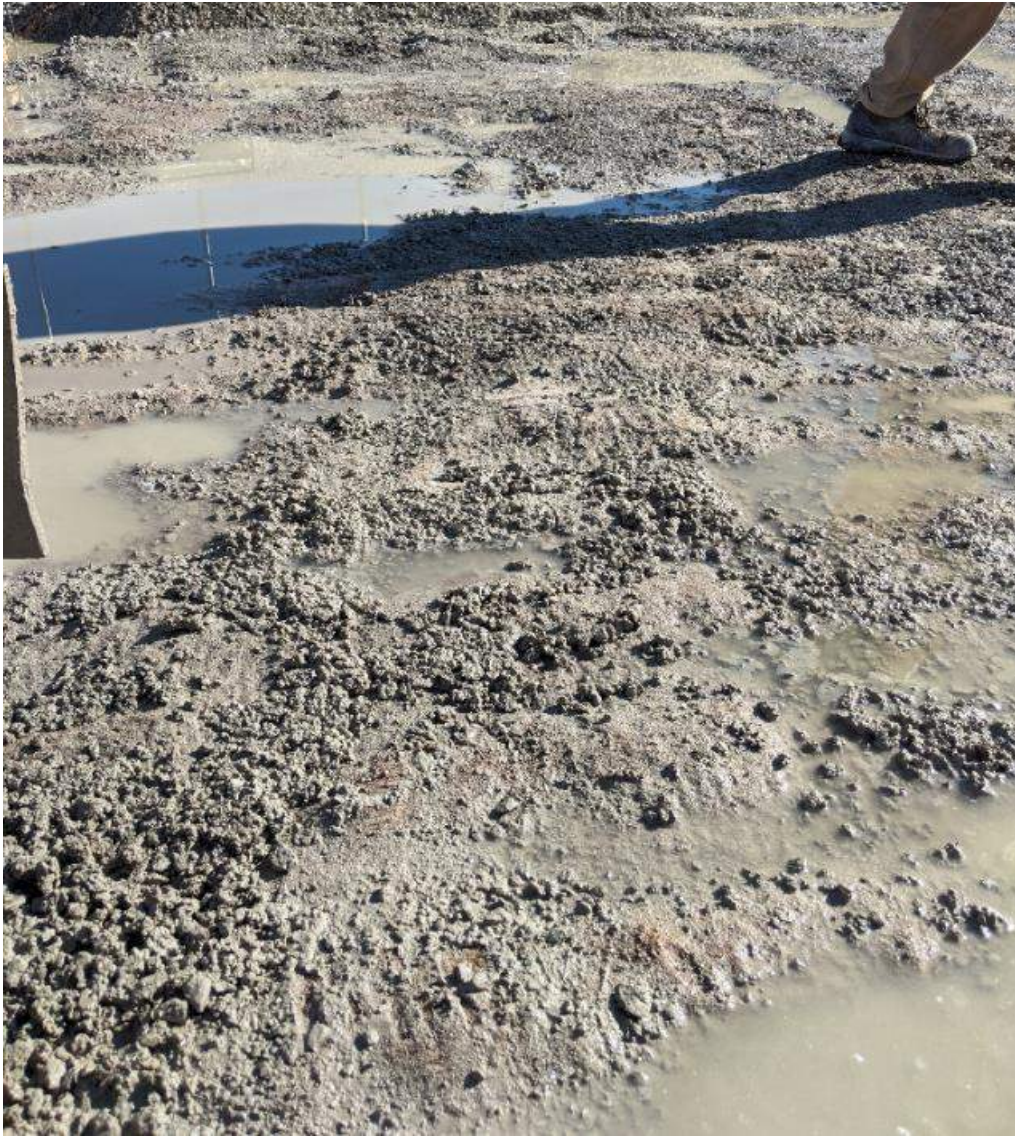
The contractor spent the day cleaning off liner on the lagoon floor, proceeding from yesterday's excavation towards the pump outlet. Multiple instances of track imprints from equipment driving over the liner were exposed. These imprints seem consistent with a deep-cleated track, such as that of a dozer. No other significant damage to the liner was noted in the exposed area.

Photograph #1: Track patterns in liner (in foreground). The patterns are difficult to capture in a photo, but should be more visible once the water has dried up and the sand can be brushed away.

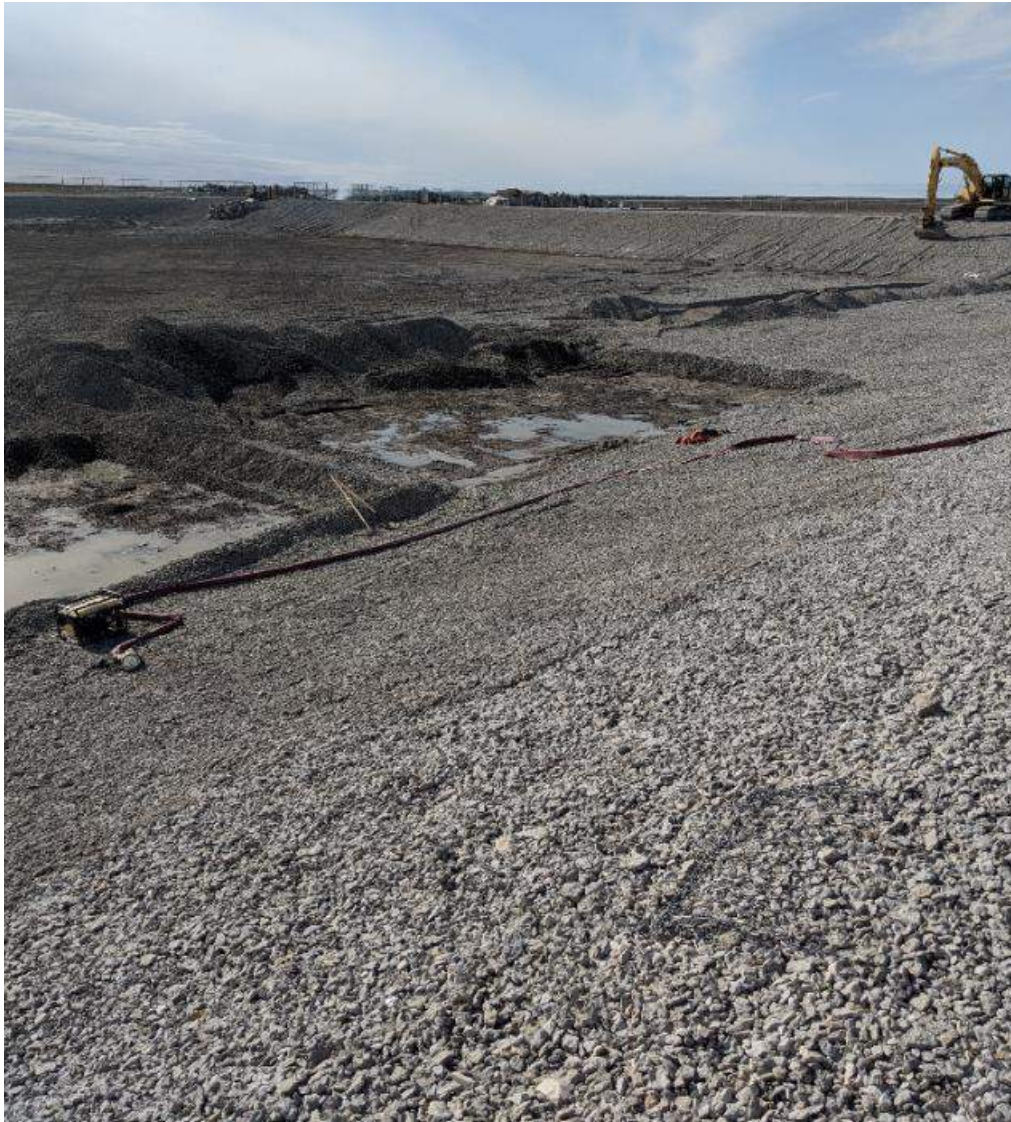
Photograph #2: Exposed area at end of day. Water appears to be retained on the liner in several areas, which was taken as an encouraging sign.
