Summary of Work – Hall Beach 2020 Field Season

Final Report

Hall Beach Sewage Lagoon
Change Order No. 5 & Leak Detection/Resolution

OTT-220382

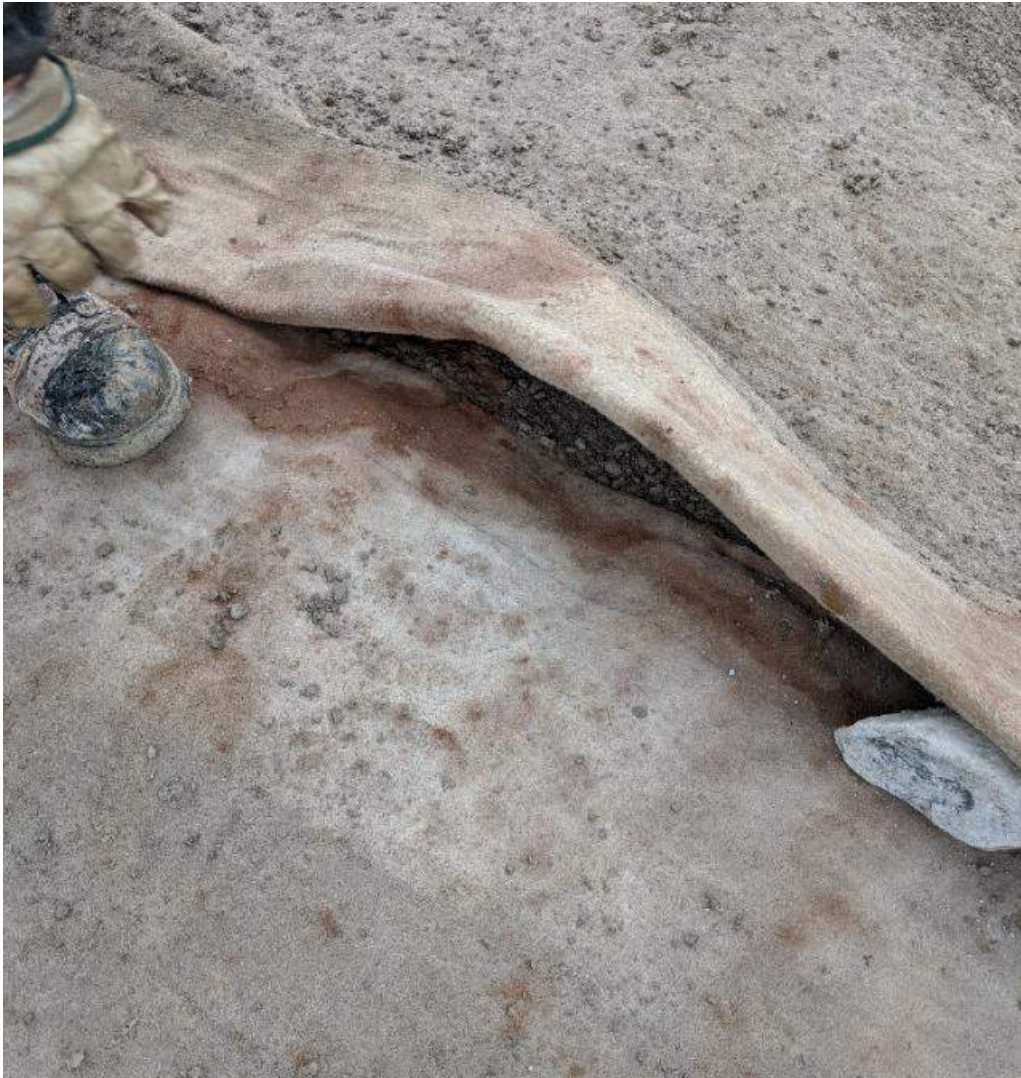
Contractor spent the day exposing liner seams to look for defects. One seam running east-west was exposed along its entire length, from the east berm to the west berm. The seam coincided with a dozer track and showed several signs of failure. In several instances, the lap had been unevenly pressed down by the dozer track and gravel was found to have entered the seam, propping it open. Near the west embankment, the seam was stuffed with gravel, holding it open. In another instance, the bentonite within the seam was non-continuous, leaving gaps to allow water through.

Photograph #1: Non-continuous bentonite strip within seam.

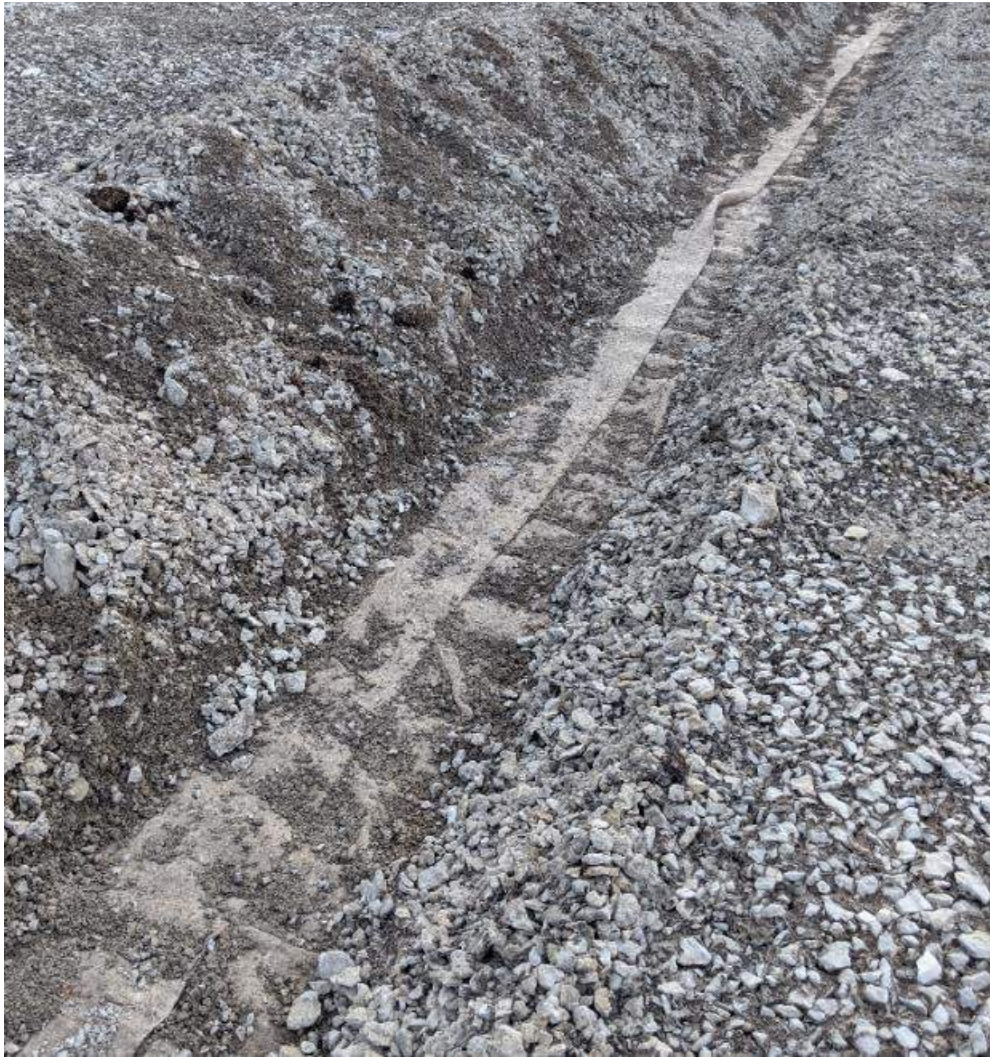
Photograph #2: Dozer track pattern along seam. Liner on right hand side was imprinted deeper than its counterpart, allowing gravel to slip between the liners.

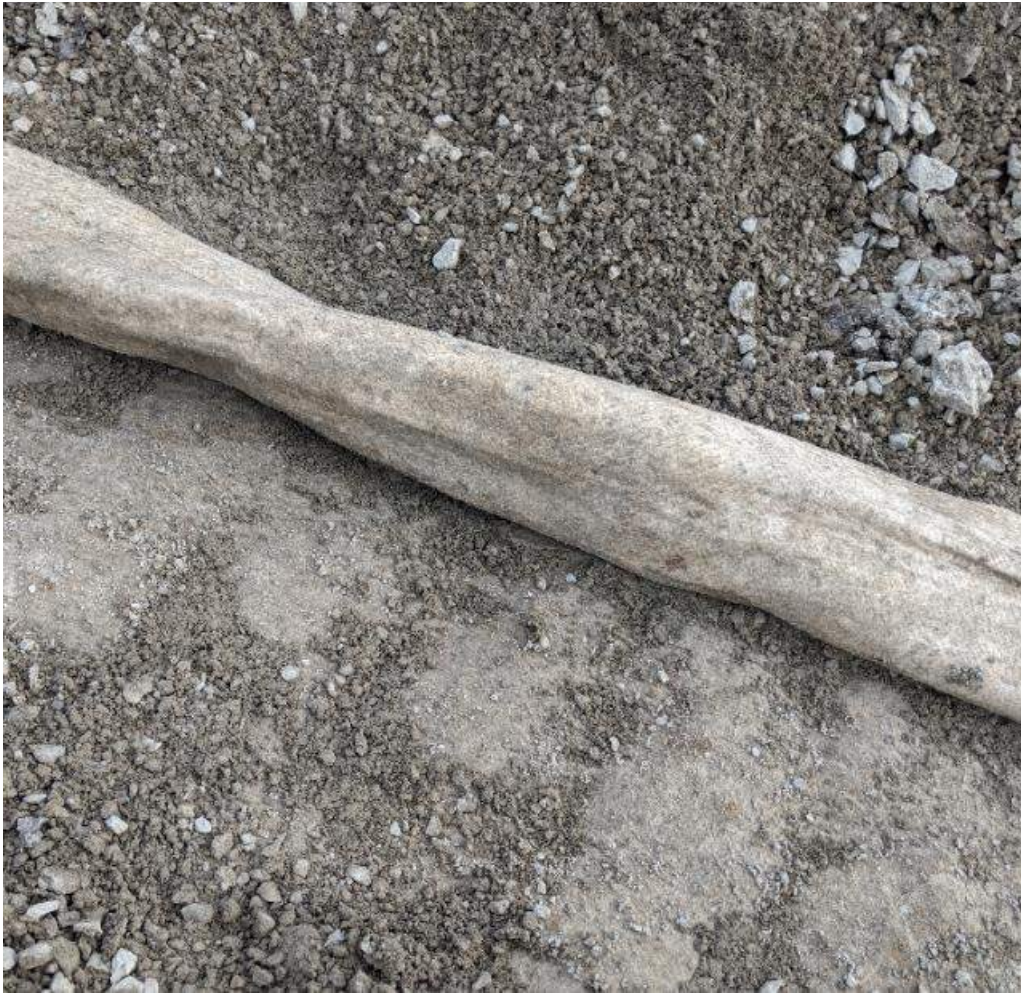
Photograph #3: Gravel was present throughout the width of this portion of the seam. A wider swath of liner will be exposed and the liner will be rolled back further, allowing for a thorough cleaning of the joint. Dozer track pattern still present here.

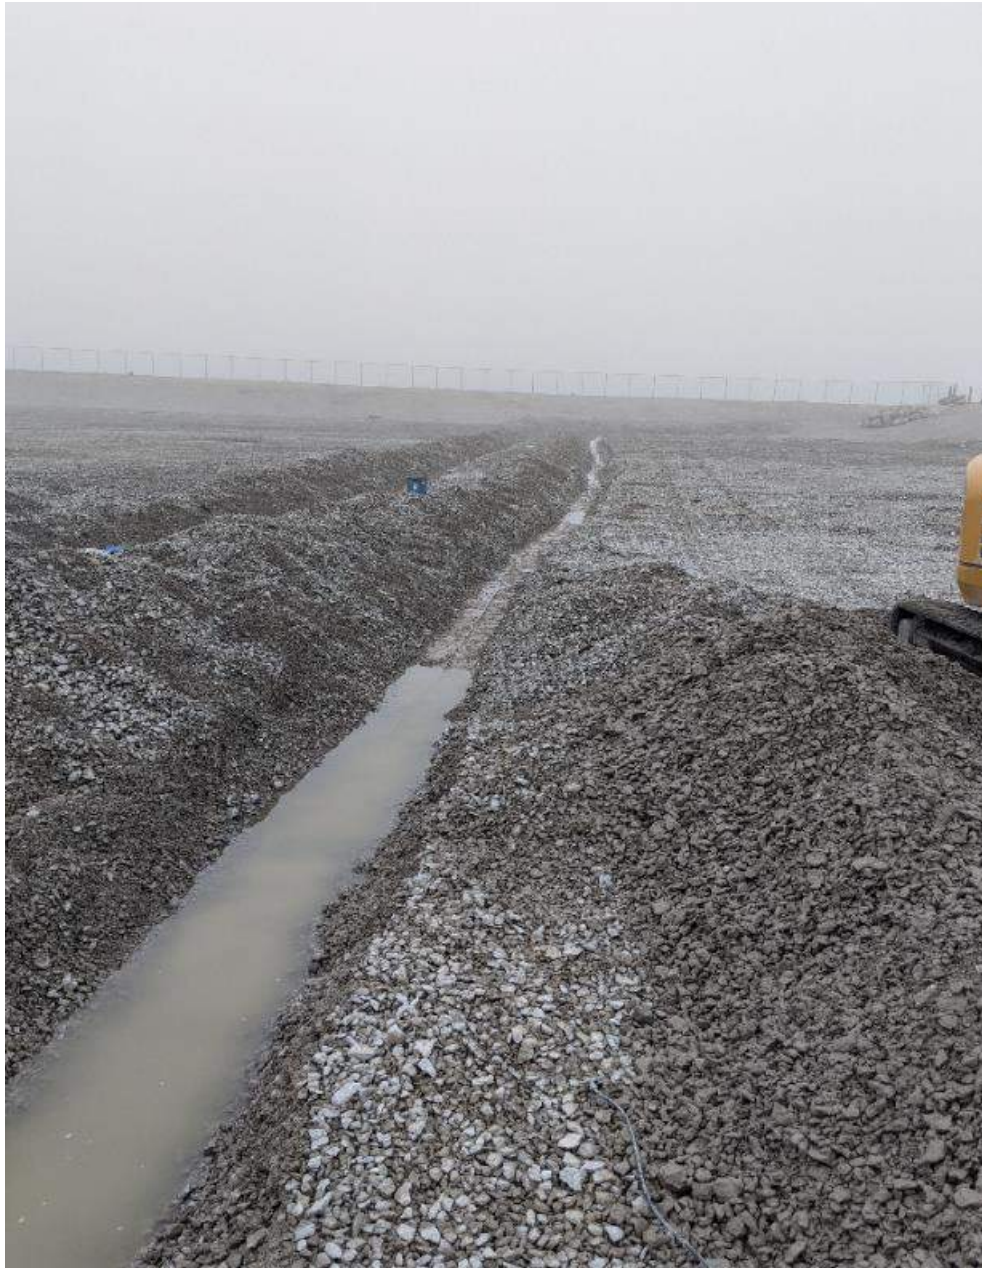
The contractor exposed a second east-west seam across the lagoon's south cell. As with the first, this seam showed signs of leaking at several locations across the cell. Gravel in the seams was the most common issue, with dozer tracks being apparent at several locations across the seam.

Photograph #1: Seam exposure in the east-west direction. Heavy rain all day caused water to pool in the exposed area.

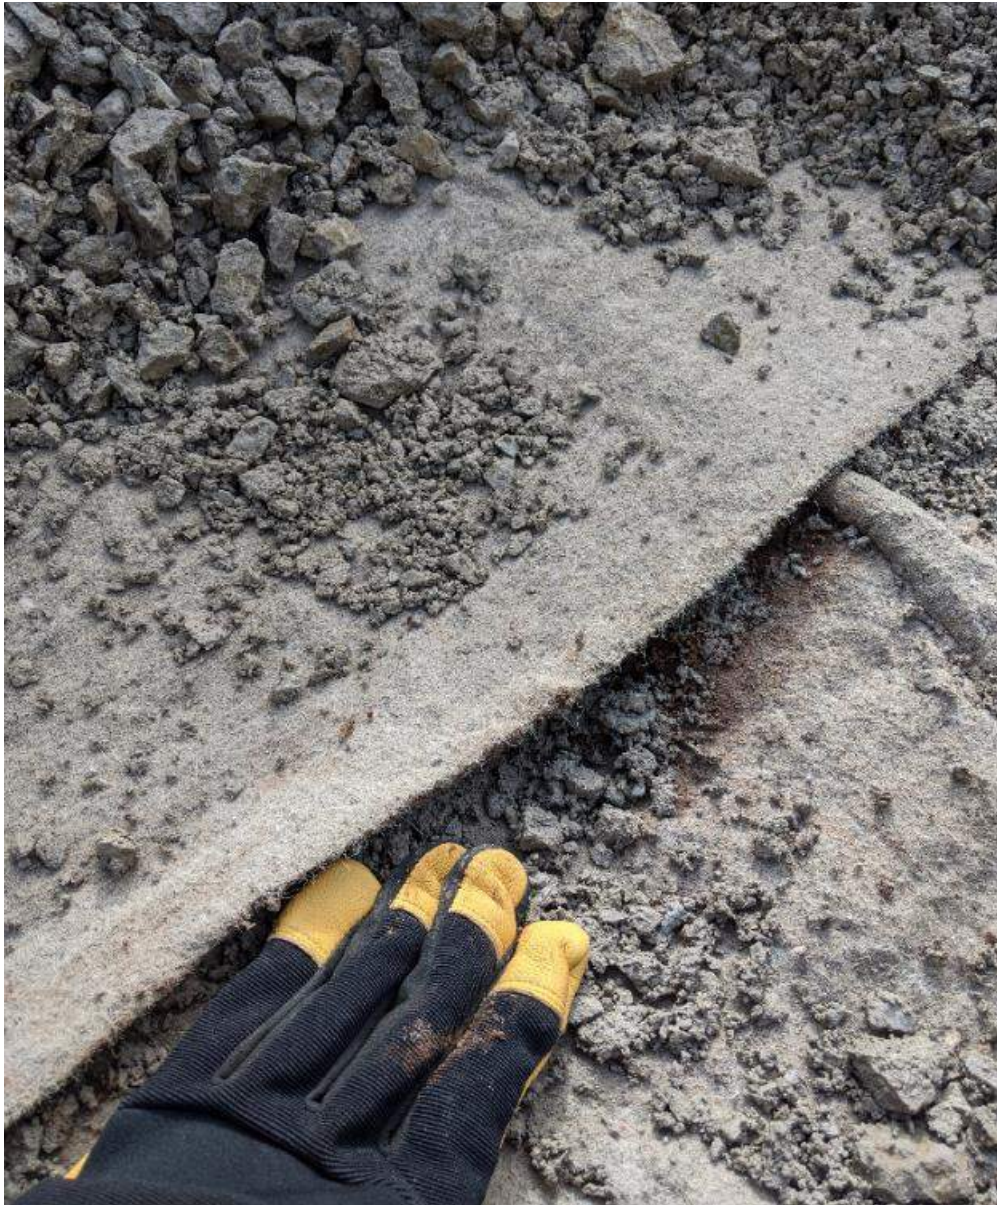
Contractor exposed two additional east-west seams today. Additional issues with gravel in the joints were found. Over 50% of the seams by length exposed so far were compromised in some form. The seams are being cleaned as they are exposed, but additional effort will be expended once the seams are re-sealed with bentonite. The contractor has ordered 120 bags of bentonite, which will be flown in, to complete the seam repairs.

Photograph #3: In-seam gravel thicknesses up to 25mm were encountered while exposing the seam.

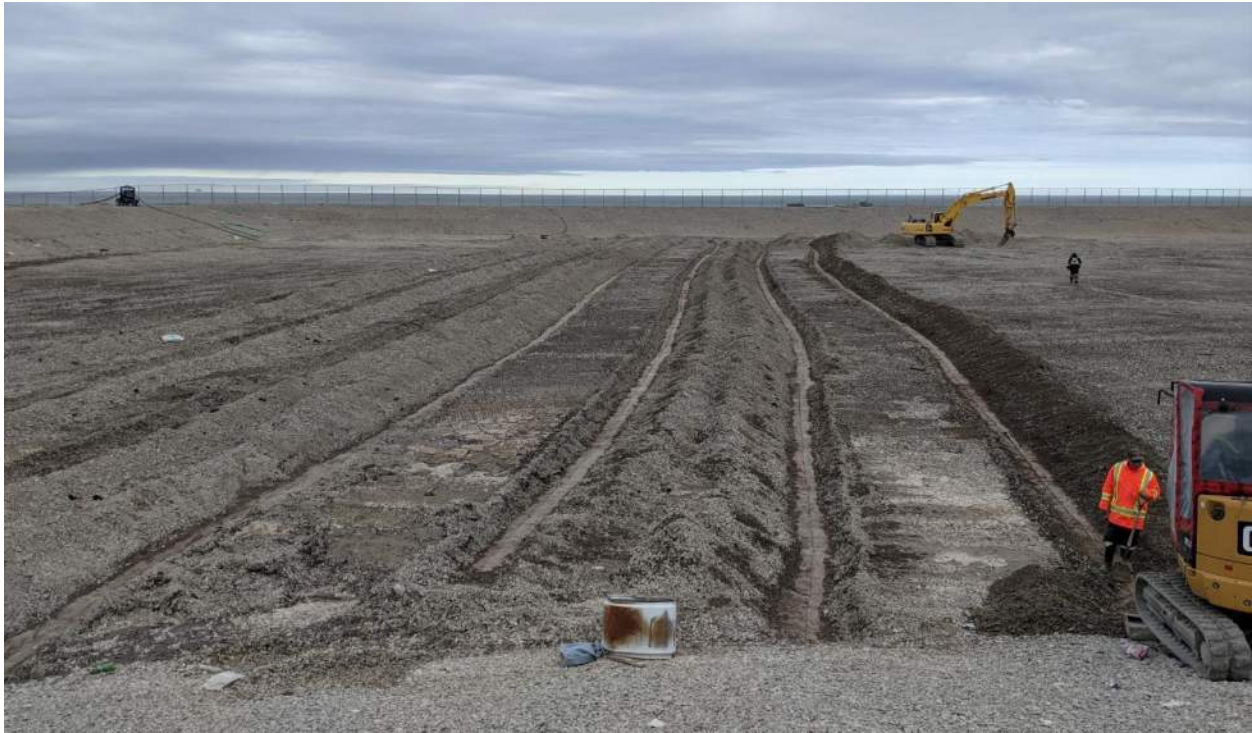
Photograph #1: Overview of work completed so far.

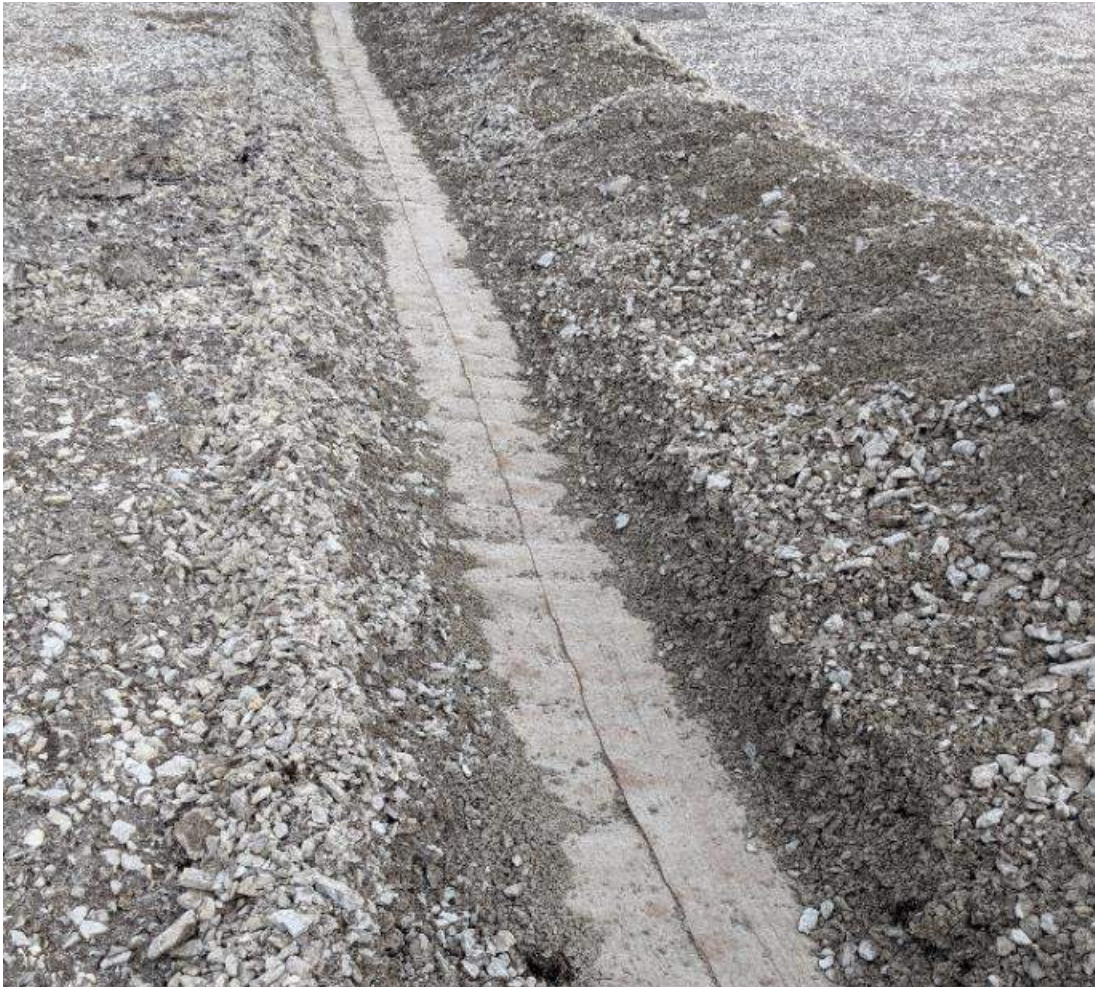
As with previous seams, signs of improperly sealed seams were found throughout the liner uncovered today.

Photograph #2: The dozer track pattern is a common feature of every seam uncovered so far.

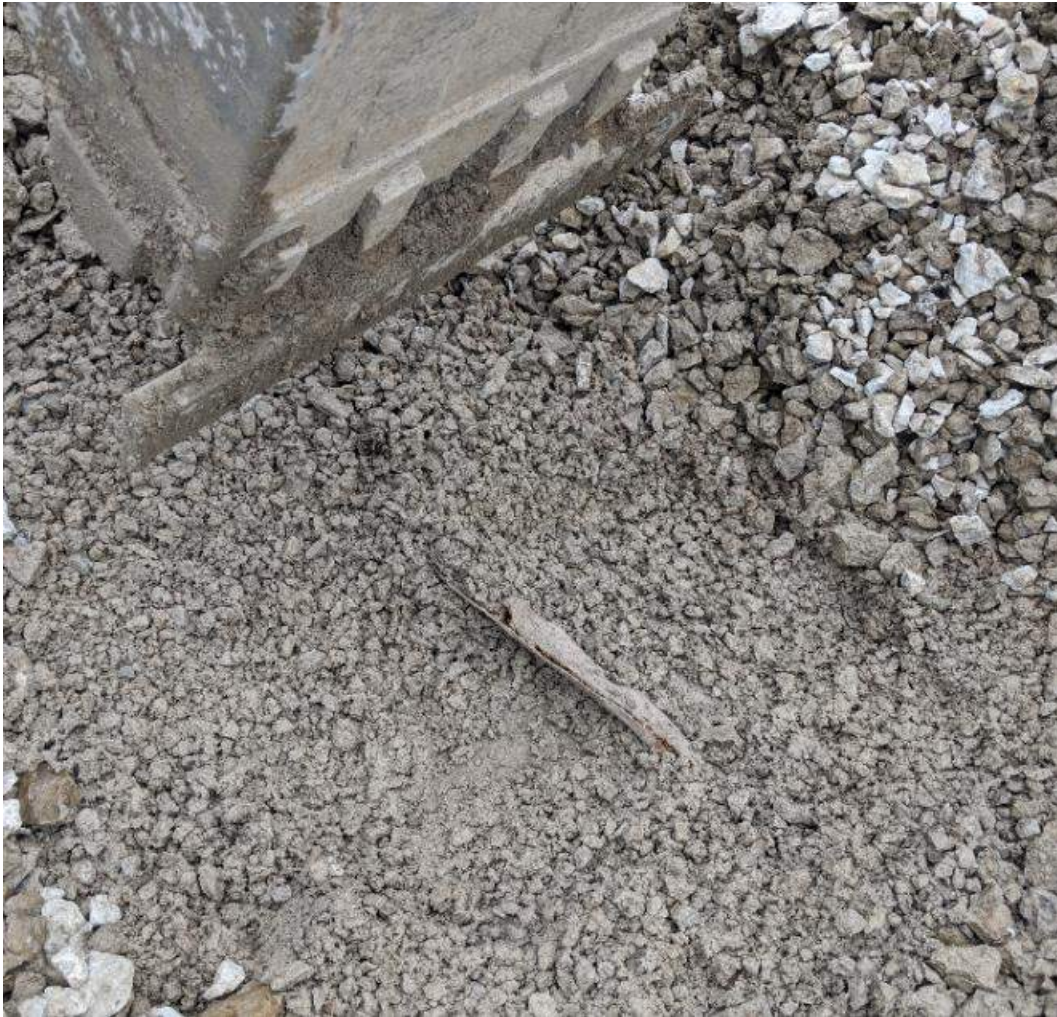
Photograph #3: Liner edge sticking straight up as it is uncovered. The bottom side of the liner (lower left side of liner as seen here) is full of gravel, preventing the seam from properly closing.

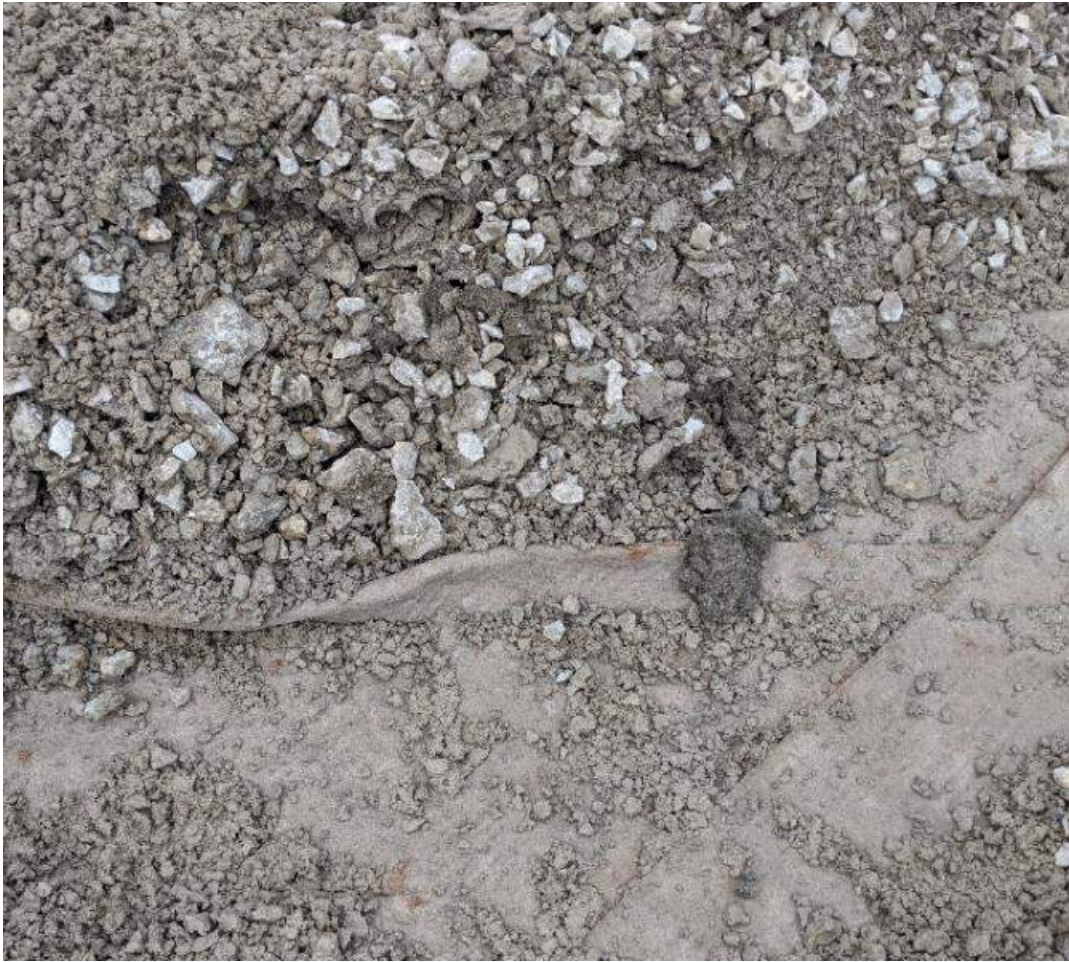
Photograph #4: Major roll next to a liner seam. The roll will be cut out and patched later on during the seam re-sealing process, prior to backfilling.

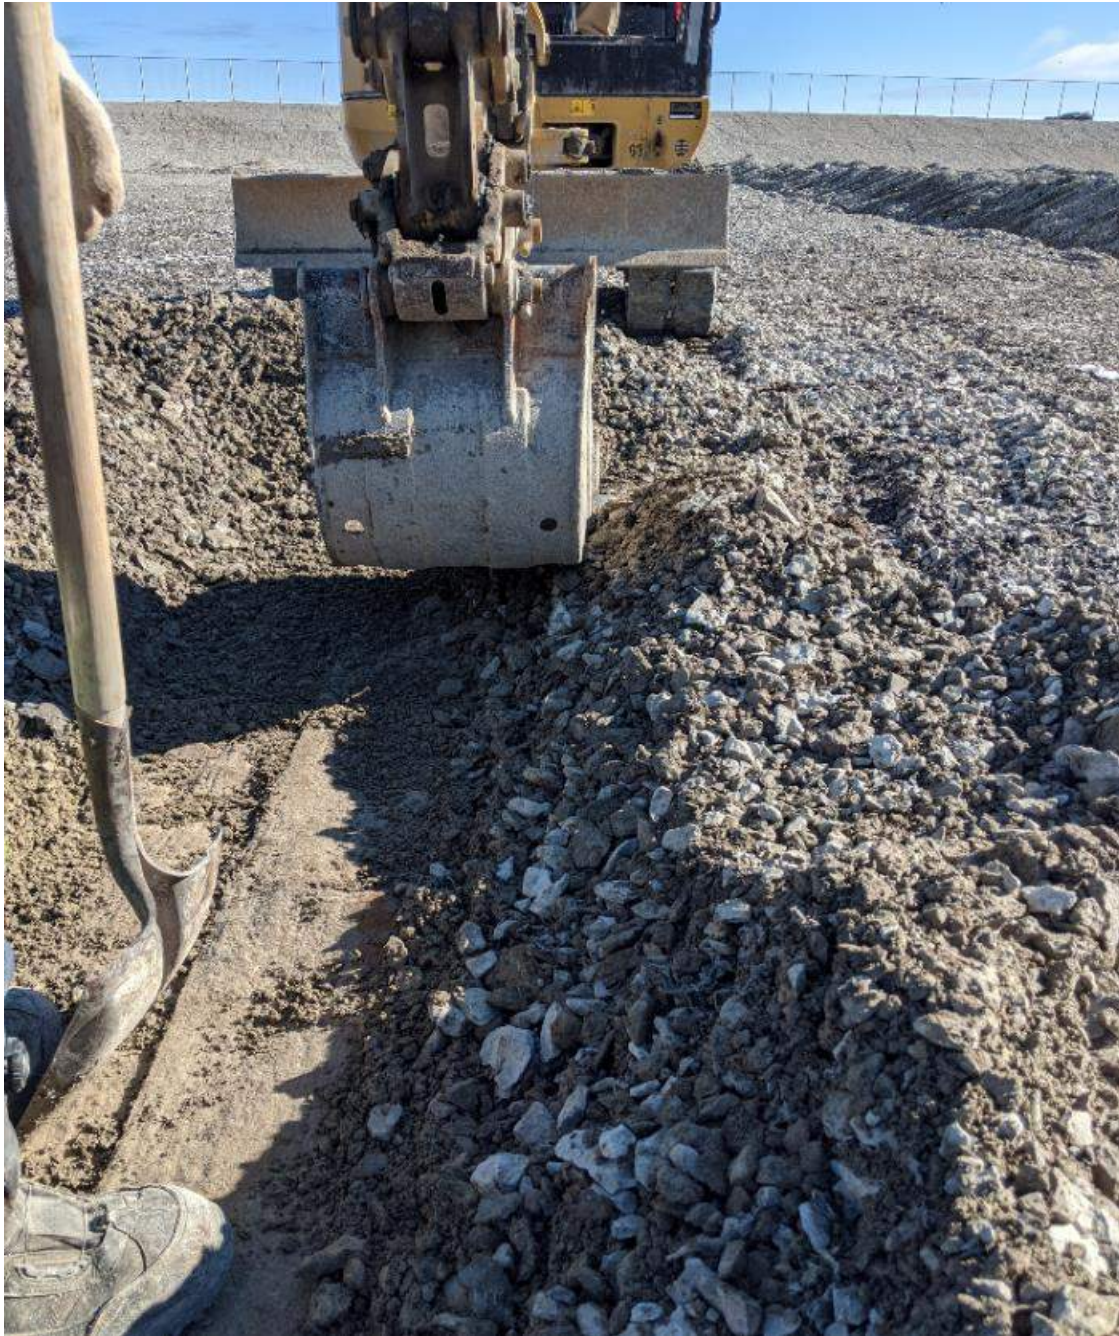
The contractor once again spent the day uncovering some east-west seams in the liner. While the seams uncovered today were in a generally better condition than others exposed so far, they still presented deficiencies such as wrinkles, gravel in the seams, and uneven subgrade. At one location, it was observed that the total depth of aggregates covering the liner, including both sand and coarse aggregates, was less than 200mm.

Photograph #1: In one location, the total depth to liner was less than 200mm. The mini-excavator's bucket is level with the undisturbed aggregate surface in this photo.

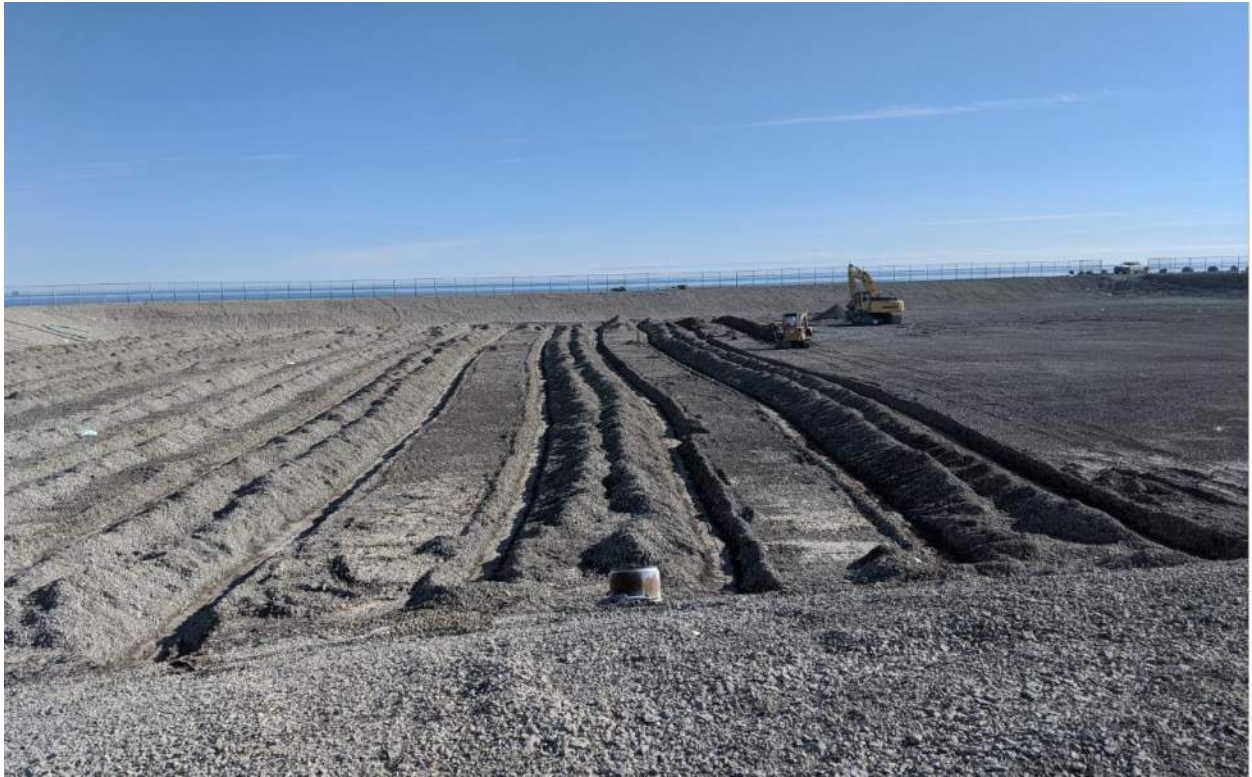
The contractor exposed an additional three seams today, bringing the total to 16. The seams exposed presented similar damages to the ones found on the first 13 seams, including gravel within the seam, dozer imprints, and wrinkles.

Photograph #1: Overview of progress so far.

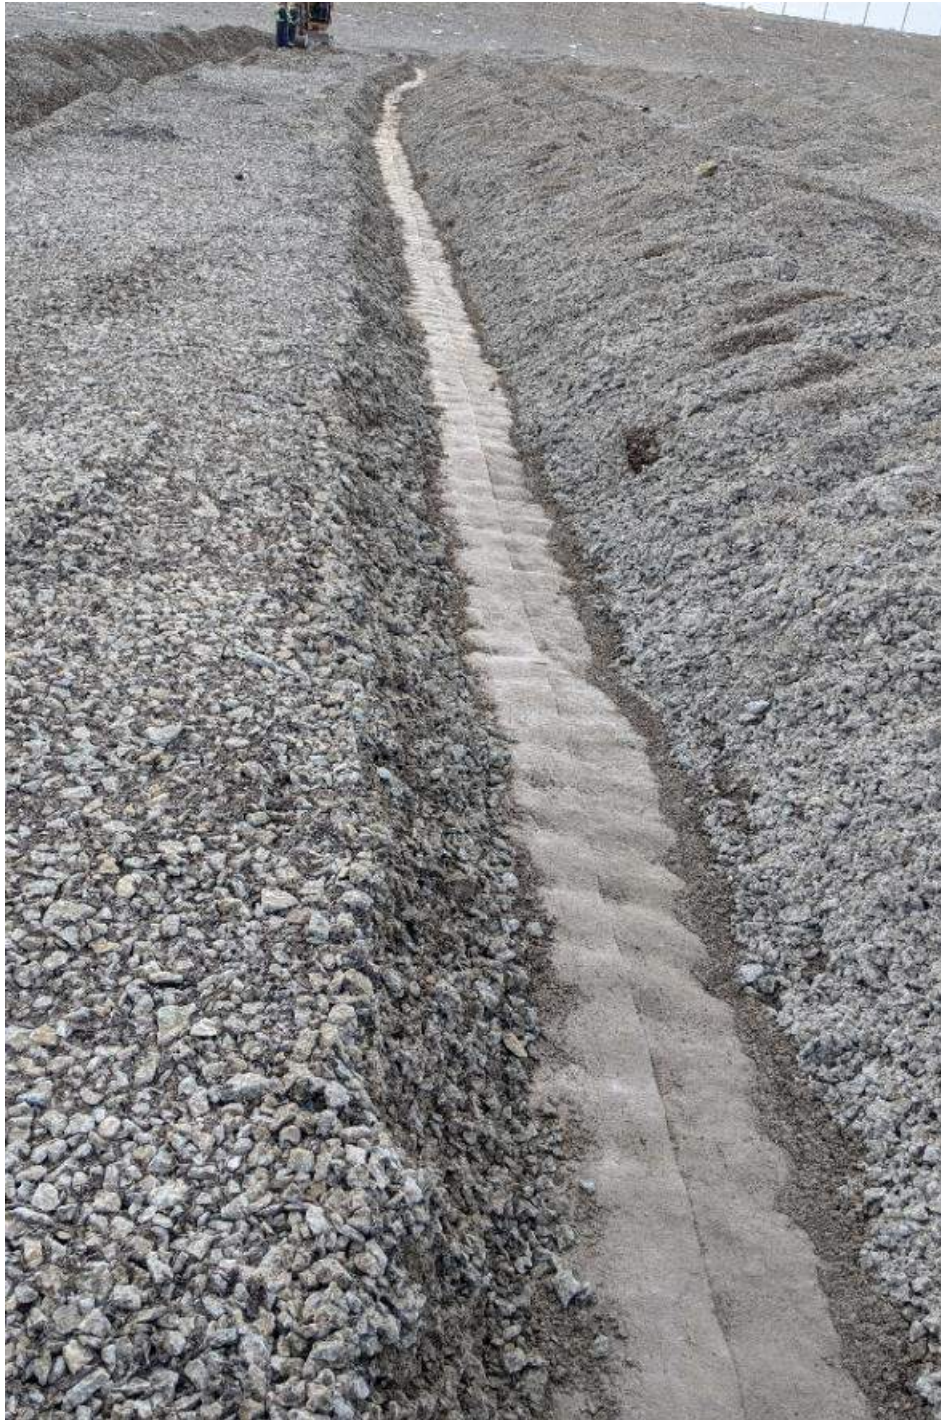
The contractor exposed two more seams today, for a total of 18. The seams presented some defects such as gravel in the seam, dozer imprints, or damage to the edges of the panels. A patch was also found next to one of the seams, presumably dating from the 2018 repairs. The bentonite that will be used to re-seal some of the seams also arrived today. Work on re-sealing some of the seams will begin tomorrow.

Photograph #1: The familiar wave pattern presented by the dozer track imprints, which is common to most seams exposed so far.

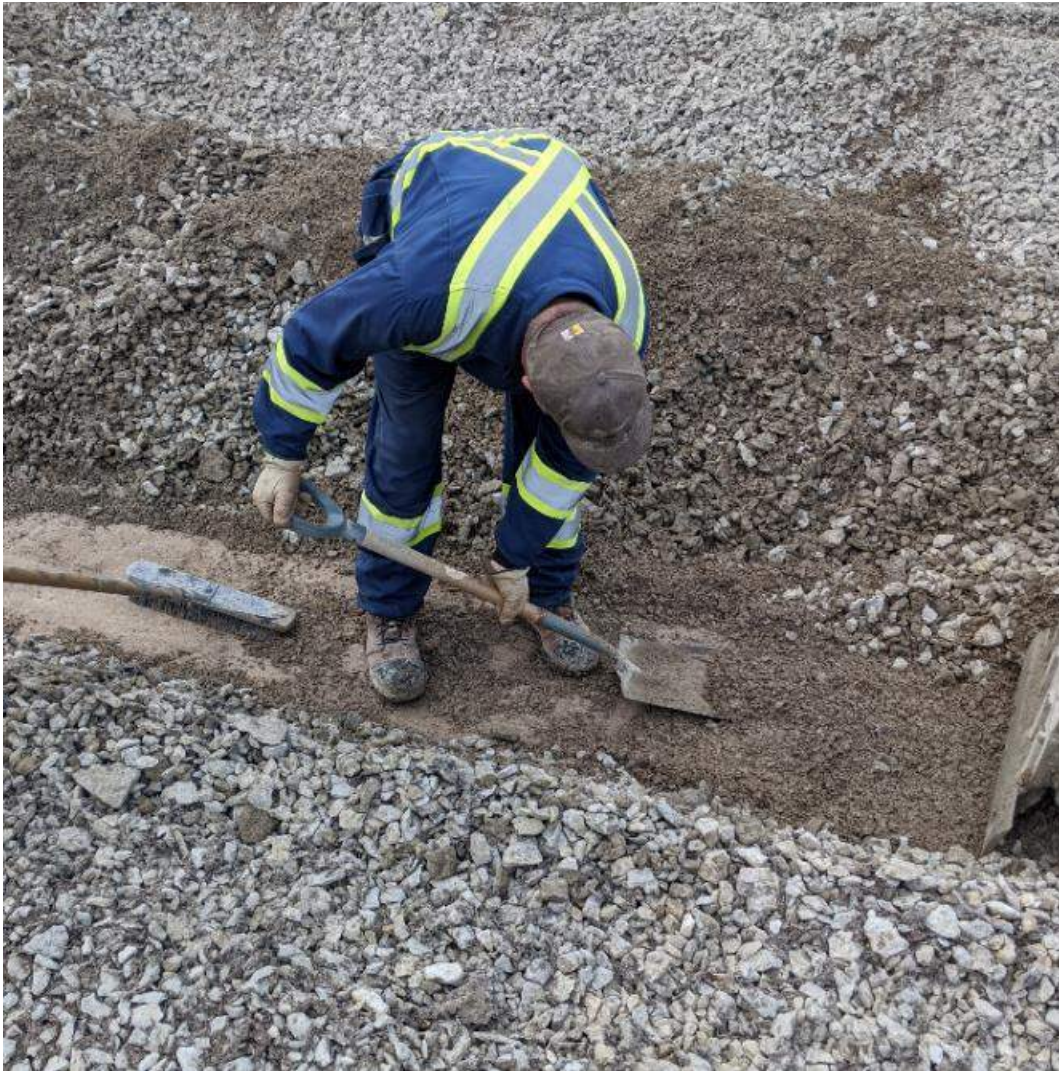
Photograph #2: A mini-excavator is used to remove most of the aggregates, the sand layer is removed by hand, and a broom is used to clean off the liner.

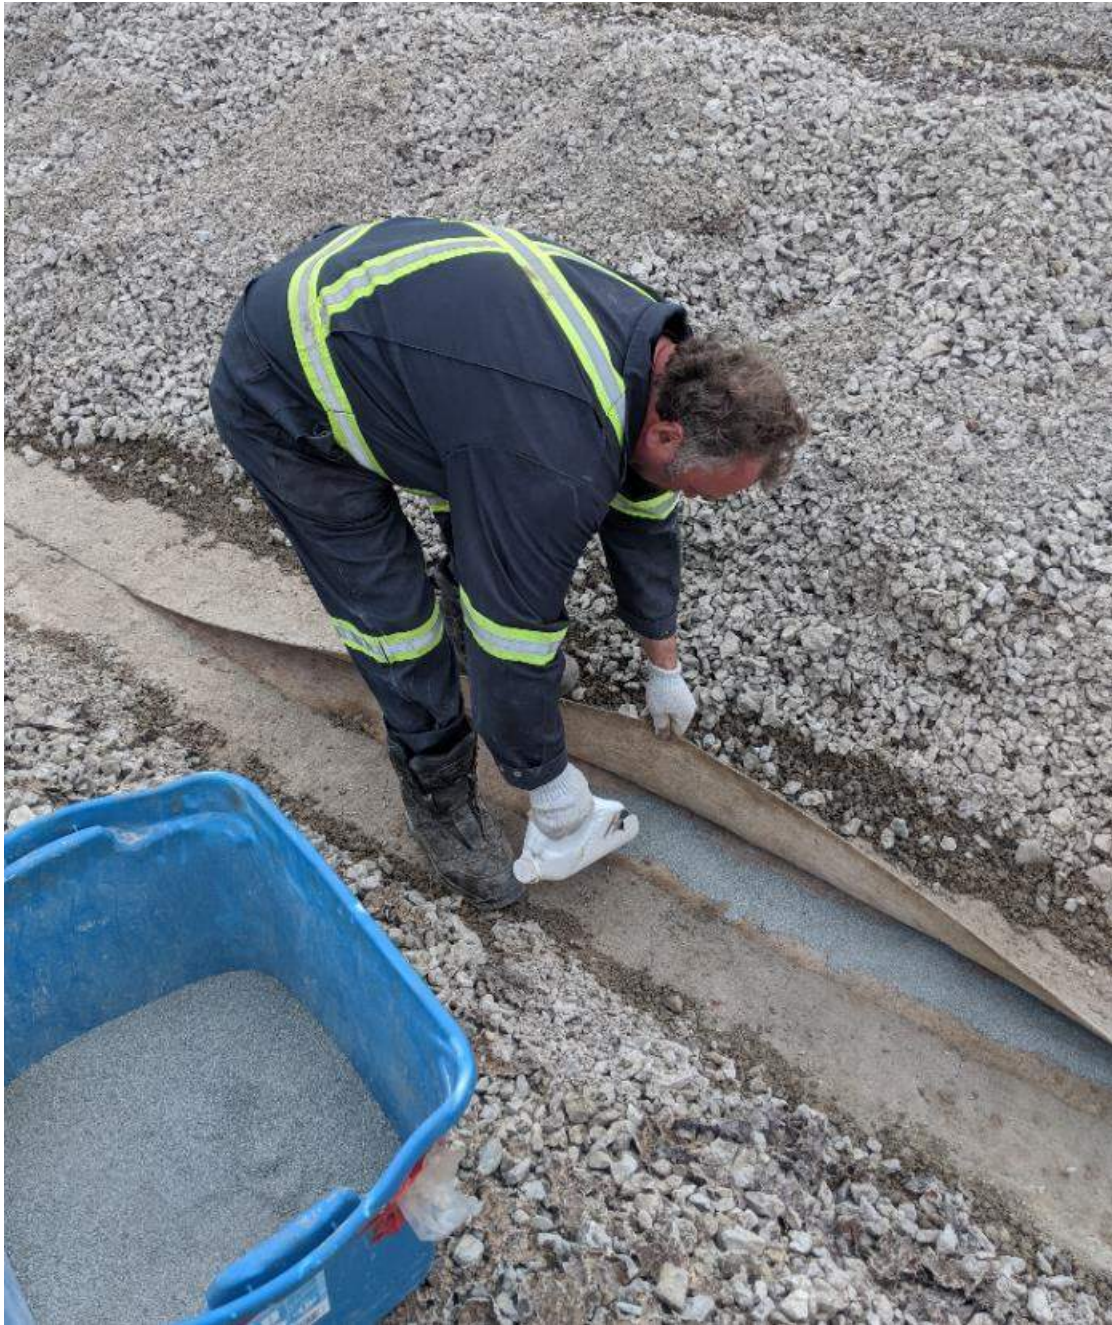
Photograph #1: Placing bentonite within the seam, in a strip running parallel to the existing strip (further into the seam, not visible in this photo).

The contractor re-sealed 3 seams with bentonite today. The seams were first opened far enough to ensure no gravel remains, then a new strip of bentonite was placed between the two layers of liner at the seam. The existing bentonite strip is, for most seams, approximately 300mm back from the edge of the top liner, allowing plenty of room to place the new 100mm wide bentonite strip approximately 100mm from the edge of the seam. Once repaired, most seams therefore contain two strips of bentonite within the overlap.

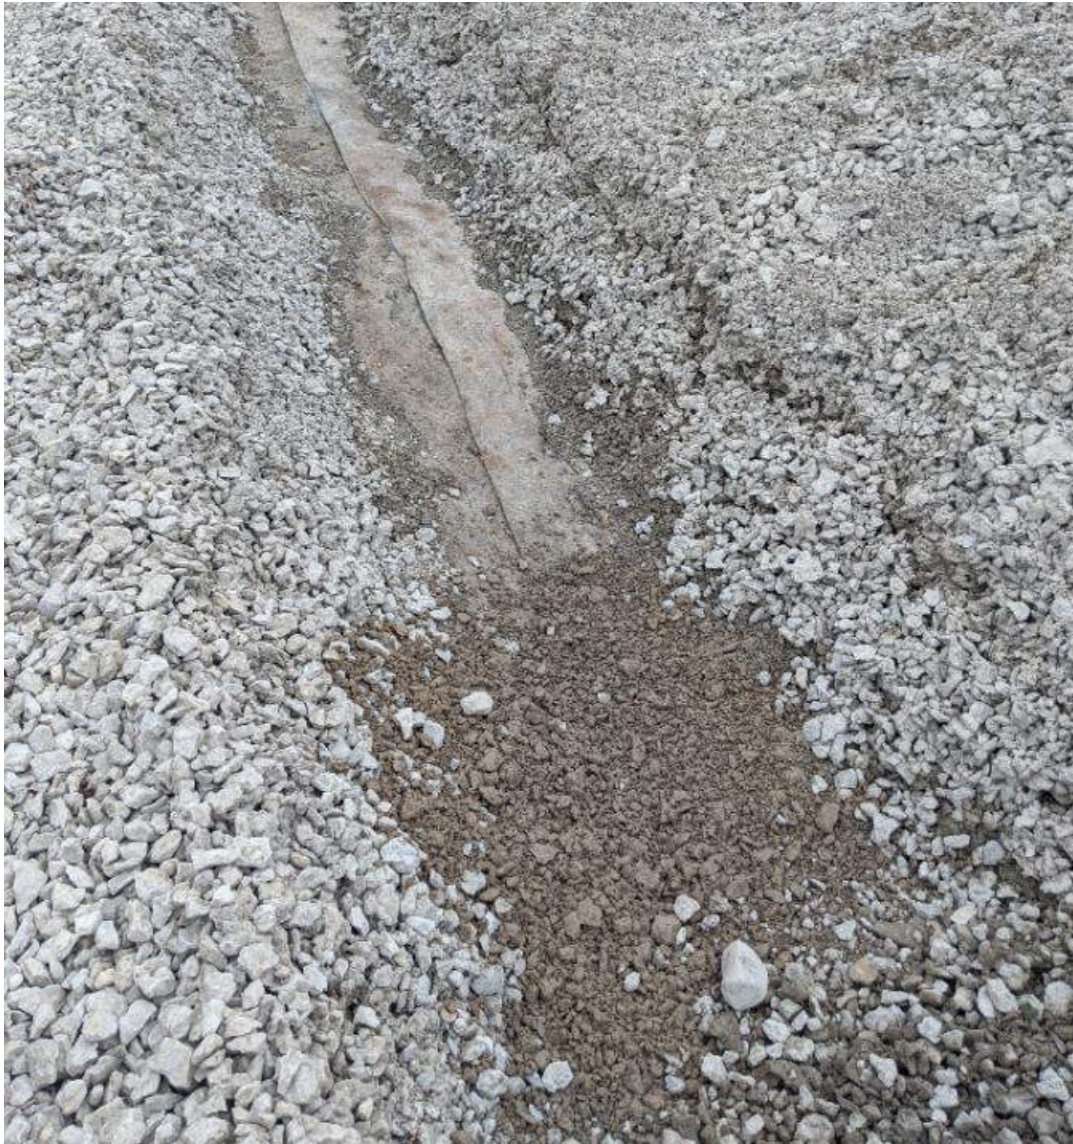
Photograph #2: Seams were covered in sand prior to being covered with the aggregates.

Once repaired, the seams were covered with approximately 100mm of newly screened sand, then backfilled with aggregates. All backfilling activities were done with the excavator, and care was taken to ensure that the excavator's treads did not damage the liner. In particular, the operator minimized the amount of turning required, and when turning, used the boom to lift the front end of the excavator off the ground. This minimized the twisting motion applied to the ground. The excavator did not enter or drive over an open trench at any time, remaining instead on areas where the full thickness of the aggregates protected the liner.

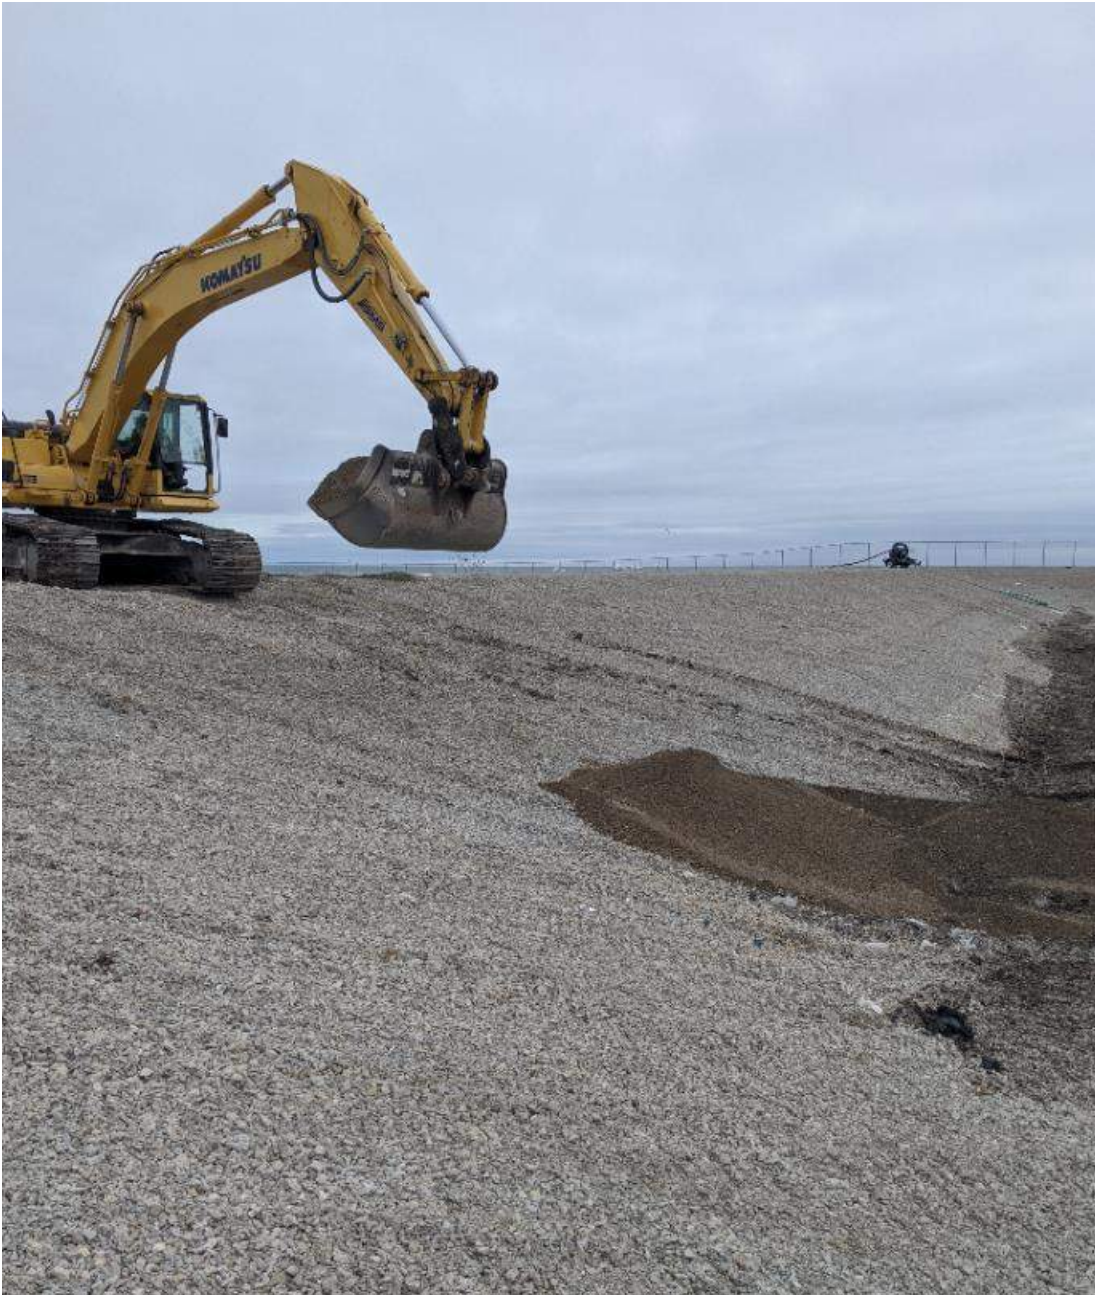
Photograph #3: Sand was lowered into the lagoon using the excavator, rather than repeatedly driving equipment down the slope, which could damage the underlying liner.

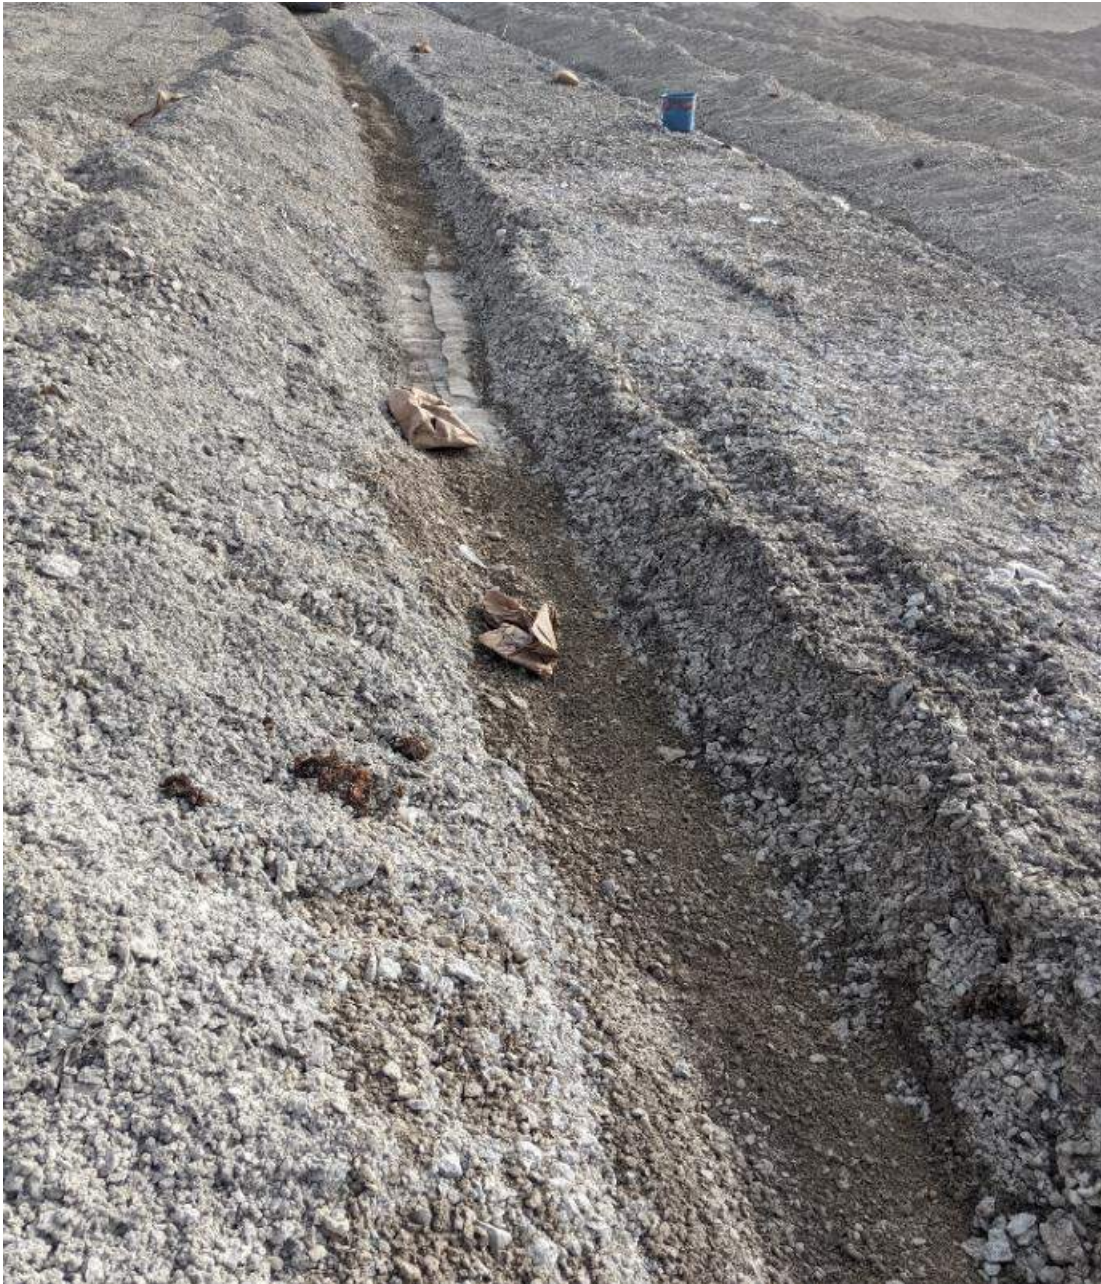
Photograph #1: Bentonite has been applied and the seam buried with fine aggregates. The areas around the north-south seams are being left open to allow for easy location and exposure of these seams once the east-west seams have been restored.

The contractor resumed the re-sealing of the seams with new bentonite. Two more seams were re-sealed today. During the re-sealing process, the liner is smoothed out to ensure a proper bond between both sides of the seam. Any rocks, garbage or debris within the seam are cleaned out, and a generous amount of bentonite is added according to manufacturer's instructions. The liner is immediately covered in aggregates with diameter <19mm, then with the aggregates that were removed to expose the seam. This provides confining pressure prior to the hydration of the bentonite, as is recommended by the manufacturer.

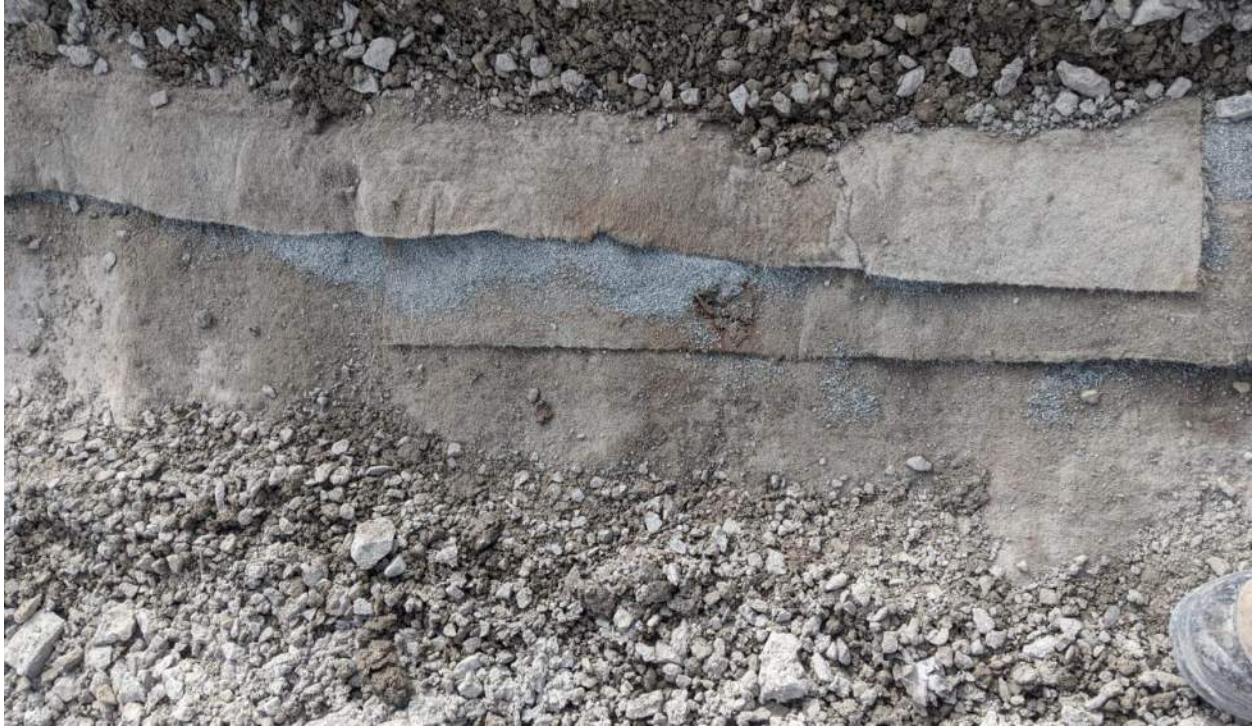
Photograph #2: In areas where multiple layers of liner are stacked, all layers are being re-sealed with bentonite.
