Summary of Work – Hall Beach 2020 Field Season

Final Report

Hall Beach Sewage Lagoon
Change Order No. 5 & Leak Detection/Resolution

OTT-220382

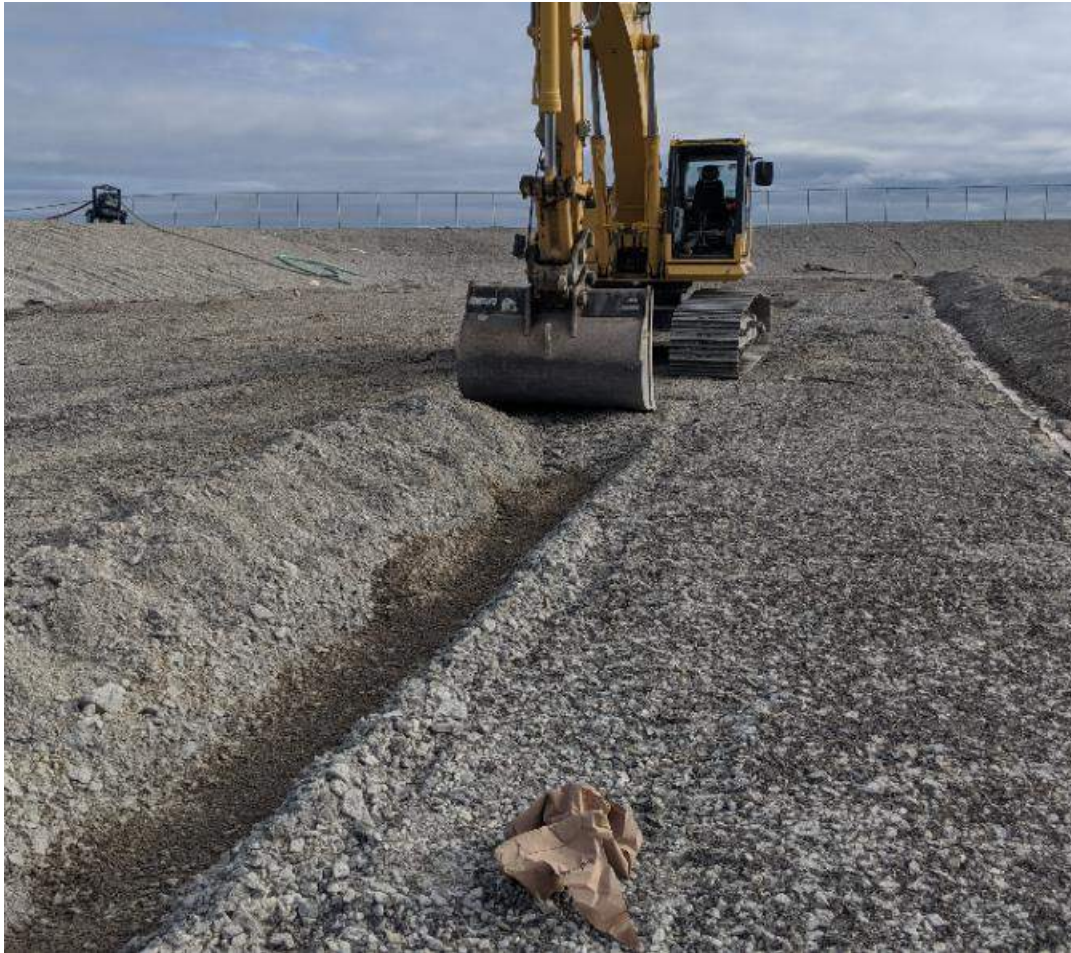
Photograph #3: Covering of the fine aggregates with the aggregates removed during the exposure process, shortly after placement of the bentonite and fines.

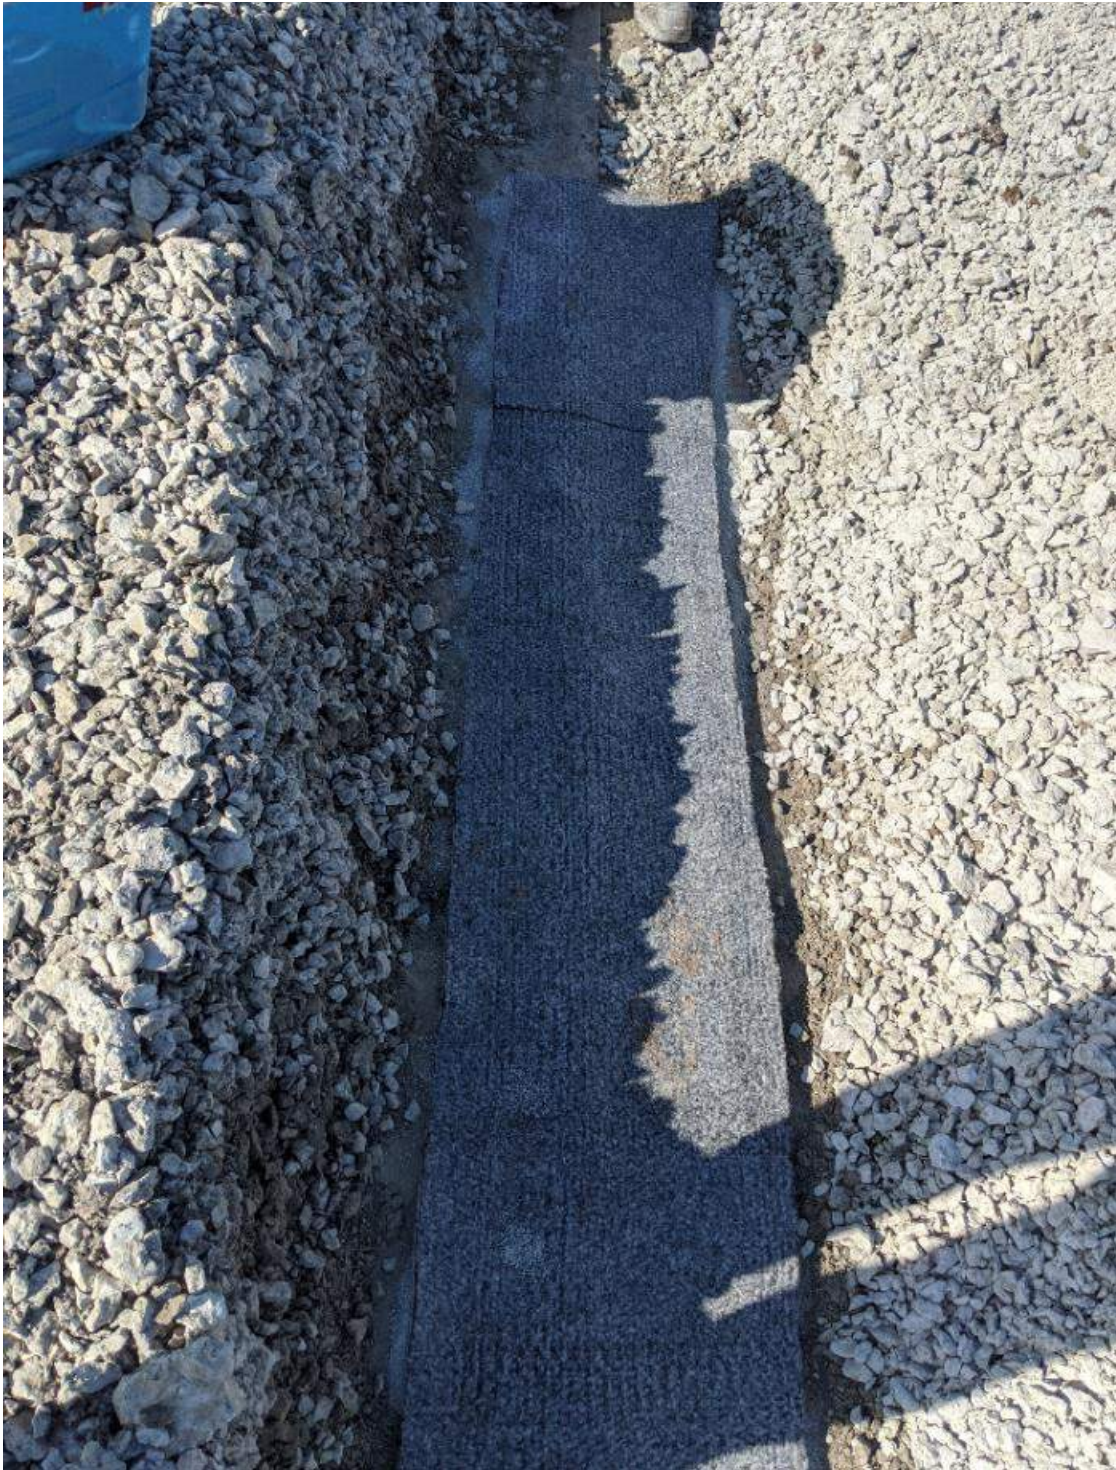
Photograph #1: Strip of liner placed over the existing seam, in a location where the existing overlap was too narrow.

The contractor spent the day re-sealing further seams with bentonite. Defects in the existing liner such as tears and punctures were covered with patches. In one seam, the existing overlap between panels was found to be less than 100mm, over a length of approximately 20m. A 400mm wide strip of liner was placed over the seam in order to ensure proper overlap.

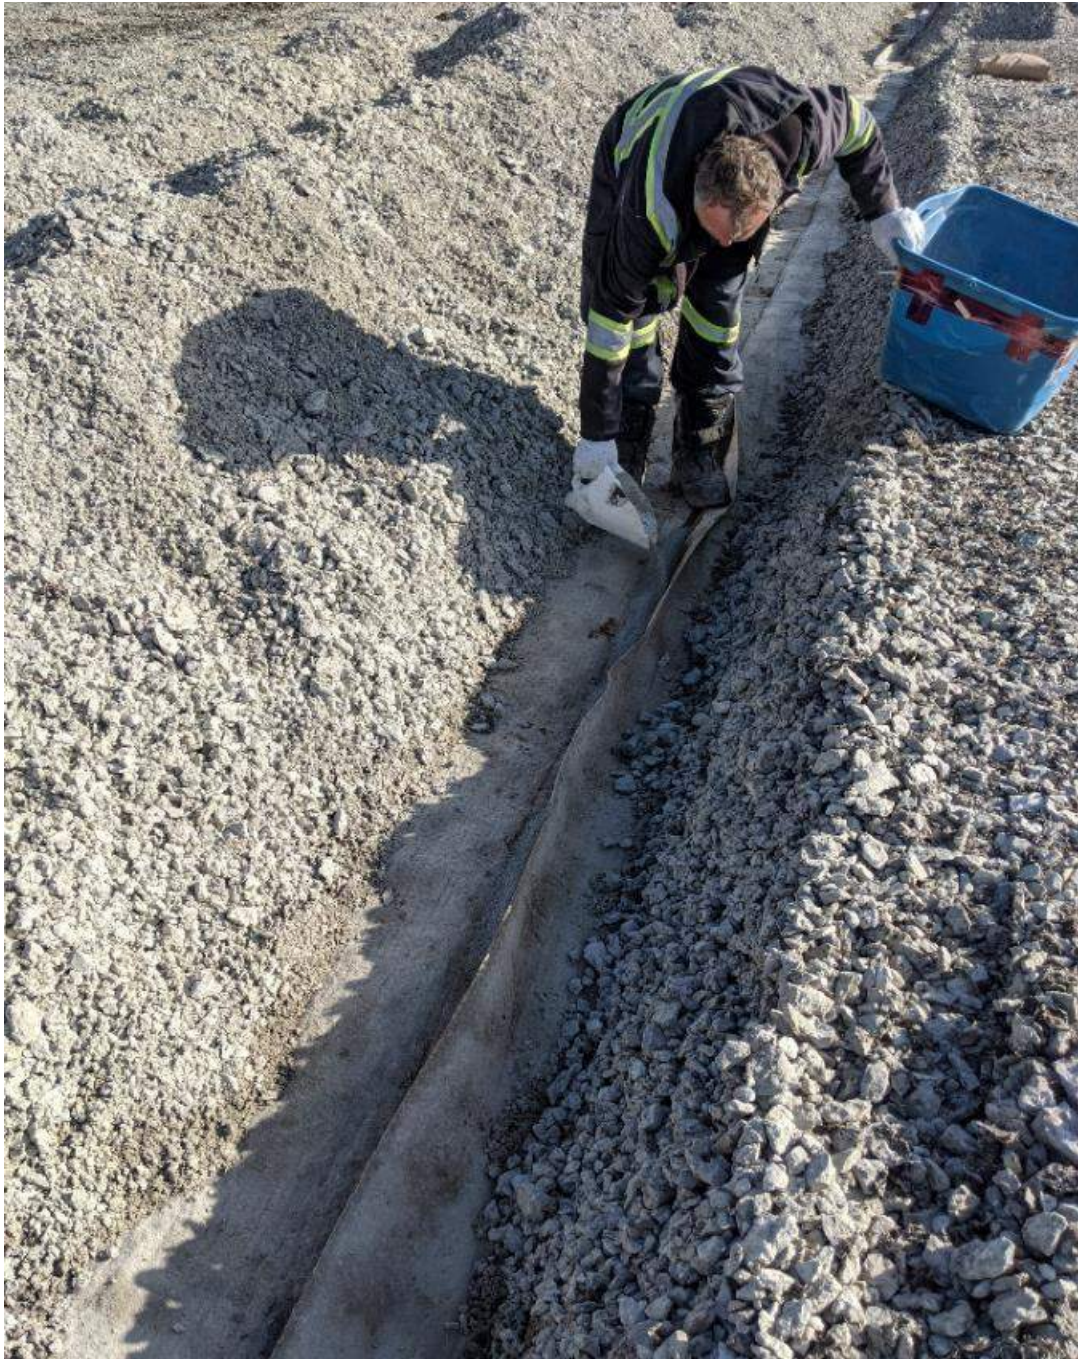
Photograph #2: Re-sealing the seams with bentonite.
- END OF REPORT -

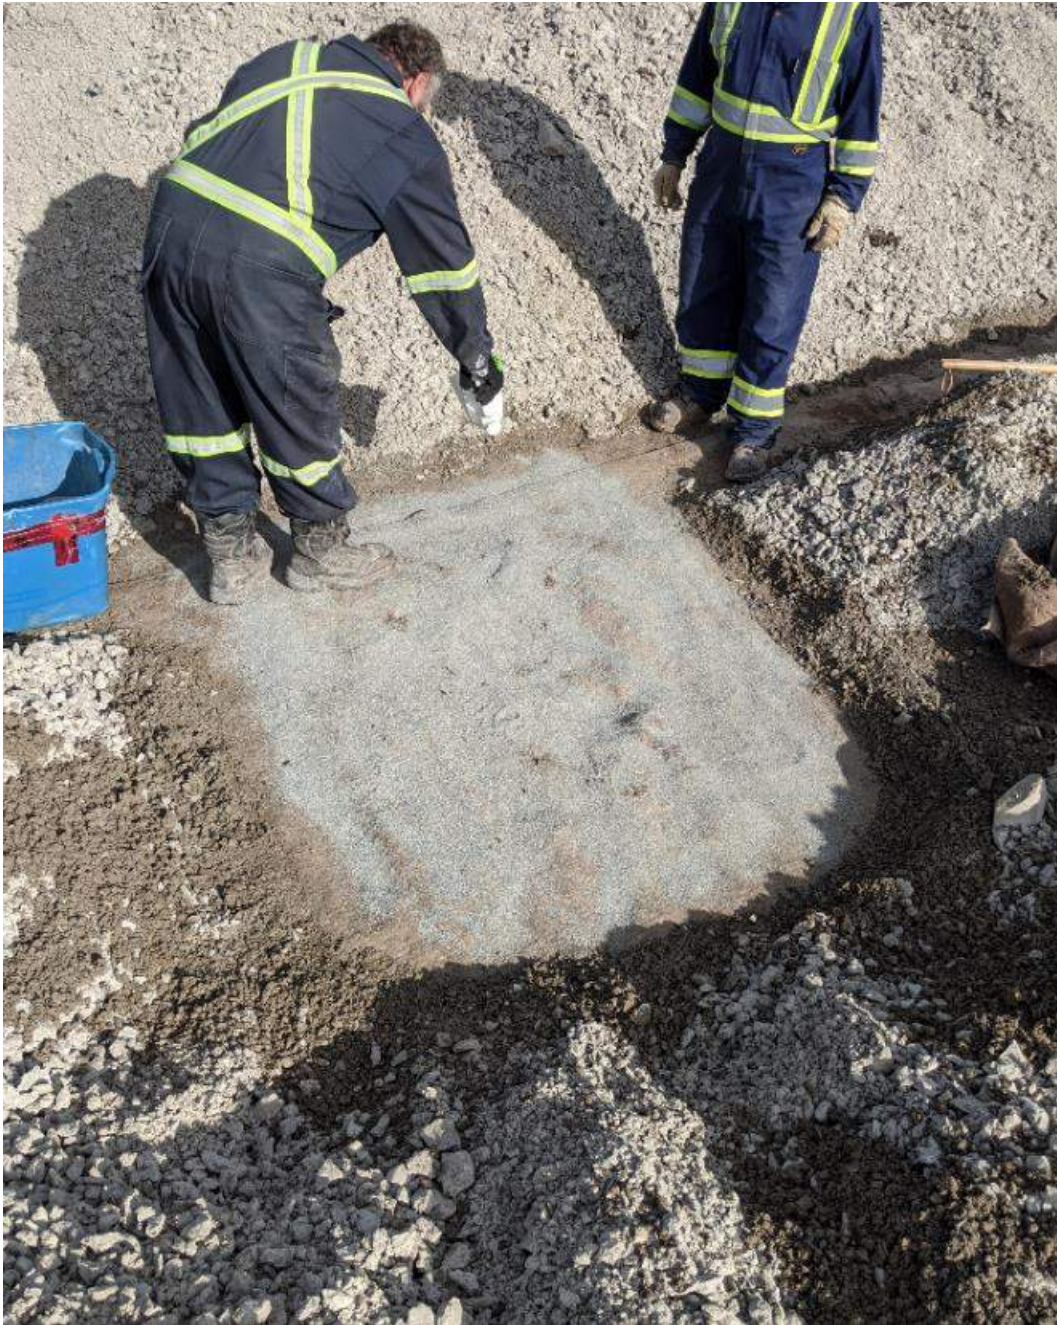
Photograph #2: Ample bentonite was applied to this patch, which replaces the patch placed in 2018.

The contractor spent the day re-sealing further seams with bentonite. Defects in the existing liner such as tears and punctures were covered with patches. A patch that is presumed to have been installed during the 2018 lagoon repairs was found and replaced. All patches were given ample overlap around the defect they cover, keeping in mind the manufacturer's recommended 200mm overlap.

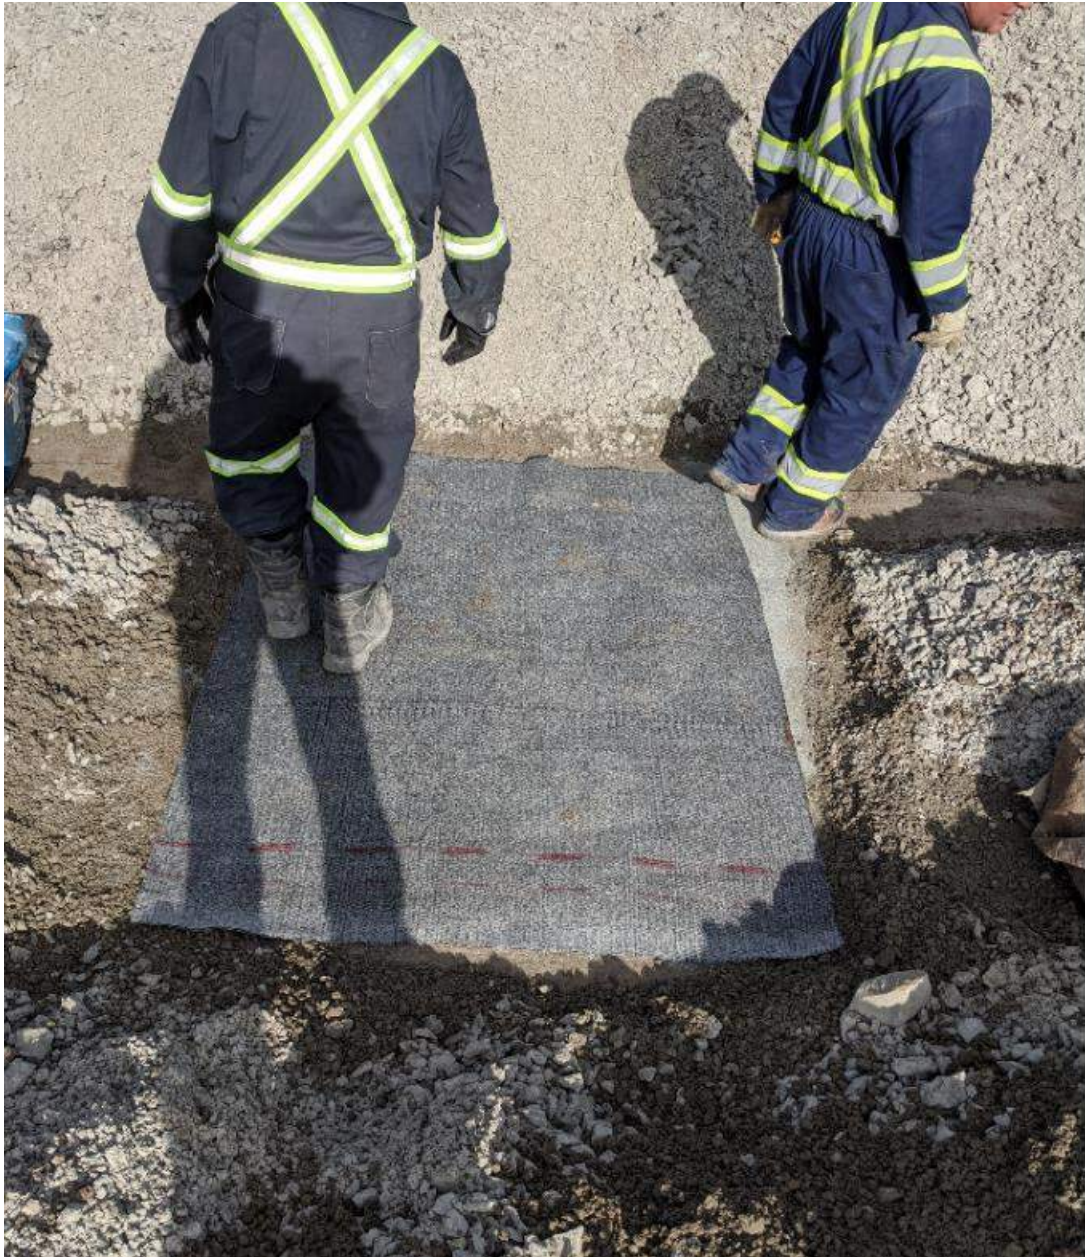
Photograph #3: Final installation of the patch replacing the 2018 patch.

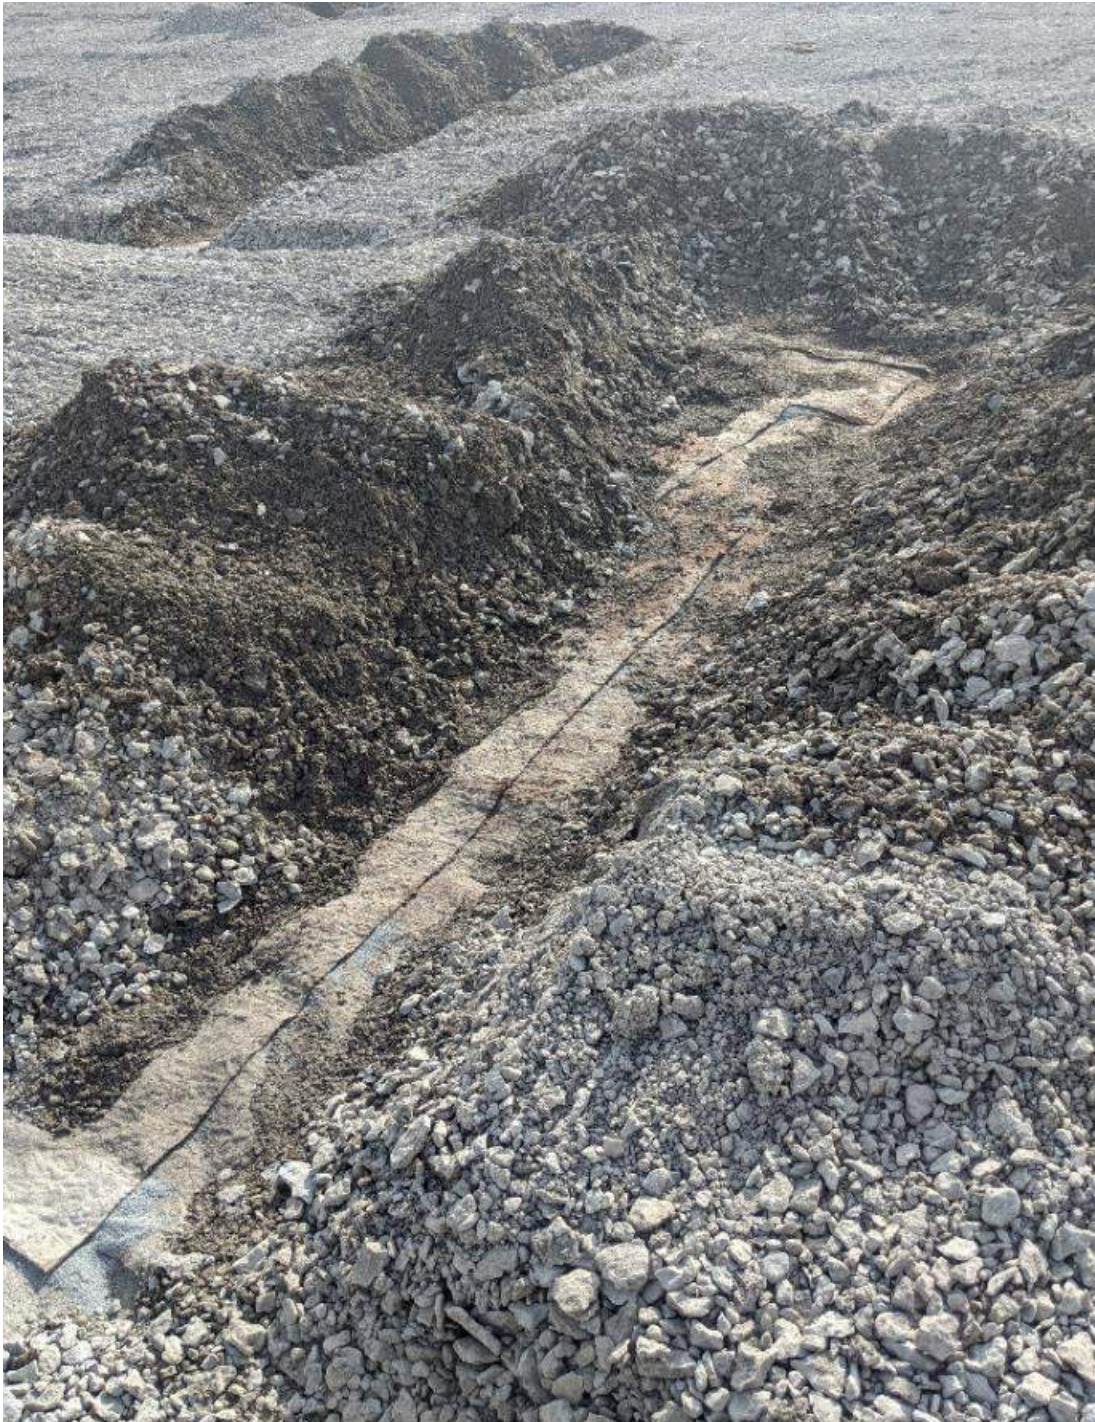
Photograph #1: North-south seam, exposed and re-sealed, awaiting backfilling. This particular seam features a key cut into the edge of the panel. No apparent feature was observed that would require this key, but it does not appear to compromise the liner integrity.

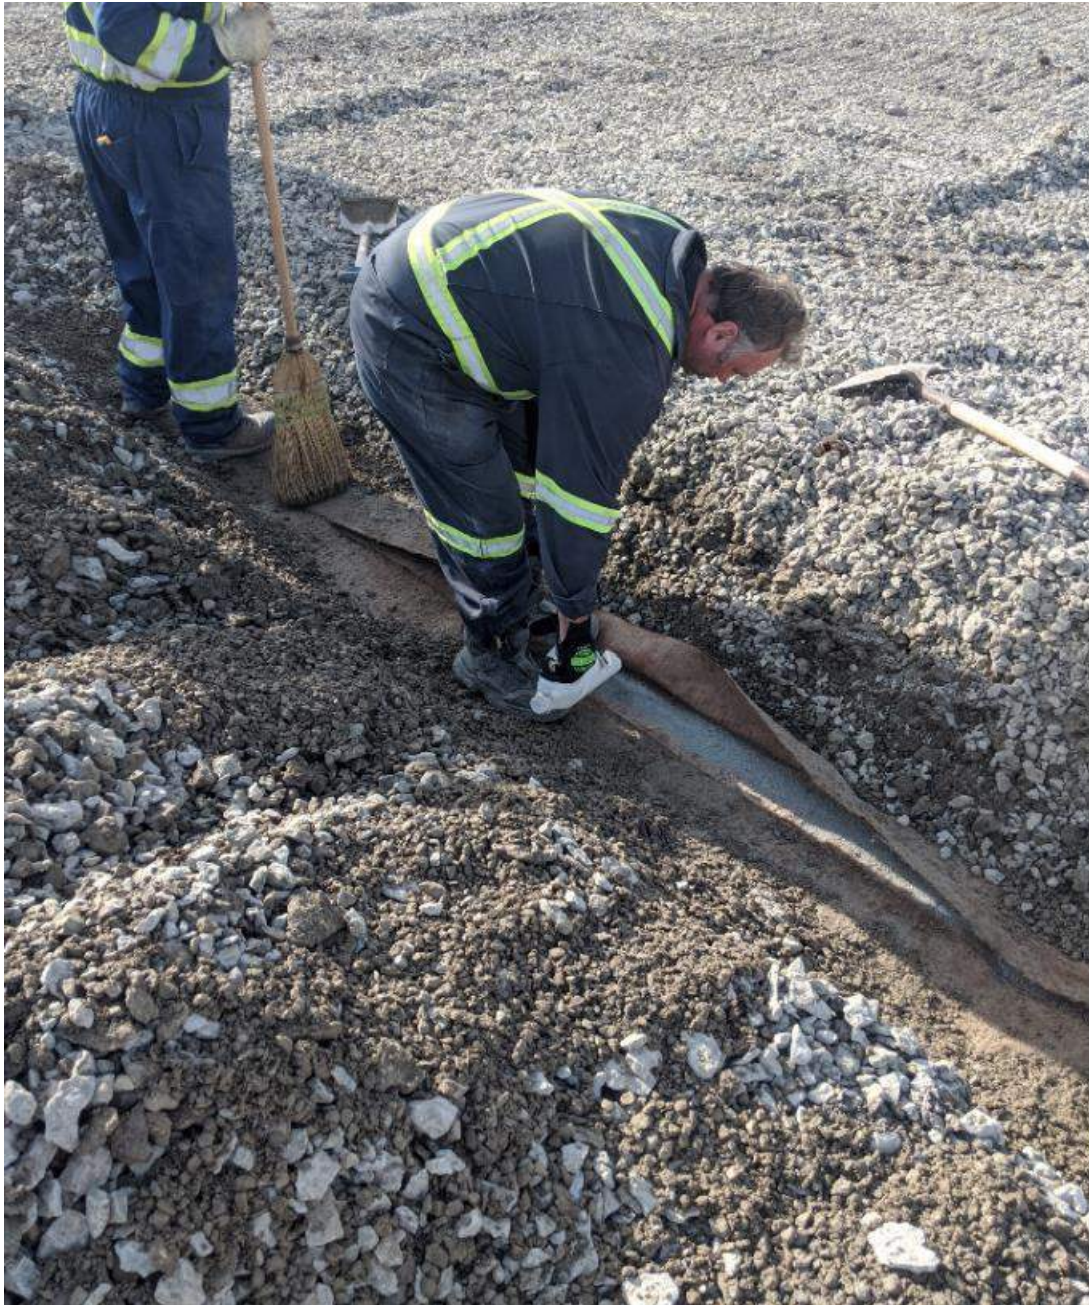
Photograph #2: North-south seam re-sealing.

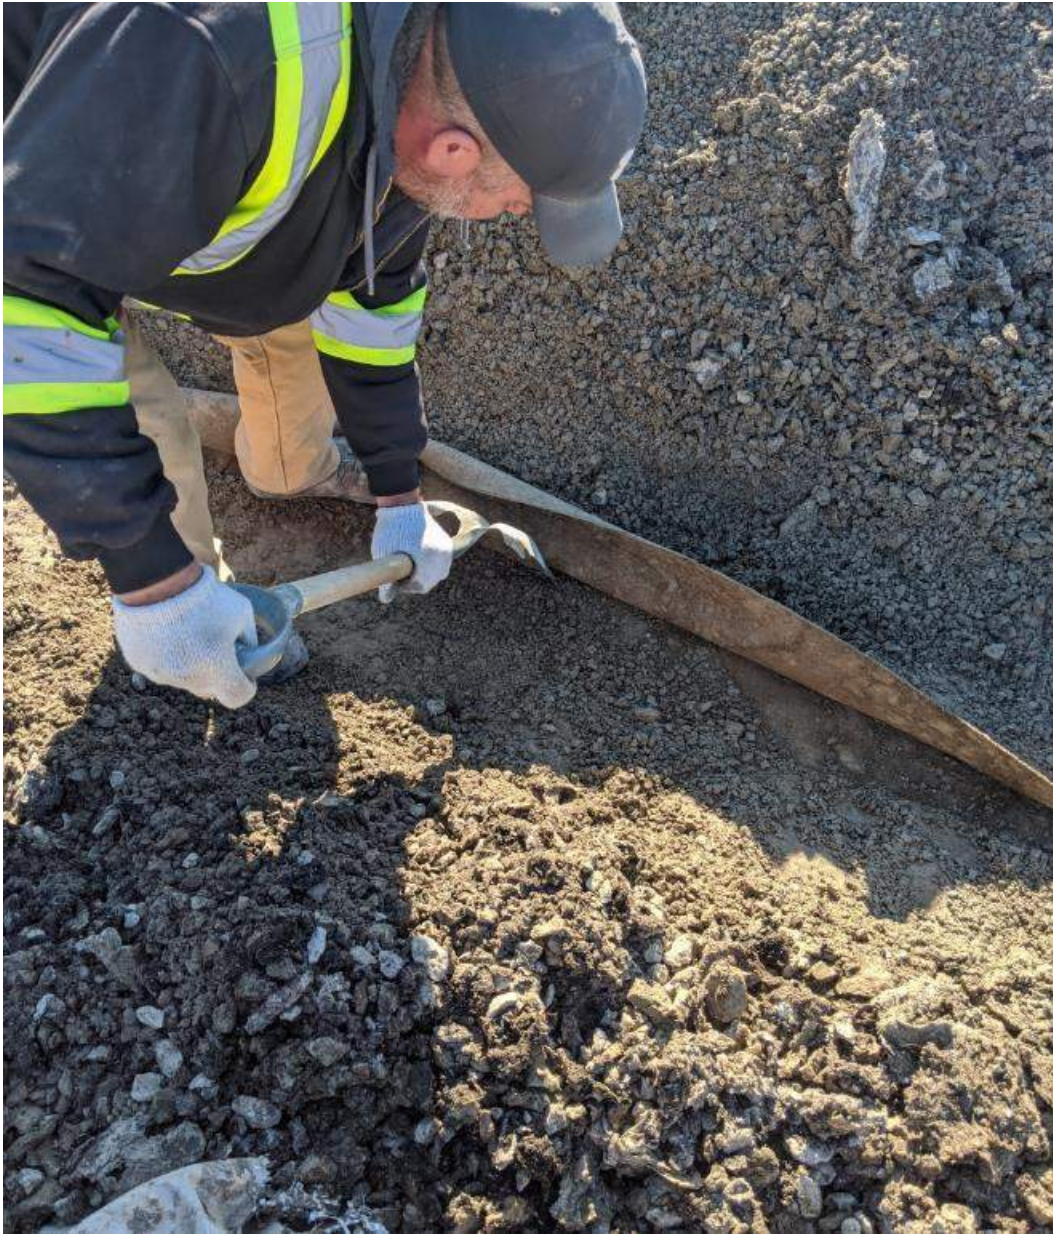
The northernmost seam, directly against the bottom of the north embankment, was also exposed, and found to have several instances of gravel in the seam. This prevented the seam from closing properly in some areas. The seam was cleaned, resealed, covered in sand, then backfilled.

Photograph #1: Gravel in the northernmost east-west seam. Full penetration through the seam.

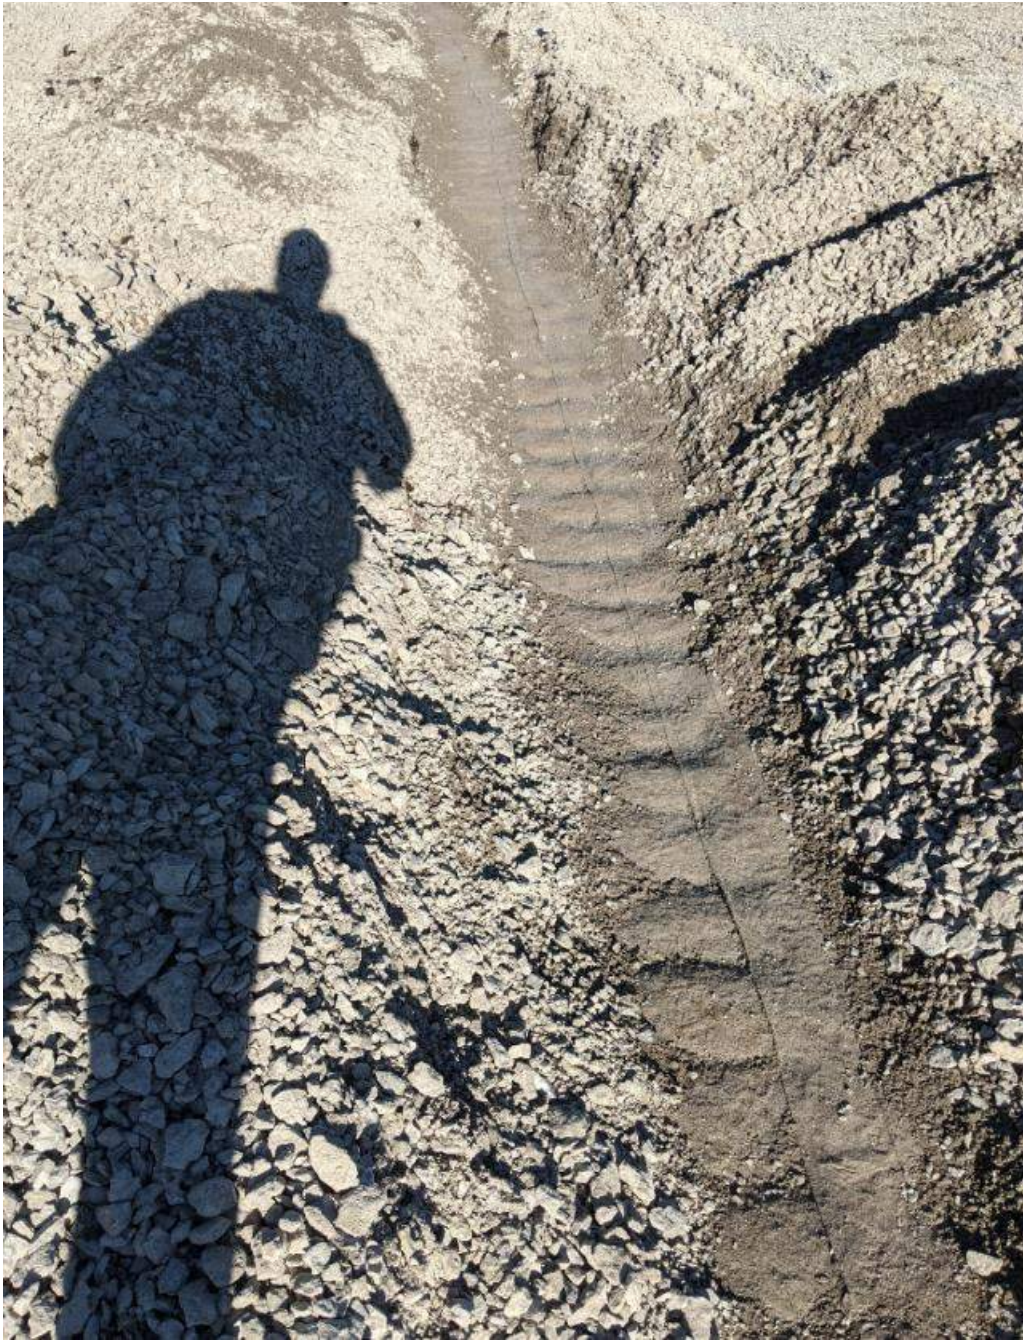
Photograph #2: Dozer tracking in the 19th east-west seam from the north.

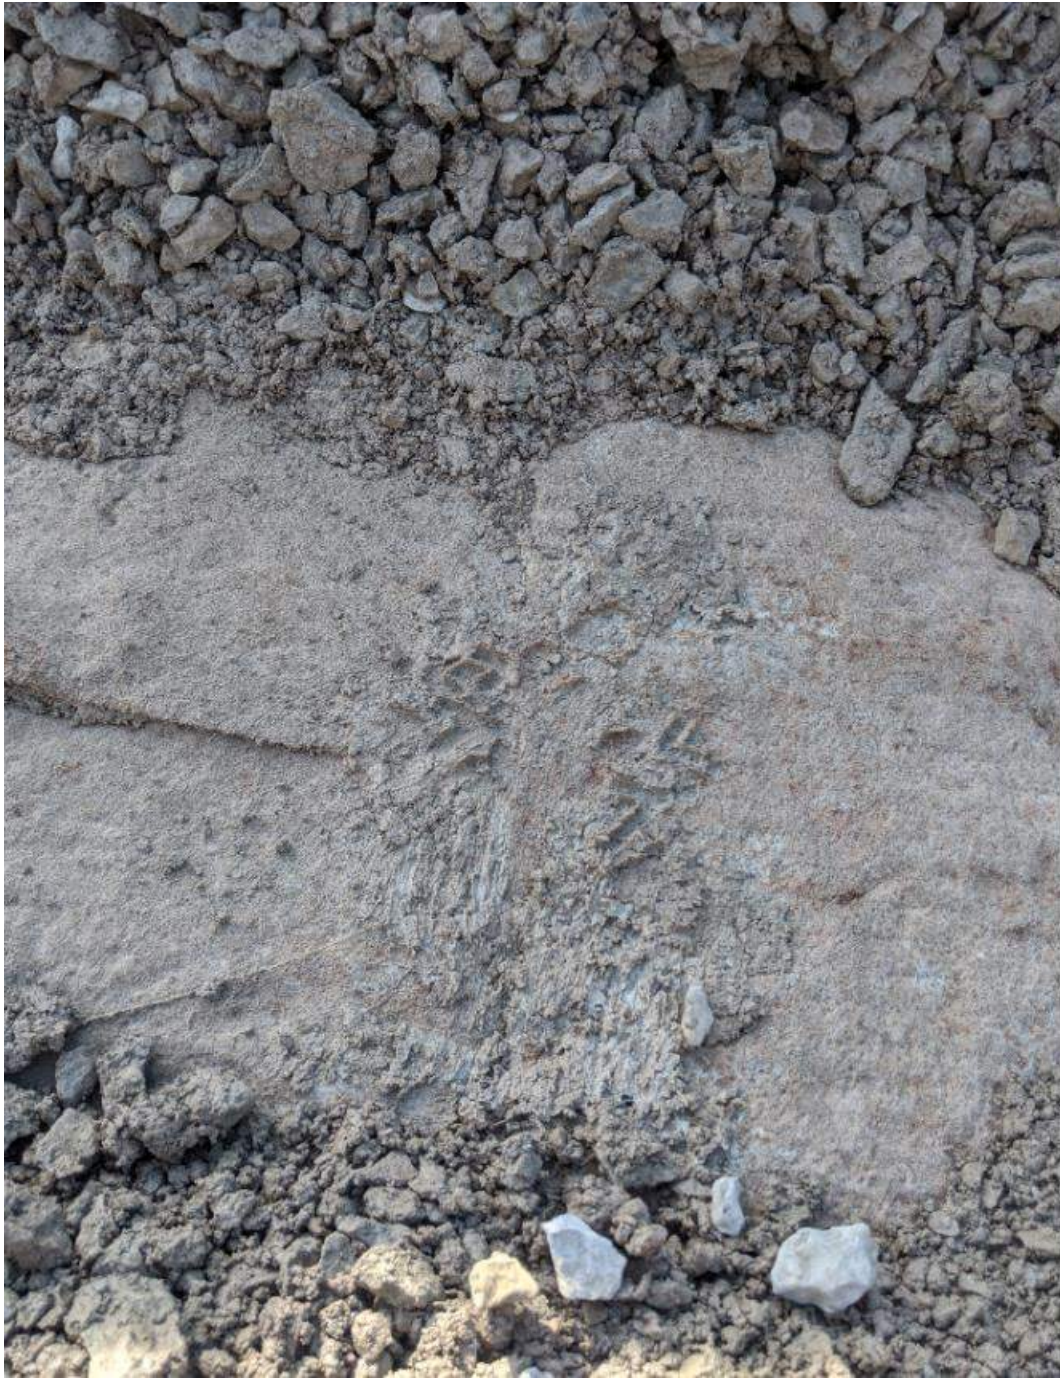
A patch was found over one of the seams. It is presumed to have been placed in 2018. There appears to have been a generous amount of bentonite placed under the patch, as bentonite was being squeezed out of the edges. This was taken as a good sign, and the patch was not disturbed.

Photograph #1: Bentonite being squeezed out of the joint around a patch.

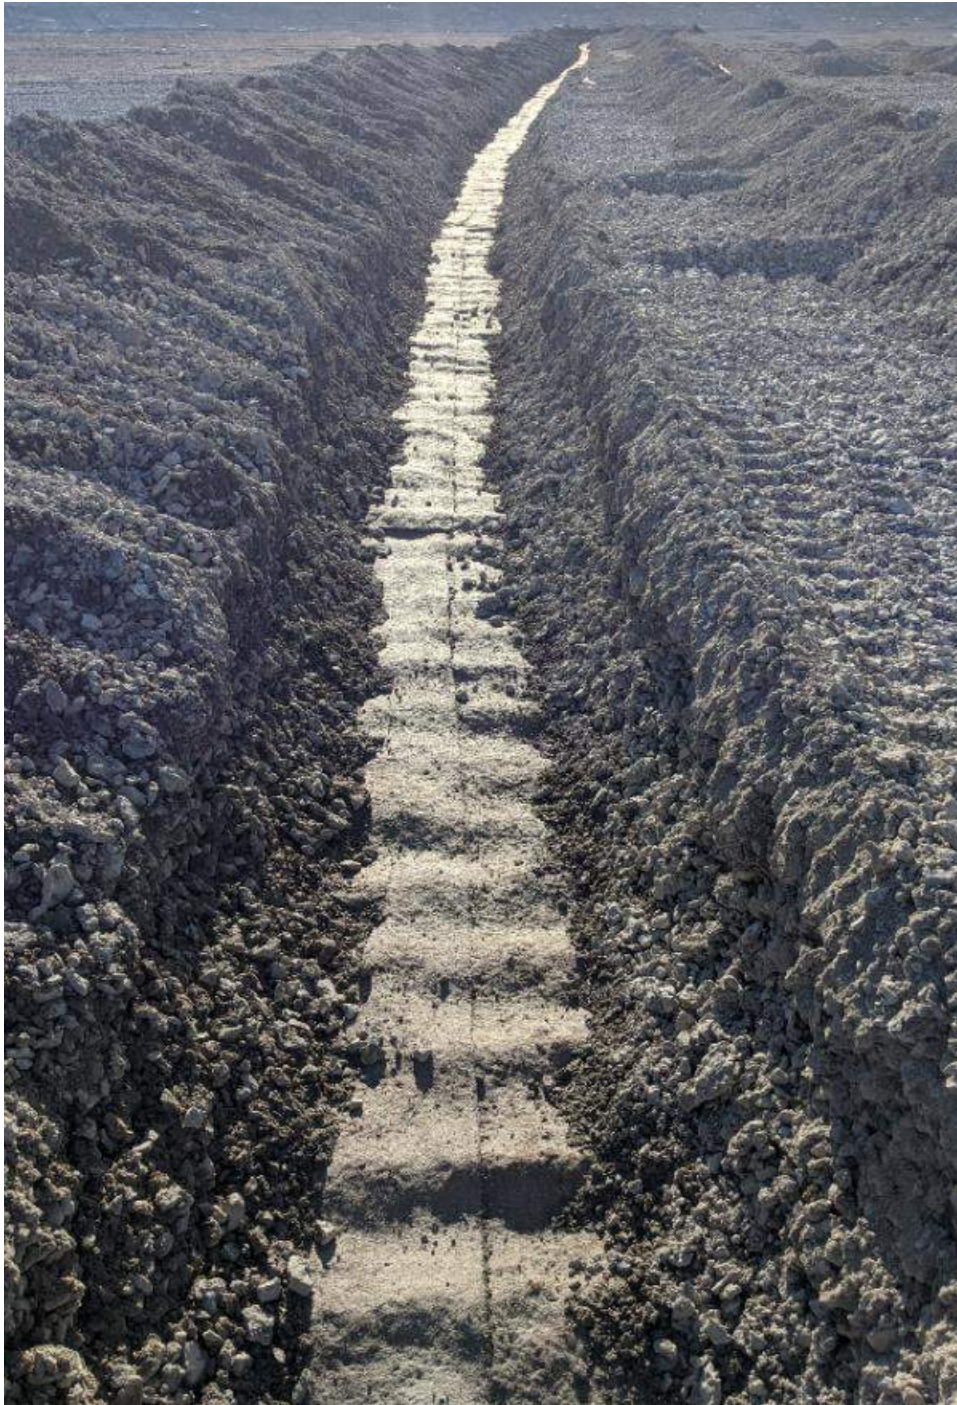
Photograph #2: Longitudinal view of one of the seams, showing wave pattern.

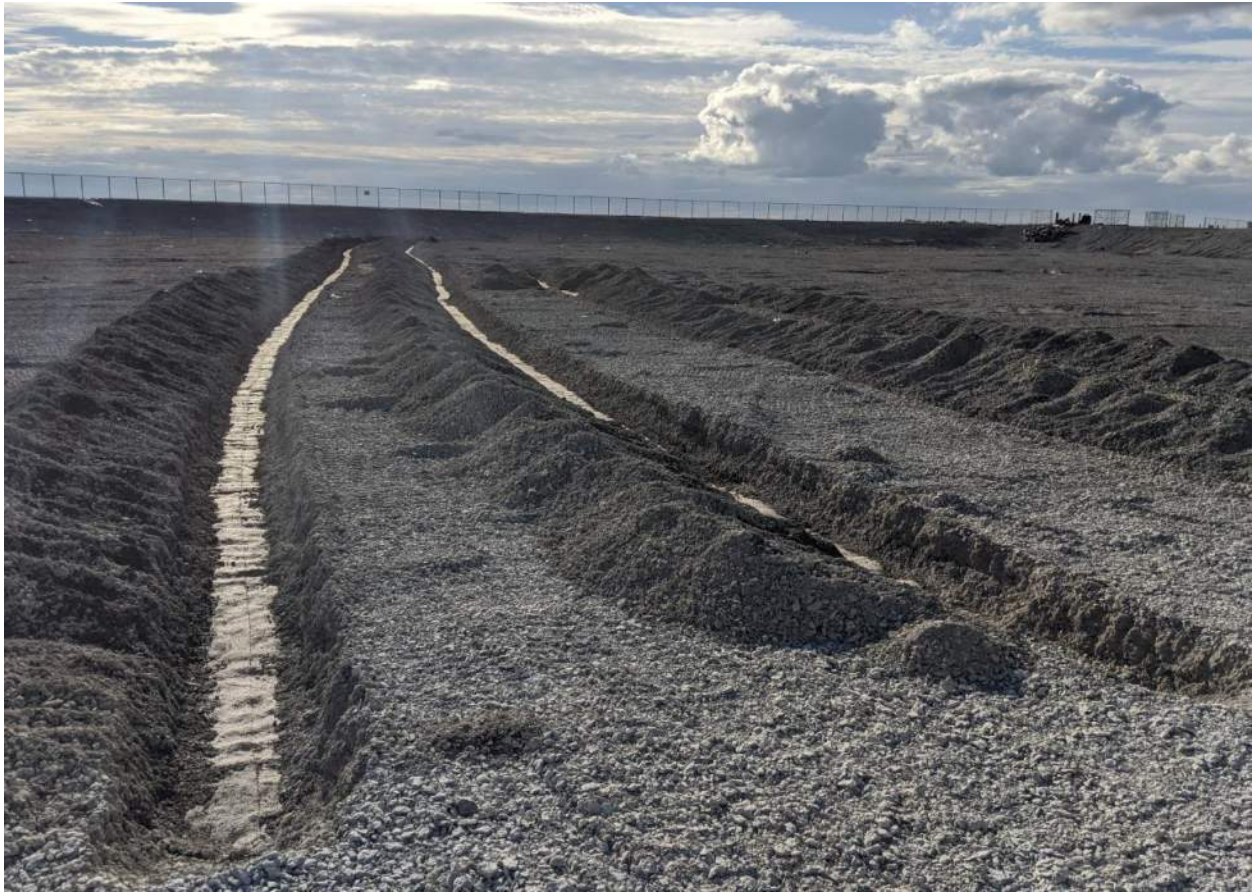
Photograph #3: Overview of work completed today.

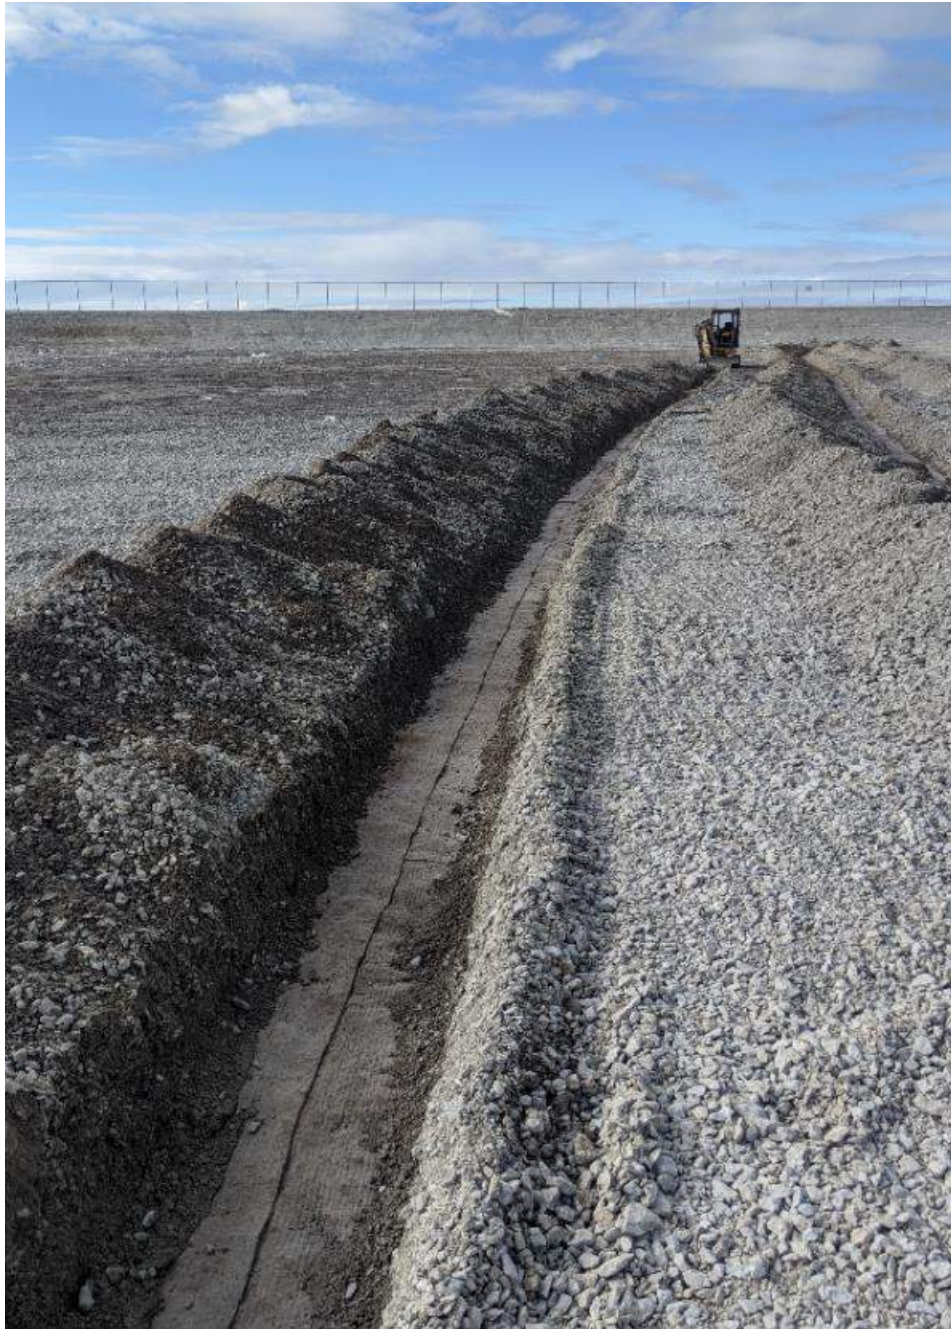
Photograph #1: Exposed seam.

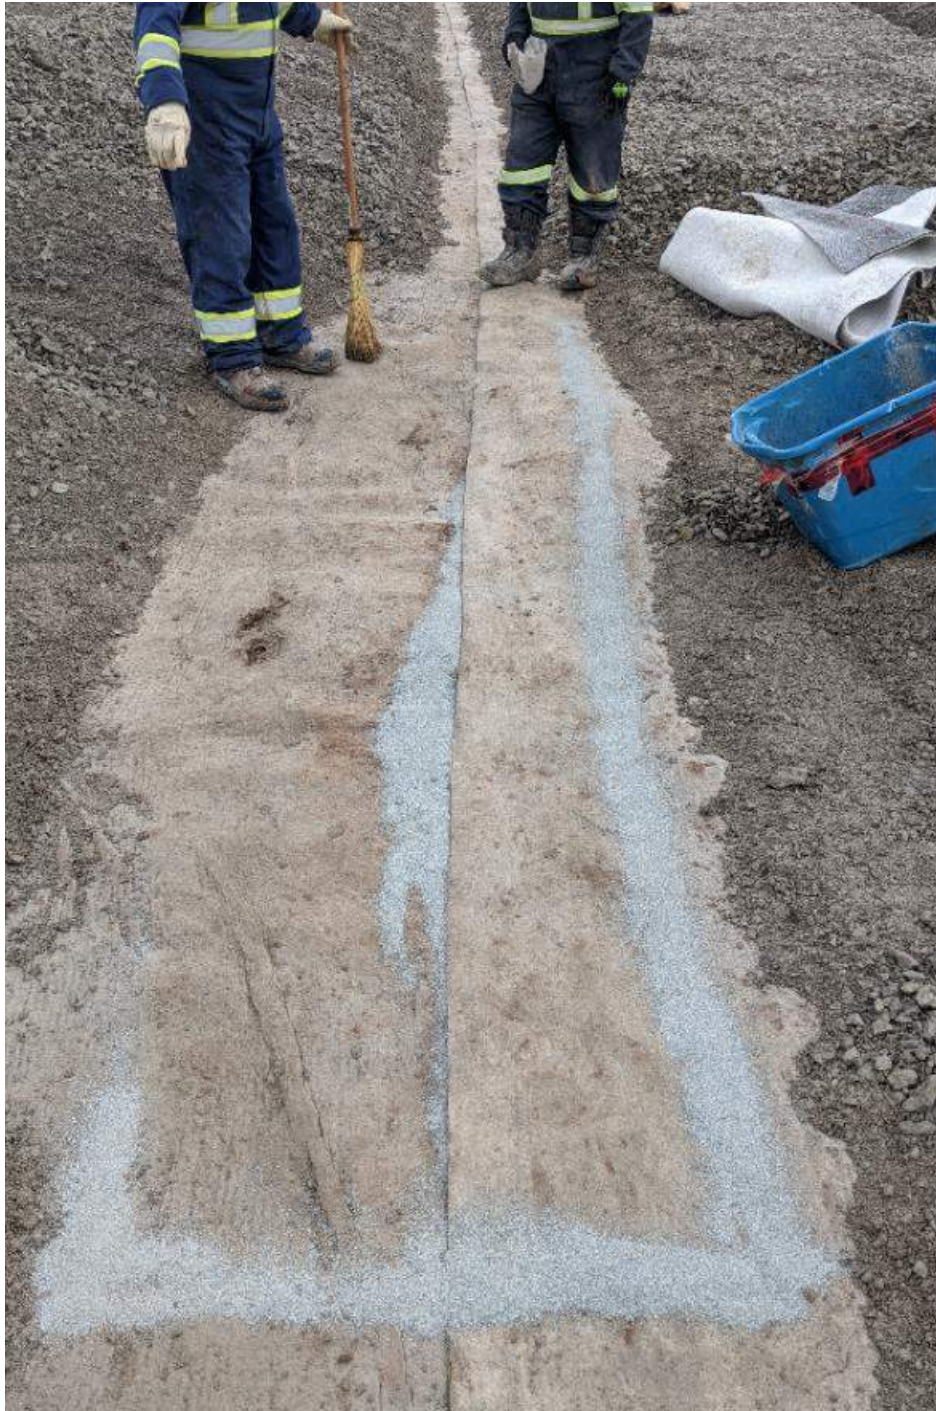
Photograph #1: Installation of patch over area where liner overlap is insufficient.

The contractor spent much of the day resealing exposed seams with bentonite. In particular, several patches were installed over areas where damage to the liner was observed. The largest patch placed today was over an area where the existing overlap within the liner was quite small, less than 75mm in some areas. The new patch ensures a minimum of 150mm of overlap around any opening within the liner.

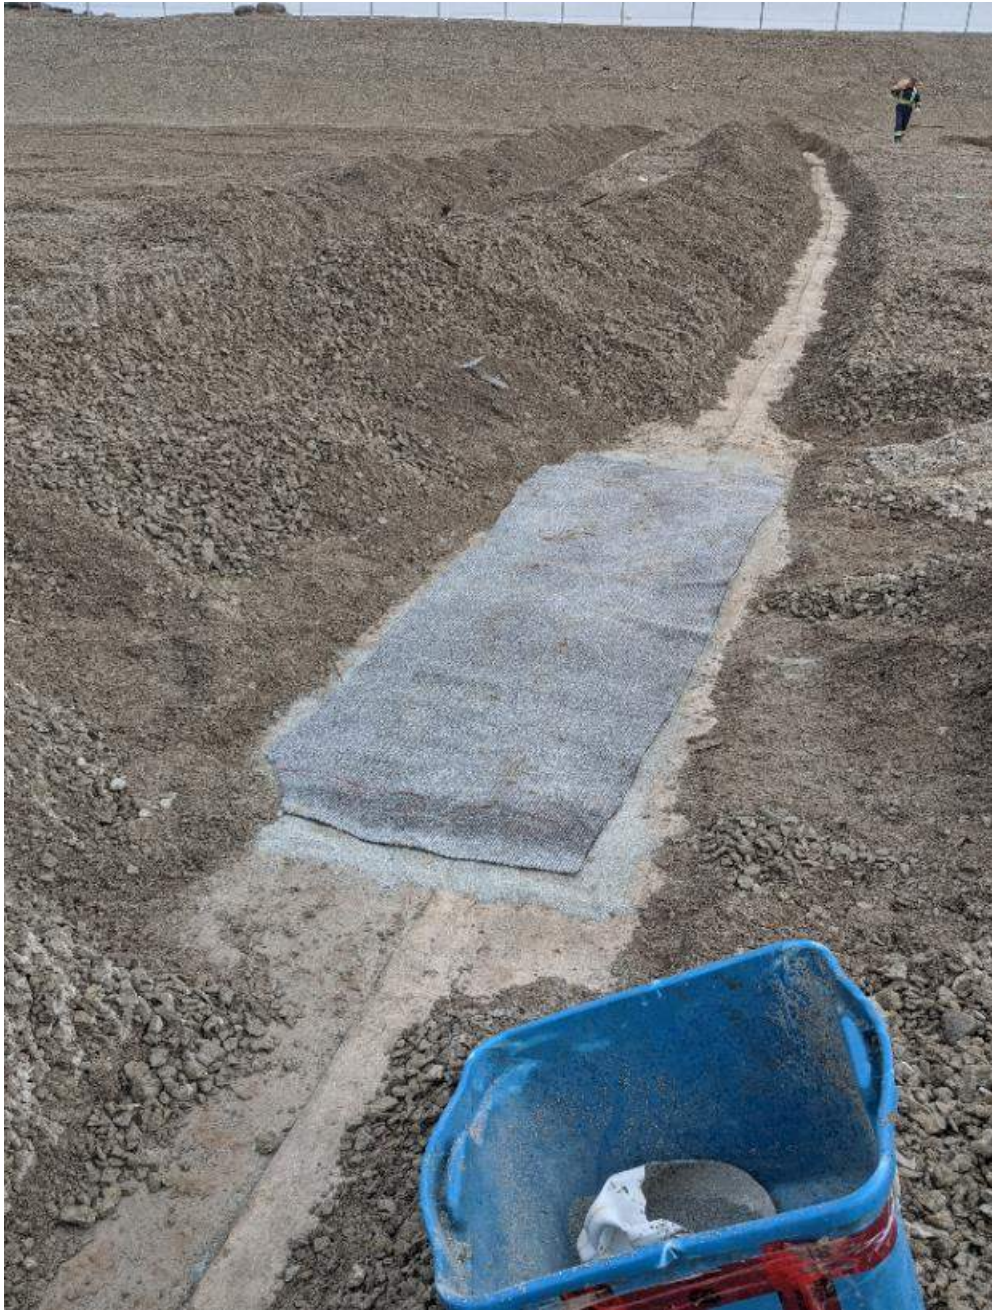
Photograph #2: Installed patch.

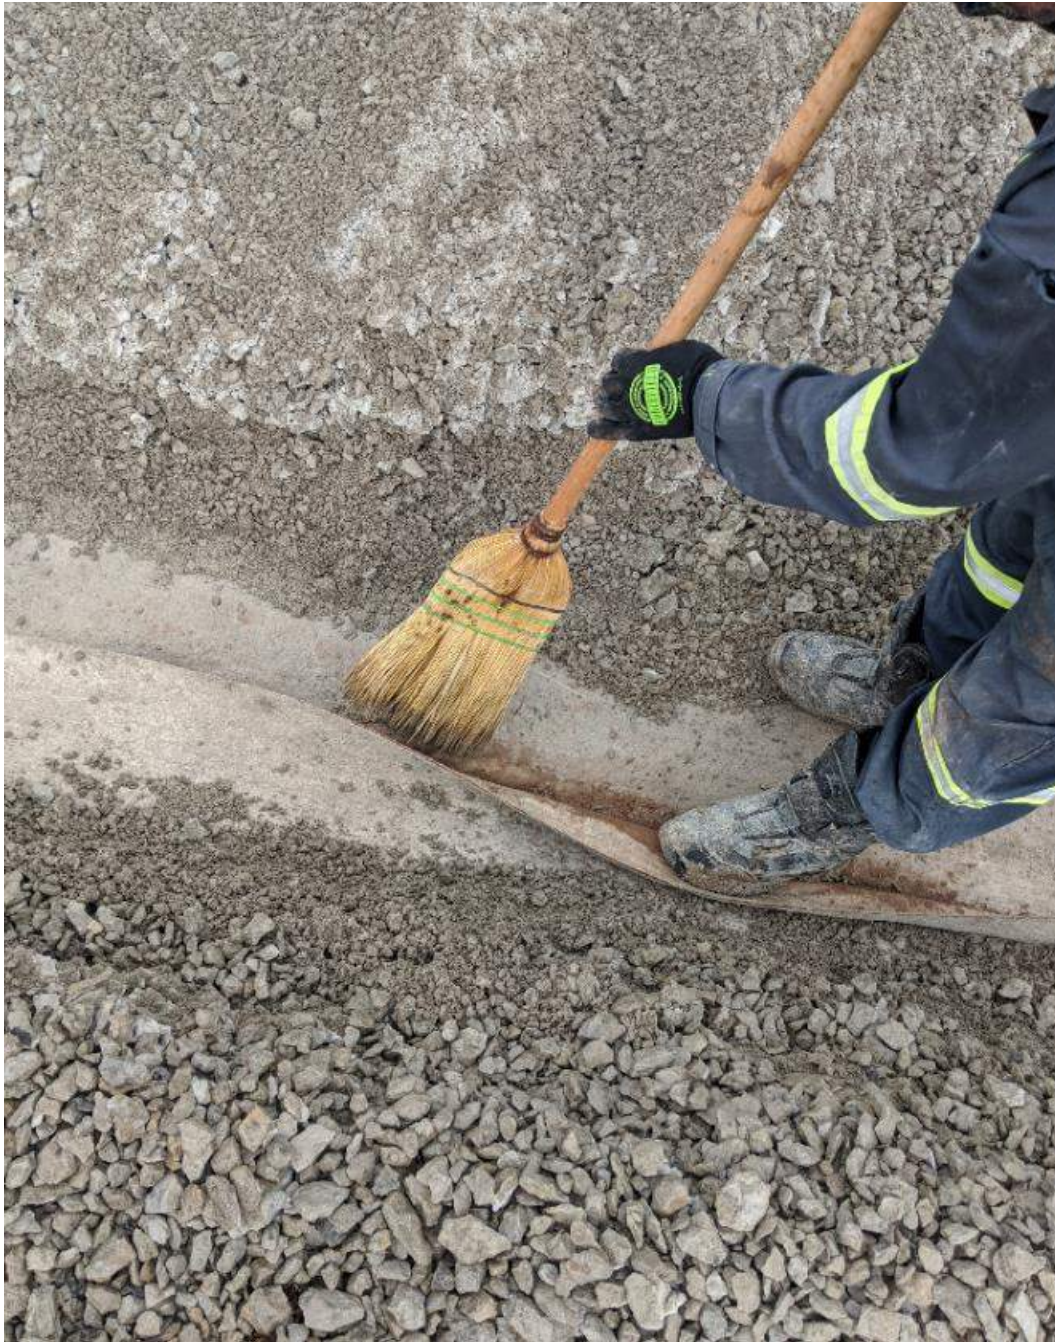
Photograph #3: Joints are broom cleaned prior to the placement of new bentonite.
