Summary of Work – Hall Beach 2020 Field Season

Final Report

Hall Beach Sewage Lagoon
Change Order No. 5 & Leak Detection/Resolution

OTT-220382

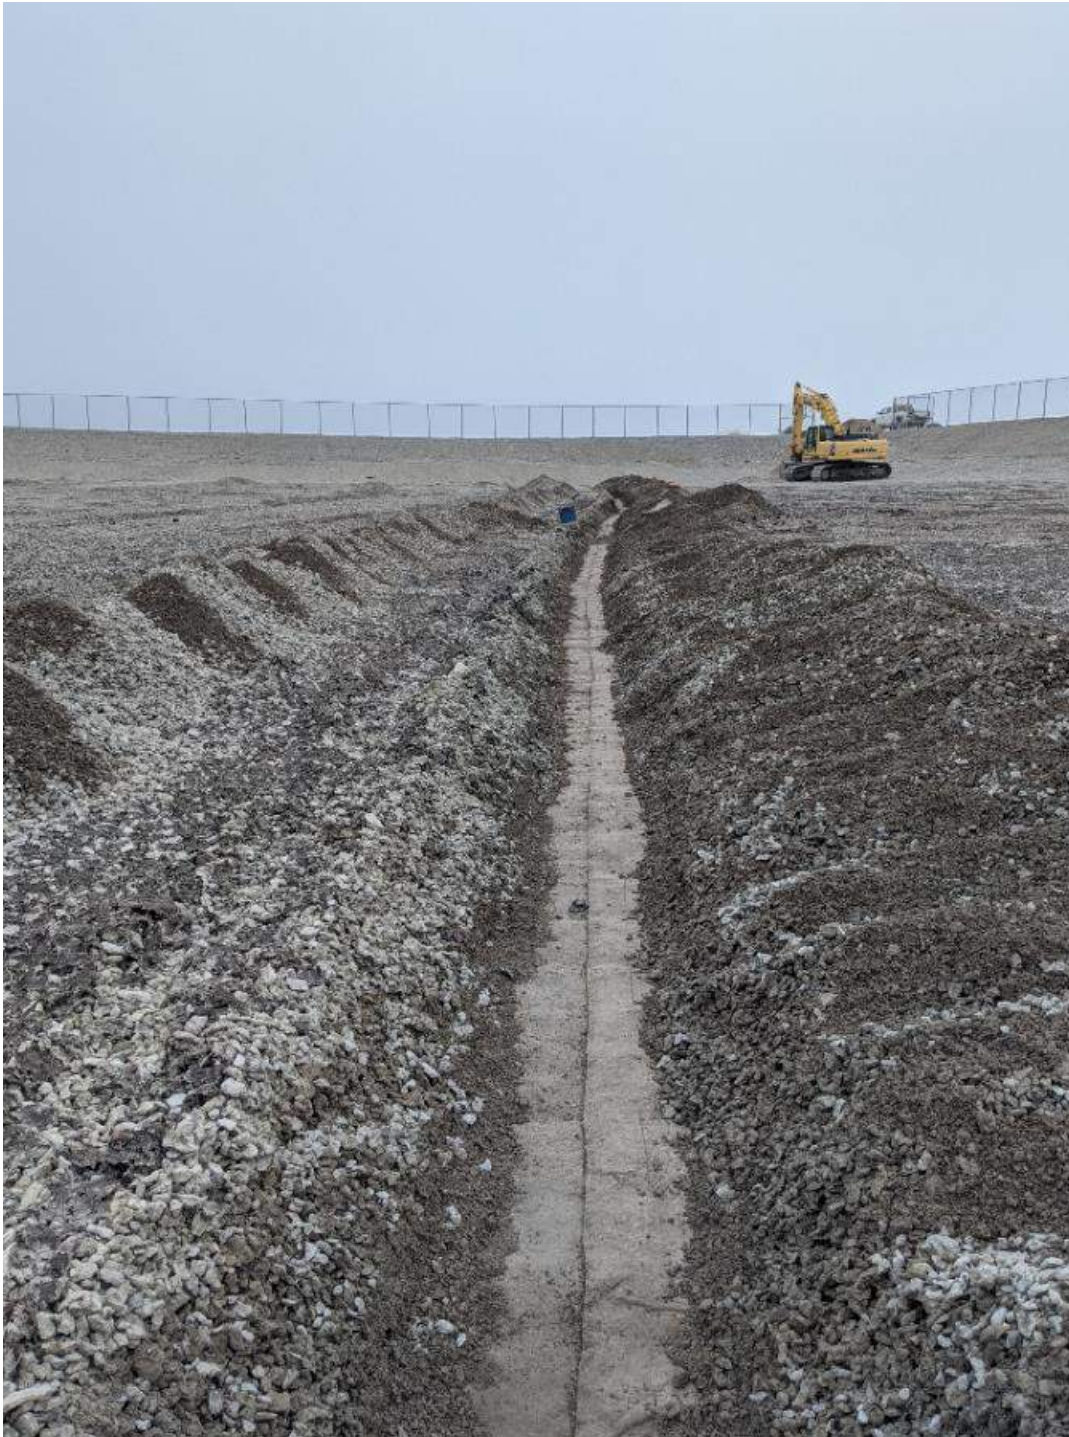
The contractor spent the day exposing further seams along the cell floor. Similar issues were found in the seams uncovered today as have been found in previously uncovered seams. The contractor completed the exposure, resealing and backfilling of two seams today. There are an estimated three or four seams remaining, plus additional seams in the southwest corner due to the lagoon's trapezoidal shape.

Photograph #1: Exposed seams.

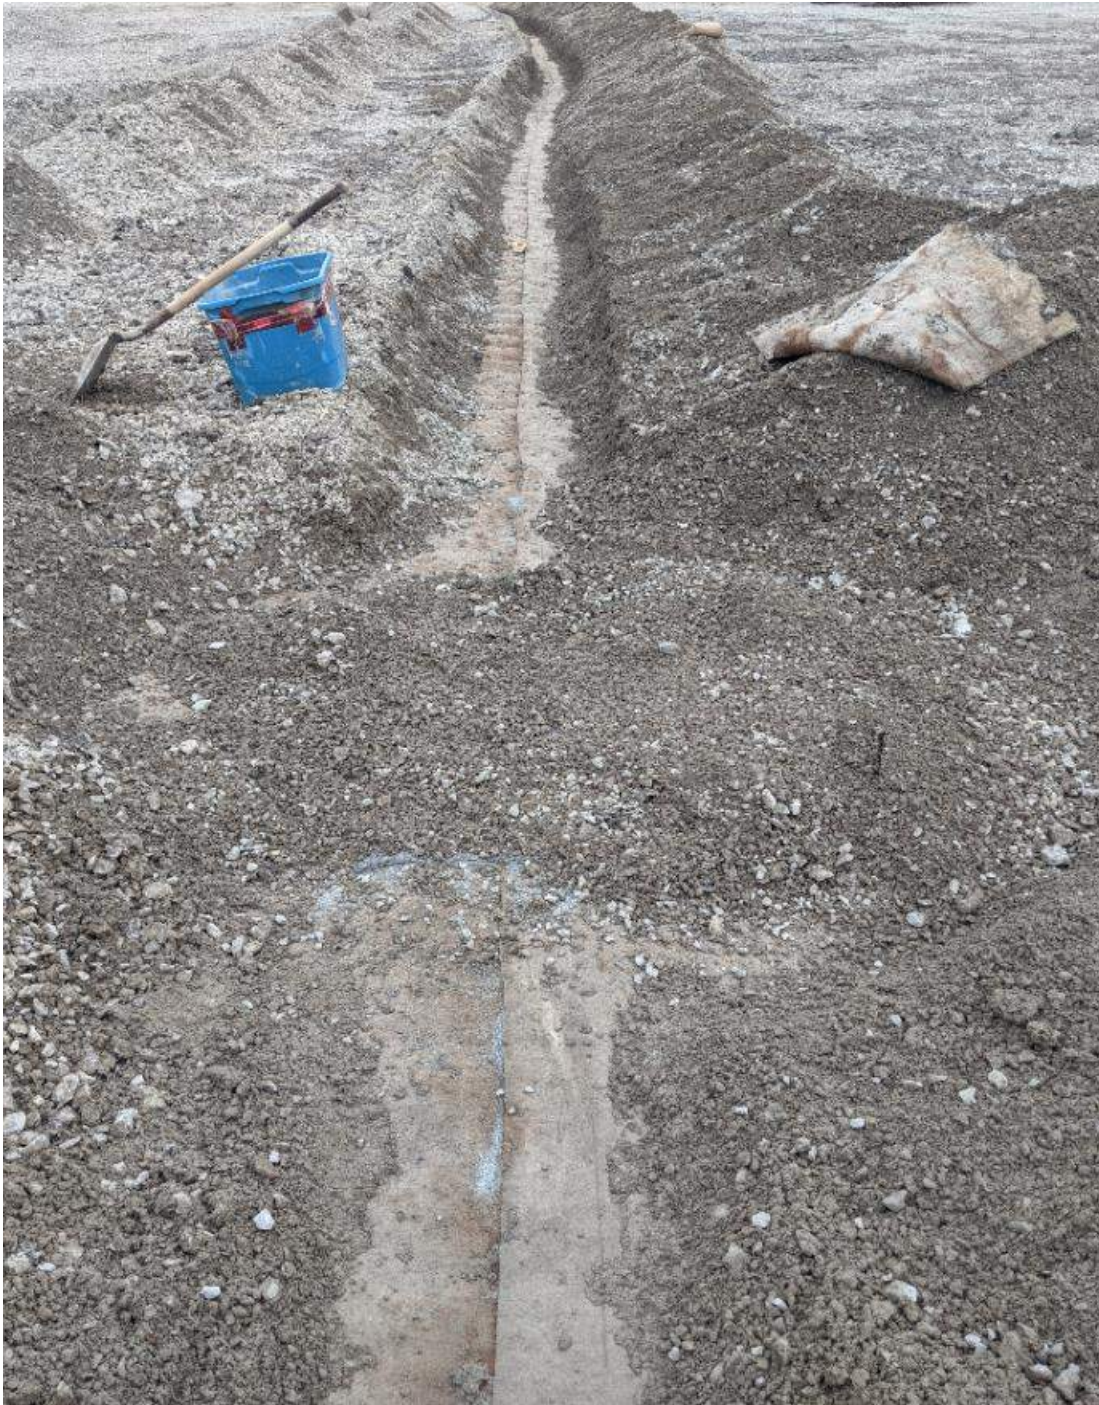
Photograph #2: Installation of patches over damaged areas, including partial backfill to hold the patch down, is being completed as resealing work progresses, with backfilling occurring at the end of the day.

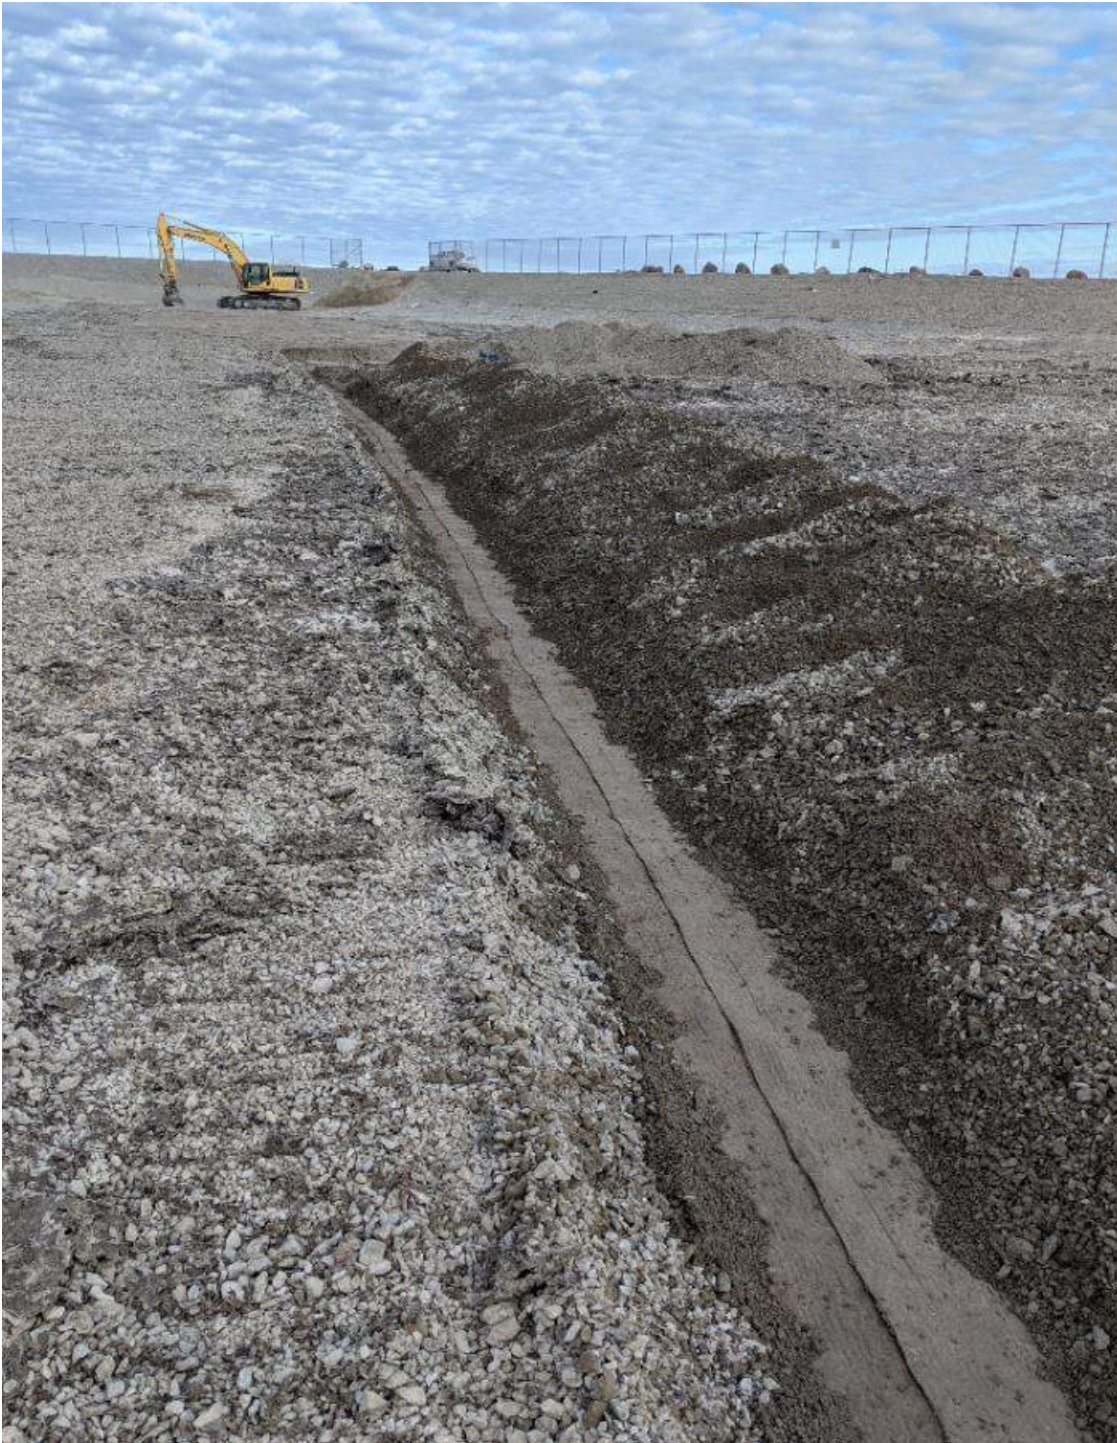
Photograph #1: Straight portion of the second to last seam.

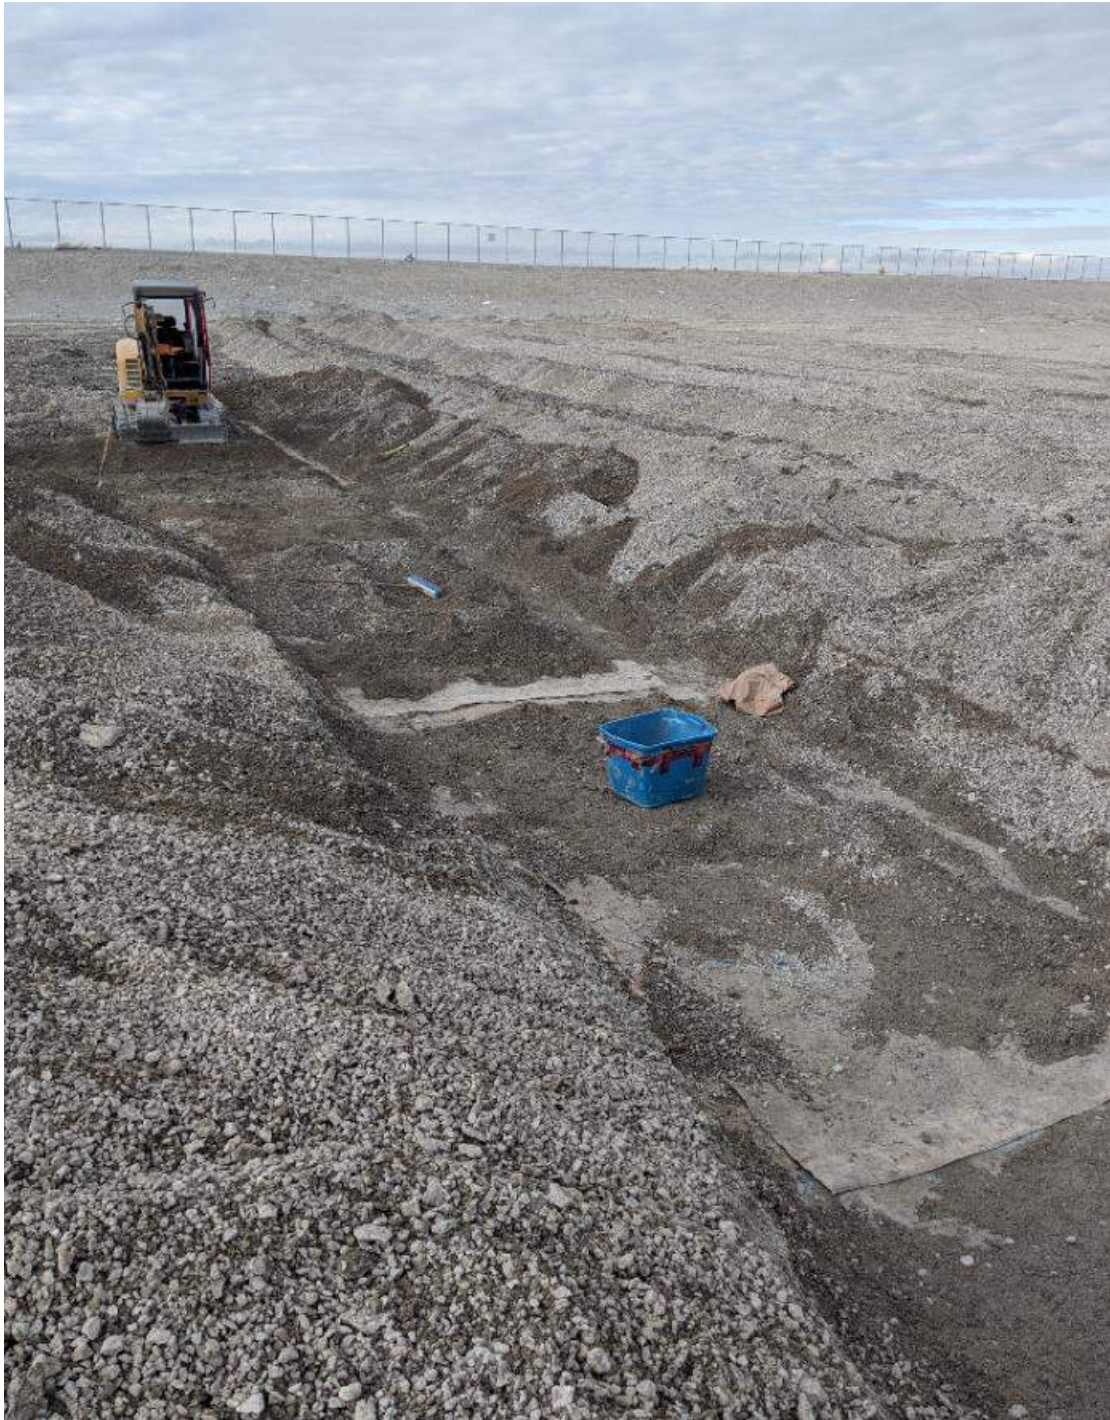
The contractor once again spent the day exposing liner. The second-to-last east-west seam was exposed today. In the western third of the lagoon, this seam was found to split apart, with the southern liner panel deflecting slightly towards the south. Patches were placed over the split, bridging the gap between the panels. It is assumed that this deflection was introduced in order to compensate for the triangular section remaining in the southwest corner of the lagoon (the cell having a trapezoidal shape). A section approximately 6m long prior to the start of the patches had insufficient seam overlap, with the section closest to the first patch being separated and allowing water to flow directly into the subgrade. The seams around each liner patch were completely exposed and resealed, like all other seams within the lagoon.

**Photograph #2: Patches bridging the gap over the widening divergence between two liner panels.
The patches get wider as they get closer to the west bank.**

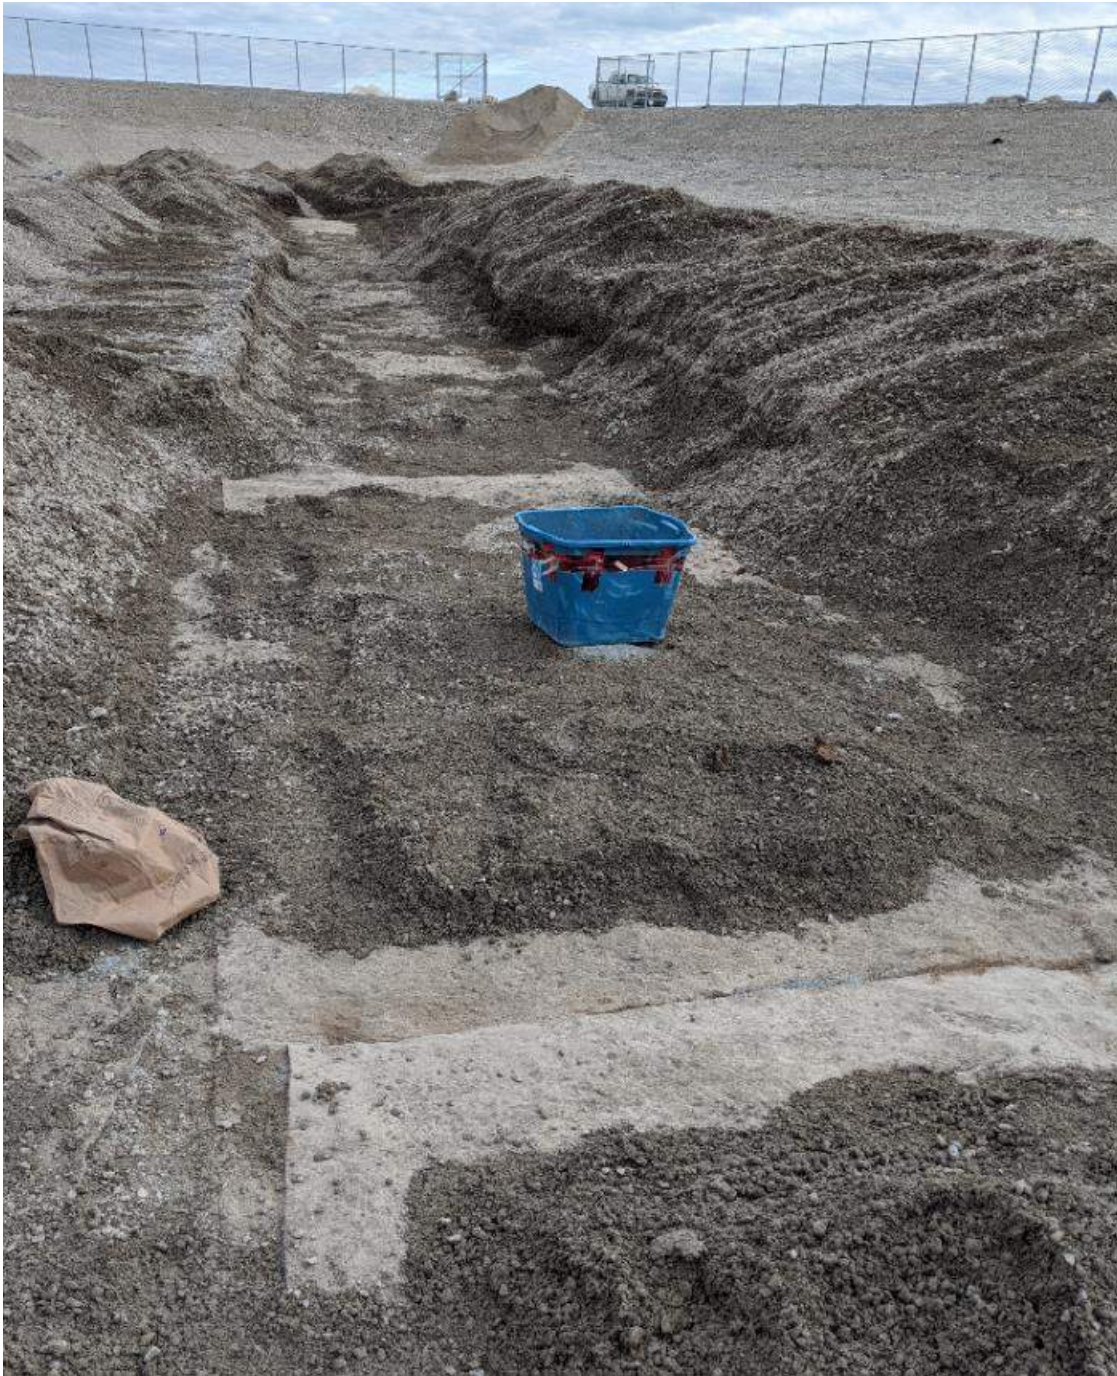
Photograph #3: The seams around each patch were exposed and resealed.

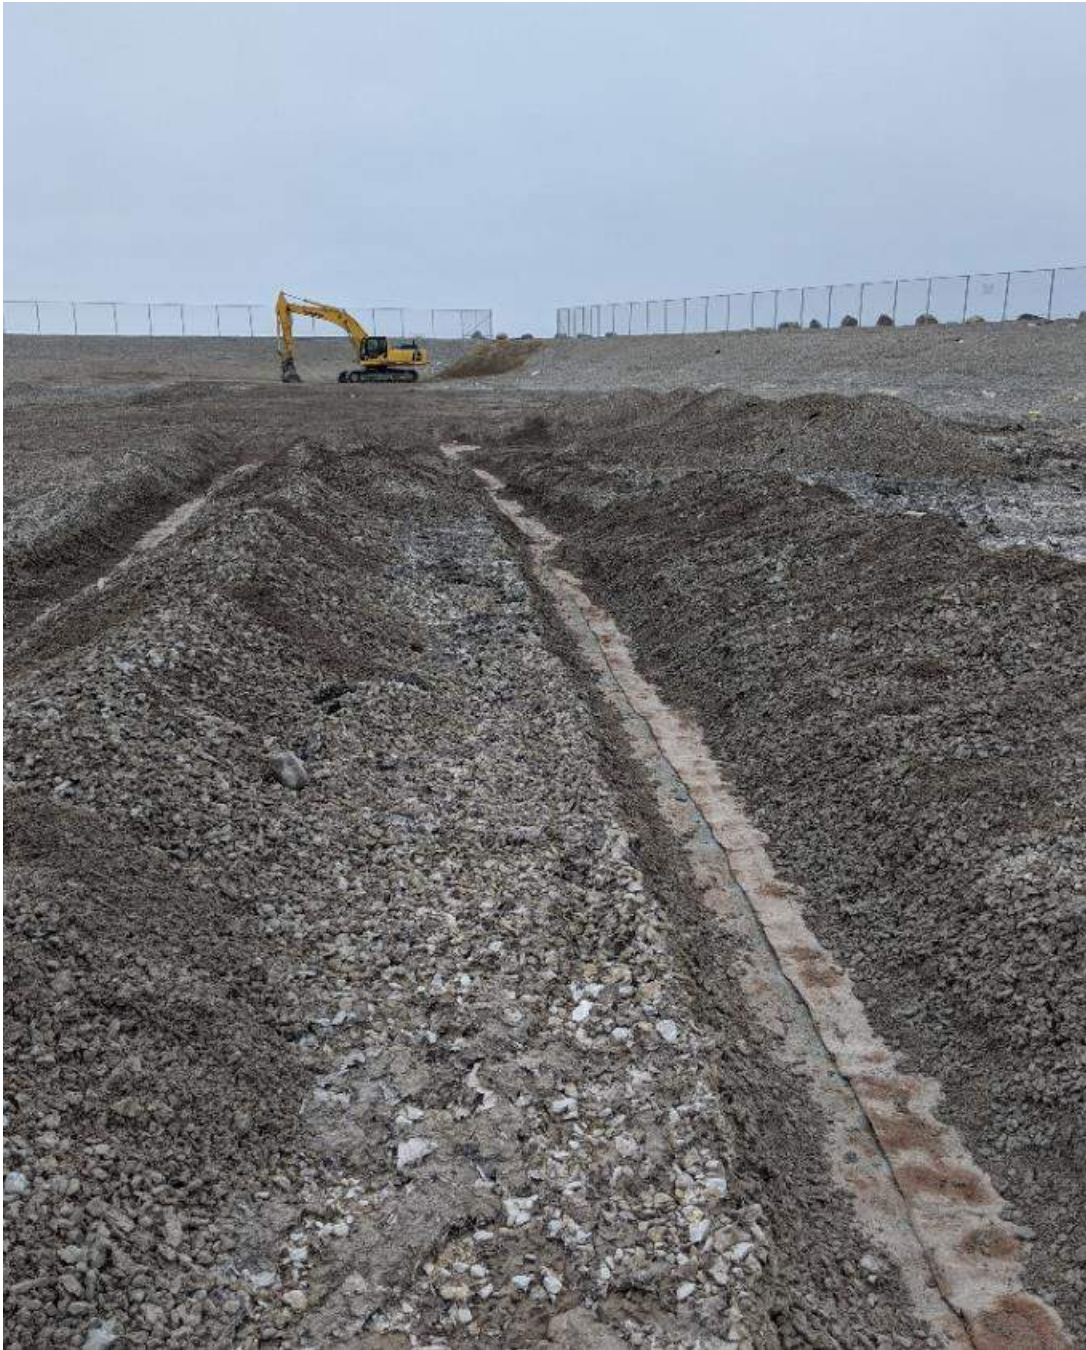
Photograph #1: Final east-west joints, partially exposed.
