**Geotechnical Investigation
Sewage Lagoon
Hamlet of Kimmirut, Nunavut**

Prepared for:
Bhabesh Roy
CGS Projects – GN
P.O. Box 379
Pond Inlet, Nunavut
X0A 0S0

Trow Associates Inc.

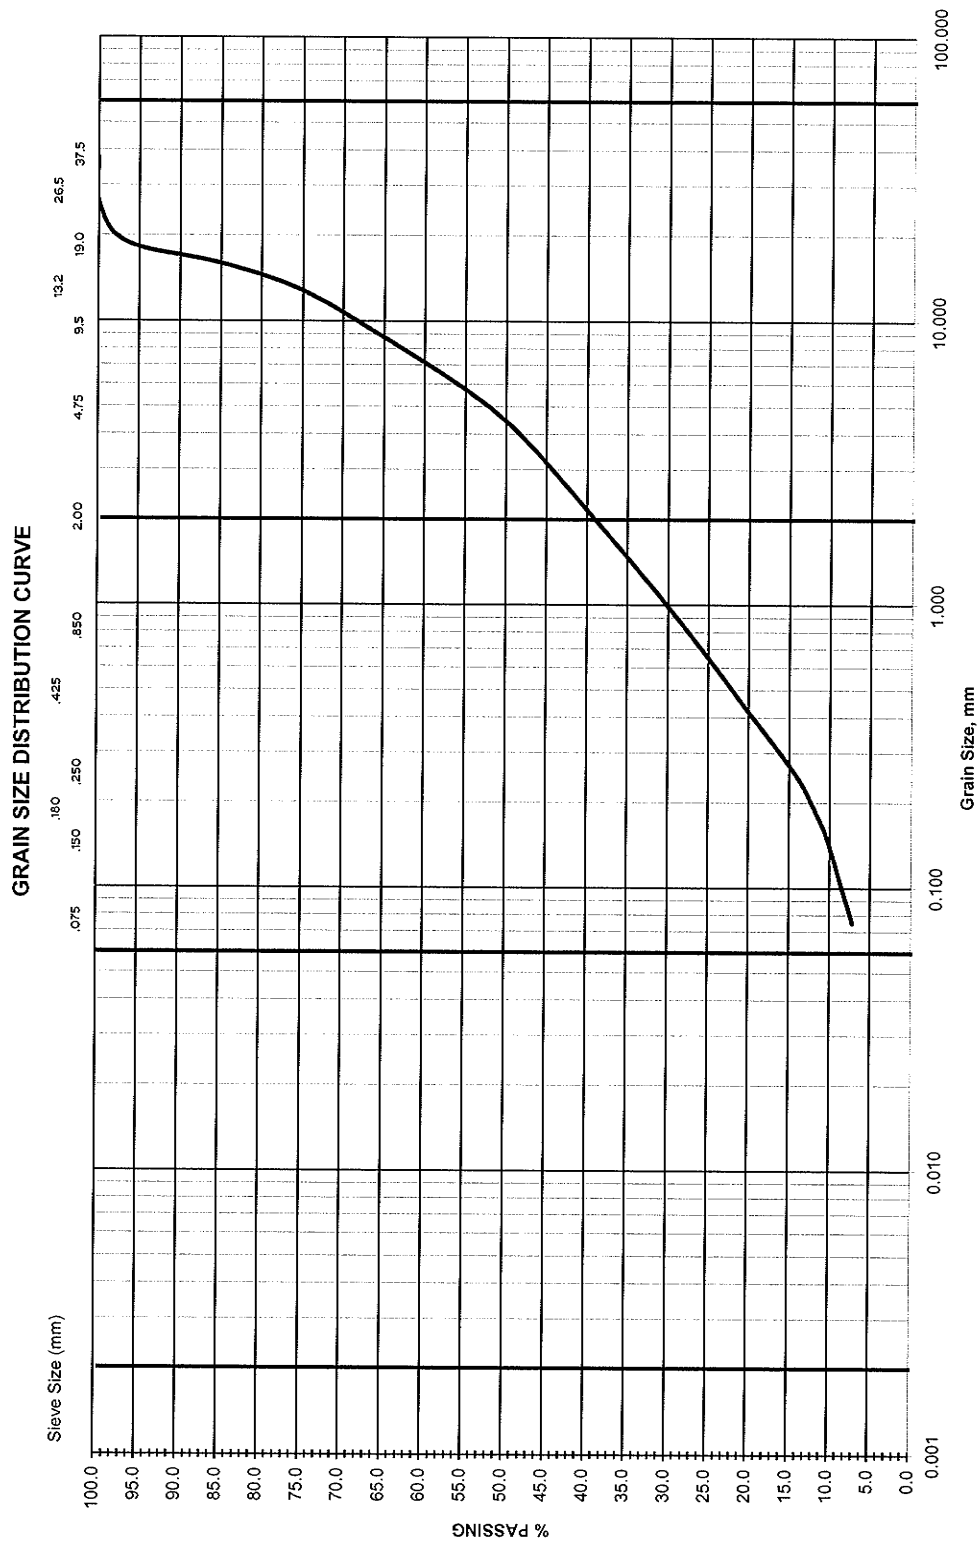
FIGURE: 20

PROJECT :	OTGE00018881B	NAME & LOCATION:			Sewage Lagoon and Landfill Facility - Hamlet of Kimmirut, Nunavut		
DATE SAMPLED:	15-Jul-07	BOREHOLE No.:	2	SAMPLE No.:	SS2	DEPTH (m):	1.3 to 1.9
SAMPLE DESCRIPTION:							
Sandy Gravel, Trace Clay

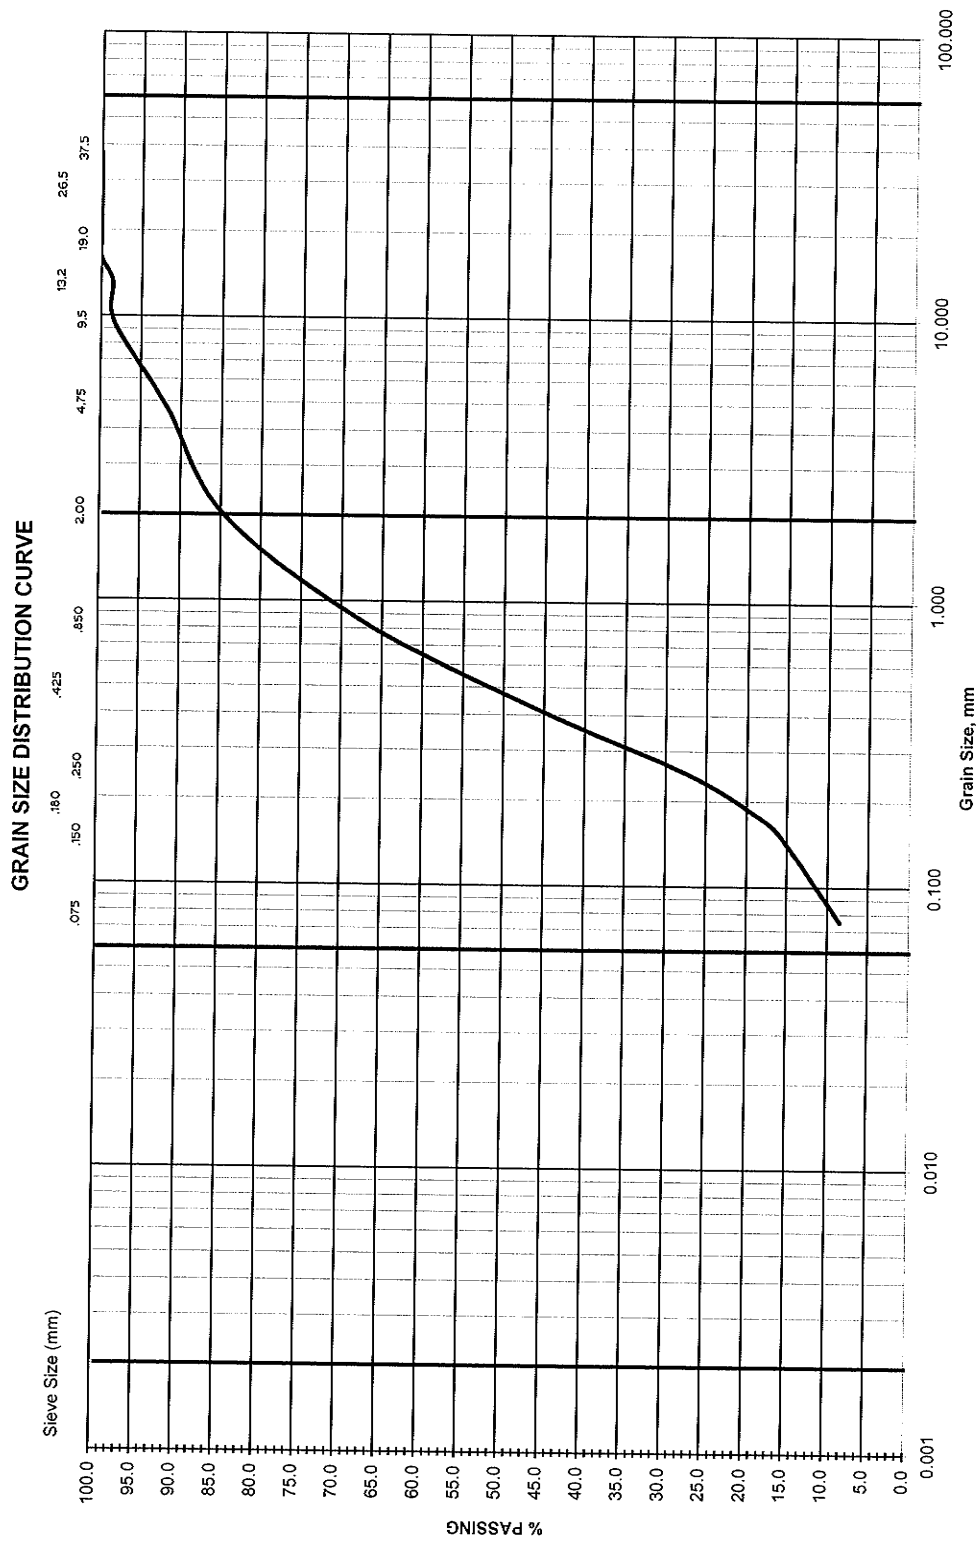
FIGURE: 22

PROJECT :	OTGE00018881A	NAME & LOCATION:		Sewage Lagoon and Landfill Facility - Hamlet of Kimmirut, Nunavut	
DATE SAMPLED:	12-Jul-07	BOREHOLE No.:	5A	SAMPLE No.:	SS1A
SAMPLE DESCRIPTION:		DEPTH (m):			
		0 to 0.6			
Sand, Some Gravel, Trace Silt

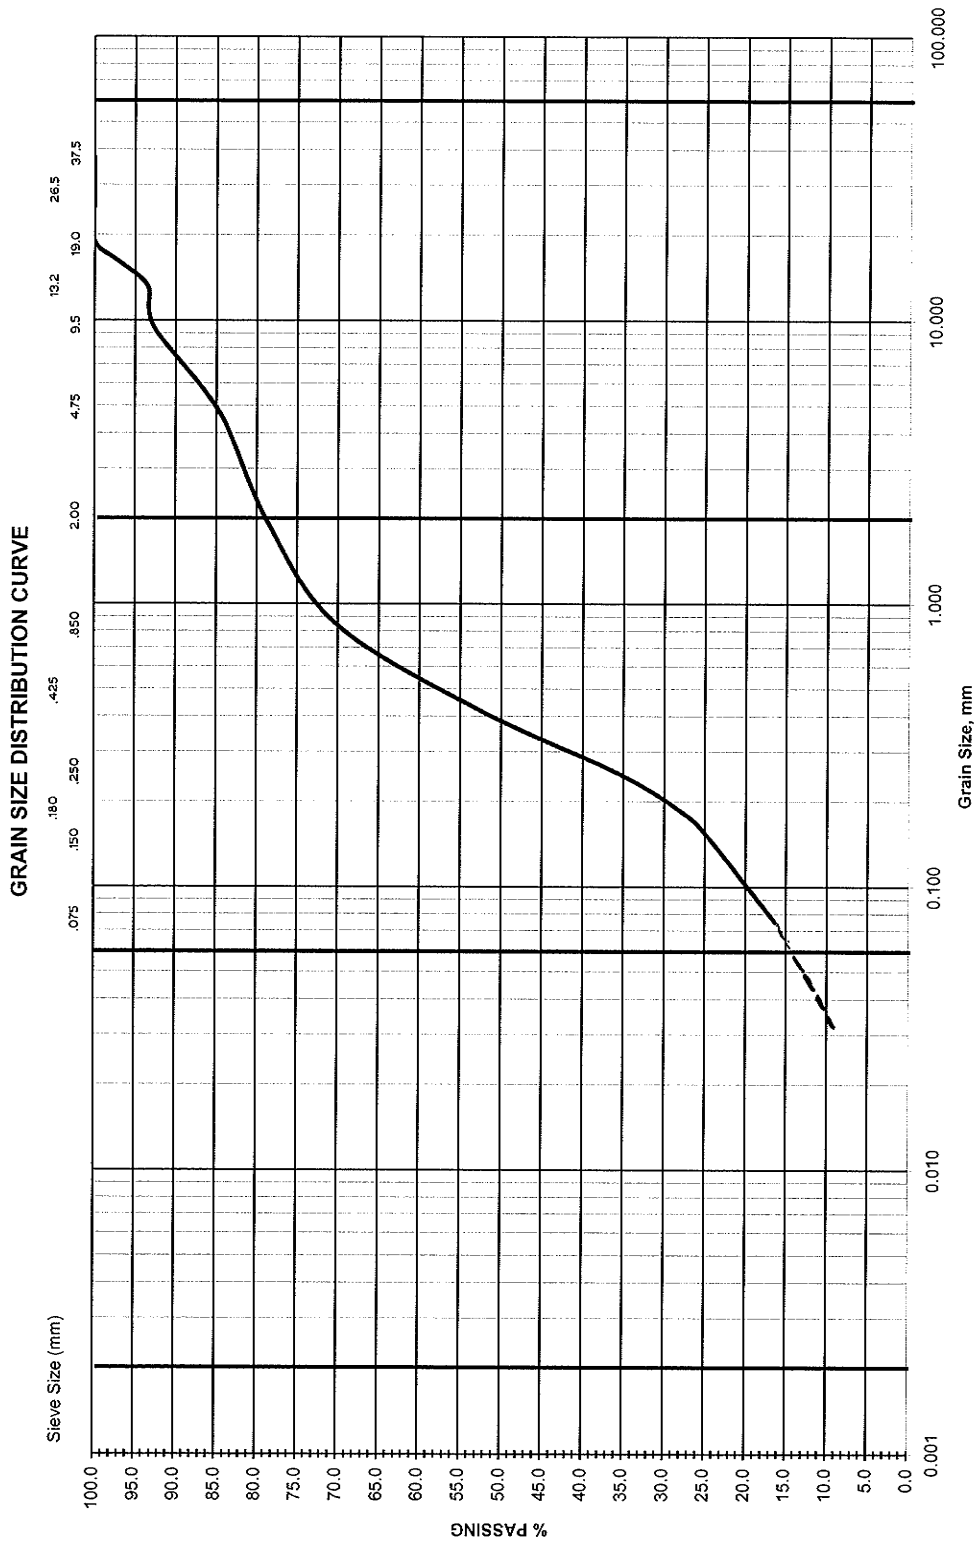
FIGURE: 24

Borehole 9, 10 and 11 were drilled at the site of the proposed landfill in order to obtain an appreciation of the geotechnical conditions in this area. These borehole (Figures 15 to 17) revealed that beneath 0 to 175 mm of topsoil, silty sand extends to the entire depth investigated in Boreholes 9 and 11 i.e. 1.2 m depth (Elevation 99.9 m to 100.2 m) and to 1.8 m depth in Borehole 10 (Elevation 99.3). A typical gradation of this stratum is shown on Figure 24. The soil comprises of 25 percent clay and silt, 67 percent sand and 8 percent gravel.

PROJECT :	OTGE00018881A	NAME & LOCATION:		Sewage Lagoon and Landfill Facility - Hamlet of Kimmirut, Nunavut					
DATE SAMPLED:	13-Jul-07	BOREHOLE No.:		6A	SAMPLE No.:		SS2	DEPTH (m):	0.6 to 0.9
SAMPLE DESCRIPTION:		Gravelly Sand, Some Silt

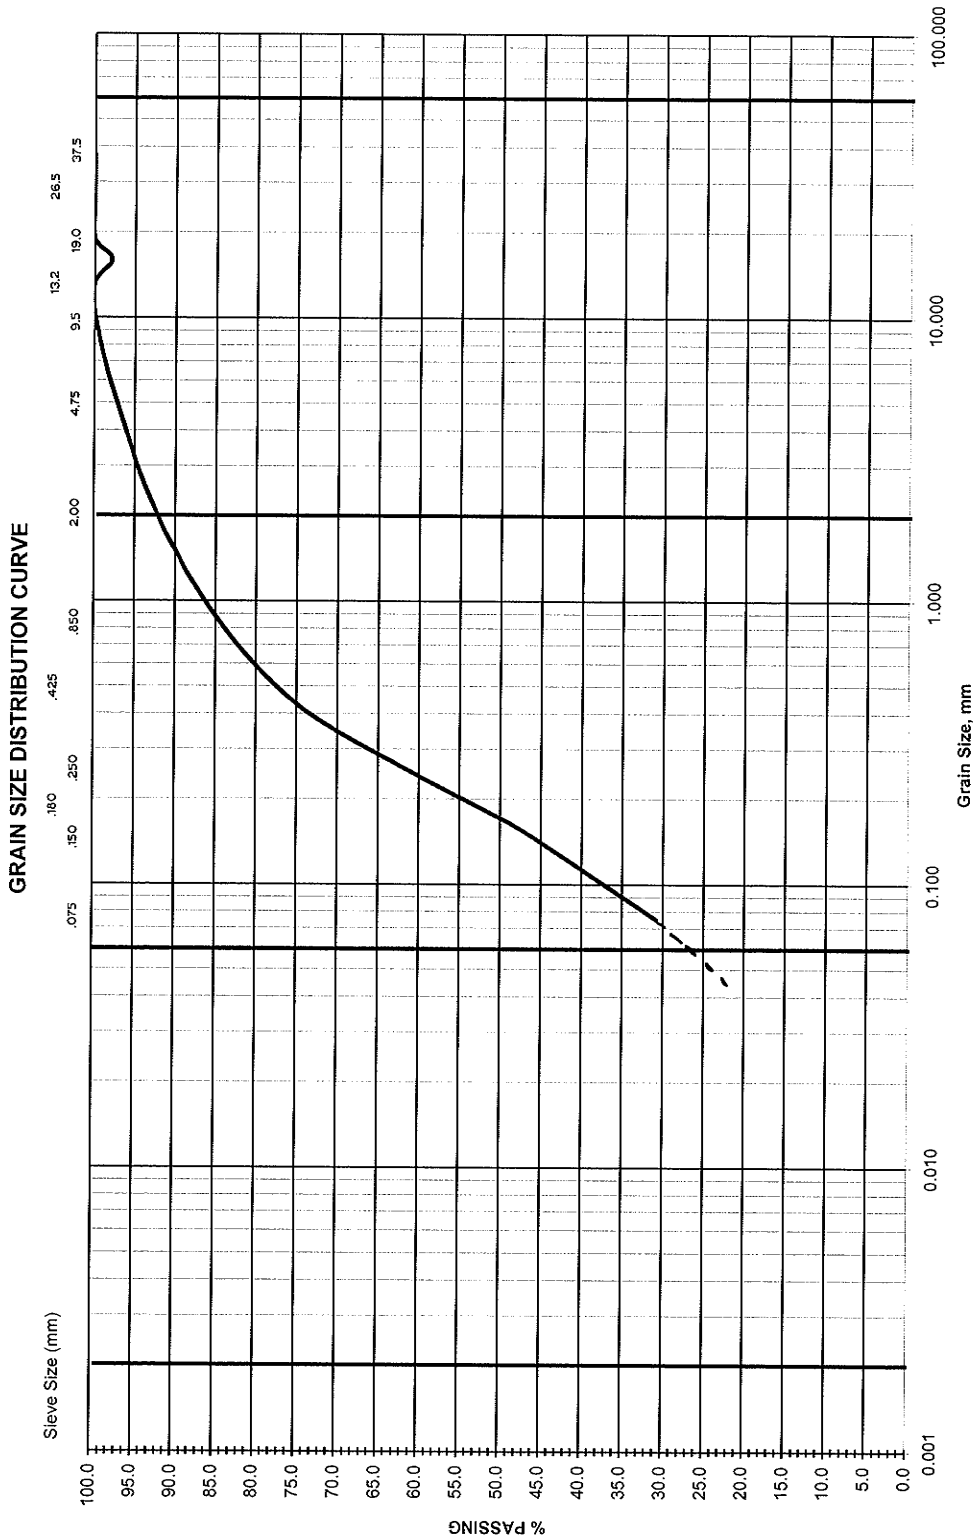
PROJECT : OTGE00018881A		NAME & LOCATION:		Sewage Lagoon and Landfill Facility - Hamlet of Kimmirut, Nunavut									
DATE SAMPLED:		15-Jul-07	BOREHOLE No.:		10	SAMPLE No.:		SS2	DEPTH (m):		0.6 to 1.2		
SAMPLE DESCRIPTION:												Silty Sand, Trace Gravel

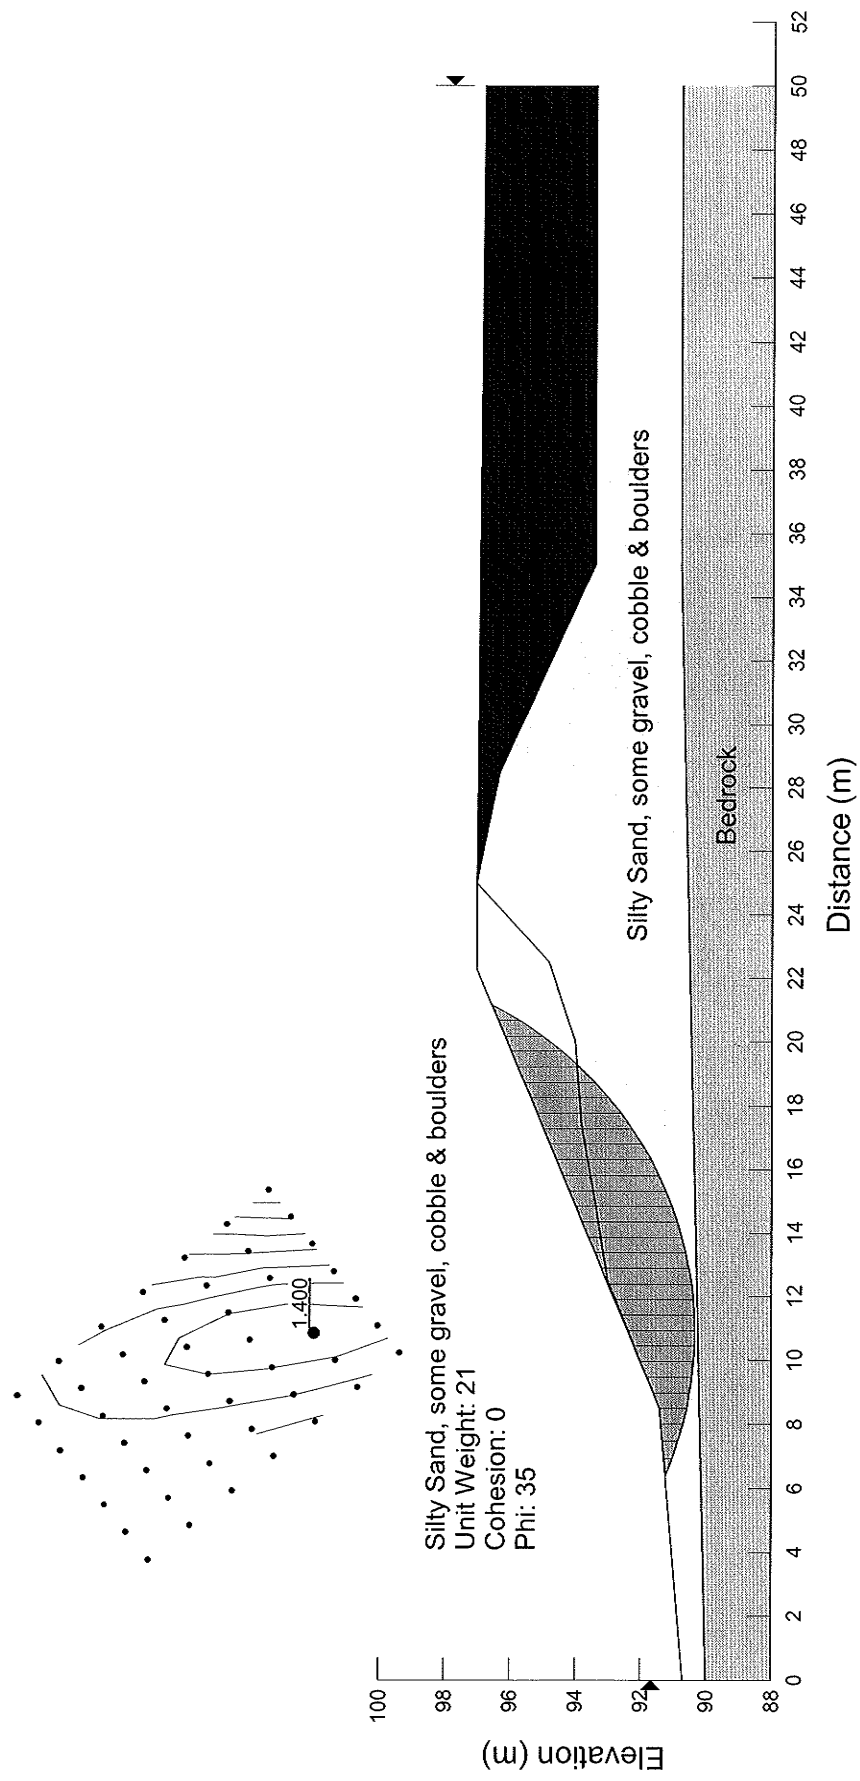
Figure 29

Existing Outer Slope Stability Assessment
Geotechnical Investigation-Kimmirut Sewage Lagoon
Steady State Seepage Condition
Seismic = 0.1
