Kugluktuk Water Treatment Plant

Raw Water Pipeline Assessment

Government of Nunavut, CGS

March 3, 2020

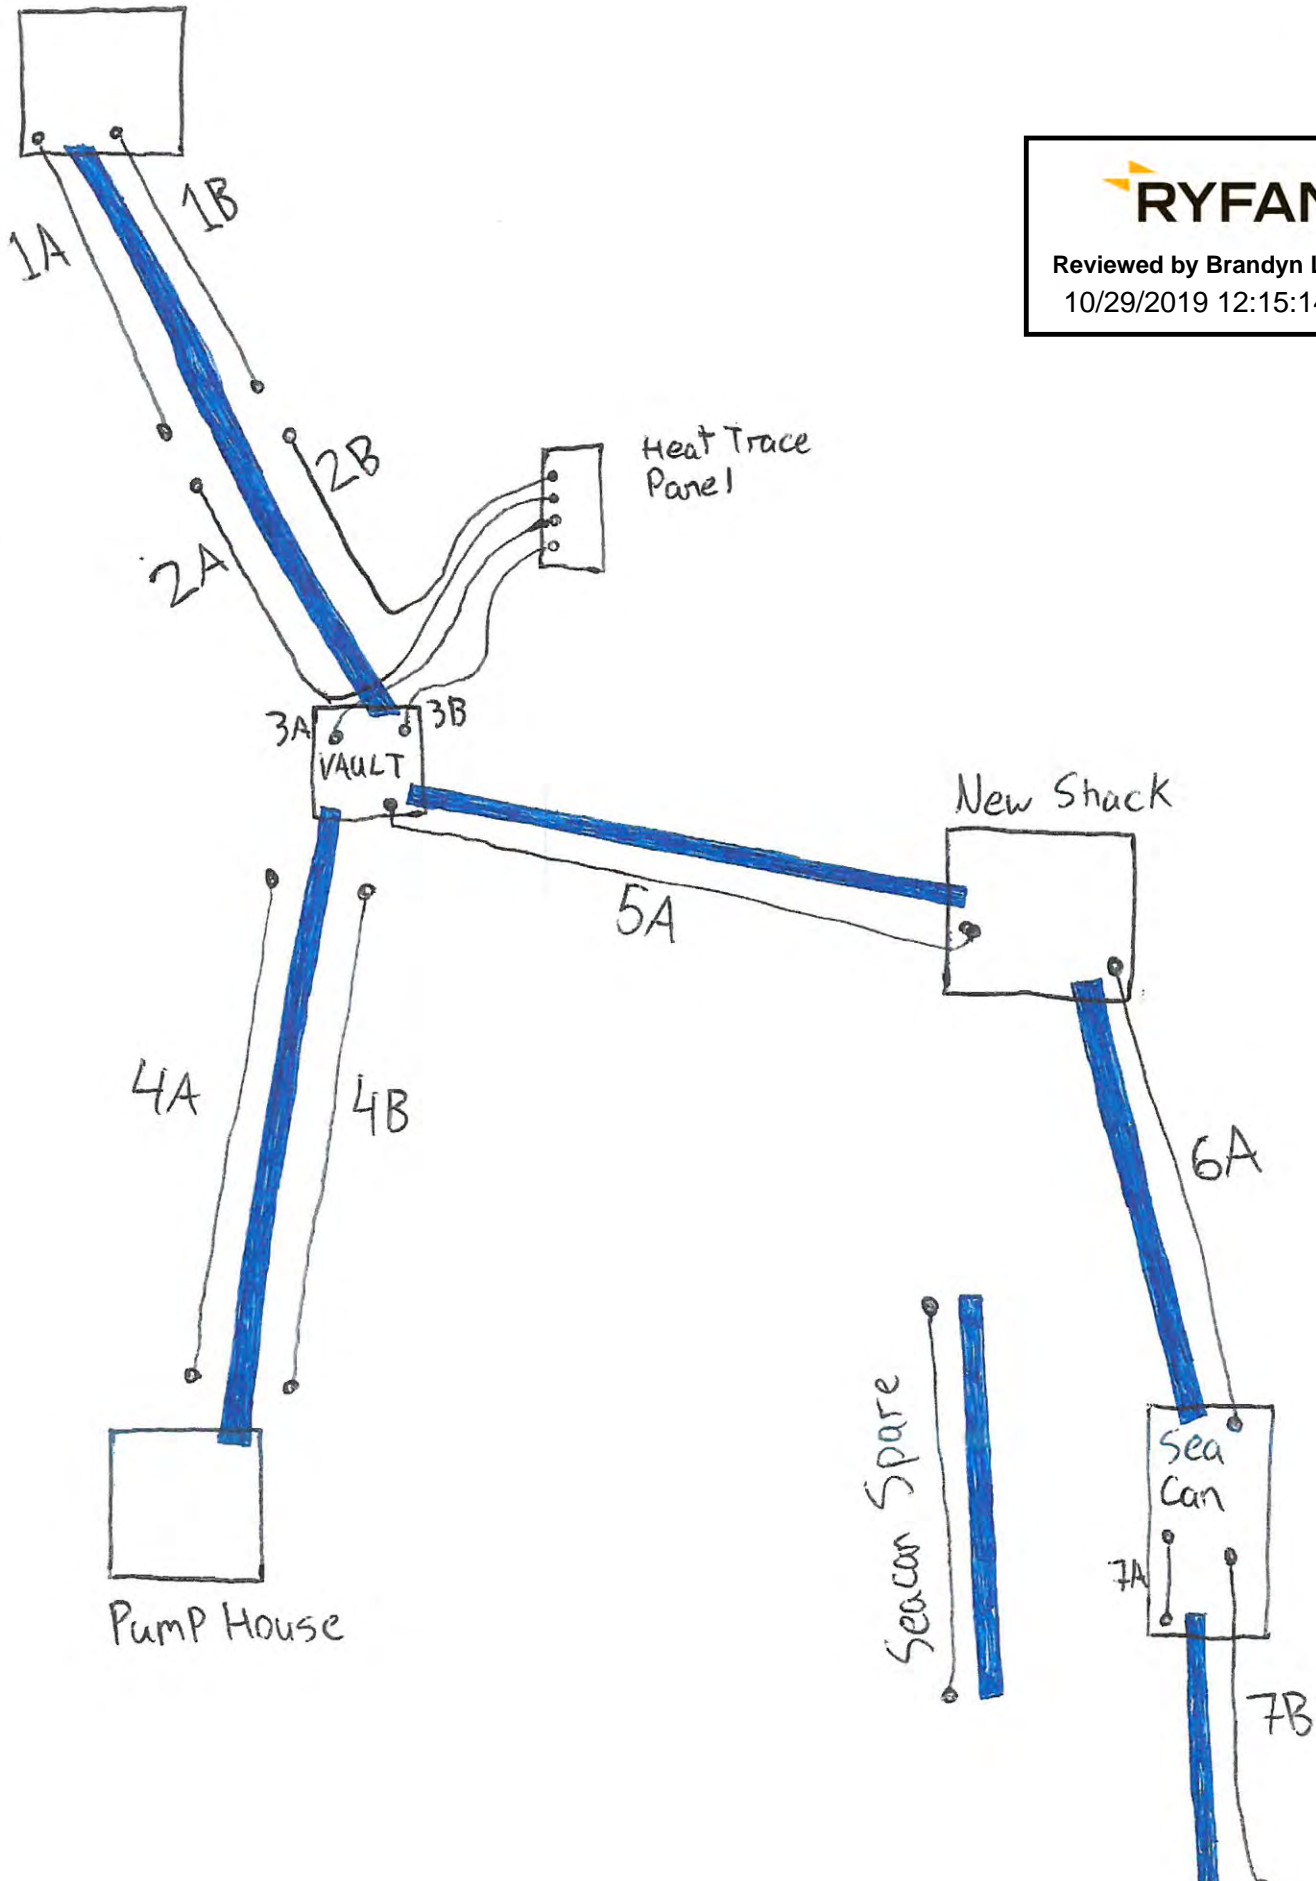
### Heat Trace Review - Kugluktuk WTP

Heat Trace Run #	Recommend Replace Y/N	Length (ft)	Replace Controller Y/N	Comments
1A	Y	345	N	
1B	Y	345	Y	
2A	Y	295	N	
2B	Y	295	N	
3A	Y	15	N	
3B	Y	15	N	Unknown Fault - may be at splice
4A	Y	175	N	Cable is water logged, and cut due to fire
4B	Y	175	N	Cable is water logged, and cut due to fire
5A	Y (Inconclusive)	130	Y	Controller filled with water, circuit was damaged
6A	N	410	N	
7A	N	8	N	
7B	N	30+	N	
7A (Spare)	Y (Inconclusive)	325	N	Doesn't seem to be installed correctly on its own circuit, inconclusive readings
	<b>Total Required Length (FT):</b>	<b>2327</b>	<b>Total Required Controllers:</b>	<b>2</b>

Recommend replacing cable
