Government of Nunavut

Design Brief

Project Name:
New Pump House Upgrades

Date Submitted:
January 2013

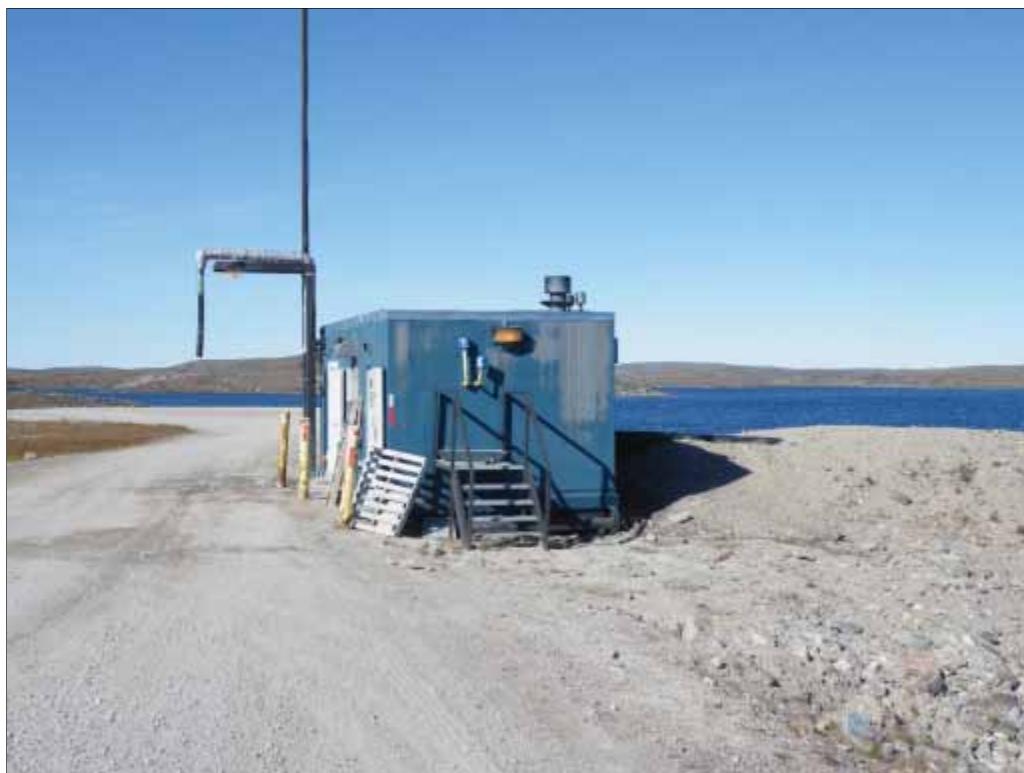
Photo 1: Site

General features of the site and access road are depicted in photograph no. 1, presented in Appendix B.
