Sewage and Solid Waste Sites, Kugaaruk, NU

Pre-Design, Phase 2

Dillon Consulting Limited

**Pre-Design Report - Phase 2, Kugaaruk Sewage and Solid Waste
Facilities Design**

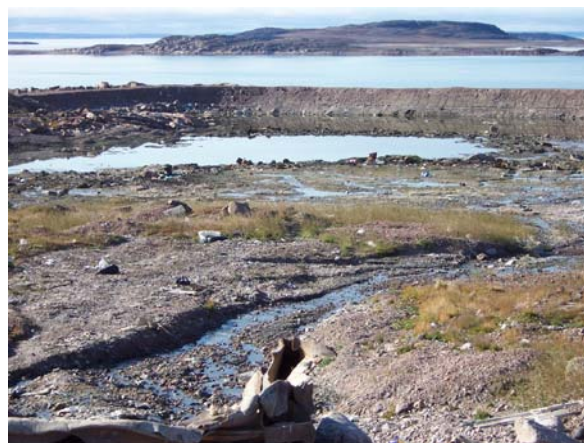
Figure 1

The CGS Project Officer and the Regional Engineer were in the midst of discussing the three options with Dillon staff when word came that the old lagoon had breached catastrophically, spilling 80 to 90 percent of its contents (see fig. 1). This necessitated a radical and immediate change of plans. The Regional Engineer asked Dillon to come up with a “quick fix” to the problem. This became the “Base Option” for the contract tender, with the stipulation that work be completed immediately. There were no guarantees that this “quick fix” option would work: this was understood at the outset. In addition, we were already approaching a change in season, and all involved were, though hopeful, somewhat realistic about the effectiveness of Option Four. However, the Regional Engineer felt that this was the only viable way to enable the community to survive for another season, and preserve as much of the project budget as possible, so that a proper long-term solution would be feasible. Both the request for the “quick fix” design and the decision to go ahead with the work were solely the responsibility of the Regional Engineer. That the repaired lagoon is leaking at this time is disappointing, but no surprise. There is still some reasonable hope that the bentonite will, with time, do its job and stop (or at least slow significantly) the flow. Below is the chronology of this project so far, followed by the Scope of Work for the construction tender issued on September 9, 2005.

The Sewage Lagoon in Kugaaruk has been failing repeatedly for many years. This failure is due to a combination of several reasons, some of which are: 1). The porosity of the imported fill for the berms is too high, 2), the slope of the berm sides may be too steep to provide sufficient retaining strength, 3). Fissures within the granite outcrop may contribute to excessive leaking, and 4). The interface between the berm and the granite outcrop may provide a drainage path for effluent.

1. Adding (keying in) granular material mixed with bentonite to increase the internal side slope and the height of the two berms retaining the lagoon. An overflow flume consisting of a nestable culvert complete with proper bedding will also be installed for this option as indicated in the drawing details. This construction option will reduce seepage, decrease the possibility of failure and increase the capacity of the lagoon to satisfy the hamlet's waste production. A pre and post construction survey will also be performed on the lagoon floor and berms.

2. In addition to Option 1, the installation of a liner and cover will be added to construction. It should be noted when accessing this option that the amount of granular/bentonite mix that will be used in option 2 will decrease to allow for the liner and liner cover.
