**Kugaaruk Sewage Lagoon
Dam Safety Review**

(FINAL)

Prepared for:
Government of Nunavut
Community and Government
Services

March 24, 2017

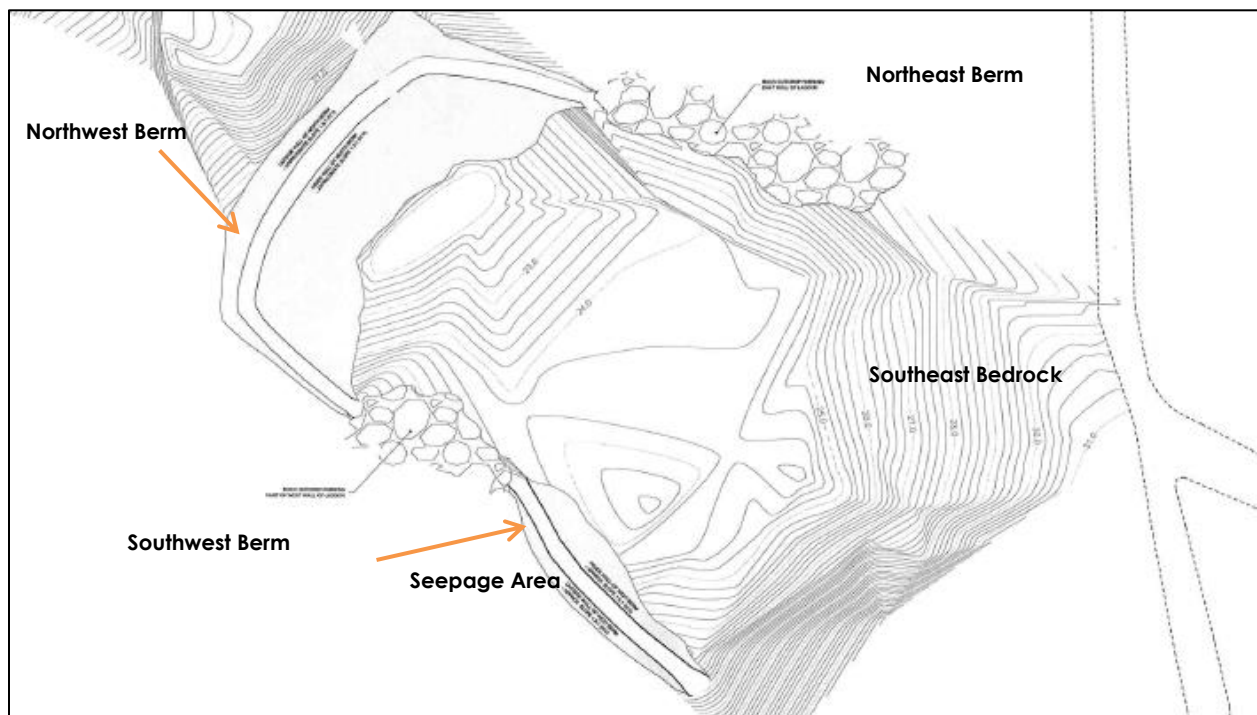
Figure 3-3: Previous Dam (Extract from Construction Drawing No: 100)

The layout of the previous lagoon is documented in Construction Drawing No: 100 (DCL, 2009) and on the GoogleEarth (**Figure 3-3**). The Lagoon utilized the existing topography with a U-shaped berm on the northwest and a separate linear berm on southwest side constructed in between the granodiorite outcrops. The berm side slopes were 1.5H:1V, which are steeper than the side slopes of the current lagoon. The base of the original reservoir footprint sloped from east at El. 27 m to west at El. 22 m. Construction drawing No: 201 (DCL, 2009) indicates that the previous berms are to be 'removed to allow for construction of the new berm with liner'.

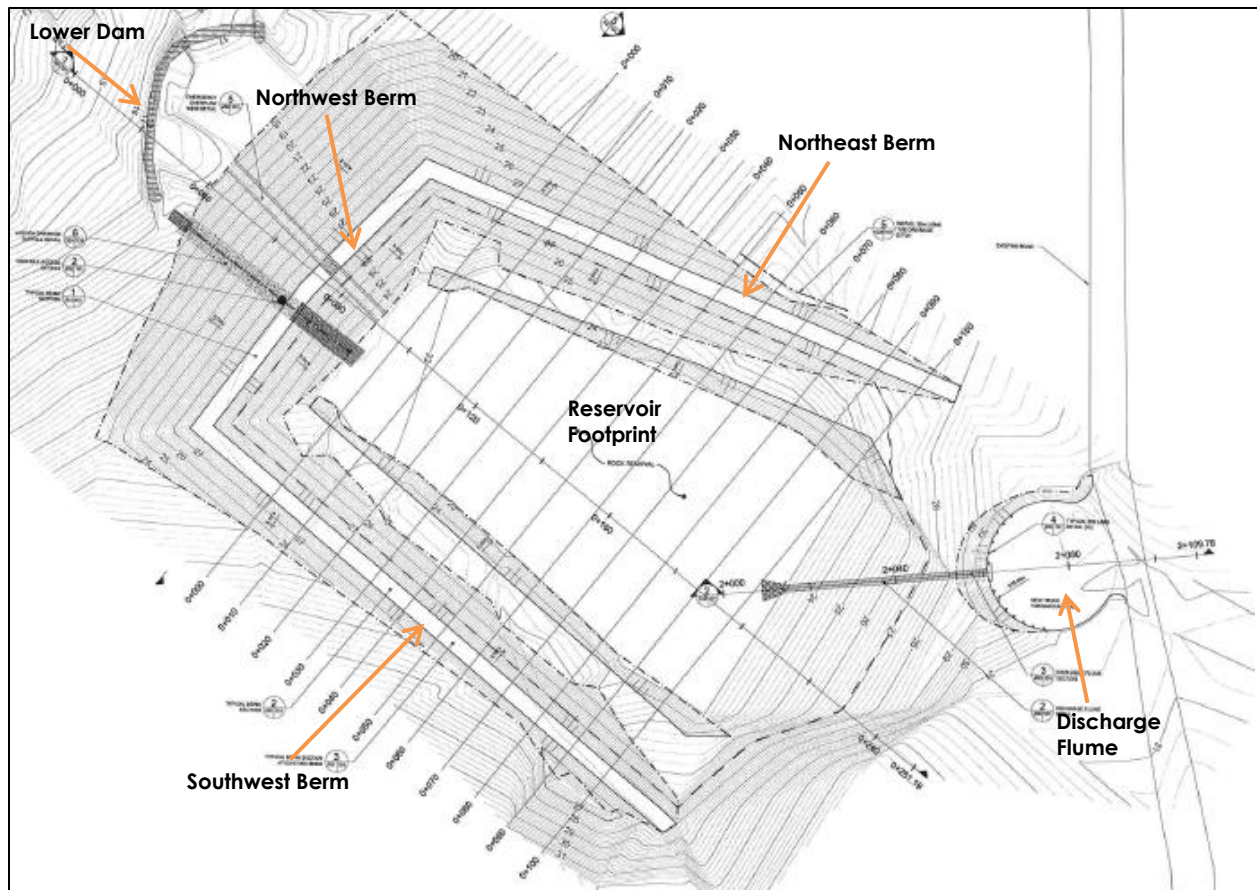
Figure 3-4: Current Dam Layout (Extract from Construction Drawing No: 101)

The layout of the new lagoon is documented in Construction Drawing No: 101 (DCL, 2009) and reproduced in **Figure 3-4**. Sections and construction details are provided in Construction Drawings No: 102, 200, 201 and 202. The upper dam was constructed in a U-shaped earthfill berm arrangement. It is formed by three (3) berms: southwest, northwest and northeast. The effluent reservoir is impounded on the southeast by bedrock.

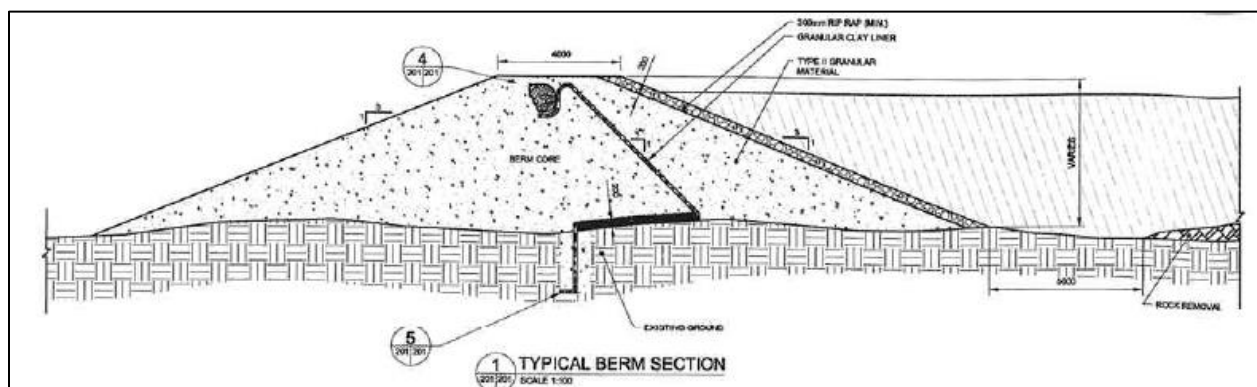
Figure 3-5: Typical Berm Section (Extracted from Construction Drawing No: 201)

AMEC (2005) proposed three approaches for the construction of the lagoon. The selected option comprised placement of sand fill, which was allowed to freeze in place. A typical section is presented in **Figure 3-5**. The berm was designed with 3H:1V side slopes with specified Type II Granular material. The topographic survey completed by Stantec confirmed that the as constructed side slopes are 3H:1V on average.

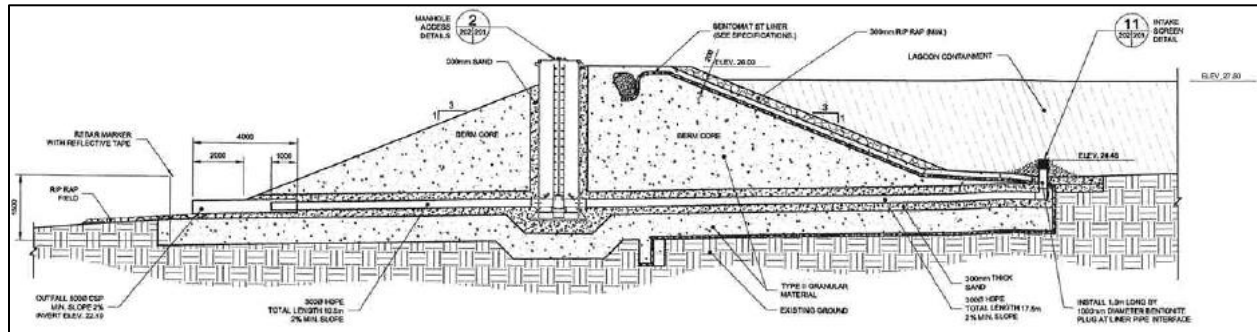
Figure 3-7: Discharge Pipe Section (Extracted from Construction Drawing No: 201)

The discharge pipe comprises a 300 mm diameter HDPE pipe beneath the northwest berm (**Figure 3-7**). It was designed with a 2 % slope between the lagoon at El. 24.5 m and the outfall

pipe at El. 22.2m. The pipe was surrounded by 300 mm layer of sand. The outfall on the downstream side of the berm comprises a 500 mm dia. corrugated steel pipe.

AMEC (2010) noted that the manhole access and discharge pipe were moved 19 m to the southeast from the original 2007 design.
